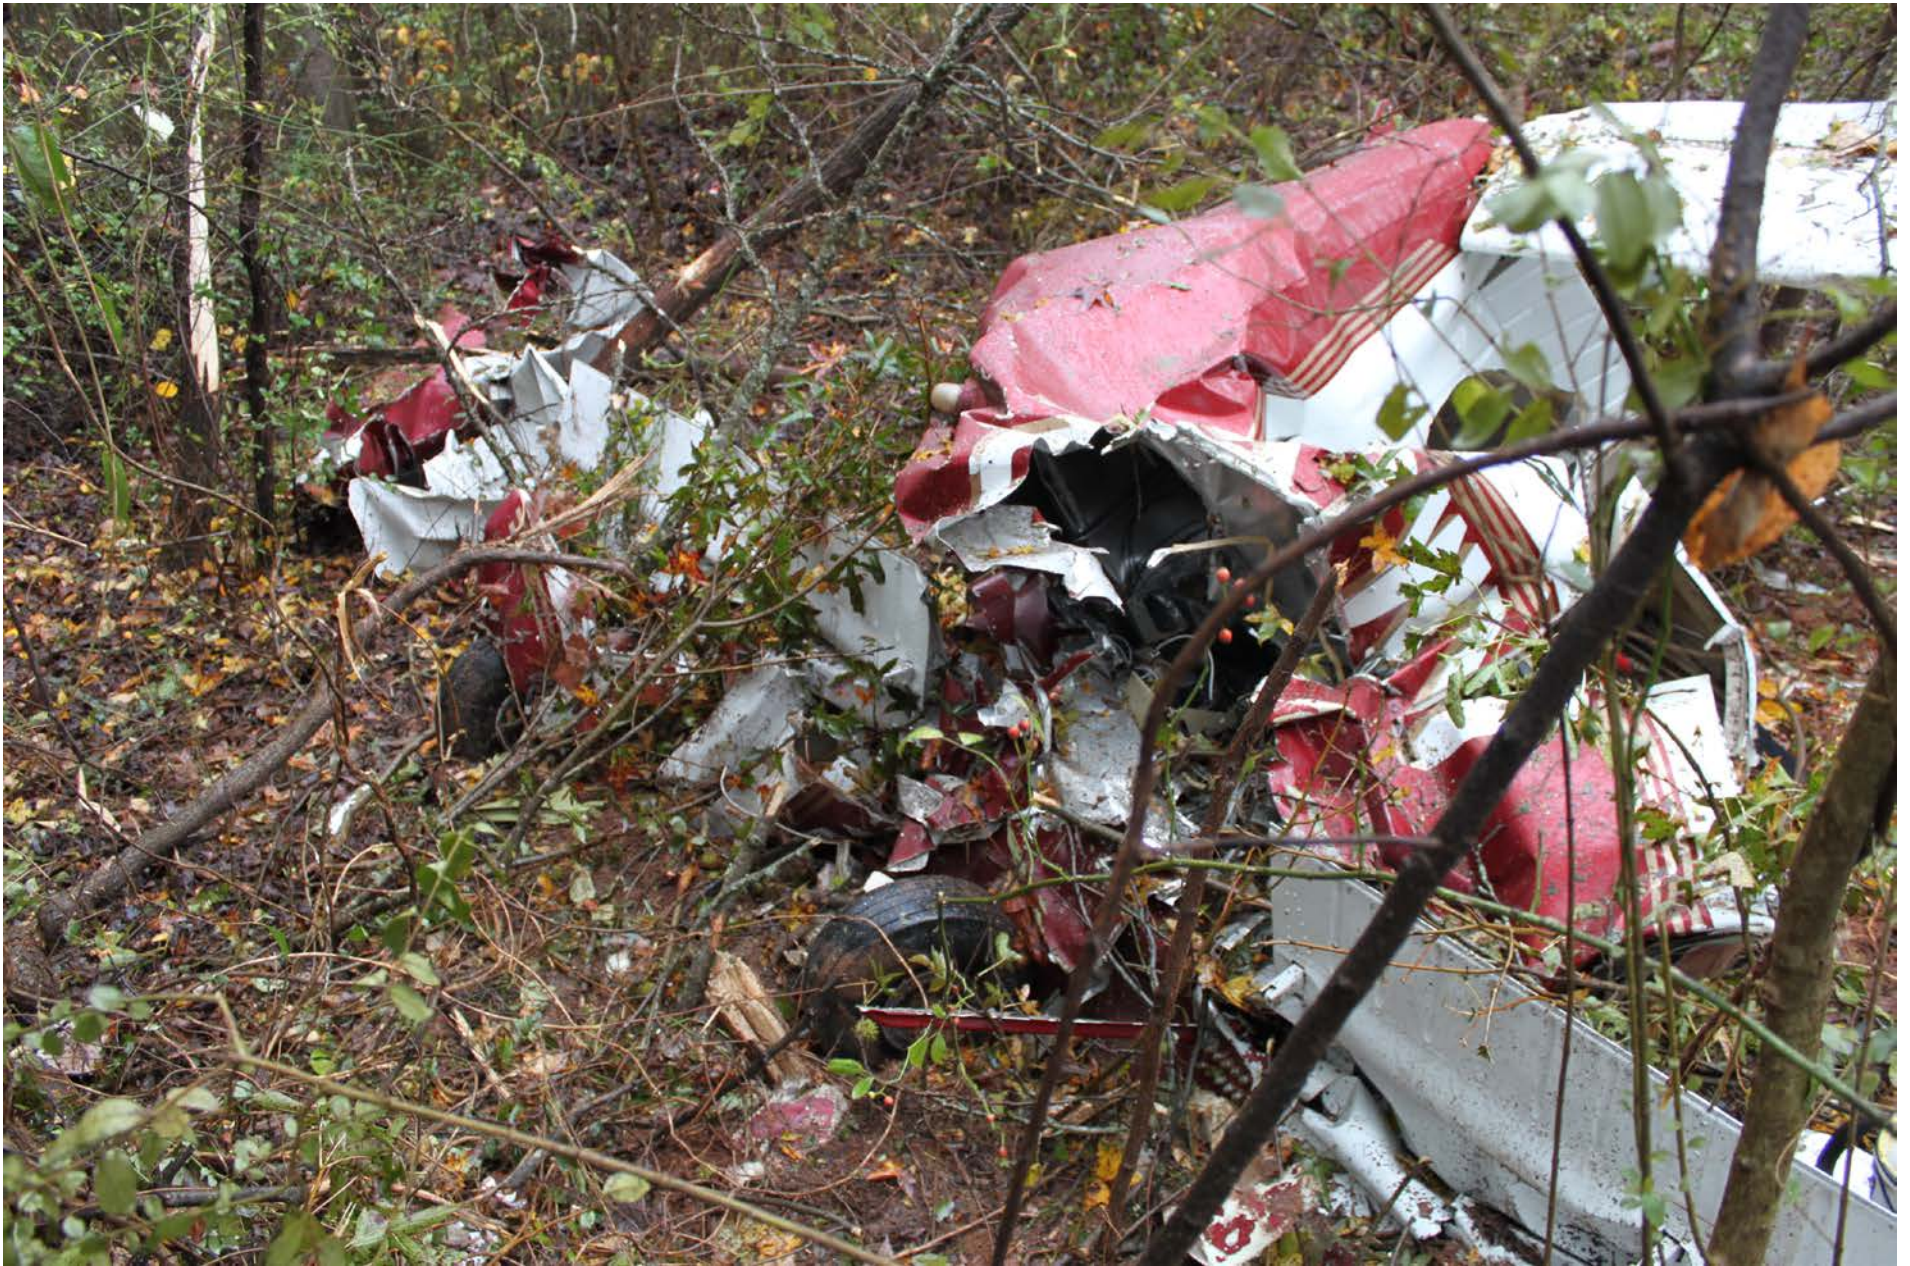
**Photo 1 – View of main wreckage in wooded area**

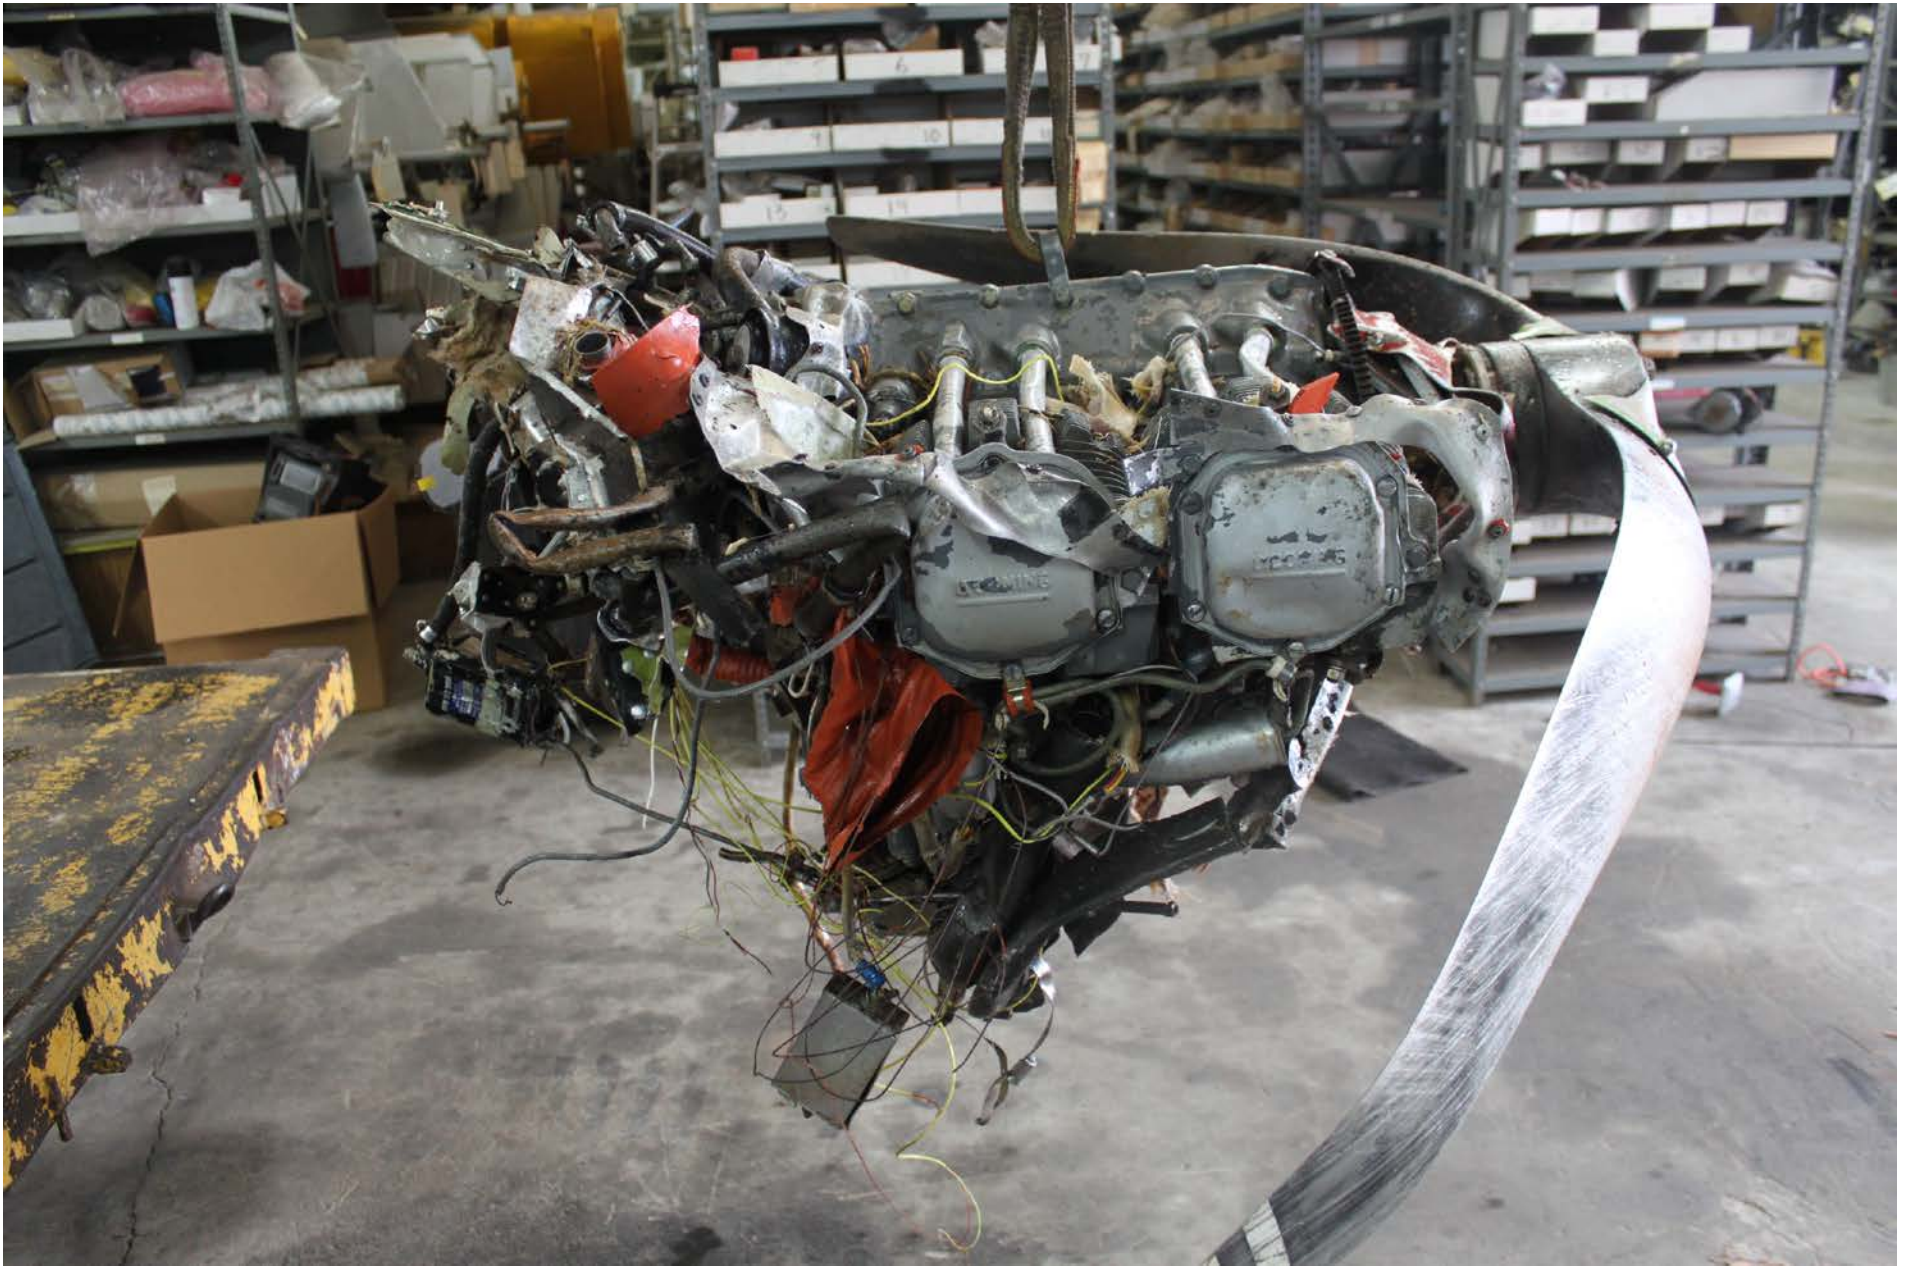
**Photo 2 - View of right side of engine**

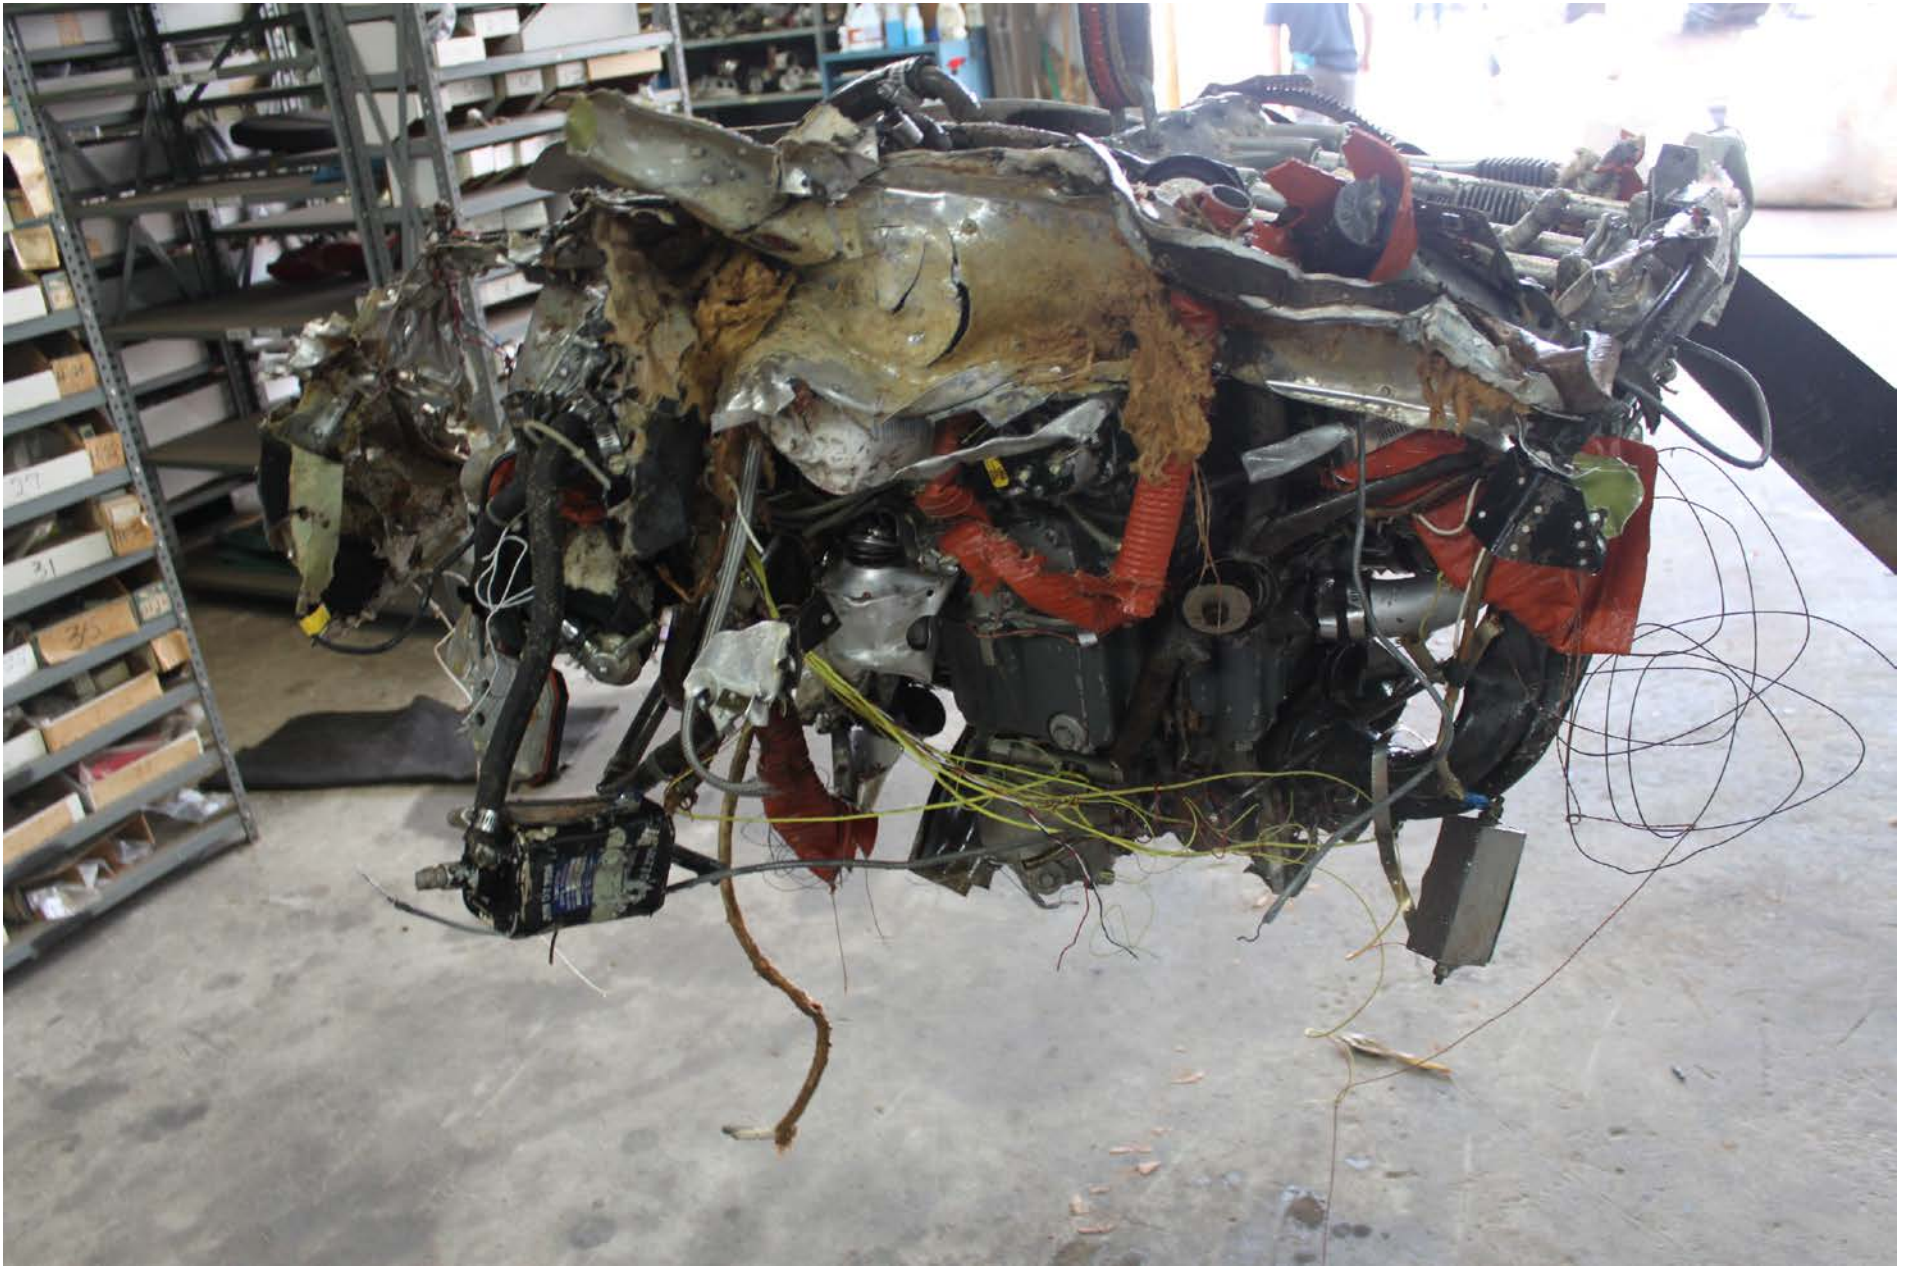
**Photo 3 - View of rear of engine**

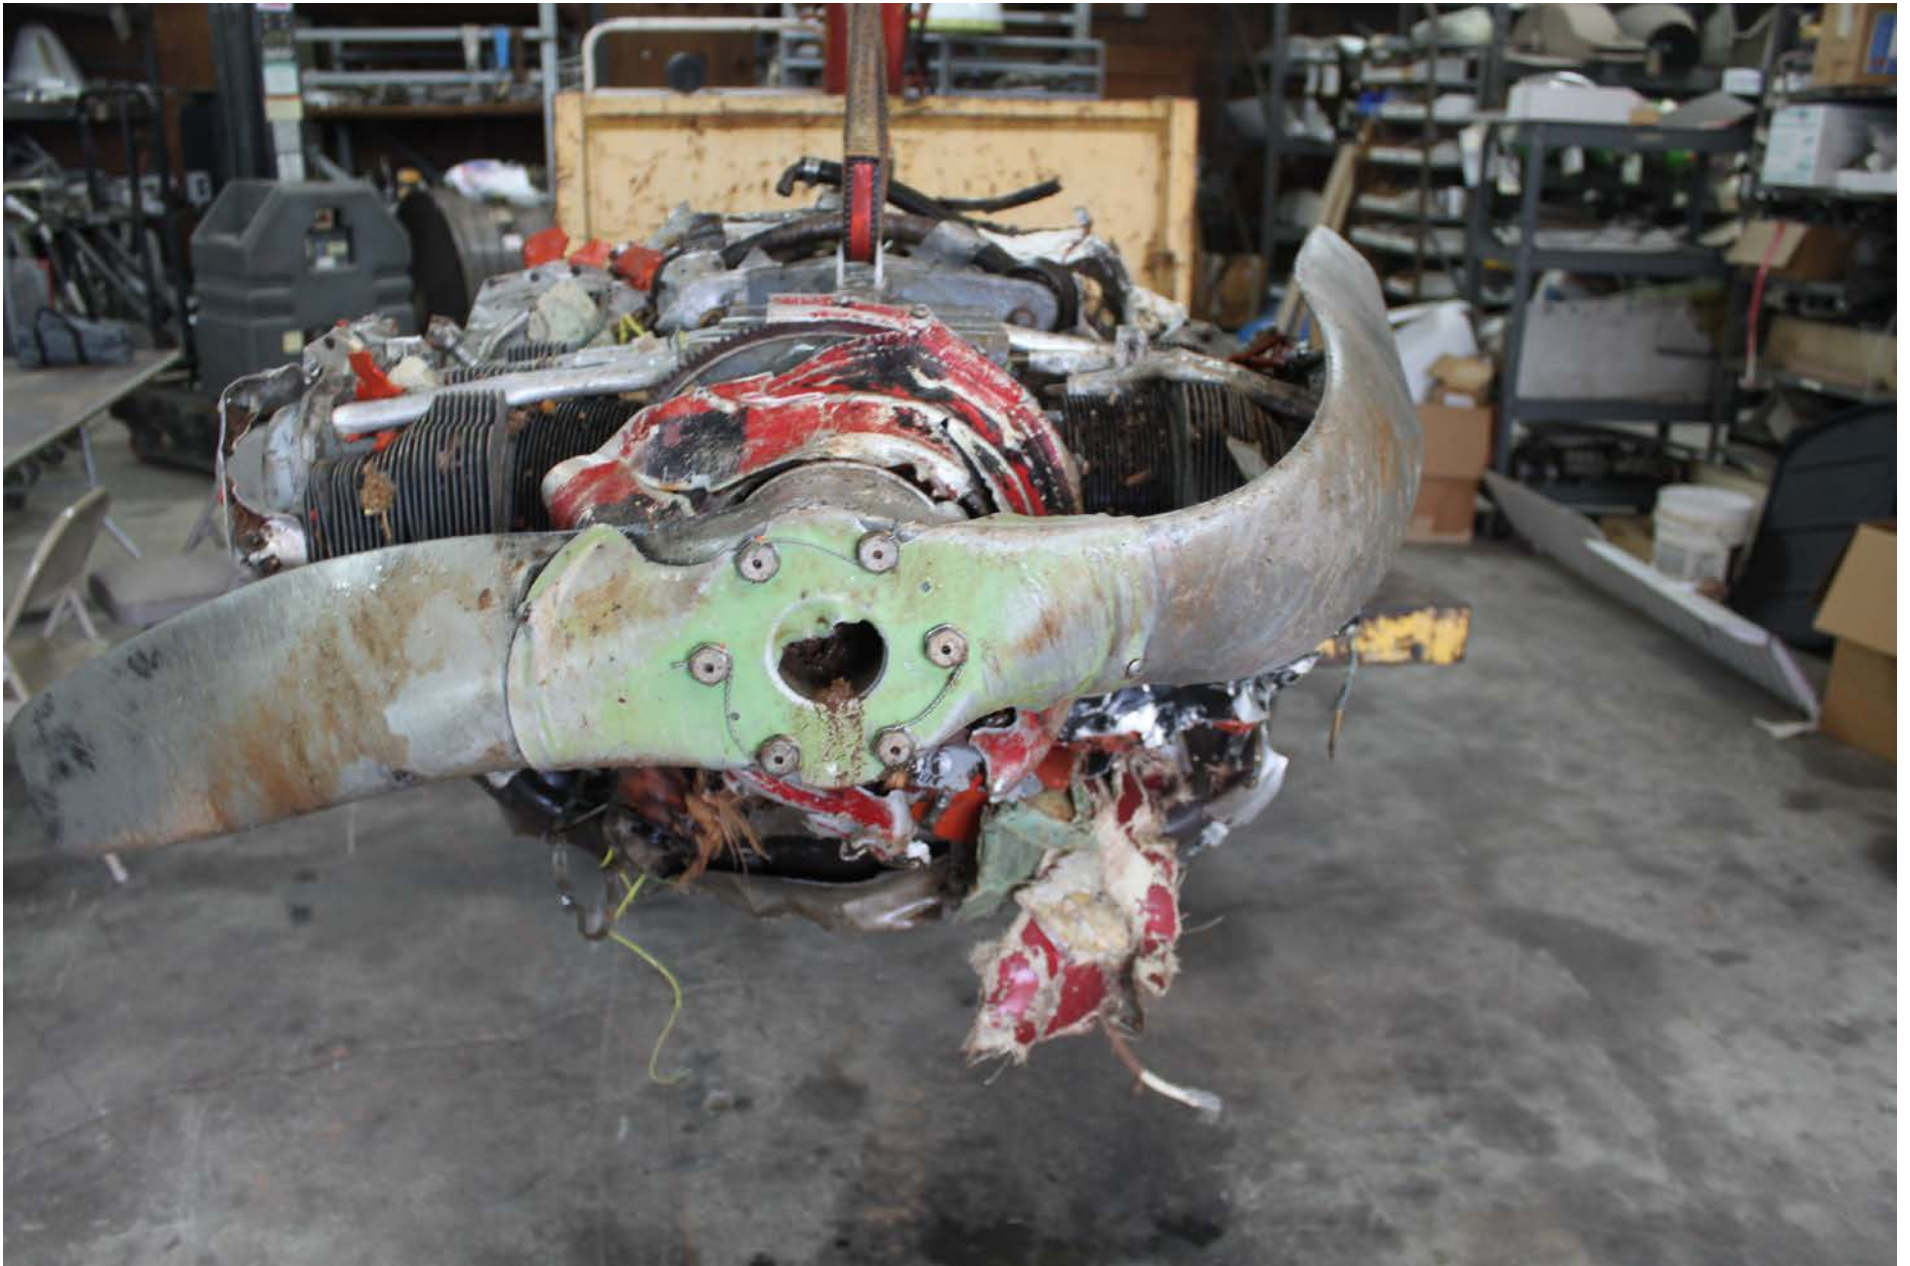
**Photo 4 - View of front of engine and damaged propeller**

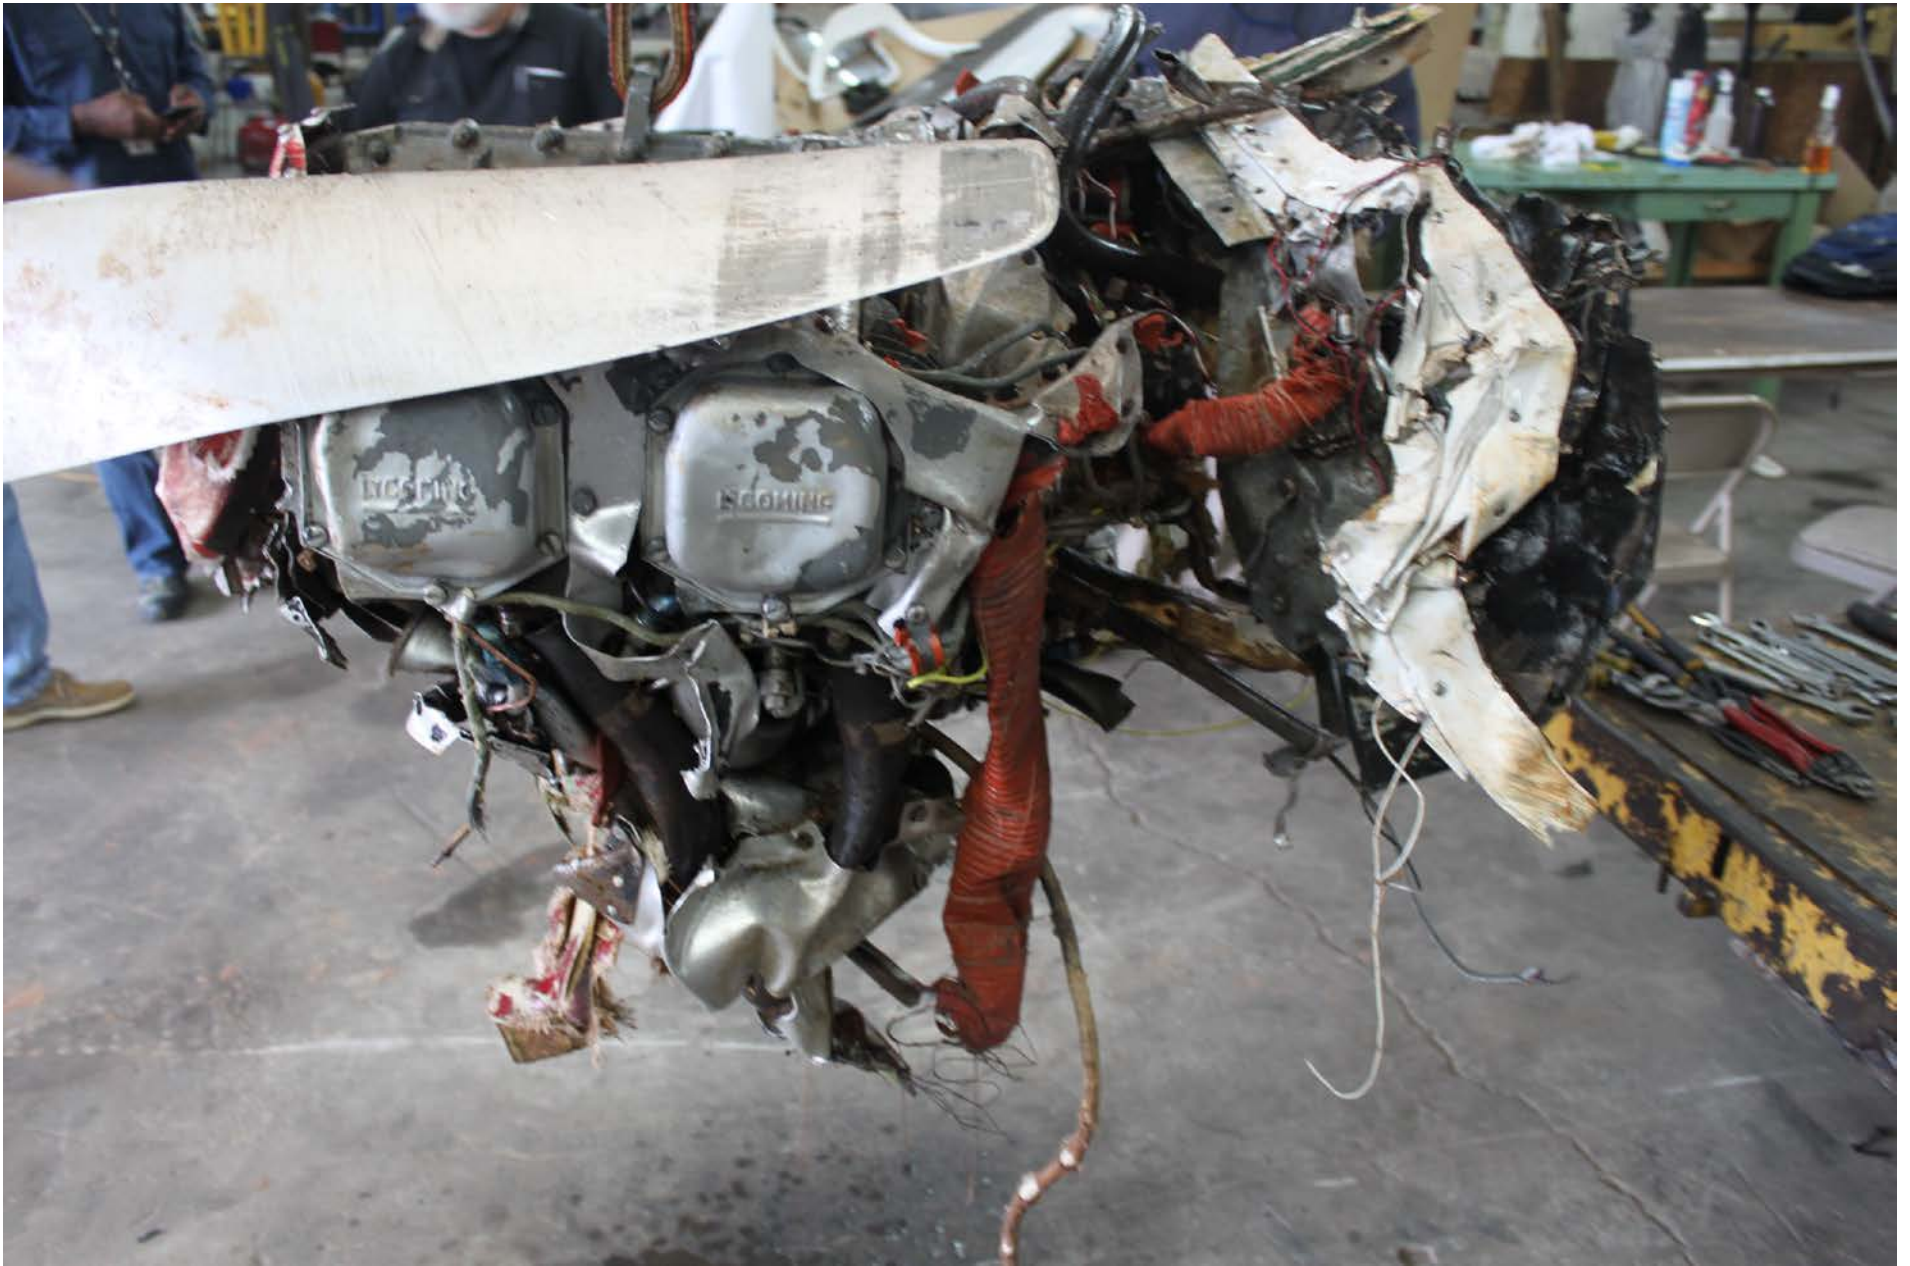
**Photo 5 - View of left side of engine**

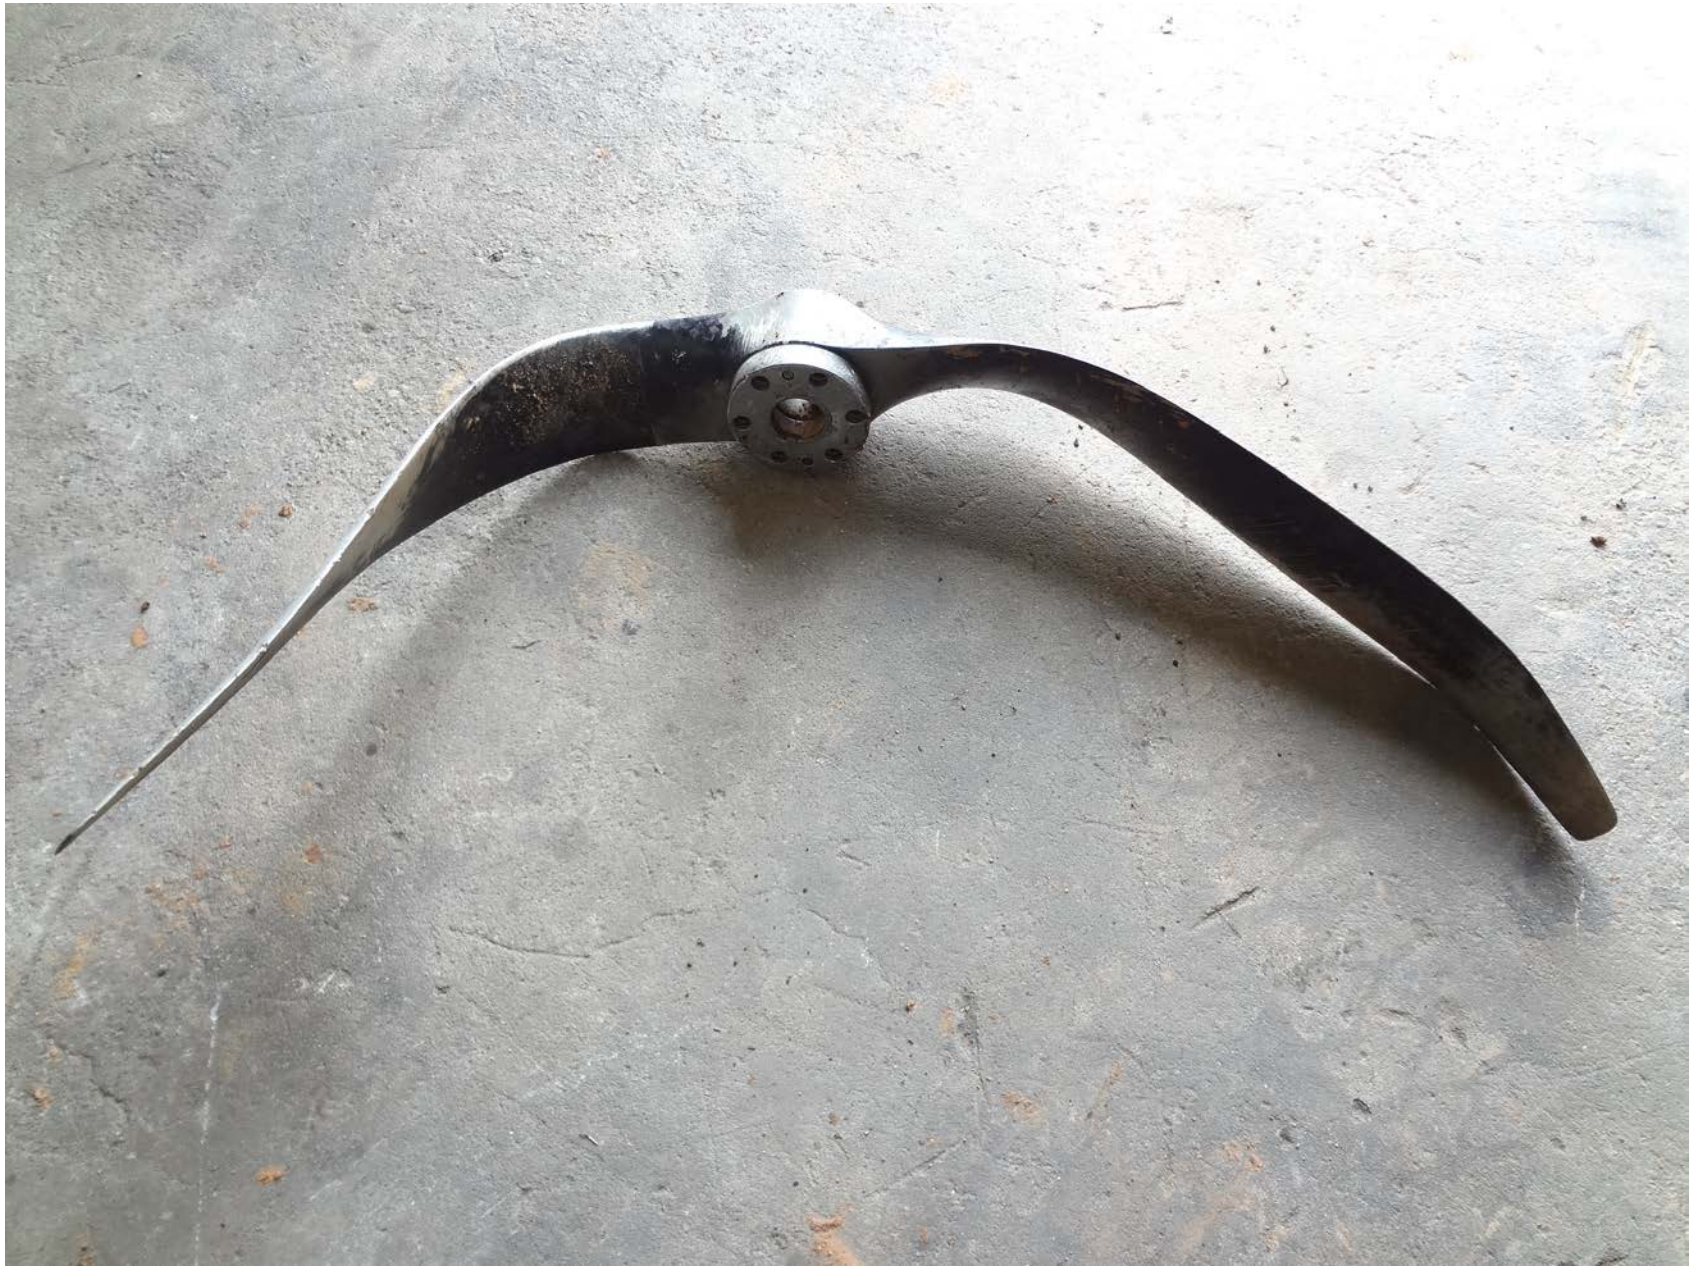
**Photo 6 – View of propeller removed from flange showing twisting and bending**
