# NATIONAL TRANSPORTATION SAFETY BOARD

## MATERIALS LABORATORY FACTUAL REPORT

Report No. 16-032

Place : Okeechobee, Florida  
Date : November 6, 2015  
Vehicle : Zenith CH701, N56553  
NTSB No. : ERA16FA033  
Investigator : Luke Schiada, AS-ERA

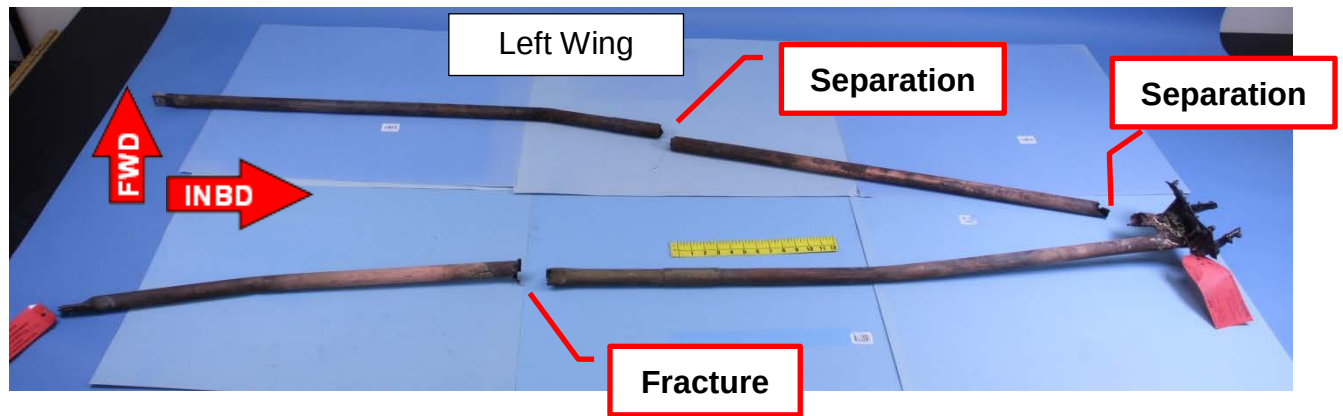
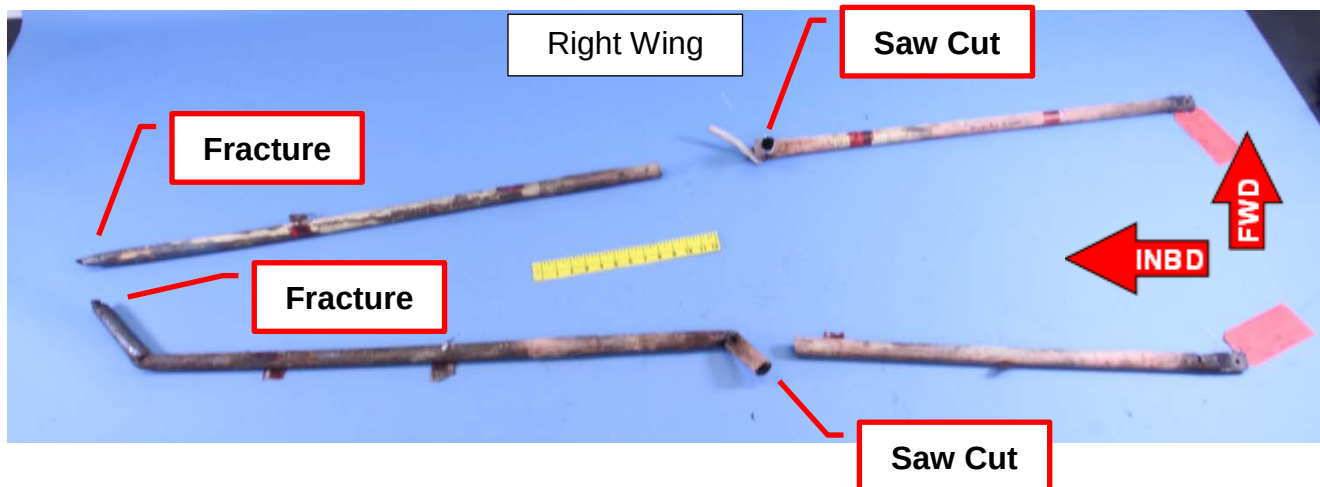
The as-received components of the right and left wing strut assemblies are displayed in figure 1. The complete lengths of the left wing struts were received along with the fuselage attachment cluster, as shown in the upper view of figure 1. The front strut was separated into three pieces and the rear strut was in two pieces. Each with the inboard pieces still bolted to the fuselage cluster. All but the inboard ends of the right wing struts were received as shown in the lower view of figure 1. Both the forward and aft struts were fractured at the inboard ends and saw cut (for shipping) near the middles.

The strut pieces had been exposed to fire and the exterior paint was charred and missing in some locations. When handled, copious quantities of corrosion deposits would exit the open areas of all the struts.

The left wing struts were separated at multiple locations. The front strut had parted through the tube section near the inboard attachment plate and again near mid-span, see separation notations in figure 1. At the inboard end the "U" plate remained bolted to the fuselage cluster with a short length of tube attached, as shown in figure 3. The mid-span separation was located just inboard of the connecting sleeve as shown in figure 4. The lower tube section was also perforated at two location below the mid-span separation. The larger perforation is visible in the both views of figure 4.

Figure 1. Overall view of the as-received pieces of the left and right wing struts with separation and fracture locations denoted.

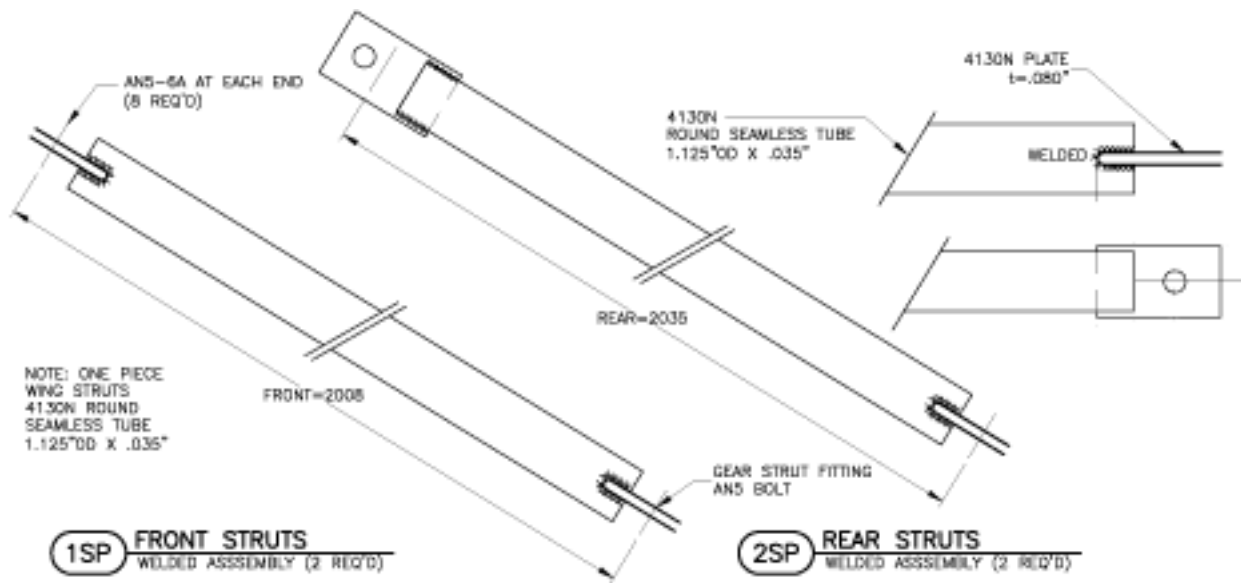
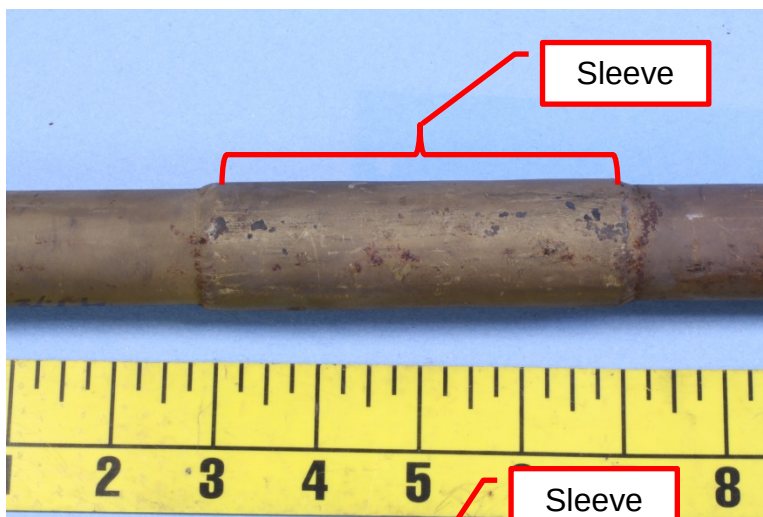
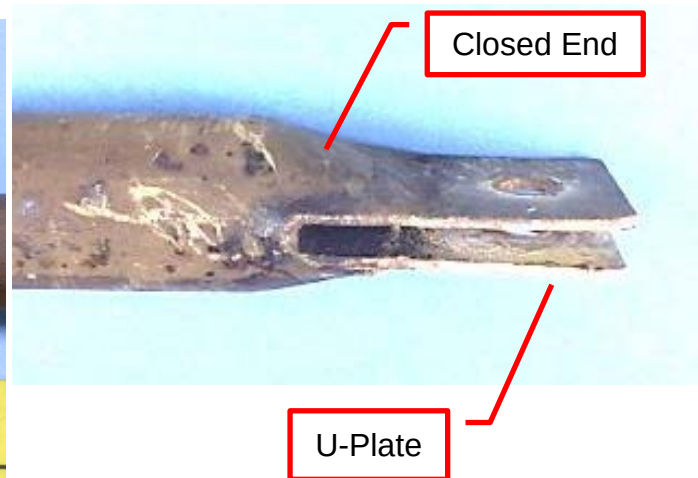
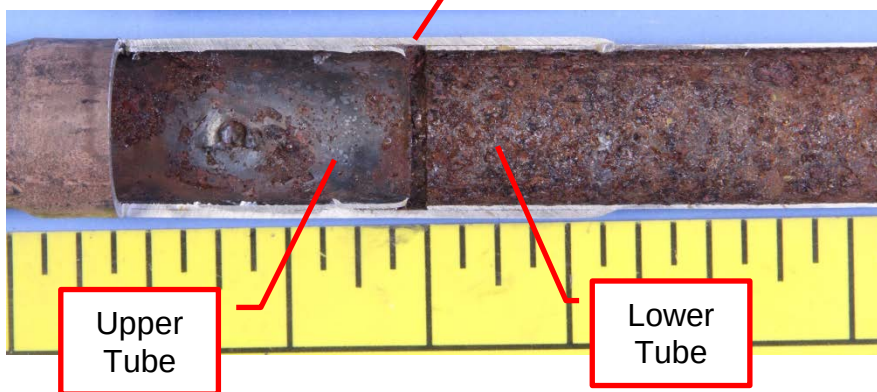
The aircraft wing strut assemblies are each (left and right) composed of two long strut tubes (front and rear) connected to the fuselage at the inboard (lower) ends and to the wing spars at the outboard (upper) end. The engineering drawing<sup>1</sup>, see upper view of figure 2, describes the front and rear struts as "one piece, 4130N<sup>2</sup> seamless tubes, 1.125" OD x .035" " of different lengths. Bent "U" plates, also 4130N, are welded into the open each ends for attaching to the fuselage and wing.

Visual examinations of the struts found each to be manufactured from two pieces of tubing welded together within a surrounding sleeve as shown in the lower left views of figure 2. Further, the as-built tube end construction details differed from the drawing. On the received struts the tube ends were shaped and welded to form closed tube ends, see middle right image of figure 2.. The drawing shows the attaching plates welded into round open tube ends.

Figure 2. Details of construction as shown on a sample engineering drawing of the struts (top). Images at left show the two piece and sleeve construction of the tubes. Image above shows the as-manufactured closed end tube detail compared to the open ended tube detail shown in the drawing.

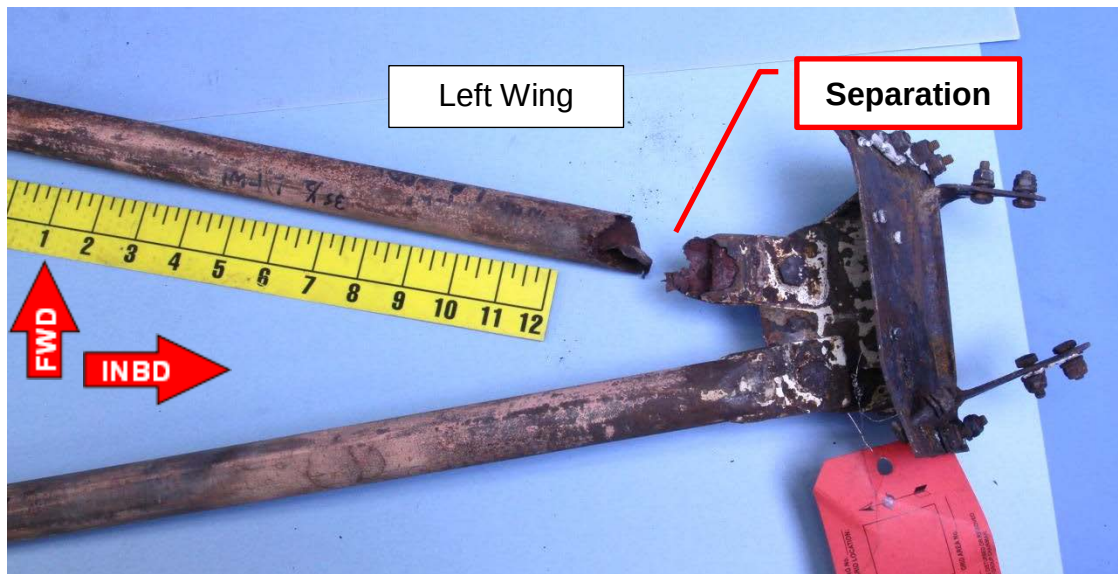
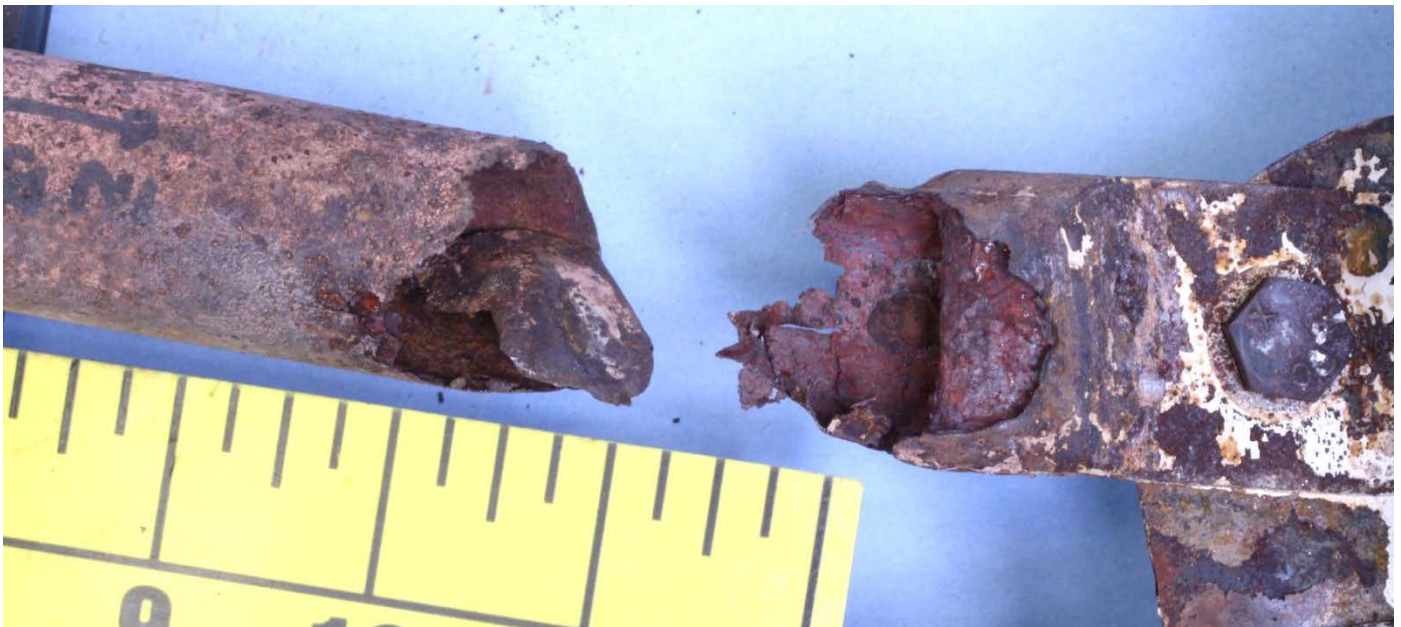
Figure 3. Views of the inboard separation area of the left wing forward strut exhibiting severe and extensive internal corrosion of the strut tube at the separation location.

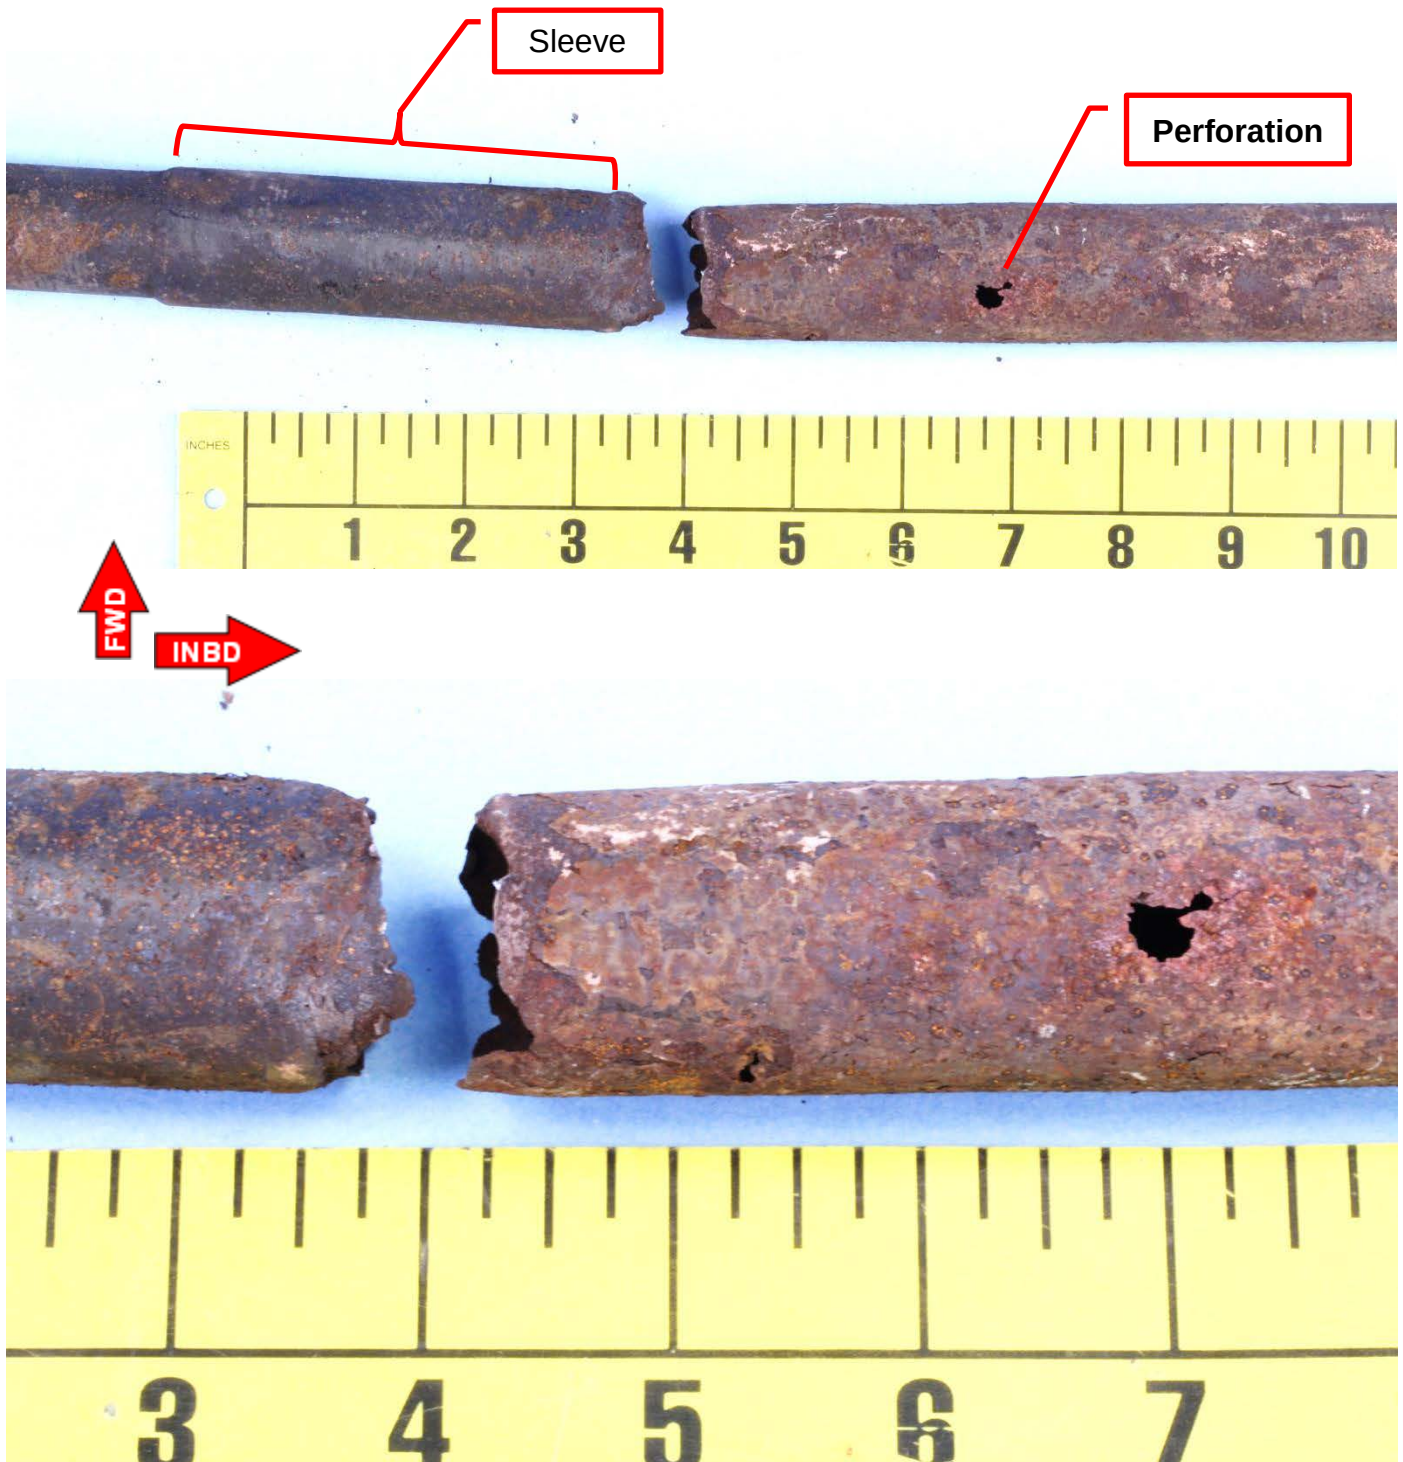
Figure 4. Two views of the mid-span separation area just inboard of the assembly sleeve. Also note the nearby corrosion perforation of the lower strut tube.

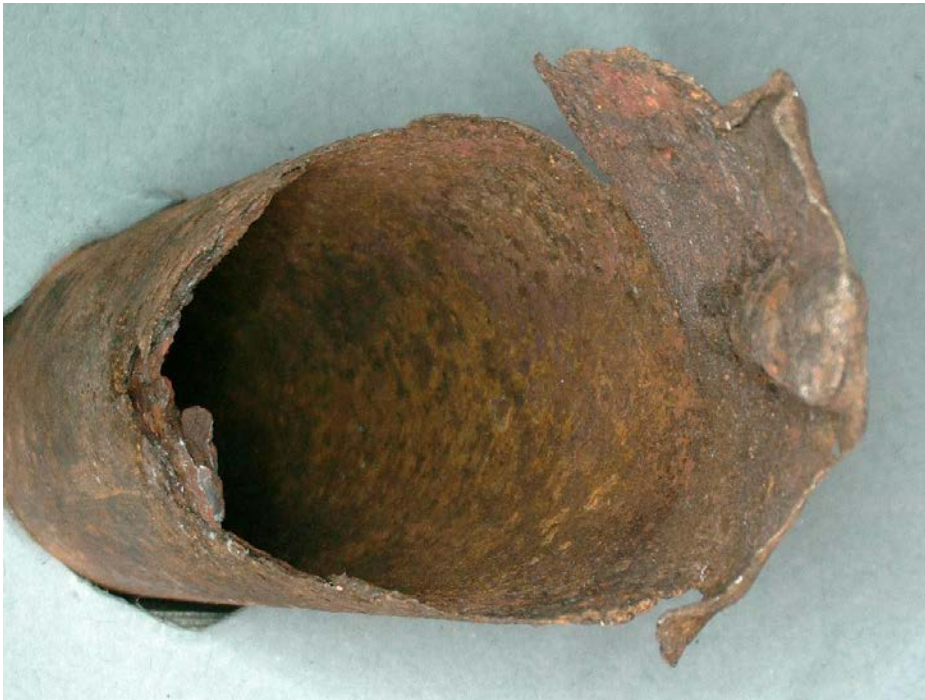
Visual and magnified optical examination found that the wall thickness of the forward tube of the left wing had been reduced to knife edges by internal corrosion at both separations. The outboard portion of the lower separation is displayed in figure 5.

Figure 5. Two views of the left wing forward strut tube separation showing the severe corrosion thinning of the tube wall at the separation.

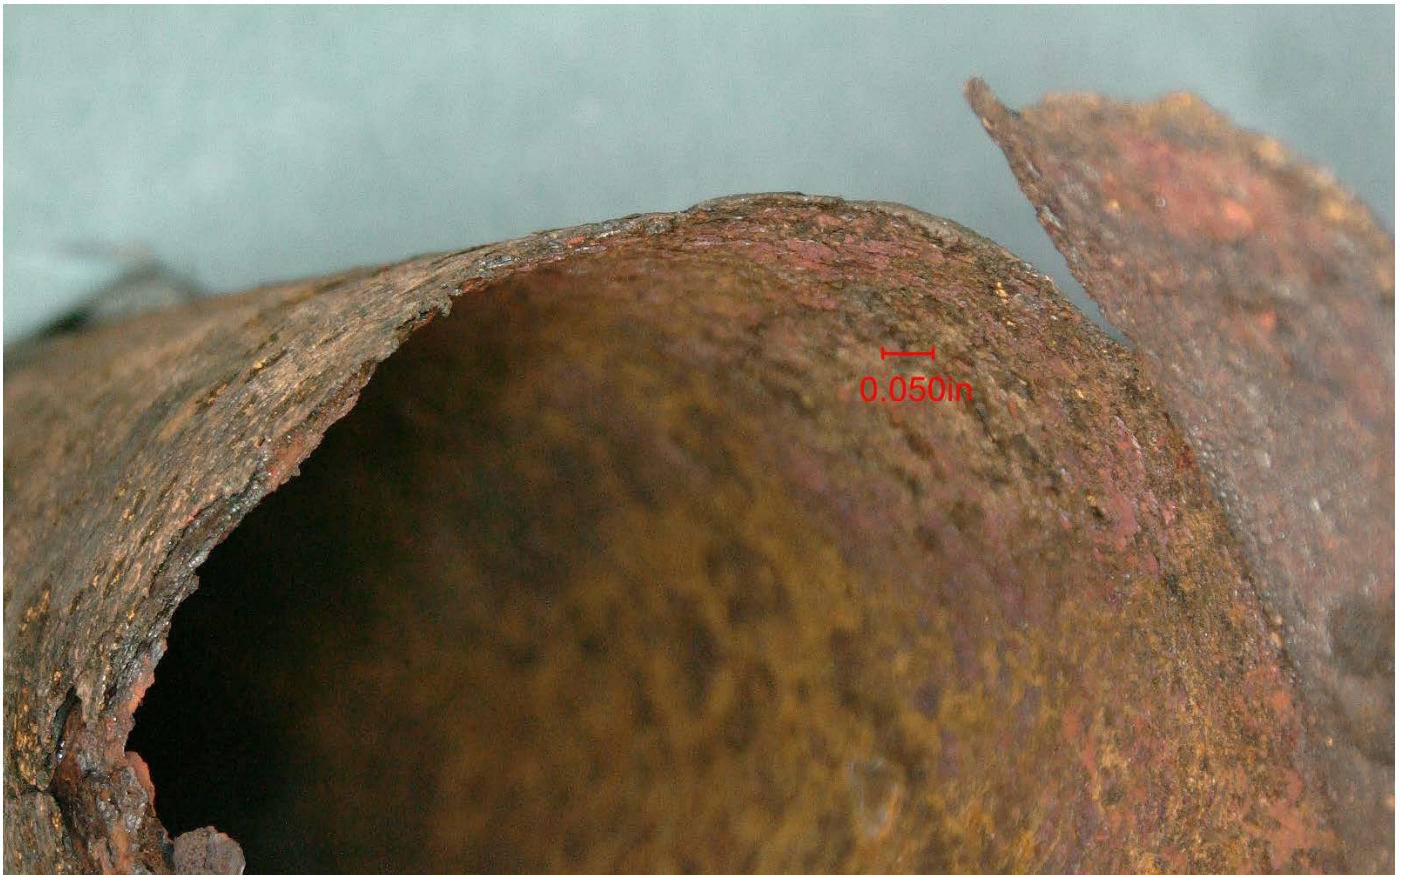
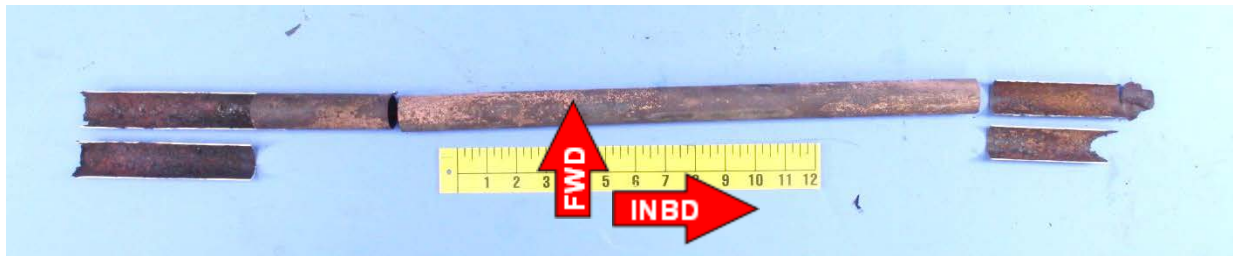
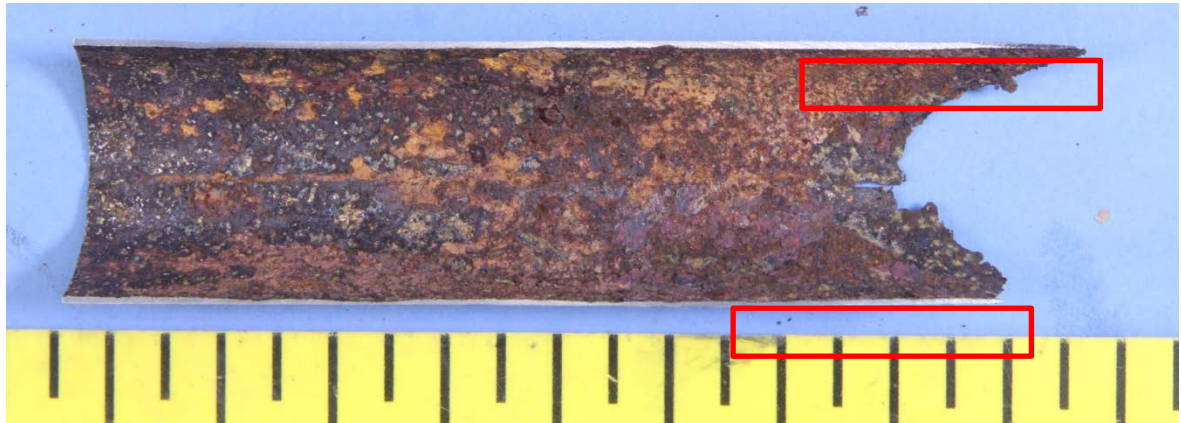
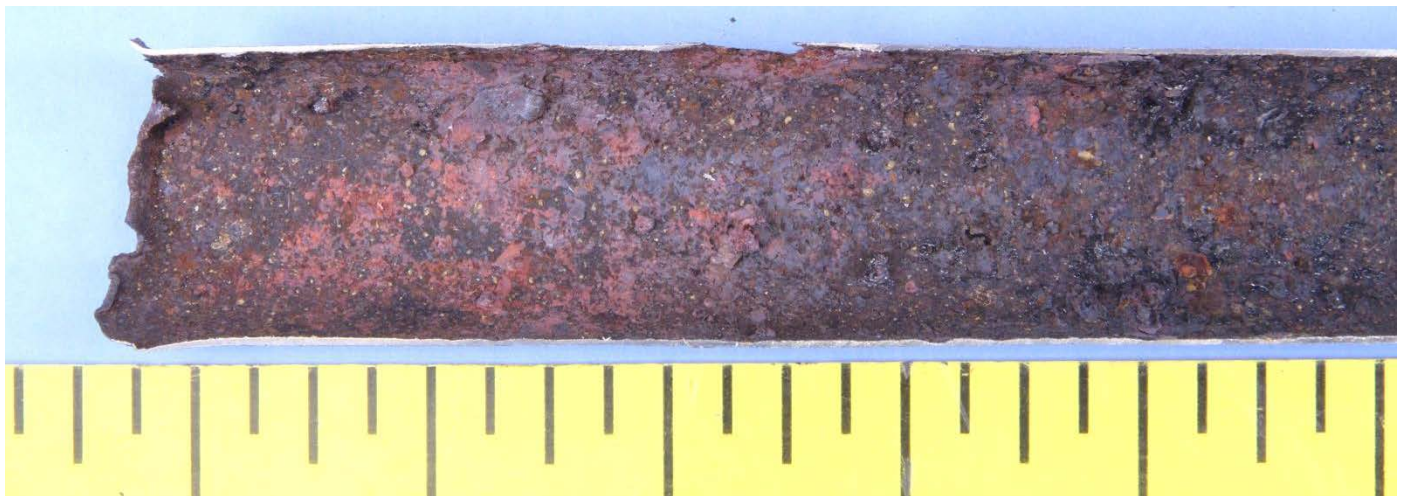
To explore the extent of corrosion, the forward strut of the left wing was longitudinally sectioned on a roughly horizontal plane and opened adjacent to both separations, as shown in the upper view of figure 6. The lower views display the severe internal corrosion at and for significant lengths beyond the separations.

Figure 6. Views of the inboard section of the left wing forward strut after the mid-span (left) and lower (right) separation locations have been longitudinally sectioned (upper image). Middle image shows the inboard separation in cross section with significant wall loss. Boxed areas of image are displayed in figure 7. Lower image show wall loss adjacent to the mid-span separation.

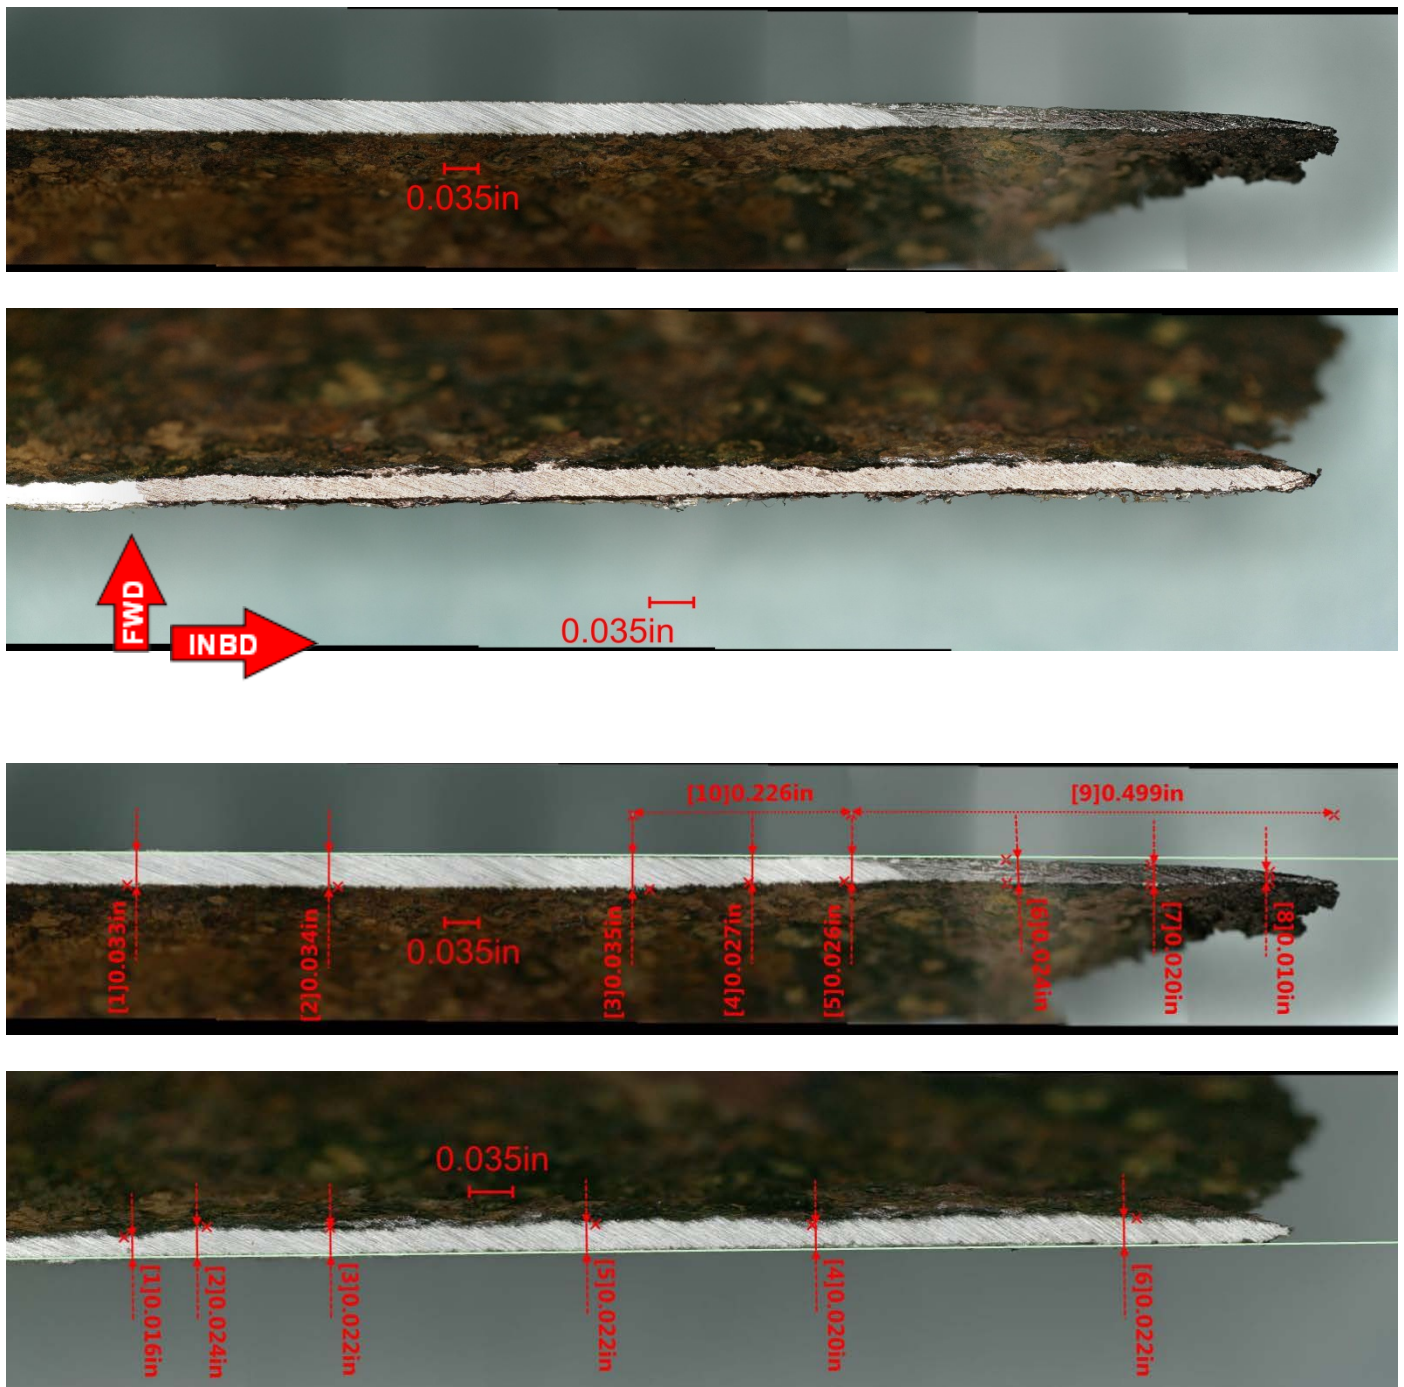
The engineer drawing indicates the nominal specified wall thickness as 0.035 inch. The upper two views of figure 7 show the corrosion and knife edges on either side of the lower separation. Measurements determined that the wall loss due to the corrosion was highly variable with location. The lower views of figure 7 show remaining wall thickness along the tube section of the strut. Significant wall loss was confined to the immediate area of the separation. While at the aft side of the strut more than 1/3 of the wall was lost for several inches outboard from the separation. Figure 8 shows the wall loss on a transverse cross section of the strut tube about 5 inches above the lower separation.

Figure 7. Upper two images show the wall adjacent to the lower separation of the left wing forward strut with the knife edge separation at right. Lower two images show the same area with wall thickness measurements superimposed.

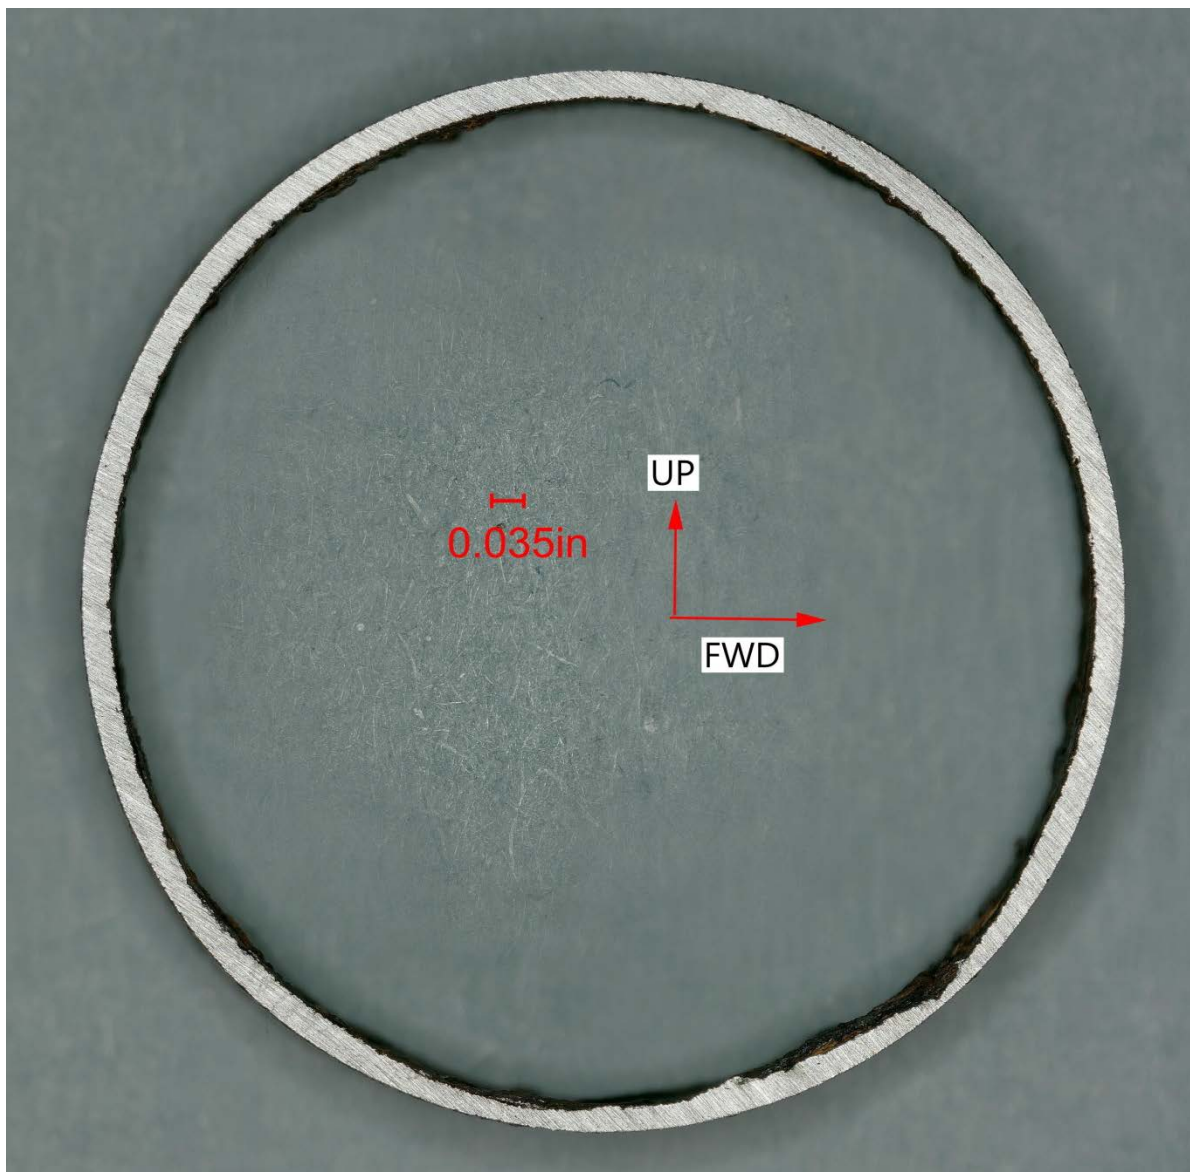
Figure 8. Cross section of the left wing forward strut lower tube showing the corrosion reduced wall thickness in the lower half.

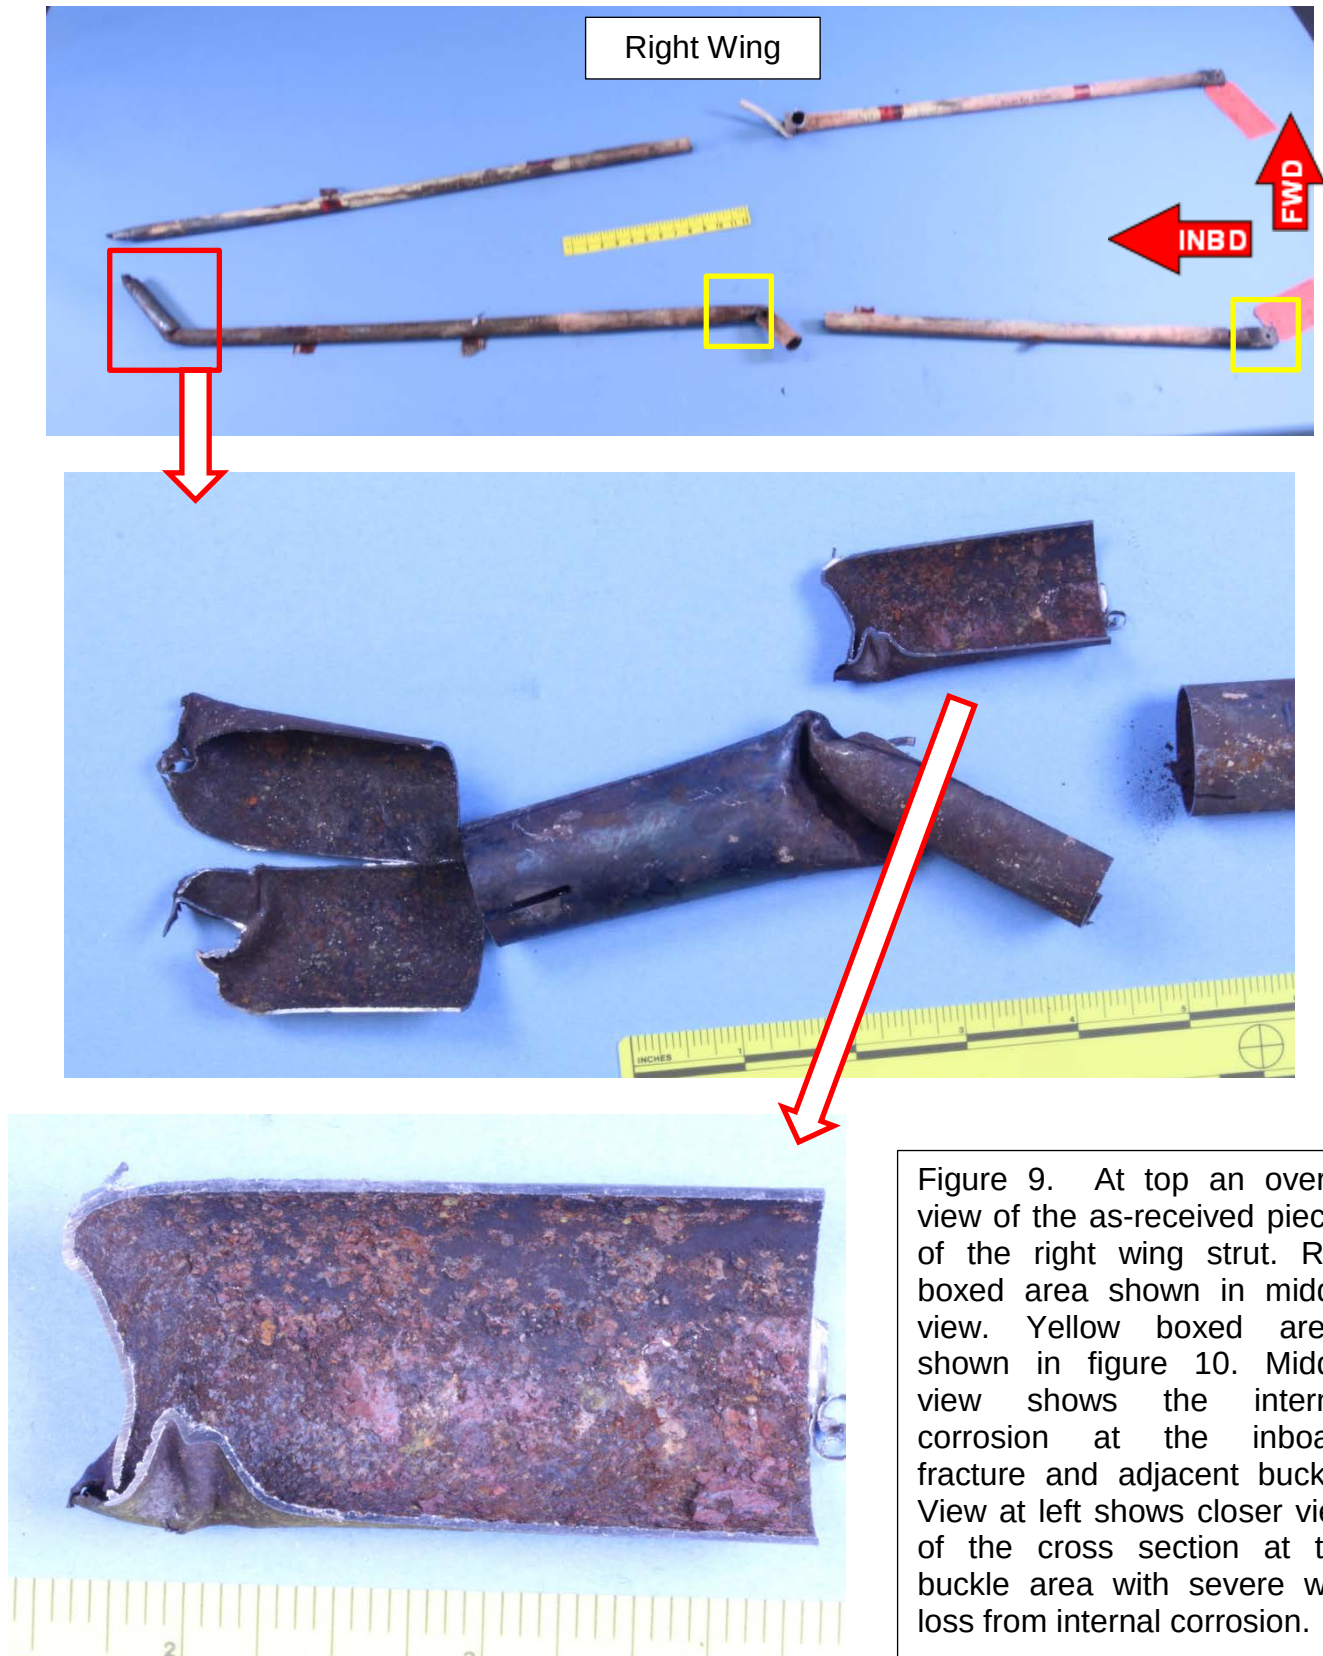
The right wing struts were separated at the inboard ends and bent and deformed in several locations, shown again at the top of figure 9. Magnified optical examinations found the separation to be consistent with overstress fractures after significant bending / buckling deformation. Close examination uncovered areas of thin wall at both strut separations. Longitudinal sectioning of the aft strut at the separation revealed significant internal corrosion and localized wall loss at portions of the separation.

Figure 9. At top an overall view of the as-received pieces of the right wing strut. Red boxed area shown in middle view. Yellow boxed areas shown in figure 10. Middle view shows the internal corrosion at the inboard fracture and adjacent buckle. View at left shows closer view of the cross section at the buckle area with severe wall loss from internal corrosion.

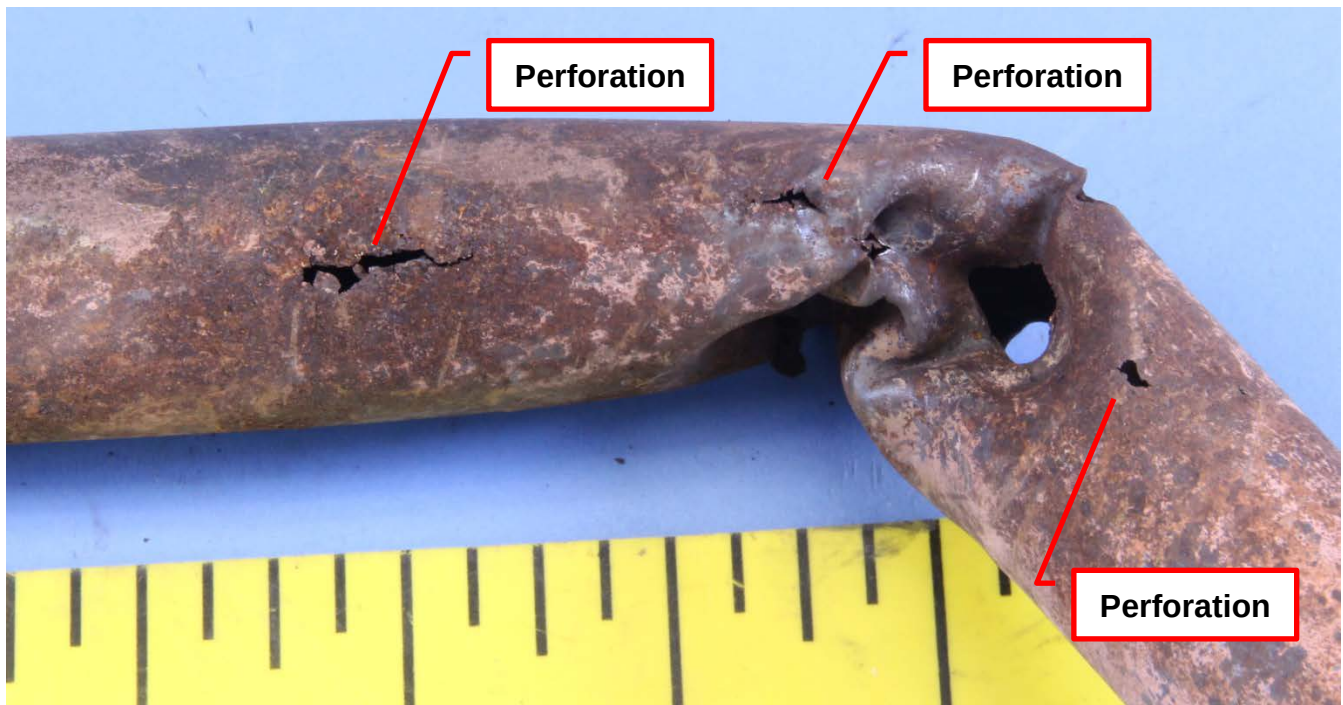
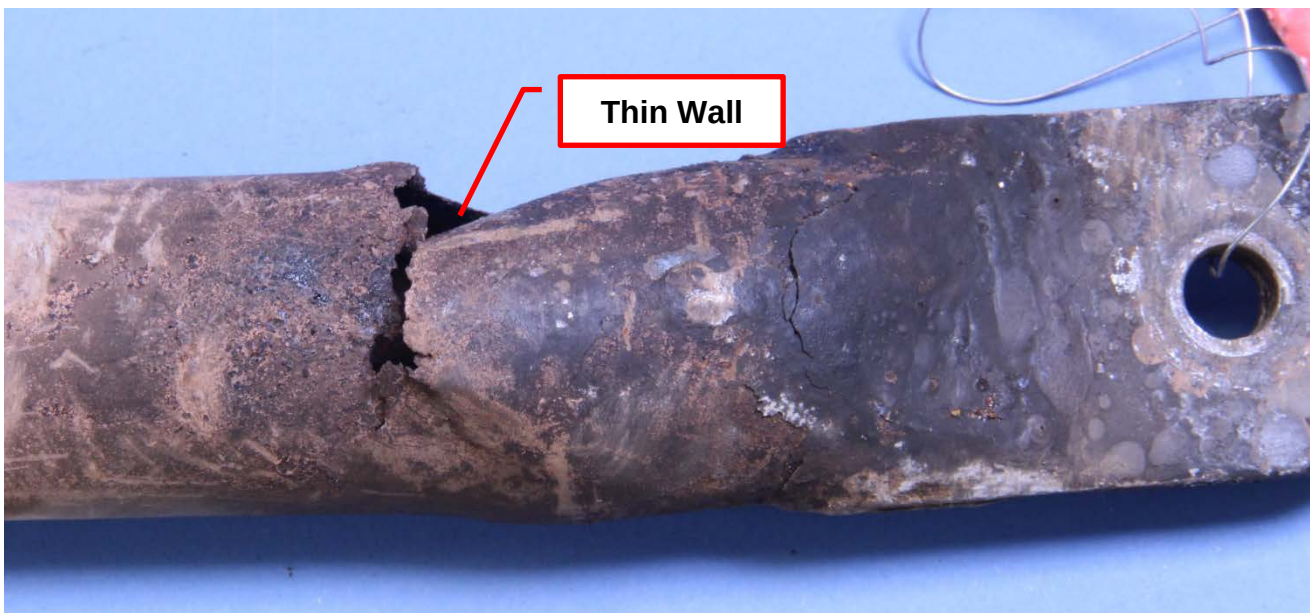
Further examinations uncovered three areas of internal corrosion of the aft tube. One area was at the bend / buckle just outboard of the separation and shown in the lower view of figure 9. Small perforation were visible in the deformed area. Longitudinal sectioning revealed severe internal corrosion of one side of the tube wall. The corrosion removed an estimated 25% of the wall. A second area of internal corrosion was evidenced by three perforations of the wall at the attachment point for the jury struts, shown in the upper image of figure 10.. The third area was at the outboard end adjacent to the "U" plate attachment as shown in the lower view of figure 10.

Figure 10. Yellow boxed areas from upper view of figure 9. Upper view shows perforations mid-span. Lower view shows this wall area at deformation near upper end of strut.
