# Continental Motors

## ENGINE FIELD INSPECTION REPORT

| ENGINE MODEL | TSIO520-UB |
| CMI FILE NUMBER | 15-297 |

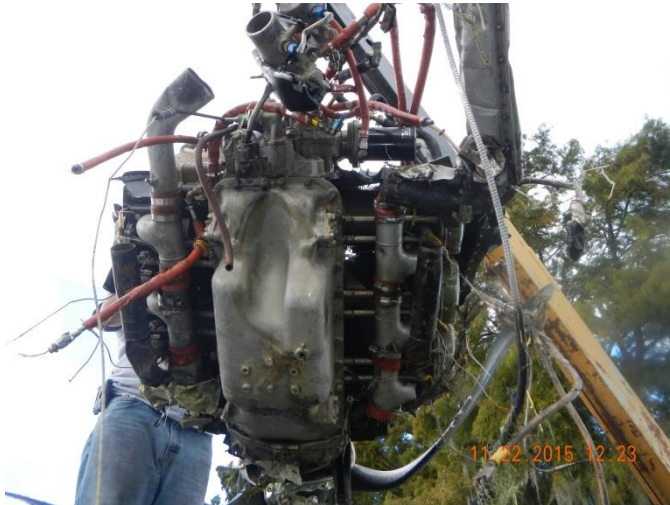
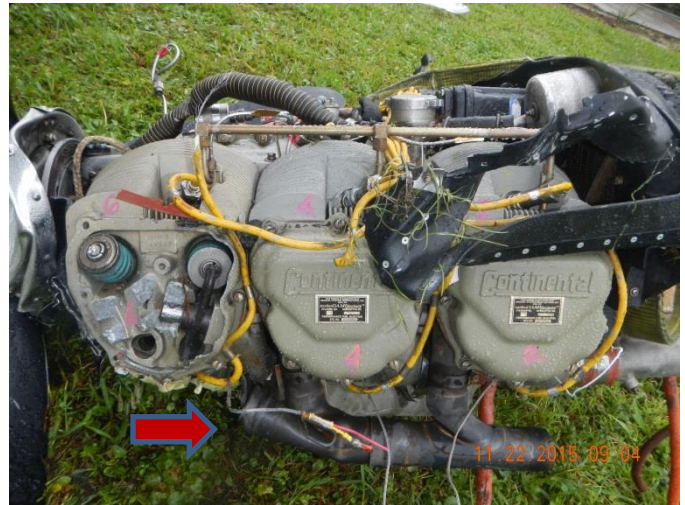
#### EXHAUST SYSTEM

Condition: Both right and left exhaust mufflers separated and were not recovered. The left exhaust collector remained attached but was impact damaged. The exhaust riser separated from cylinder # 6. The right exhaust collector received impact damage and the exhaust riser for cylinder # 1 separated.

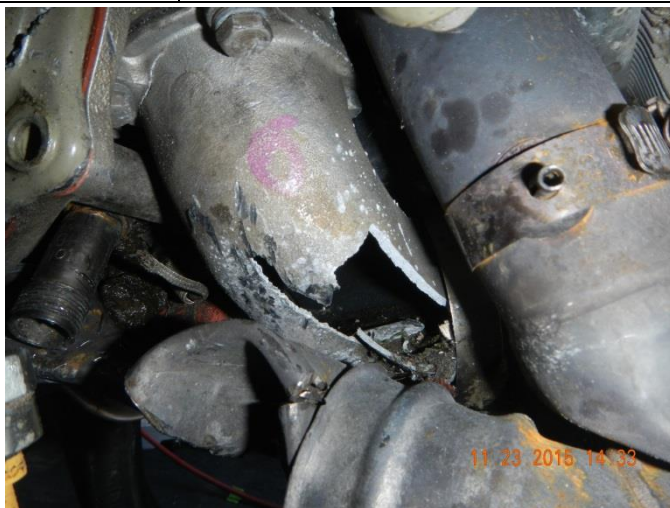
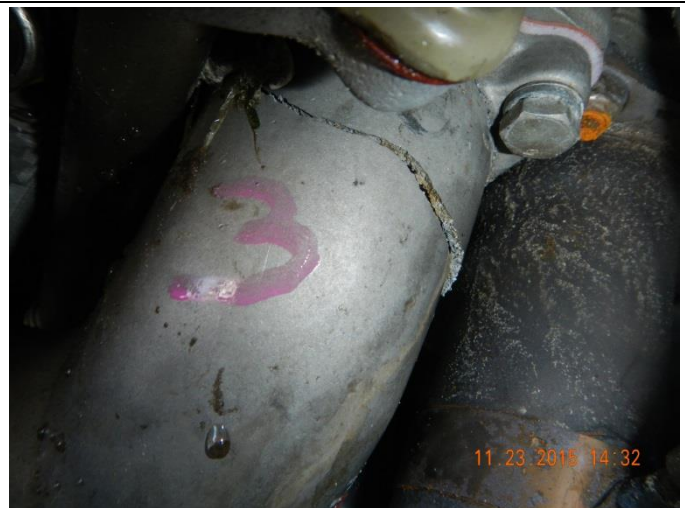
#### INDUCTION SYSTEM

Condition: The induction system received impact damage including the induction elbows at cylinders three, five and six. These induction elbows fractured but remained attached to their respective cylinder head. The forward induction balance tube was impact damaged as was the left rear wye pipe.

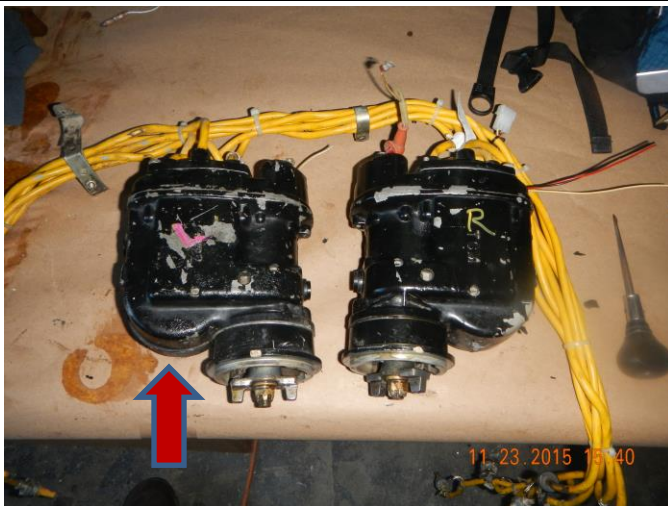
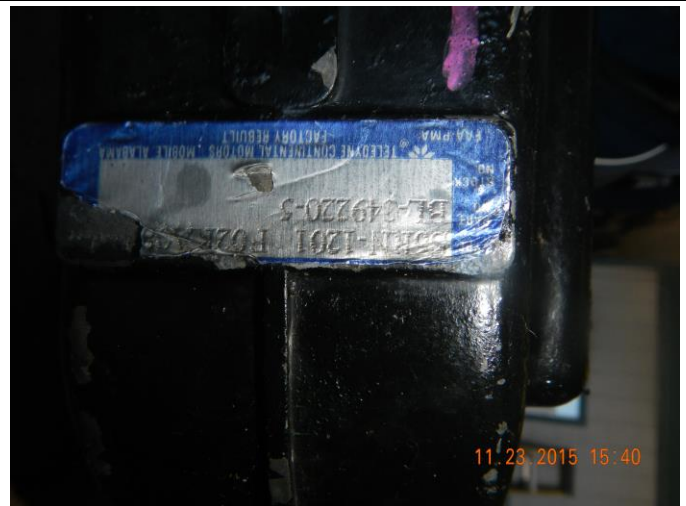
| LEFT MAGNETO | Manufacturer: TCM | P/N: BL-249220-5 | S/N:F02KA084R |
|---|---|---|---|
| Condition: | The left magneto failed to produce spark when the engine was manually rotated. The magneto was removed and partially disassembled, water removed and components dried using shop air. Once reassembled, the left magneto produced spark through each ignition lead when rotated manually using a power drill for a rotation source. | | |

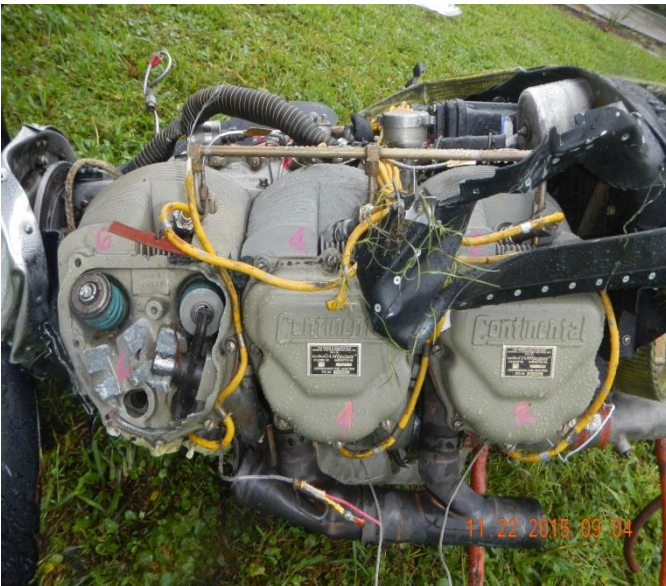
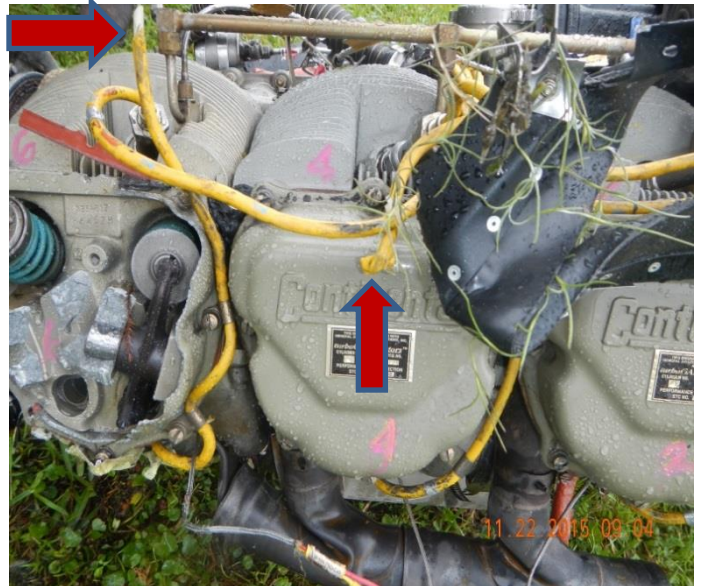
## IGNITION HARNESS

**Condition:** The ignition harness remained intact with the exception of the individual ignition lead for the # 6 cylinder lower spark plug. This ignition lead was cut / pinched during impact and separated from its spark plug. Red arrows in the photos indicated the damaged ignition lead.

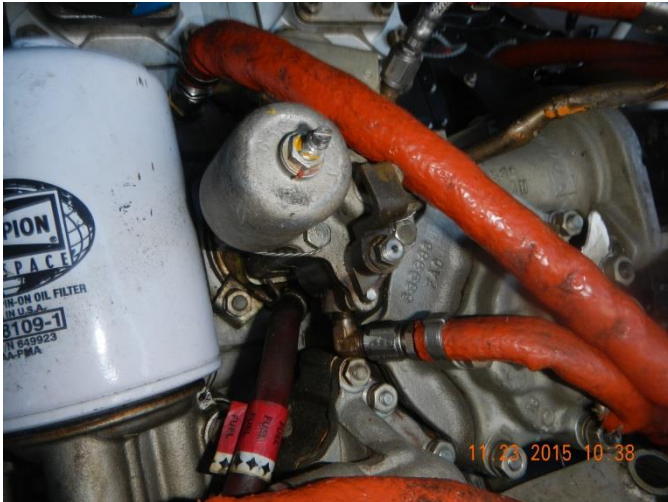
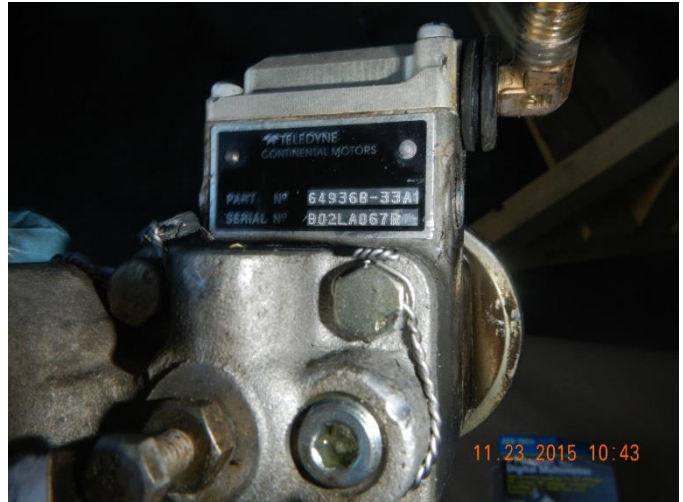
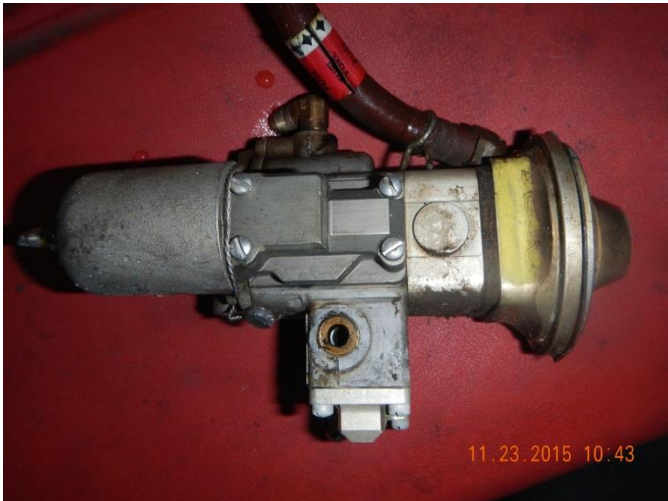
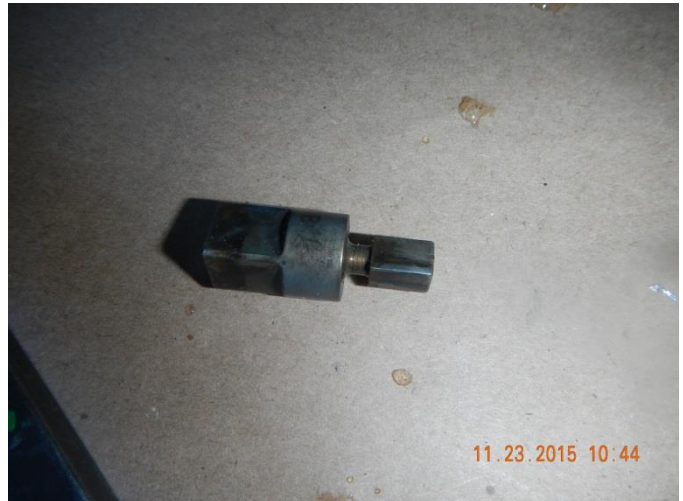
| <b>FUEL PUMP</b> | Manufacturer: TCM | P/N: 649368-33A | S/N: B02LA067R |

| Condition: | The engine driven fuel pump remained intact and in place with the exception of brass hose fittings which were impact damaged. The drive link was intact. | | |

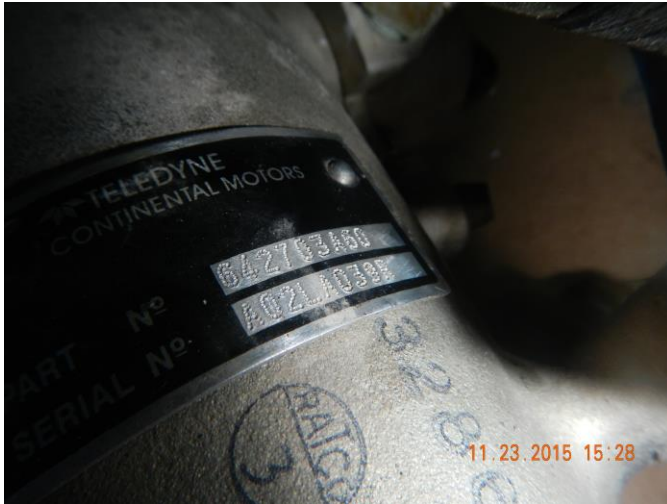
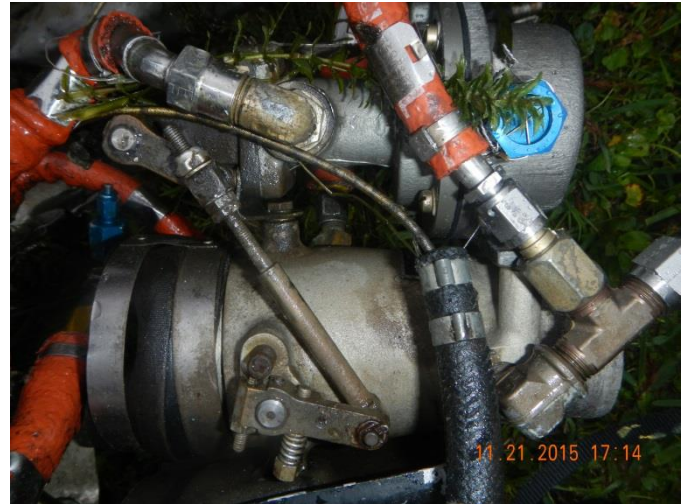
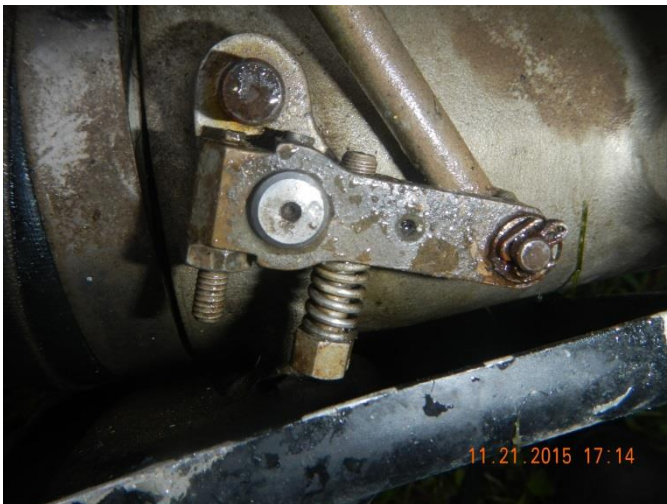
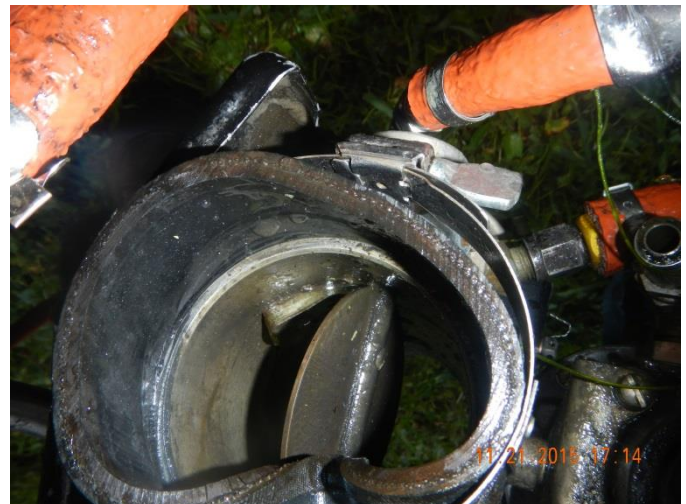
## THROTTLE BODY METERING UNIT

Condition: The throttle body remained attached only by a metal brace bar and control cables. All flexible fuel hoses remained attached with the exception of the main fuel inlet hose which separated from the airframe firewall fitting. The throttle body remained intact and the throttle plate was found in the fully open position.

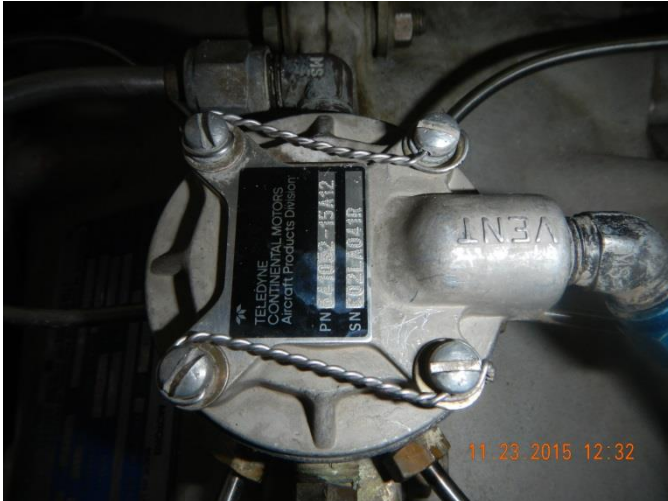
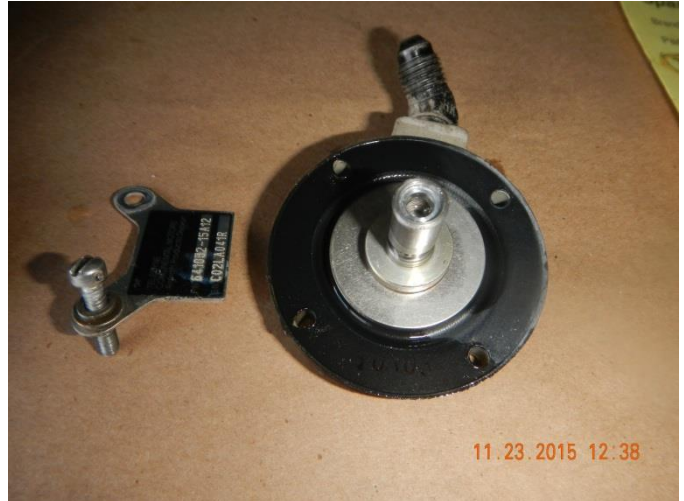
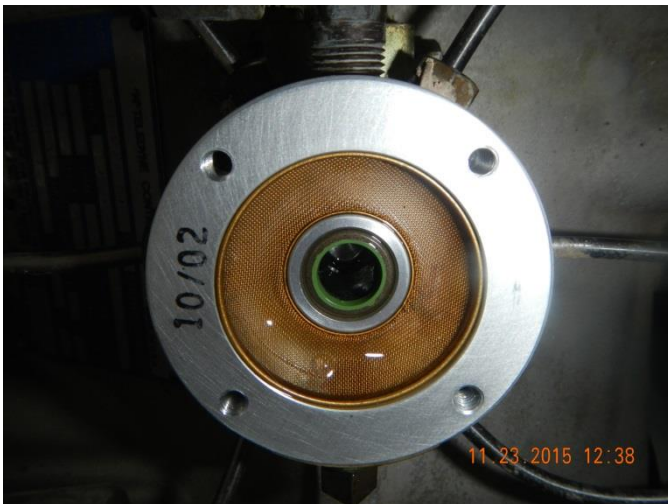
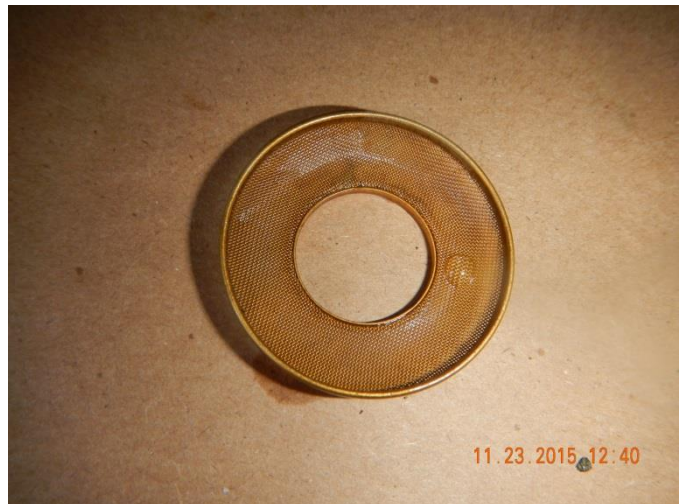
## FUEL MANIFOLD VALVE

Condition: The manifold valve was disassembled and inspected and found to contain a small amount of aviation fuel. A very small amount of water was found on the internal fuel screen.

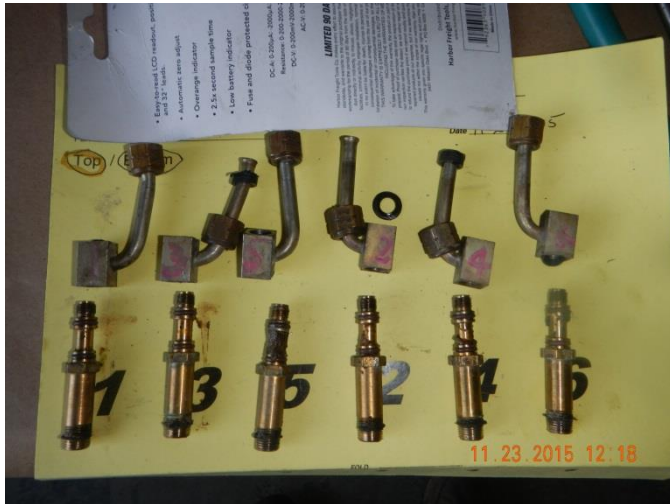
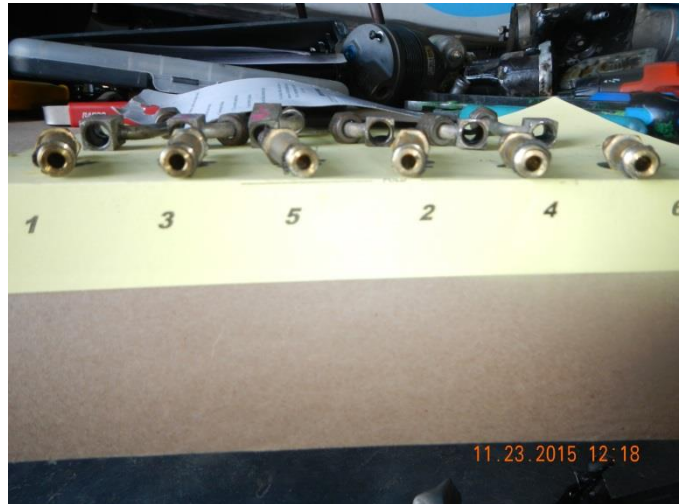
## FUEL NOZZLES

| Position | #1 | #3 | #5 | #2 | #4 | #6 |
|---|---|---|---|---|---|---|
| Condition: | The fuel injectors were removed, inspected and found to be uncontaminated. | | | | | |

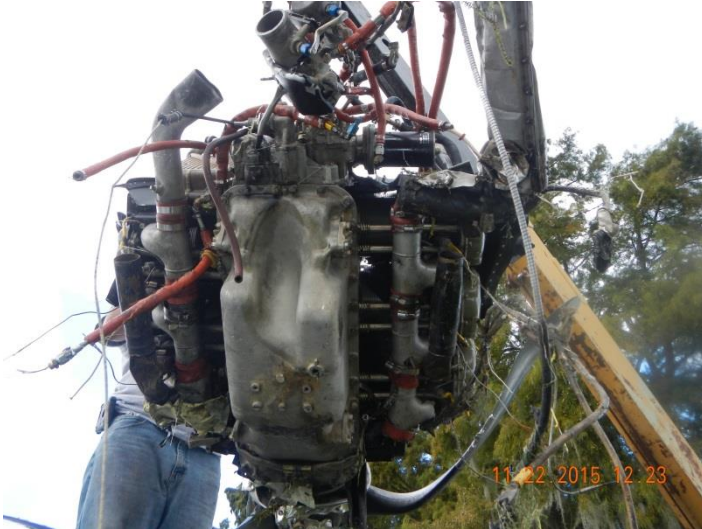
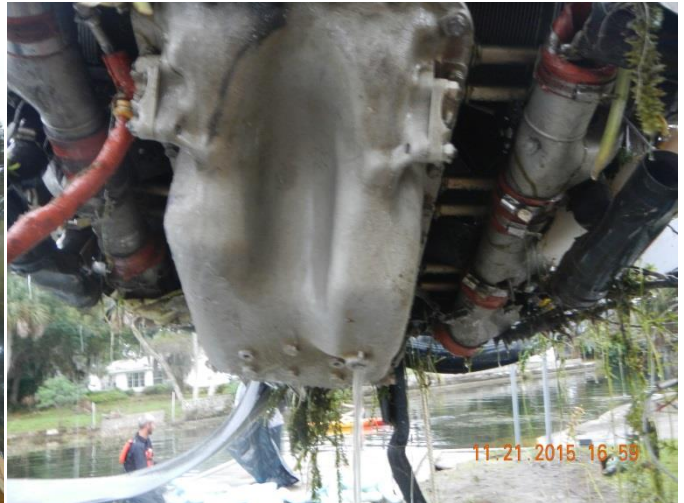
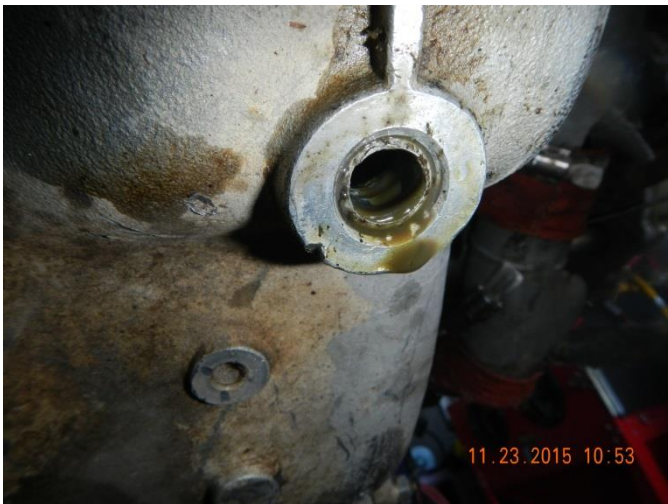
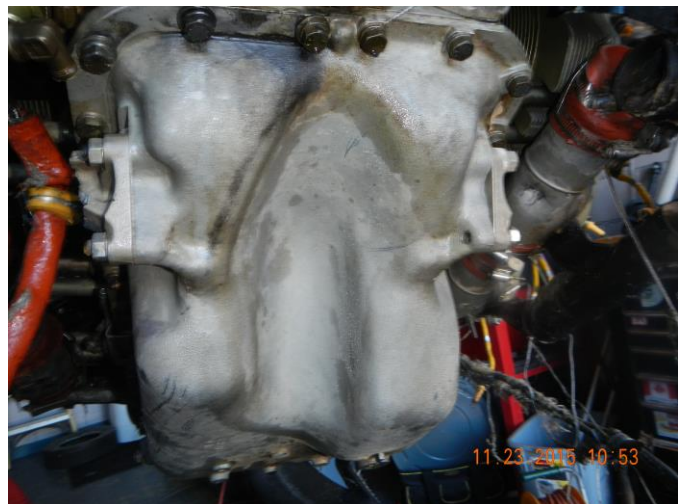
#### OIL SUMP

The oil sump was intact with the exception of the engine mounts which separated. The quick drain valve separated.

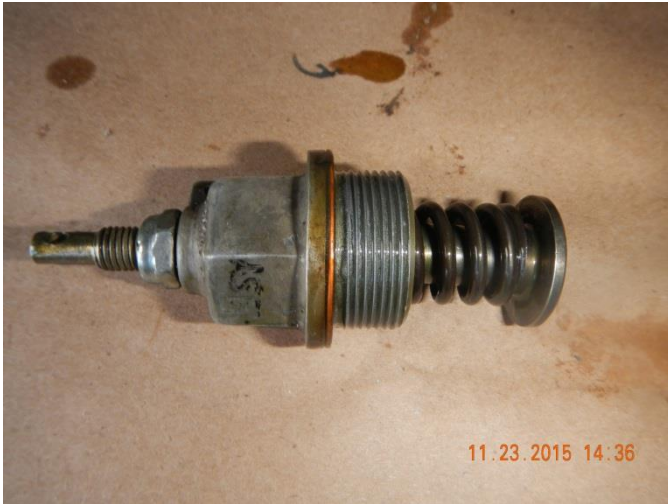
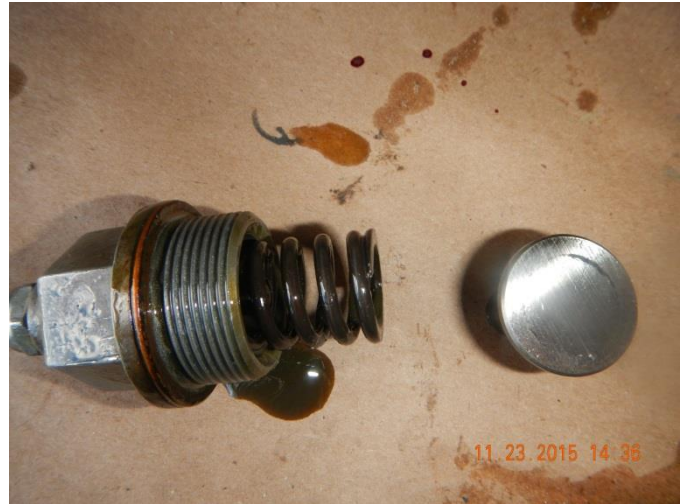
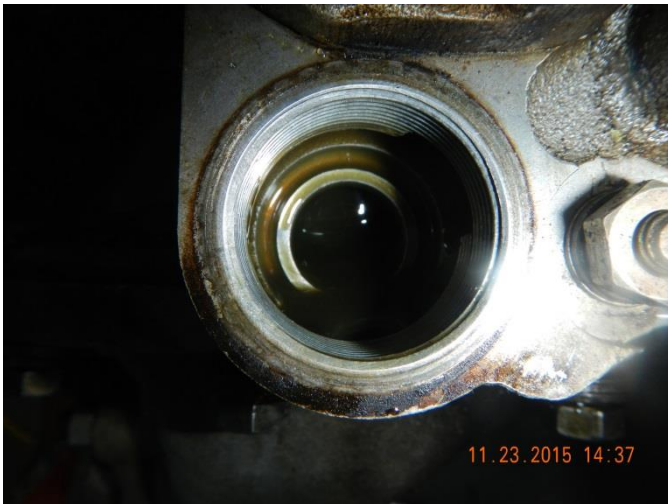
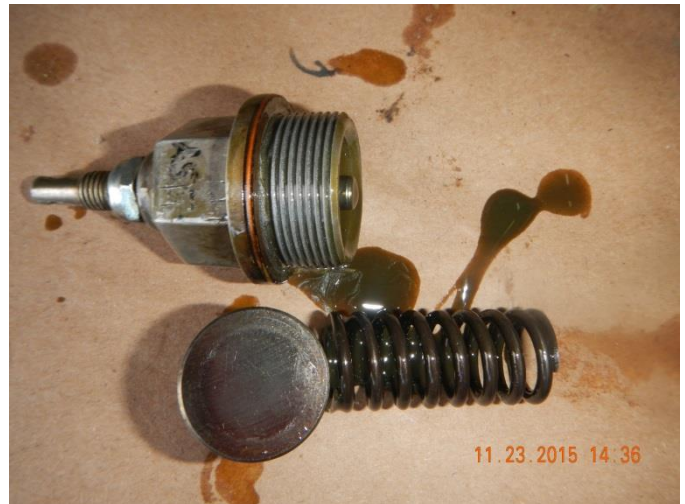
## OIL PRESSURE RELIEF VALVE

The oil pressure relief valve was removed and inspected. No apparent damage.

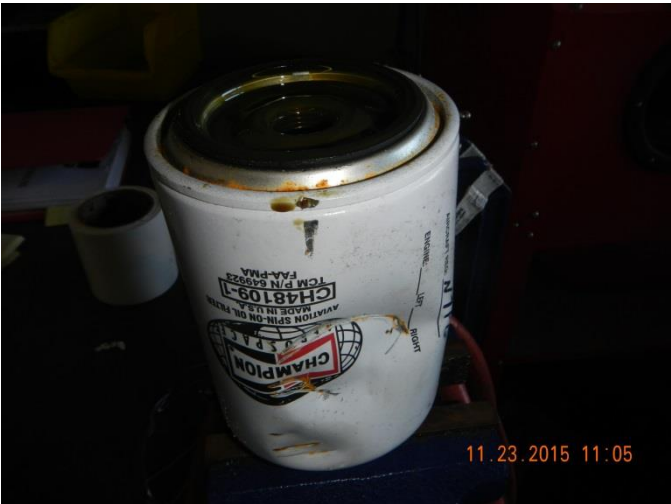
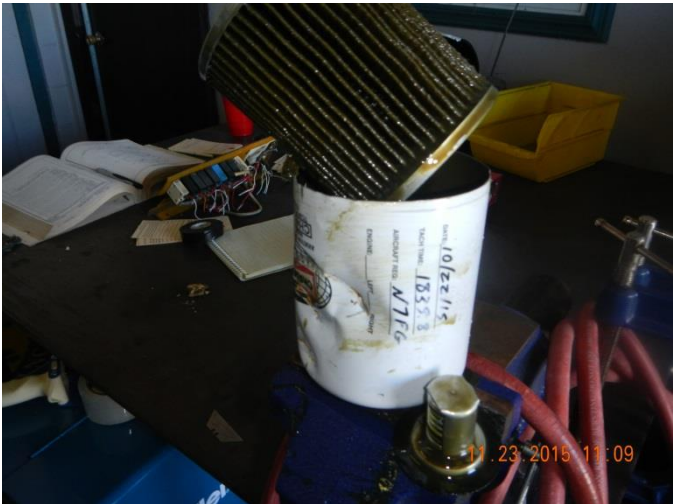
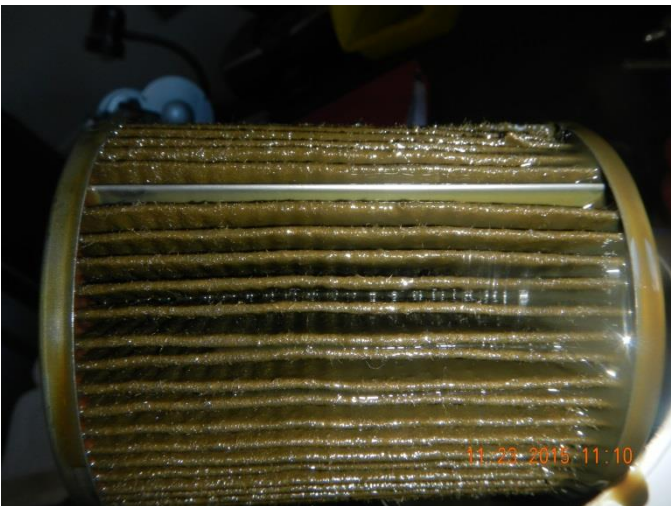
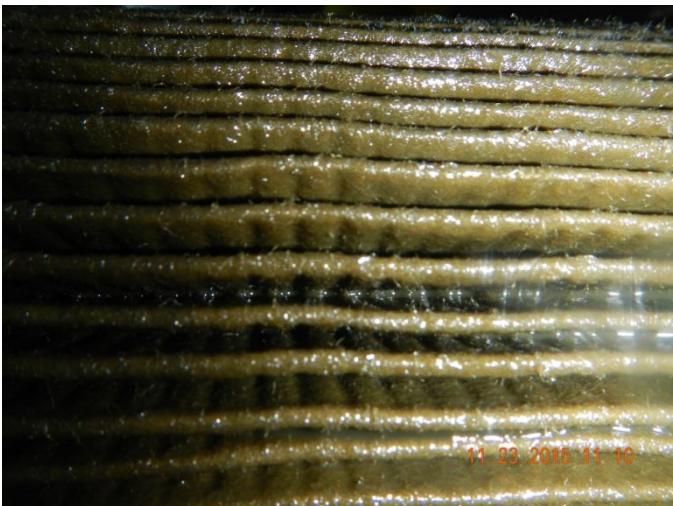
| OIL FILTER | Manufacturer: Champion | P/N:PH48109 |

| Condition: | The external canister was impact damaged. The filter was opened and examined.<br>No contaminants were found. | |

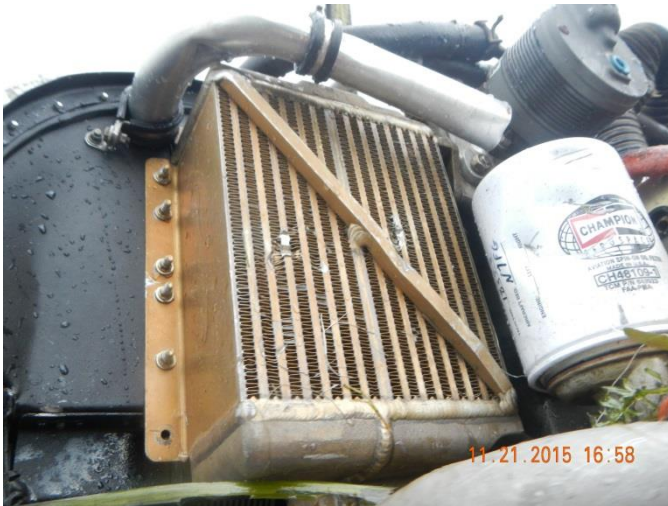
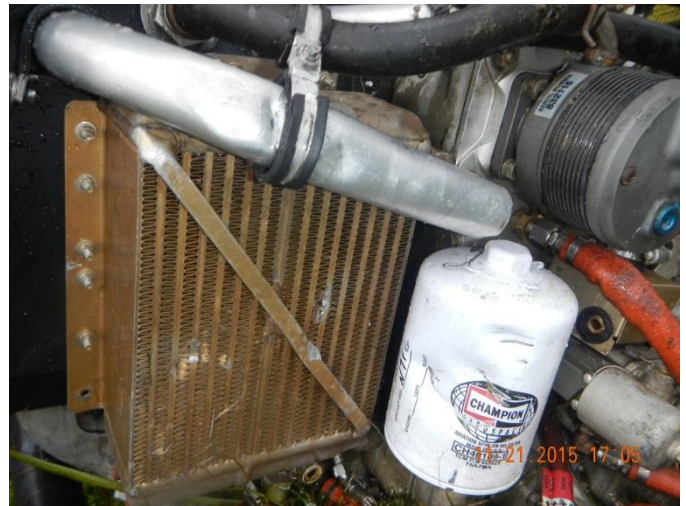
### OIL COOLER

Condition: Minor impact damage to cross brace and cooling fins. The outlet fitting was broken.

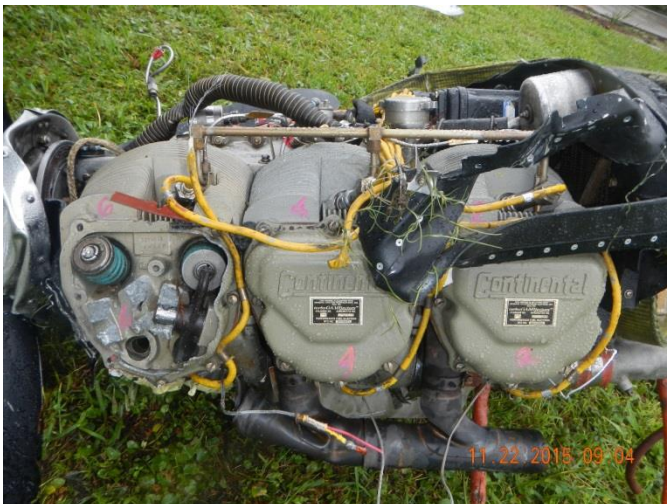
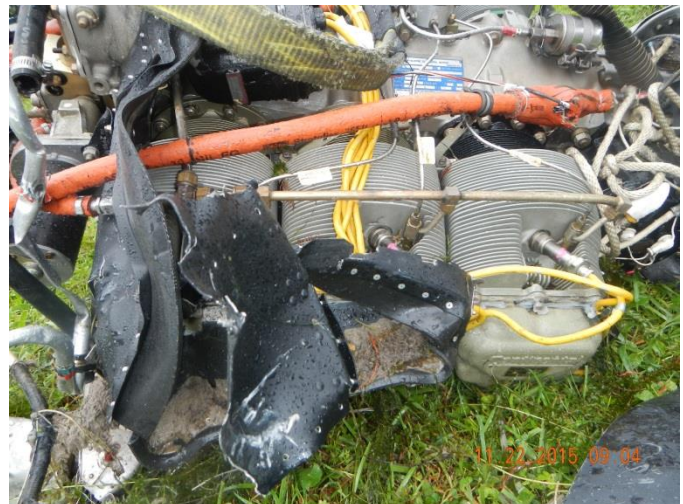
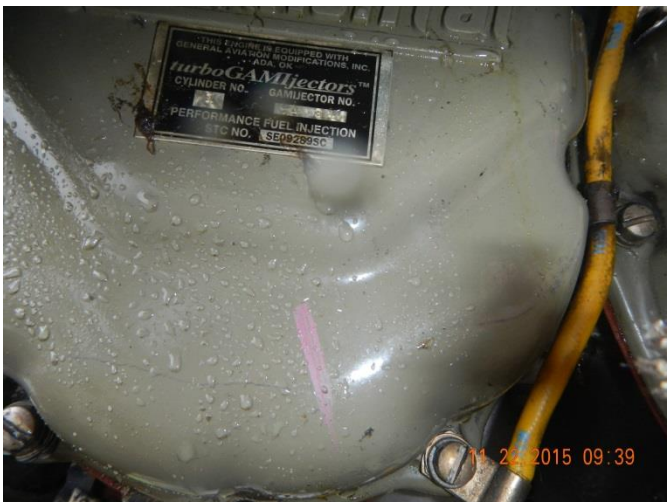
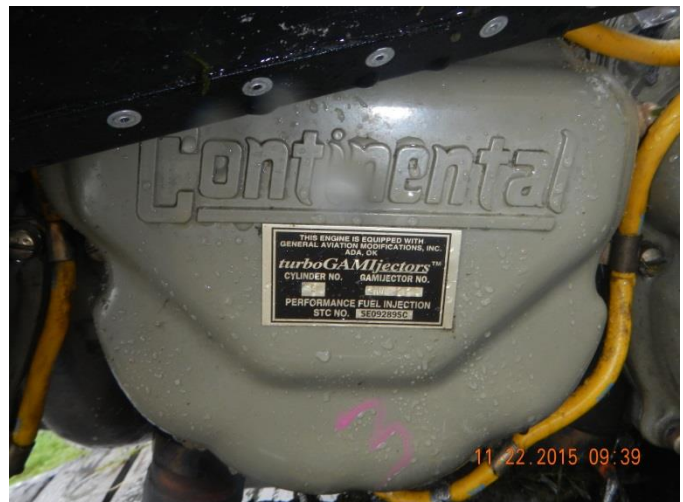
### CYLINDERS

All six cylinders remained intact with the exception of cylinder # 6 which received impact damage to its cylinder head, exhaust rocker arm bosses, rocker shaft and rocker box cover. The rocker box cover for cylinder # 6 separated and was not recovered. The exhaust valve rocker shaft and shaft bosses separated and were not recovered. The # 6 exhaust valve and valve spring remained attached but were impact damaged.

A lighted borescope inspection was performed on each cylinder. All intake and exhaust valves were in place and intact. Each cylinder contained oil and water contamination. Intake and exhaust valves appeared normal in cylinders one through five even with the amount of contamination present. Cylinder number 6 exhaust valve appeared to be partially open. Impact damage to cylinder number 6 included a bent exhaust valve stem and bent pushrod which would not allow the damaged exhaust valve to fully close.

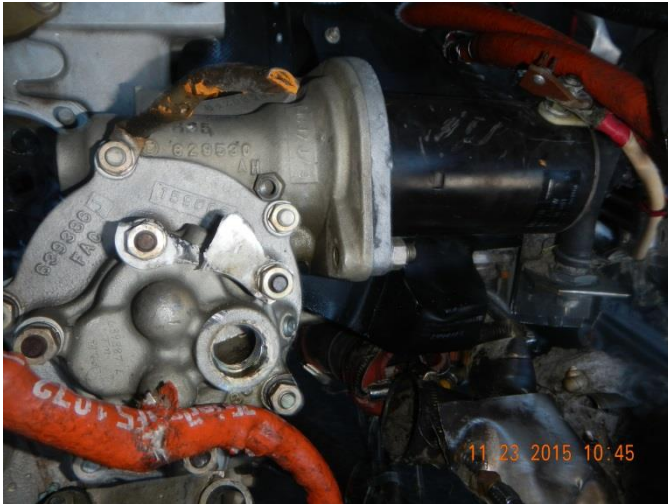
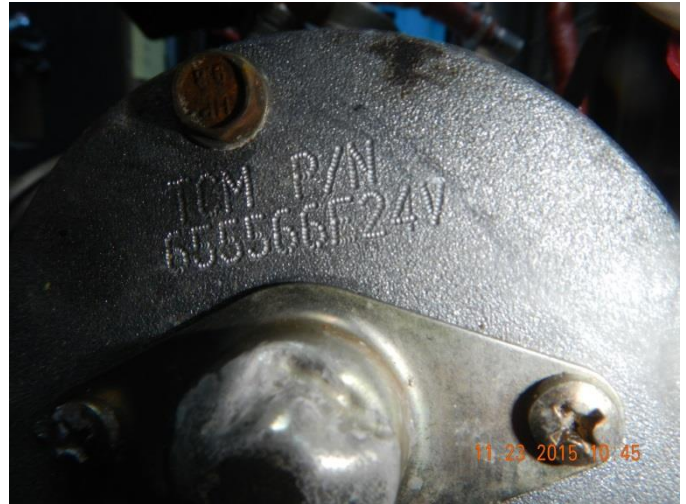
| <b>STARTER</b> | Manufacturer: Iskra (CMI) | P/N: 655566F24V | S/N: 02 280 0253 |

| Condition: | The starting motor appeared to be undamaged | | |

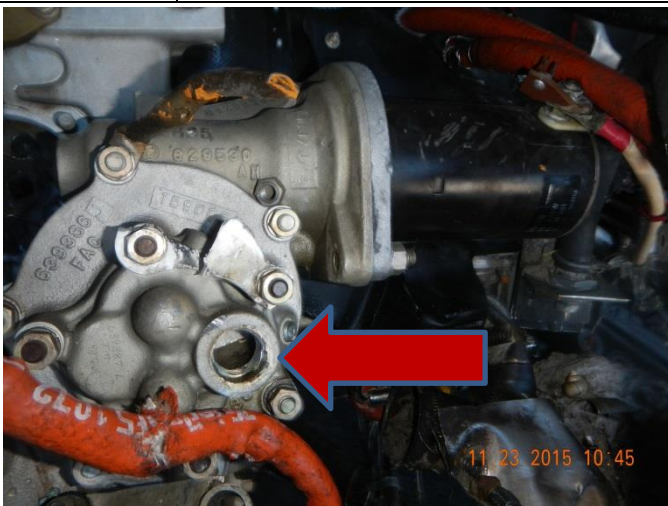
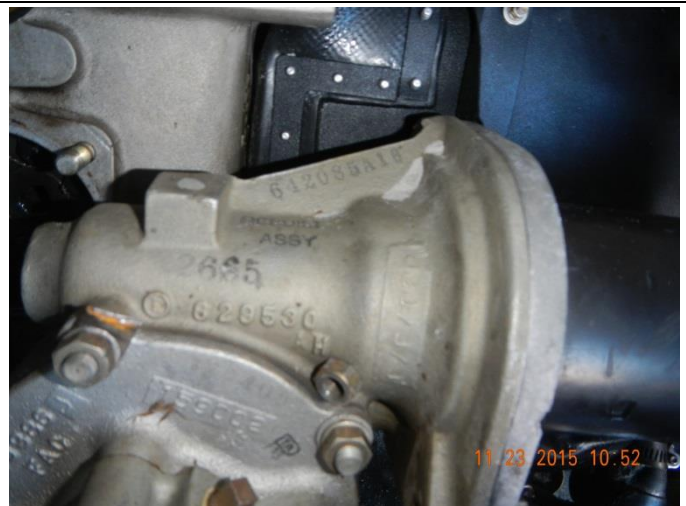
| <b>STARTER ADAPTER</b> | P/N: 642085A16 |

| Condition: | The starter adapter appeared to be undamaged with the exception of the fitting on the rear of the adapter which separated. The red arrow in the photo on the left points to the broken fitting. |

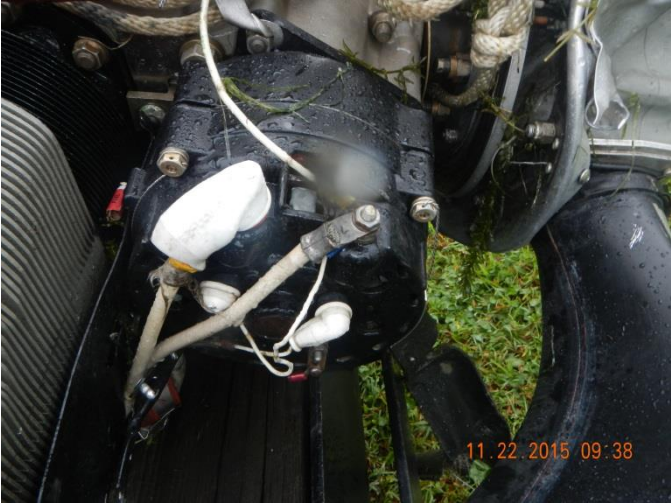
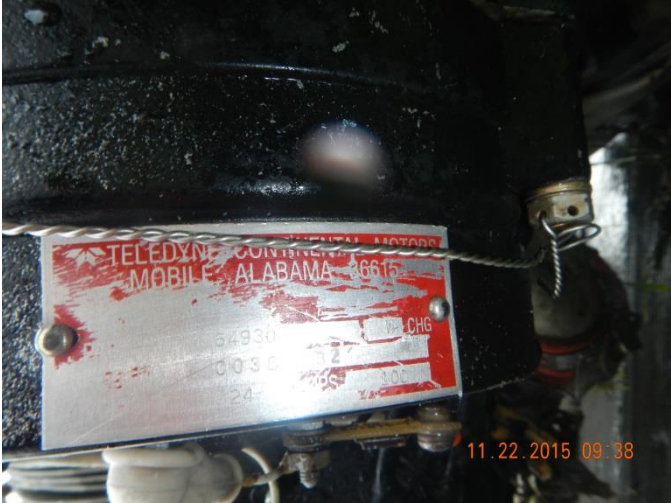
| ALTERNATOR | Manufacturer: TCM | P/N: 649304 | S/N: Undetermined |

| Condition: | The engine driven alternator appeared to be undamaged. | | |

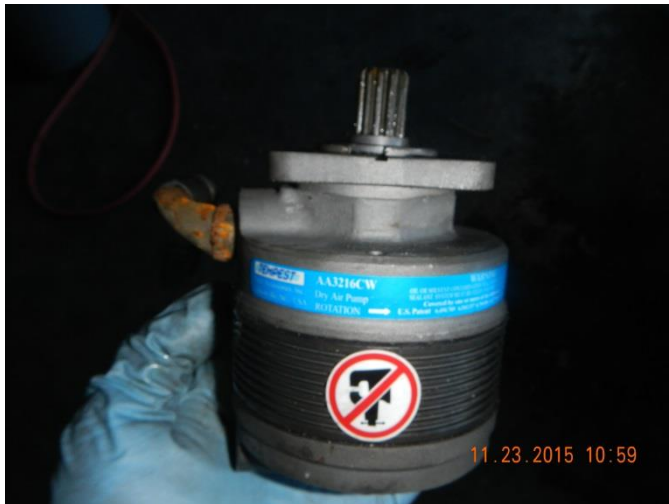
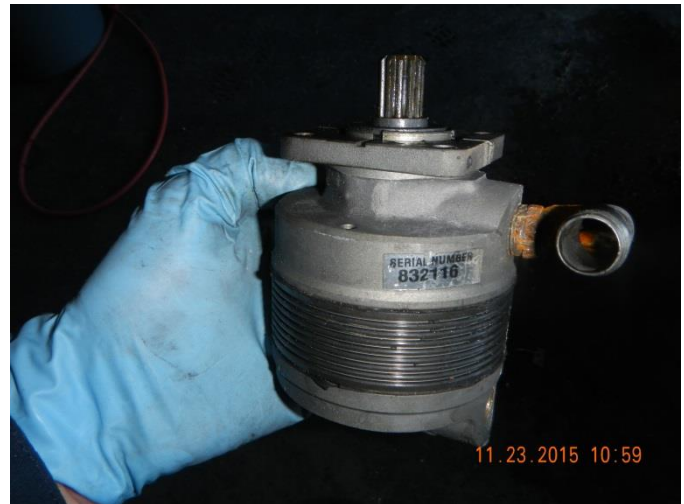
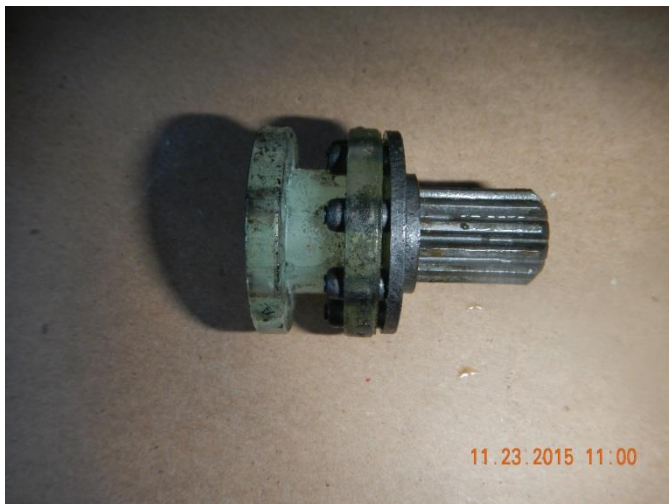
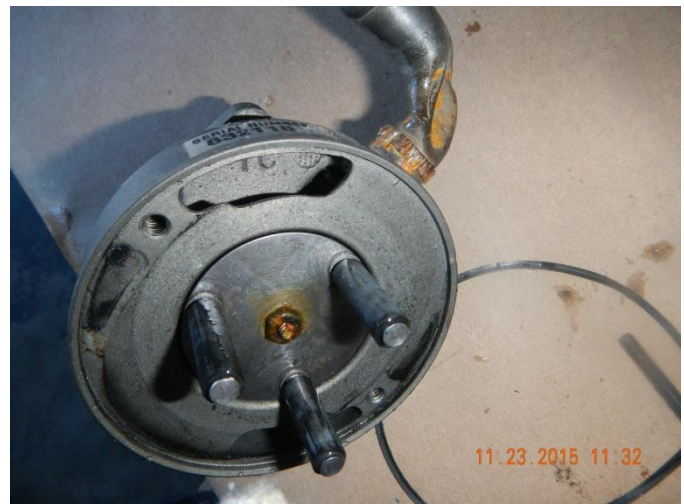
Condition: The vacuum/pressure pump remained intact with the exception of the exhaust fitting which separated. The pump rotated freely when the (intact) drive was manually rotated. The pump was disassembled. The rotor was intact and the carbon veins were found to be locked in the rotor slots by pond contamination. The veins were removed. All were intact and measured 1- 3/8 inches in length.

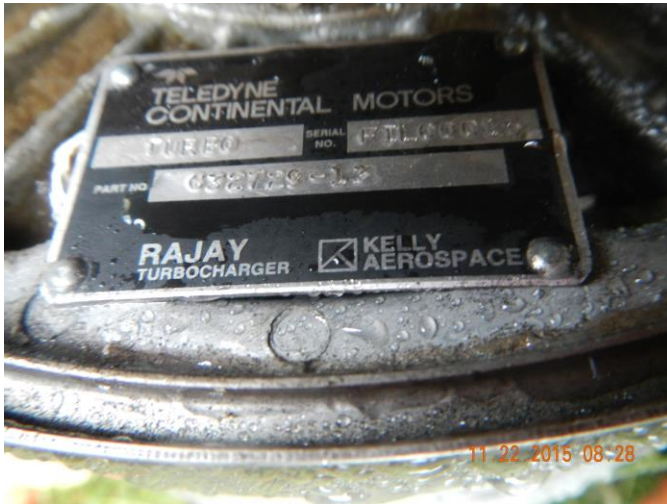
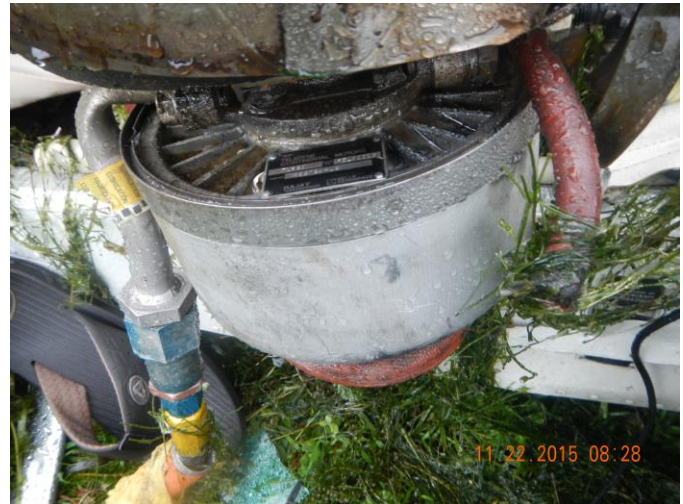
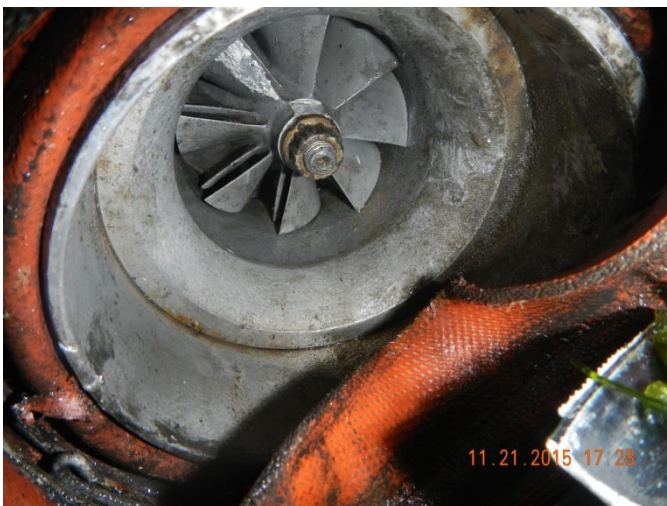
Condition: The turbo charger separated but was recovered. The turbine and compressor wheels remained intact but received impact damage. Neither the turbine or compressor wheels could be rotated manually

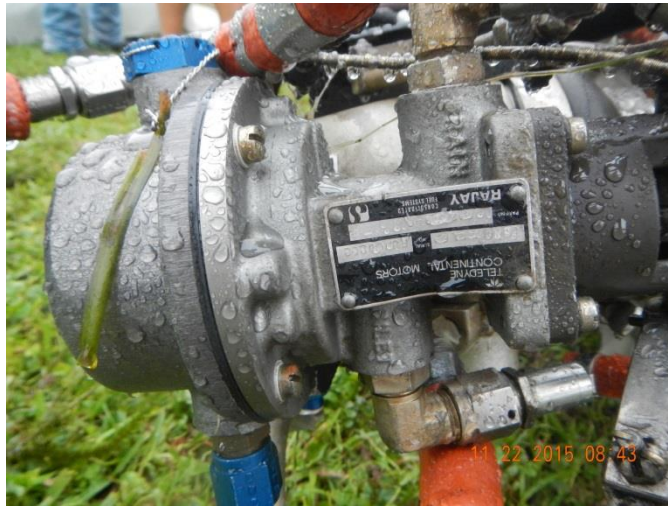
| <b>TURBO CONTROLLER</b> | Manufacturer: TCM | P/N:642628-6 | S/N:FJN00262 |

| Condition: | The controller appeared to be undamaged. | | |

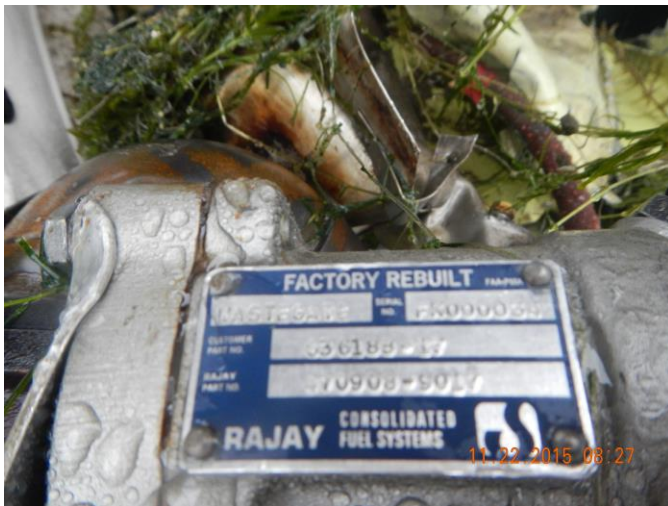
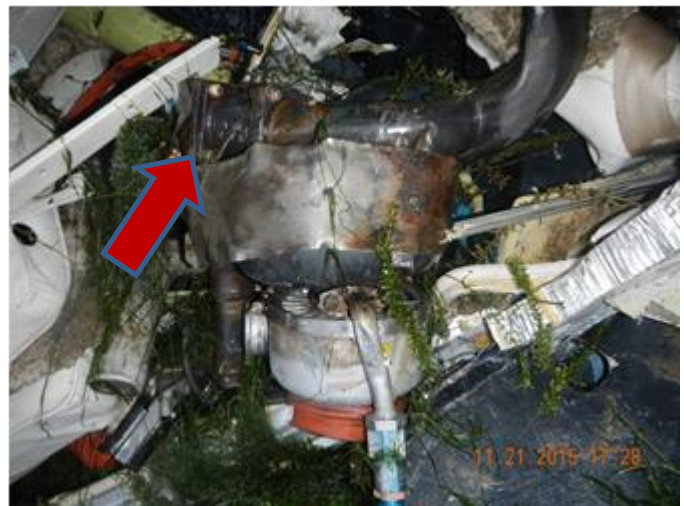
| <b>WASTEGATE/ WASTEGATE CONTROLLER</b> | Manufacturer: Ray Jay-Consolidated Fuel Systems | P/N:636188-17 | S/N:FK000034 |

| Condition: | The waste gate remained intact and in place. The red arrow in the photo points to the waste gate. | | |

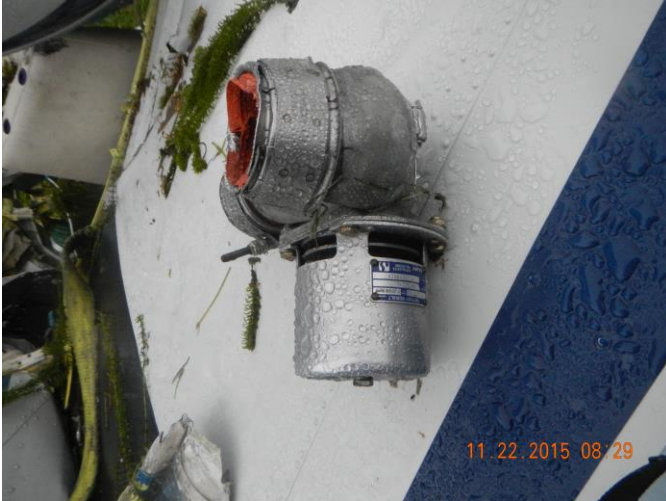
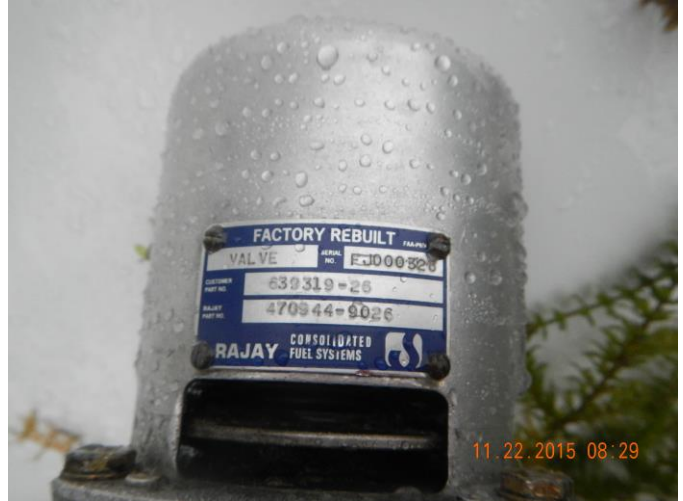
Condition: The overboost valve separated but was recovered by divers and presented for inspection. There was no apparent damage caused by impact.

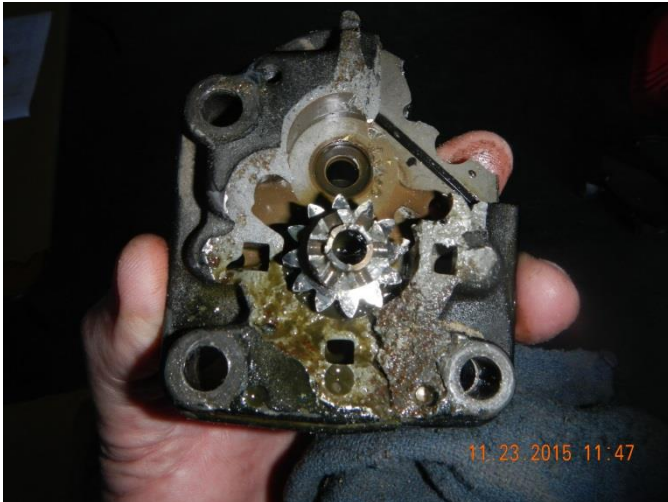
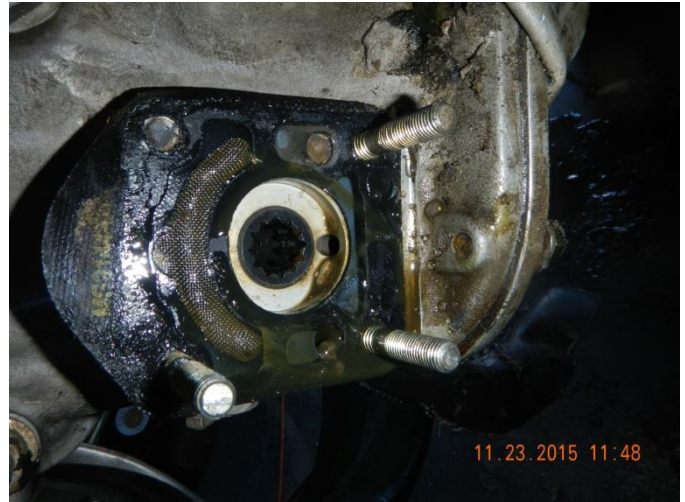
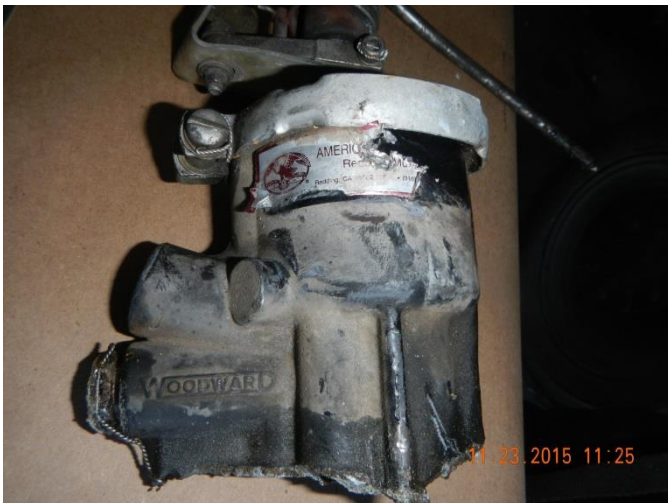
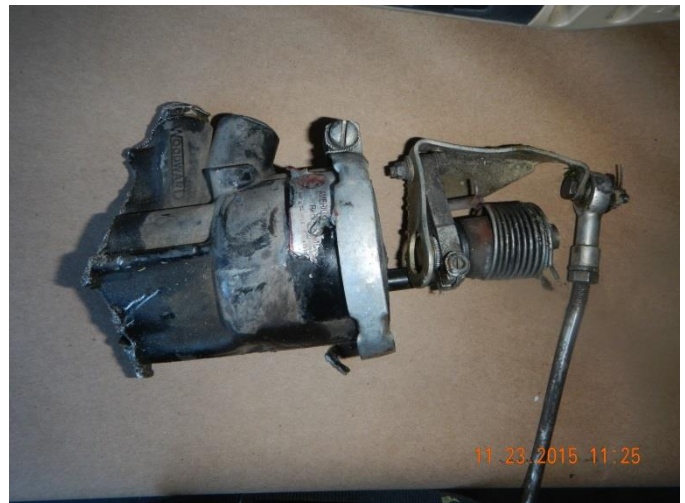
| <b>PROPELLER GOVERNOR</b> | Manufacturer: Woodward | P/N: Undetermined | S/N: Undetermined |

| Condition: | The propeller governor received impact damage and was fractured near the mounting collar. The governor housing broke apart when removal was attempted. The control arm was broken from the main housing. | | |
