# Continental Motors

## ENGINE FIELD INSPECTION REPORT

| ENGINE MODEL | TSIO520-UB |
| CMI FILE NUMBER | 15-297 |

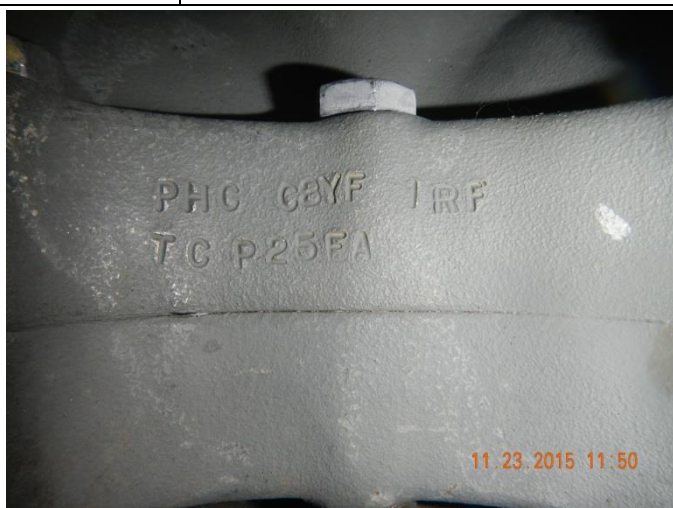
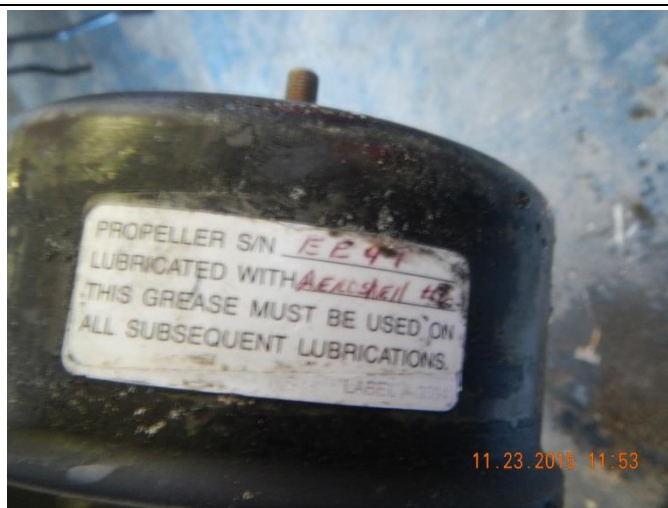
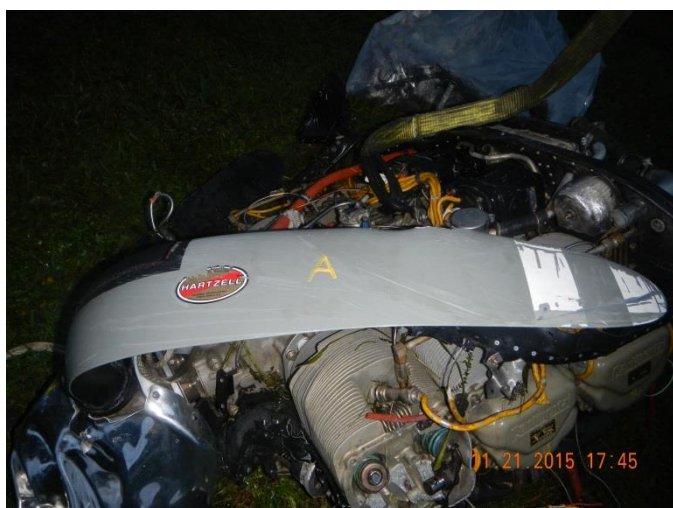
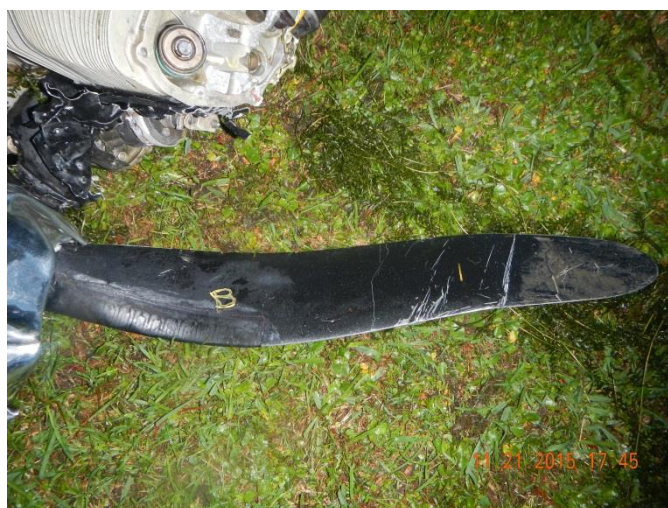
| <b>PROPELLER</b> | Manufacturer: Hartzell | P/N:PHC C8YF1RF | S/N:EE47 |

Condition: The three bladed constant speed propeller remained attached with significant impact damage to its spinner and propeller blades. The aluminum spinner was crushed rearward pressing the cone around the propeller dome and hub. The spinner was removed to expose the propeller hub. Each of the three propeller blades was marked with a letter A, B, or C for photo identification.

Blade A received smooth rearward bending due to impact forces beginning approximately 4 inches from the blade root. The blade's leading edge received heavy gouging beginning approximately 10 inches from the blade tip. Blade A was loose in the hub allowing the blade to rotate within the hub mount.

Blade B received smooth rearward bending due to impact forces beginning approximately 7" from the blade root. The propeller blade received significant leading edge gouging beginning approximately 13" from the propeller tip.

Blade C received smooth rearward bending due to impact forces beginning approximately 5" from the blade root. The propeller blade received deep leading edge gouging beginning 15-19" from the blade tip. Blade C was loose in the hub allowing the blade to rotate within the hub mount.
