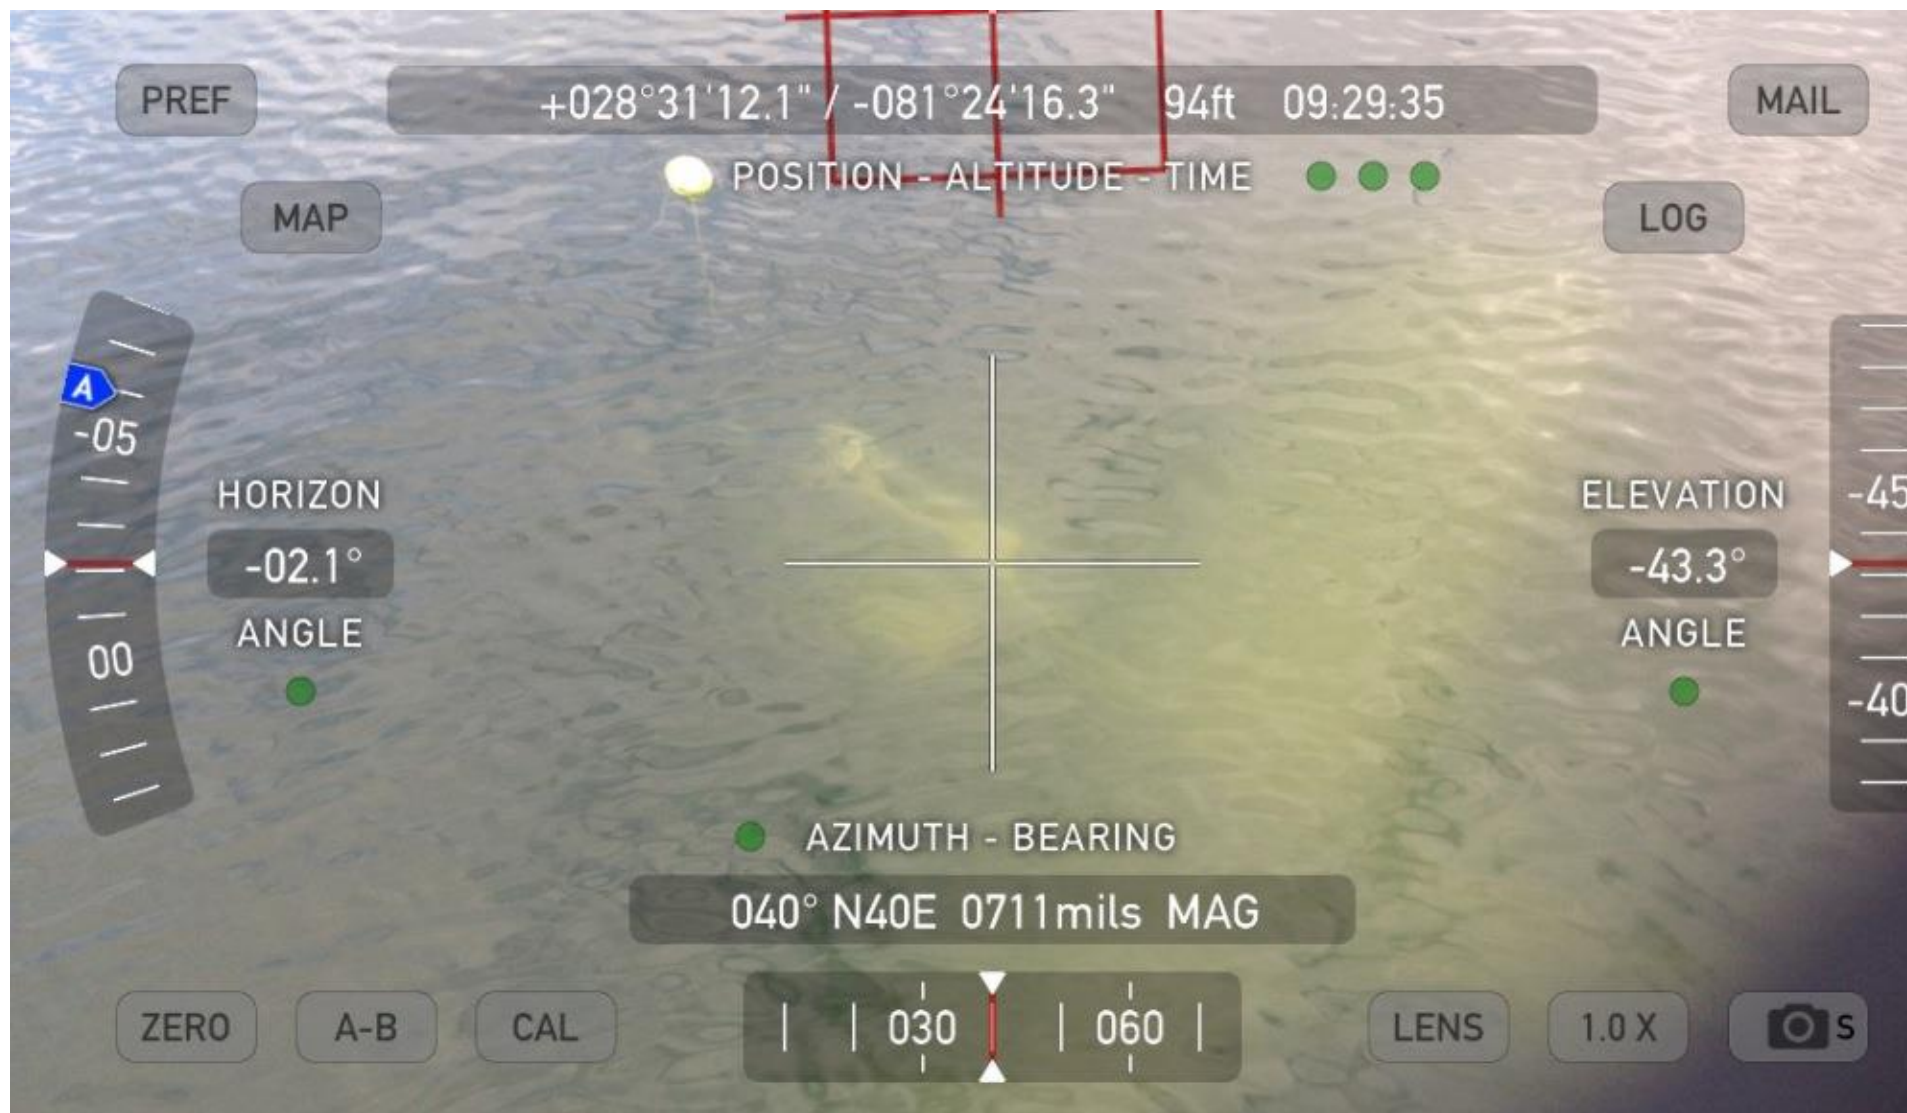
**Photo 1 – NTSB Digital Photograph. Theodolite Image of the Submerged Wreckage**

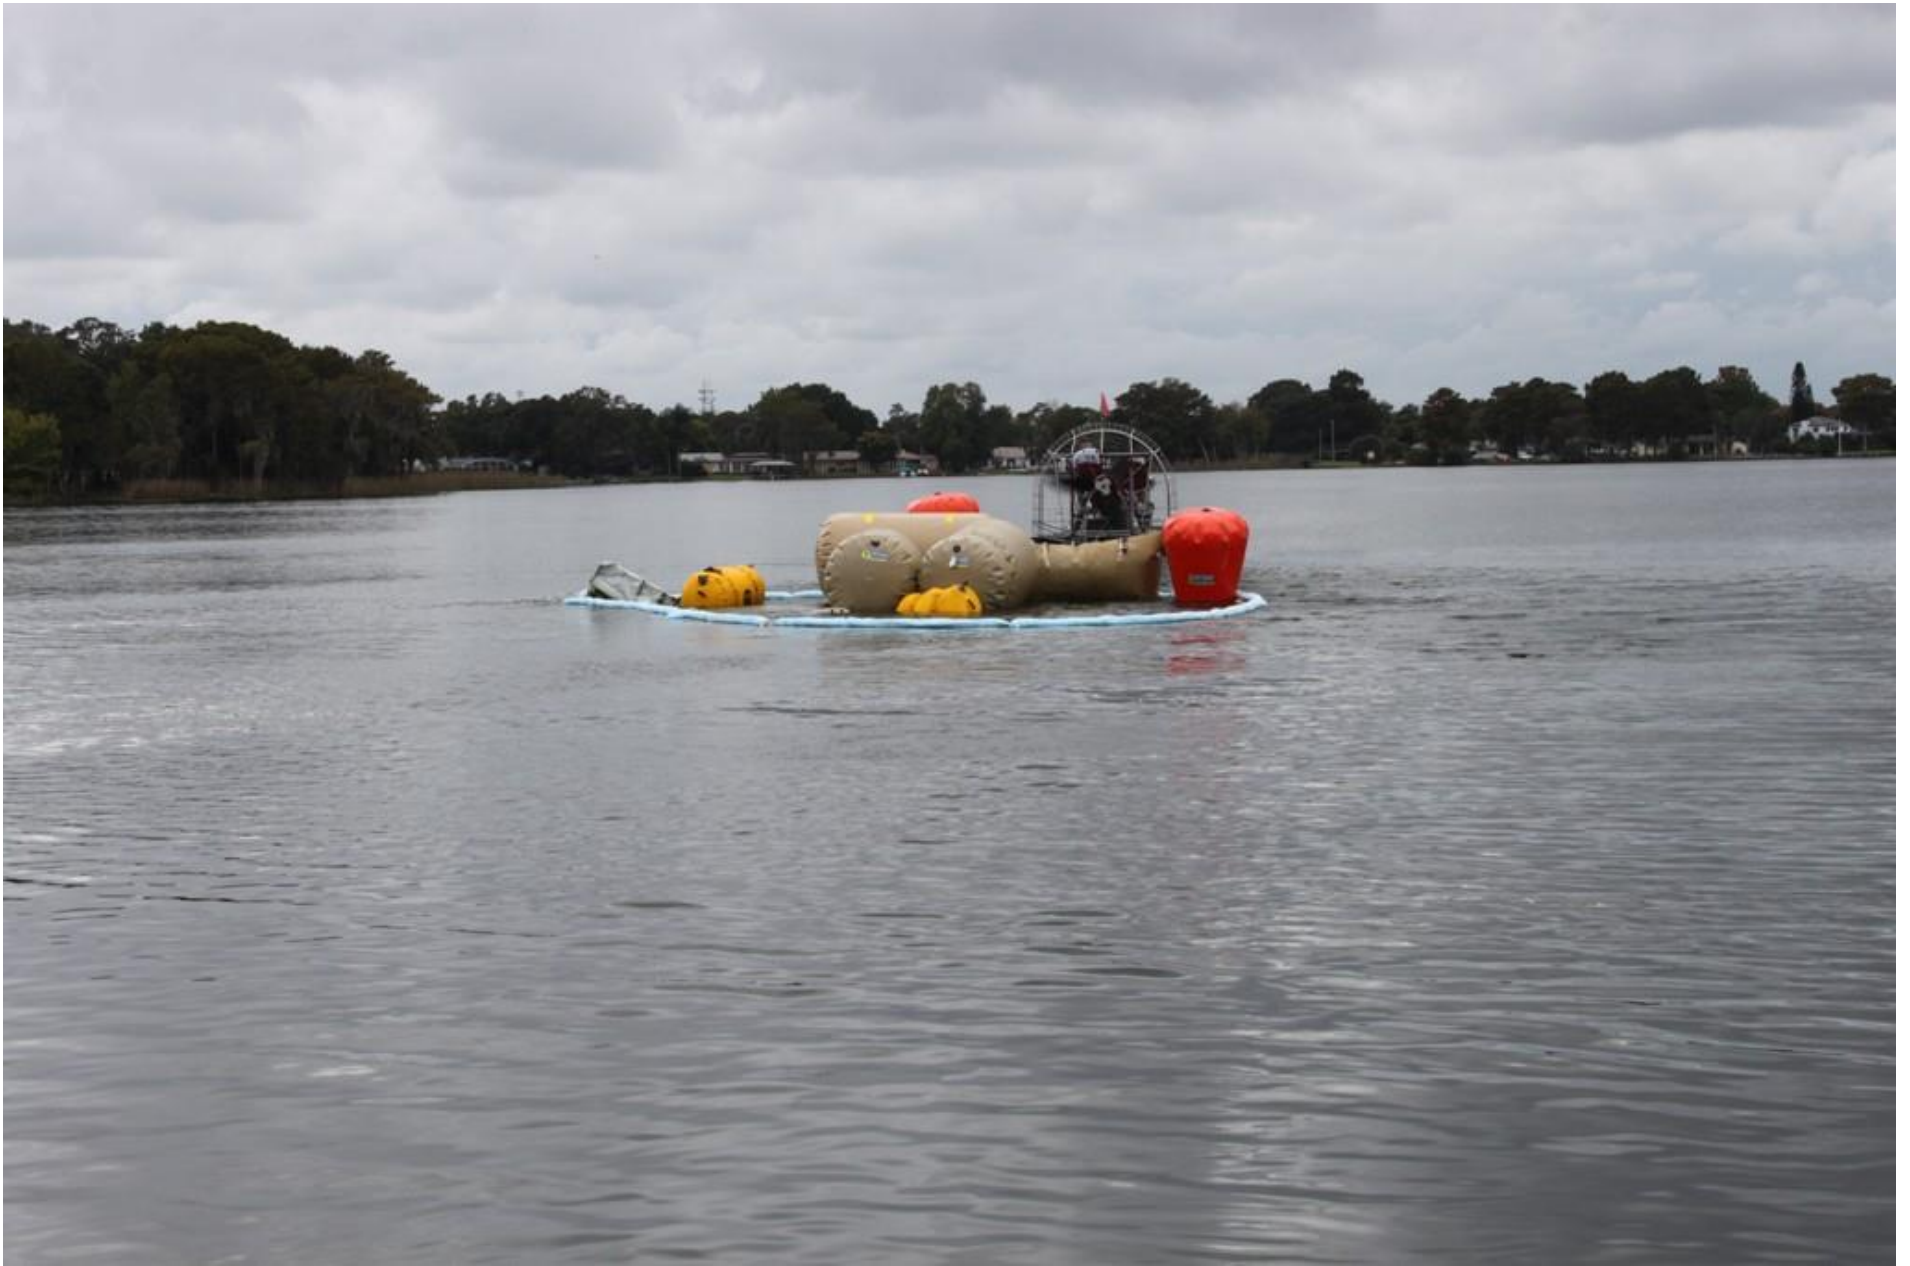
**Photo 2 - NTSB Digital Photograph. View of the Wreckage Being Towed to Shore For Recovery**

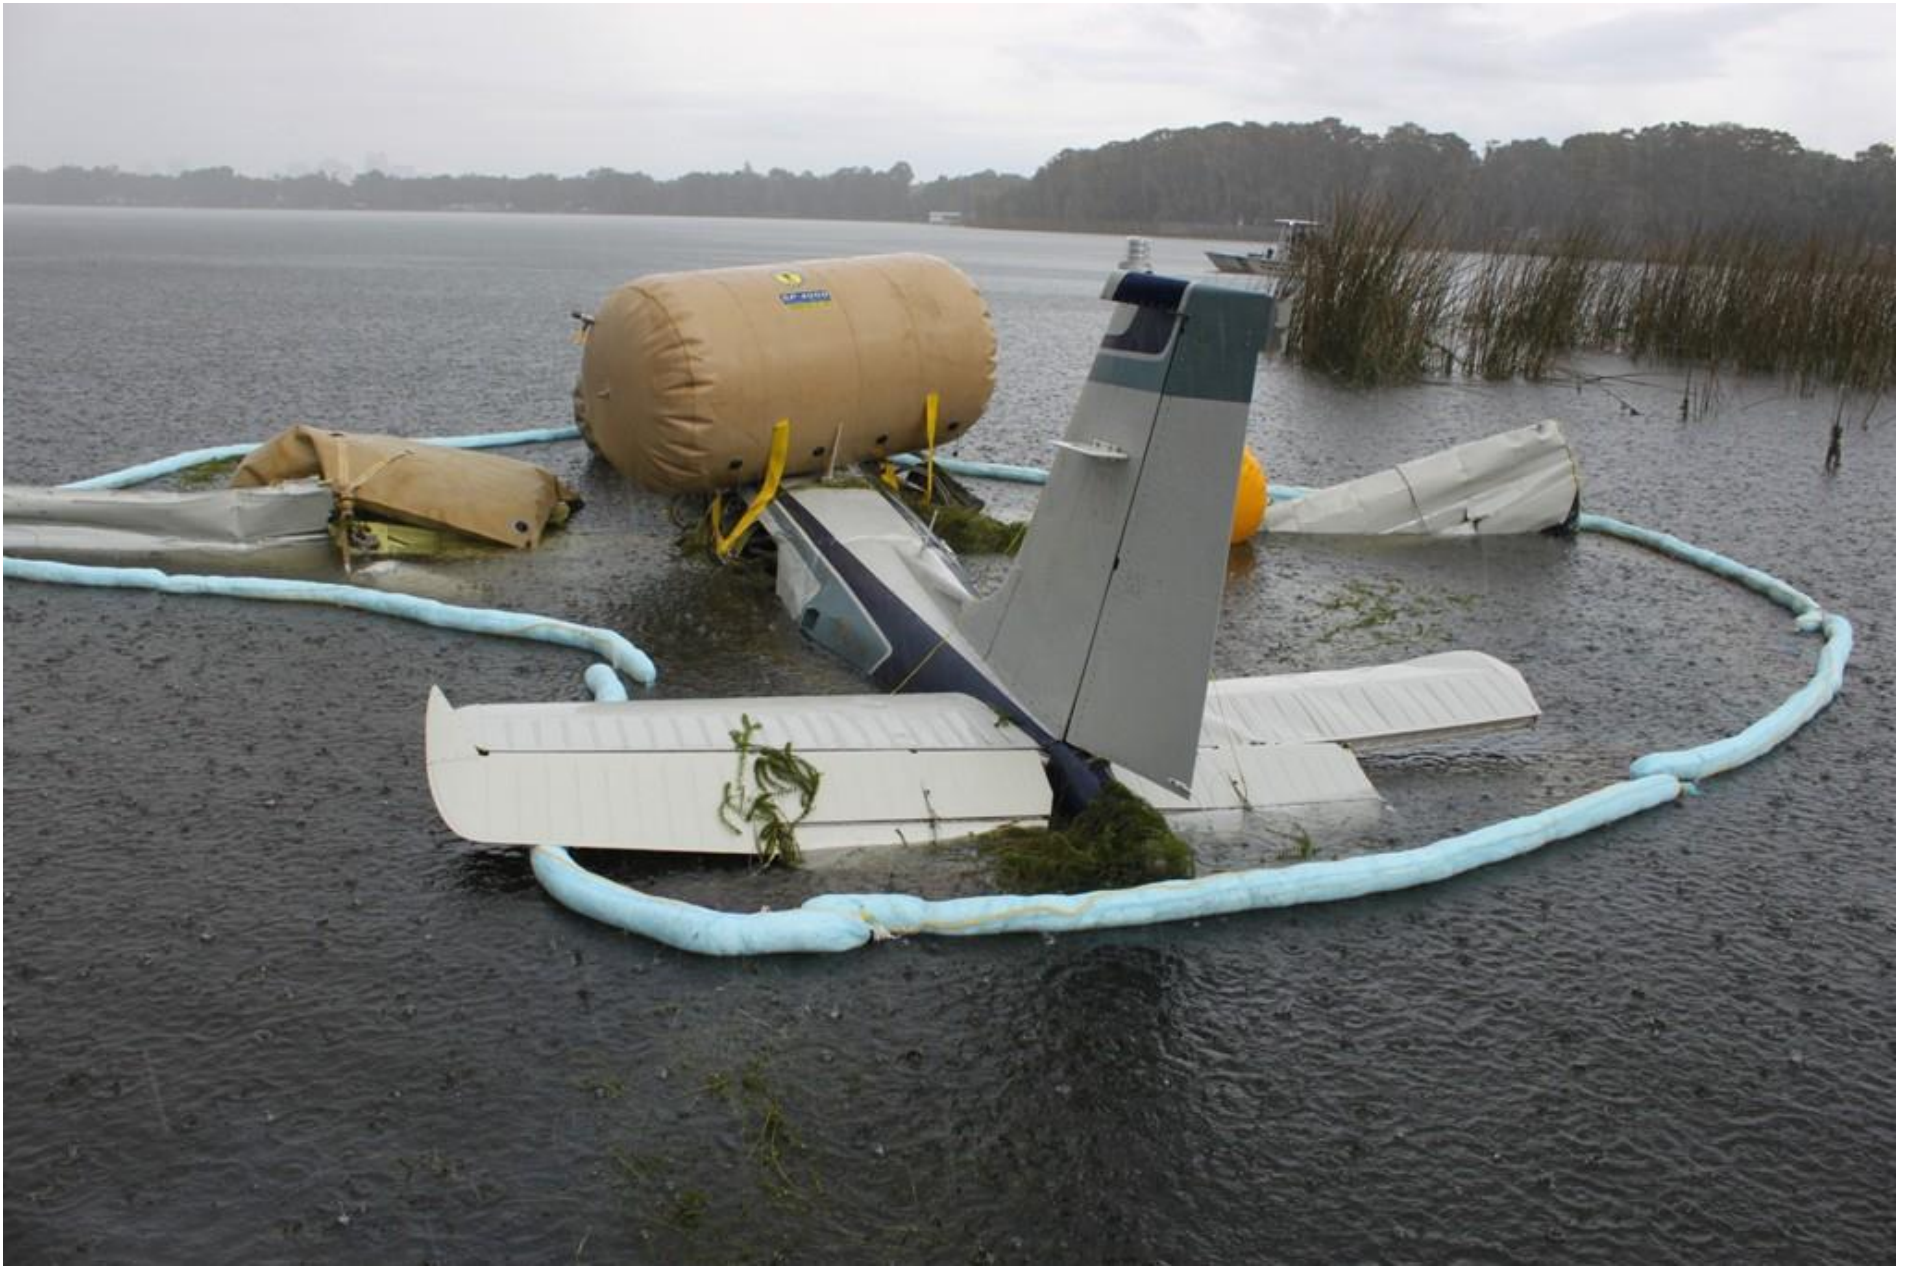
**Photo 3 - NTSB Digital Photograph. View of the Empennage Before Recovery from the Water**

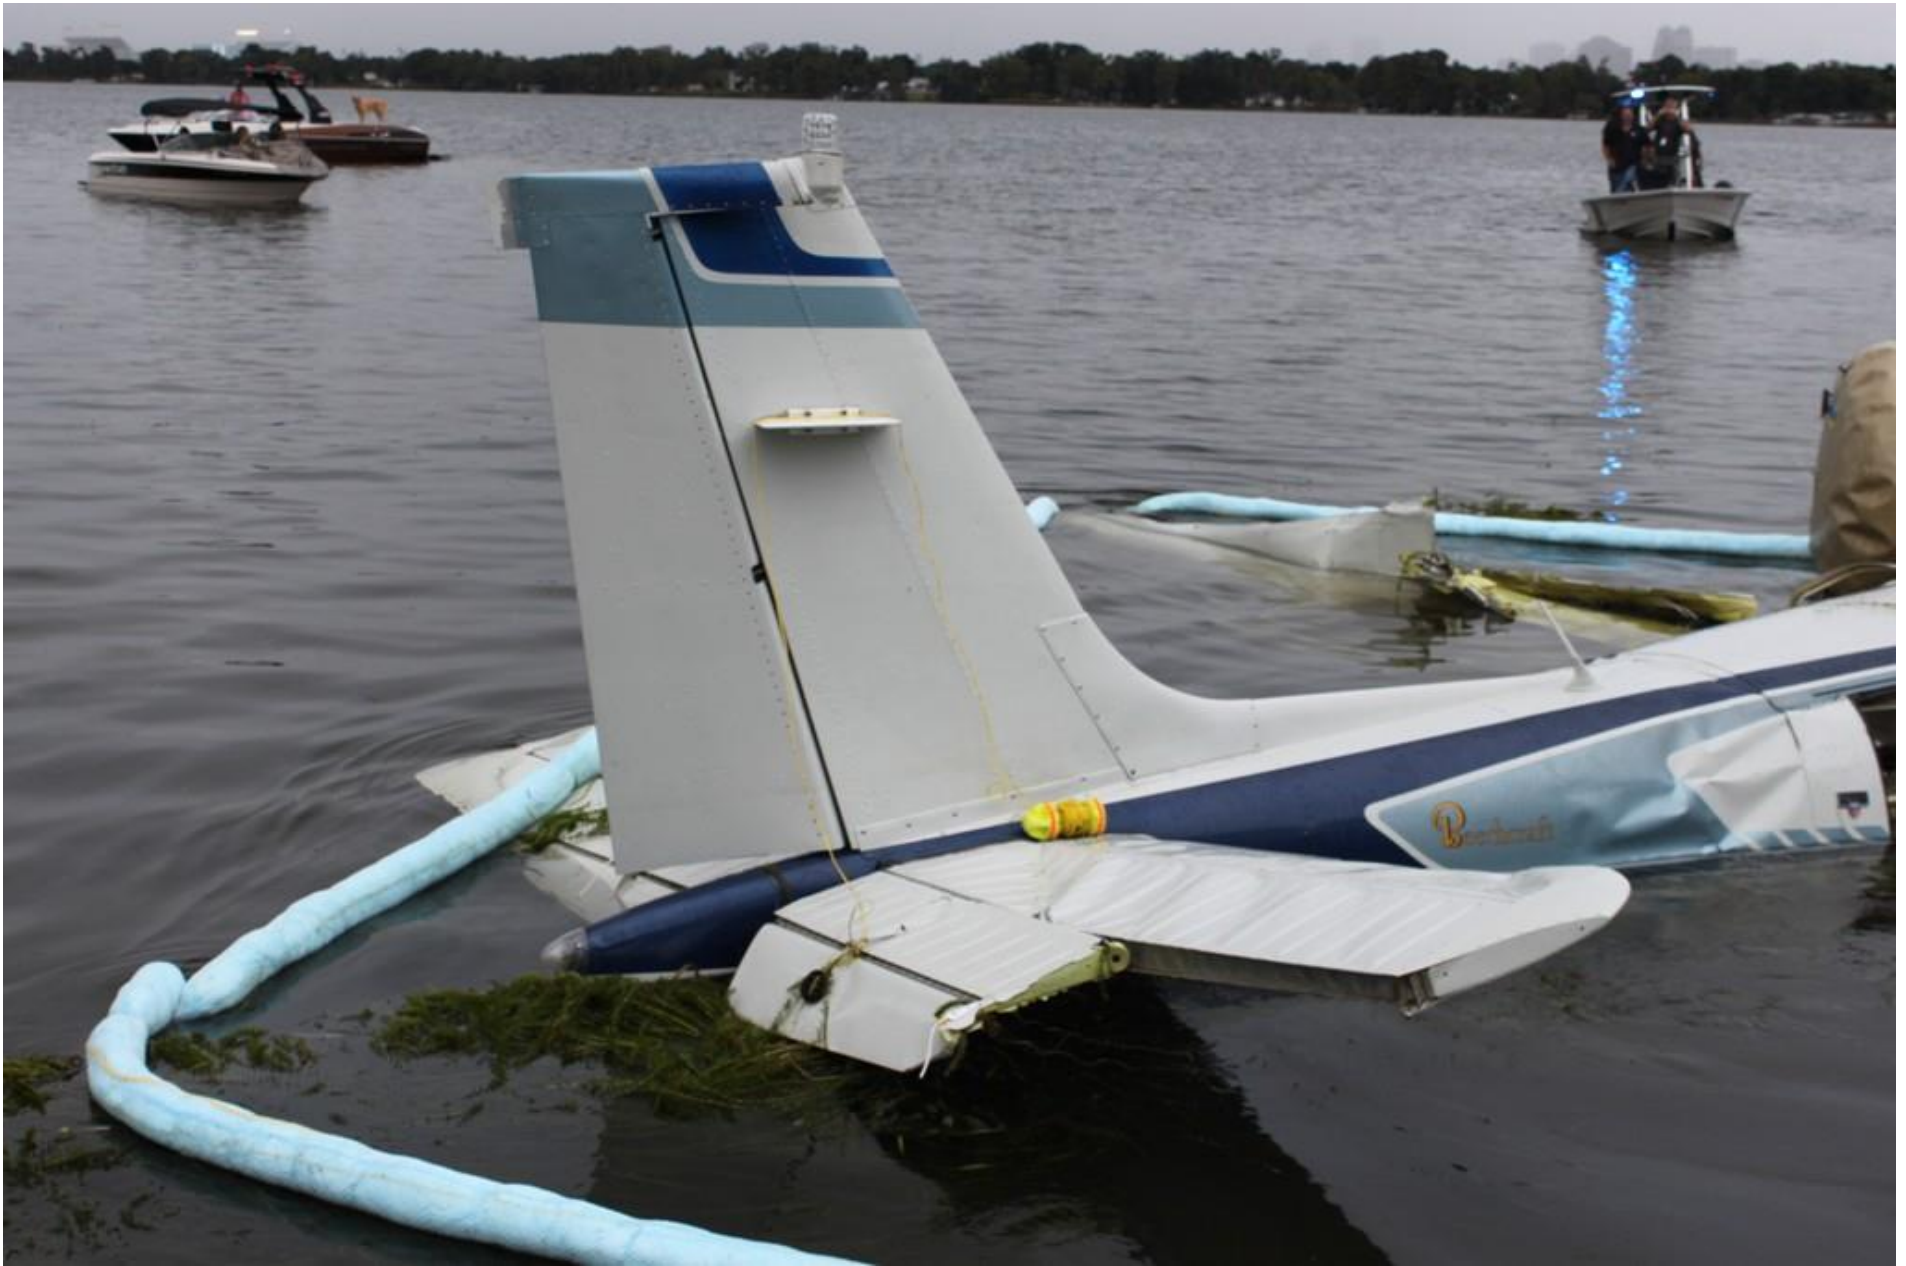
**Photo 4 - NTSB Digital Photograph. View of the Right Side of the Empennage Before Recovery from the Water. Note the Position of the Right Elevator Trim Tab**

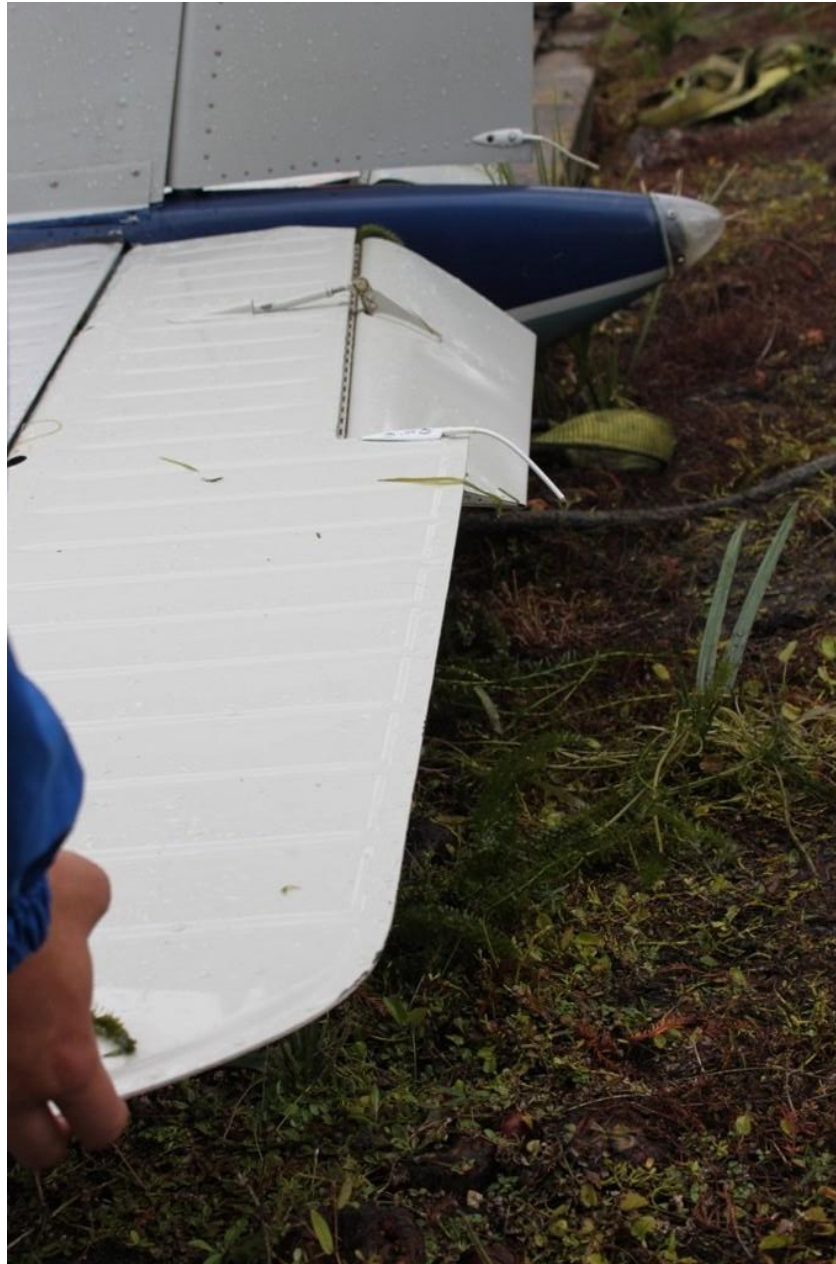
**Photo 5 - NTSB Digital Photograph. Left Side View of the Left Elevator, Elevator Trim Tab, and Portions of Vertical and Horizontal Stabilizer and Rudder.**

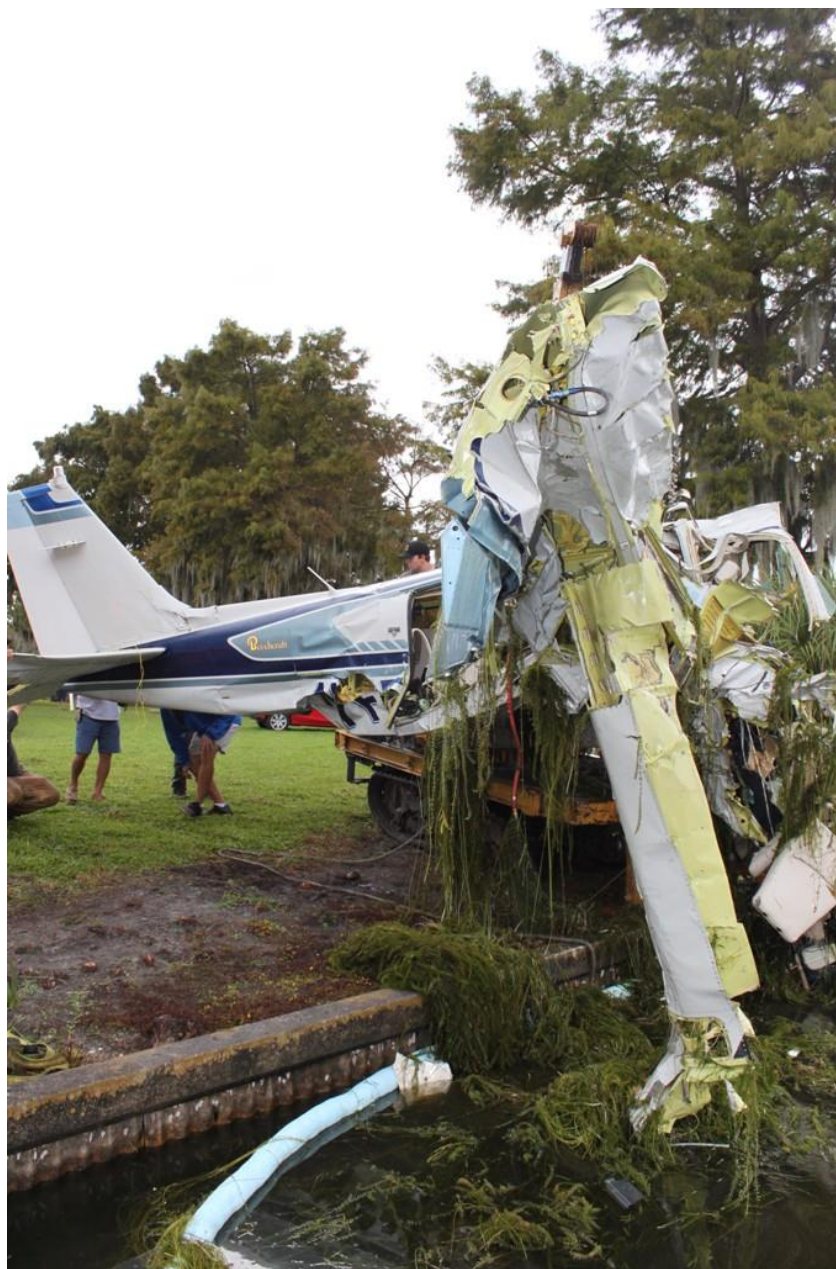
**Photo 6 - NTSB Digital Photograph. Right Side View of the Wreckage During Recovery from the Lake**

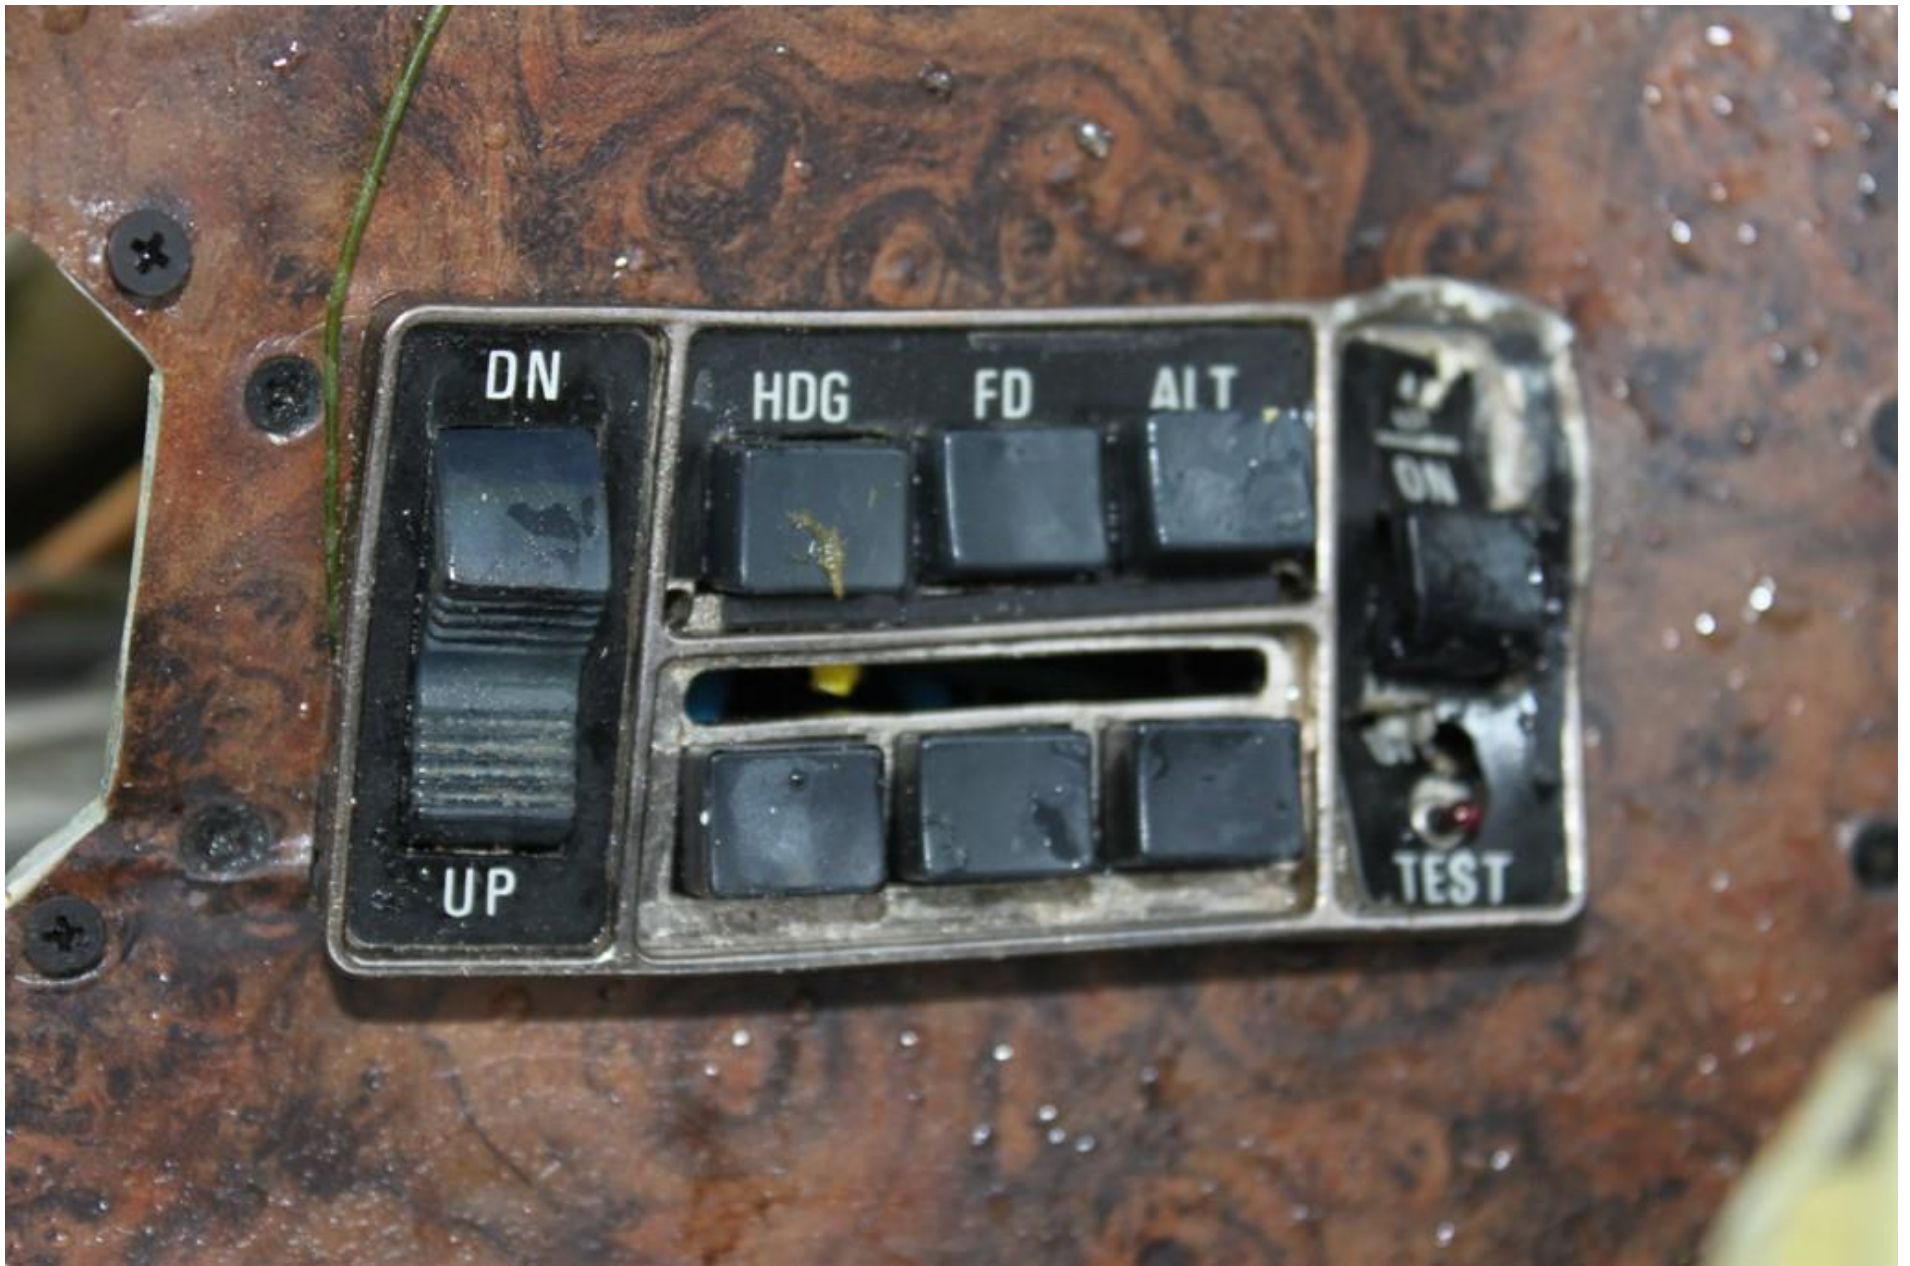
**Photo 7 - NTSB Digital Photograph. View of the Autopilot Mode Controller**

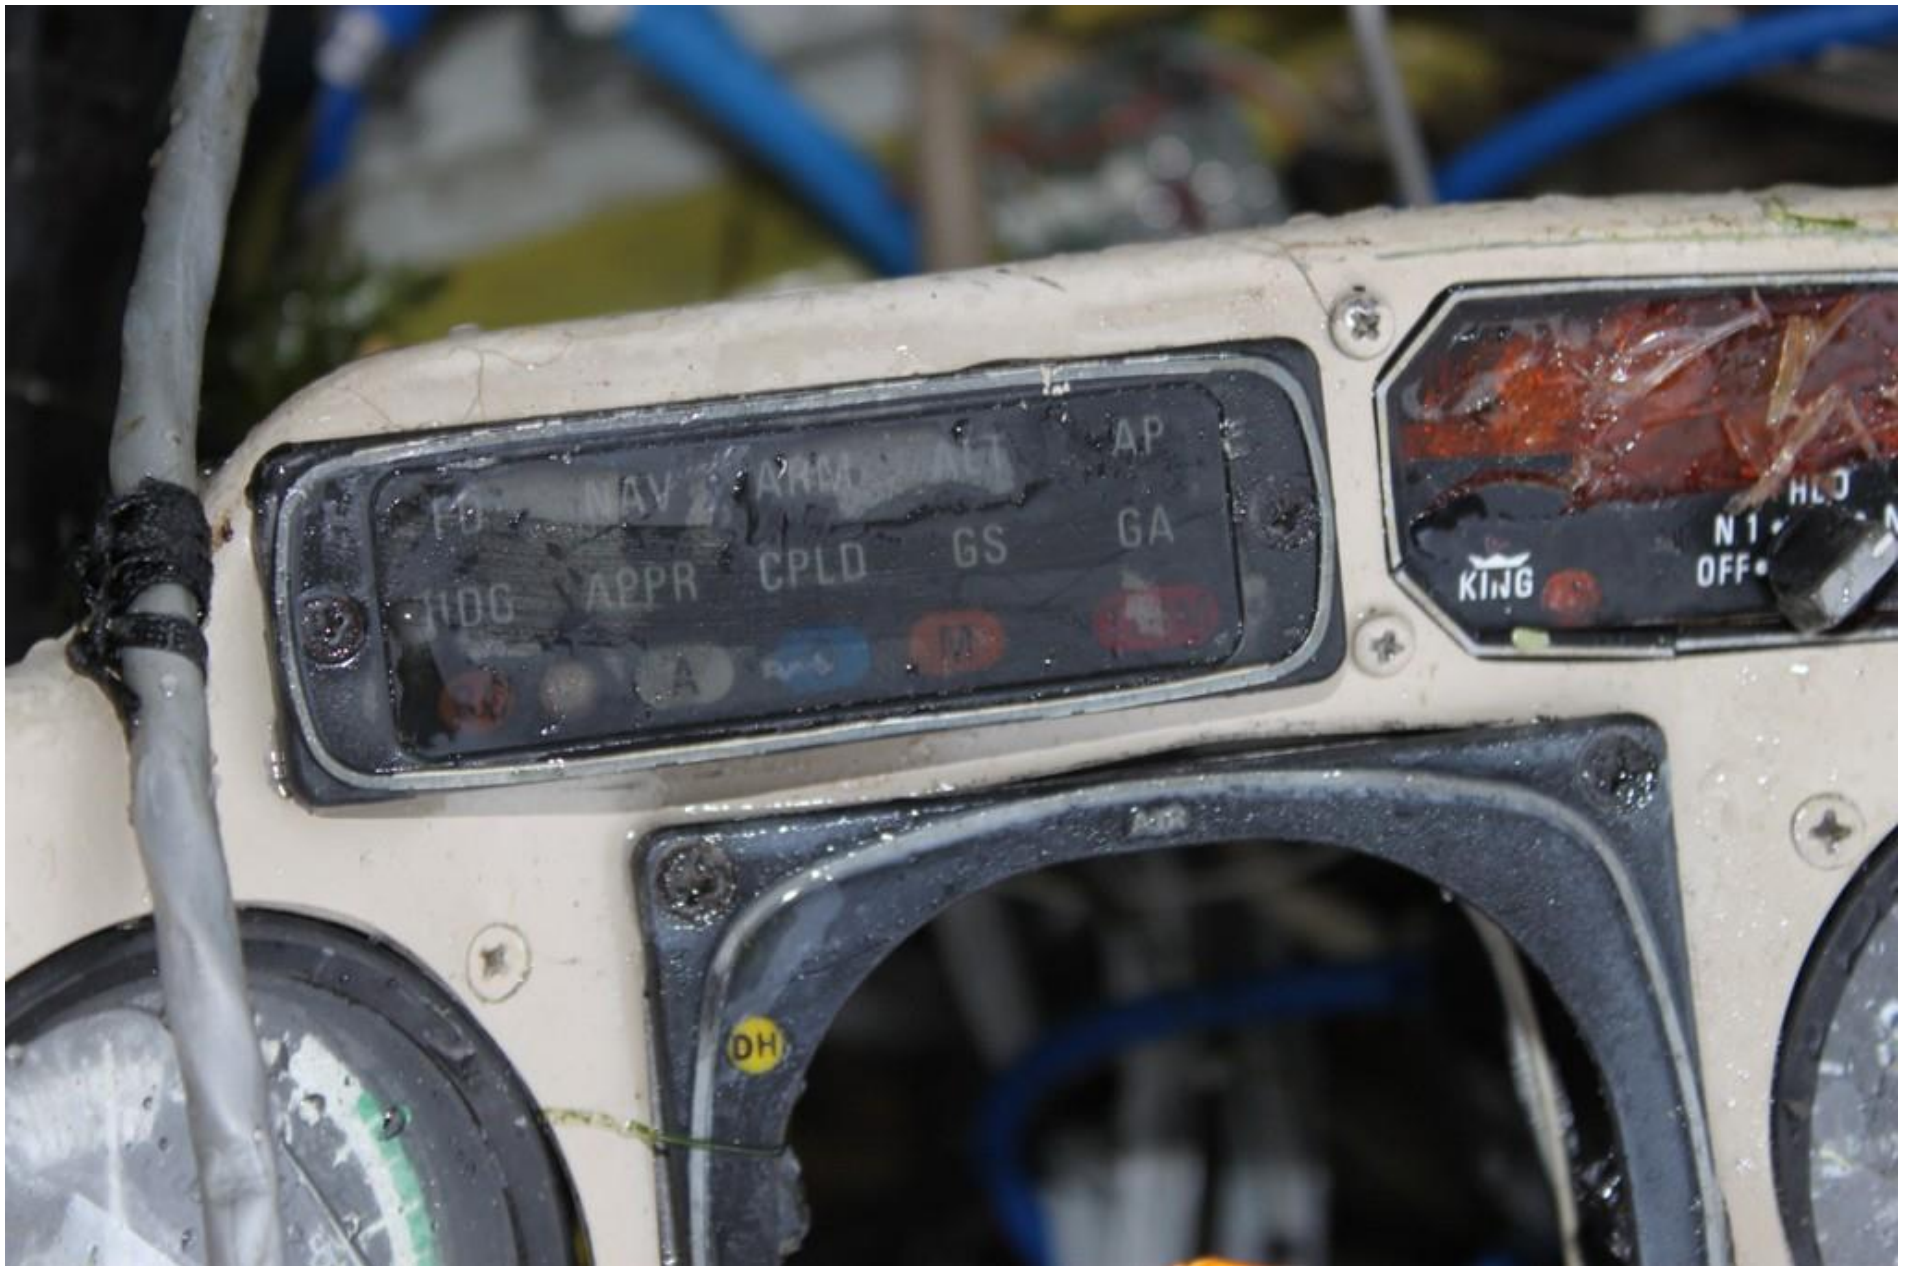
**Photo 8 - NTSB Digital Photograph. View of the Autopilot Mode Annunciator Panel**

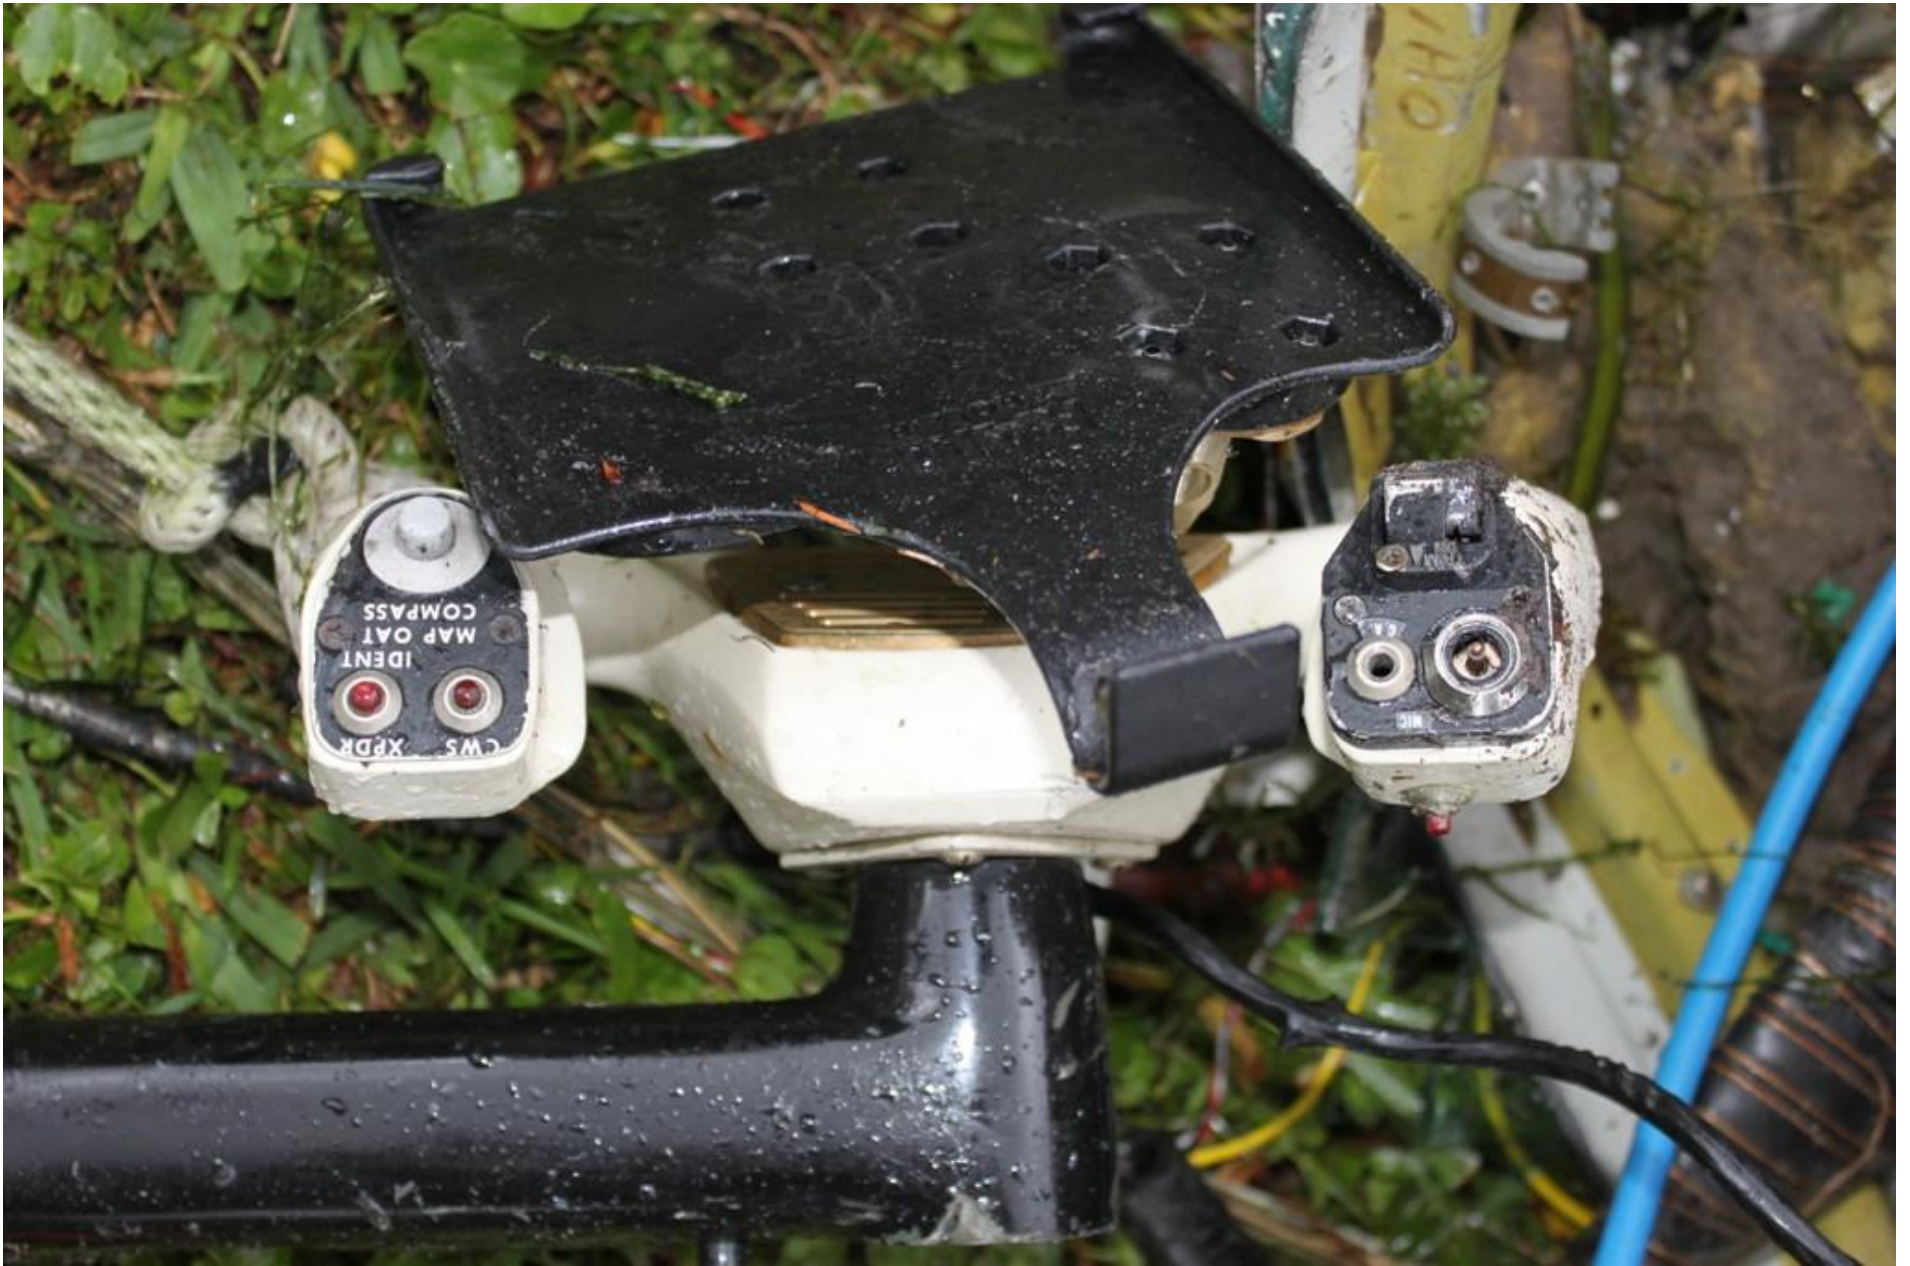
**Photo 9 - NTSB Digital Photograph. View of the Pilot's Control Yoke.**

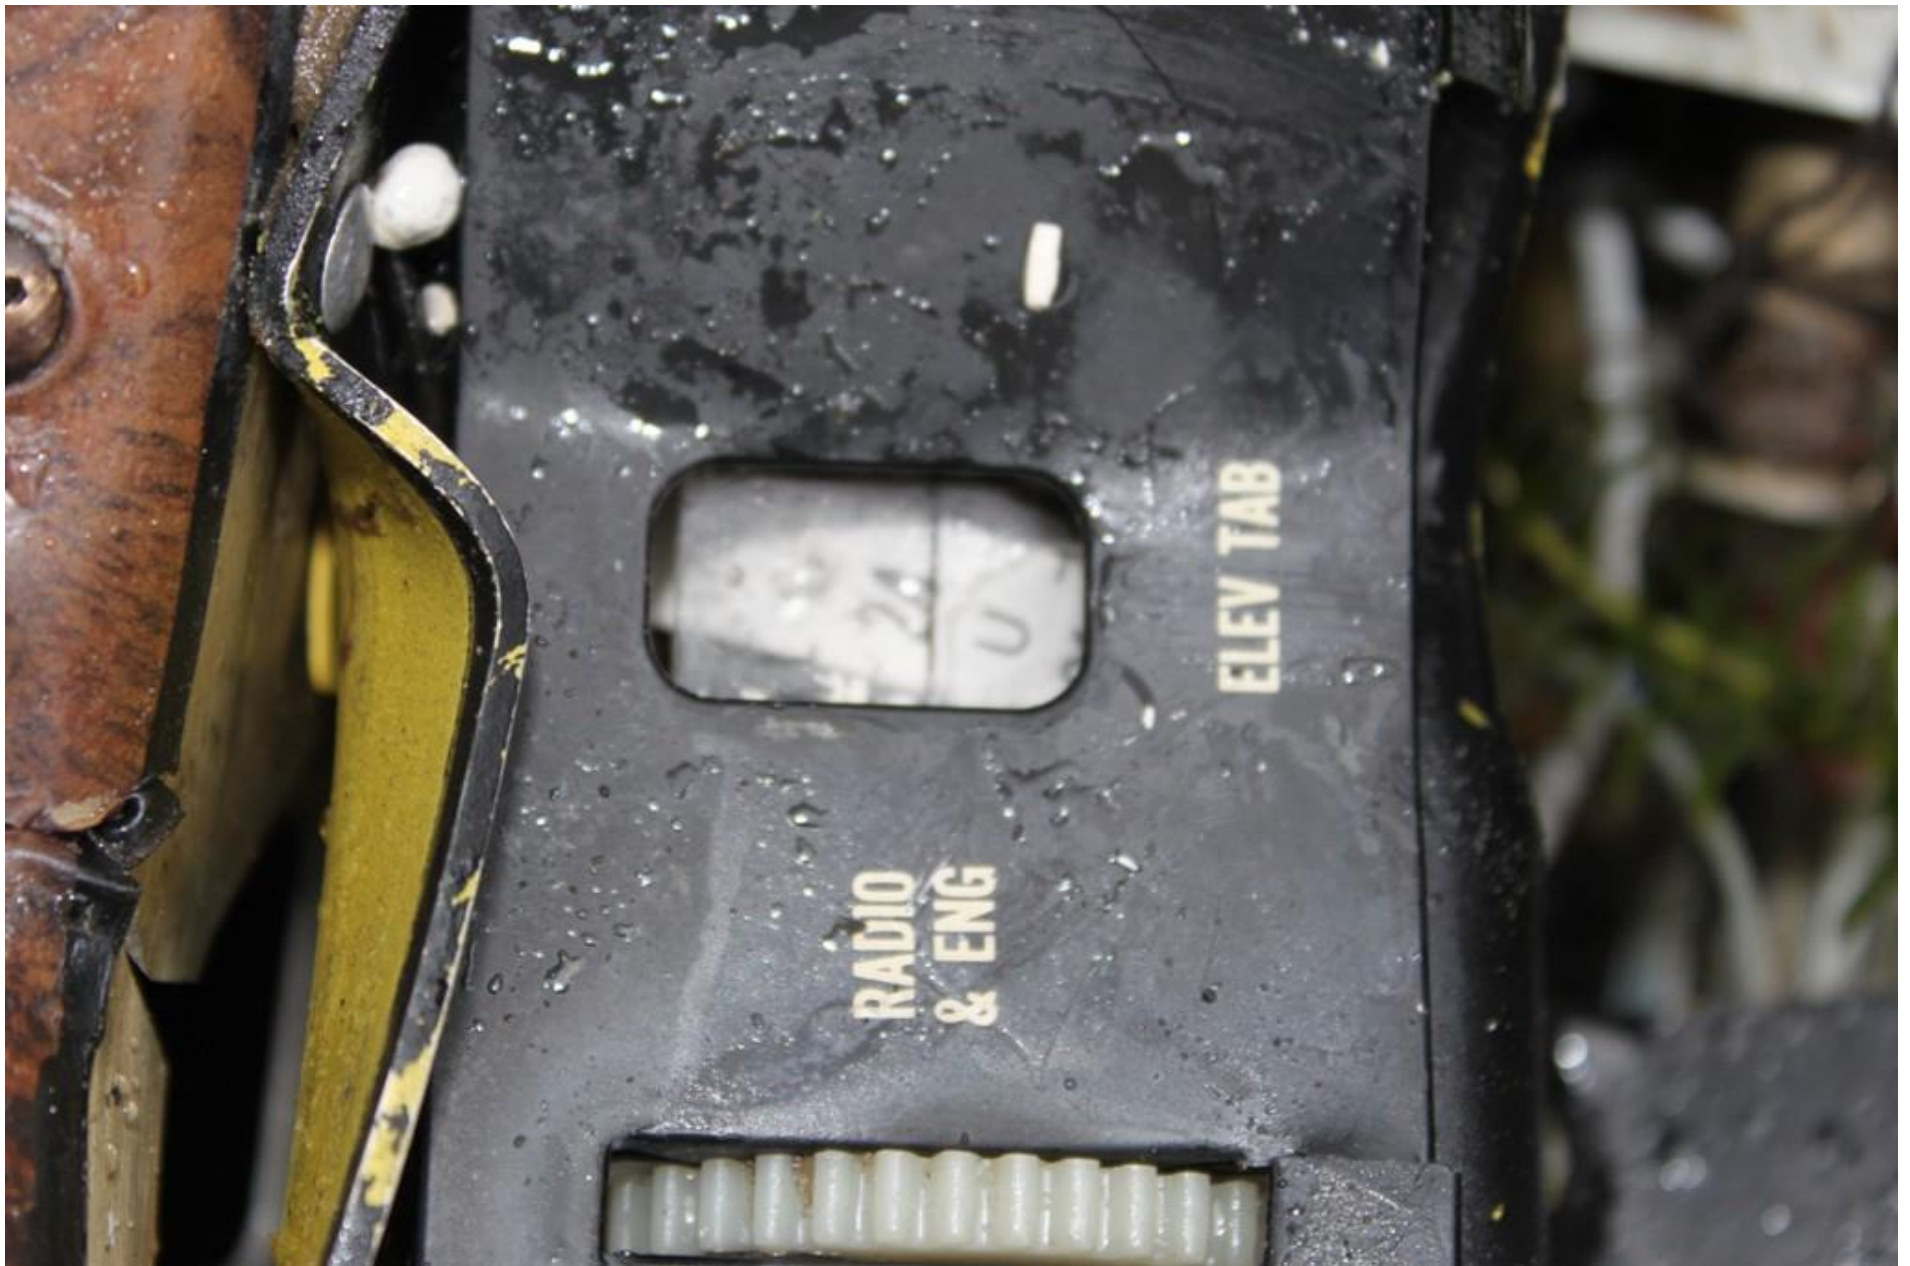
**Photo 10 - NTSB Digital Photograph. View of the Elevator Trim Indicator**
