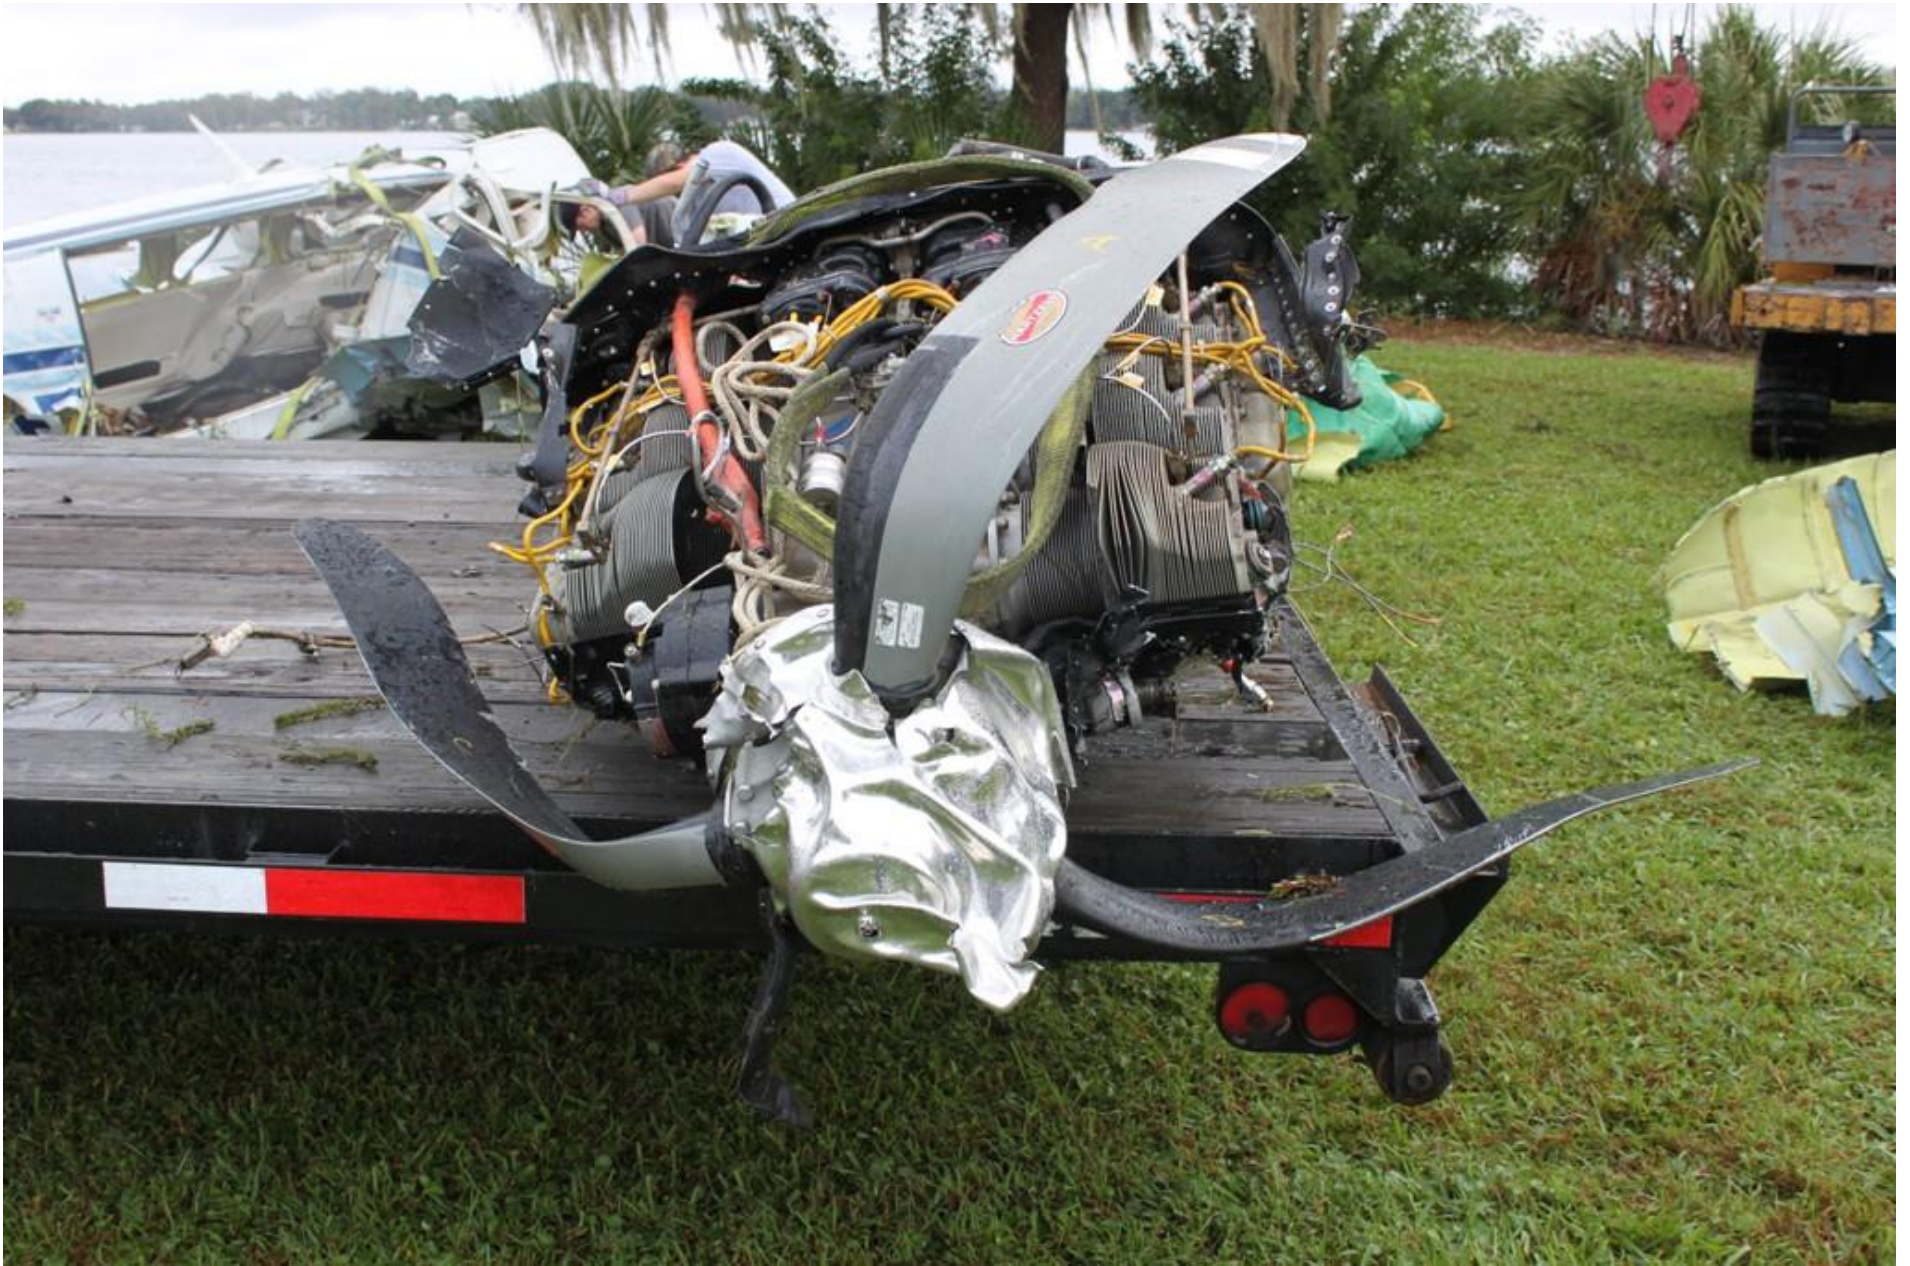
**Photo 11 - NTSB Digital Photograph. View of the Engine and Propeller Assembly**

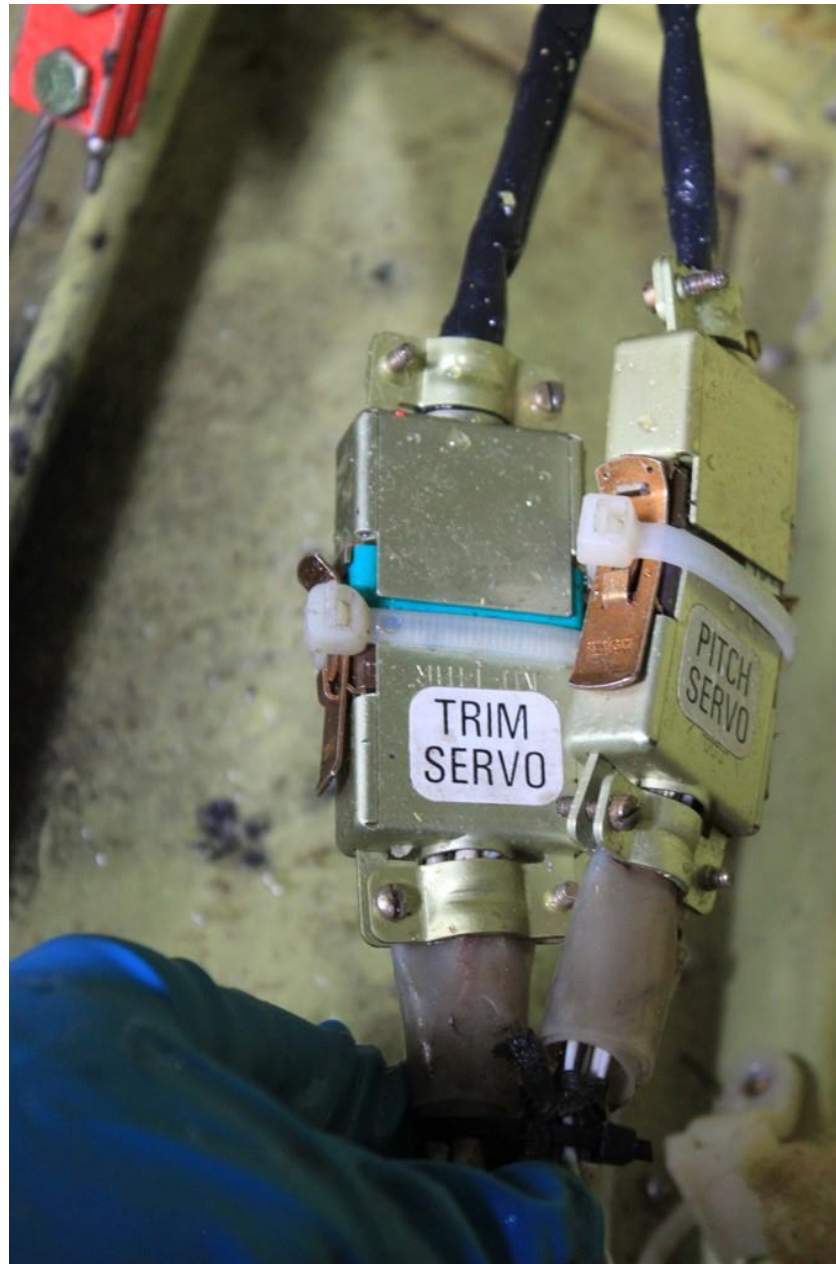
**Photo 12 - NTSB Digital Photograph. View of the Connections for Trim and Pitch Trim Servos**

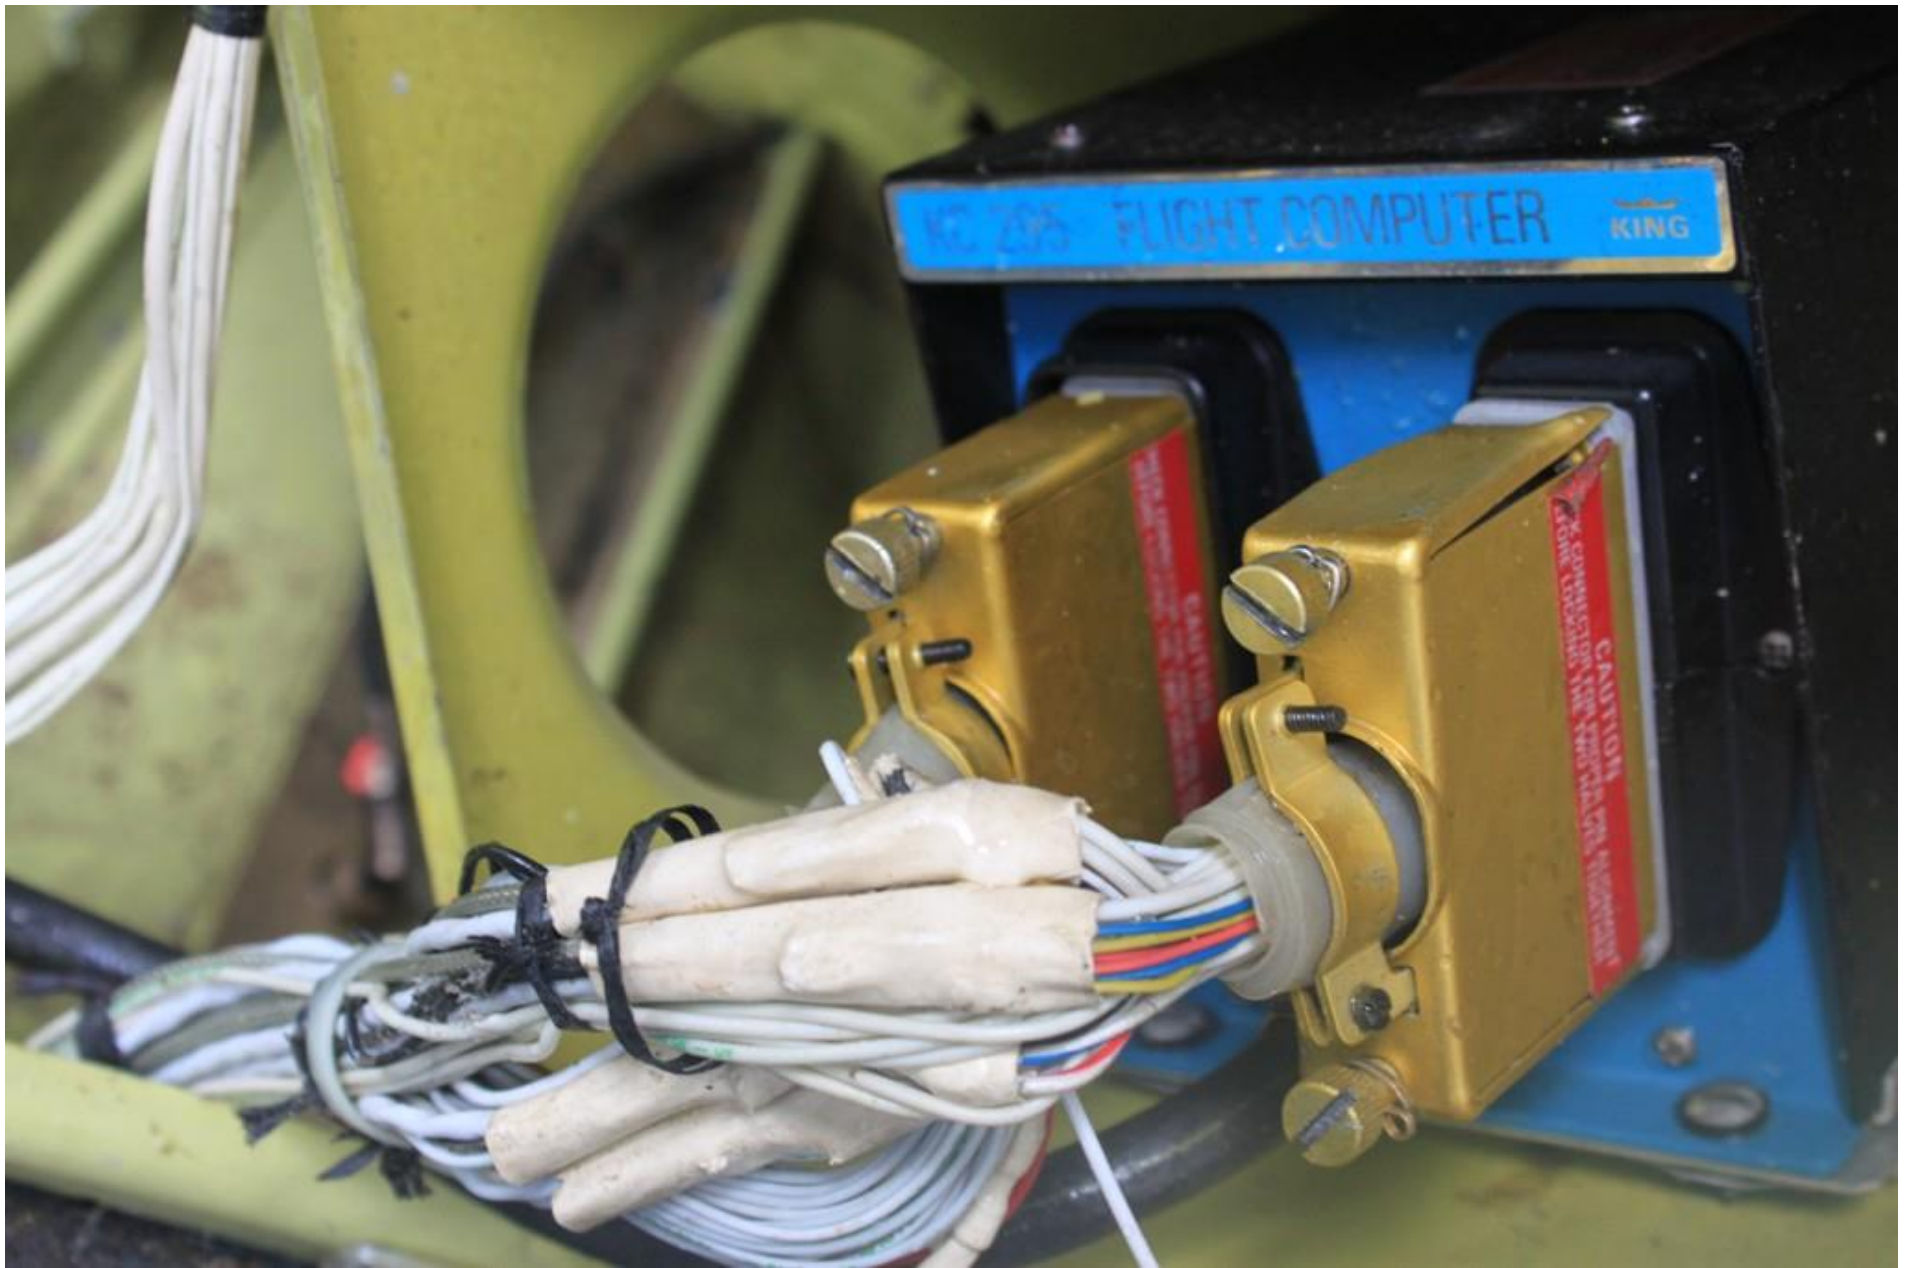
**Photo 13 - NTSB Digital Photograph. View of the Connections at the Autopilot Flight Computer**

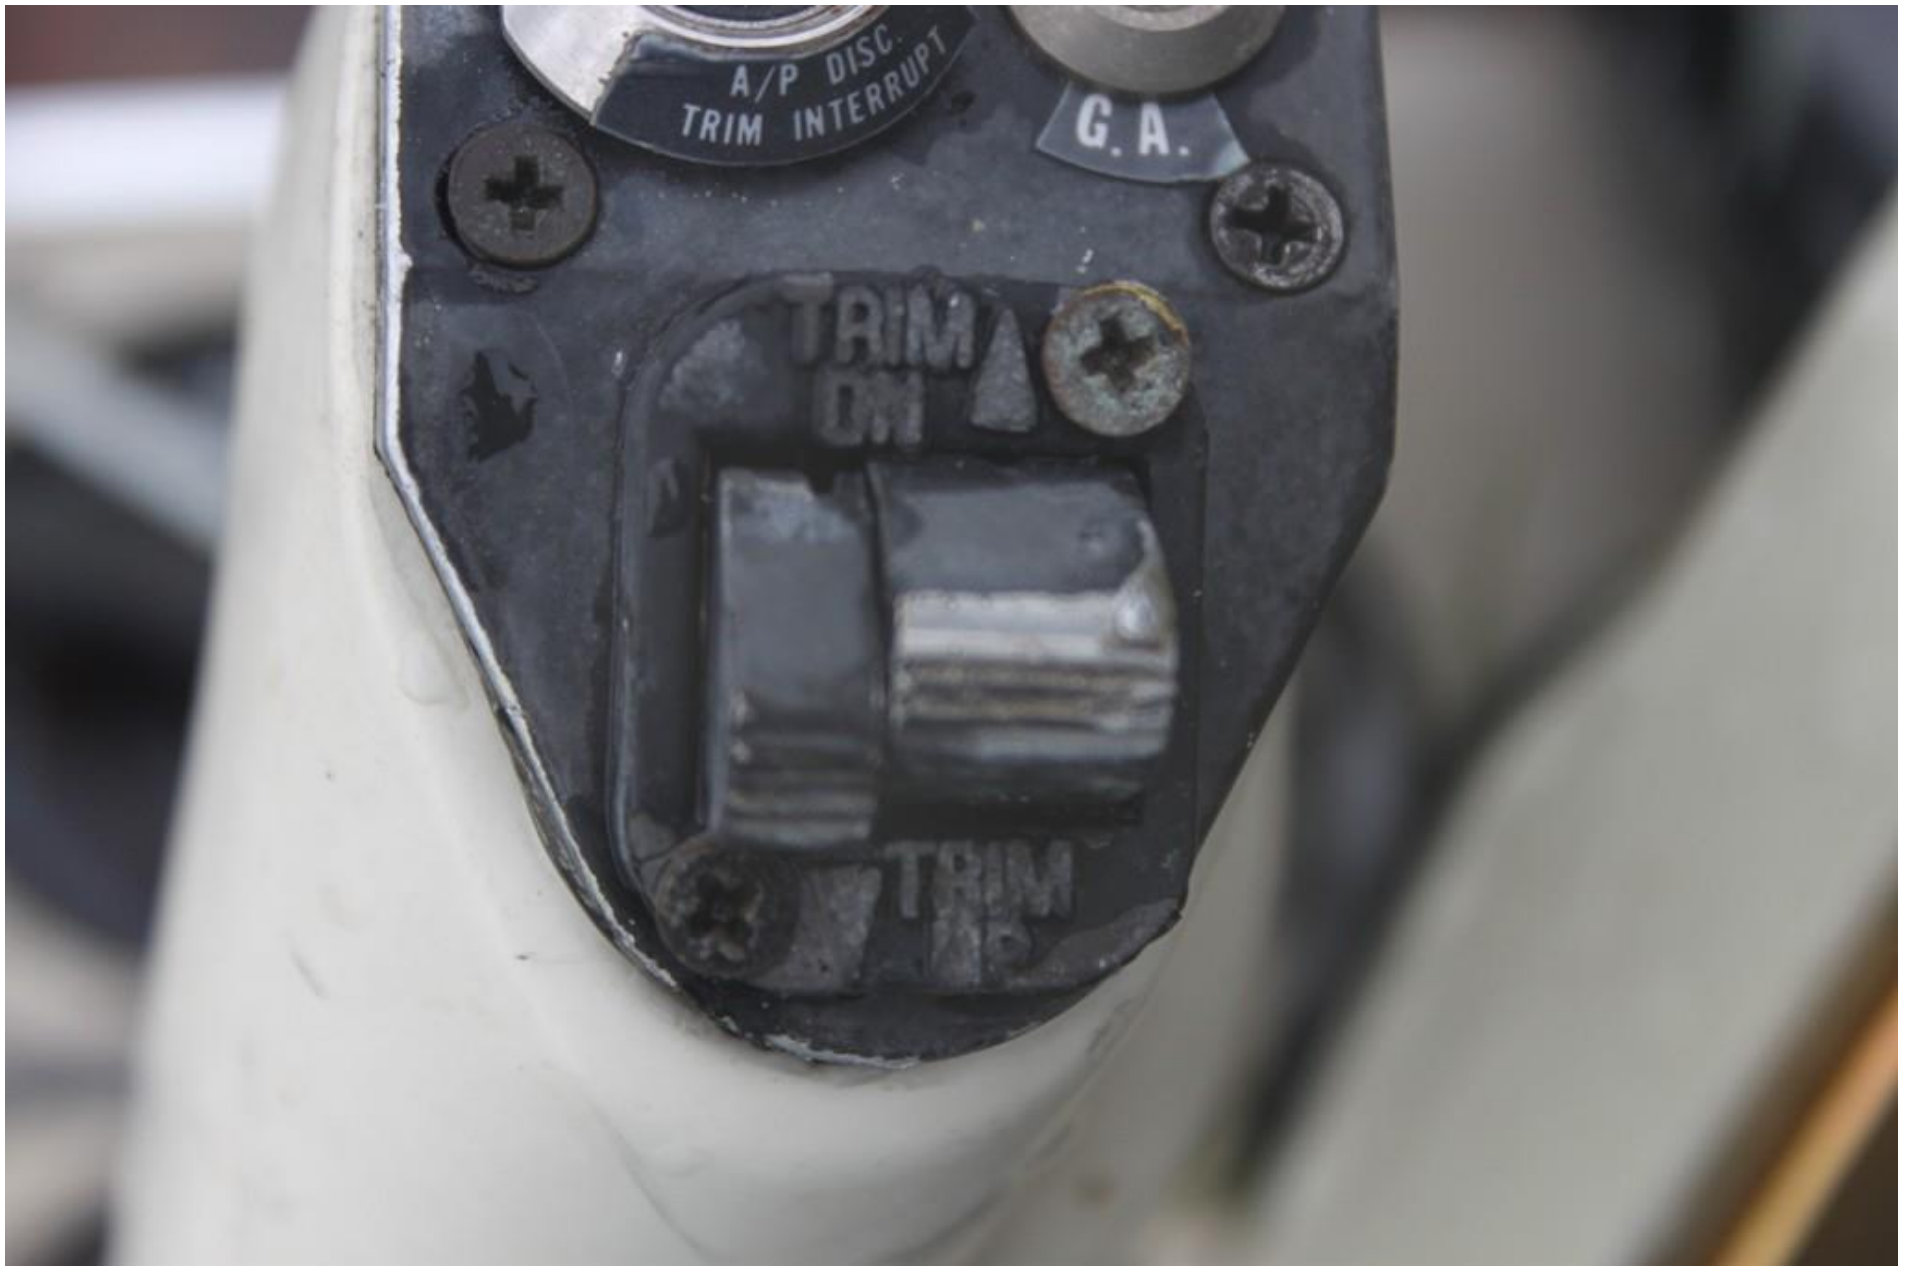
**Photo 14 - NTSB Digital Photograph. Close-Up View of the Autopilot Trim Switch Assembly**
