**NATIONAL TRANSPORTATION SAFETY BOARD**

**MATERIALS LABORATORY FACTUAL REPORT**

Report No. 16-113

Place : Orlando, FL  
Date : November 20, 2015  
Vehicle : N7FG, Beech A36TC  
NTSB No. : ERA16FA043  
Investigator : Timothy Monville

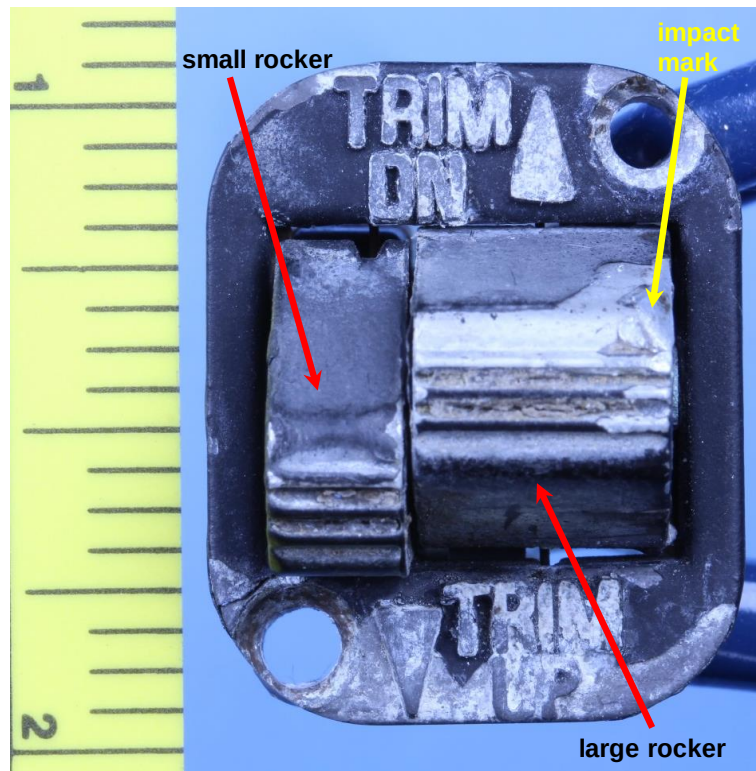
The top view of the as-received switch in figure 1 indicates the respective rockers as well as the as-received position of the small rocker. The small rocker was found to be stuck or jammed down towards the 'TRIM UP' position as shown in figure 1. In addition to the small rocker position and the significant impact mark on the large rocker (see figure 1), cracks were observed and documented at several locations around the sides of the housing. A schematic of the switch assembly is shown in figure 2.

Figure 1. Top view of as-received autopilot trim switch.

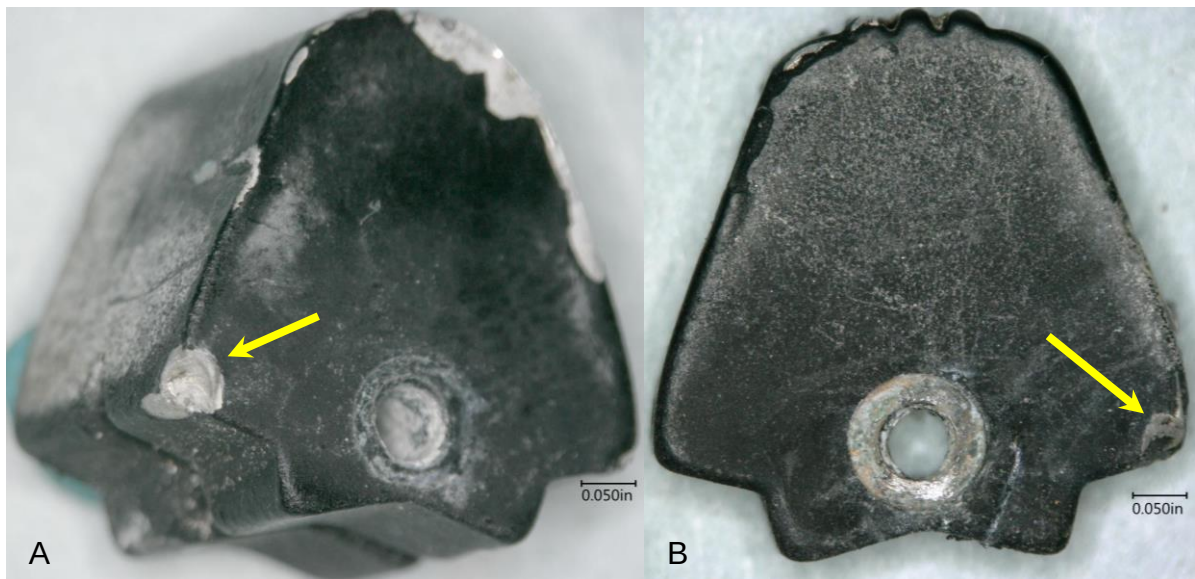
Upon disassembly, impact marks were found on the bottom outboard sides of both rockers where they meet their respective aft stop plates. The impact locations are indicated by yellow arrows in figure 3. Both stop plates were also deformed at their aft positions indicated by the white arrows in figure 4. The stop plate associated with the large rocker appeared to be bent inward while the small rocker plate sustained more damage.

Figure 3. Images shows the outboard sides of the large (A) and small (B) rockers where the yellow arrows point to impact damage on both rockers' aft positions.

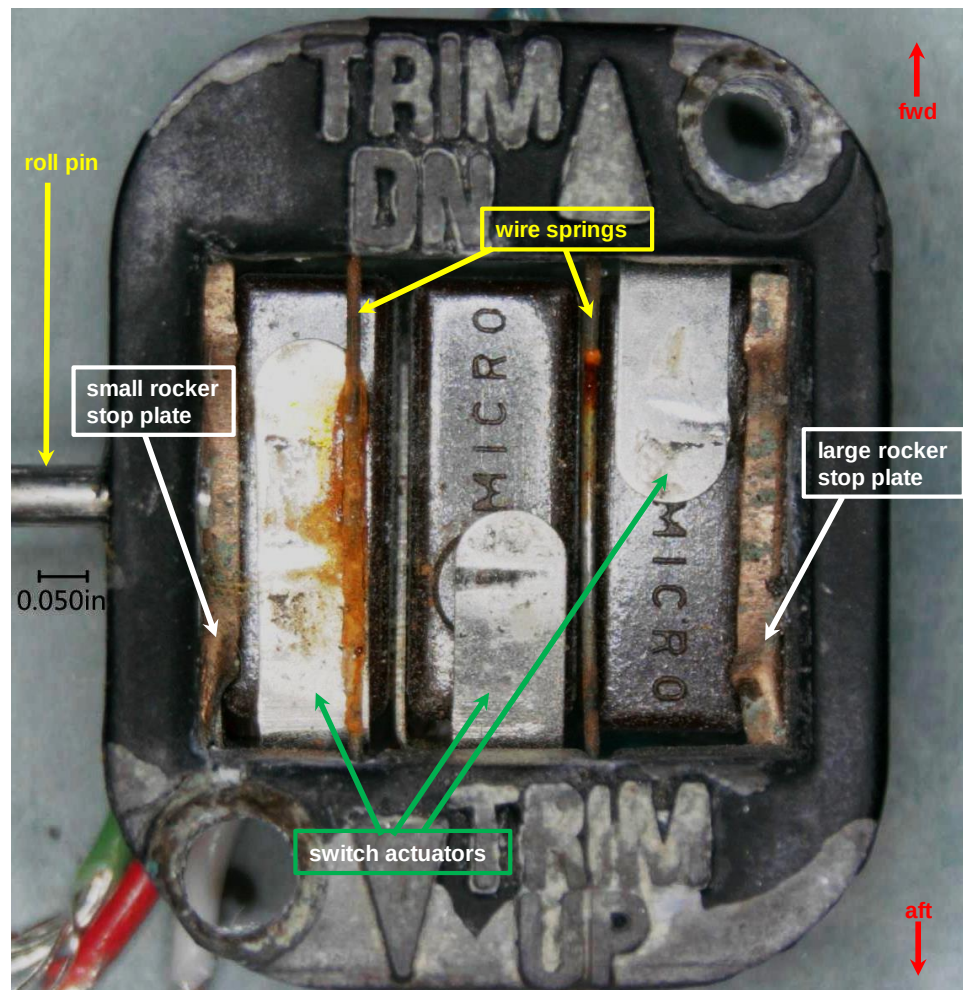
Figure 4. The partially disassembled switch with rockers removed.

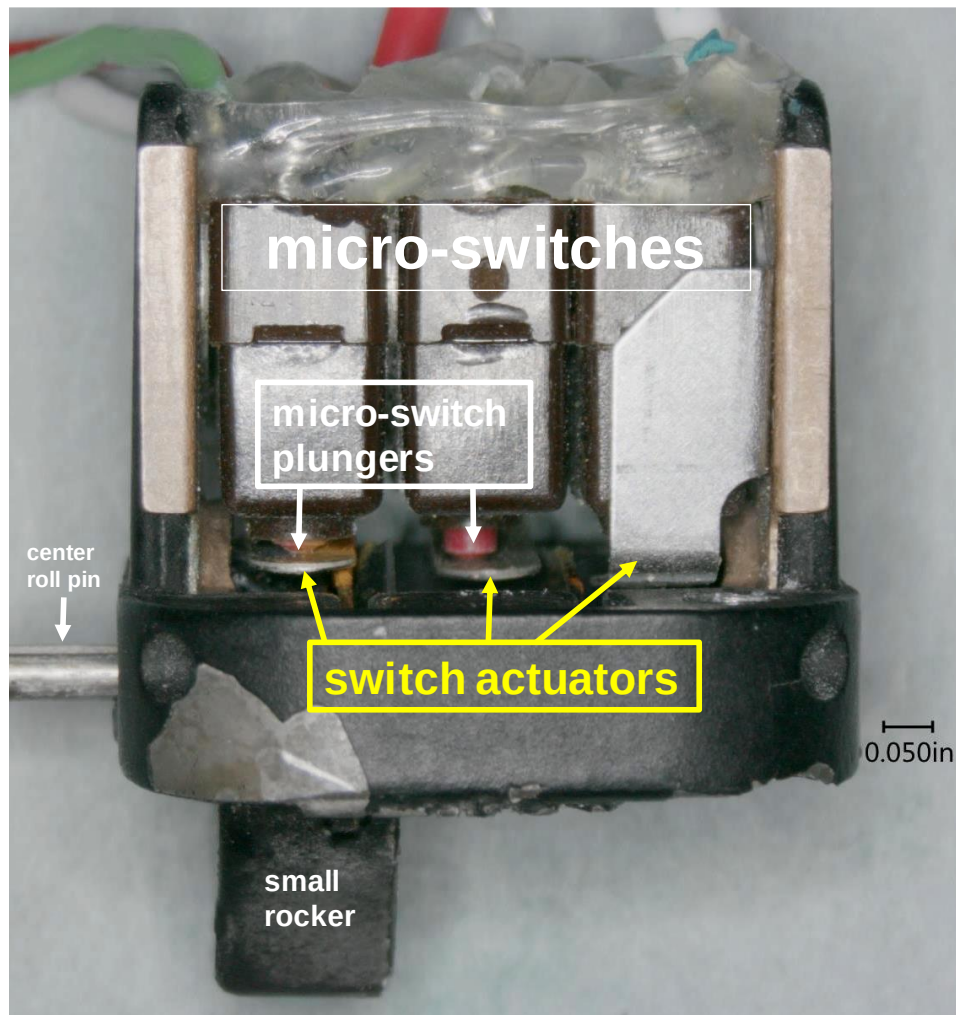
Figure 5 is an upside down view of the switch prior to removing the small rocker. This image shows the small rocker-controlled actuator plate pressed against the micro-switch plunger. After removing the small rocker, the wire spring guiding the rocker was found to be positioned over and depressing the switch actuator plate as can be seen in figure 4. Figure 6 shows the bowed small rocker-controlled actuator plate while figure 7 is a closer view focused on the bent middle actuator plate. The straight lines in these two images were added as references to indicate their respective deformation.

Figure 5. View showing small rocker plunger depressed.

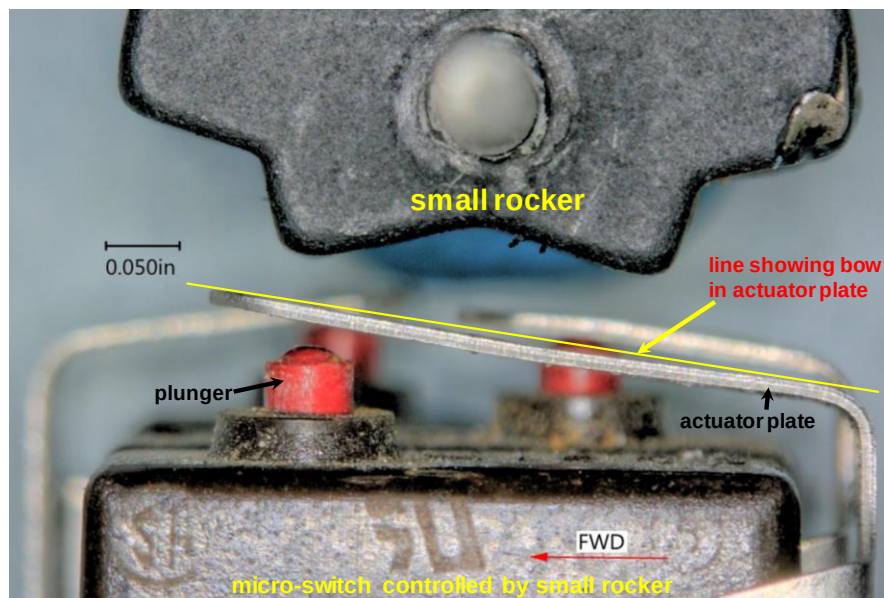
Figure 6. Showing bow in small rocker-controlled actuator plate.

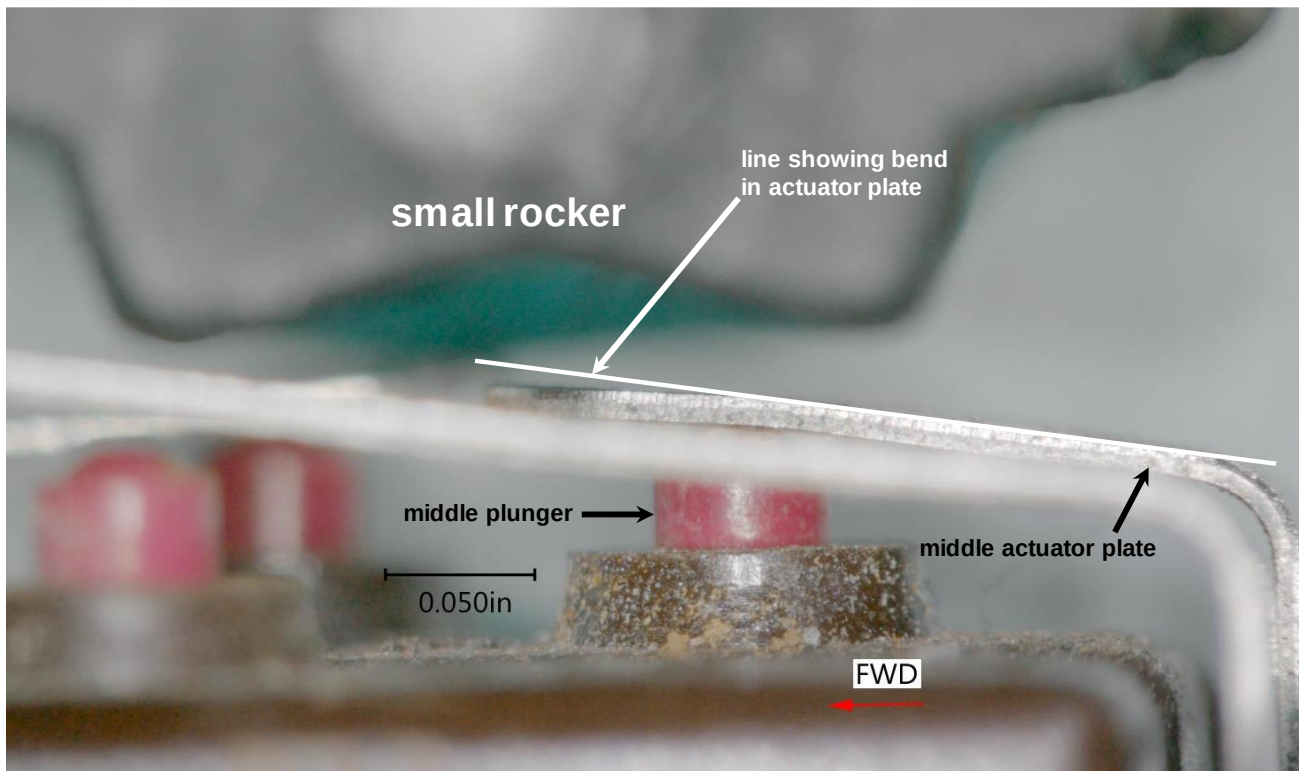
Figure 7. Showing bend at tip of middle actuator plate.

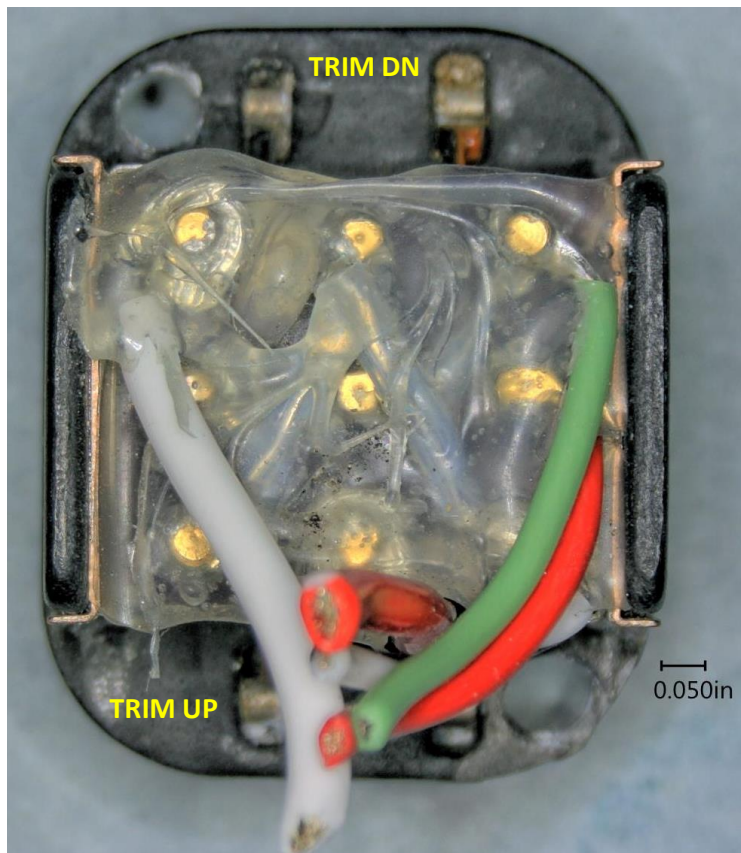
Prior to and after disassembly, electrical conductivity was measured using a digital multimeter at each micro-switch wire connection as listed in tables 1 - 4. All micro-switch wires were firmly attached (soldered) to their respective poles as shown in figure 8. Figure 9 is a wiring schematic of the three micro-switches. The as-received switch electrical testing results are listed in table 1 while tables 2 and 3 list test results when the large rocker was rotated to the trim-up and trim-down positions respectively. With the micro-switches removed (all three as a group) from the switch assembly housing, the position of each micro-switch (S101, S102, & S103) was determined by measuring and recording the continuity between all of the wires coming out of the switch. These test results are listed in table 4.

Figure 8. Bottom view showing electrical wire connections to micro-switches.
