**NATIONAL TRANSPORTATION SAFETY BOARD**

**Computed Tomography Specialist's Factual Report**

ERA-16-FA-043

Operator: Kavak Aviation, LLC  
Location: Clear Lake, Orlando, Florida  
Date: November 20, 2015  
Time: 1127 eastern standard time  
Airplane: Beech A36TC, N7FG

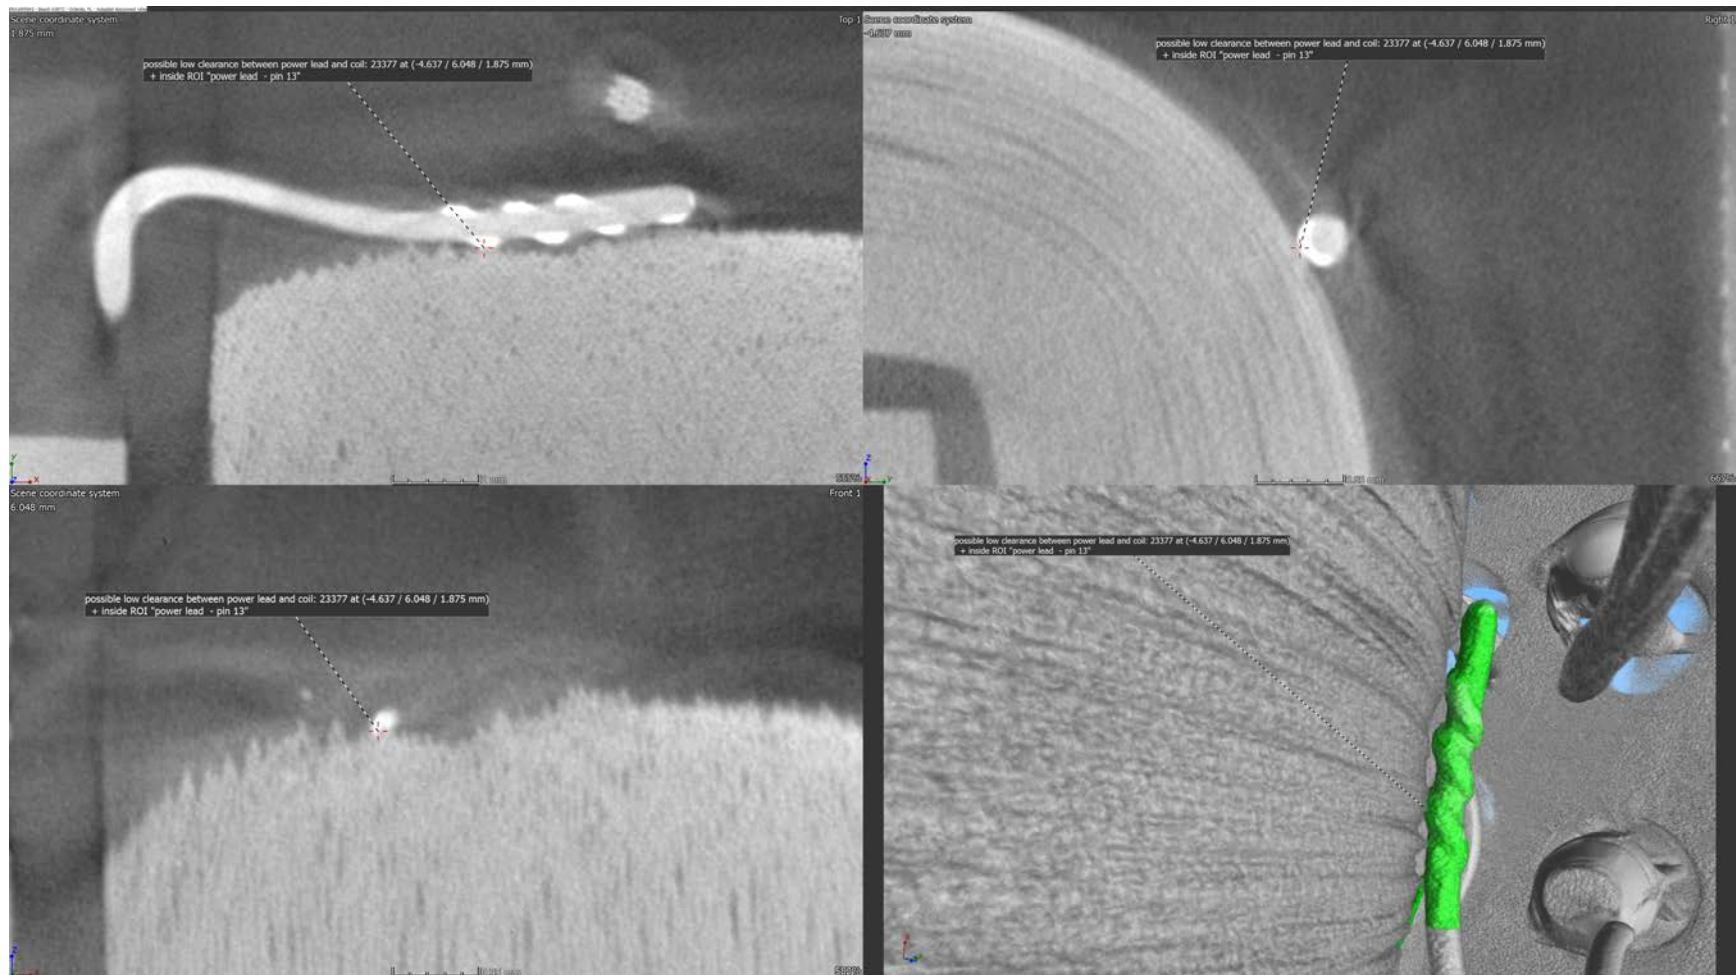
Review of the autopilot disconnect relay images showed that only pins 4, 12, 13, and 14 had external connections; there was a potential low clearance point between the power lead from pin 13 and the relay coil; and there were no indications of broken components, interference between components, welded contacts, or other anomalies within the relay.

Figure 7  
Autopilot disconnect relay – Possible low clearance between power lead and coil

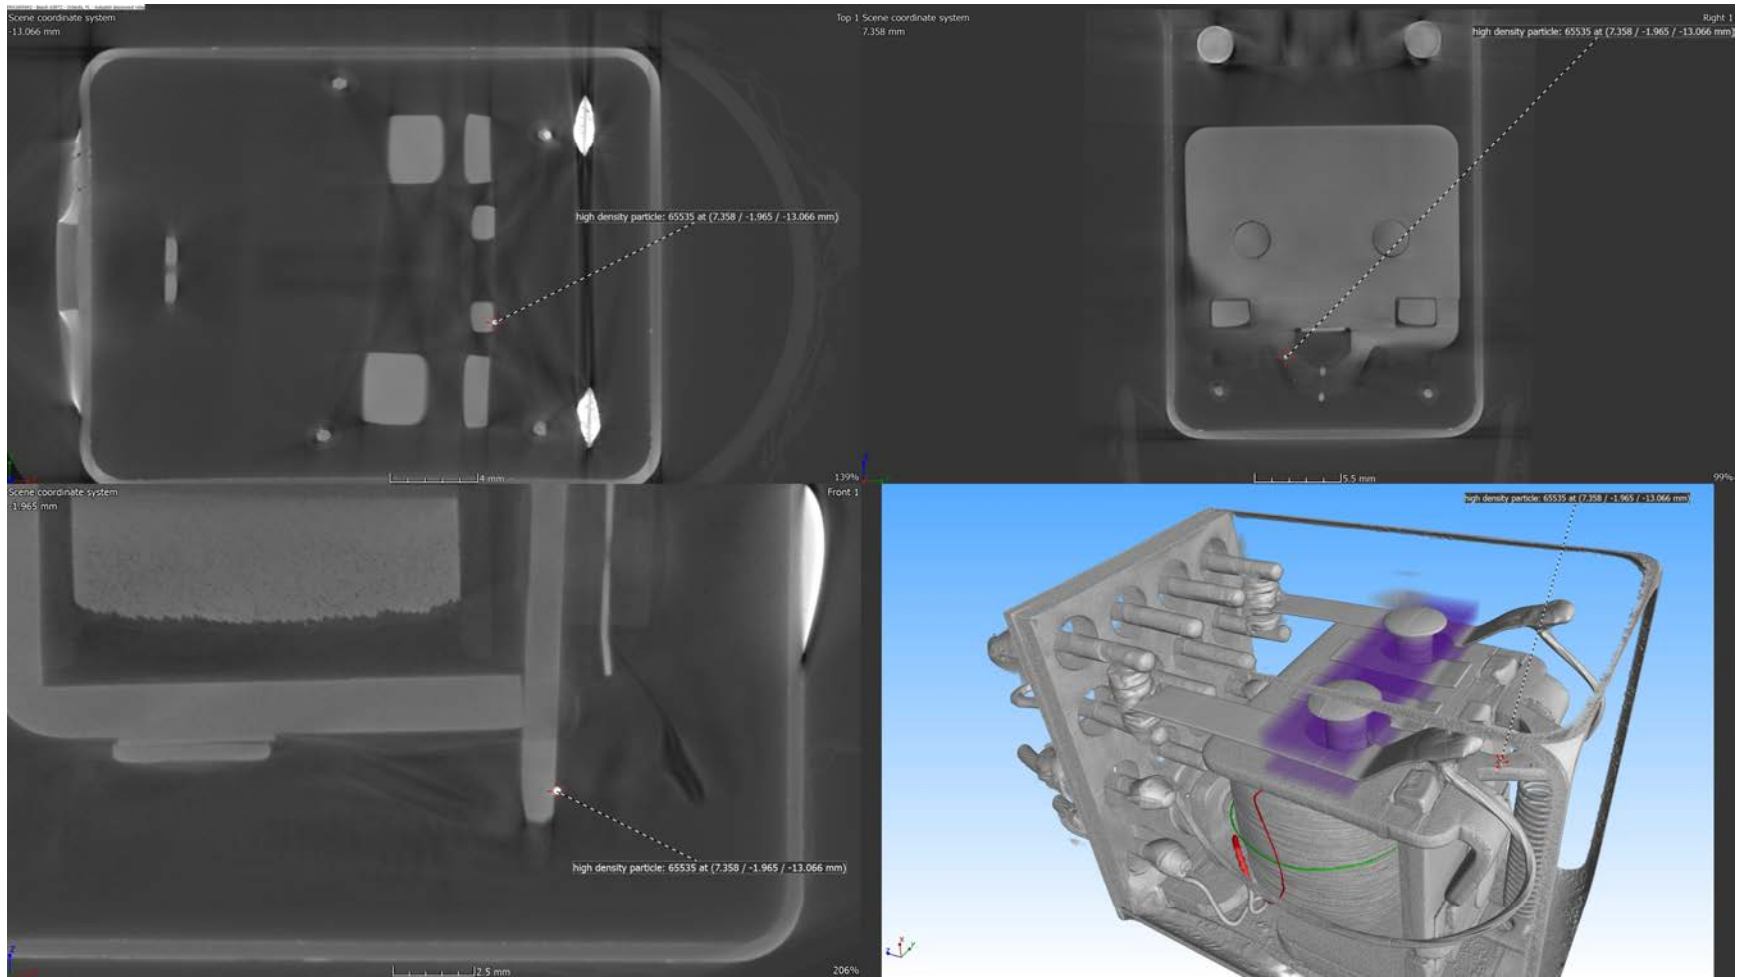
Figure 14  
Autopilot disconnect relay – High density particle

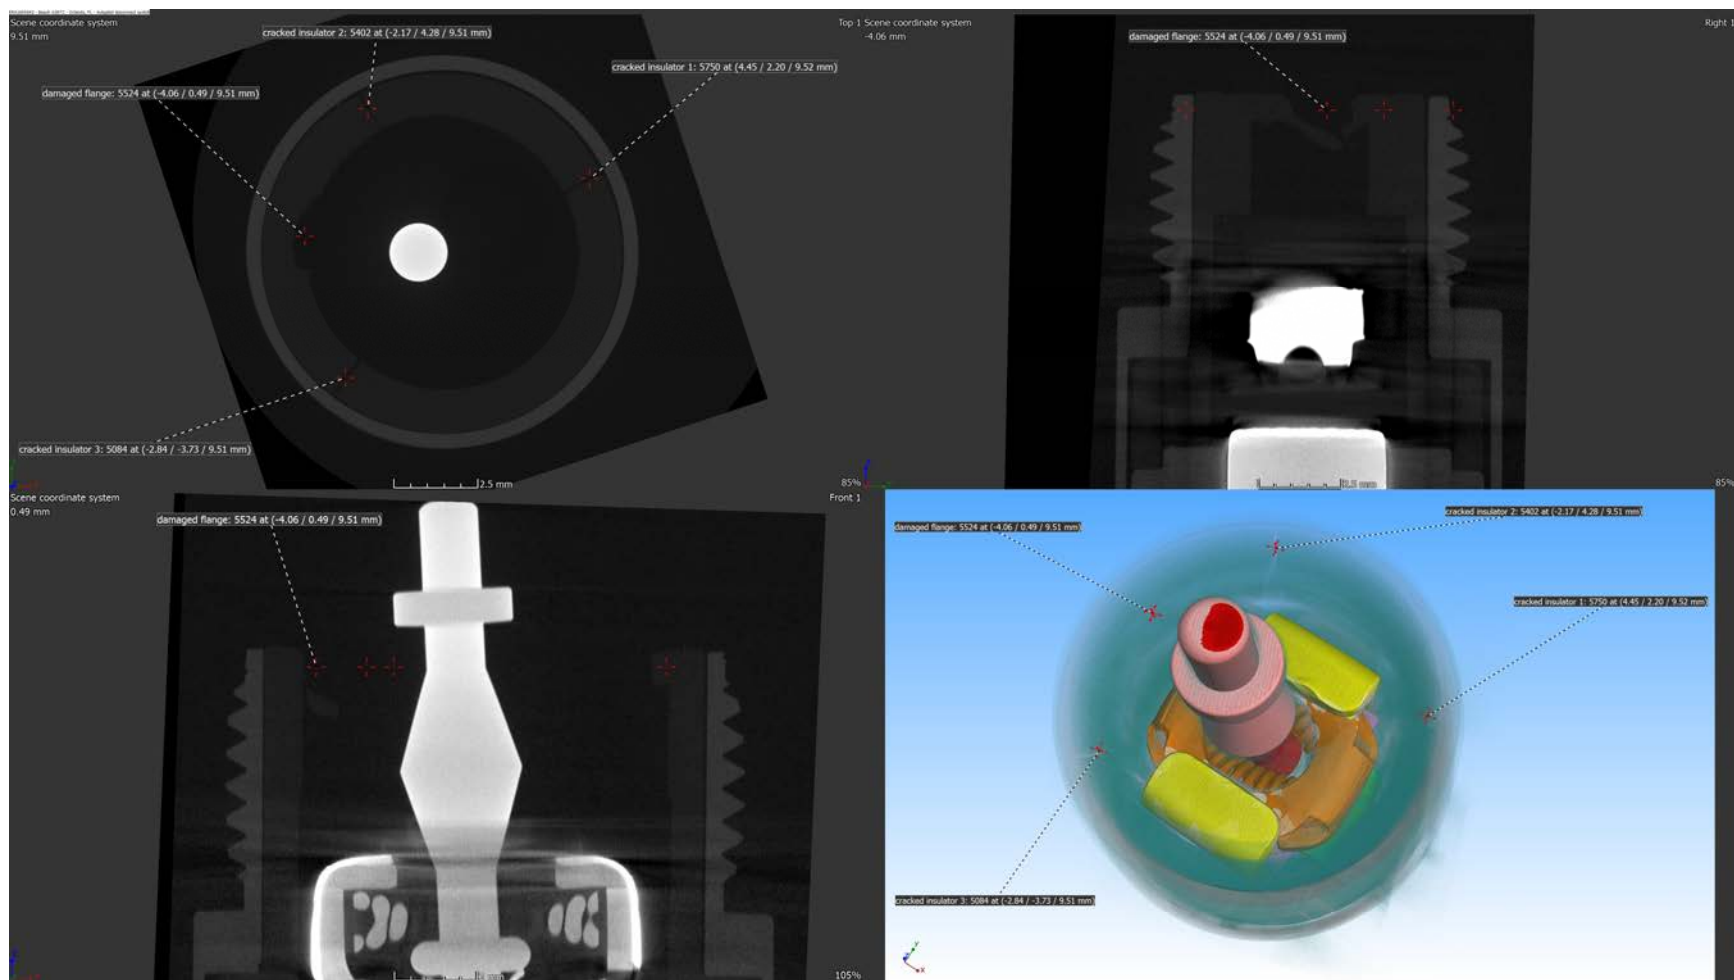
Figure 19  
Autopilot disconnect/trim interrupt switch – Damaged flange

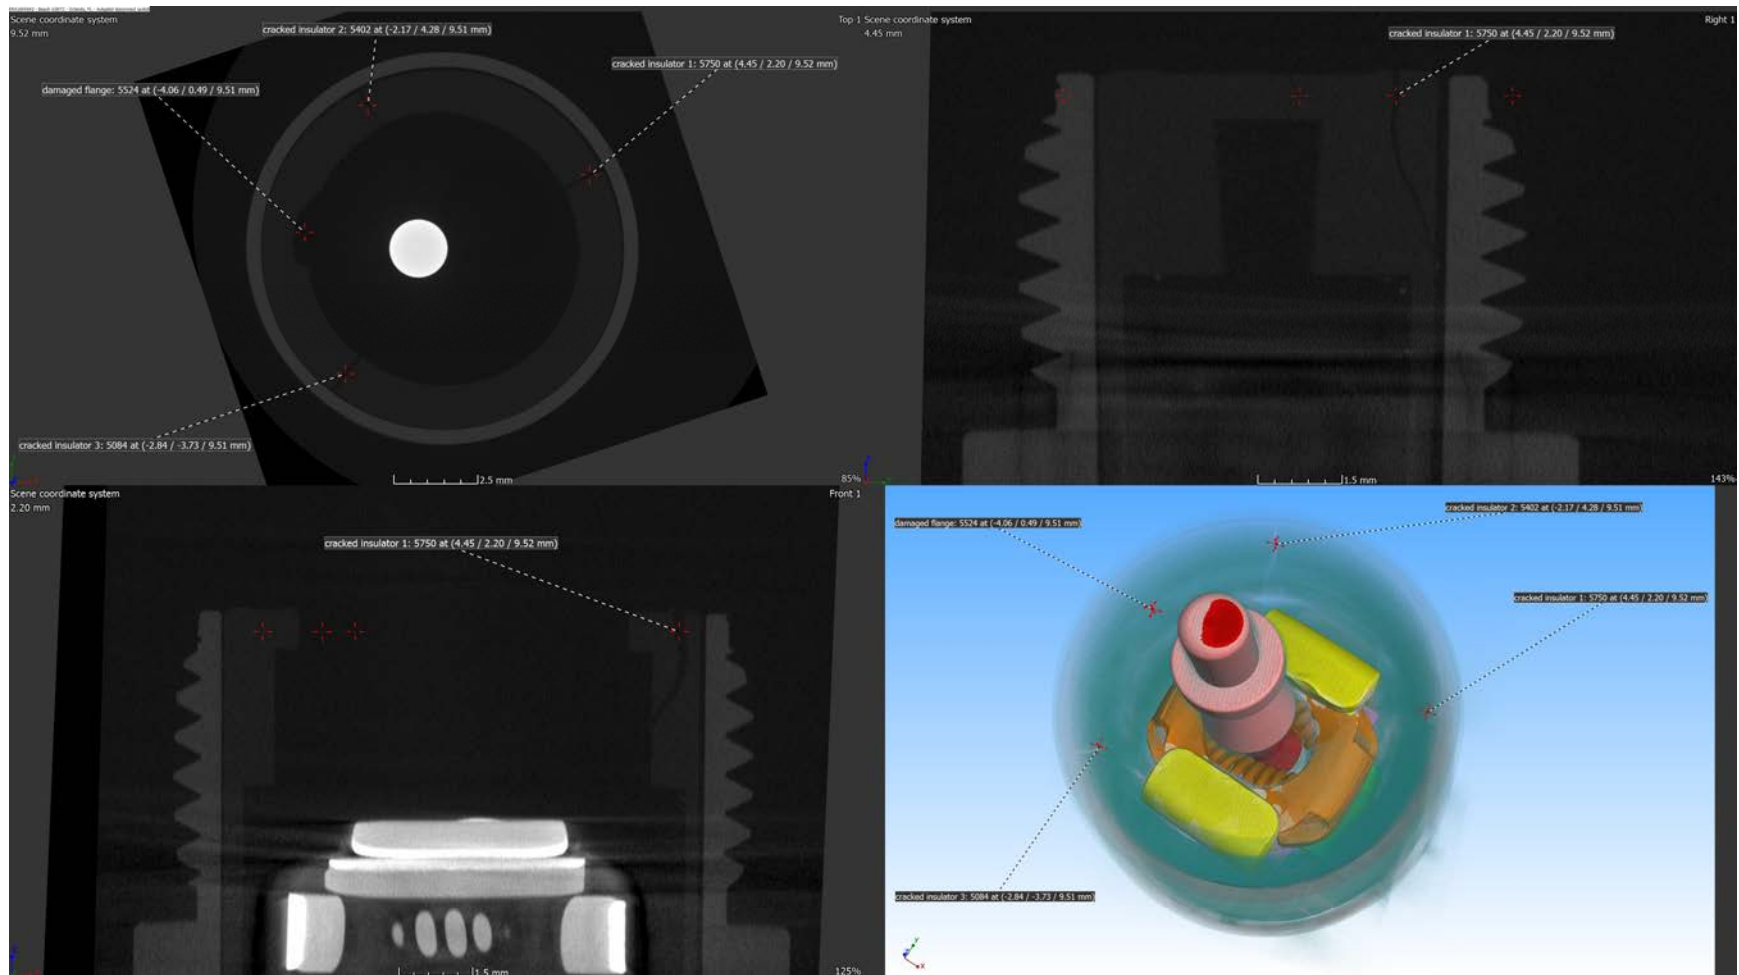
Figure 20  
Autopilot disconnect/trim interrupt switch – Cracked insulator 1

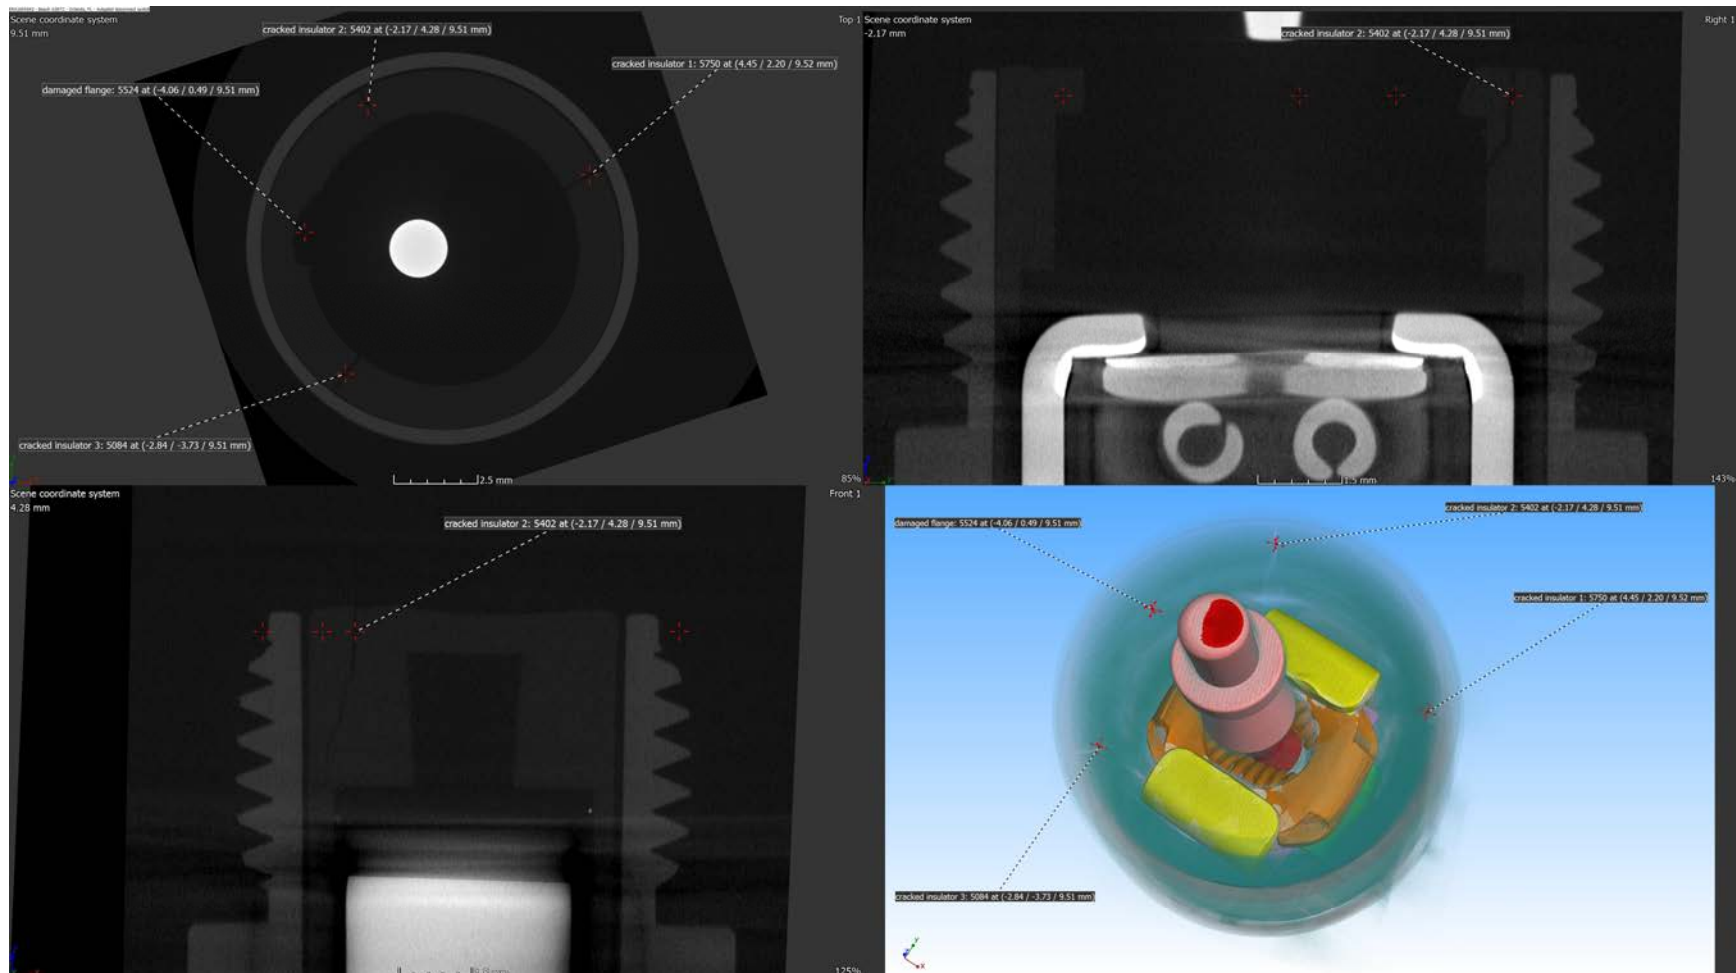
Figure 21  
Autopilot disconnect/trim interrupt switch – Cracked insulator 2

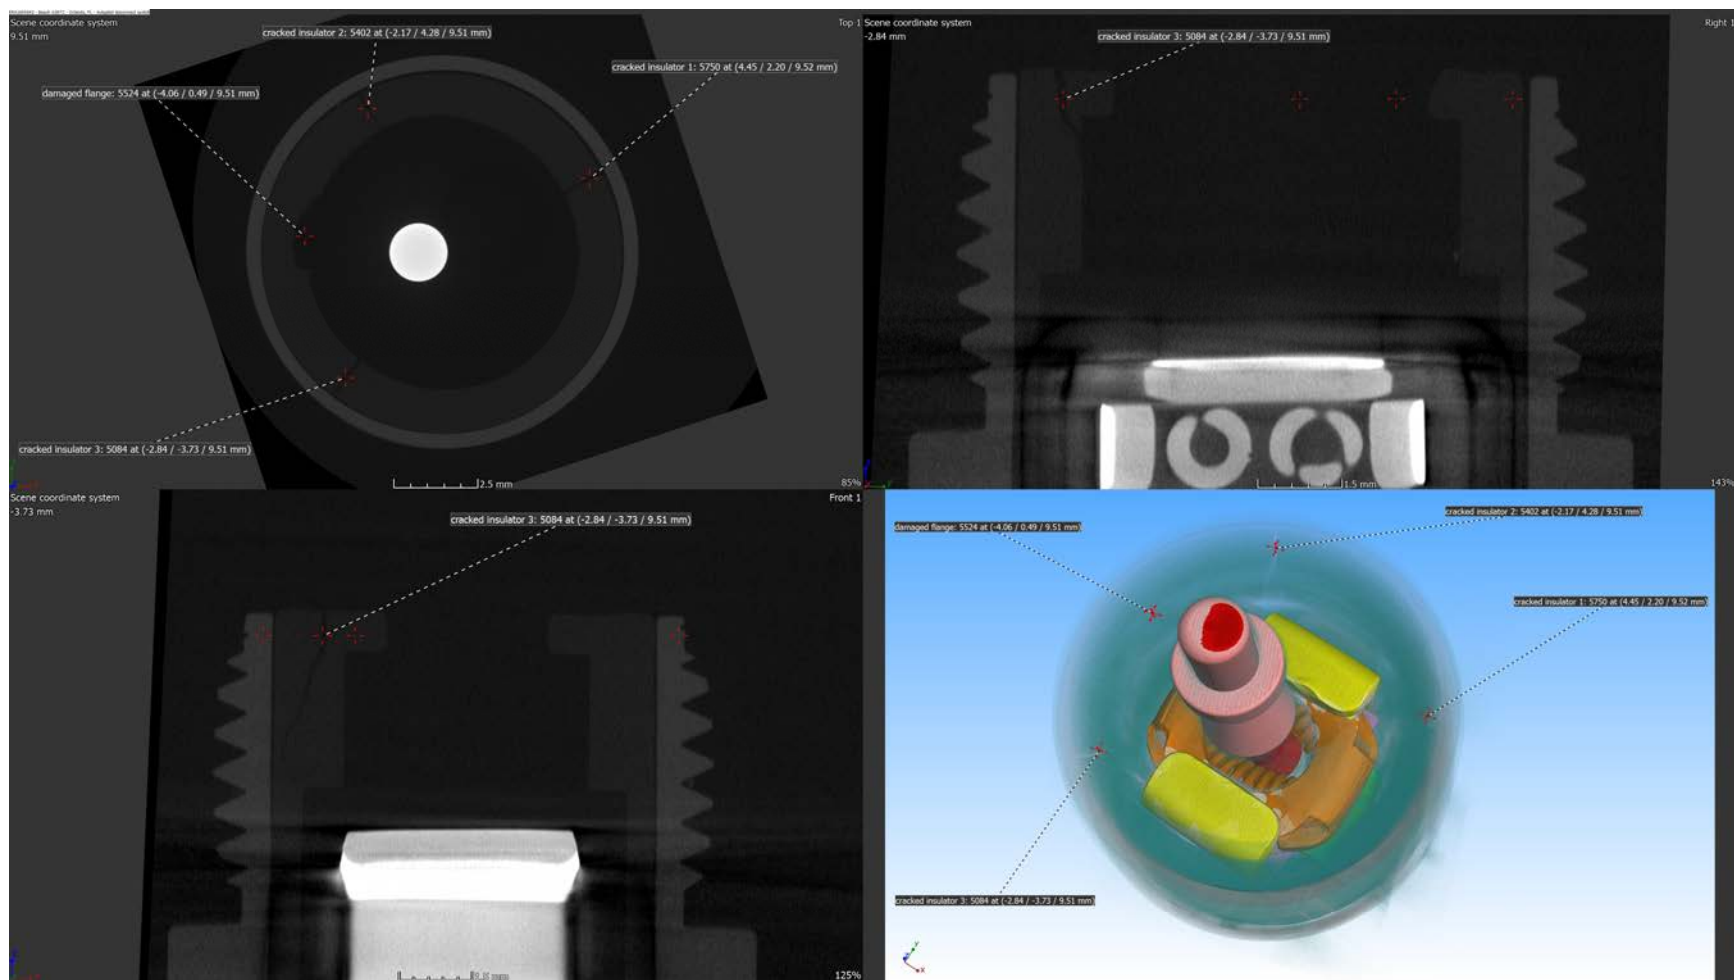
Figure 22  
Autopilot disconnect/trim interrupt switch – Cracked insulator 3

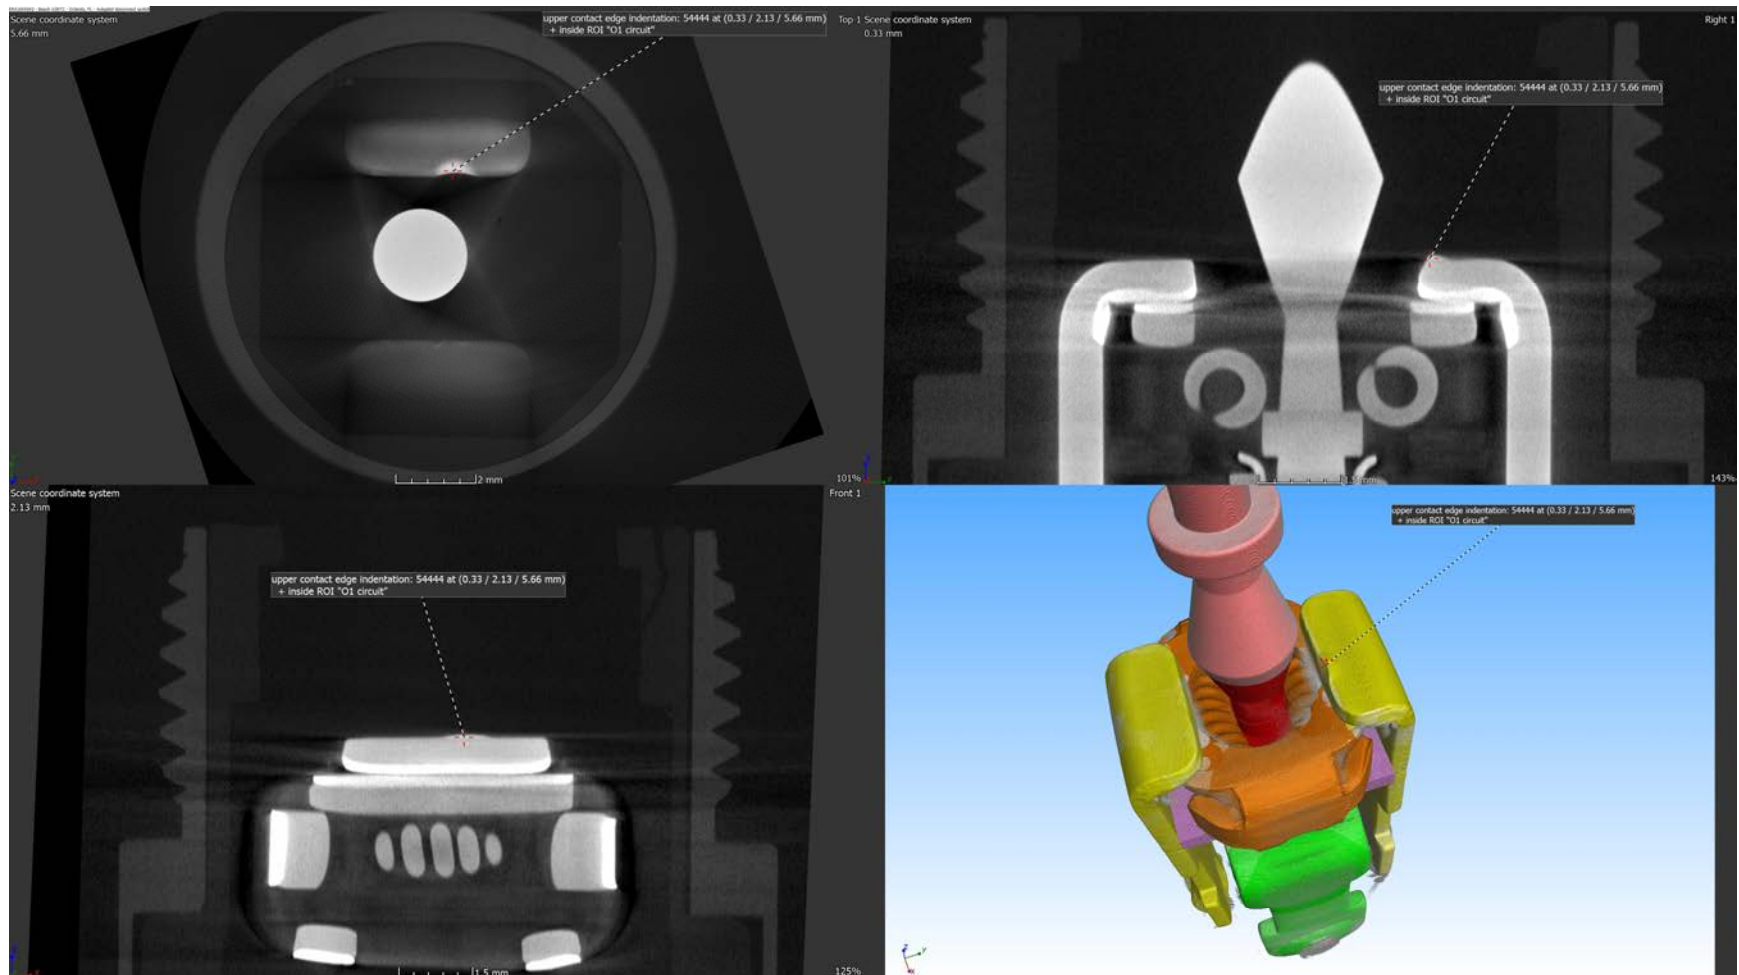
Figure 23  
Autopilot disconnect/trim interrupt switch – Upper contact edge indentation

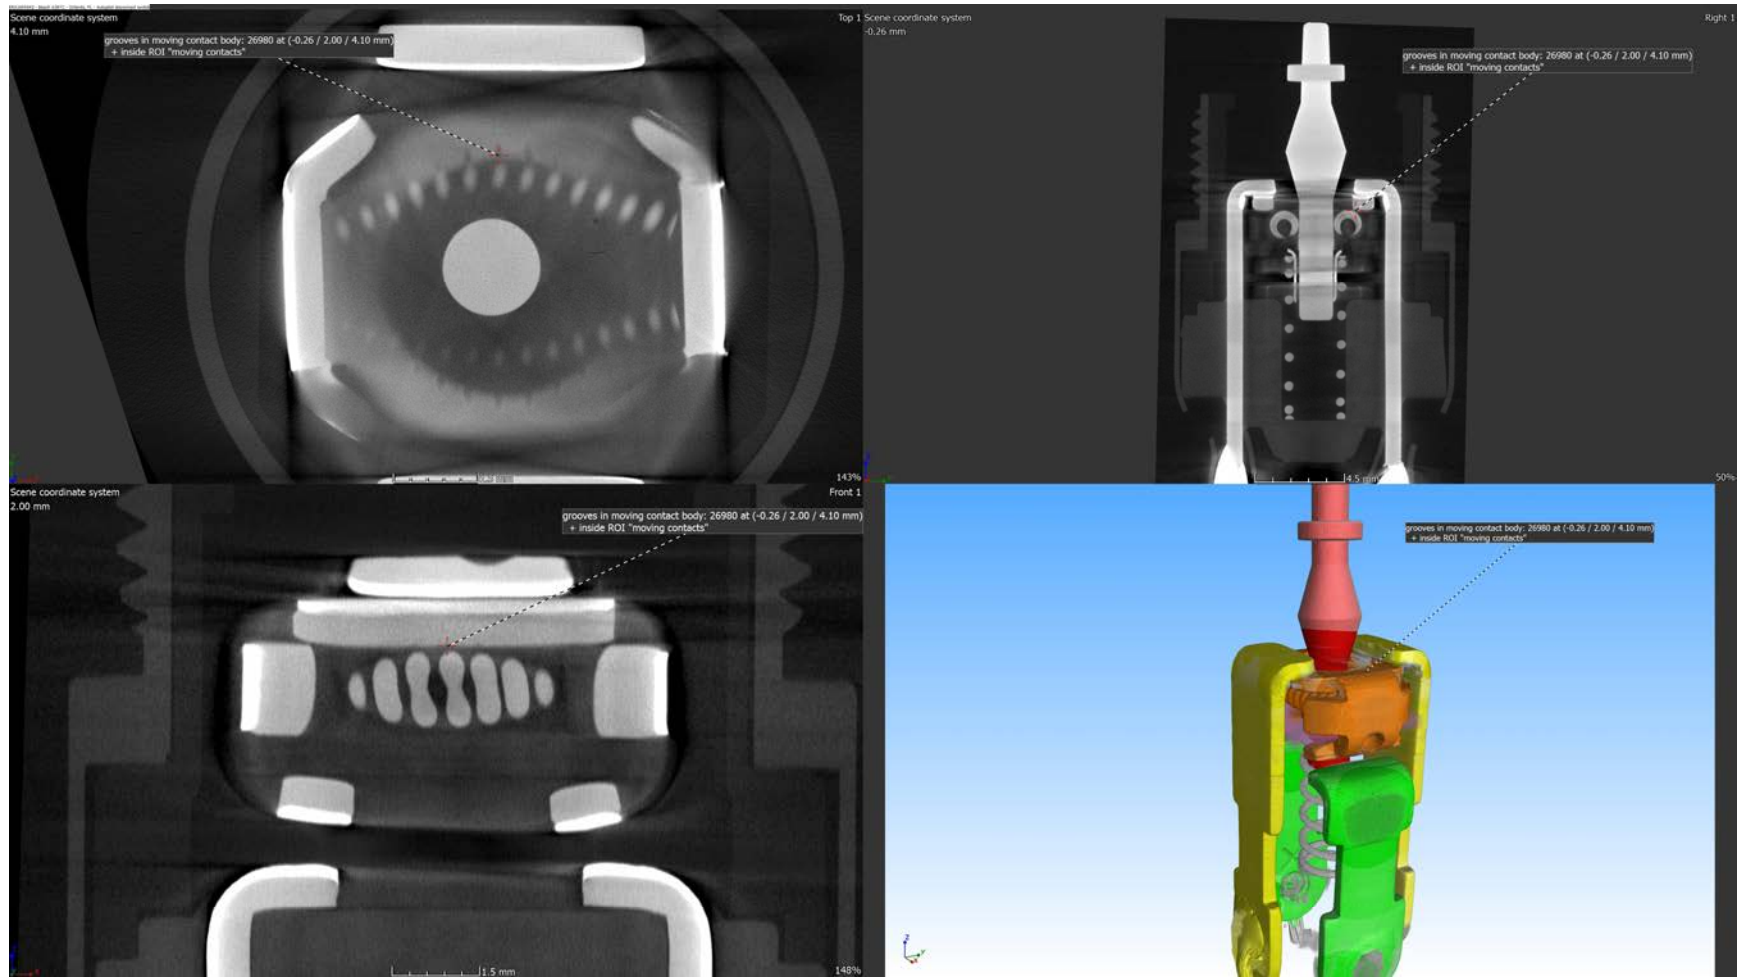
Figure 31  
Autopilot disconnect/trim interrupt switch – Grooves in moving contact body

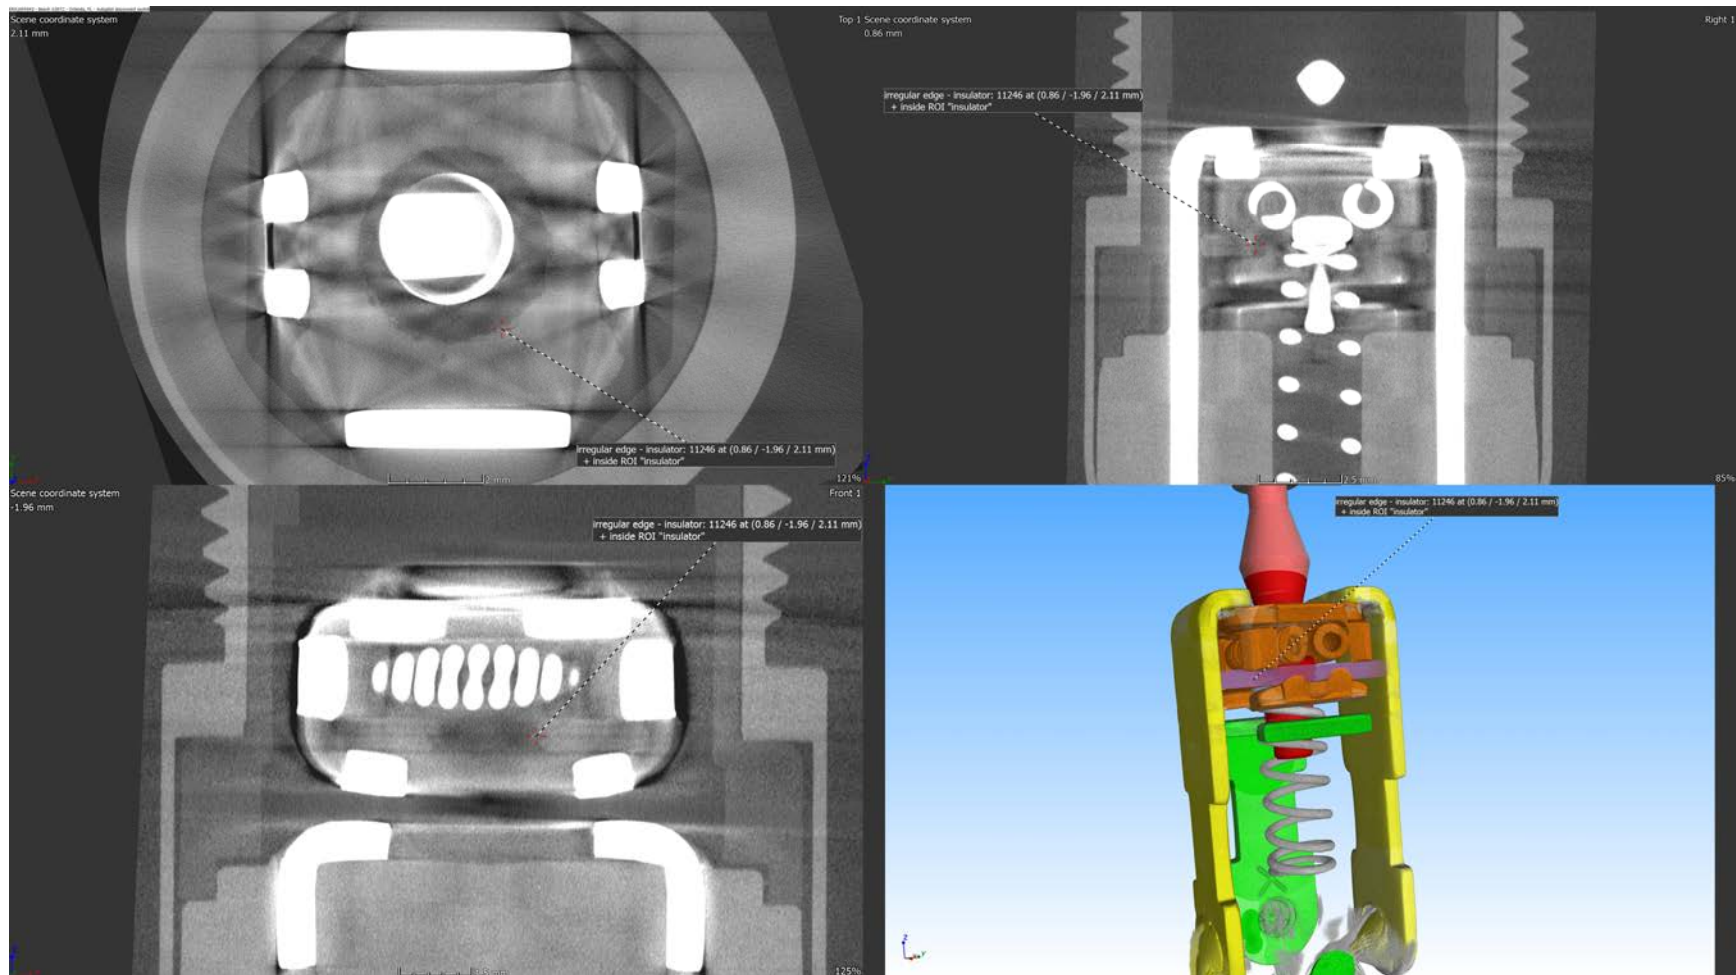
Figure 33  
Autopilot disconnect/trim interrupt switch – Insulator irregular edge

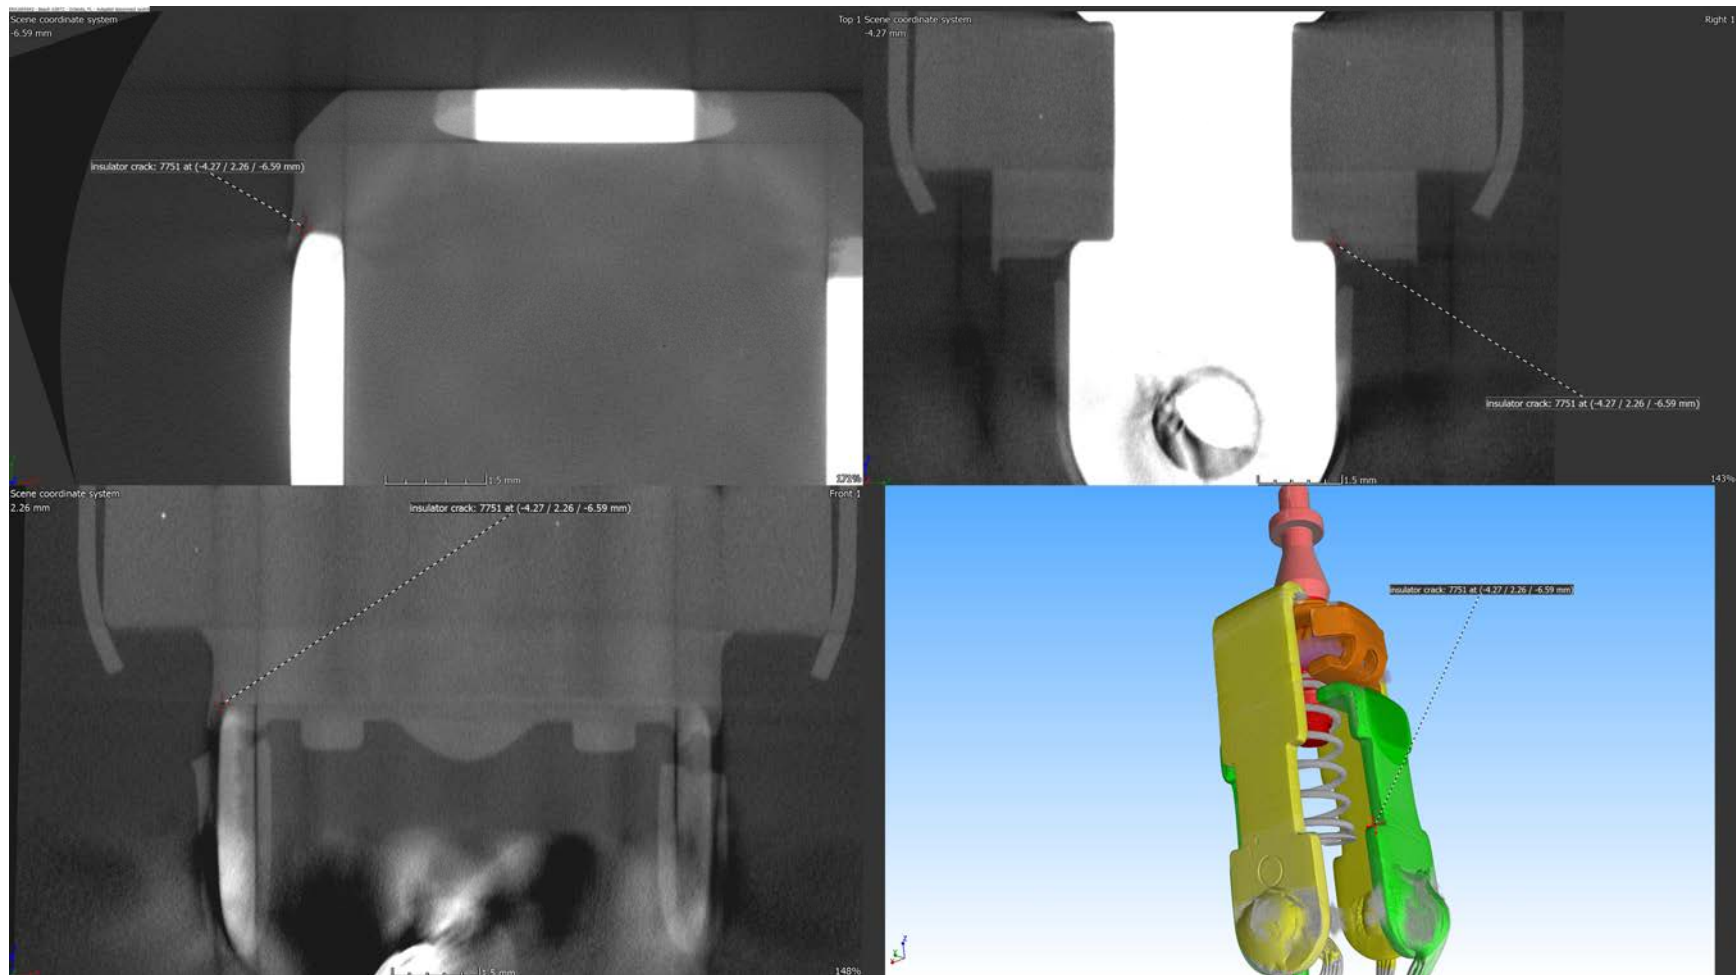
Figure 34  
Autopilot disconnect/trim interrupt switch – Insulator crack

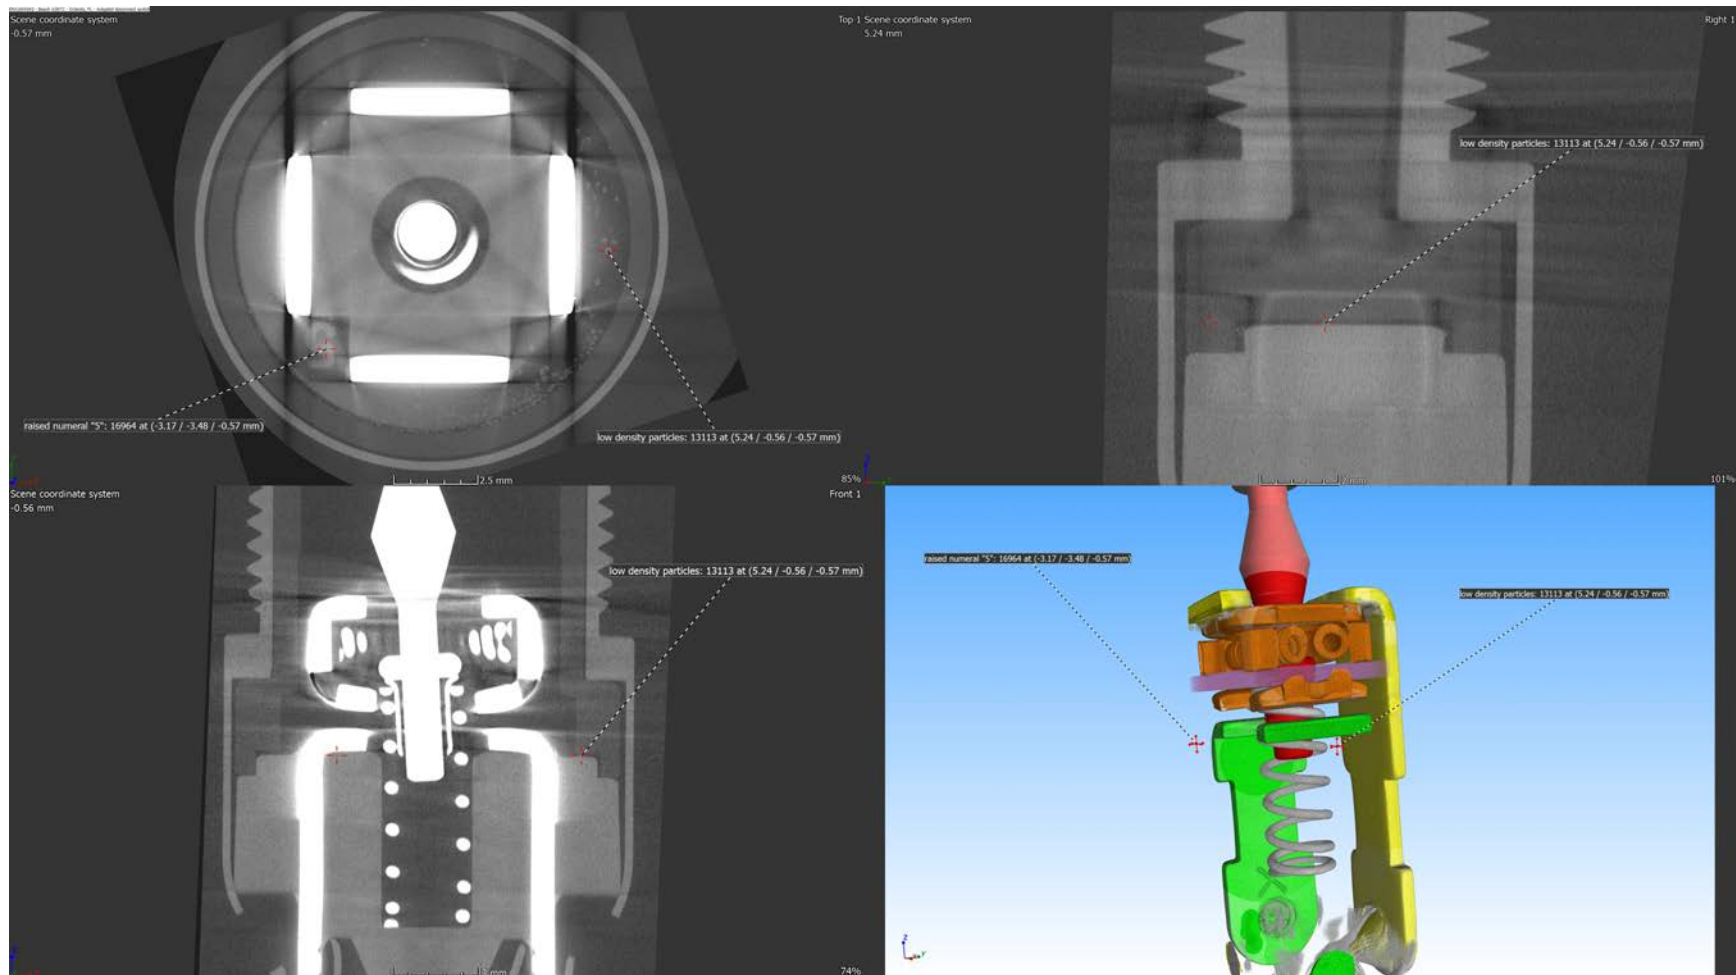
Figure 35  
Autopilot disconnect/trim interrupt switch – Low density particles and raised numeral 5

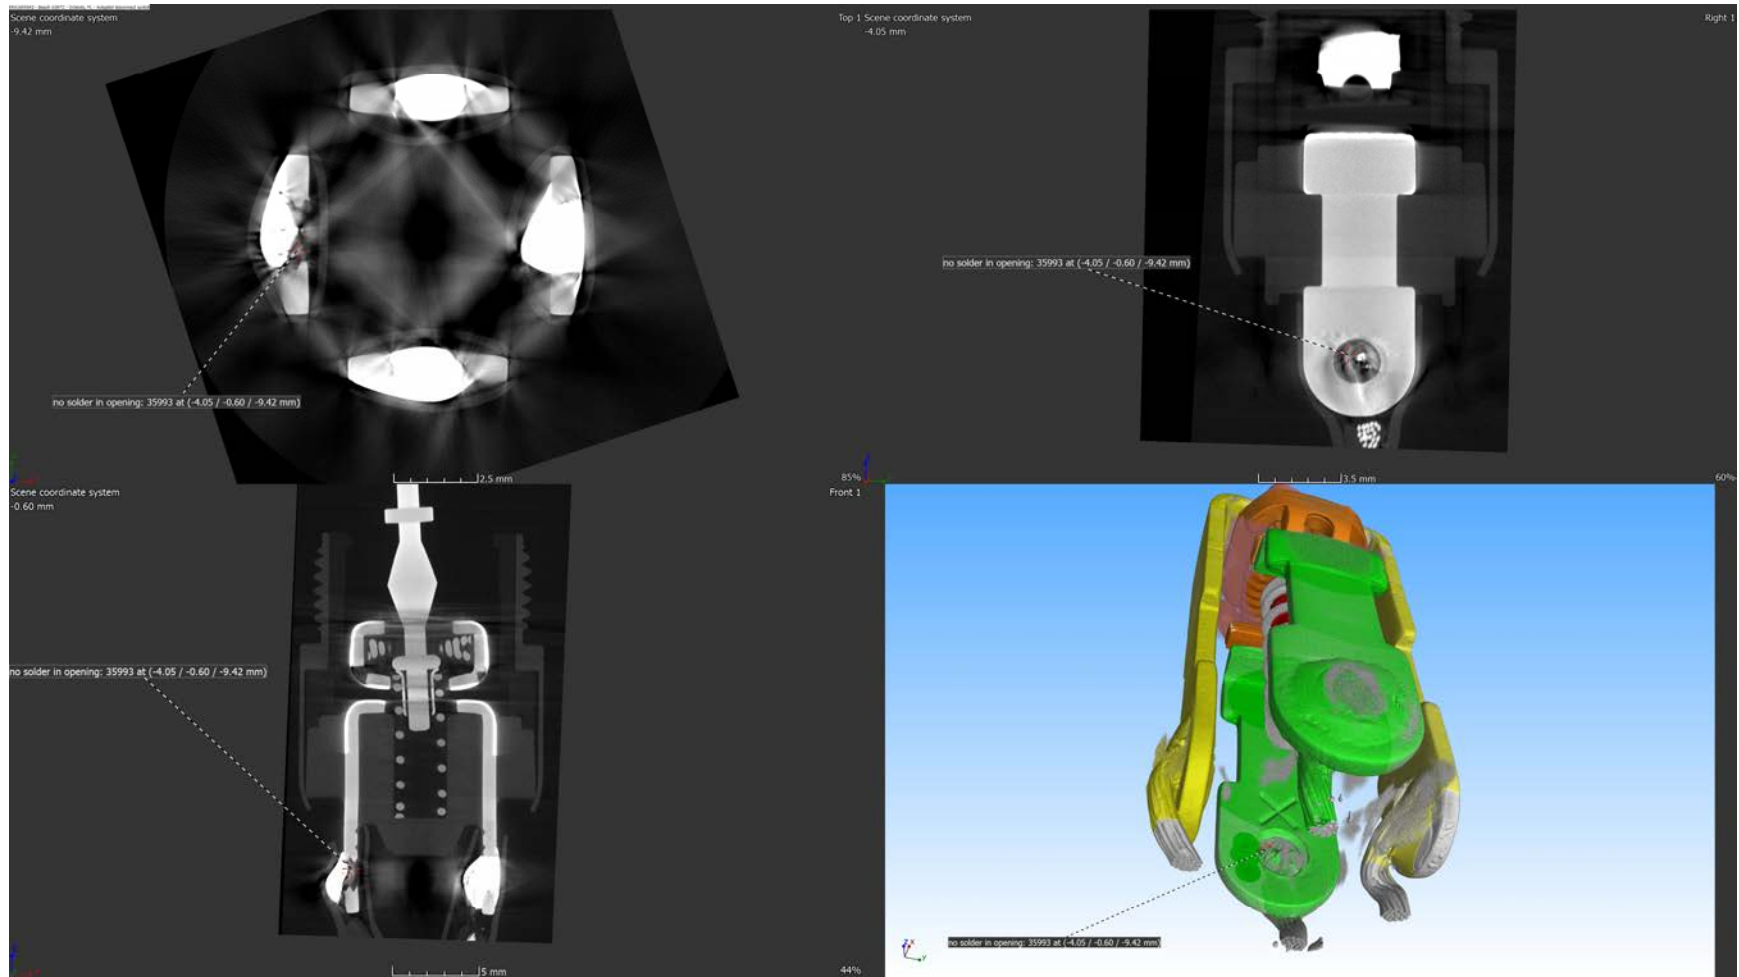
Figure 36  
Autopilot disconnect/trim interrupt switch – No solder in terminal opening

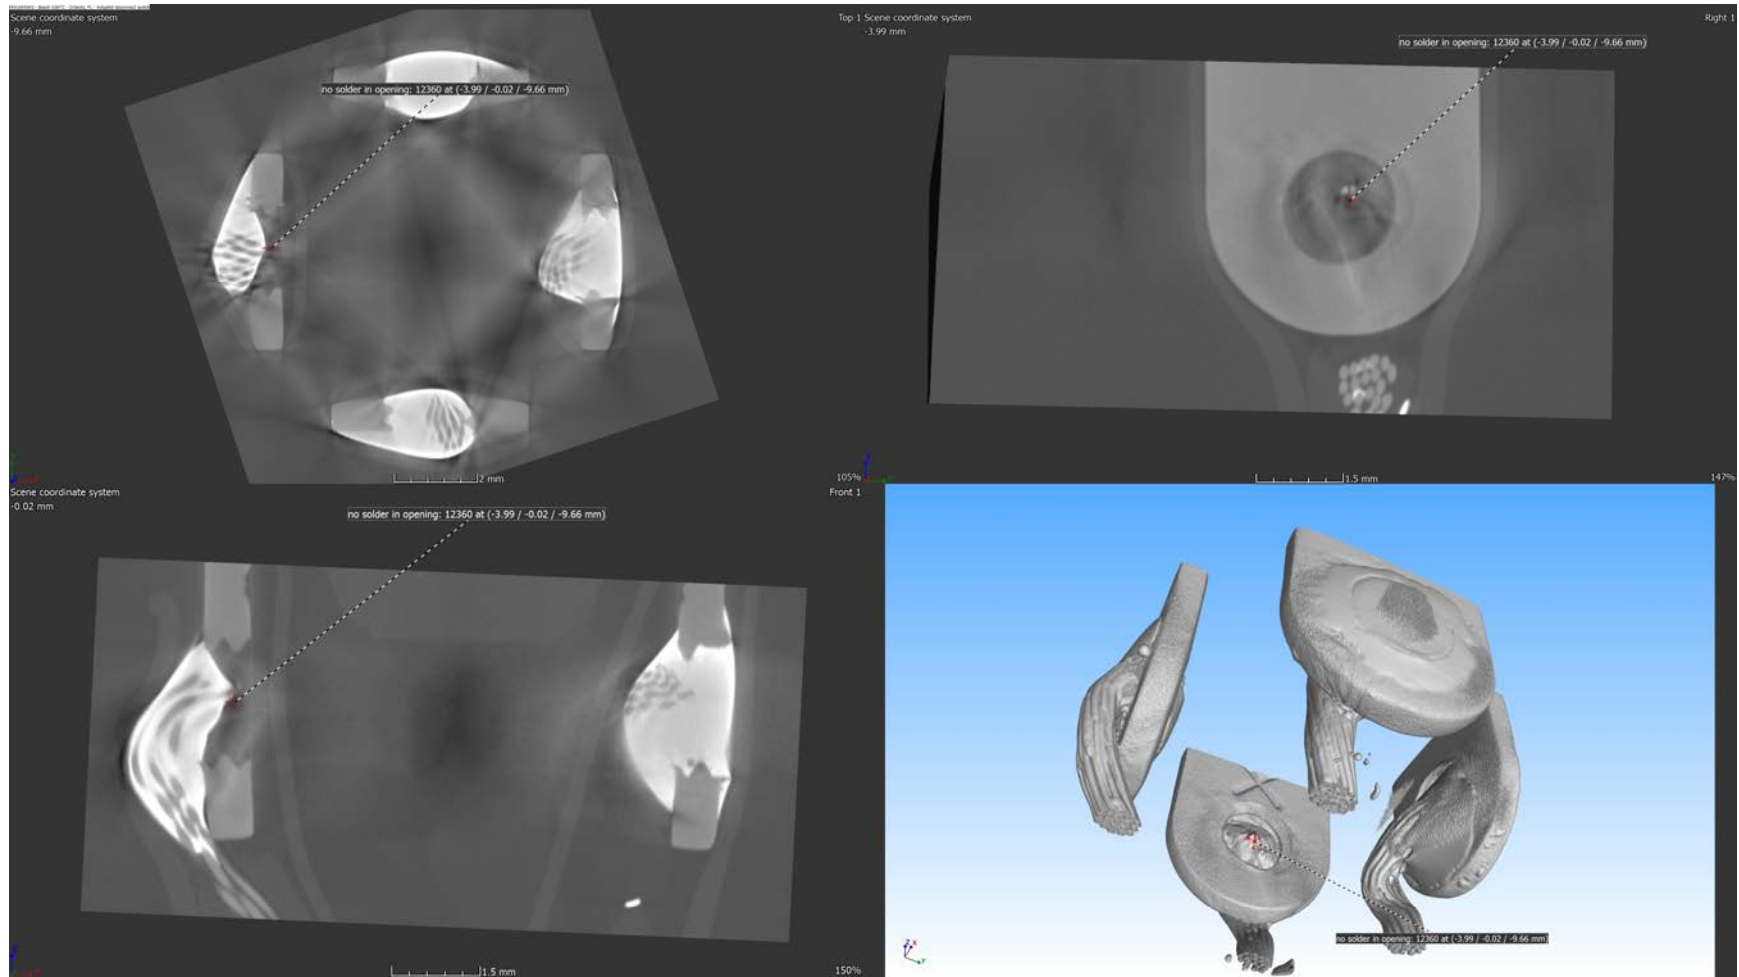
Figure 38  
Autopilot disconnect/trim interrupt switch – Solder connections only – No solder in terminal opening – view 1
