**NATIONAL TRANSPORTATION SAFETY BOARD**

**Computed Tomography Specialist's Factual Report**

ERA-16-FA-043

Operator: Kavak Aviation, LLC  
Location: Clear Lake, Orlando, Florida  
Date: November 20, 2015  
Time: 1127 eastern standard time  
Airplane: Beech A36TC, N7FG

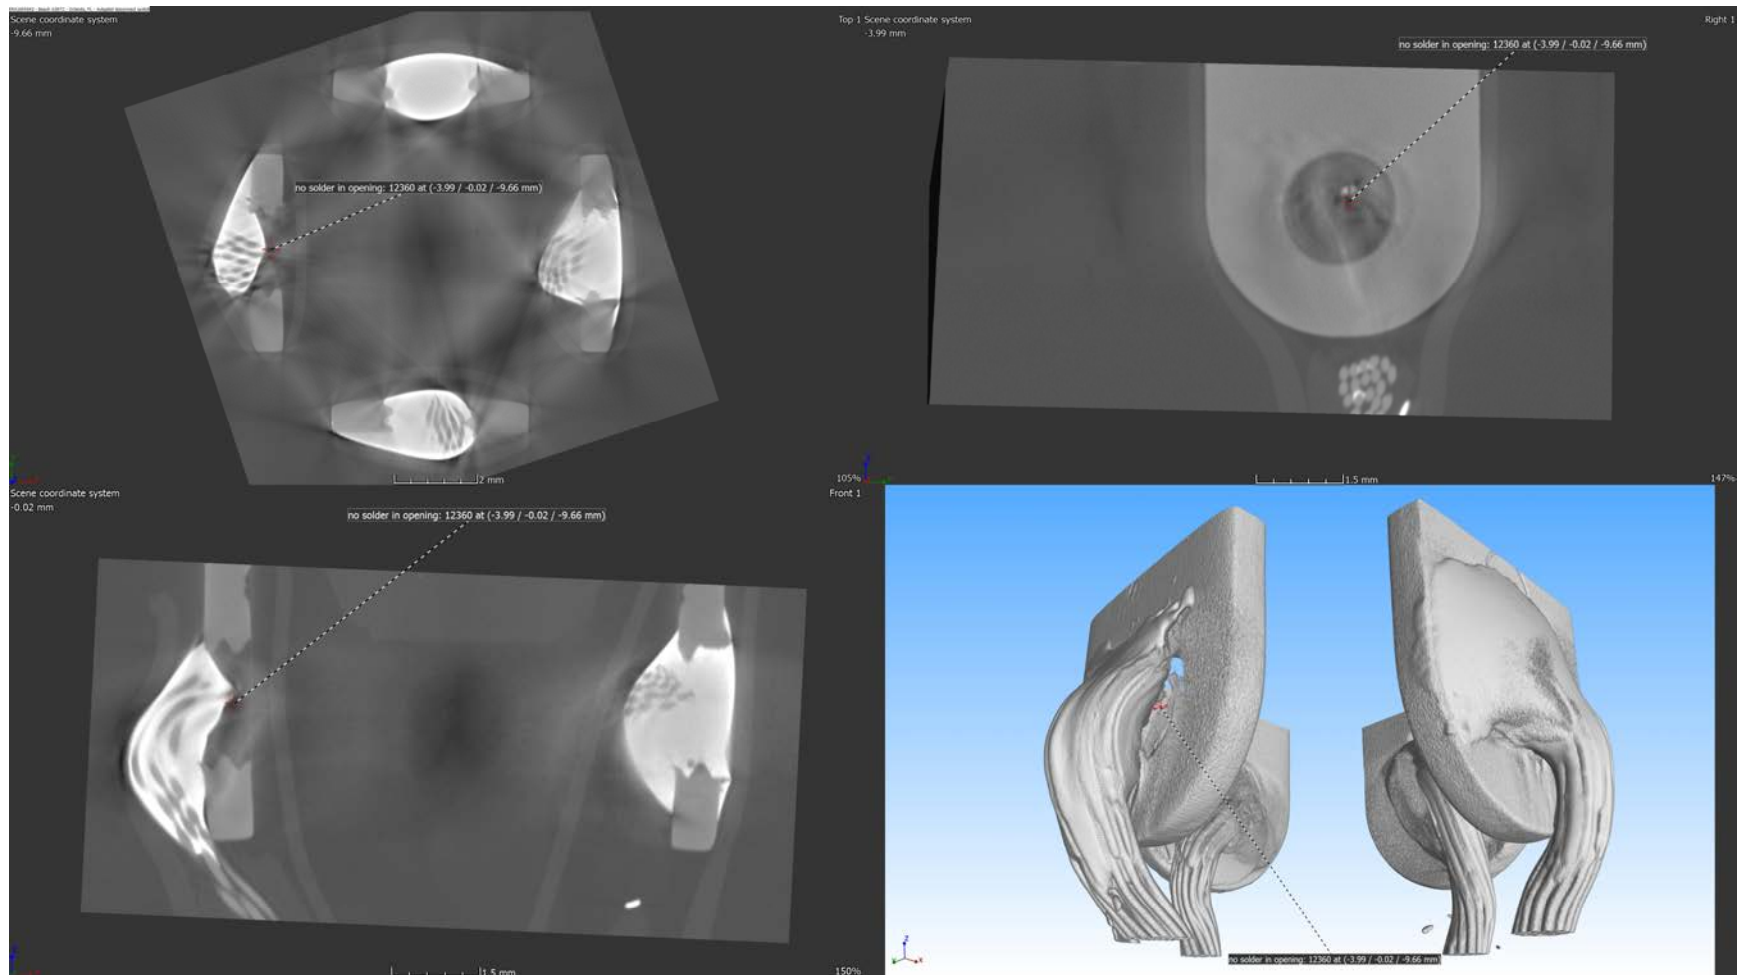
Figure 39  
Autopilot disconnect/trim interrupt switch – Solder connections only – No solder in terminal opening – view 2

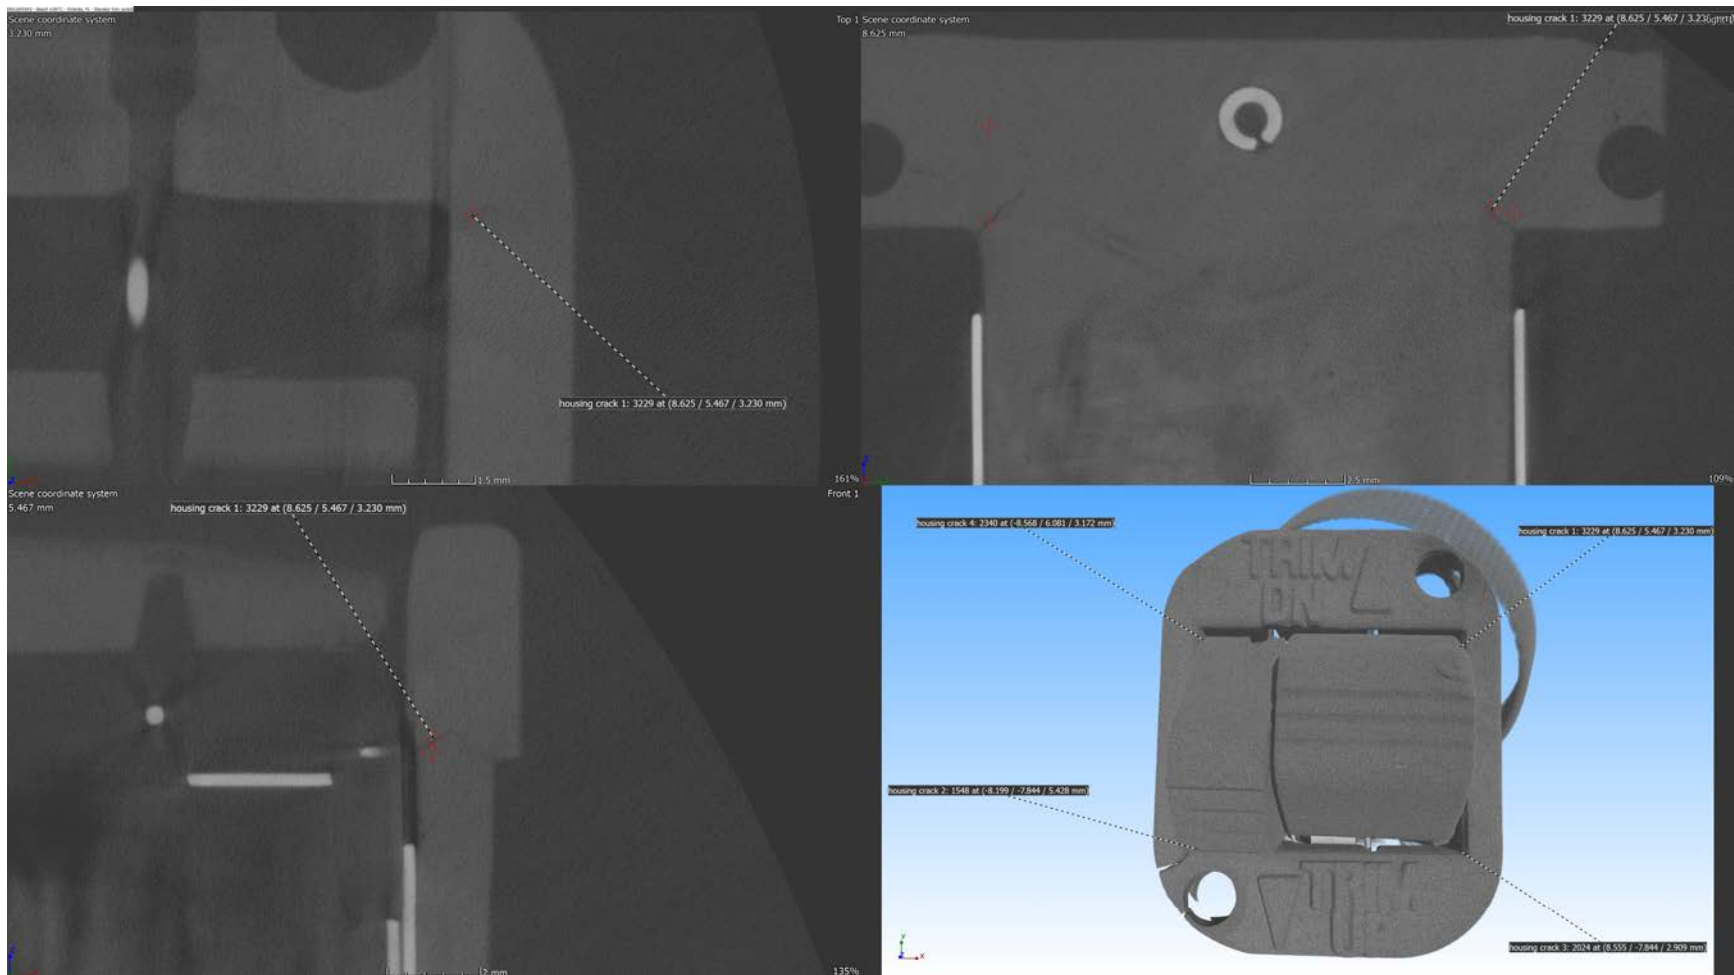
Figure 43  
Autopilot trim switch assembly – Housing crack 1

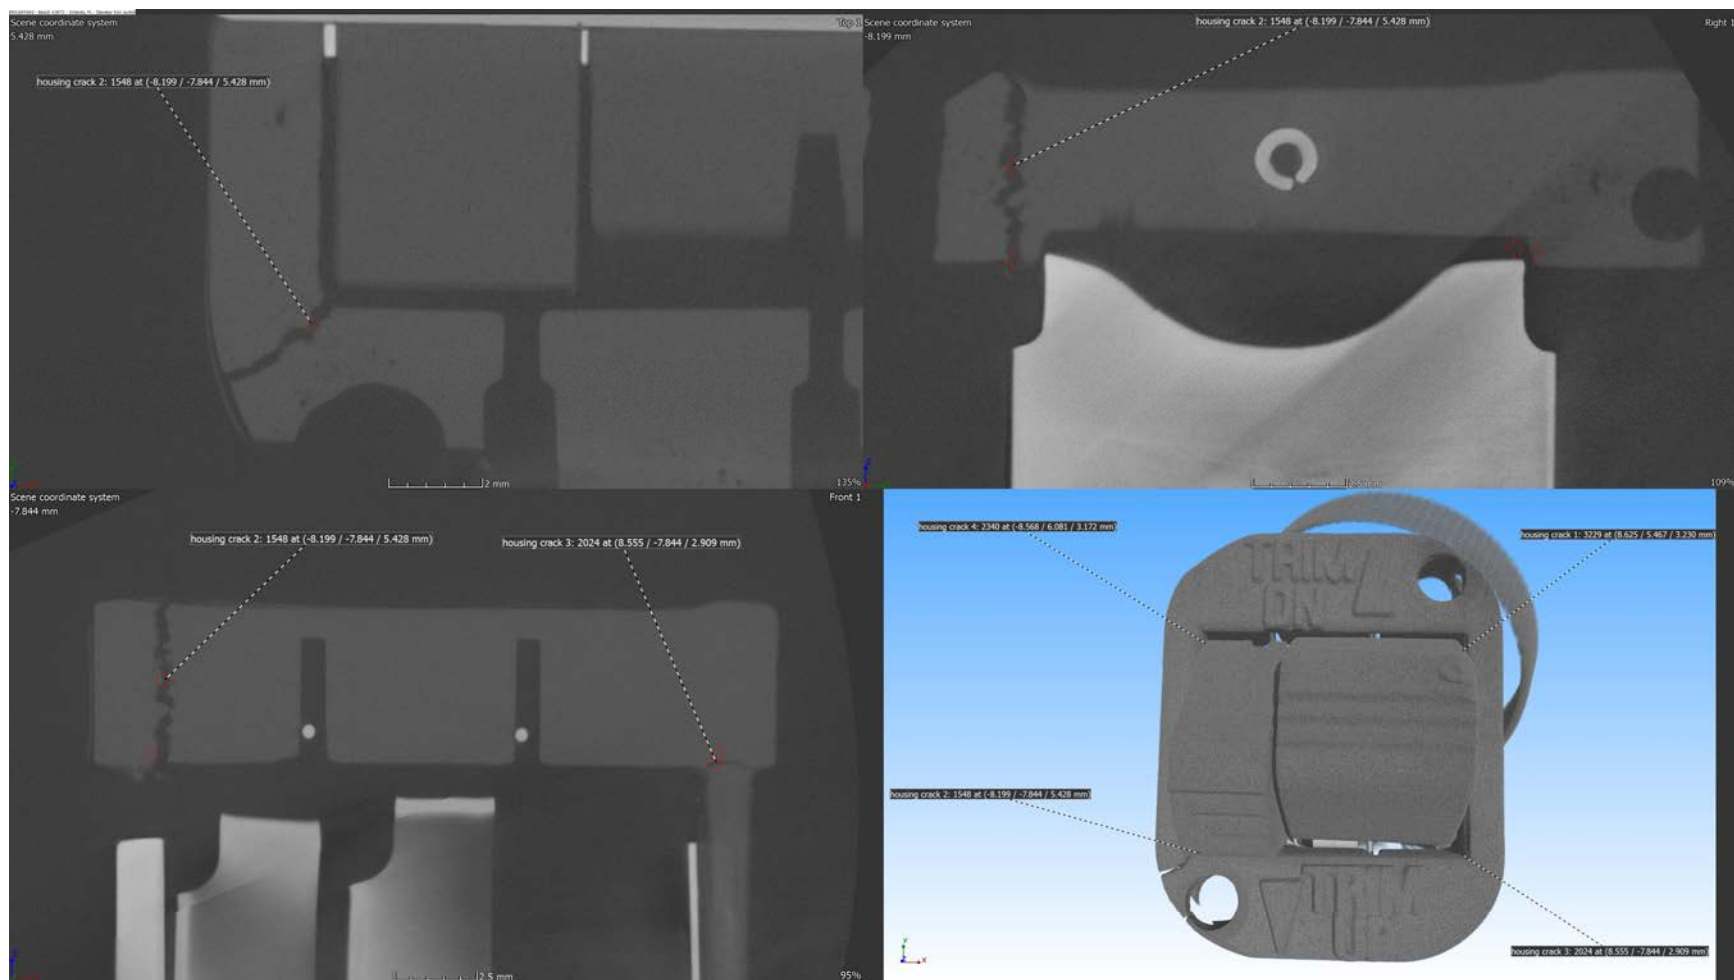
Figure 44  
Autopilot trim switch assembly – Housing crack 2

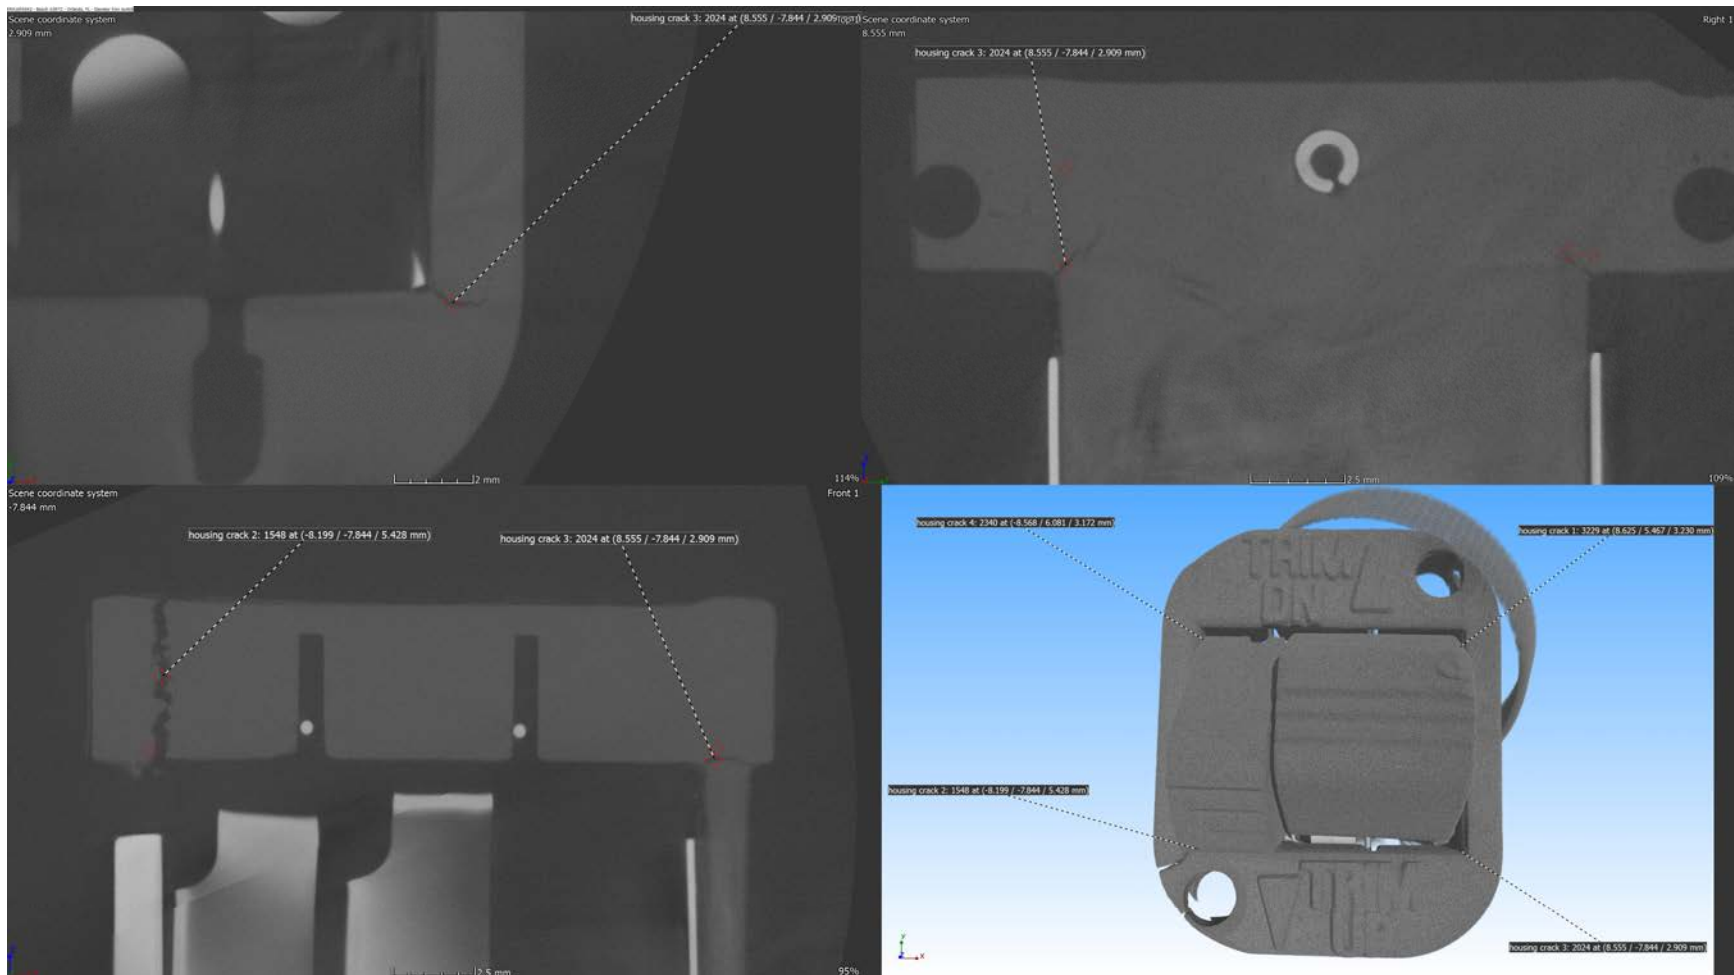
Figure 45  
Autopilot trim switch assembly – Housing crack 3

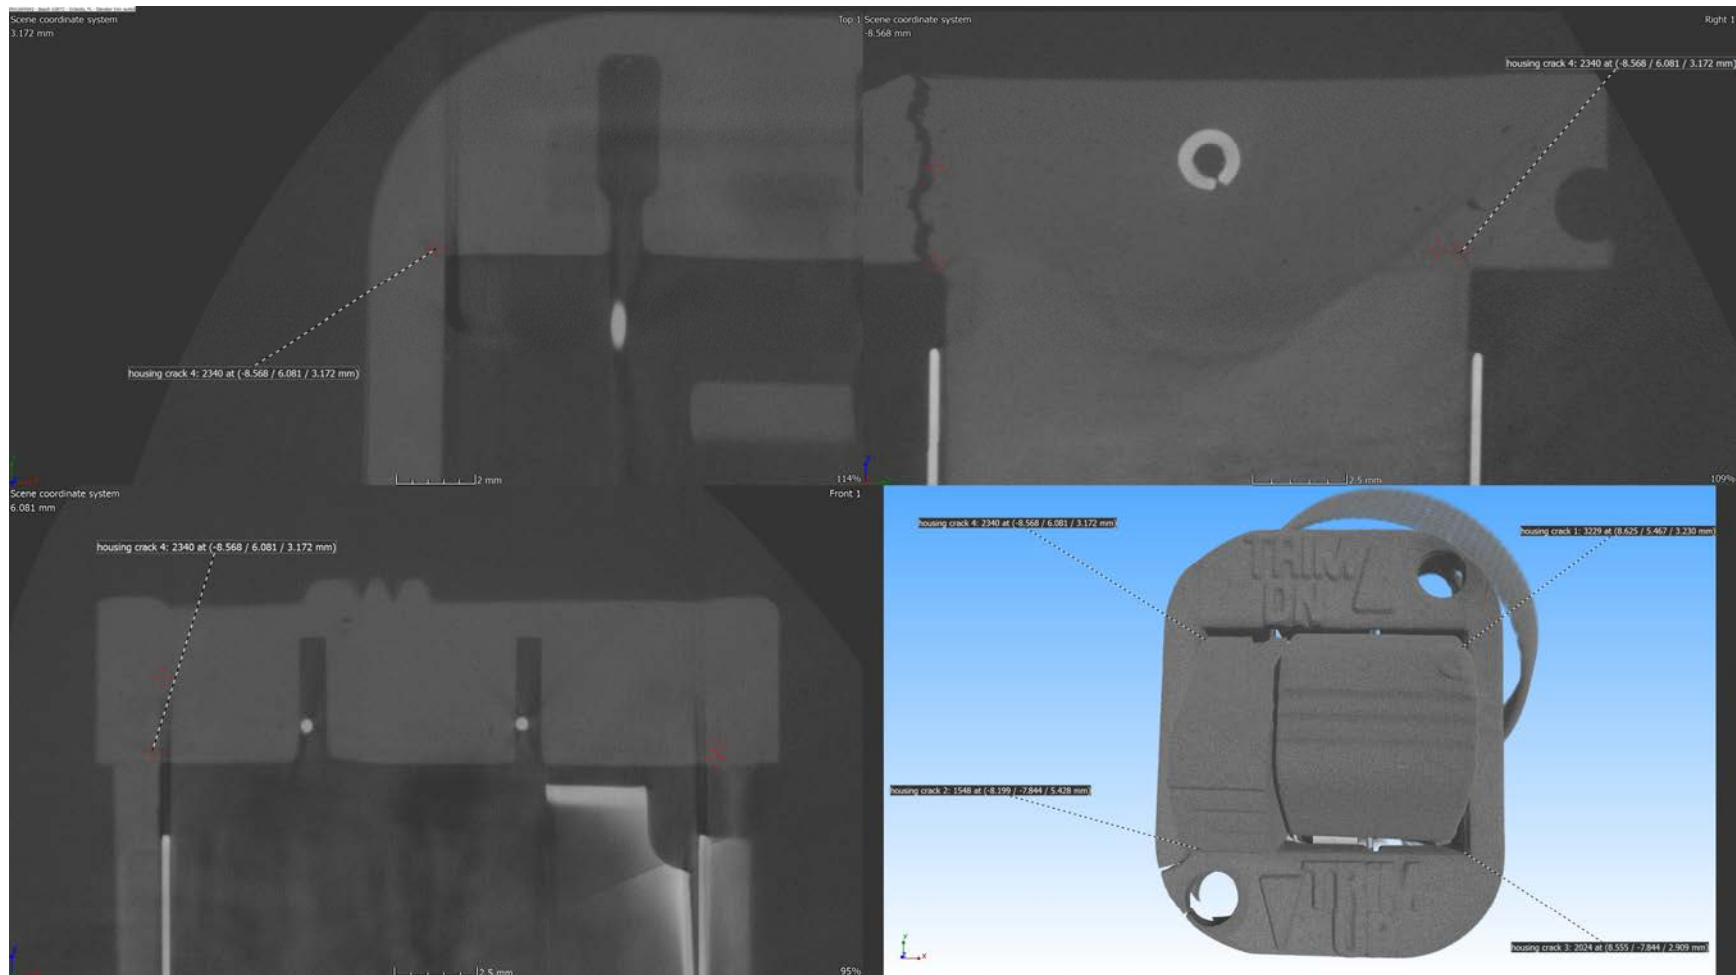
Figure 46  
Autopilot trim switch assembly – Housing crack 4

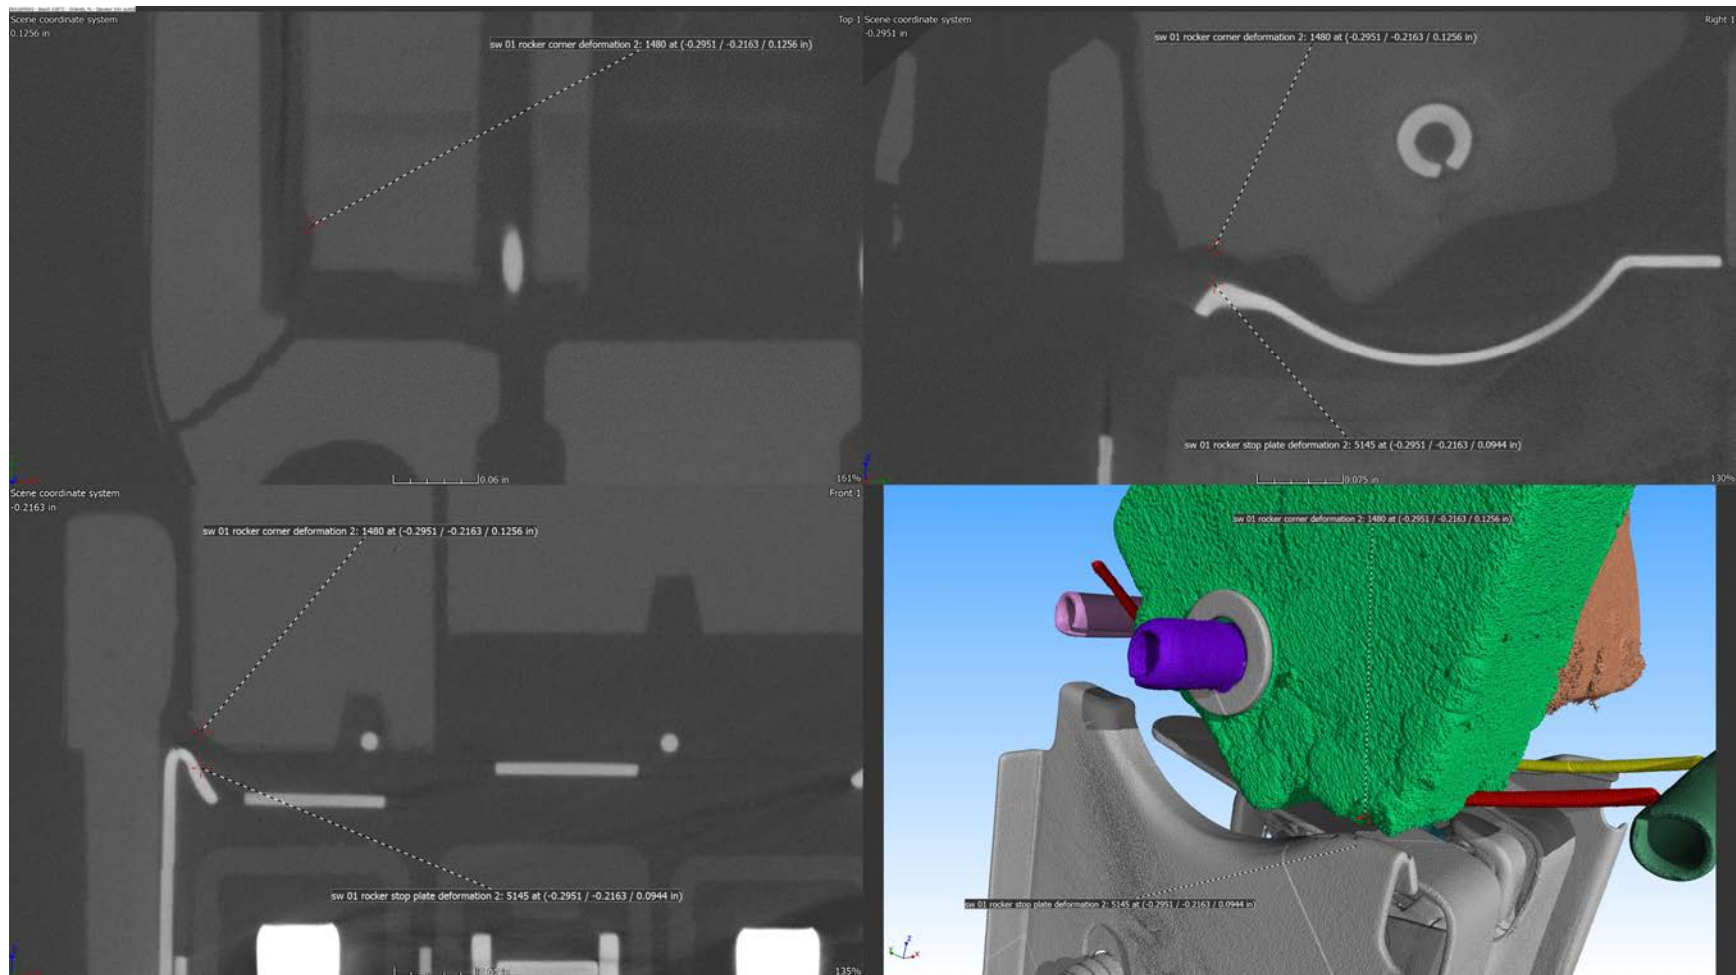
Figure 49  
Autopilot trim switch assembly – Switch 01 rocker corner deformation area 2

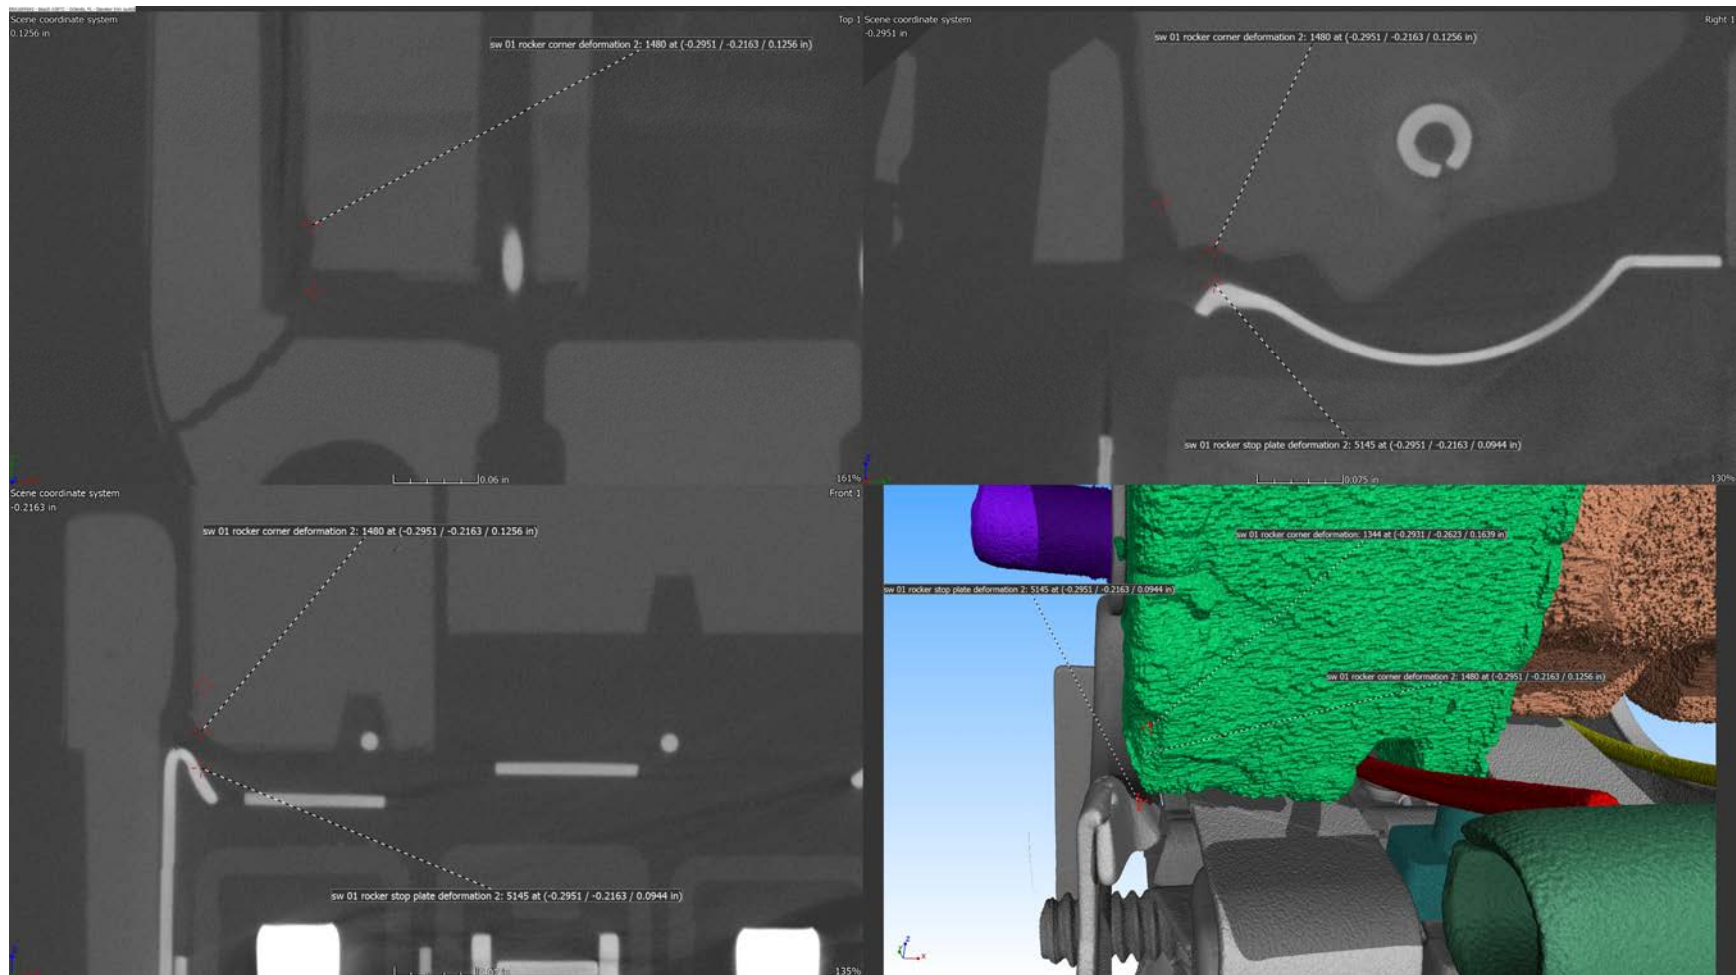
Figure 50  
Autopilot trim switch assembly – Switch 01 rocker stop plate deformation area 2

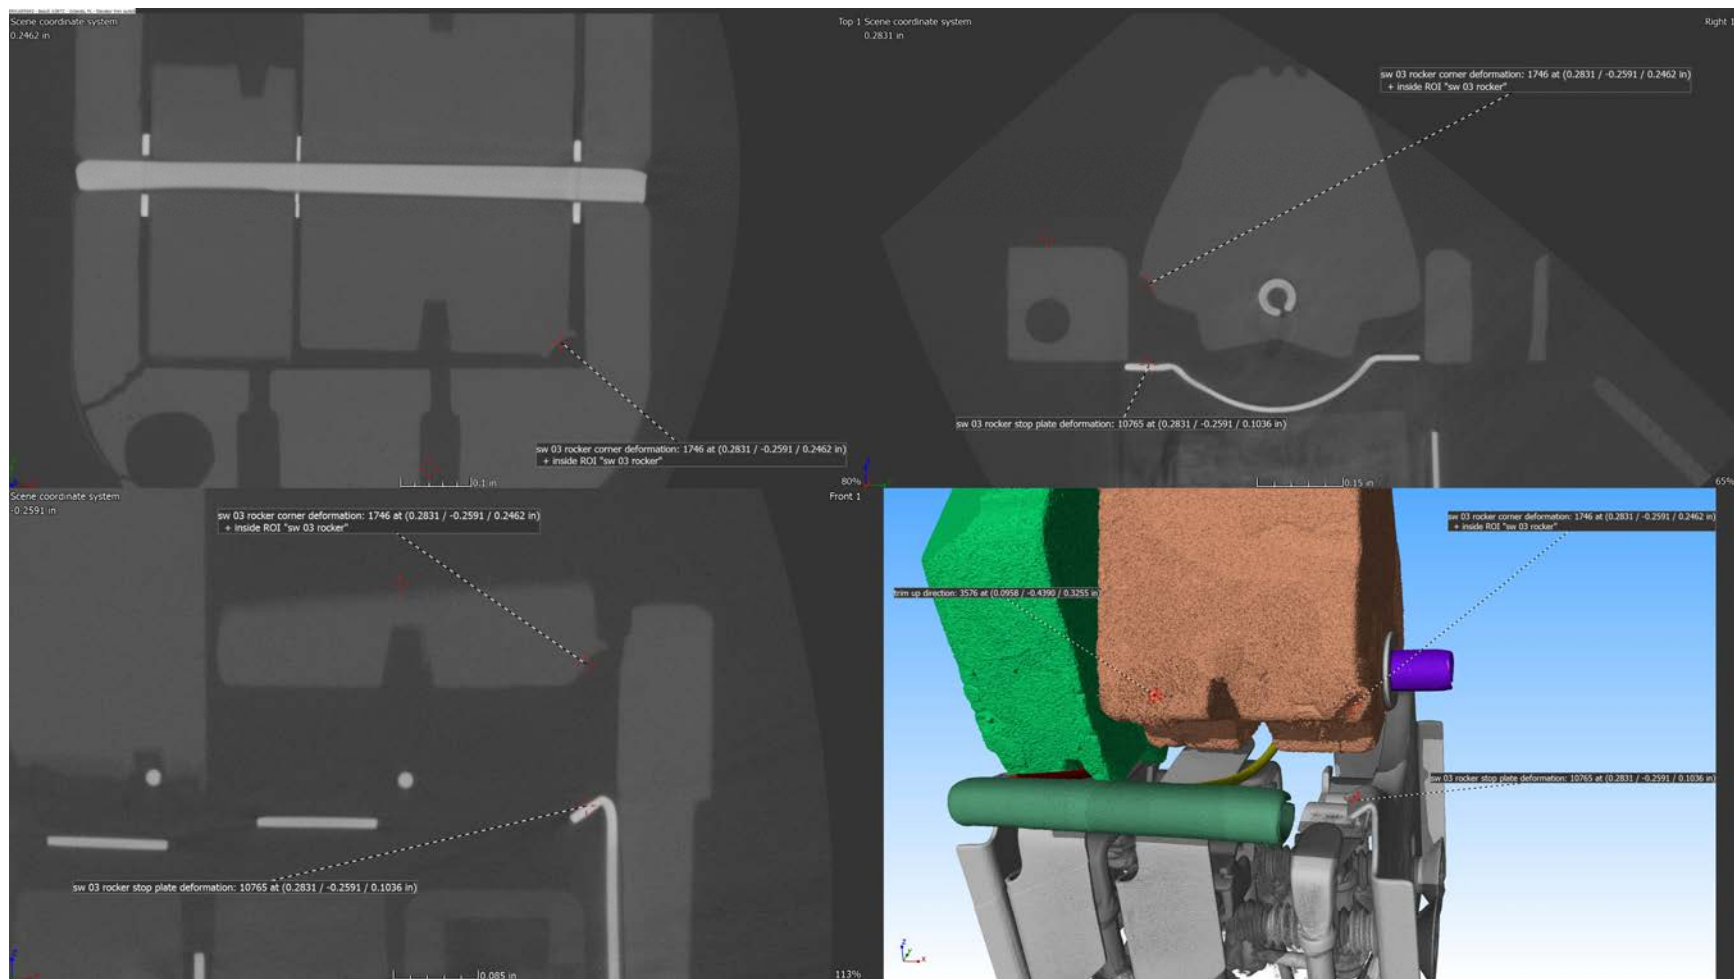
Figure 51  
Autopilot trim switch assembly – Switch 03 (sw 03) rocker corner and stop plate deformation

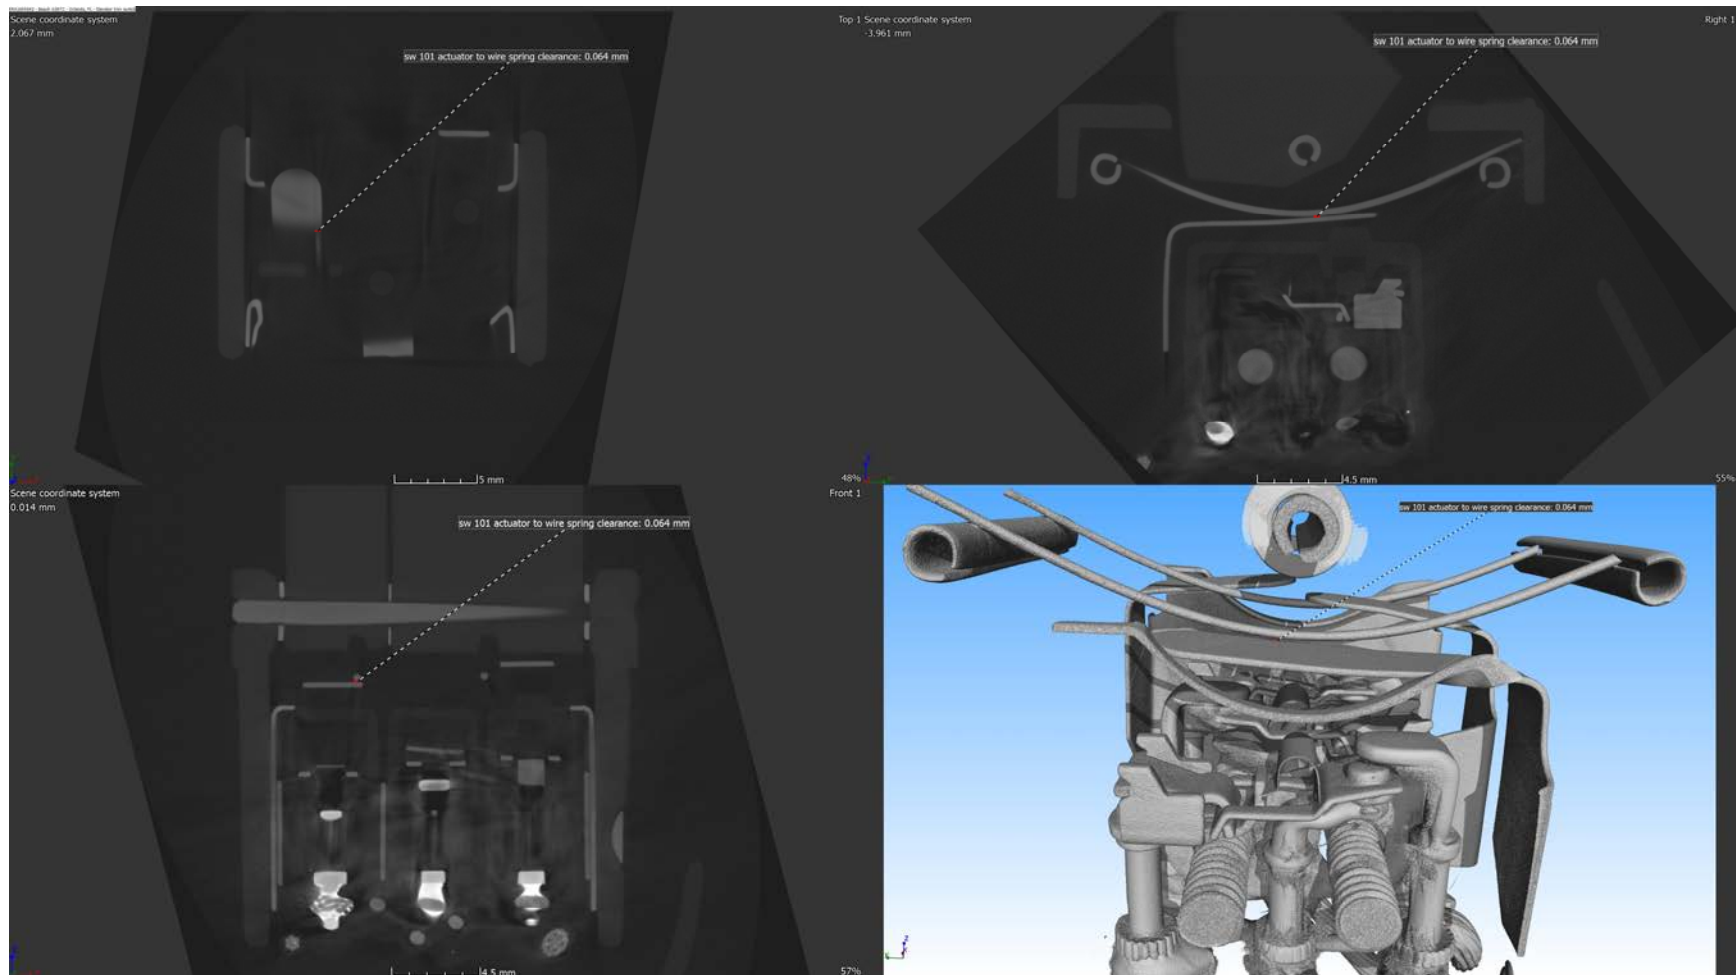
Figure 65  
Autopilot trim switch assembly – Switch 101 actuator to wire spring clearance

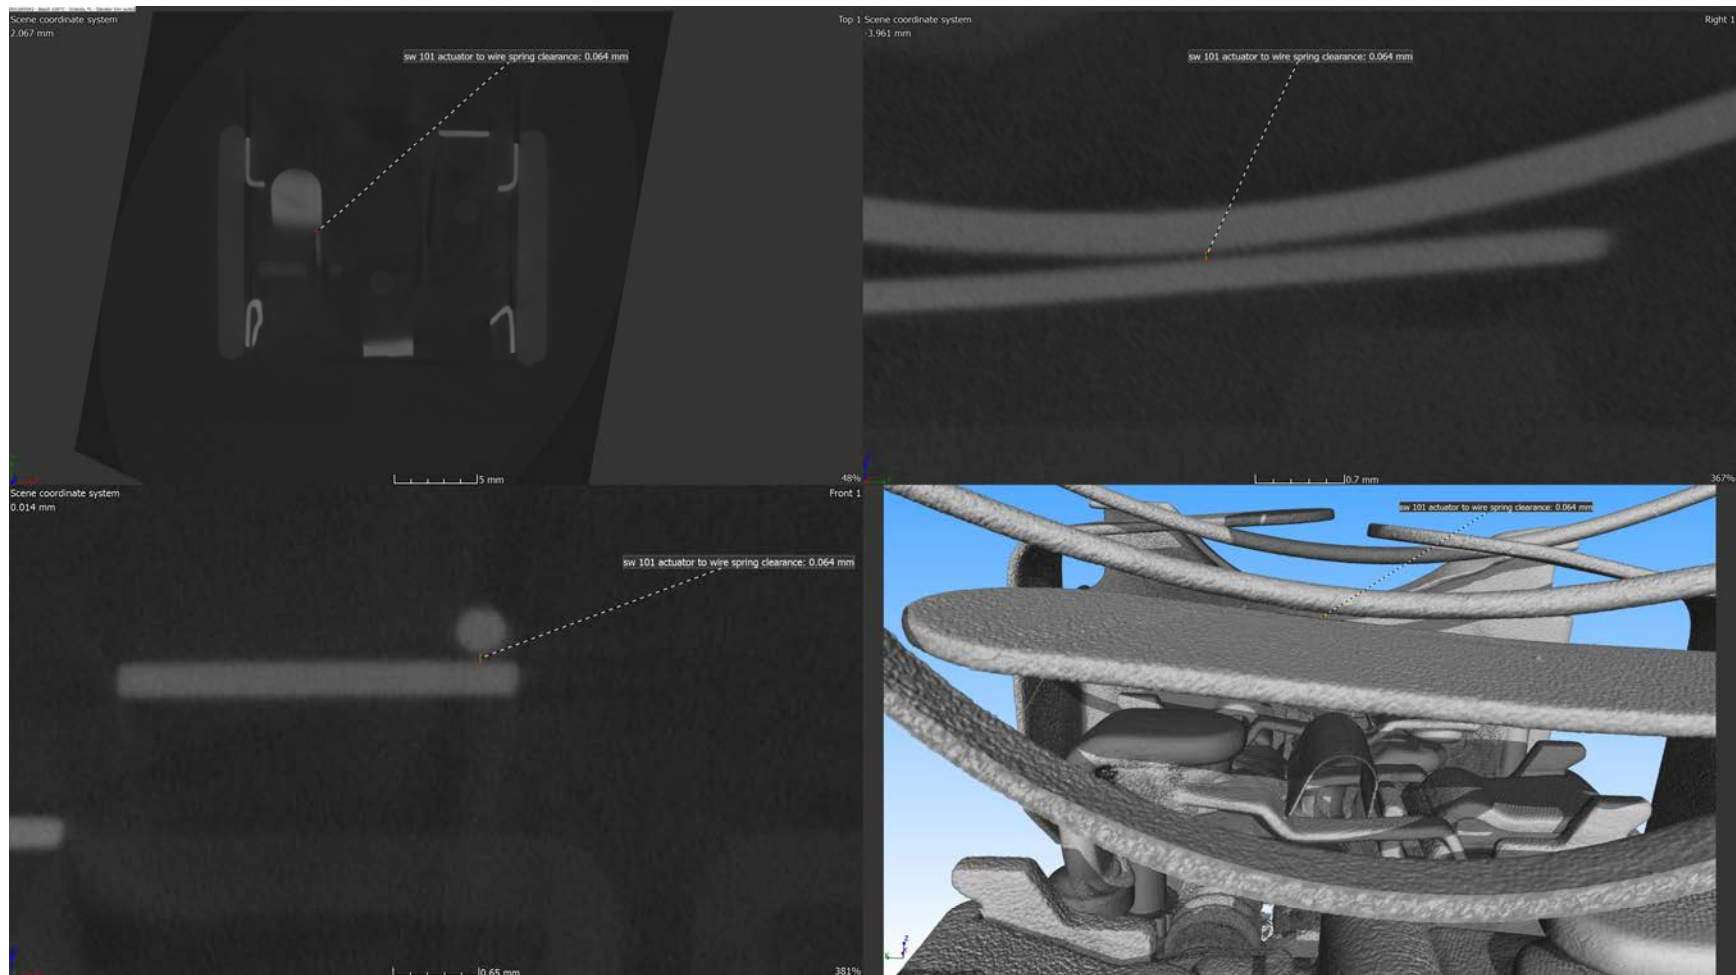
Figure 66  
Autopilot trim switch assembly – Switch 101 actuator to wire spring clearance – close up view

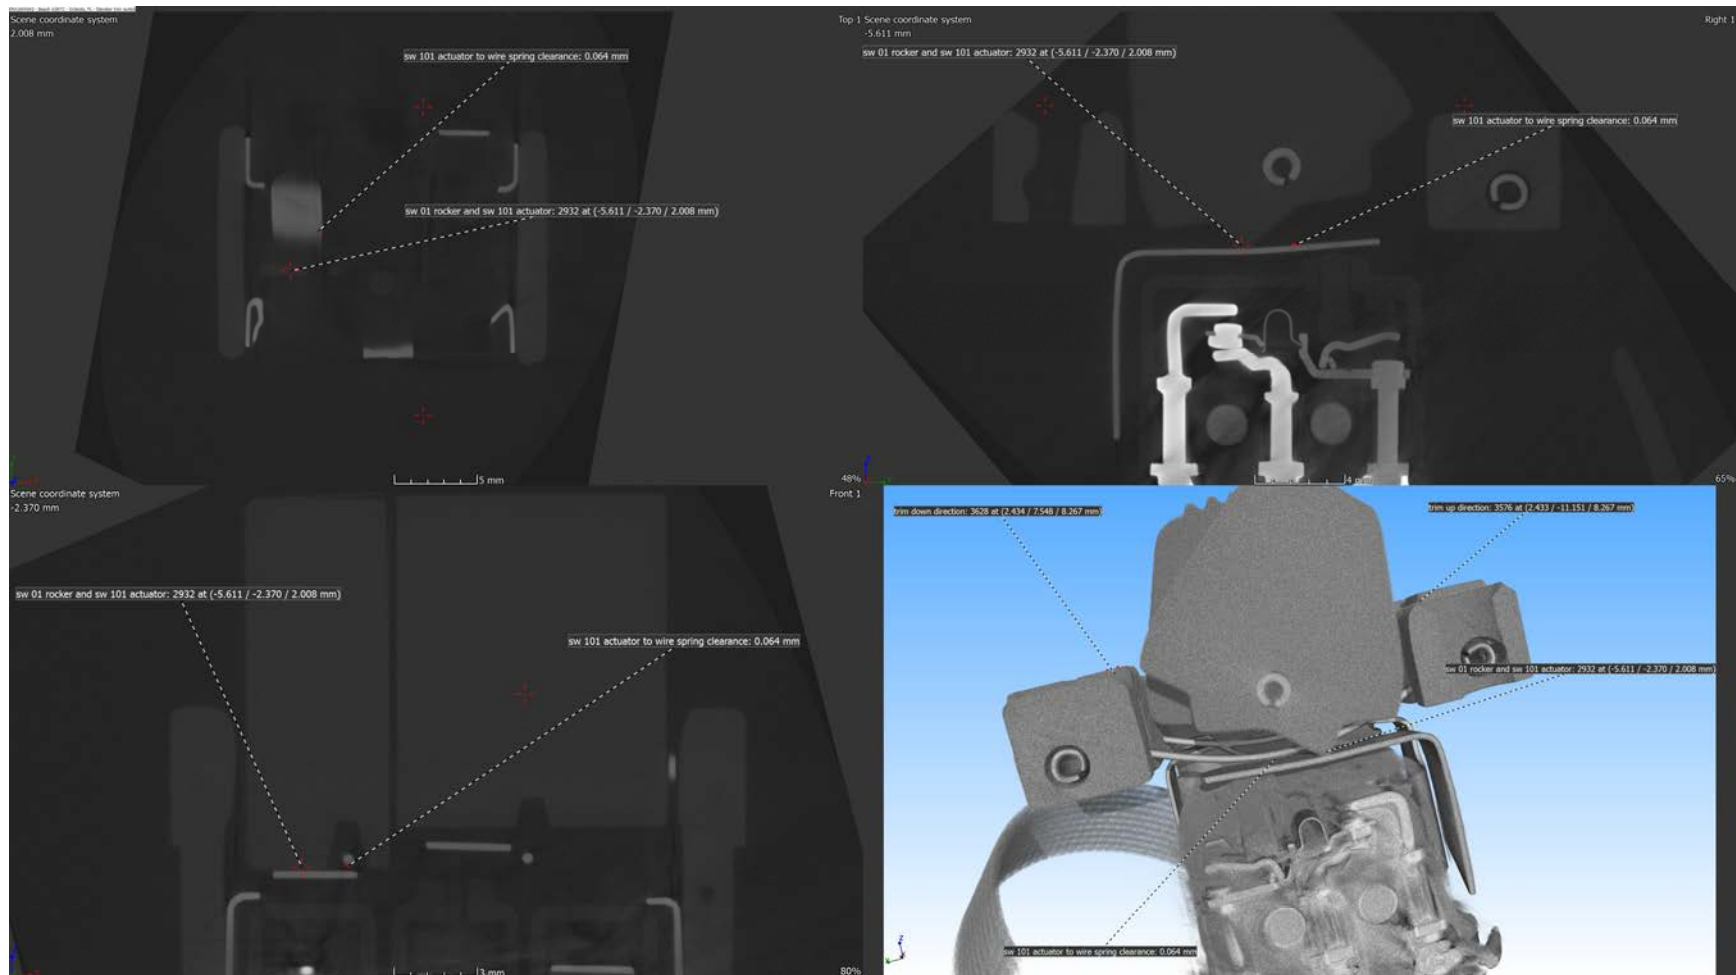
Figure 67  
Autopilot trim switch assembly – Switch 01 rocker and switch 101 actuator
