# **National Transportation Safety Board**

## **Performance Study**

### **Specialist Report**

| NTSB Number: | ERA16FA043 |

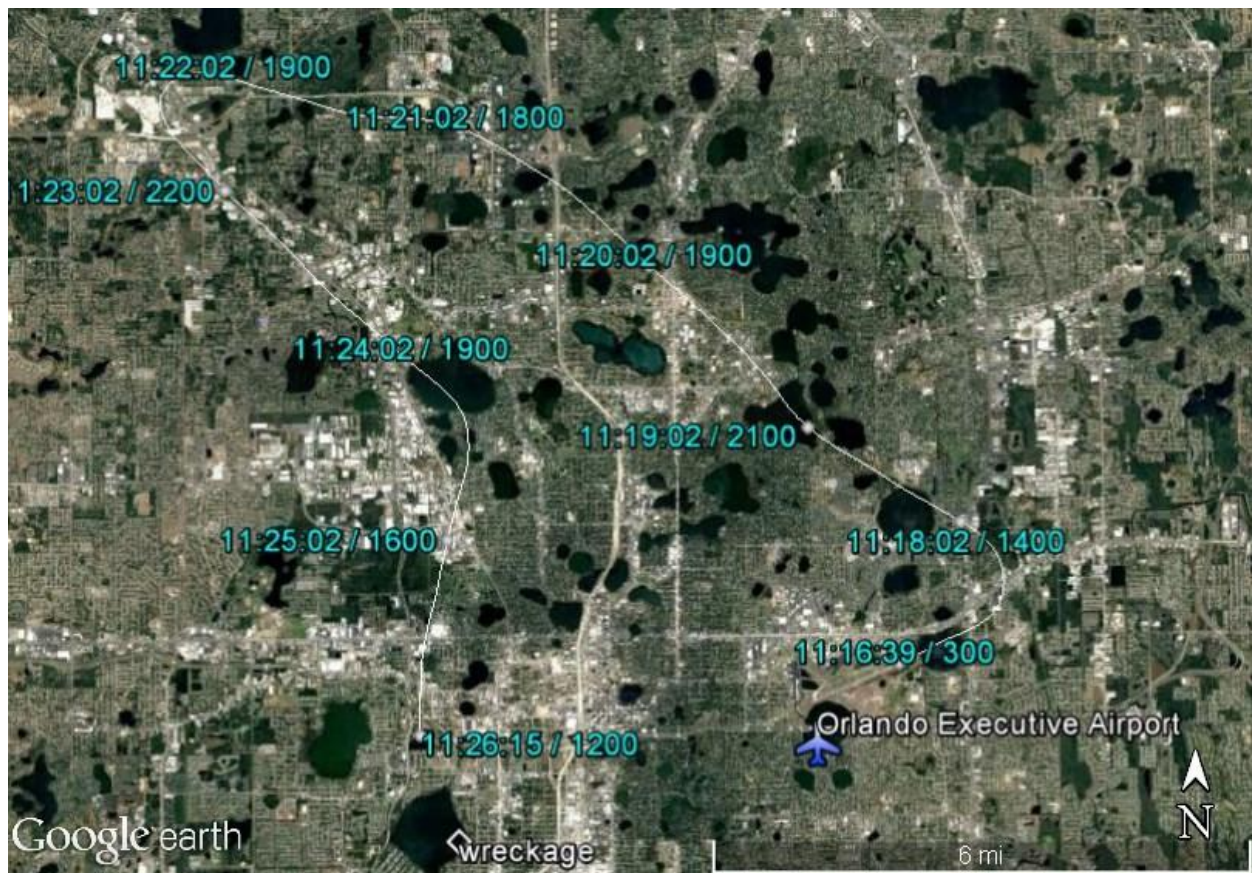
**Figure 1.** Radar flight path.

The flight path is shown in Figure 1. The airplane took off from runway 7 at Orlando Executive Airport and began along a northwesterly track. At about 11:22 the airplane turned to the left onto a southeasterly track back towards the airport. At about 11:24:20 the airplane turned right onto a more southerly track which continued until radar contact was lost.

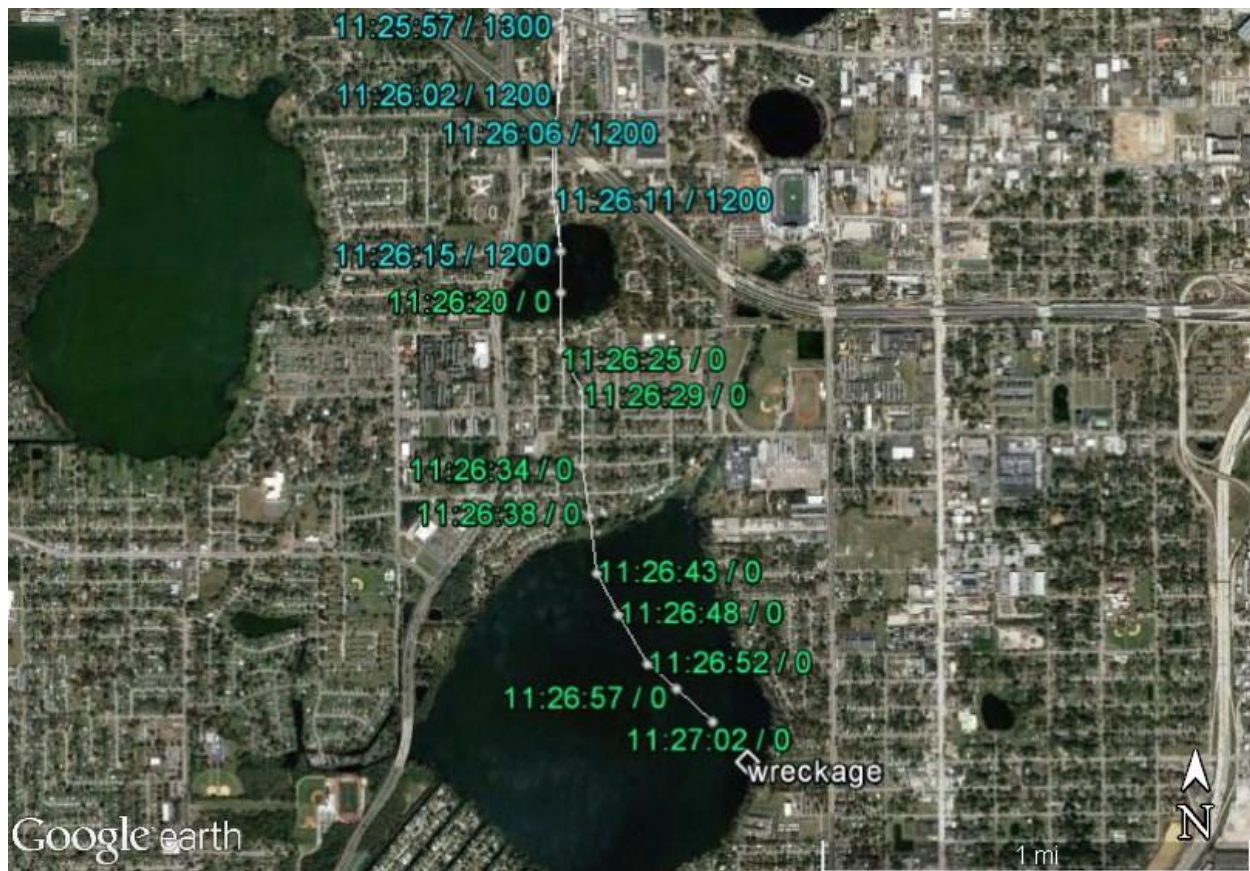
**Figure 2.** End of radar flight path (blue) with primaries (green).

The last secondary radar return (blue, Figure 2) from the aircraft was received at 11:26:15, over a mile north of the wreckage. A path of primary radar returns likely tracking the accident airplane is shown on the map in green. The radar returns can be used to calculate the groundspeed of the airplane. The altitude data included in the secondary returns can be used to determine the appropriate wind speed and direction (shown in Table 1), by which the groundspeed can be used to determine airspeed. Primary radar returns do not contain altitude information, but can be used to calculate groundspeed.

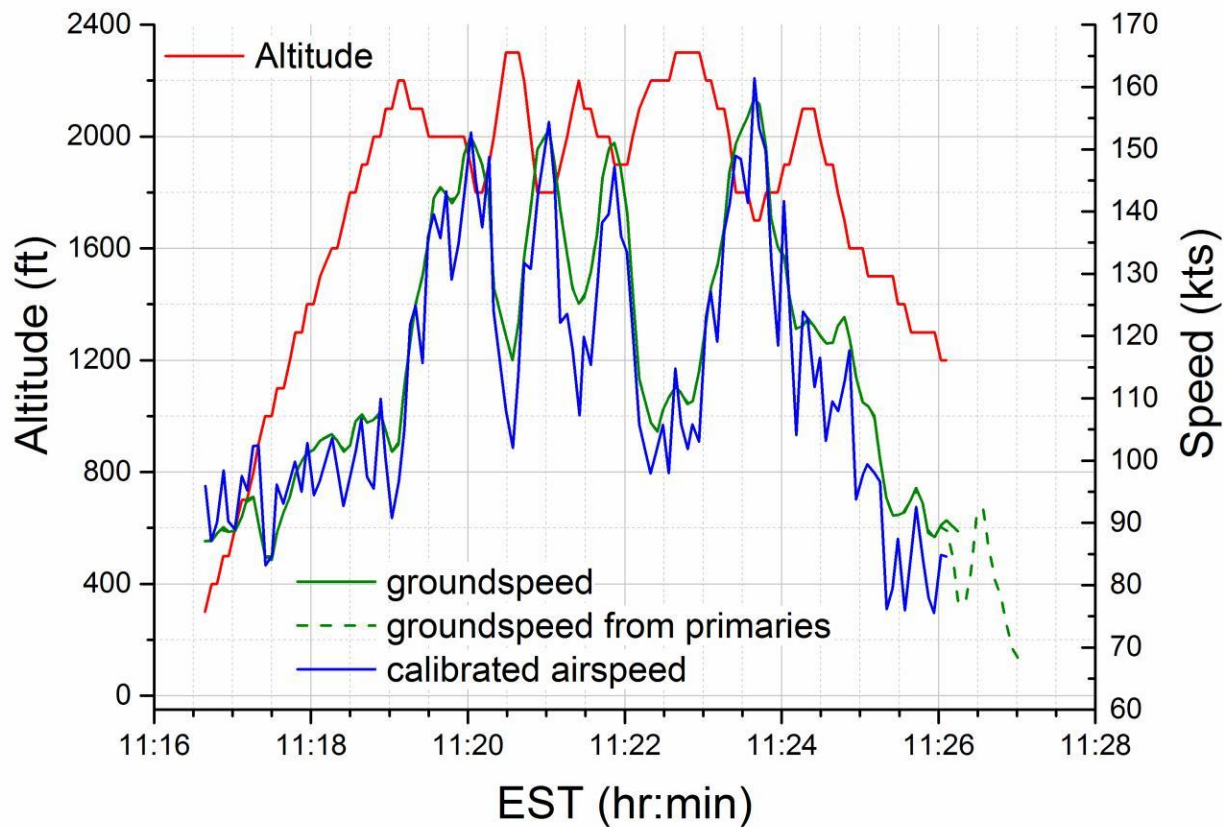
**Figure 3.** Altitude and calculated groundspeed and airspeed.

Figure 3 shows the calculated groundspeed from the primary and secondary radar returns and the airspeed from just the secondary returns. During its climbs and descents, the airplane's speeds varied from 100 to 150 kts, gaining speed on descents and losing speed on ascents. However, during the last descent the aircraft was losing speed throughout starting at 2,100 ft and 122 kts at 11:24:20 and ending at 1,200 ft and 78 kts at 11:26:11. In just under two minutes the aircraft lost 44 kts of airspeed and 900 ft of altitude (a descent rate of 486 ft/min). After 11:26:15, radar returns did not contain altitude information. For the last 47 seconds of returns groundspeed only was calculated and is shown as a dotted green line.

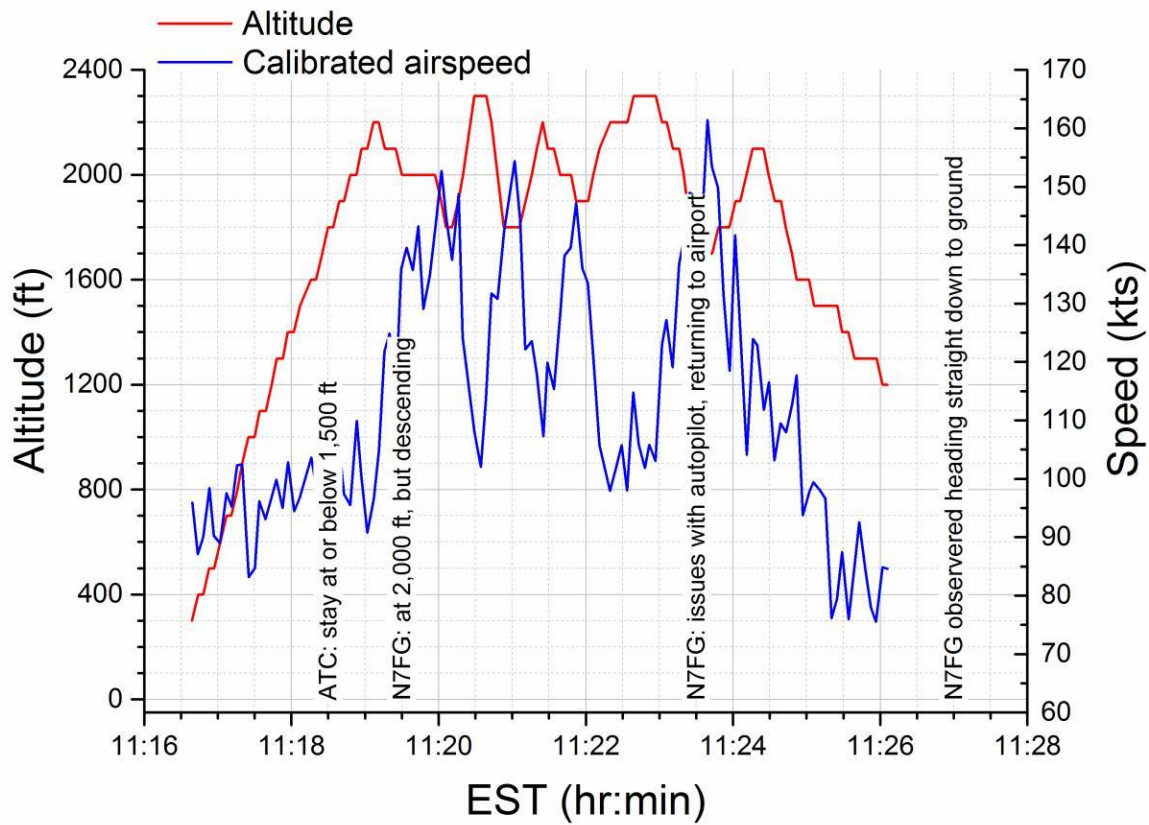
**Figure 4.** Altitude, airspeed, and selected ATC communications.

Figure 4 shows the altitude and calibrated airspeed from radar with selected air traffic control (ATC) communications.<sup>1</sup> At about 11:18, ATC told the pilot to stay at or below 1,500 ft and outside the Bravo airspace of MCO. The airplane passed 1,500 ft and continued to 2,200 ft. The pilot reported the airplane was above 1,500 ft, but that he would descend. The airplane proceeded through a series of descents and ascents with varying airspeeds, but did not return below 1,500 ft until its final descent into the ground. At 11:23 the pilot reported autopilot issues and stated he was returning to the airport. This is consistent with the flight path shown in Figure 1.

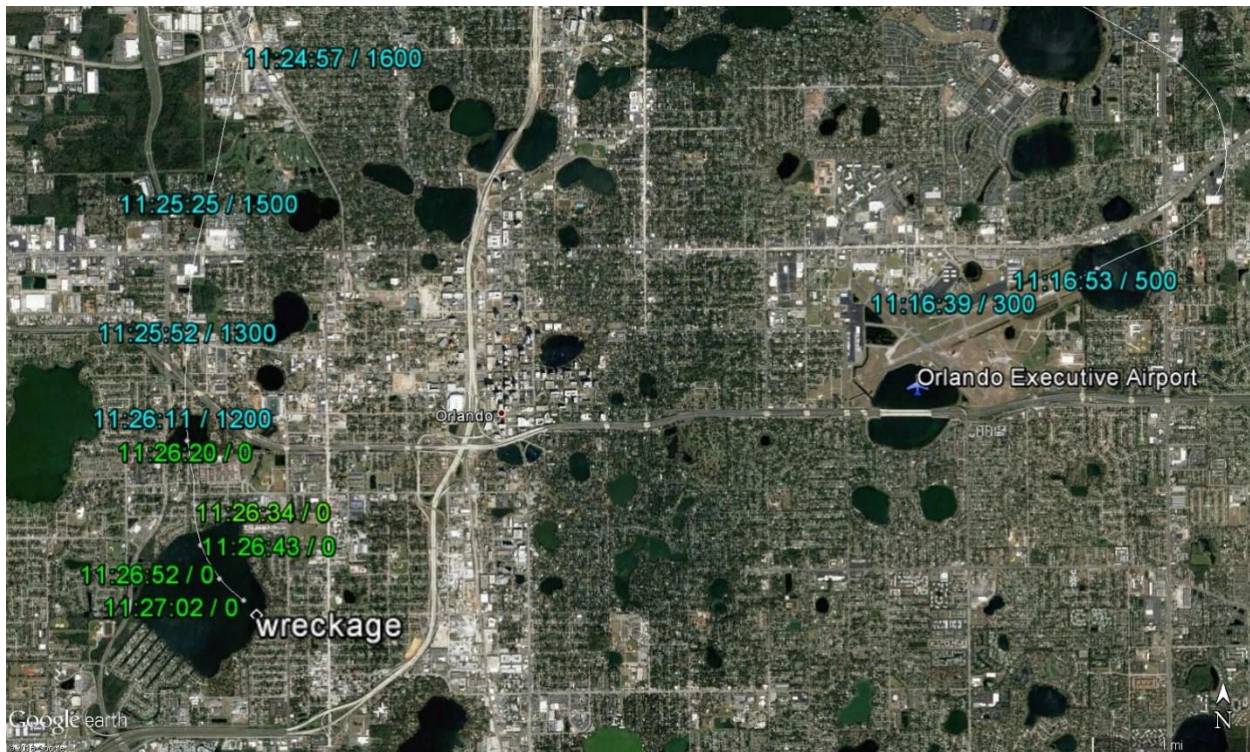
**Figure 5.** End of flight path and airport.

Figure 5 show the end of the flight and the airport the pilot planned to return to. The wreckage was about 3.7 NM from the threshold of runway 7.

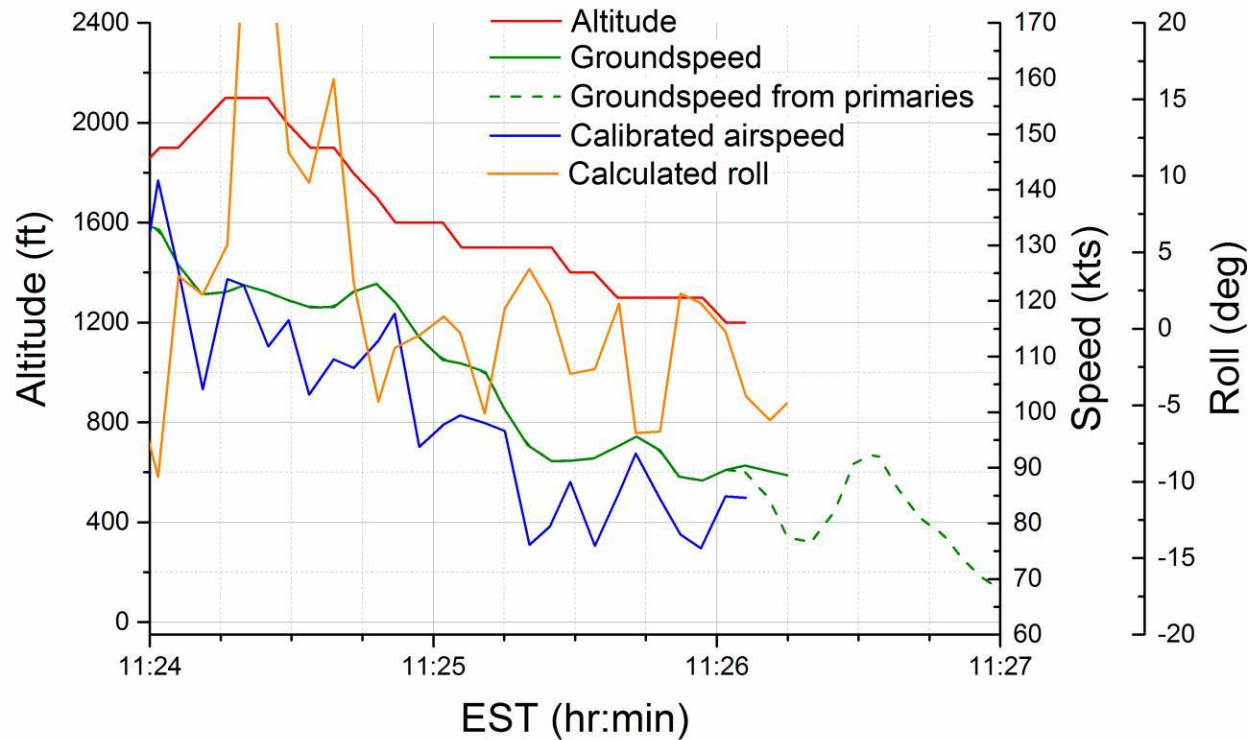
**Figure 6.** Altitude, calculated groundspeed and airspeed, and bank angle for the end of flight.

Figure 6 shows the final three minutes of flight in terms of altitude, ground and airspeed, and calculated bank angle. The groundspeed continued to decrease during the last 47 seconds of flight recorded without altitude data. Airspeed, while not calculated from the primary returns, had been trending slightly lower than the aircraft's groundspeed, because of a small tailwind component.

The last calculated groundspeed was about 68 kts at 11:27:02. Airspeed for the last three minutes of flight (Figure 6) was between 5 and 10 kts slower than the groundspeed. It was likely the airplane's airspeed was close to the reported stall speeds for the estimated weight at the end of the primary radar data.

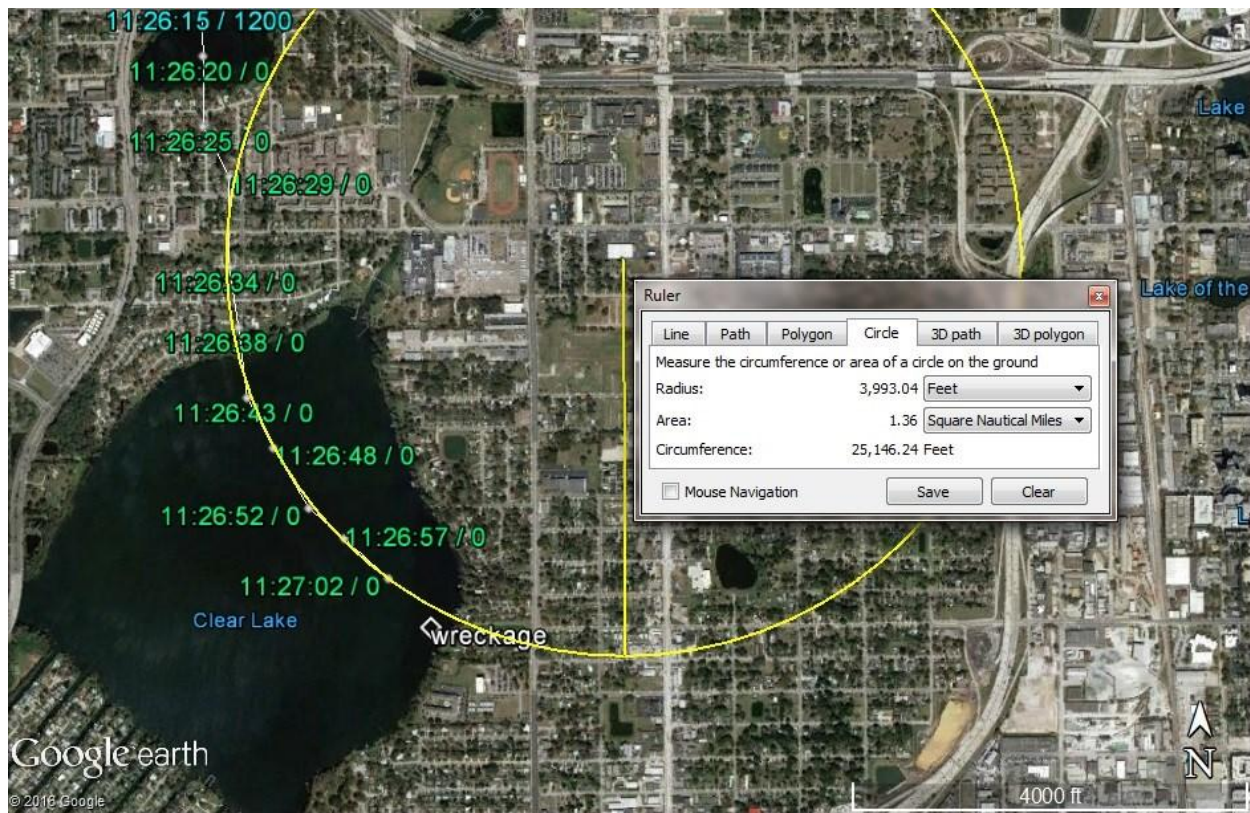
**Figure 7.** Estimated radius of final left turn.

Figure 7 shows a circle with a radius of about 4,000 ft can be fitted to the final radar return points. At 80 kts and a radius of 4,000 ft, the bank angle of the turn would be approximately  $8^\circ$  left wing down.

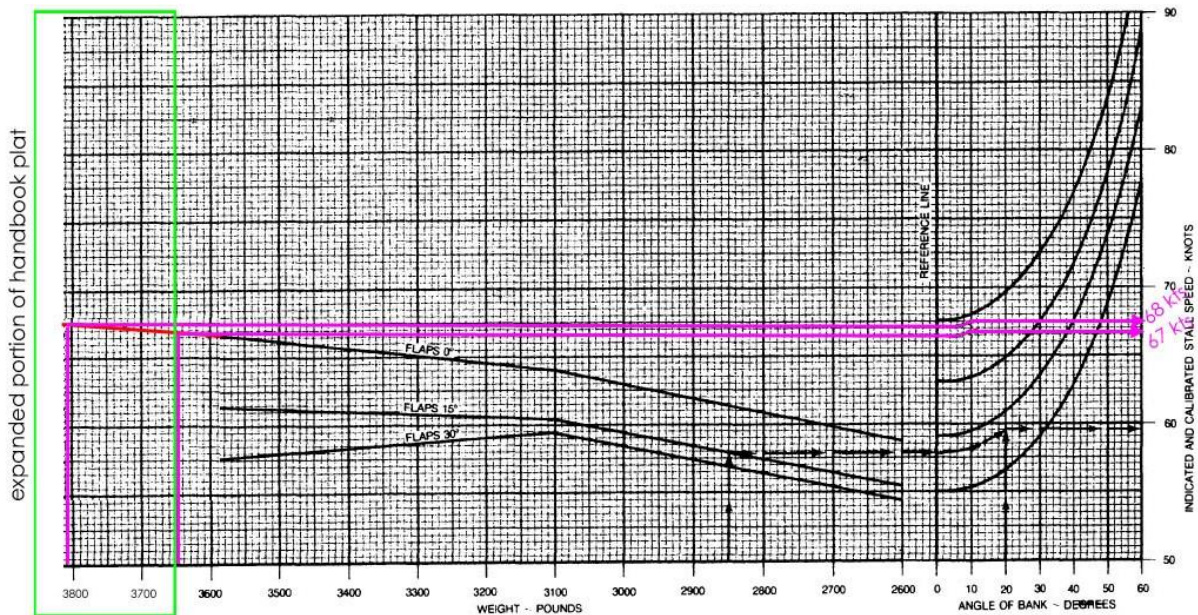
**Figure 8.** Stall speeds for Bonanza A36TC.

The gross weight of the accident airplane was determined to be 3,833 lbs due to the installation of wing tip tanks<sup>2</sup>. Figure 8 shows the stall speeds from the Pilot's Operating Handbook [1] which show a stall speed of 67 kts for the maximum gross weight of the aircraft as manufactured (3,650 lbs). Additionally, the plot was expanded and extrapolated out to 3,800 lbs of weight which could raise the stall speed to 68 kts.
