# Physical Analysis Report on ERA16FA063

Prepared by Binghamton University  
for the National Transportation  
Safety Board, April 5, 2016

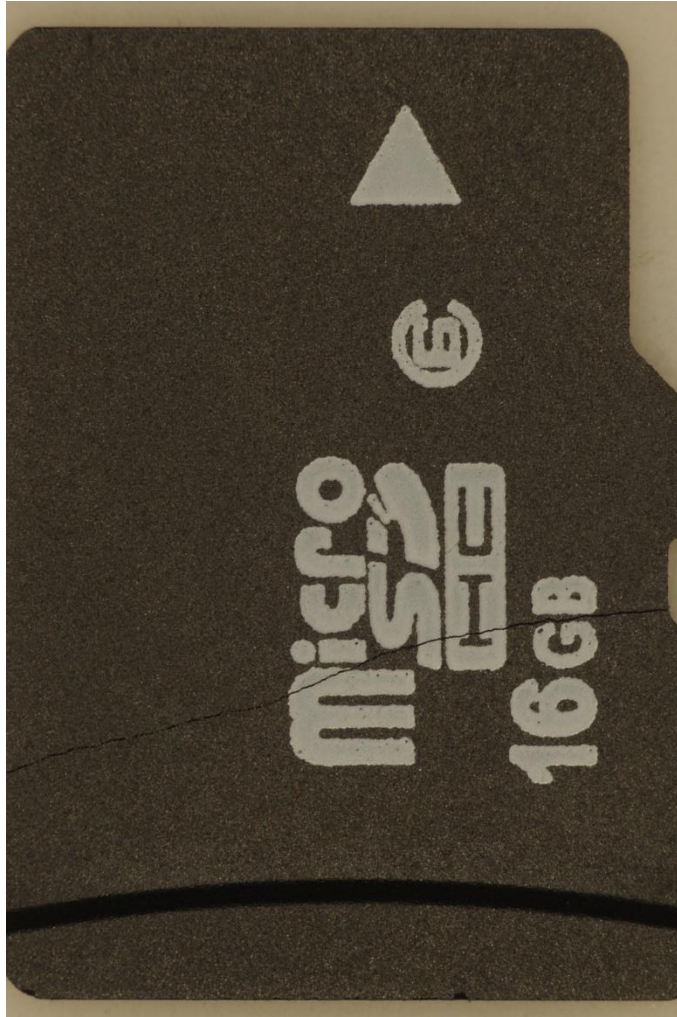
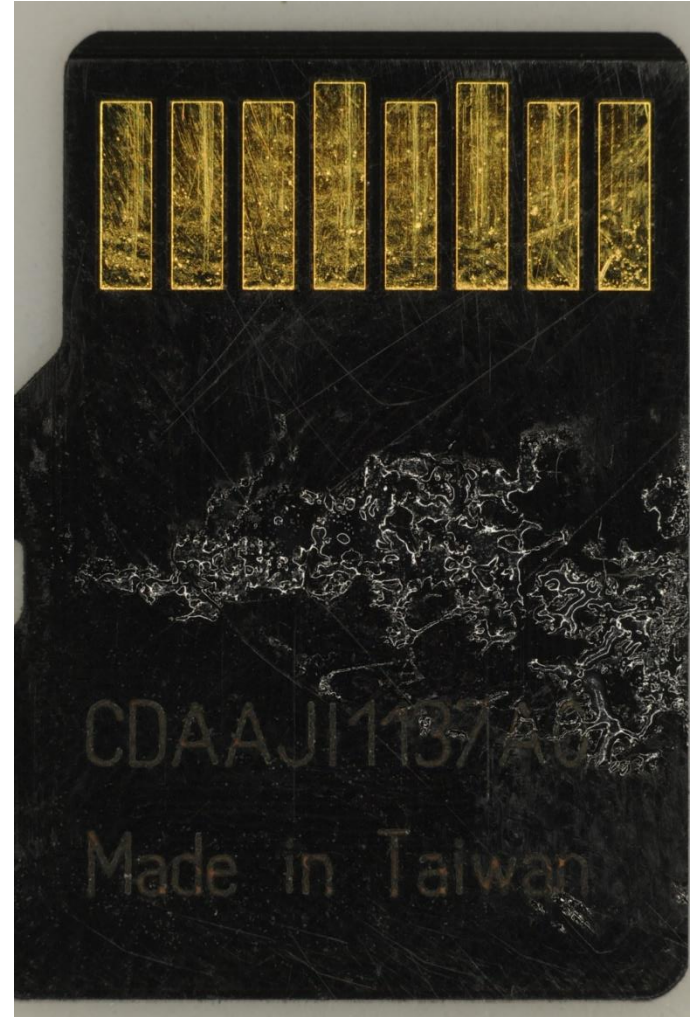
# Micrograph of the Top and Bottom Surfaces

- Package appeared substantially in tact, save for a crack traversing the entire body
    - No evidence of a thermal excursion
    - Foreign material on the bottom side of the package; likely transferred from the housing (not included with the specimen)

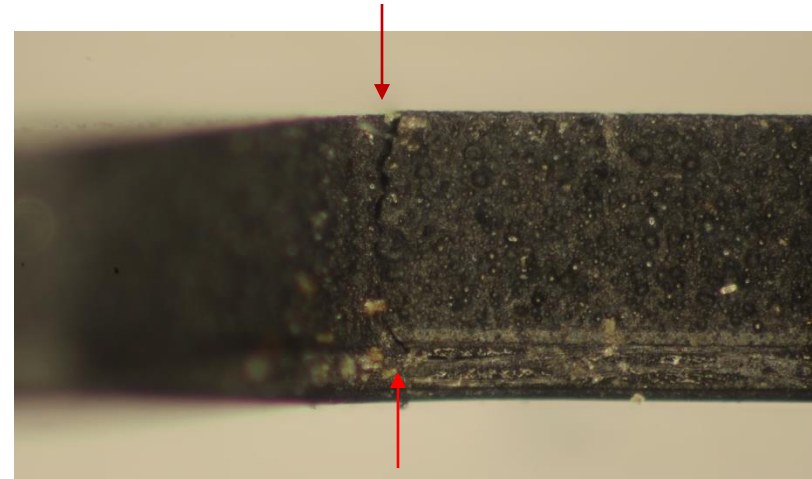
Crack Penetrates Through  
the Overmold

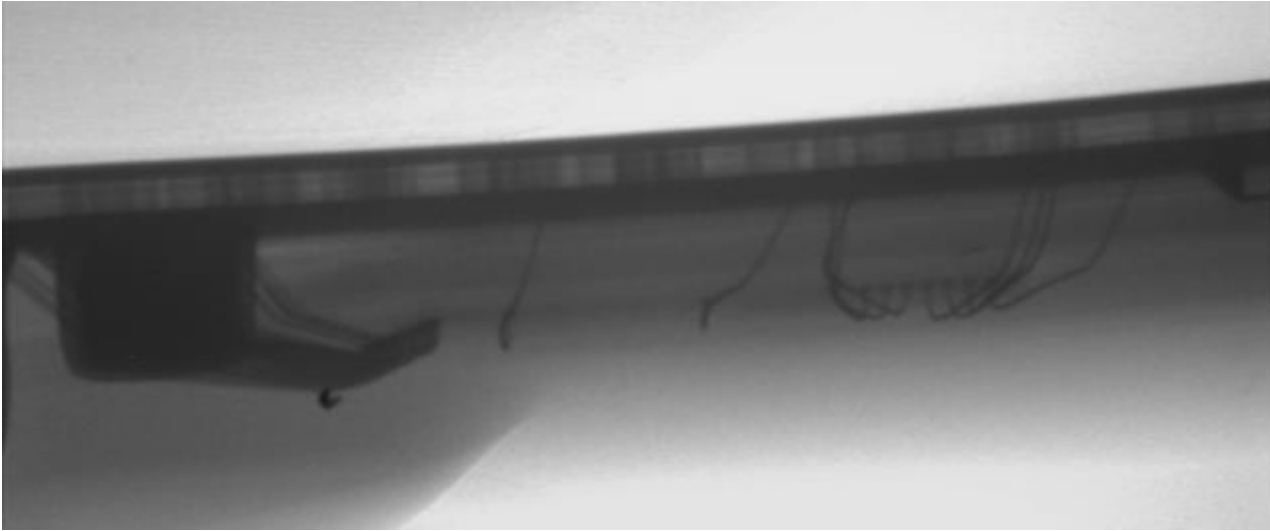
# Side View of Wirebonds

Two layers of circuitry  
in the substrate

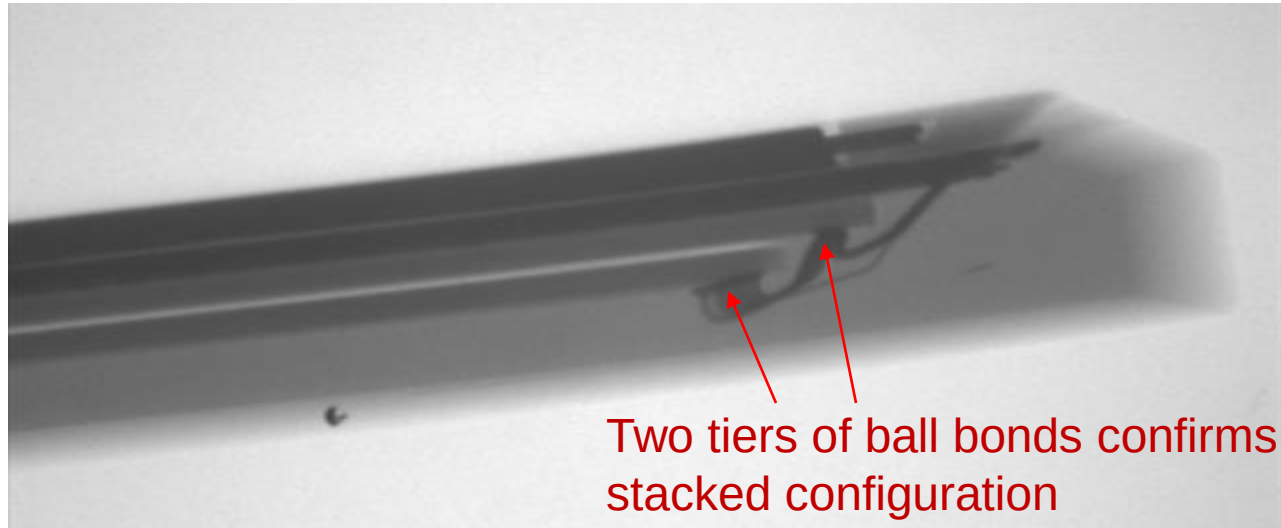
Two tiers of ball bonds confirms  
stacked configuration

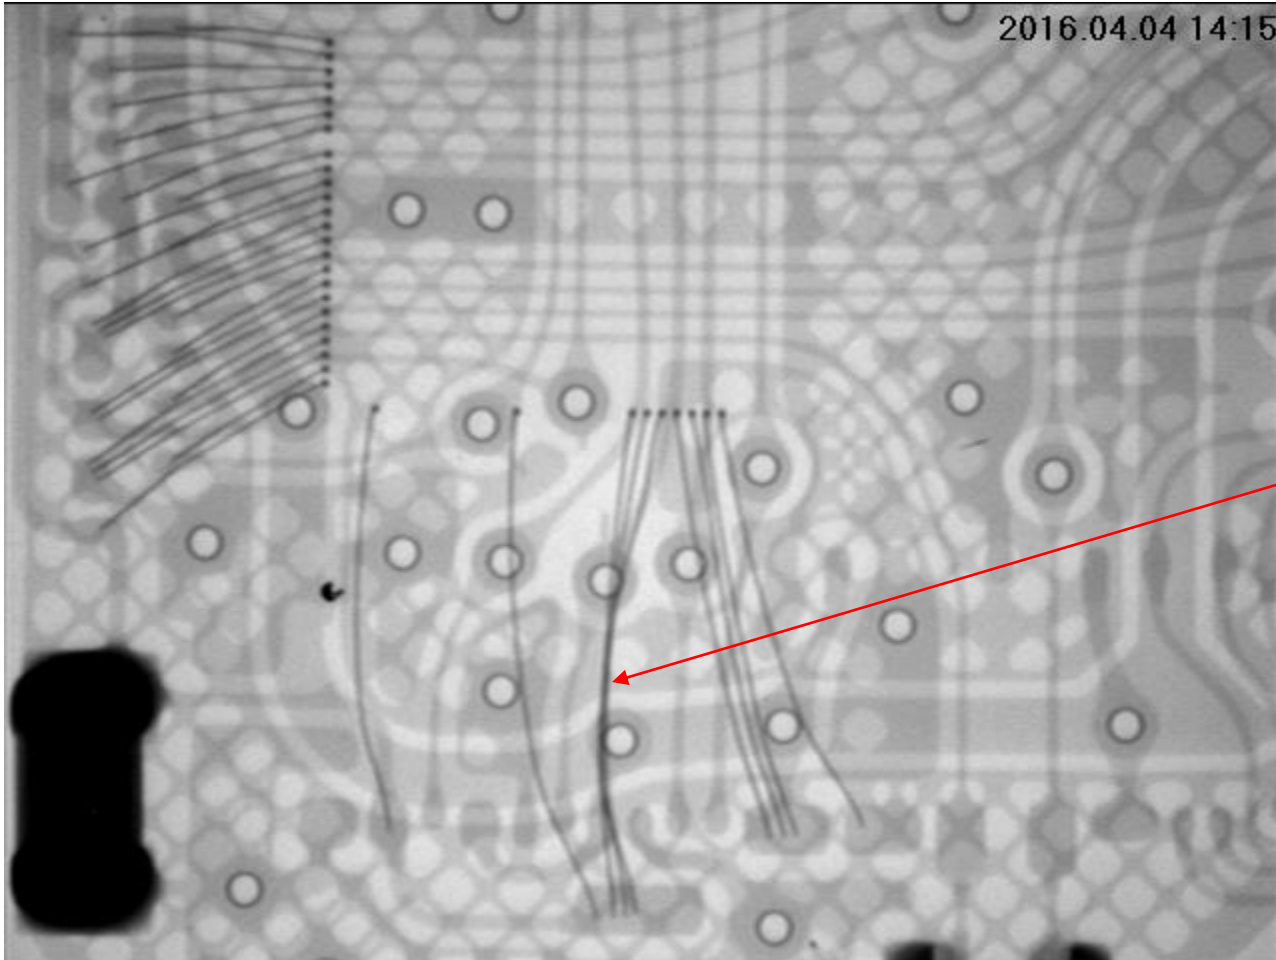
# X-ray Inspection of the Module; Wirebonds on the Grip Side

Wire bonds  
all appear  
to be in tact

Wire sweep  
(likely from  
assembly)

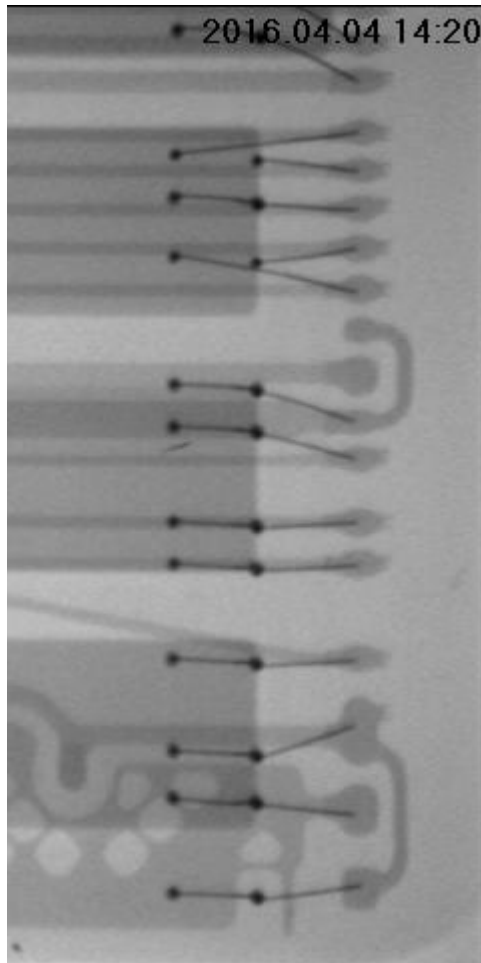
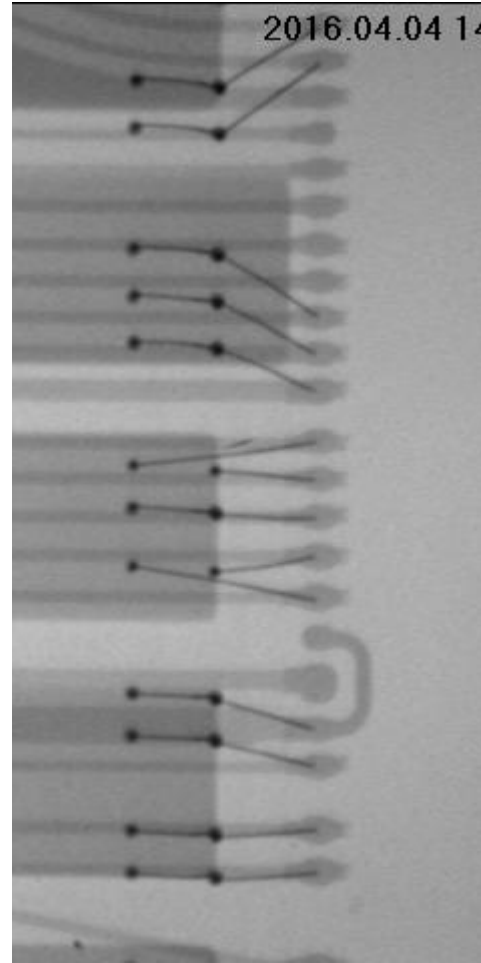
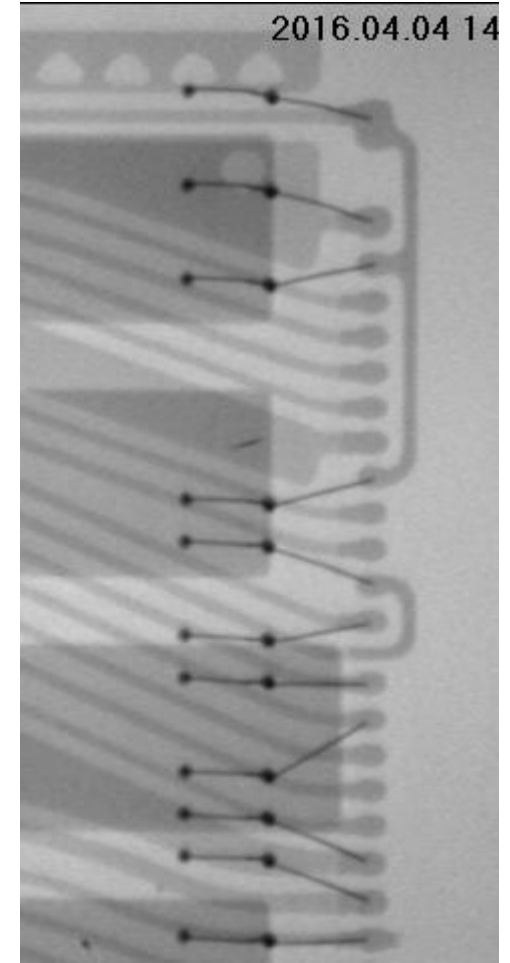
# X-ray Inspection of the Module; Wirebonds on the Connector Side

Wire bonds  
all appear  
to be in tact

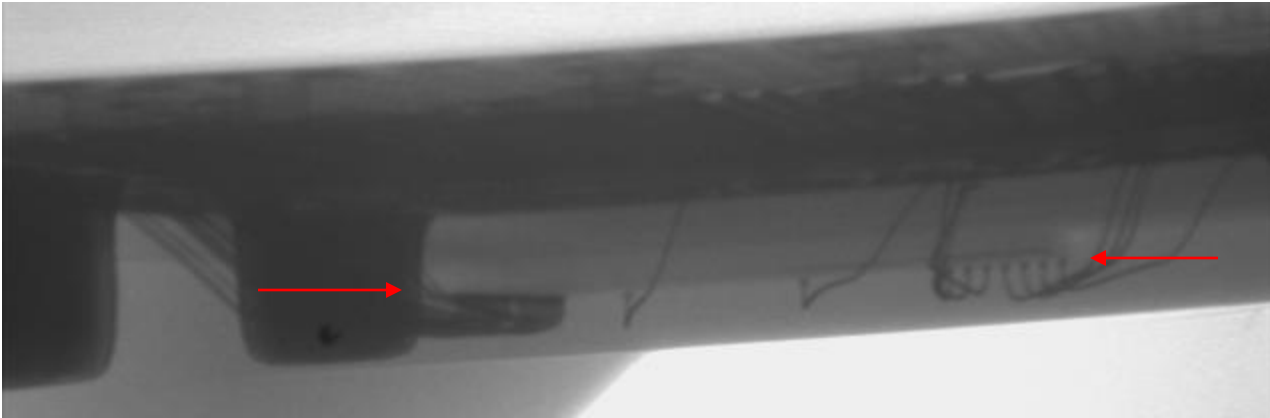
# X-ray Inspection; Edge View of the Wire Bond Arrays

Wire bonds in a level plane; no evidence of “bowing” from the chip

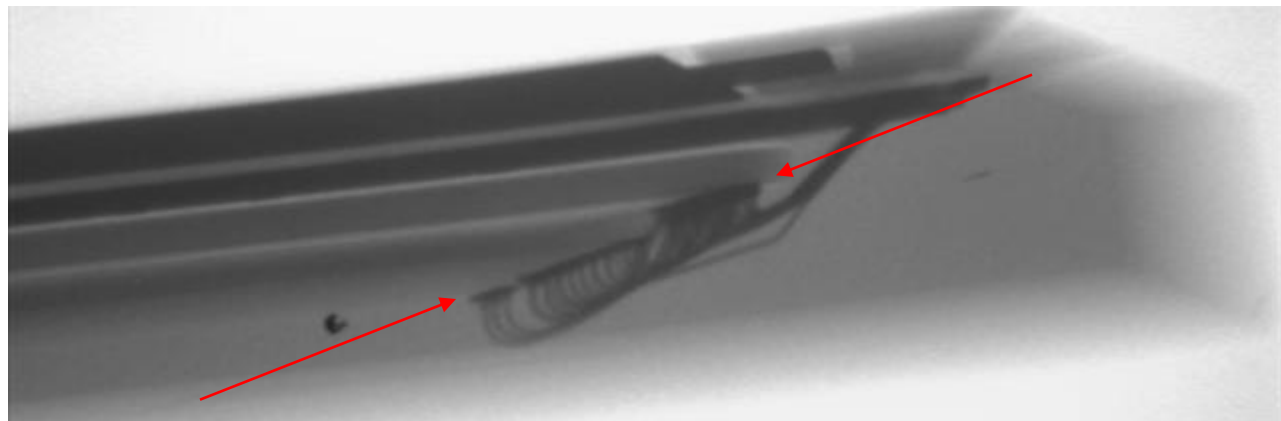
Wire bonds in a level plane; no evidence of “bowing” from the chip

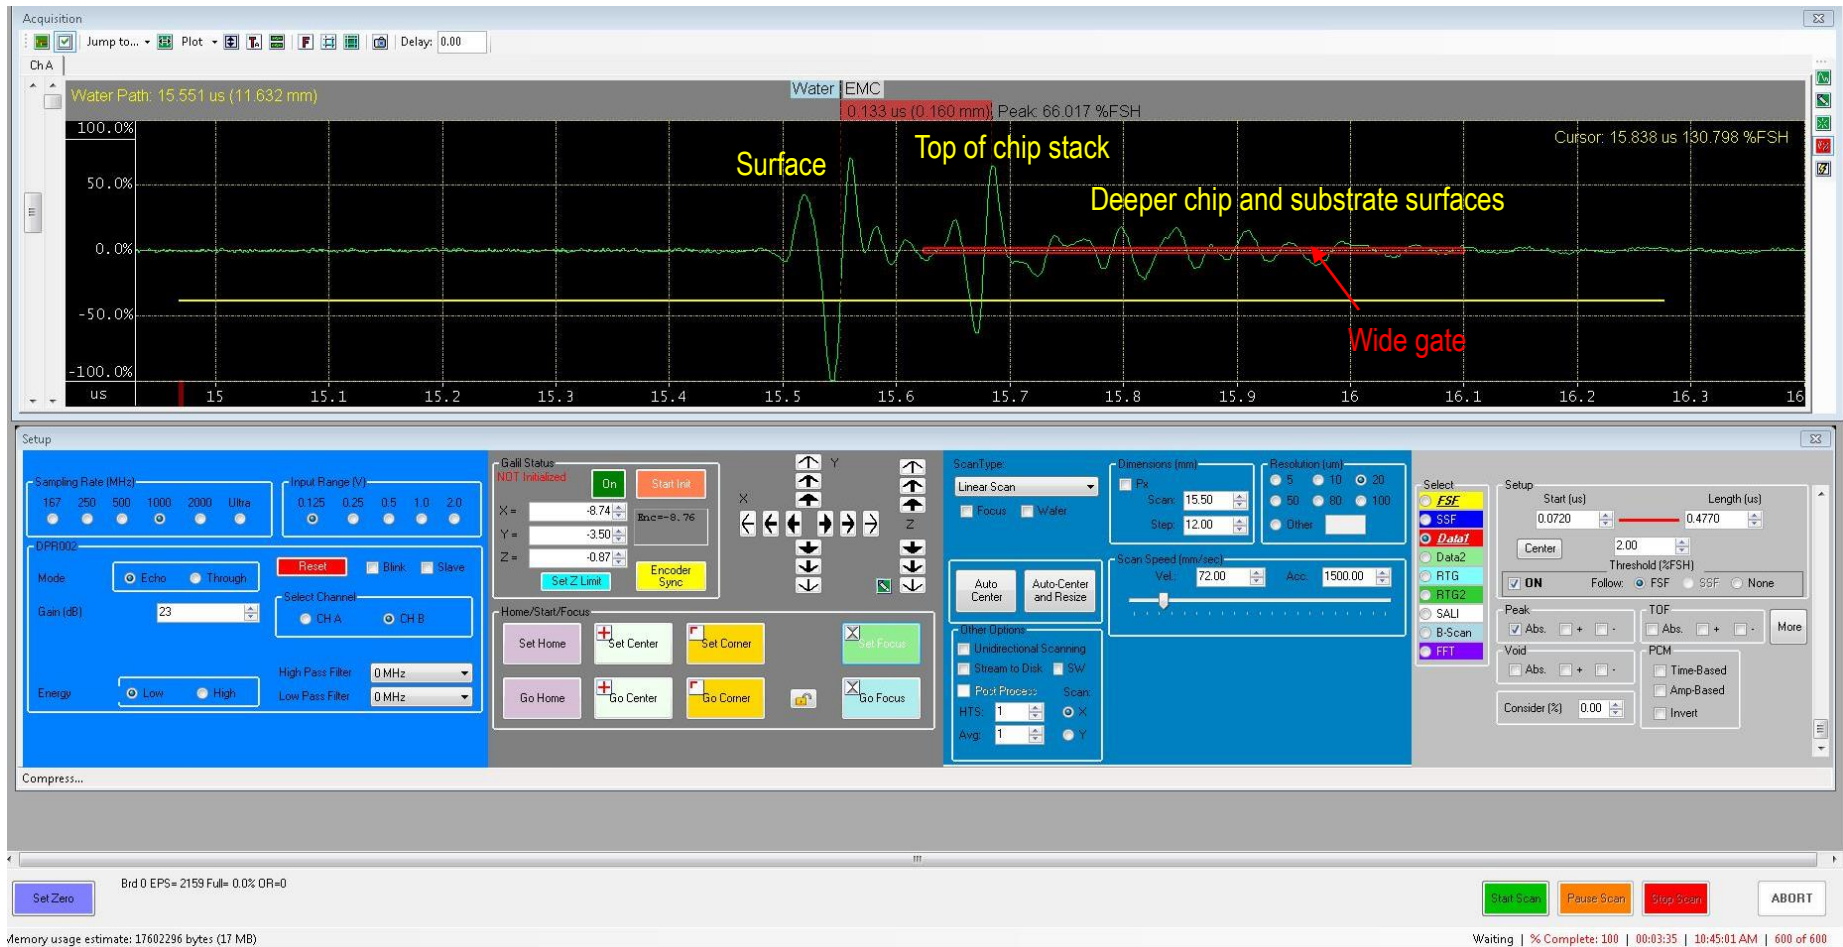
# C-SAMs of the Module

- Surface of the chips clearly visible as is the shadow of the wire bonds
    - Stacked configuration is confirmed
    - Chips occupy almost all of the area of the package, including region through which the crack exists
    - Additional anomalies appearing to be crack lines suggest extensive damage to the chip stack
    - B-scan confirms additional cracking below the surface of the package
