# NATIONAL TRANSPORTATION SAFETY BOARD

## MATERIALS LABORATORY FACTUAL REPORT

Report No. 16-064

Place : Wake, Virginia  
Date : January 14, 2016  
Vehicle : Flightstar II  
NTSB No. : ERA16FA089  
Investigator : Aaron McCarter, AS-ERA

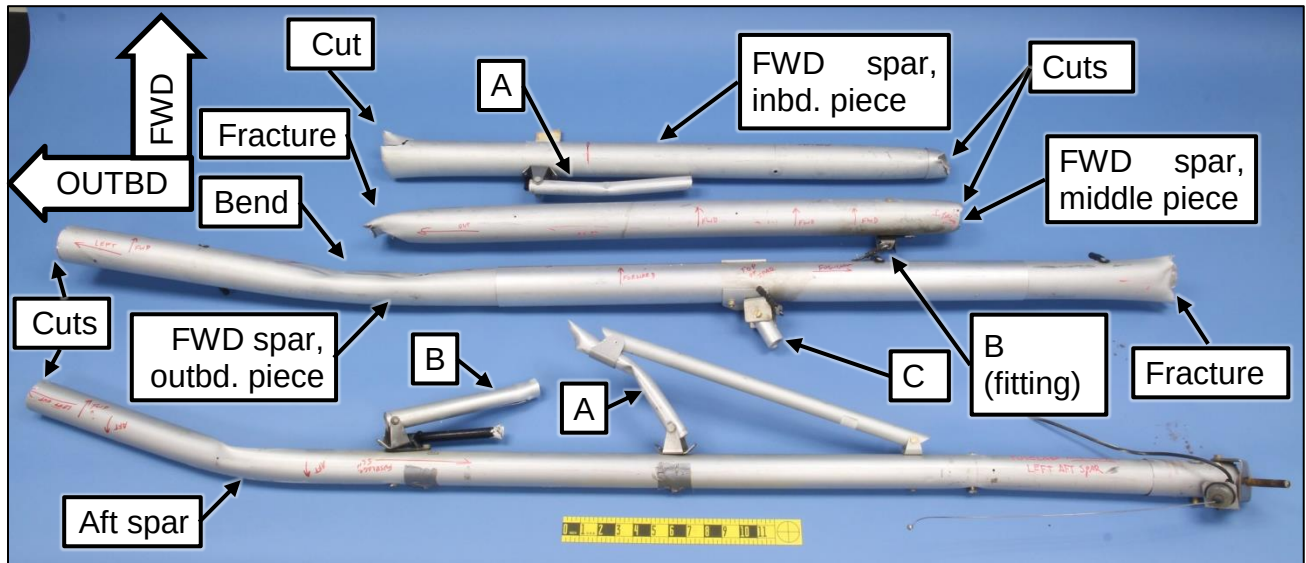
An overall view of the submitted components is shown in figure 1 as received in the materials laboratory. The forward spar is shown in 3 pieces in the upper portion of the image, and the aft spar is shown at the lower side of the image. The forward and aft spars had a tubular cross-section that was bisected with a vertical web, appearing like back-to-back "D" channels. Portions of the chordwise brace tubes were attached to the spars and were labeled A to C from inboard to outboard. The forward spar had been cut in 3 locations and was also bent and fractured. Also attached to the front spar, the fitting for attaching brace tube B, the fitting for attaching the strut, and chordwise brace tube C had been cut. The aft spar was bent but intact and had been cut at the outboard end of the submitted piece.

The inboard piece of the forward spar shown in figure 1 had been cut at each end, and the cut at the outboard end of the inboard piece mated to the inboard end of the middle piece. The spar cross-section was pinched with contact marks adjacent to the cut ends, consistent with cutting by a scissor-like action. The outboard ends of the outboard piece of the forward spar and the outboard end of the aft spar were cut without deformation consistent with a saw cut.

A segment of chordwise brace tube A remained attached to the forward spar. The end of the tube was fractured with uniform wall thinning and fracture on a slant plane, features consistent with ductile overstress fracture under tensile load.

The forward spar had mating fracture surfaces between the outboard end of the middle piece and the inboard end of the outboard piece. The fracture was located 27 inches inboard of chordwise brace tube C. The fracture features showed buckling deformation at the upper aft side of the spar and curving deformation on the forward face consistent with the outboard end of the spar displacing upward and aft relative to the fracture location.

The aft spar included pieces of chordwise brace tubes A and B. Chordwise brace tube A was deformed outboard, and the end was pinched consistent with a scissor-like shear cut. The bracket attaching brace tube B was twisted consistent with the brace tube rotating counterclockwise (as viewed looking forward) relative to the aft spar. The slotted end of brace tube B was also deformed with bulging of the slotted area and flaring of the forward end, features consistent with bending deformation with the forward end of the tube piece moving aft relative to the aft spar attachment. A brace cable was missing at the aft side of the attachment fitting, but the eye shield remained in place. The eye fitting was cracked and deformed with cable wire impressions on the surface, consistent with high tensile loads on the cable.

The aft spar was bent outboard of brace tube B, and the overall deformation was consistent with the outboard end displacing forward relative to the bend. The tube wall was dented inward locally at the bend, consistent with impact with another object.

Figure 1. Overall view of the submitted forward and aft spar pieces from the left wing with attached chordwise brace tubes labeled A, B, and C as viewed looking at the upper surfaces.

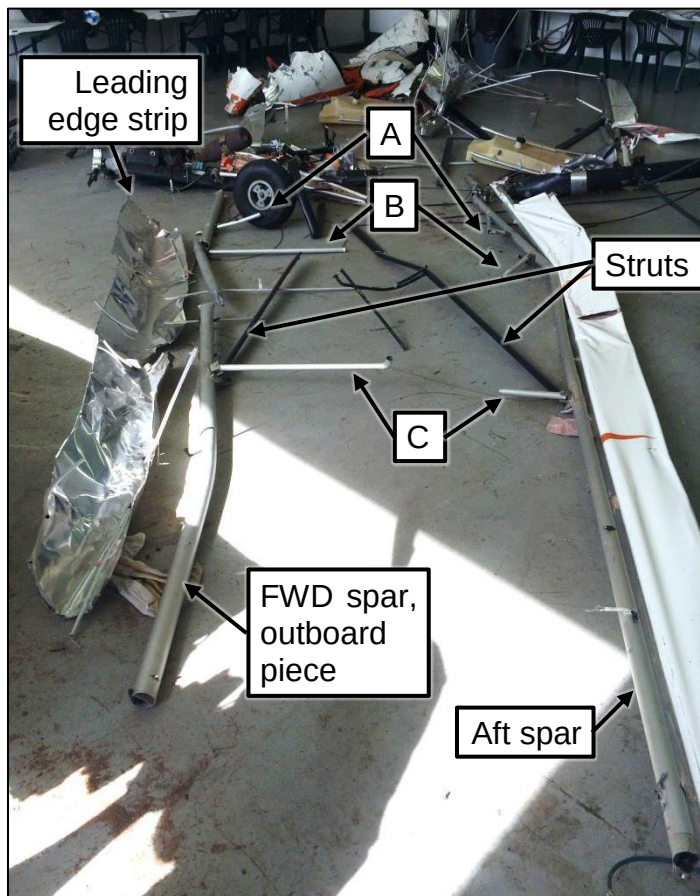
Photographs from on-scene and the reconstruction were provided by the IIC and were reviewed in conjunction with the laboratory examination. Several of the photographs are shown in figures 2 through 4. In figure 2, the reconstruction of the left wing is shown with pieces placed in their approximate relative positions. Chordwise brace tubes A, B, and C are labeled as shown in figure 2. Two wing struts, also labeled in figure 2, attached to the lower sides of the forward and aft spars at the location corresponding to chordwise brace tube C. Additional support tubes connected the middle of the struts to the lower sides of the spars at the location corresponding to chordwise brace tube B.

The wings had been modified from the as-manufactured condition. Modifications included adding an aluminum leading edge strip (shown labeled in figures 2 and 3), different skin material, different wing profile, and riveted rib attachments to the spars.

Figure 2. Overall view of the reconstructed left wing pieces including the aluminum leading edge strip.

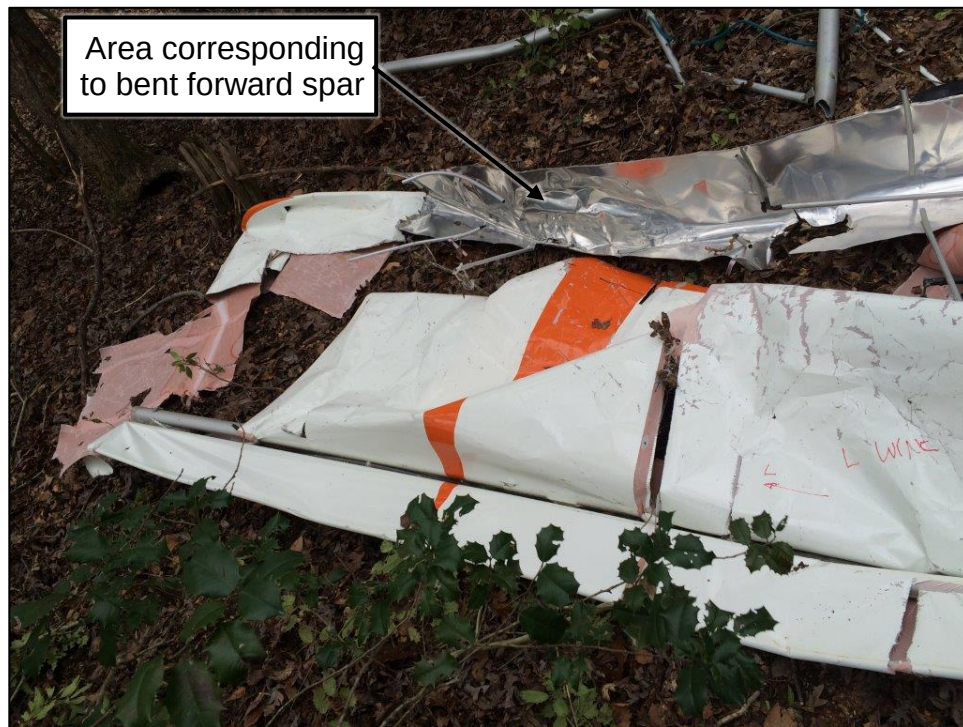
The forward spar was bent at a location between 21.5 inches and 29 inches outboard of chordwise brace tube C. The overall deformation of the spar was consistent with the outboard end moving forward and up relative to the bend. Two distinct creases were noted within the inside radius of the bend spaced 5 inches apart. In photos, the leading edge aluminum strip appeared wrinkled in the area corresponding to the location of the bend in the forward spar (see figure 3).

Figure 3. Left wing skin and leading edge strip as viewed on-scene.

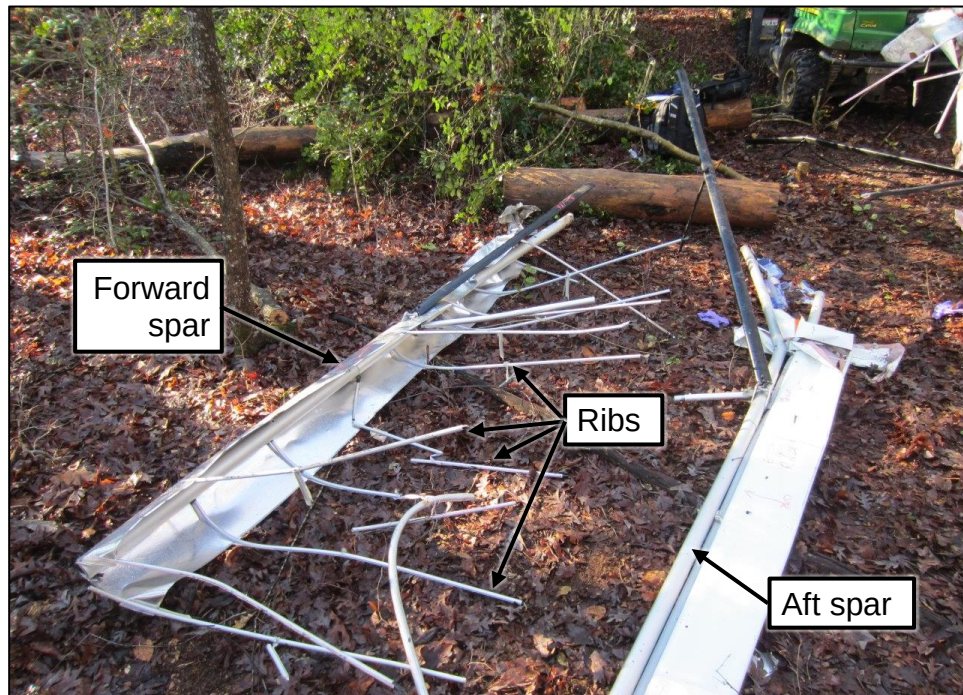
Ribs had been attached to the spars at locations along the span of the forward and aft spars. A view of ribs still attached to the right wing as viewed on-scene is shown in figure 4. The ribs consisted of curved tubes forming an approximately symmetric airfoil with plastic attachment fittings inserted at each end of each tube. The fittings were then riveted to the upper and lower sides of the spars. A close view of one

Figure 4. Overall view of the right wing showing the leading edge strip and ribs (several are labeled) attached to the forward spar.

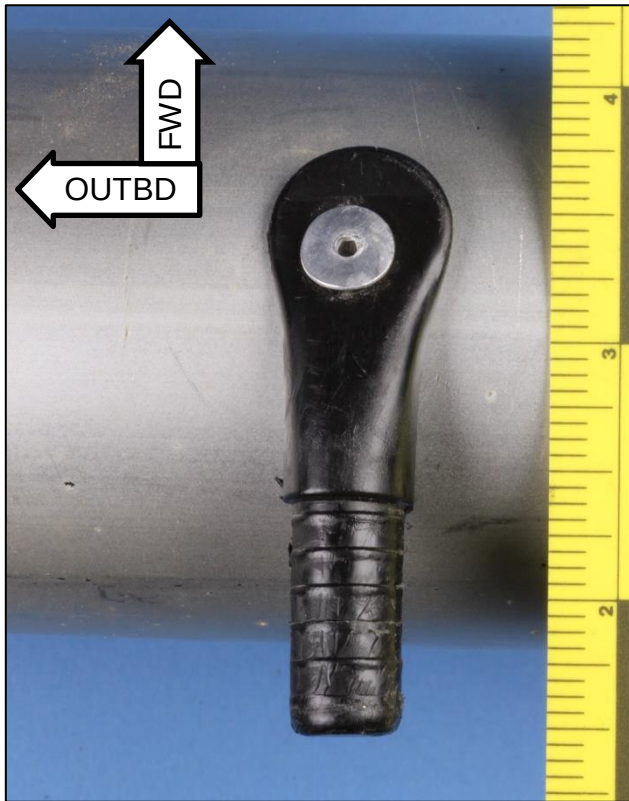
of an attachment fitting on the left wing where the rib tube had separated from the barbed end of the attachment fitting is shown in figure 5.

Figure 5. Rib attachment fitting on the forward spar inboard of chordwise brace tube C.

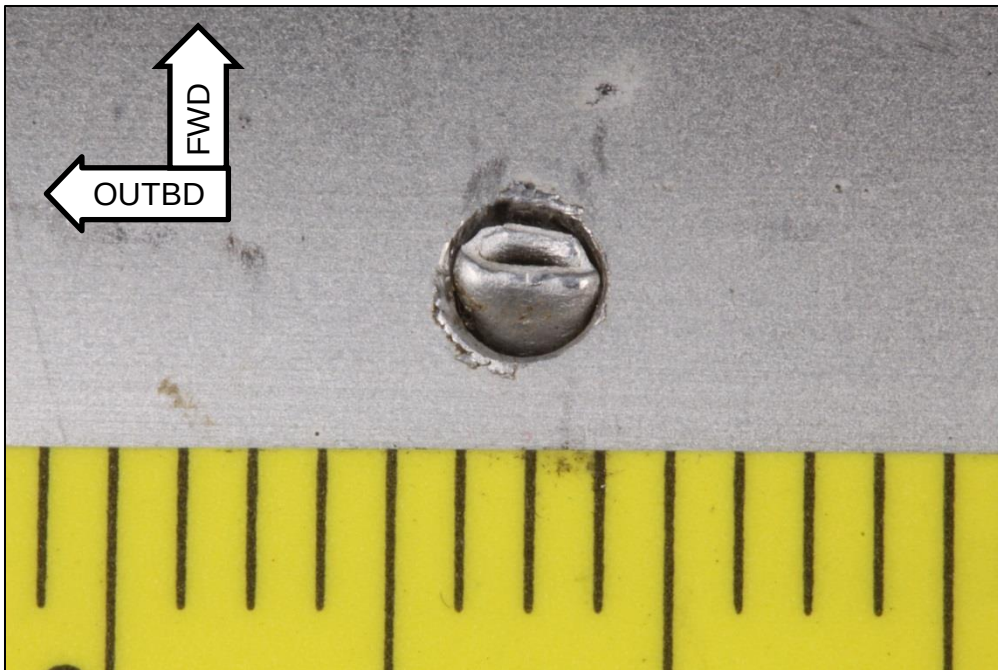
The condition of the rib attachment locations were examined visually on the forward and aft spars, upper and lower attachments, and results of the examination are documented in tables 1 and 2. The rib locations, each consisting of an upper and lower tube, were numbered sequentially from the inboard end of the wing with an "R" prefix before the number for reference in the first column in tables 1 and 2, and the spanwise location relative to features on the spar are noted in the second column. The forward spar pieces had rib attachment locations for the inboard 10 ribs as listed in table 1, and the aft spar had attachment locations for the inboard 4 ribs as listed in table 2. As described in the third column in tables 1 and 2, some of the locations had a hole with no remnant of the rivet or attachment fitting, while other locations showed an intact rivet and attachment fitting (as in figure 5). In some cases, a remnant of a sheared rivet was present within the hole in the spar, such as the case shown in figure 6. At a few locations, the attachment fitting was fractured.

Figure 6. Sheared rivet for the rib attachment fitting on the forward spar outboard of chordwise brace tube C.
