## MEMORANDUM FOR RECORD

**Douglass Brazy**  
**Air Safety Investigator**  
**Eastern Region Aviation**

**Subject:** ERA16FA097, N401PT, Lancair IV-P, 01/30/16, Albany, Georgia, Record of Conversations with Mr. Agnew James, Ms. Ruth Crawford, January 1-February 2, 2016.

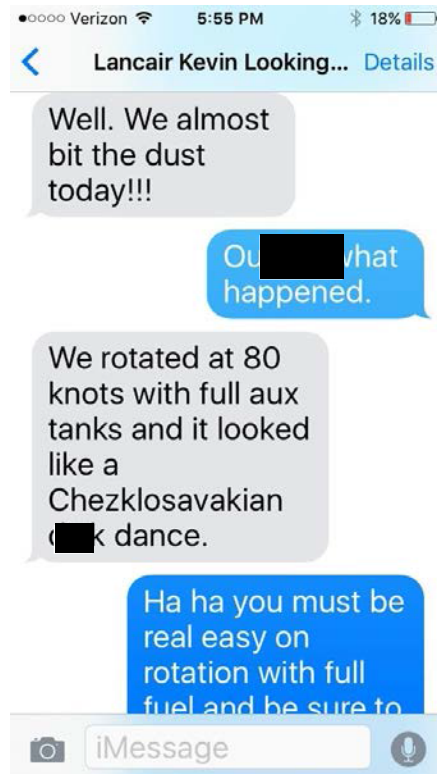
About 2 weeks prior to the accident, Mr. Coalson sent the following text message to Mr. Cook:

Mr. Cook said that the nose gear door was damaged during the same takeoff referred to in this text message.

Mr. Cook said that Mr. Knight and Mr. Coalson subsequently flew N401PT to Deland to have the nose gear door repaired or replaced, and maintenance on the starter generator. When they arrived, Mr. Knight was in the left seat, and Mr. Coalson was in the right seat. Mr. Cook said that he believed the damage to the nose gear door, which occurred during the landing gear retraction, was likely the result of uncoordinated flight during which the side slip wind pushed the gear door inward, and impinged against the nose wheel.
