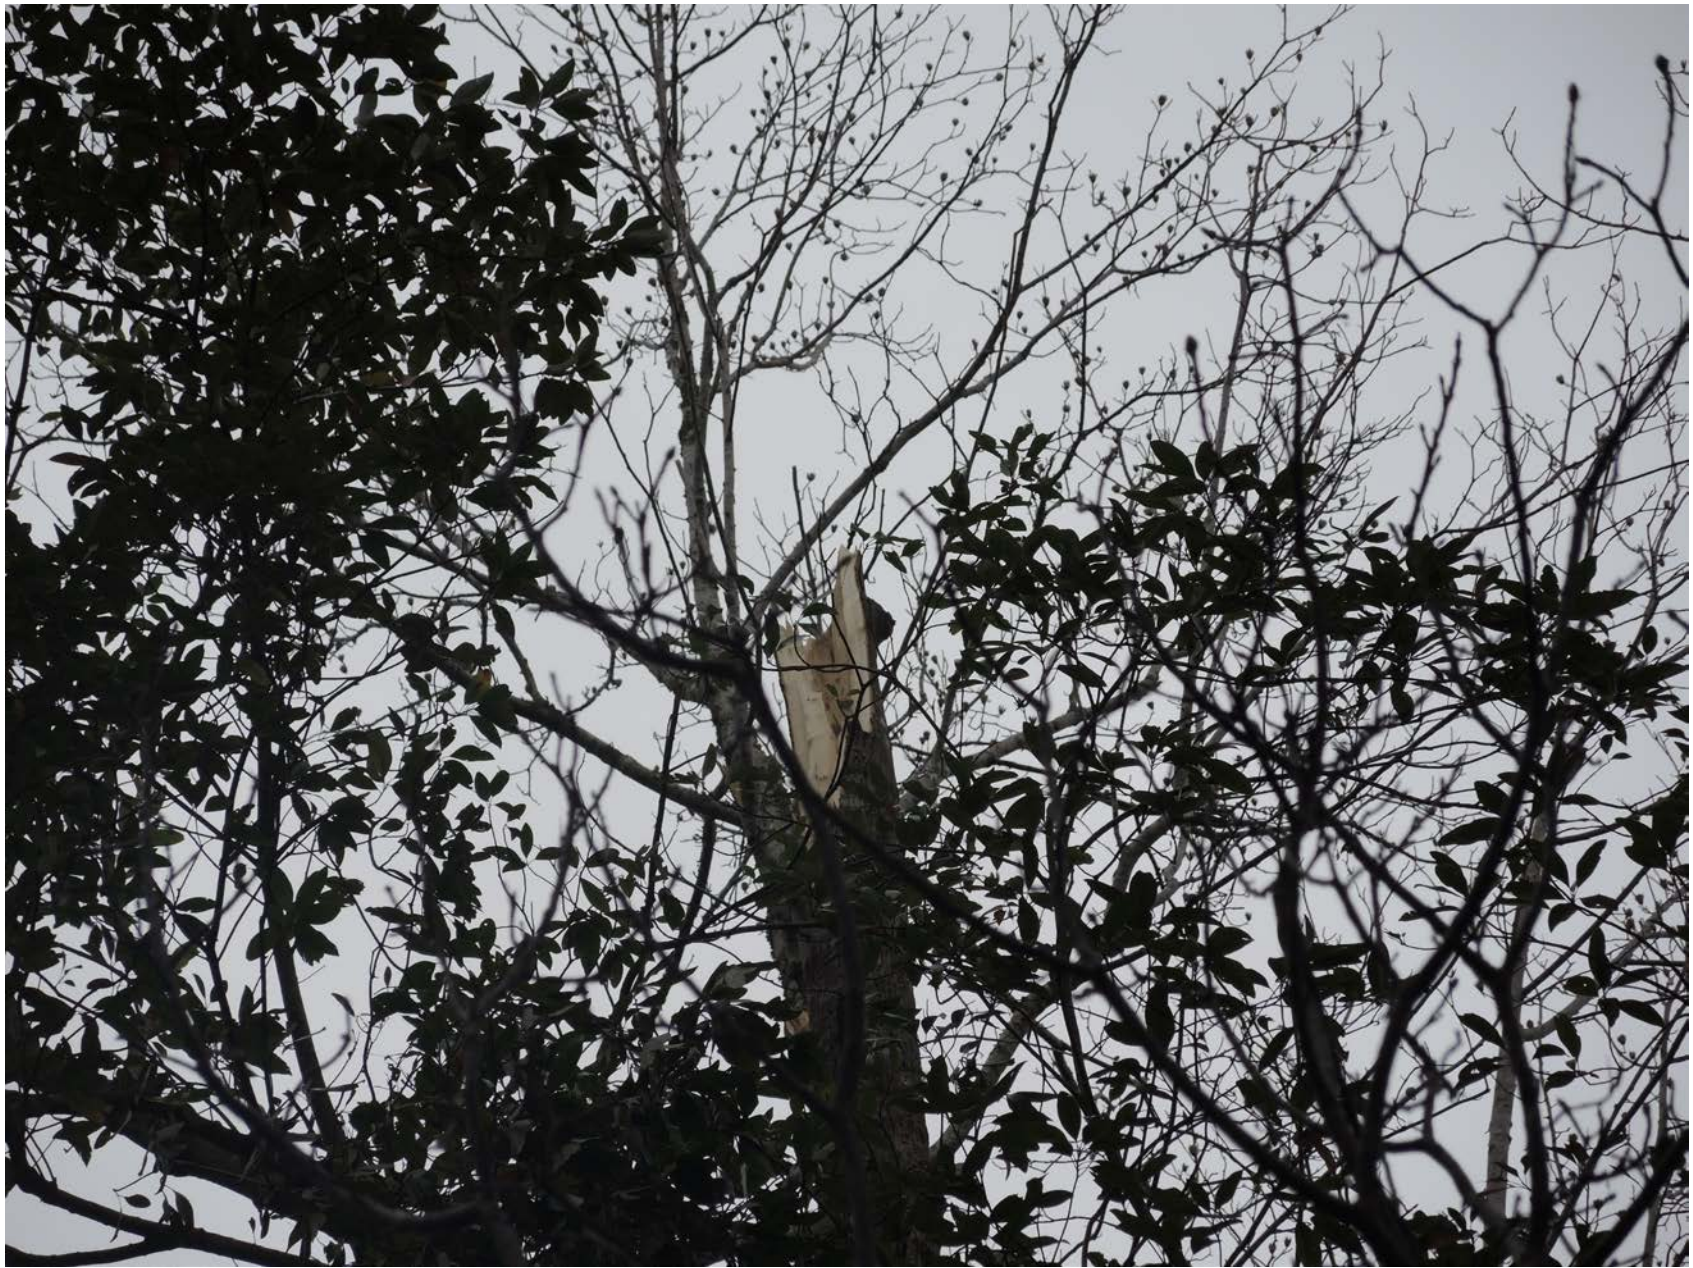
**Photo 1 – Tree canopy showing initial impact point**

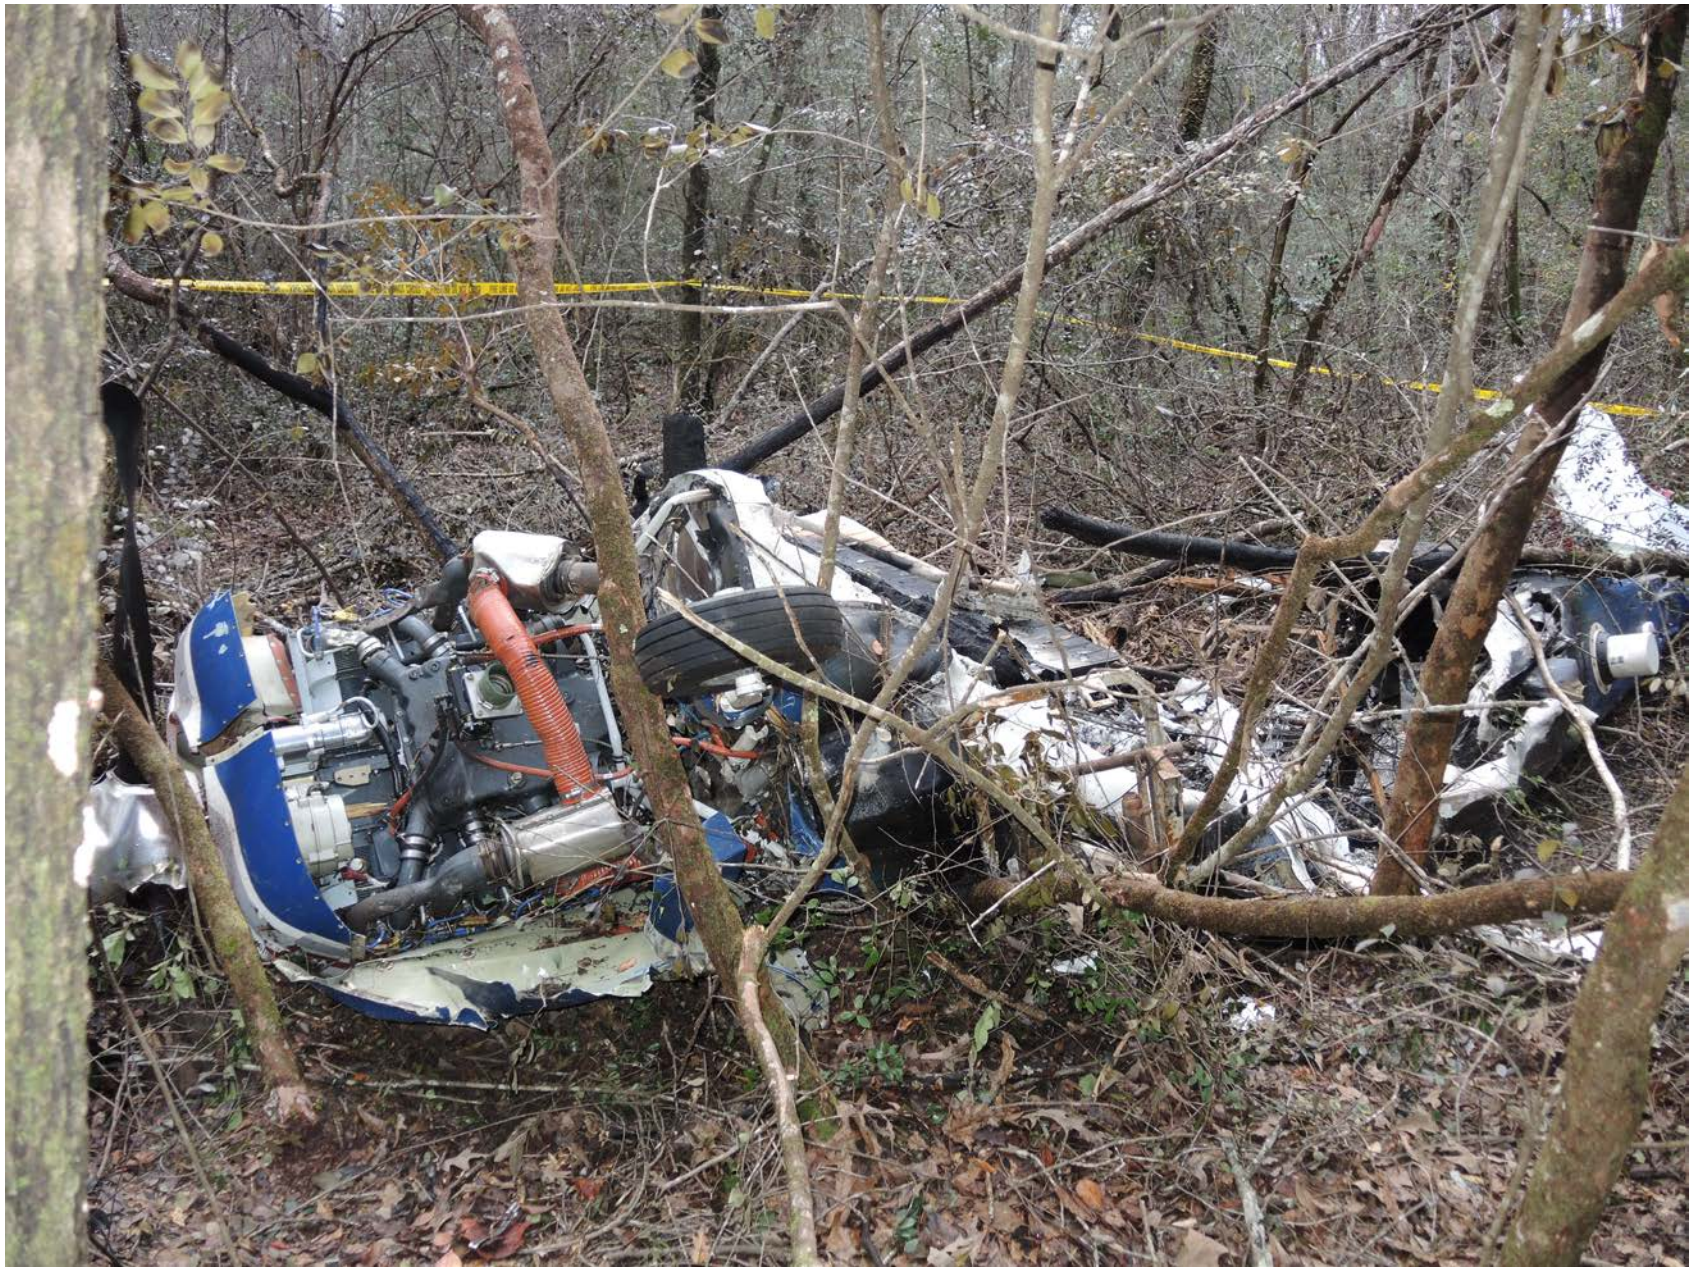
**Photo 2 – Main wreckage**

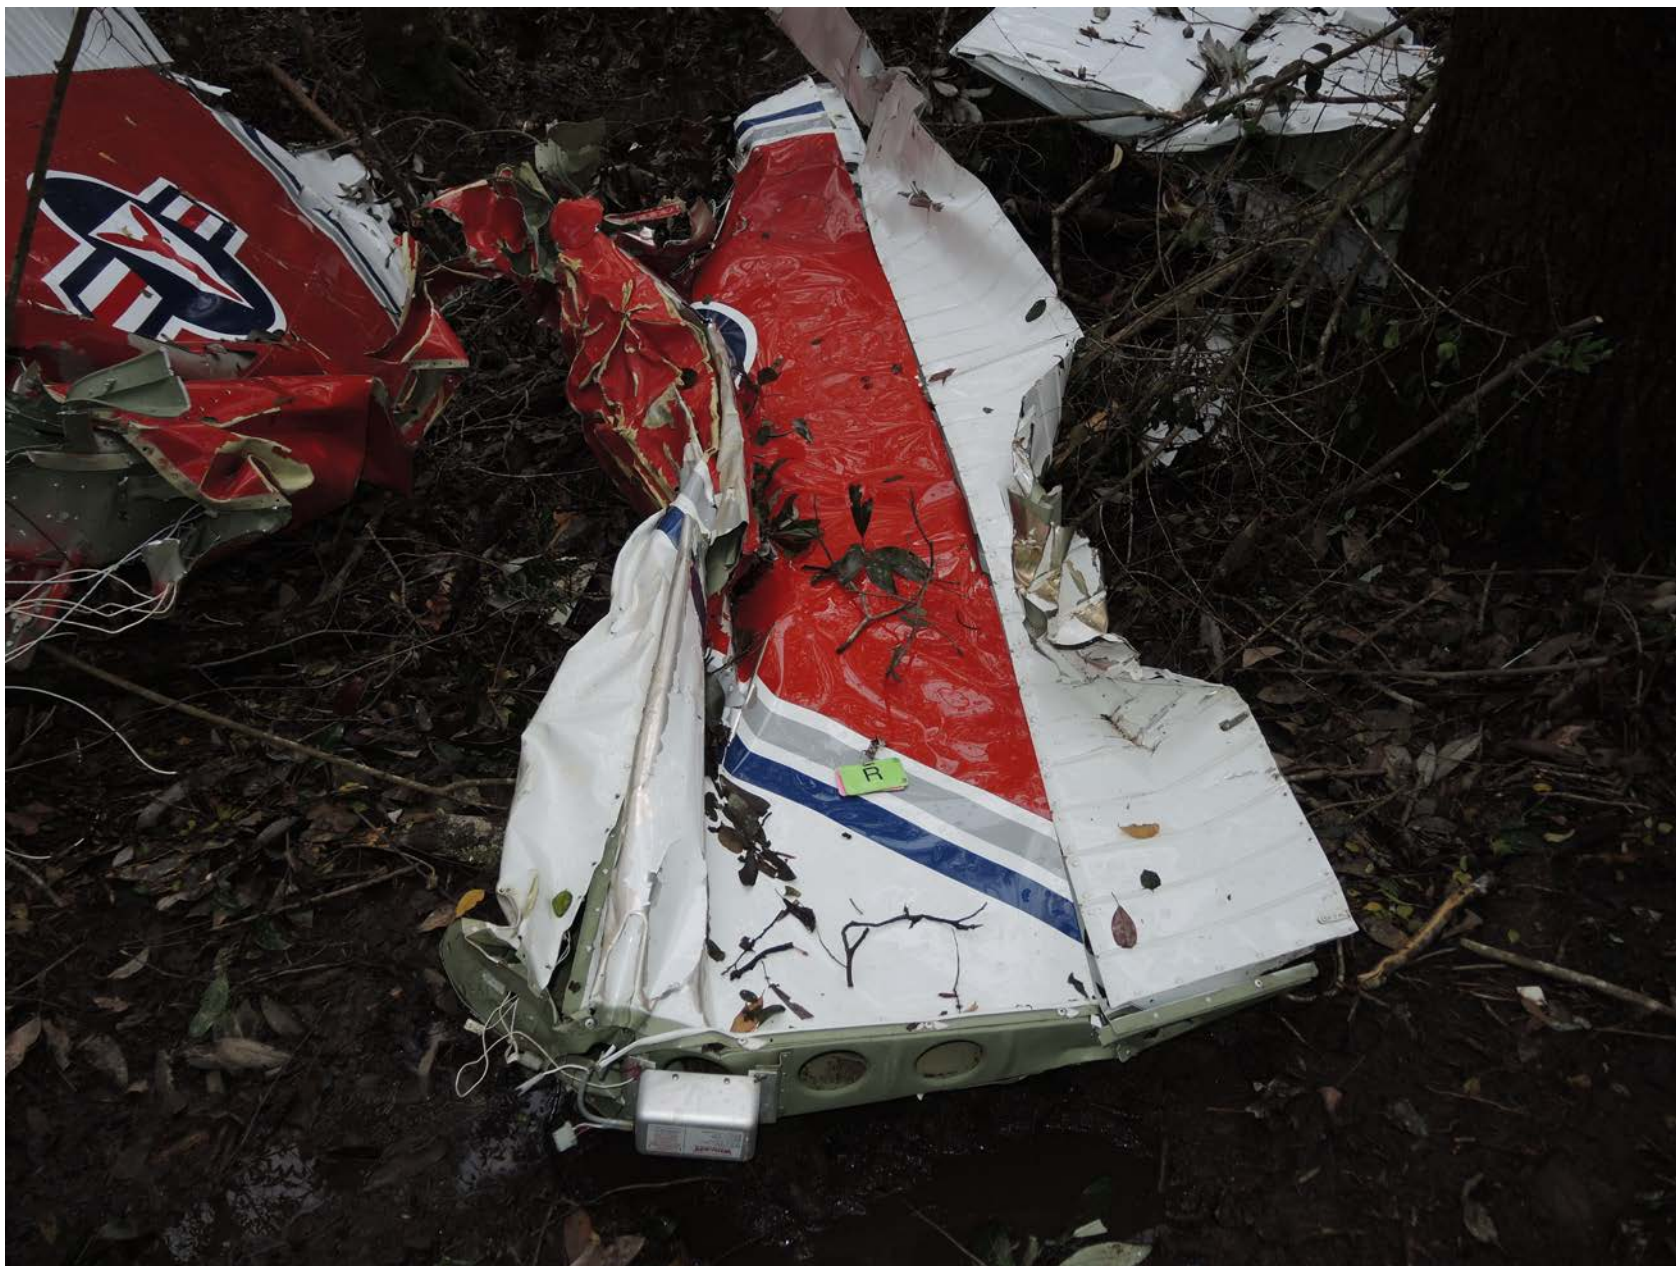
**Photo 3 – View of damaged outboard right wing**

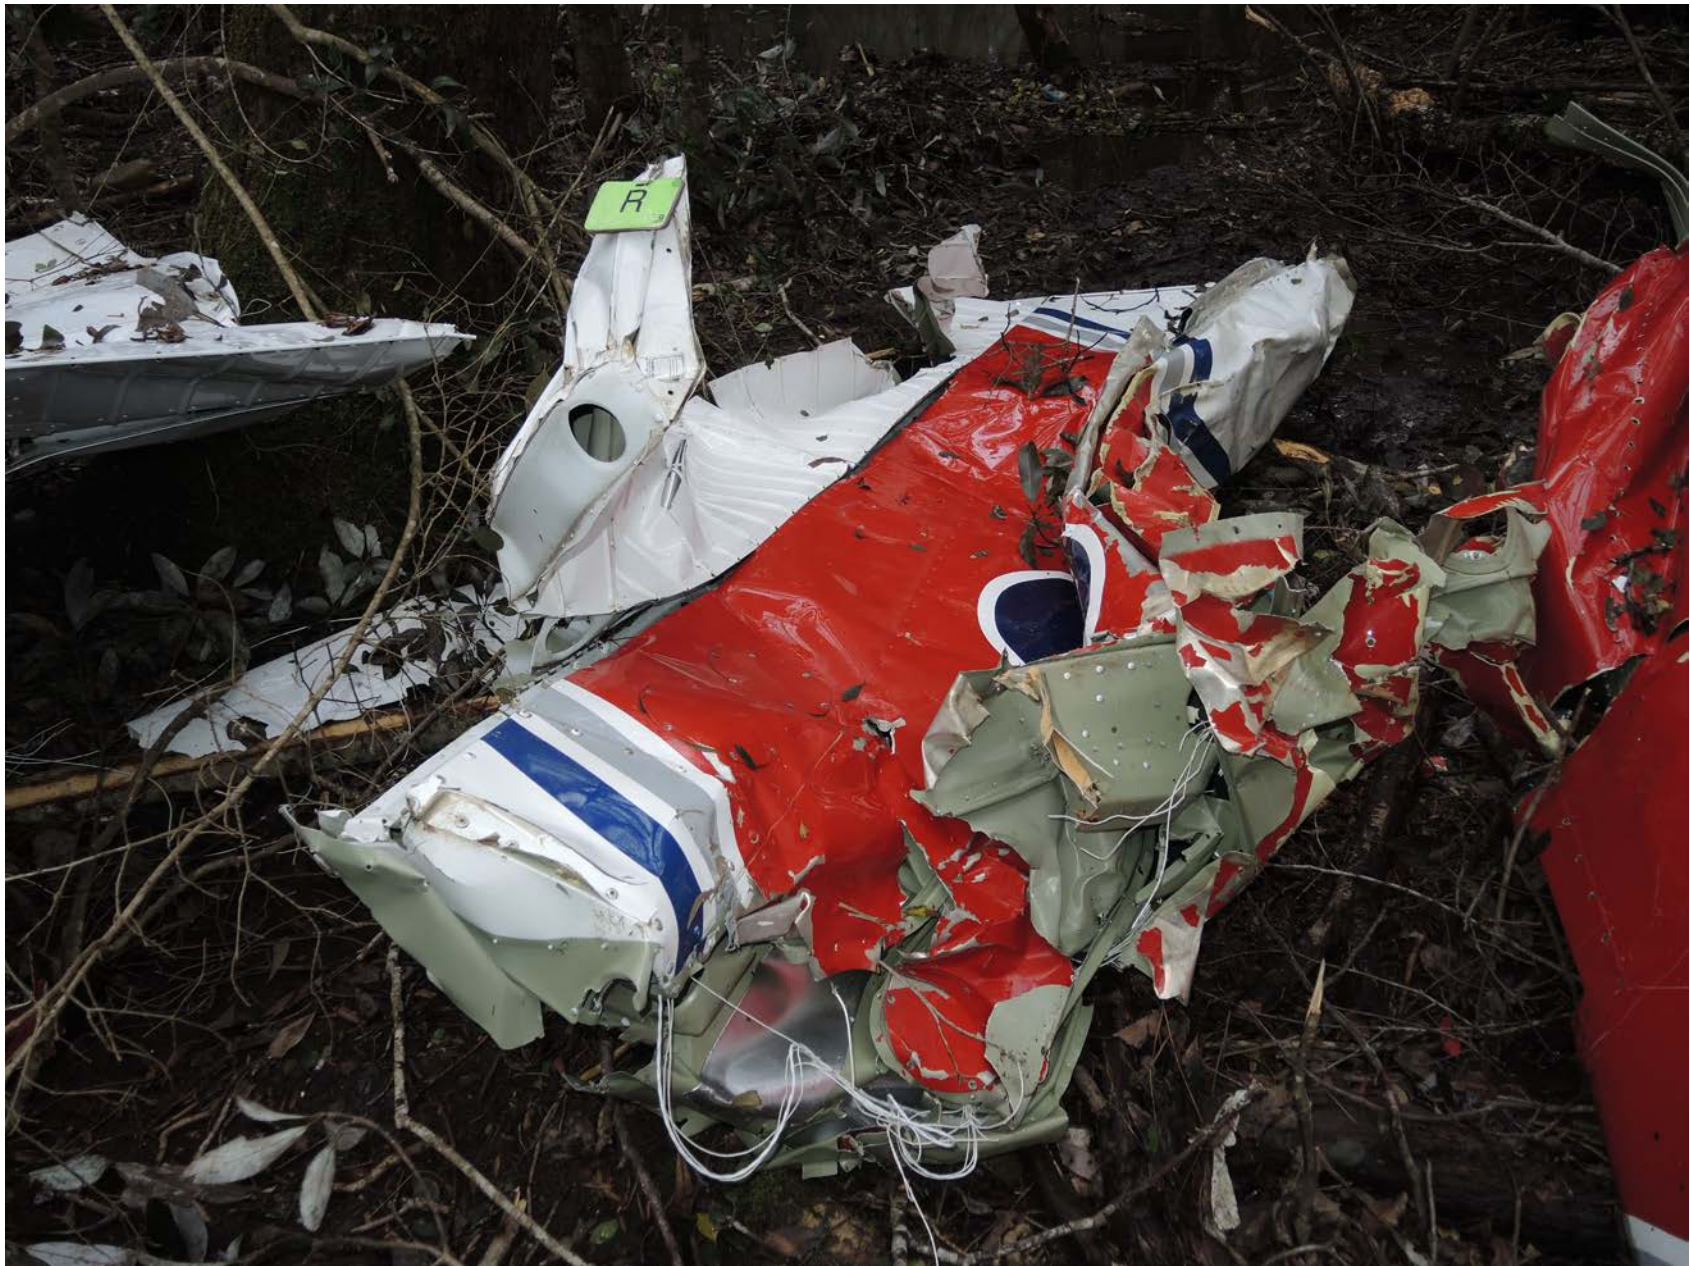
**Photo 4 - View of damaged inboard right wing**

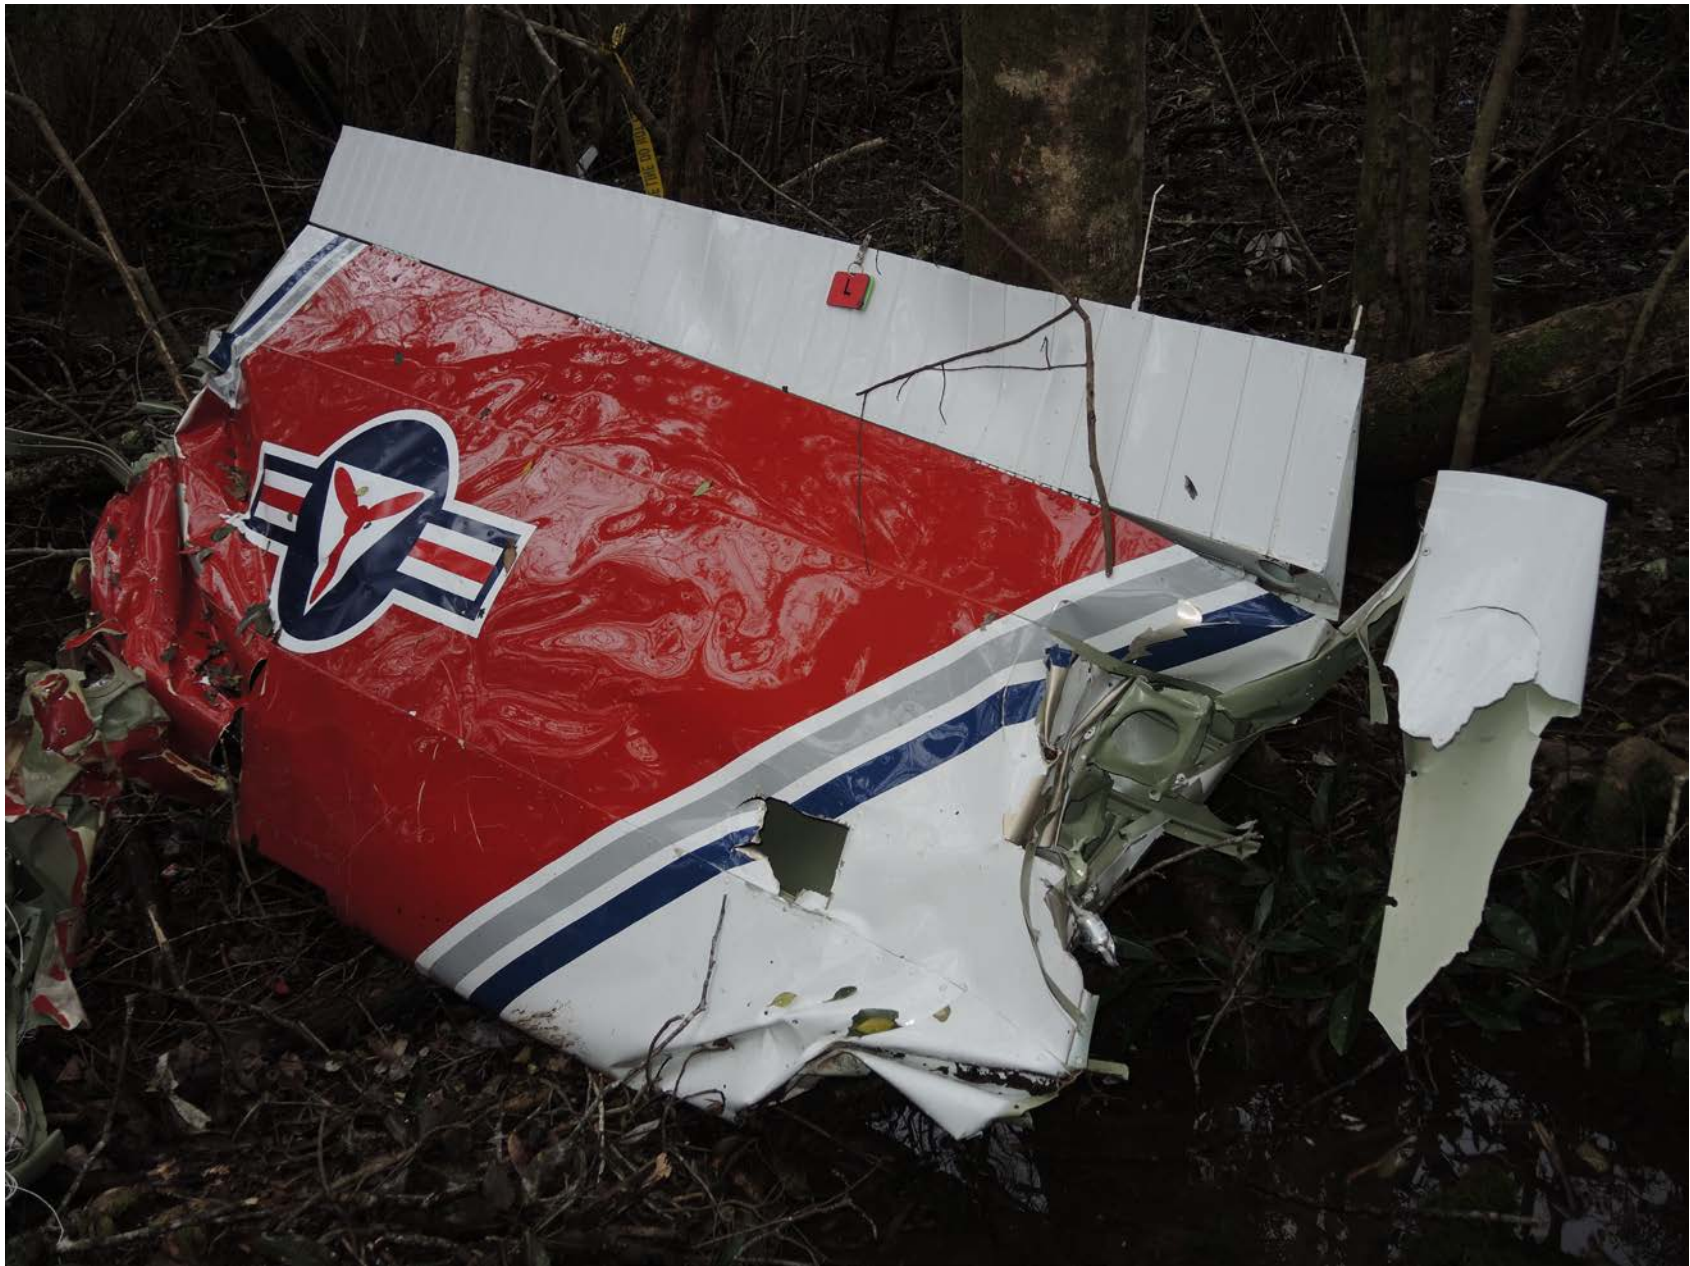
**Photo 5 – View of damaged outboard left wing**

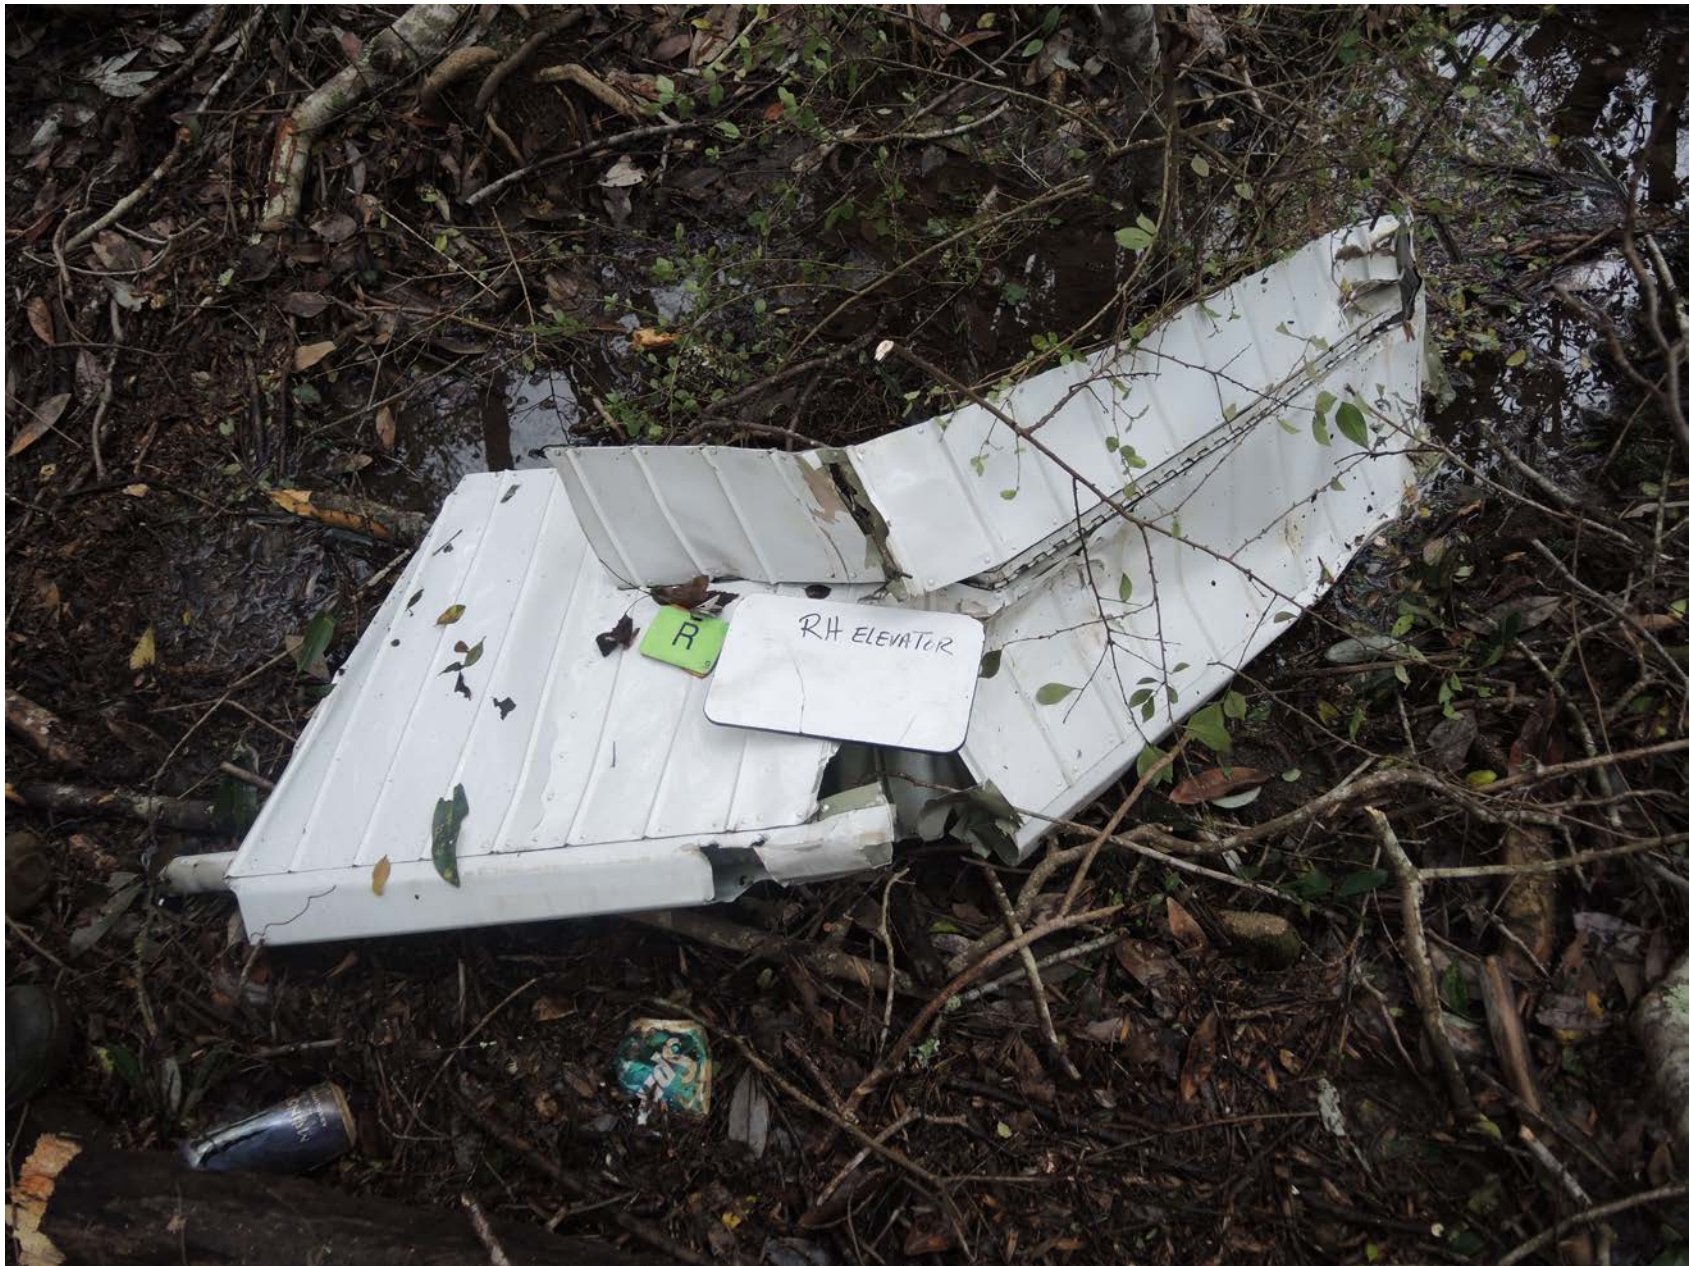
**Photo 6 – View of damaged right elevator**

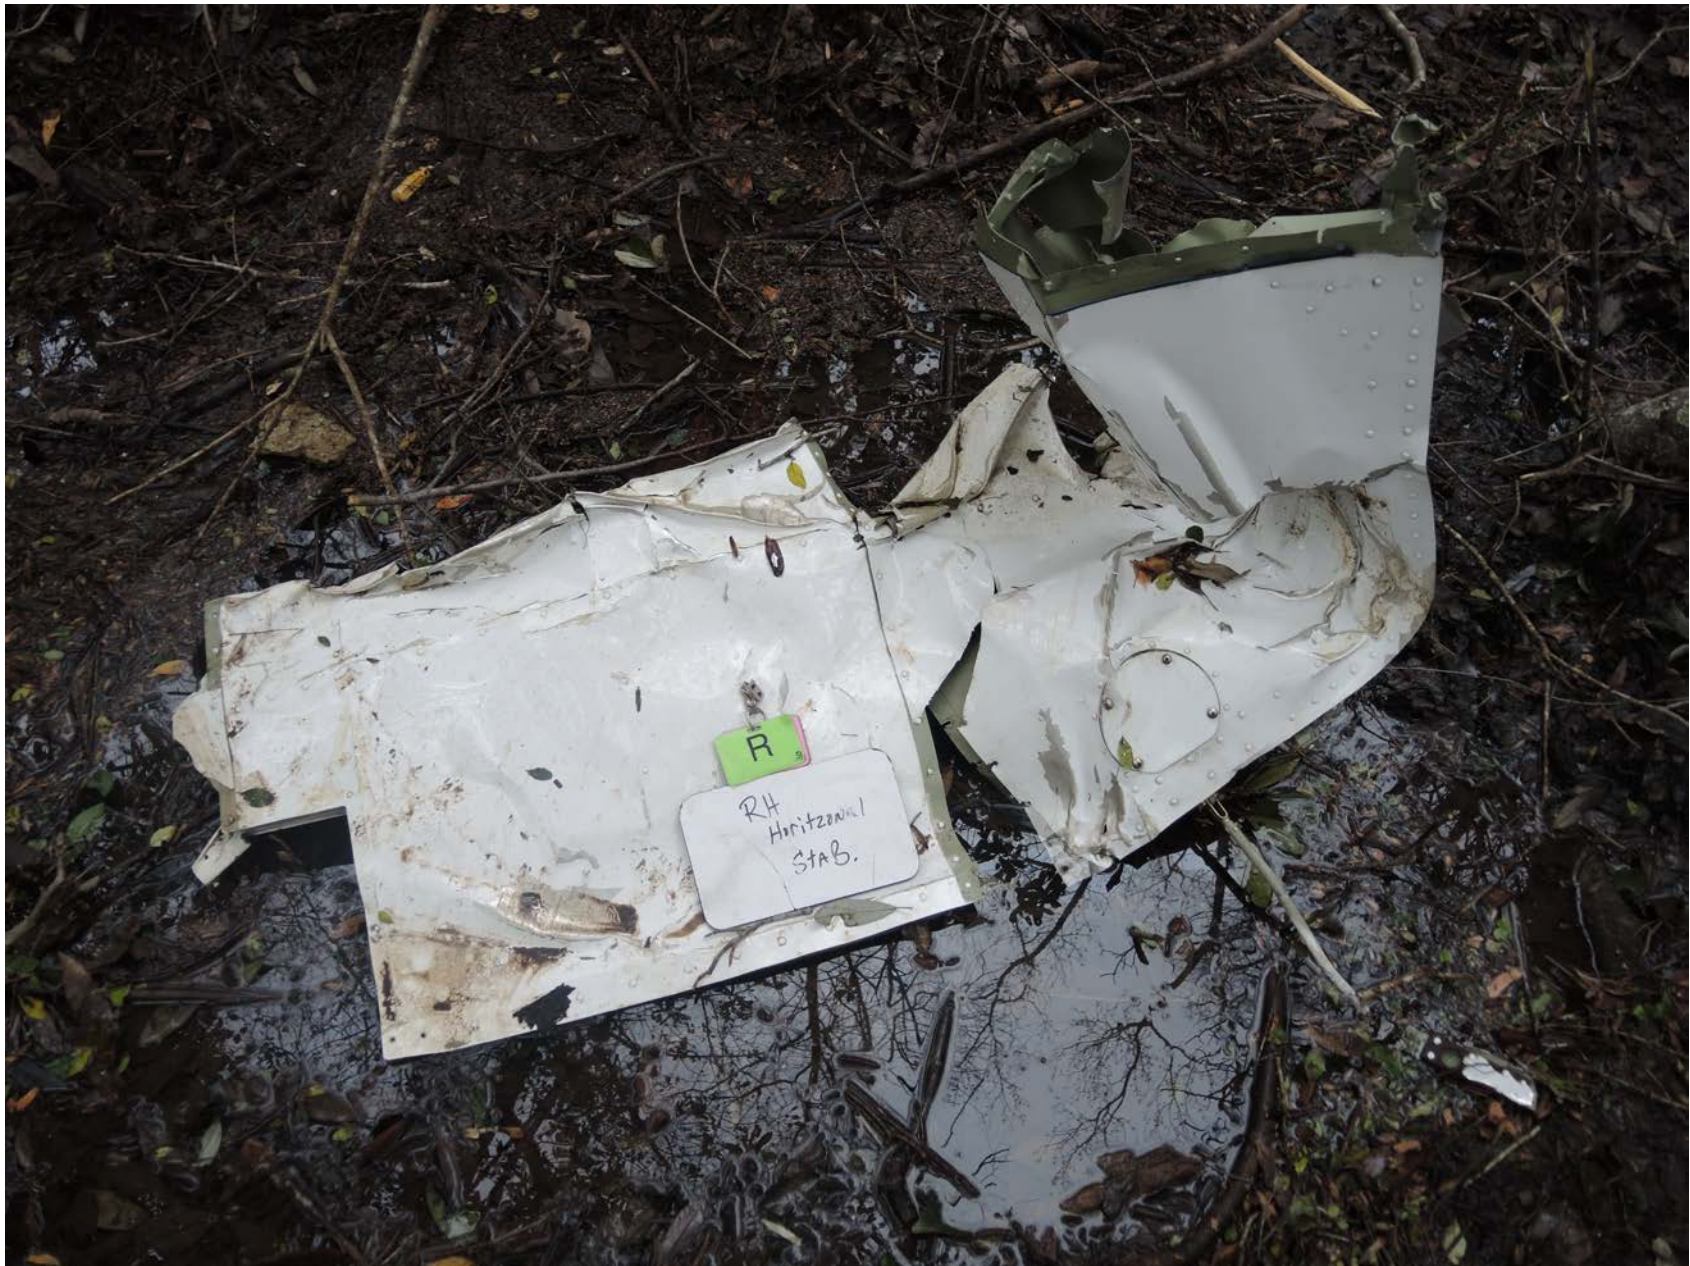
**Photo 7 – View of damaged right horizontal stabilizer**

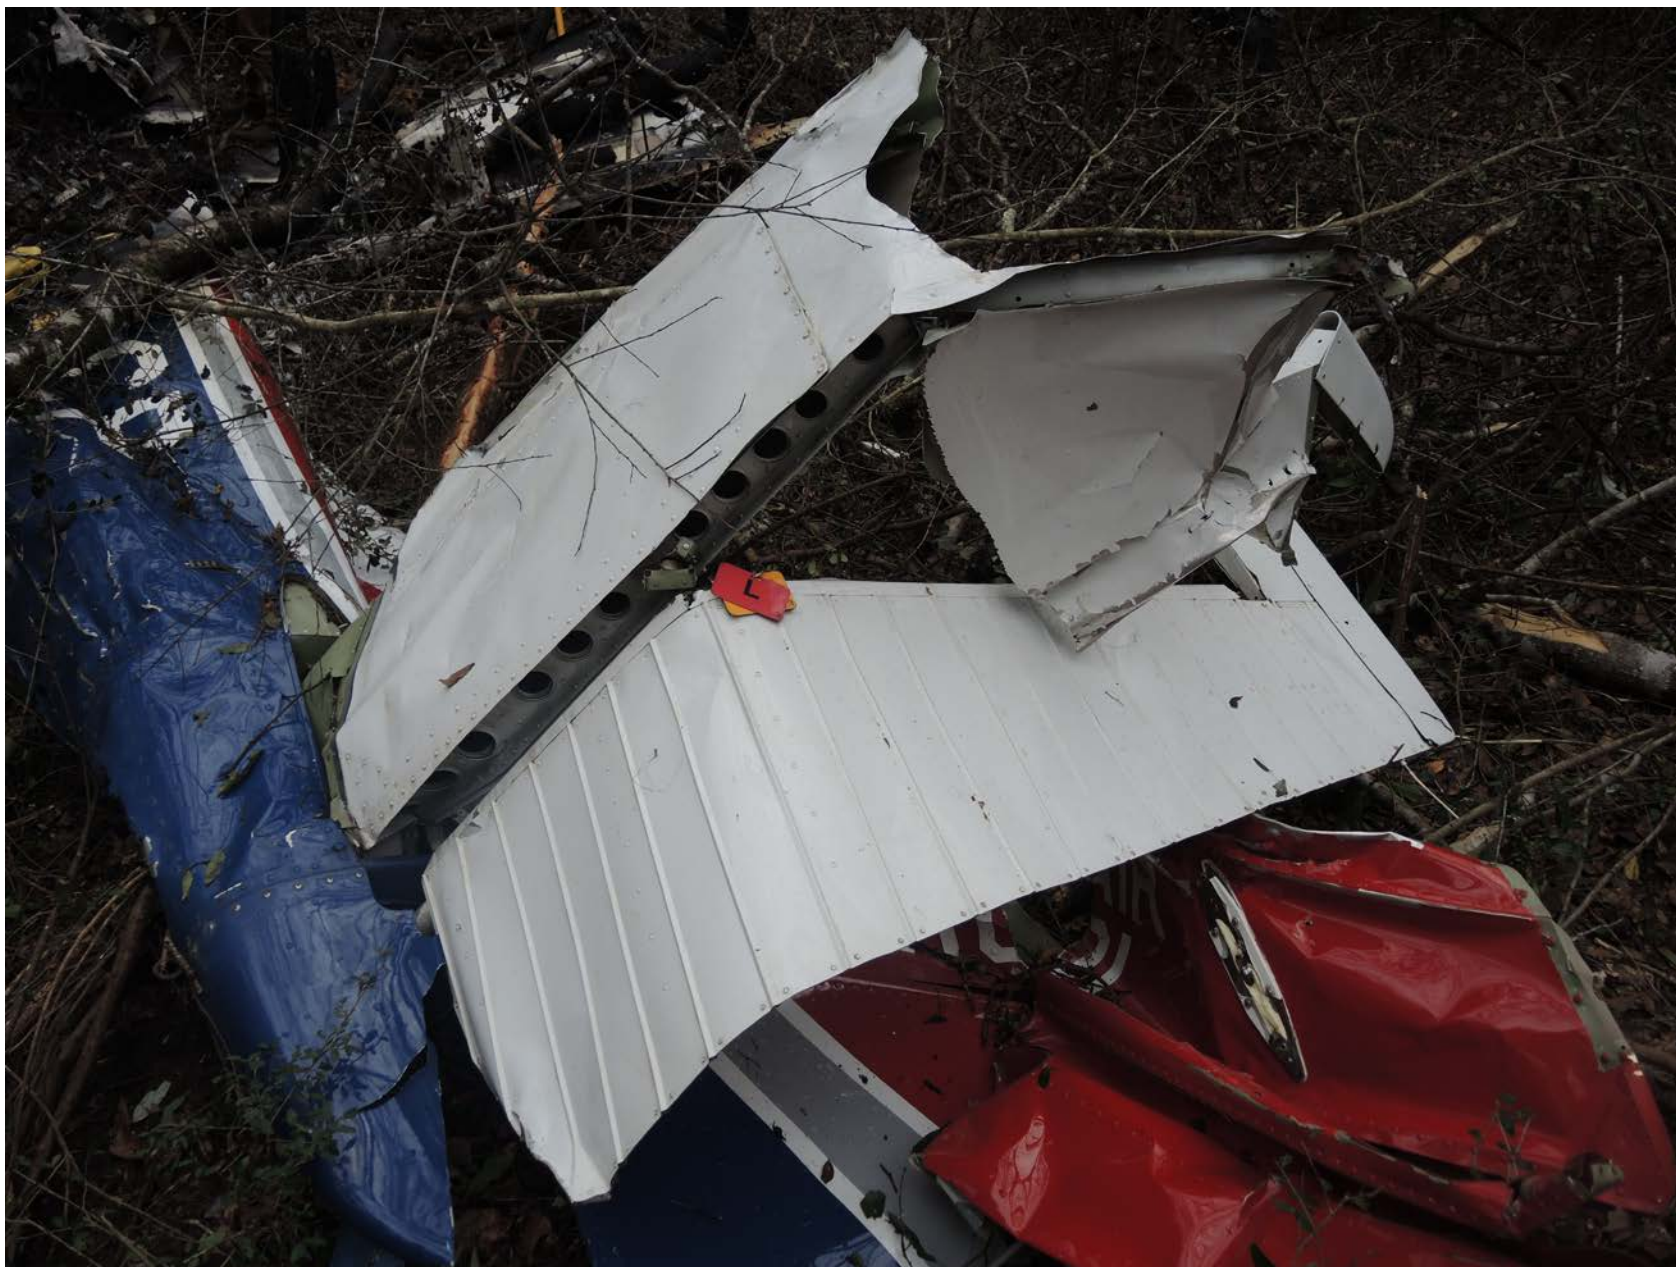
**Photo 8 – View of damaged left horizontal stabilizer and left elevator**

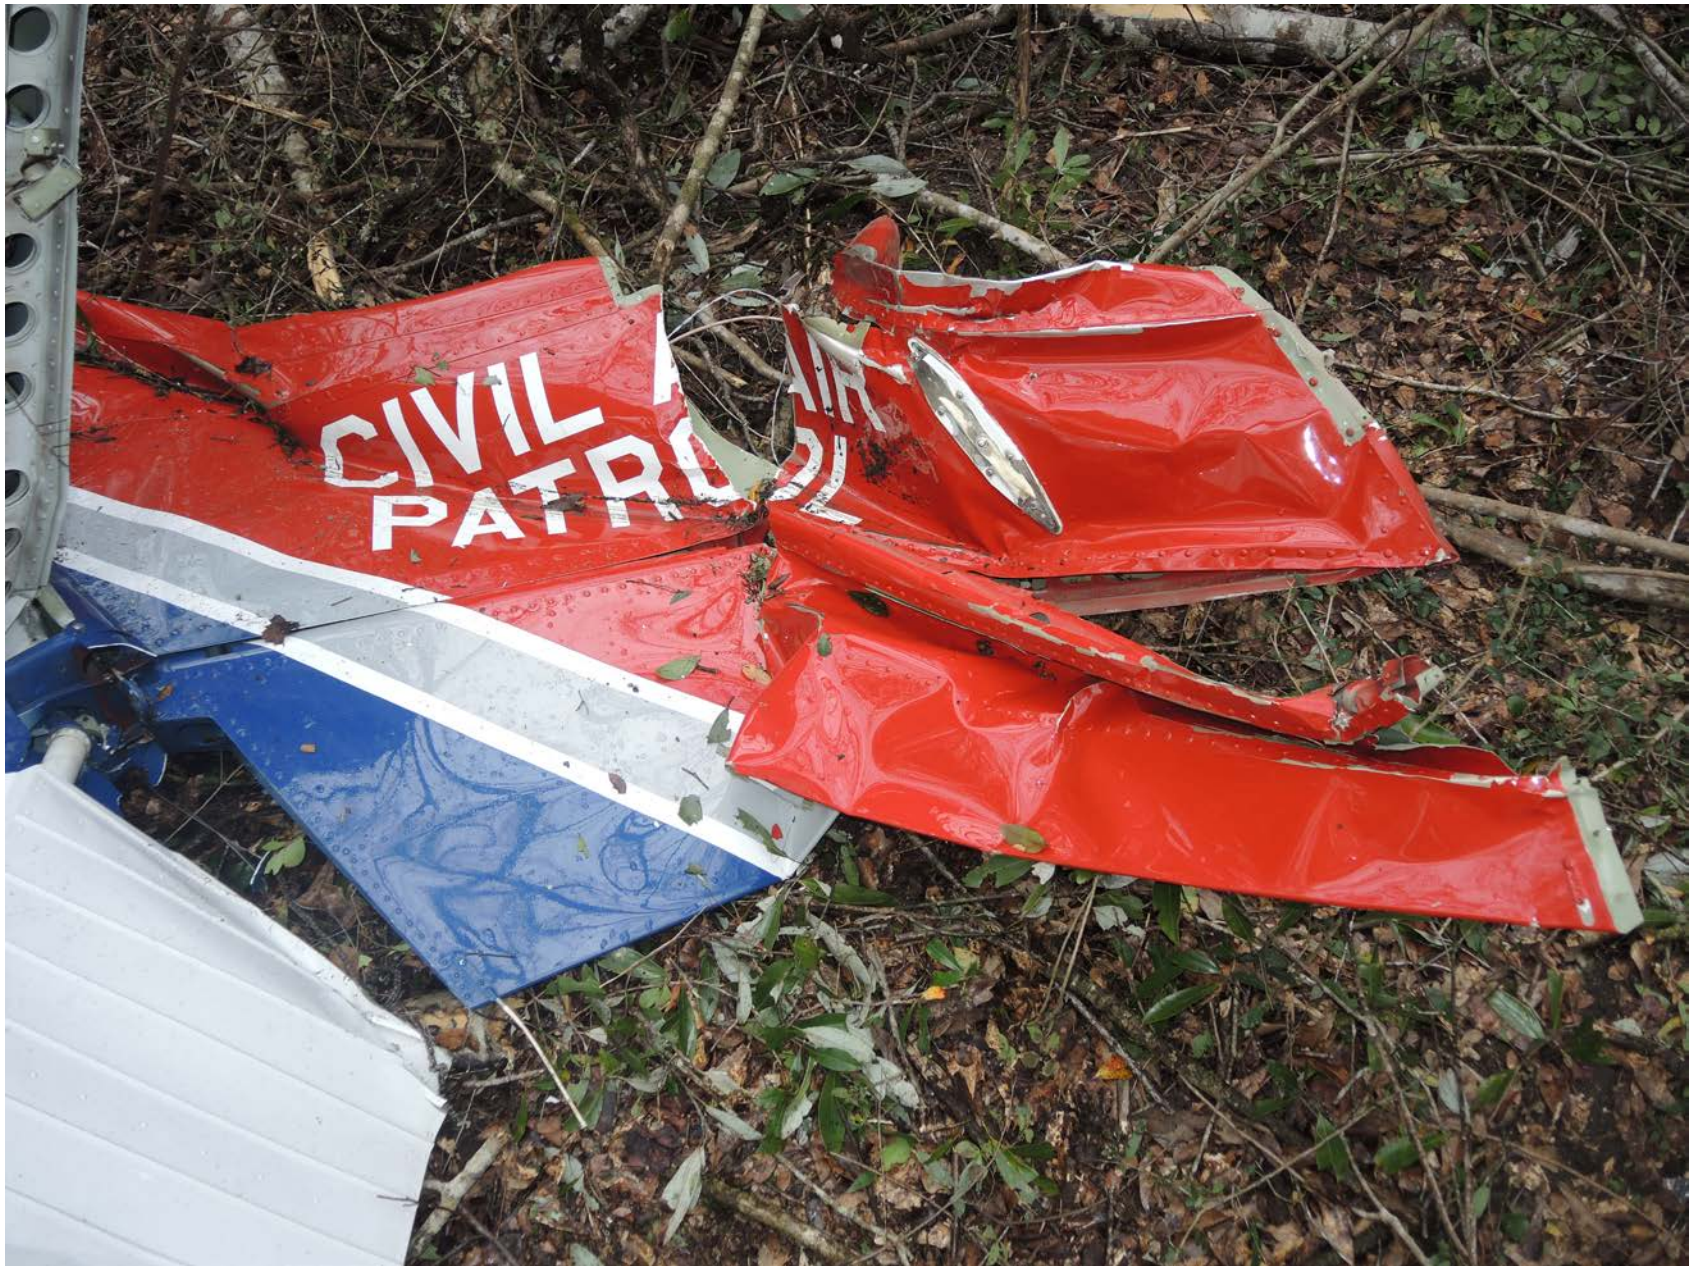
**Photo 9 – View of damaged vertical stabilizer and rudder**

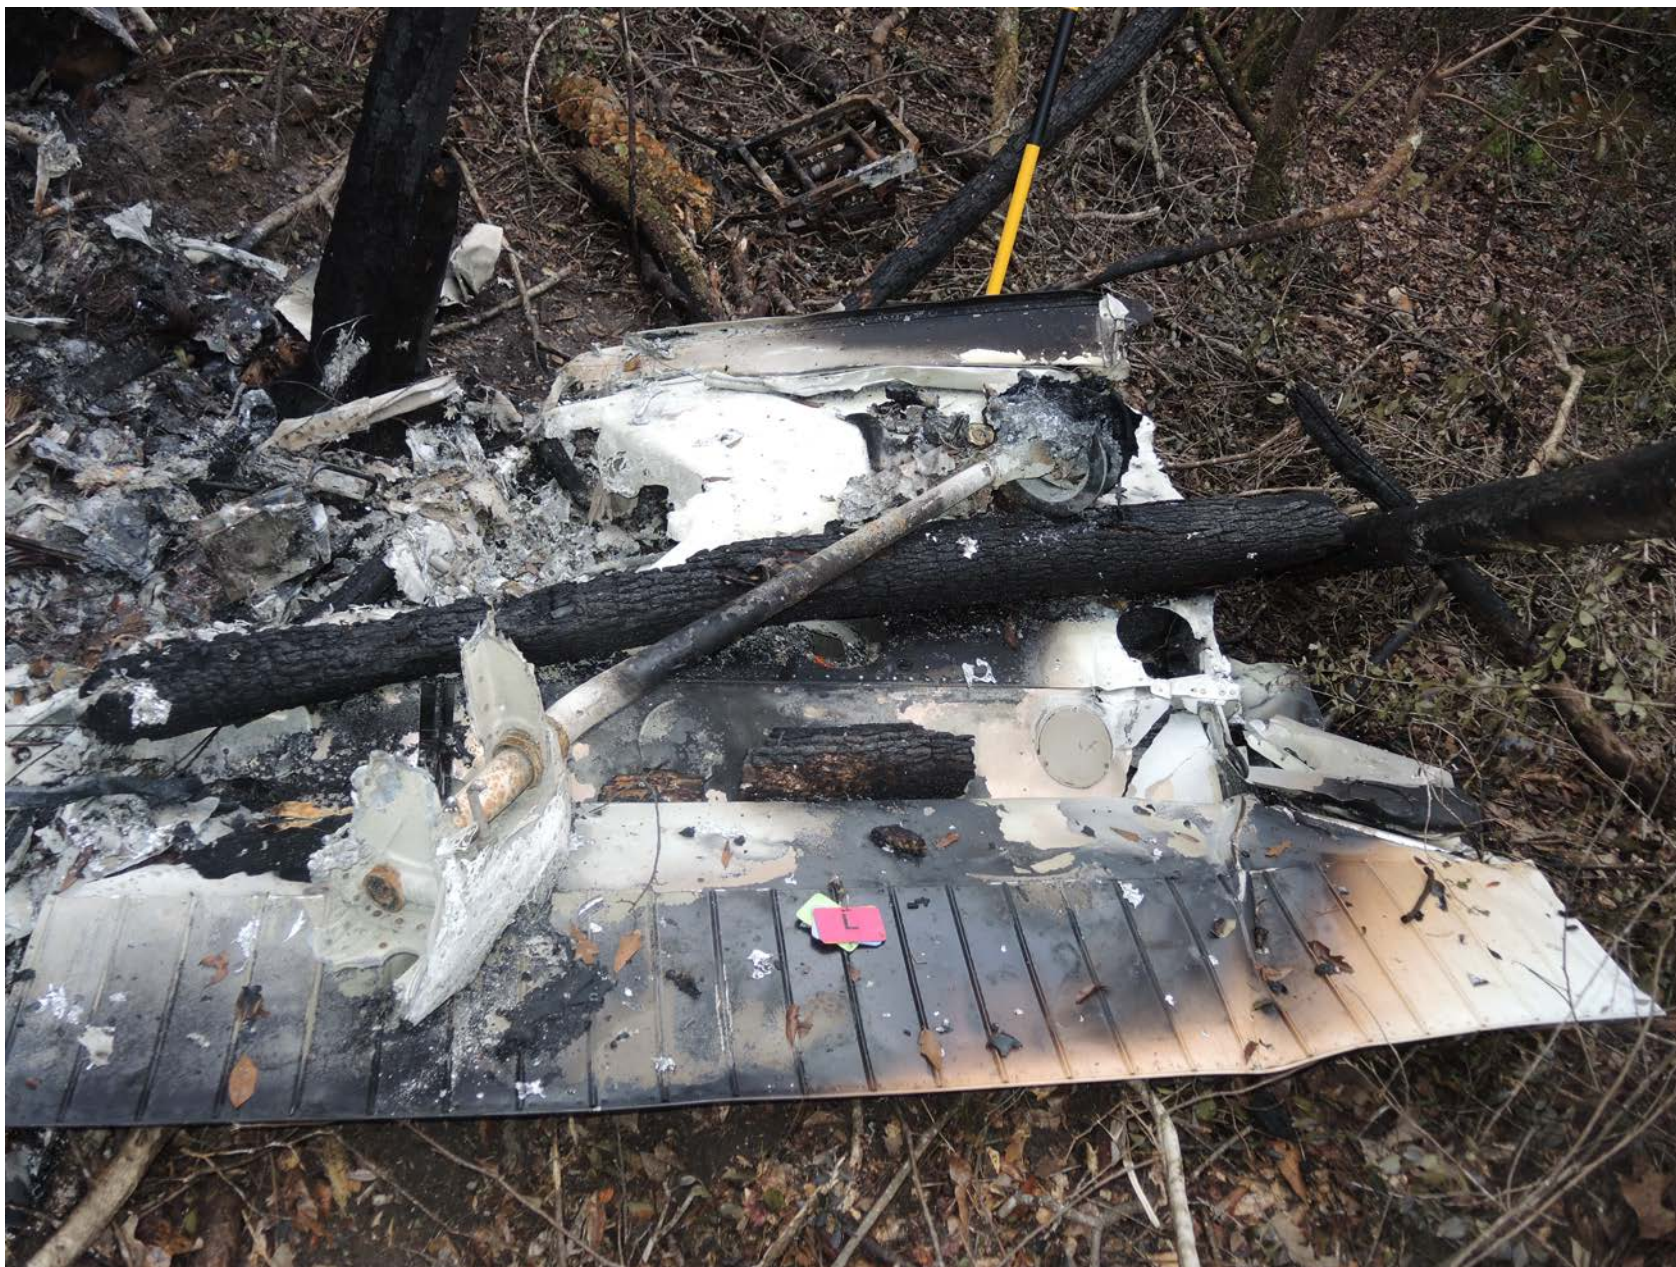
**Photo 10 – View of fire damaged inboard left wing**
