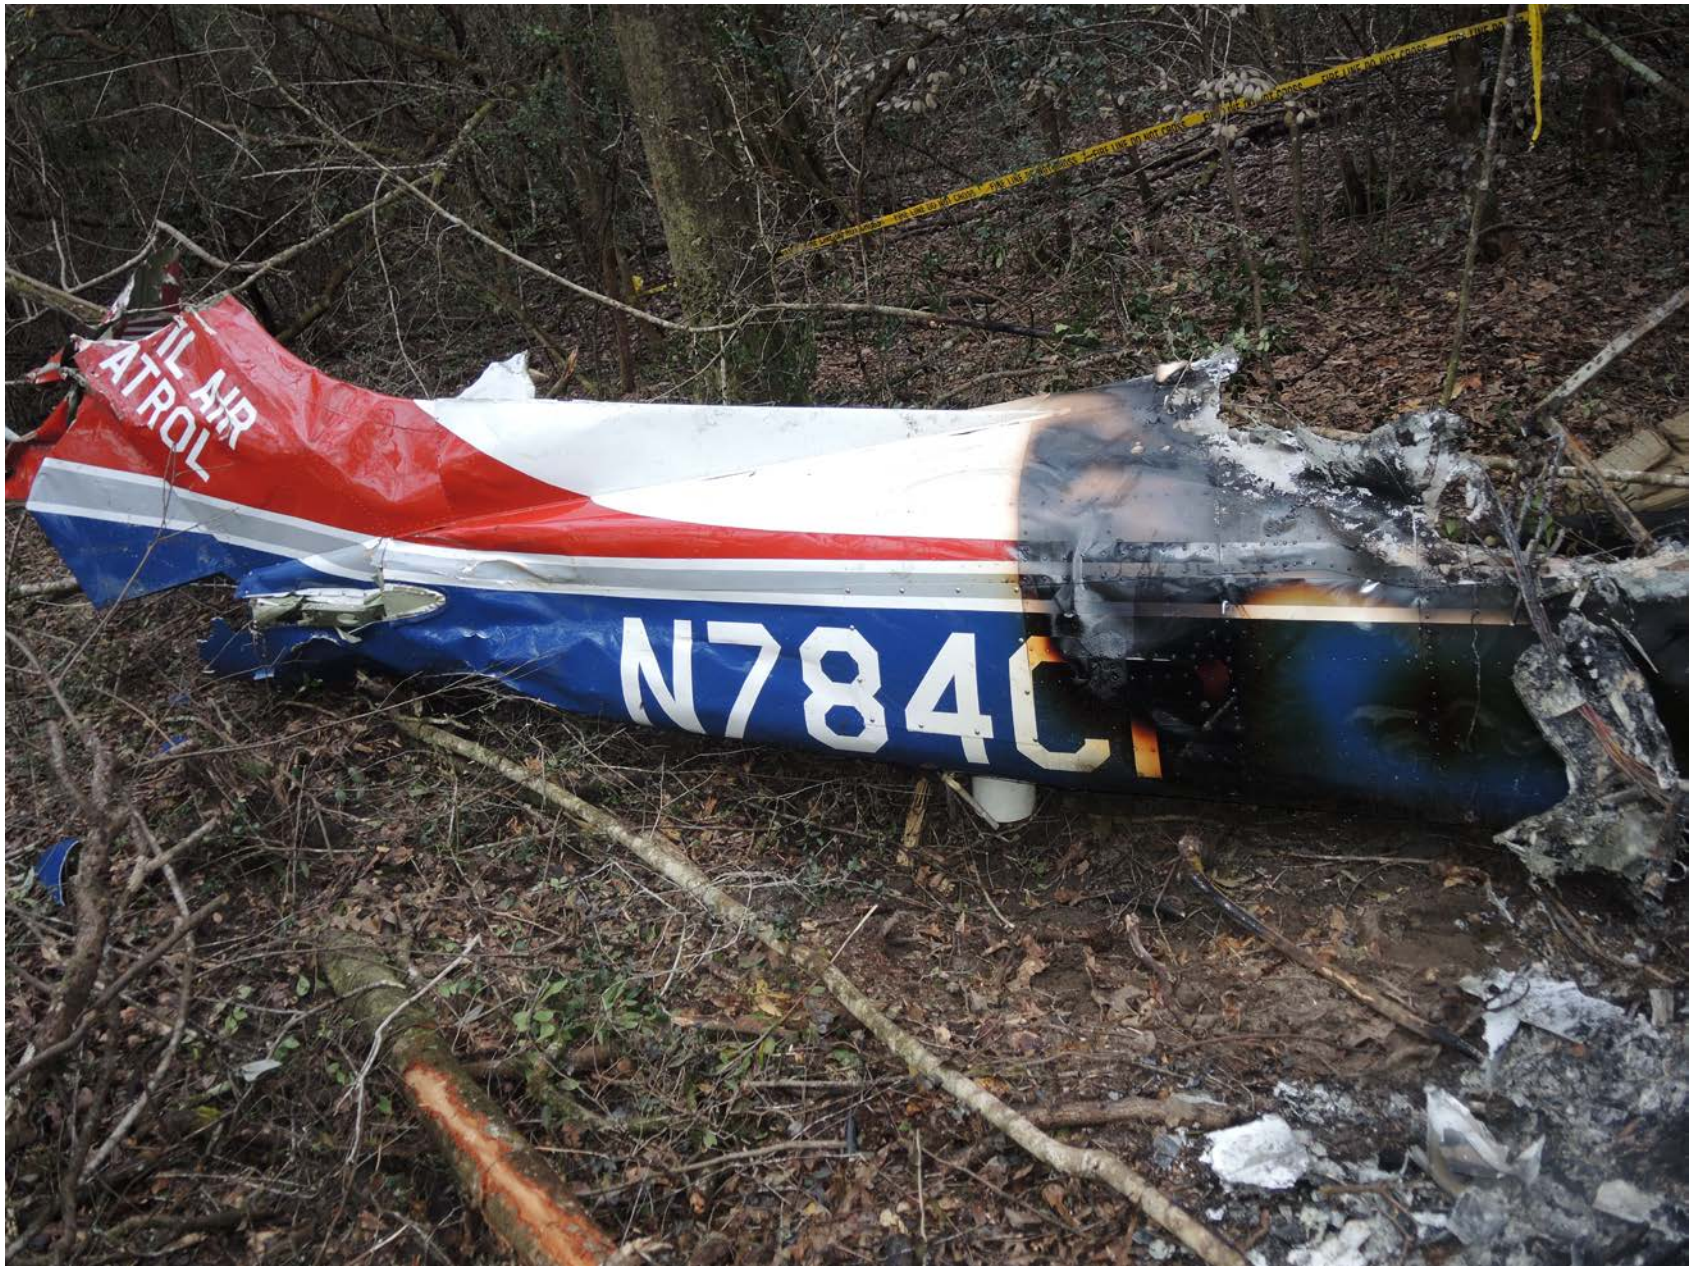
**Photo 11 – View of fire damaged empennage**

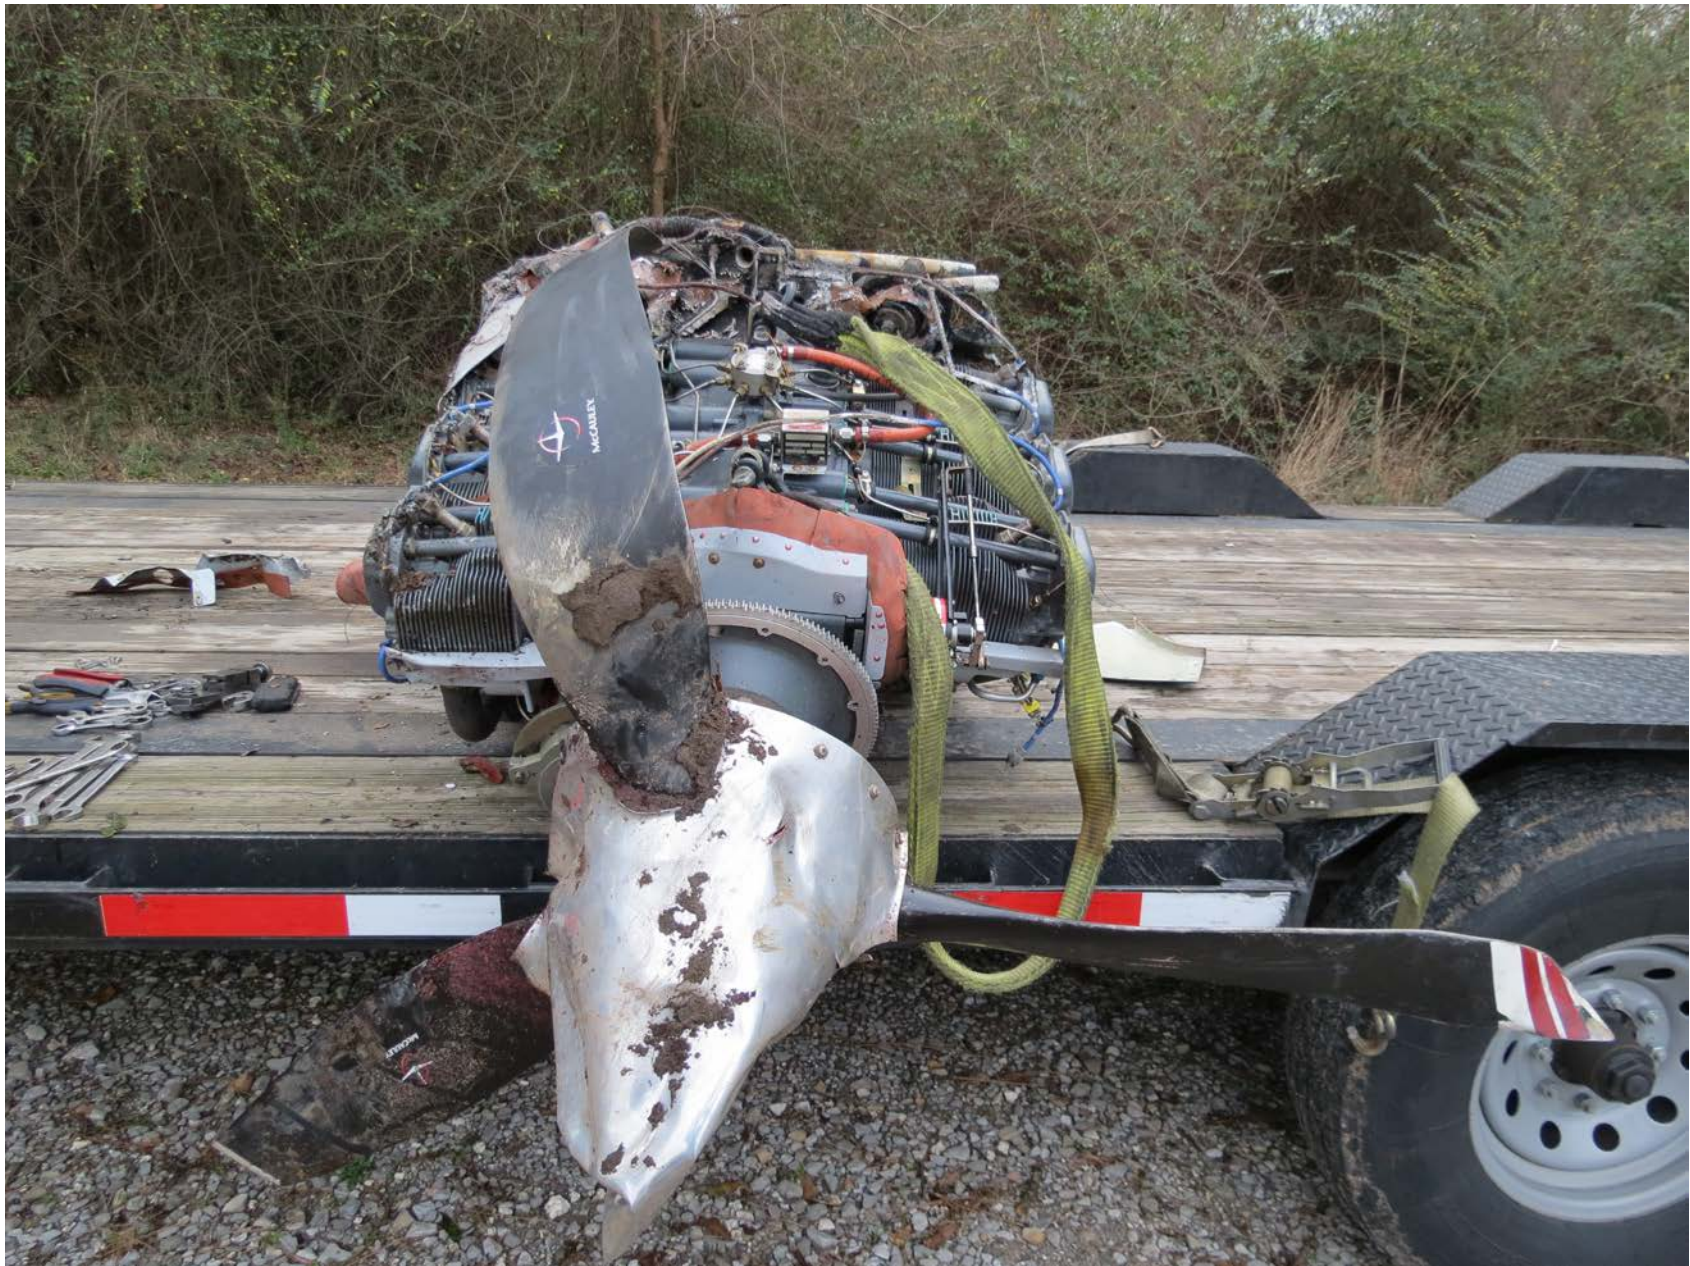
**Photo 12 – Front view of damaged engine**

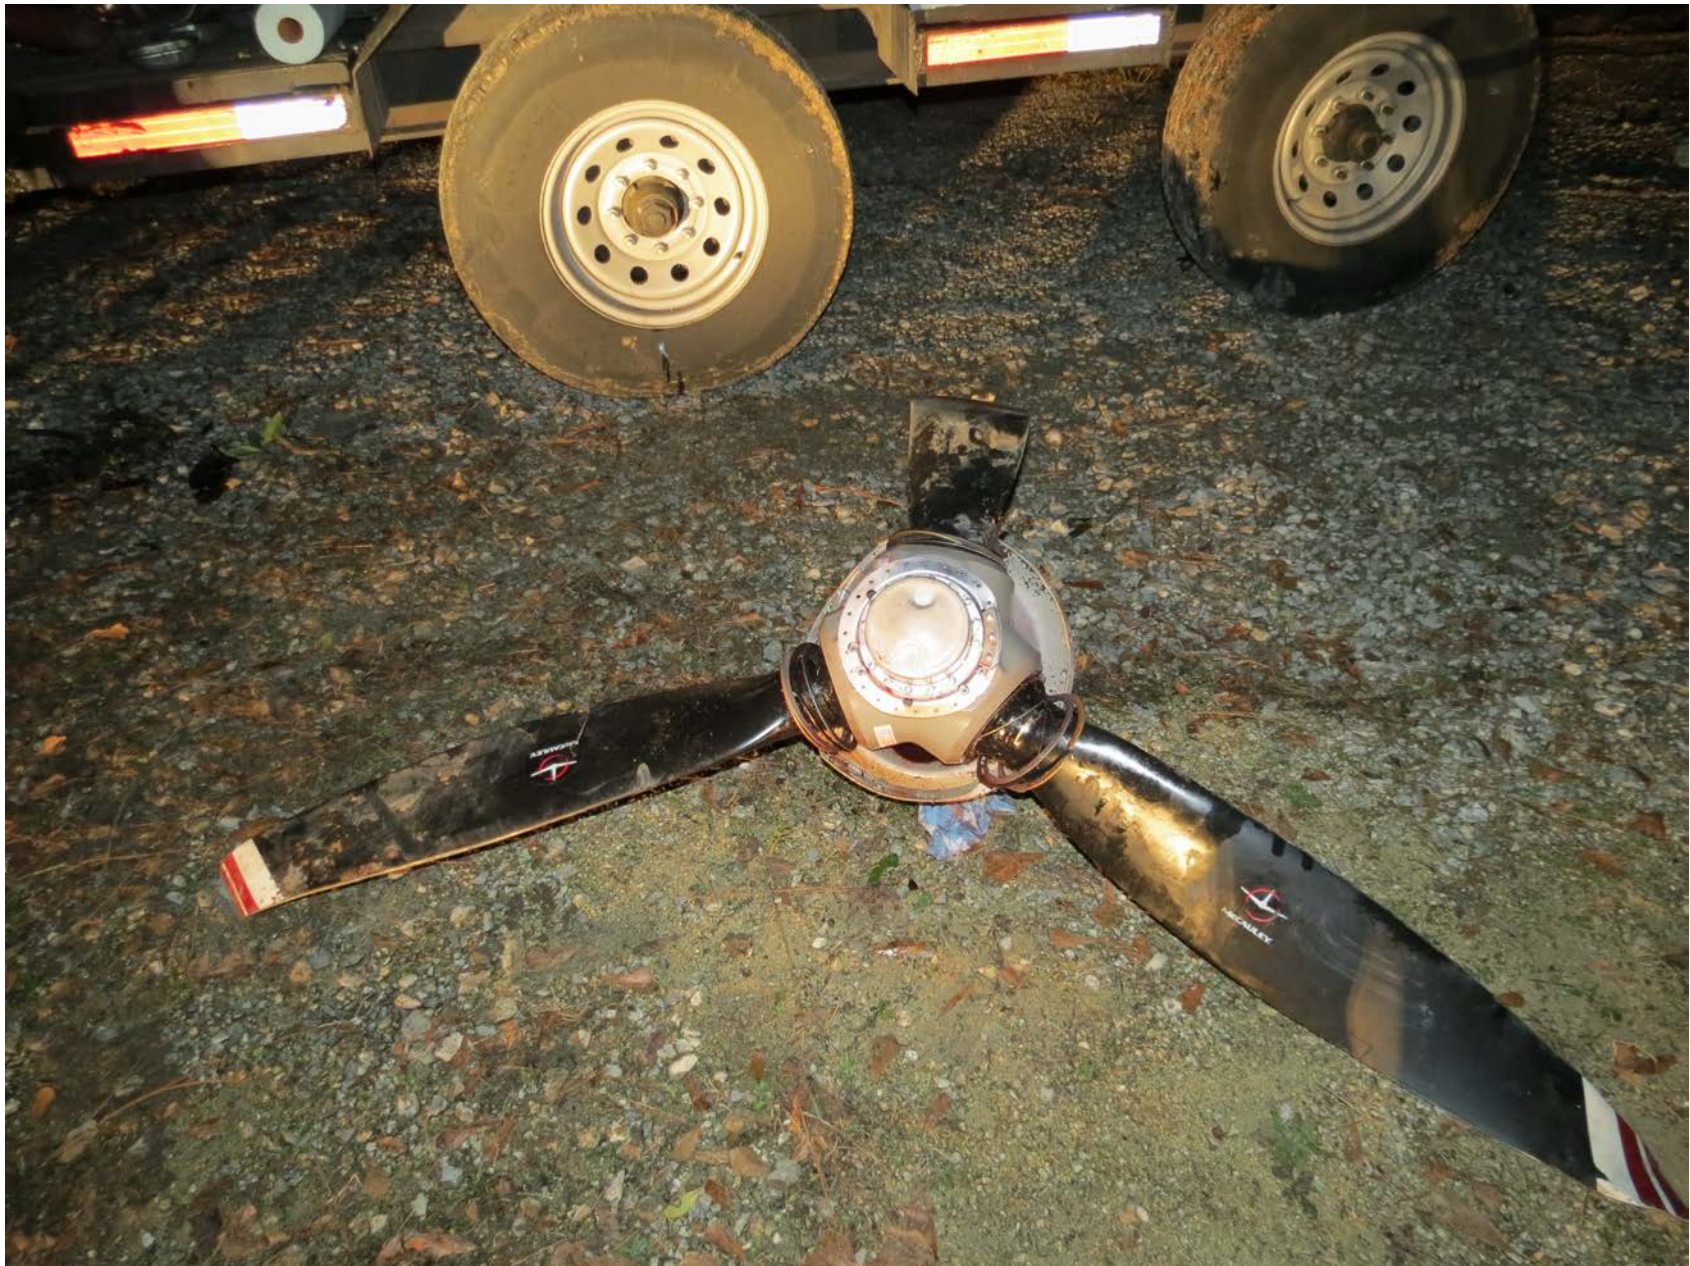
**Photo 17 – Front view of propeller showing damaged blades**

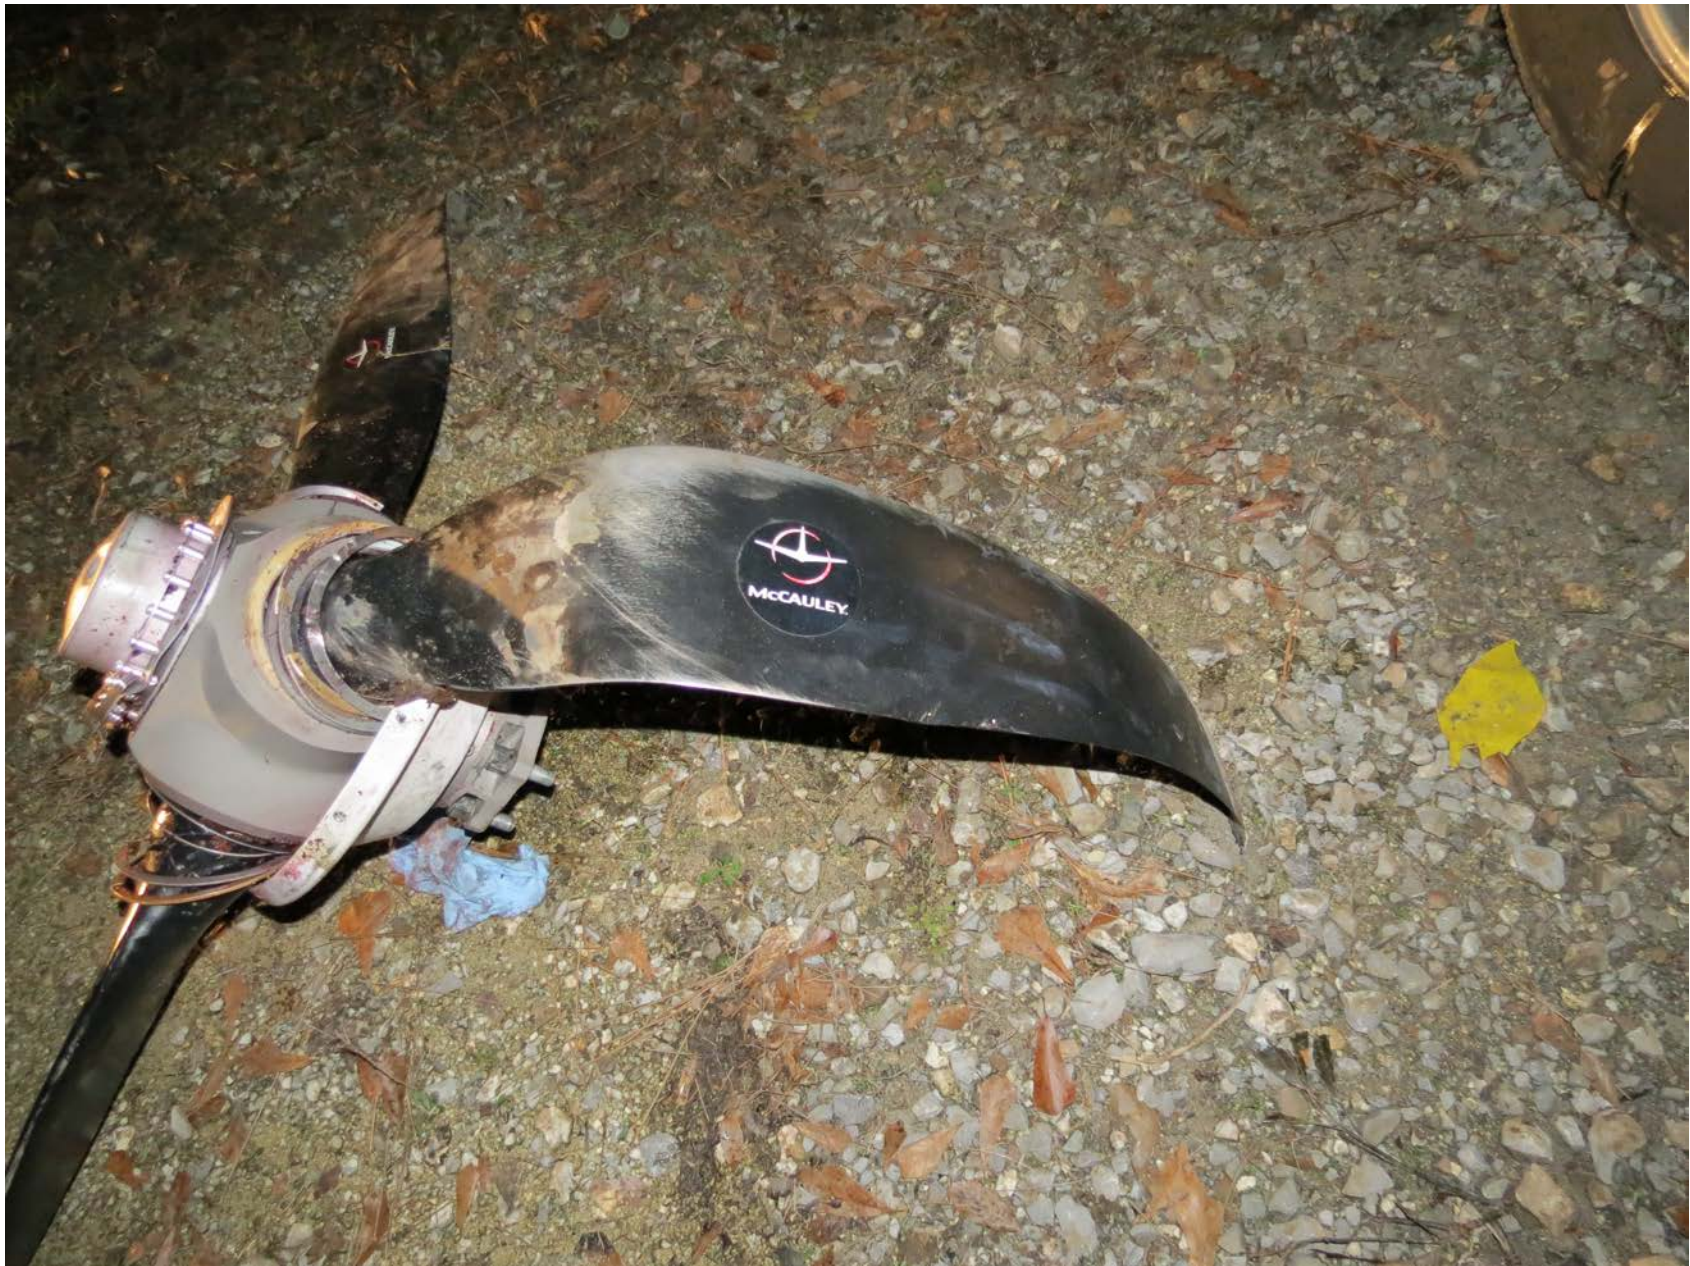
**Photo 18 - Top view of propeller showing damaged blades**

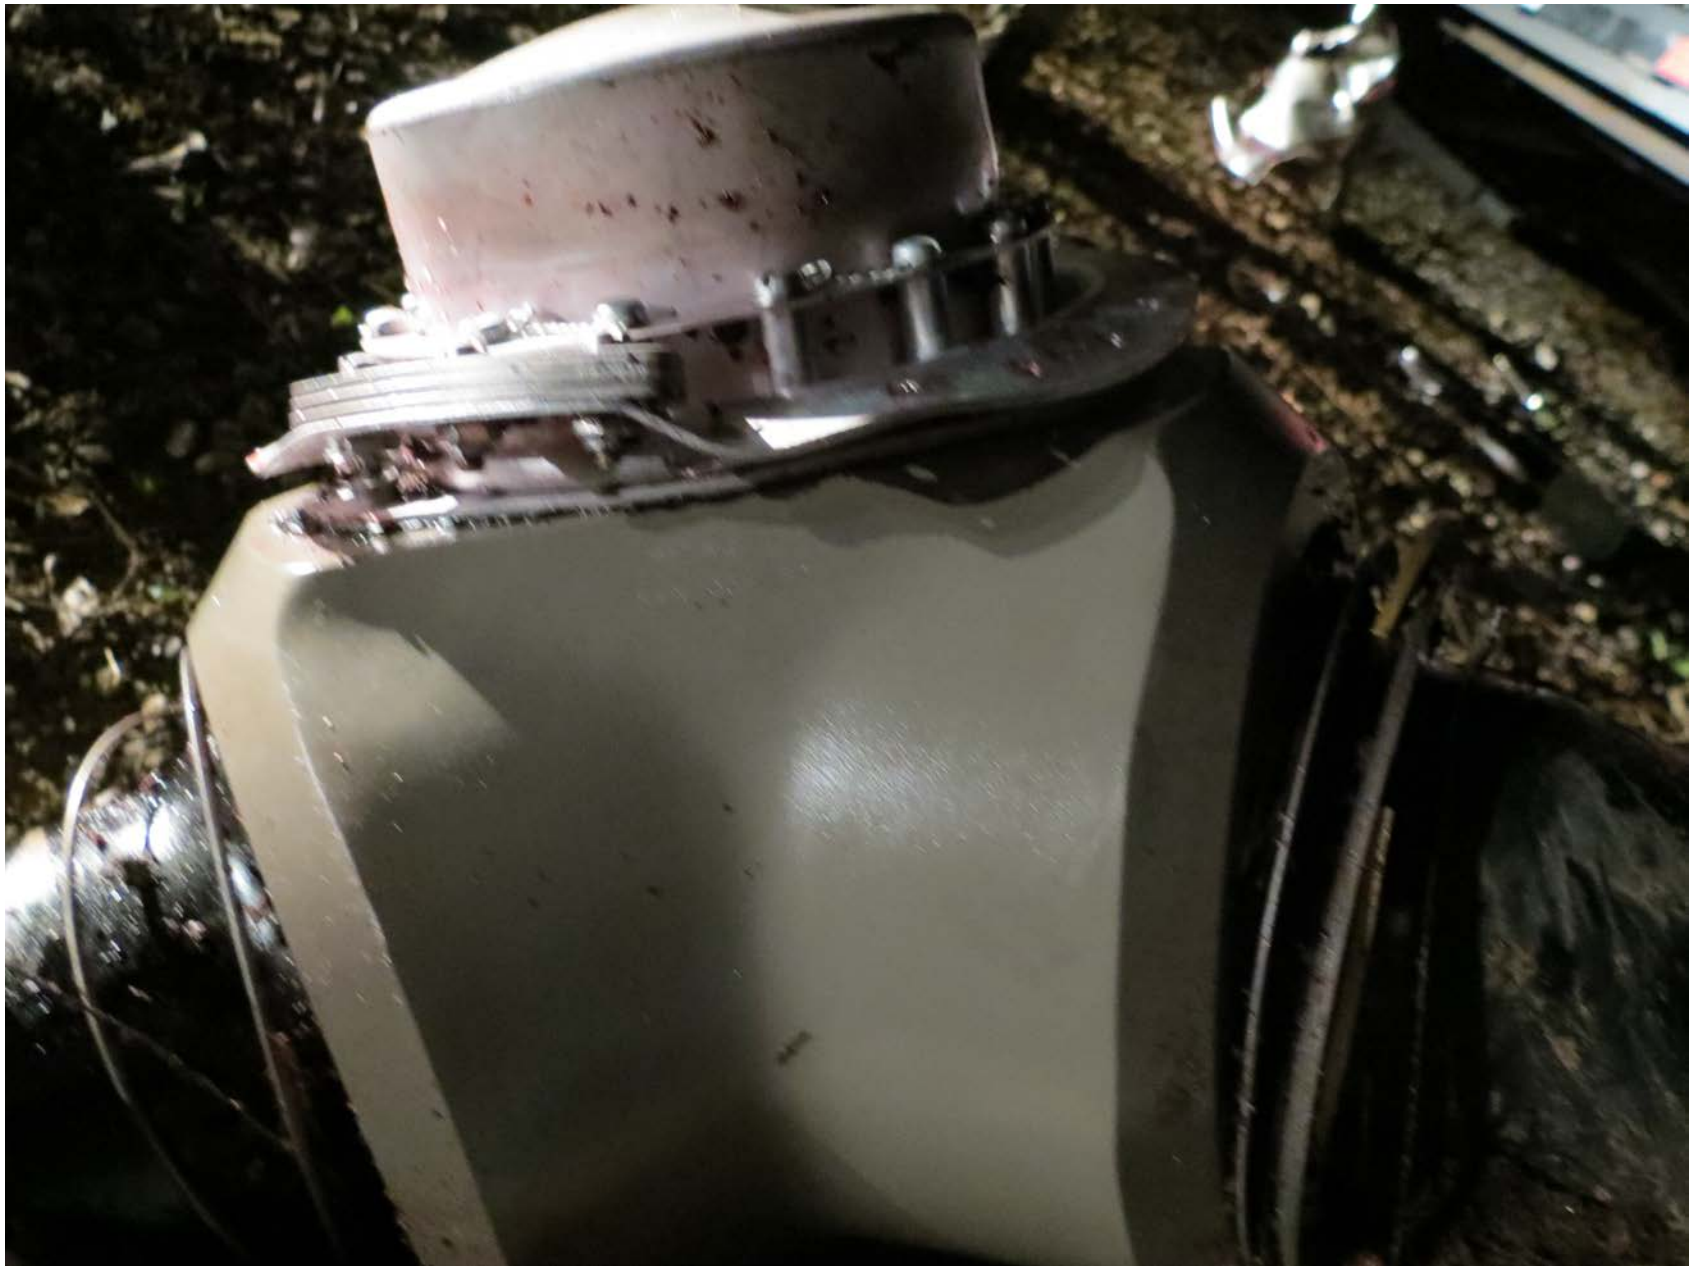
**Photo 19 - View of damaged propeller hub**
