# NATIONAL TRANSPORTATION SAFETY BOARD

## MATERIALS LABORATORY FACTUAL REPORT

Report No. 16-059

Place : Clermont, Florida  
Date : March 12, 2016  
Vehicle : EAB Sheehen Dane RV-8A, N838RV  
NTSB No. : ERA16FA127  
Investigator : Millicent Hoidal, AS-ERA

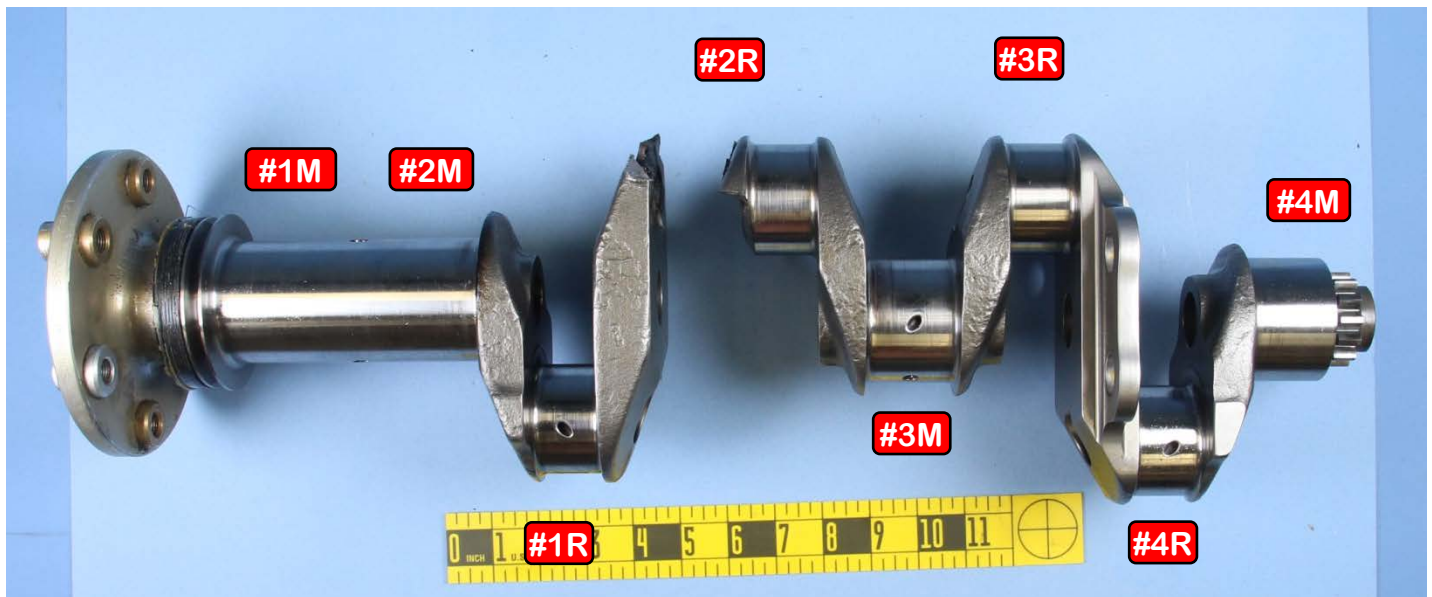
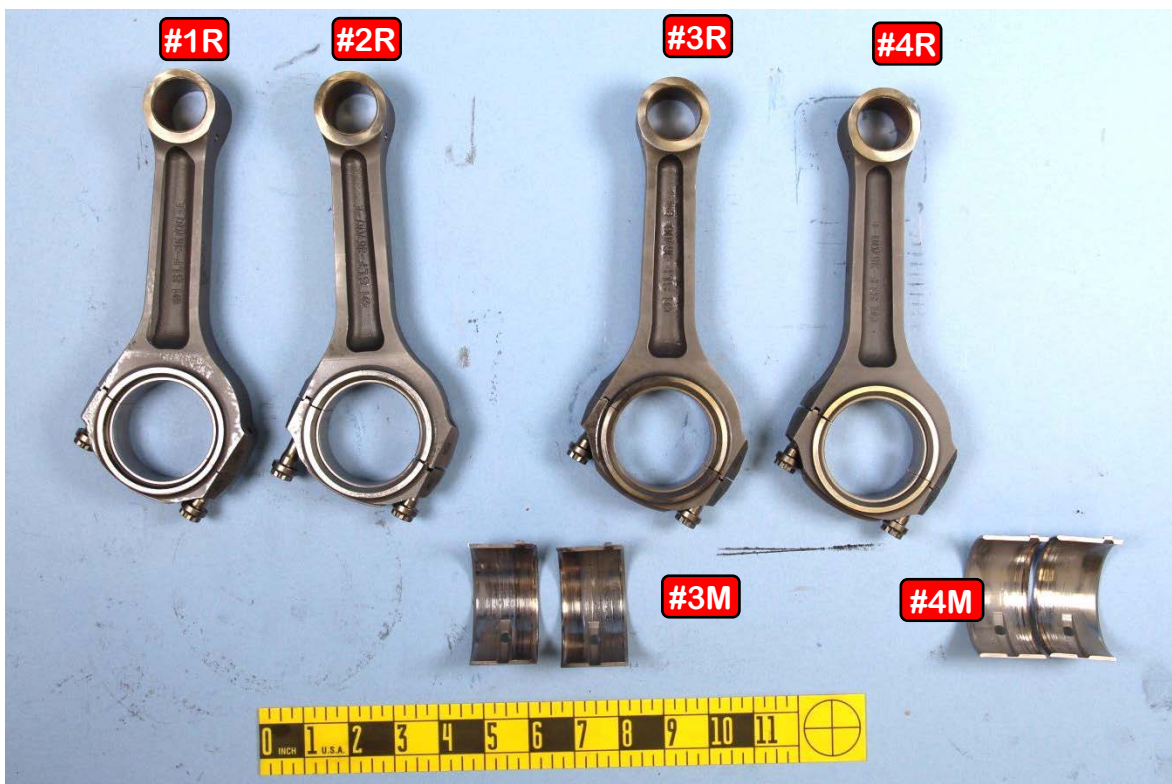
The crankshaft fractured at the forward radius of the #2<sup>1</sup> connecting rod journal as shown in the upper view of figure 1. The propeller flange of the crank was marked with part number SV40650 A ASSY and serial number 69521. It had reportedly accumulated 20 hours of service since new. The as-received connecting rods with bearings and #3 and #4 main bearings are displayed in the lower view of figure 1.

The rods were generally in good condition. The #1 rod had heavy rub and heat bluing on the faces around the rod bearing. The corresponding cheeks on the crankshaft also showed rubbing damage and heat tinting. The #2 rod had light contact damage on one face and the other two rods did not have perceptible damage.

The received main bearings showed heavy rotational scoring and damage on the bearing surfaces. The bearings were also scored and rotationally damaged at the forward edges consistent with rearward movement of the crankshaft. The forward radius of the #3 and #4 showed matching damage. The rod bearings had light wear with some circumferential particle scoring.

Figure 1. The as-received crankshaft at top and connecting rods and bearing below. Crankshaft fractured through the #2 cylinder rod journal. Journals and mains are labeled with position. Aircraft forward at left.

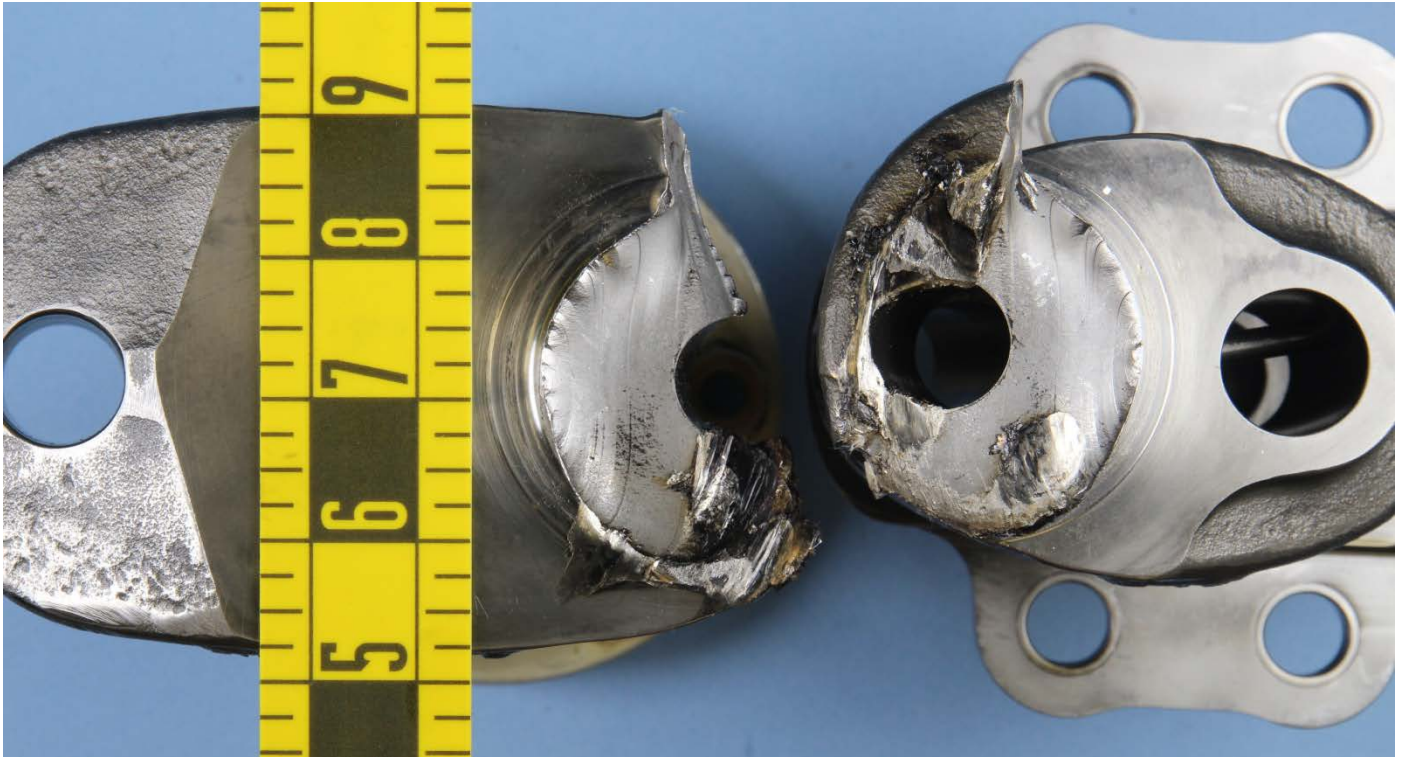
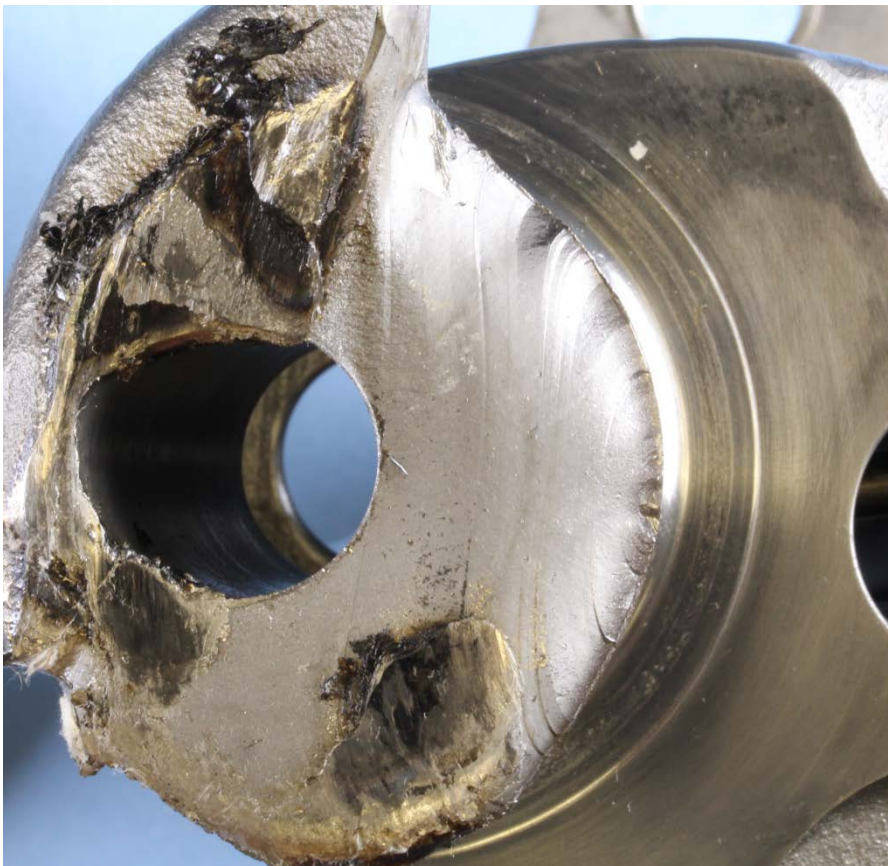
Visual examinations of the fracture surfaces revealed extensive beach markings and a finely textured surface indicative of fatigue progression from the vicinity of the forward radius of the rod journal, as shown in figure 2. The origin was rotationally located opposite the top-dead-center position of the piston. Higher magnification inspections established that the fatigue initiated at a single sub surface location, as shown in figure 3. The origin location measured 0.027 inch below the radius surface.

Figure 2. The fracture faces of the #2 rod journal showing fatigue features emanating from the area of the forward radius. Aft fracture face shown at left.

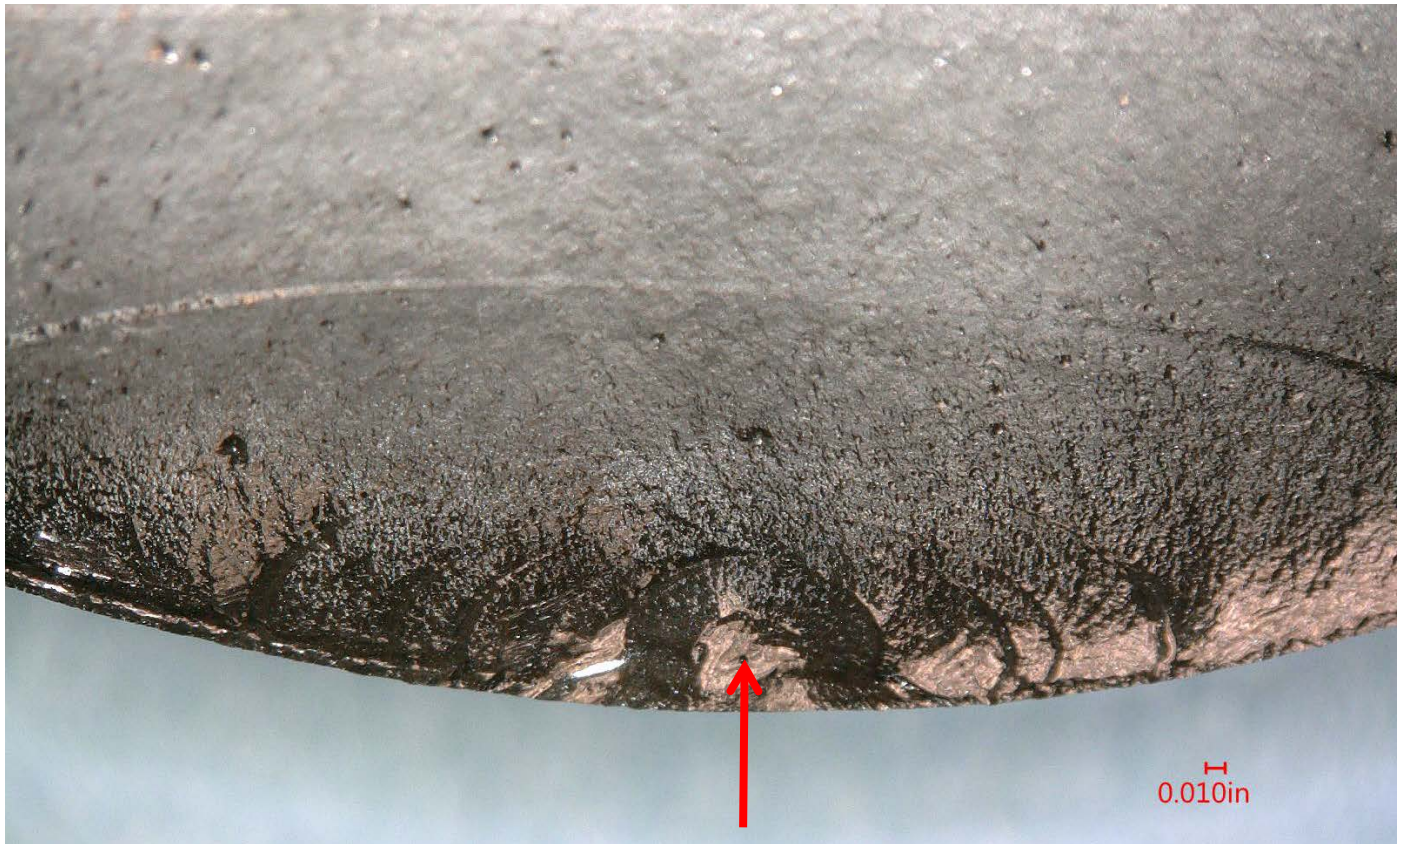
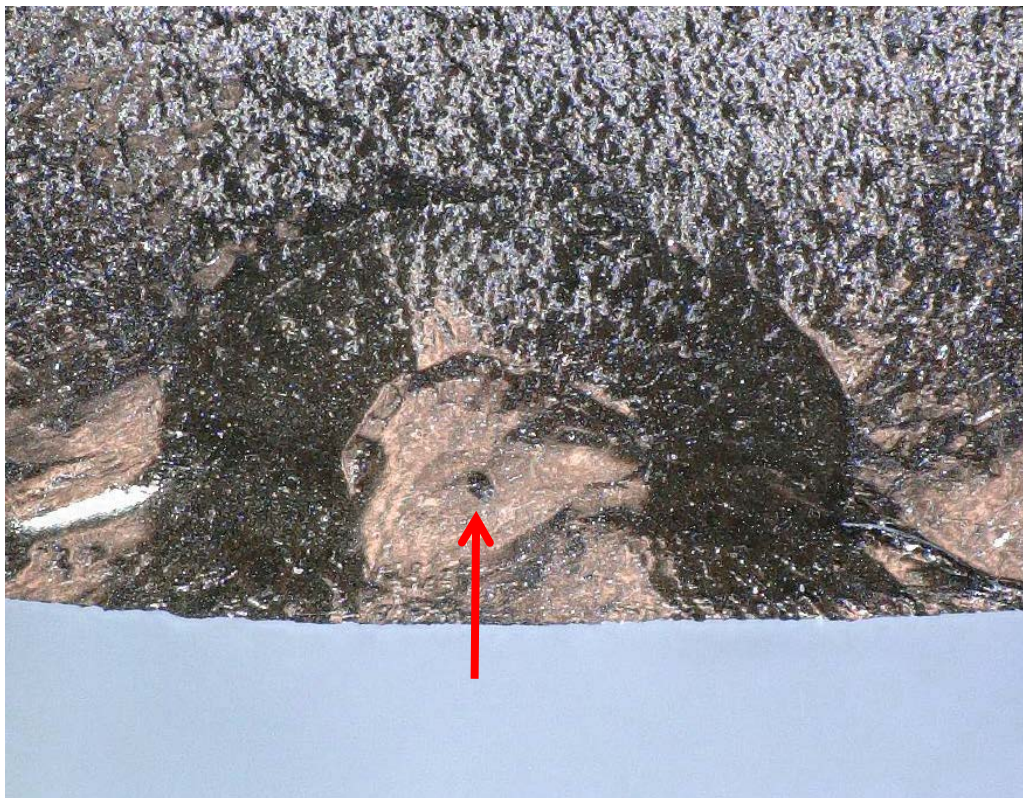
Figure 3. Optical views of the subsurface fatigue initiation (red arrow) and the beach marks expanding away from it.

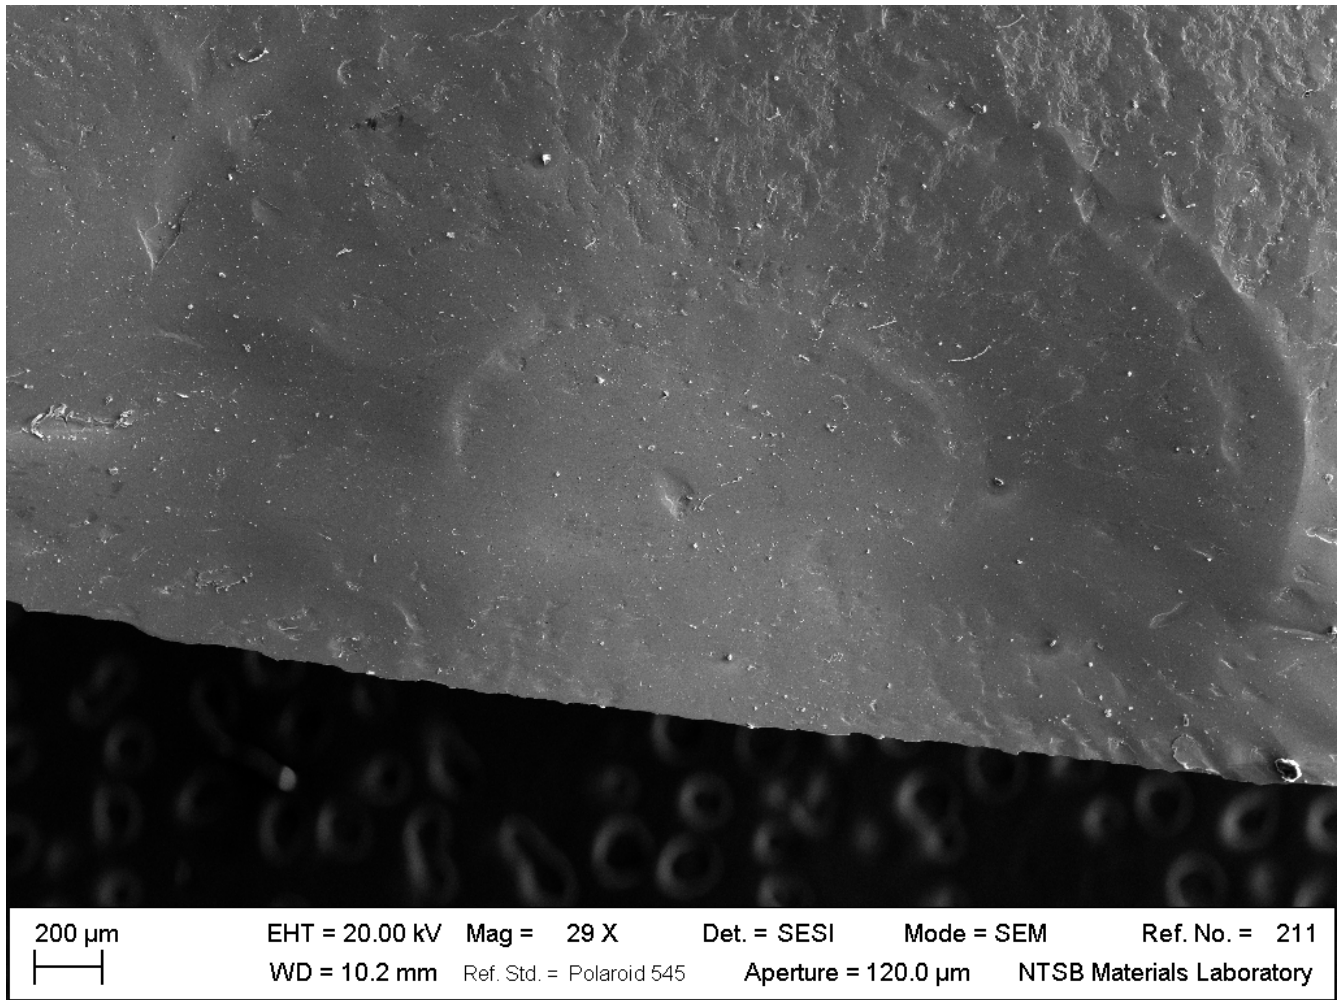
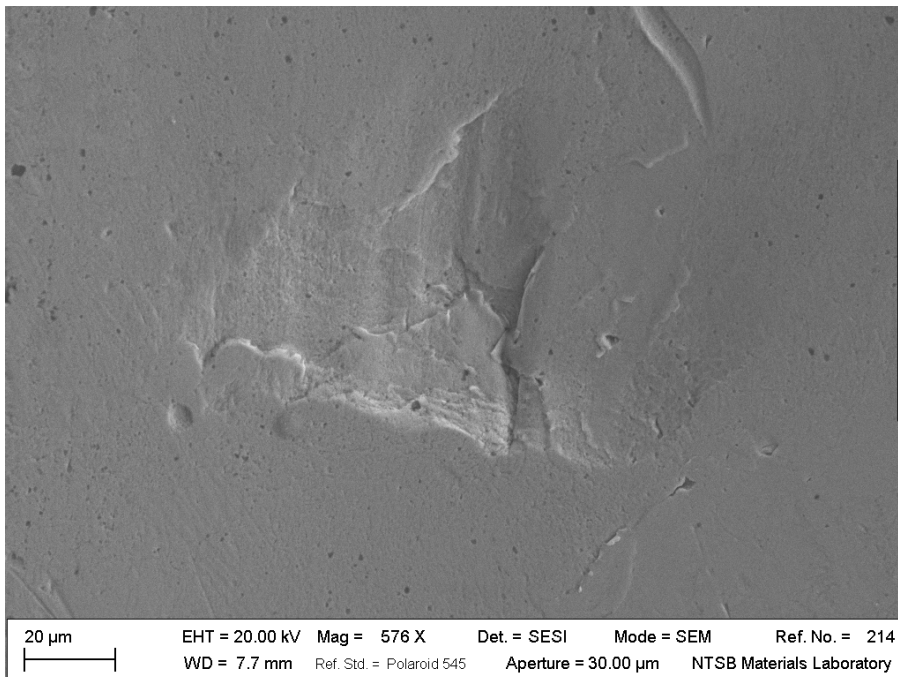
The aft fracture face was removed by an abrasive saw cut, transversely through the approximate center of the rod journal, then ultrasonically cleaned in acetone. Scanning electron microscope (SEM) viewing of the fracture surface also found markings consistent with fatigue progression from a subsurface location. However, SEM examinations also revealed extensive mechanical damage consistent with crack closure and crack face recontact that obliterated the fine details of the fracture, as shown in figure 4. The approximate origin location corresponds to a slight depression on the

fracture surface, see lower view of figure 4. Fracture features within the depression were also damaged.

Figure 4. SEM views of the fatigue origin area at top showing the depression and extensive damage to the fine fracture details. Closer view of the depression at left.

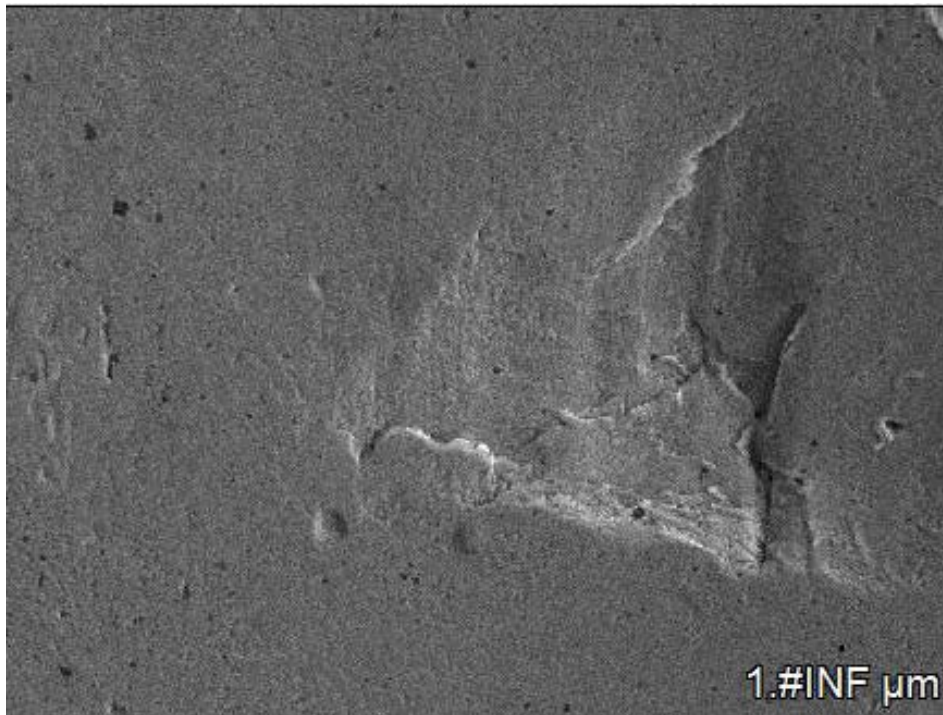
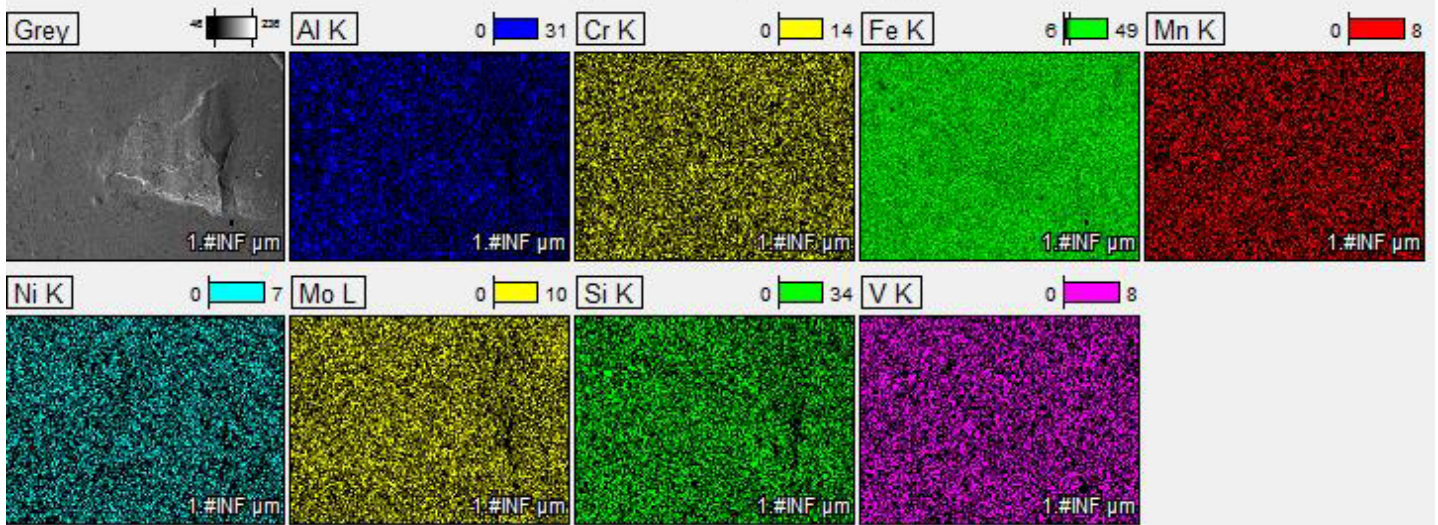
Energy dispersive x-ray (EDS) spectra and maps of the origin location did not indicate an inclusion or chemical variations in the area. The EDS spectra of the crankshaft away from the origin was consistent with a low alloy steel containing chromium, molybdenum, nickel, manganese and vanadium as major alloy elements.

Figure 5. Energy dispersive x-ray maps of the depression and surrounding area showing no significant segregations of elements, aluminum, chromium, iron, manganese, nickel, molybdenum, silicon and vanadium.

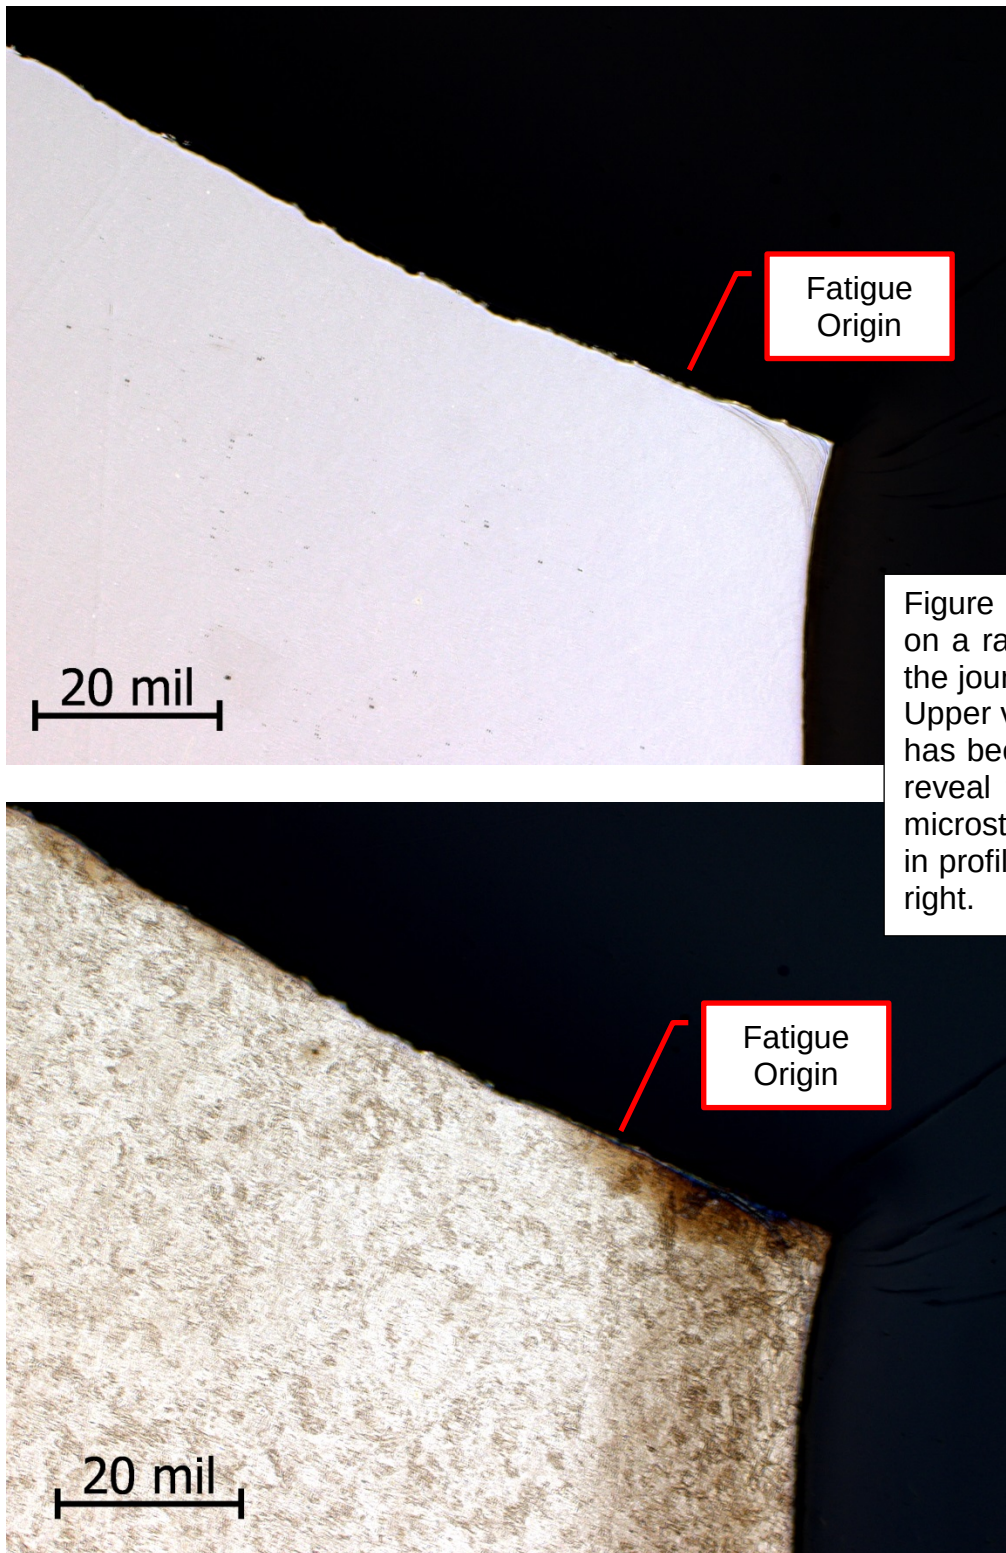
A metallographic section was cut longitudinally through the #2 rod journal near the fatigue origin. The section was progressively polished to near the origin location. No inclusions or foreign material was noted at or near the origin location in any of the successive polish steps. The steel was very clean and only one inclusion was noted on one polish step anywhere in the sample.

Etching the metallographic specimen with 2% Nital<sup>9</sup> revealed the case and core microstructure as shown in the lower view of figure 8. Both case and core microstructures were tempered martensite with the case structure containing individual white etching iron nitrides and etching darker. Both typical of the specified heat

treatments. No iron nitride surface layer or networks were visible. Visually, the total case appeared to be about 0.025 inch deep.

Figure 8. Metallographic images on a radial cross section through the journal near the fatigue origin. Upper view unetched. Lower view has been etched with 2% Nital to reveal the nitride case and core microstructures. Fracture surface in profile at top, journal surface at right.

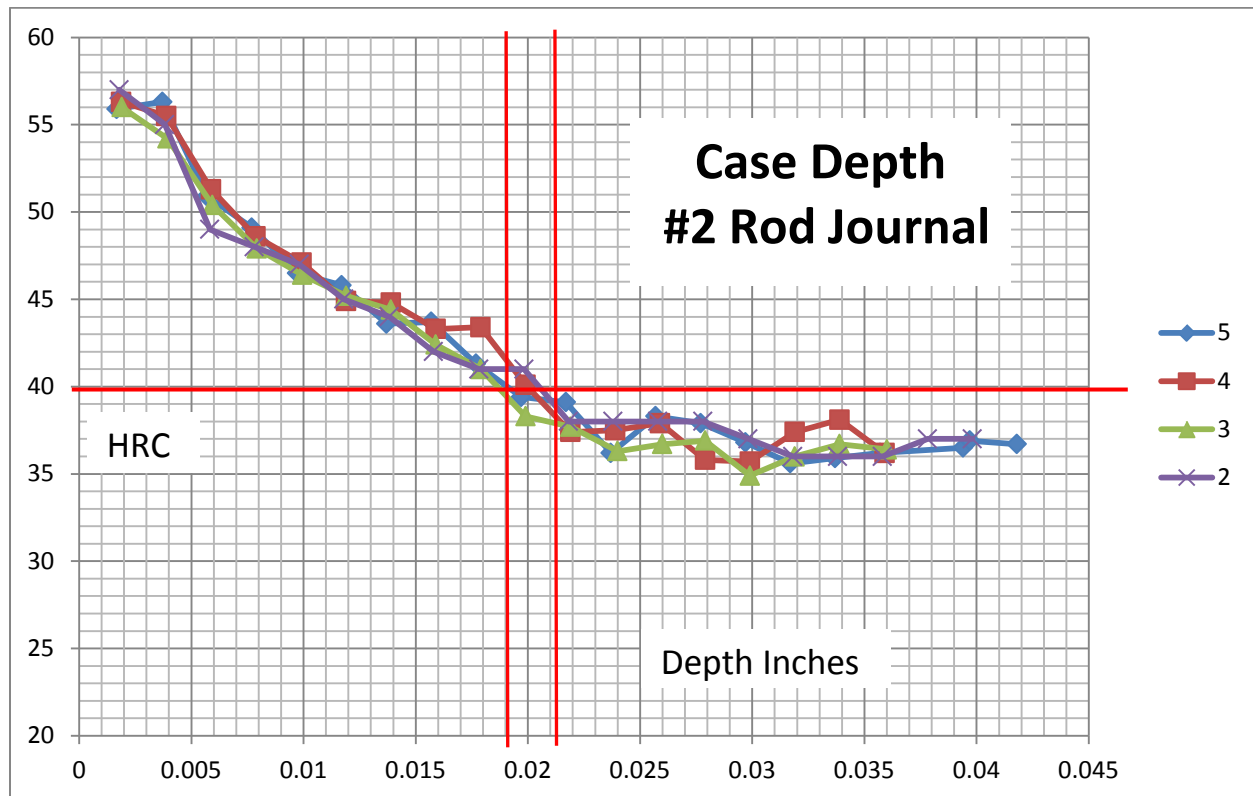
Effective case depth was determined by four micro hardness traverses on the metallographic specimen. The hardness data are presented in the graph contained in figure 9. The effective case depth, measured at HRC 40, was between 0.018 inch and 0.023 inch meeting the drawing's specifications. Core hardness was measured on a cut section through the #2 rod journal. The 5 measurements averaged HRC 35.7 satisfying the drawing requirements.

Figure 9. A graph showing four plots of microhardness versus depth below the journal surface. Case depth (vertical red lines) is defined as where the hardness drops to HRC 40 red horizontal line.
