**[Docket No. FAA-2010-1101; Directorate Identifier 2009-CE-013-AD; Amendment 39-16690; AD 2011-10-09]**

**Airworthiness Directives; Cessna Aircraft Company Models 150, 152, 170, 172, 175, 177, 180, 182, 185, 188, 190, 195, 206, 207, 210, T303, 336, and 337 Airplanes**

**ACTION:** Final rule.

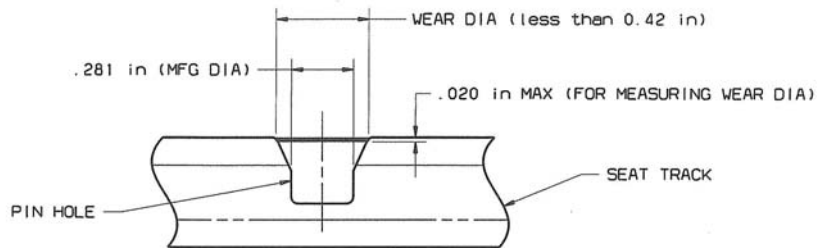
Figure 1. Diameter of seat pin locking engagement hole

(3) Inspect the diameter of each seat locking pin engagement hole in the pilot and copilot seat rails for excessive wear. Due to wear on the rail surface at the hole opening, we allow this measurement 0.020 of an inch below the surface of the rail. You must take this measurement somewhere between the surface of the rail or no more than 0.020 of an inch below the surface of the rail.

(i) If the diameter of any of the holes is 0.42 of an inch or more (see figure 1), before further flight, replace the rail.

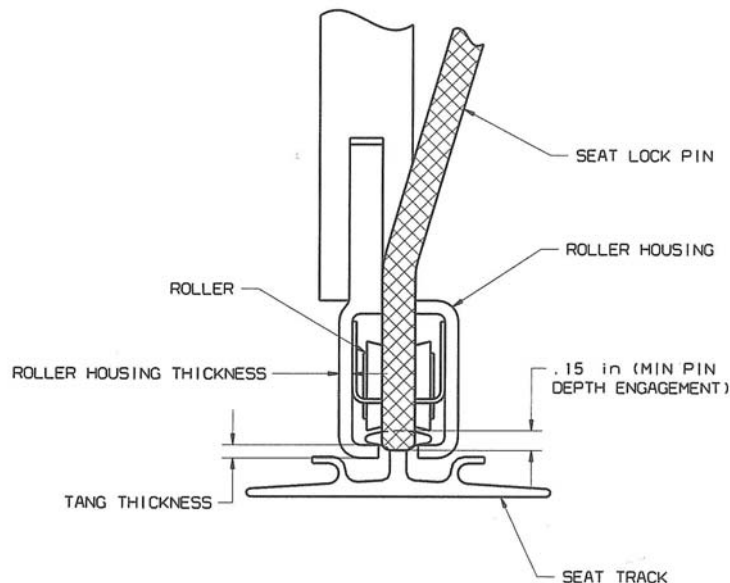
Figure 2. Seat locking pin depth engagement

(10) Lift up the forward edge of each seat to eliminate vertical play of the seat locking pin in the engagement hole, and from this position, inspect the depth of engagement of each seat locking pin (see figure 2). If the rail is worn, this depth is measured from the worn surface, not the manufactured surface.

(i) If engagement of any of the seat locking pins measures less than 0.15 of an inch, before further flight, replace or repair any seat components necessary to achieve a seat pin engagement of a minimum of 0.15 of an inch.

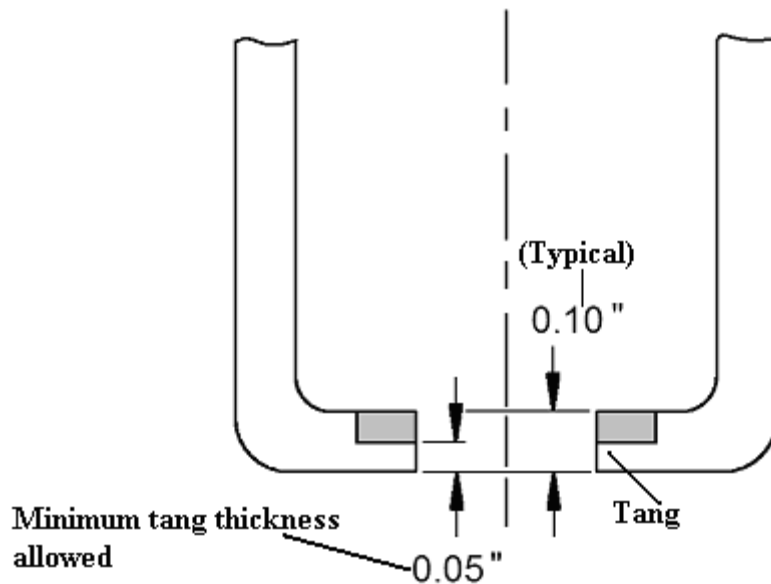
**Figure 3. Closeup of seat roller housing and tang thickness**

(5) Inspect the thickness of the tang (see figure 2 and figure 3). Due to wear of the tang chafing against the seat rail, measure the tang thickness where the tang inner edges contact the seat rail.

(i) If the tang thickness measures less than 0.05 of an inch, before further flight replace the roller housing.

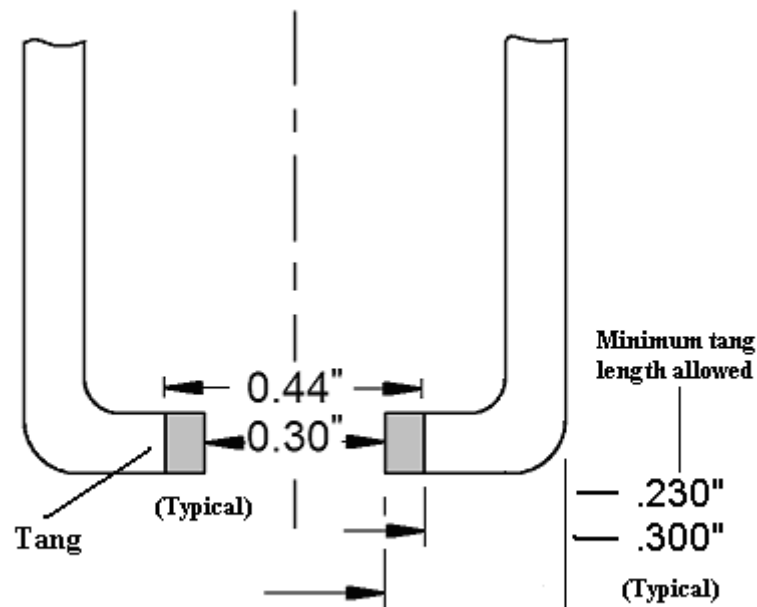
**Figure 4. Closeup of seat roller housing and tang gap width**

We have changed the callouts in figure 4 to measure the tang length from outside of the roller housing instead of from inside of the roller housing. We have also changed the description of the tang measurement in figure 4 to more accurately describe the measurement.

(6) Due to wear or deformation of the tangs, inspect the tang length from the inner edge of the tang to the outer edge (the bend area) of the roller housing (see figure 4).

(i) The minimum measurement allowed for the remaining tang length is 0.230 inches remaining on either of the tangs, from the inner edge of the tang to the outer edge (the bend area) of the roller housing. If the measurement is less than 0.230 inches on either of the tangs, before further flight, replace the roller housing.

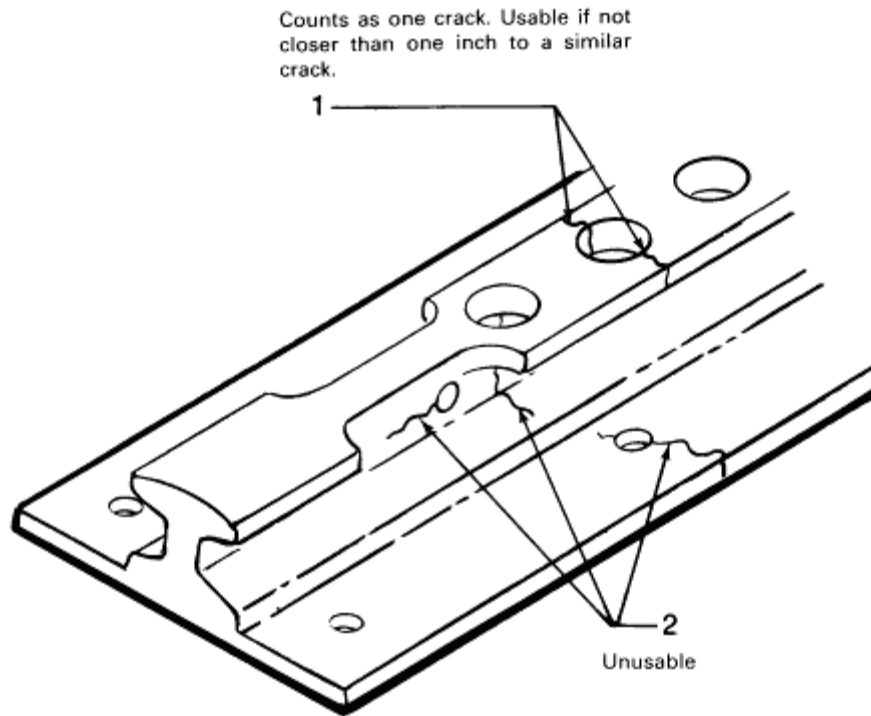
**Figure 5. Seat rail**

(8) Visually inspect the seat rails for cracks.

- (1) Any portion of web or lower flange is cracked (index 2).
- (2) Any crack in crown of rail is in any direction other than right angle to length of rail.
- (3) Number of cracks on any one rail exceeds four, or any two cracks (index 1) are closer than one inch.

(i) If there are seat rail cracks that exceed the crack criteria in figure 5, before further flight, replace the seat rail.
