# NATIONAL TRANSPORTATION SAFETY BOARD

## MATERIALS LABORATORY FACTUAL REPORT

Report No. 16-037

Place : Charleston, West Virginia  
Date : March 26, 2016  
Vehicle : Cessna 172N  
NTSB No. : ERA16FA141  
Investigator : Daniel Boggs, AS-ERA

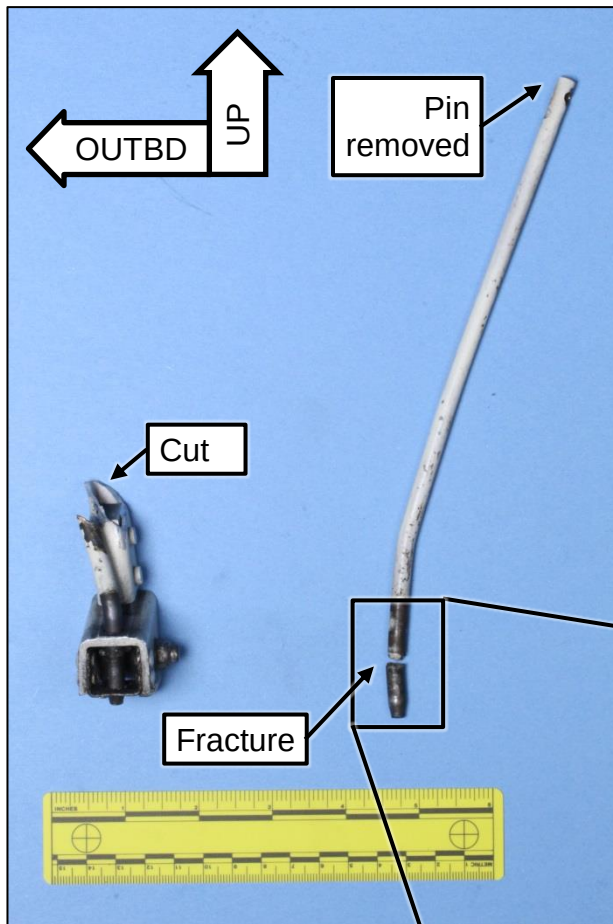
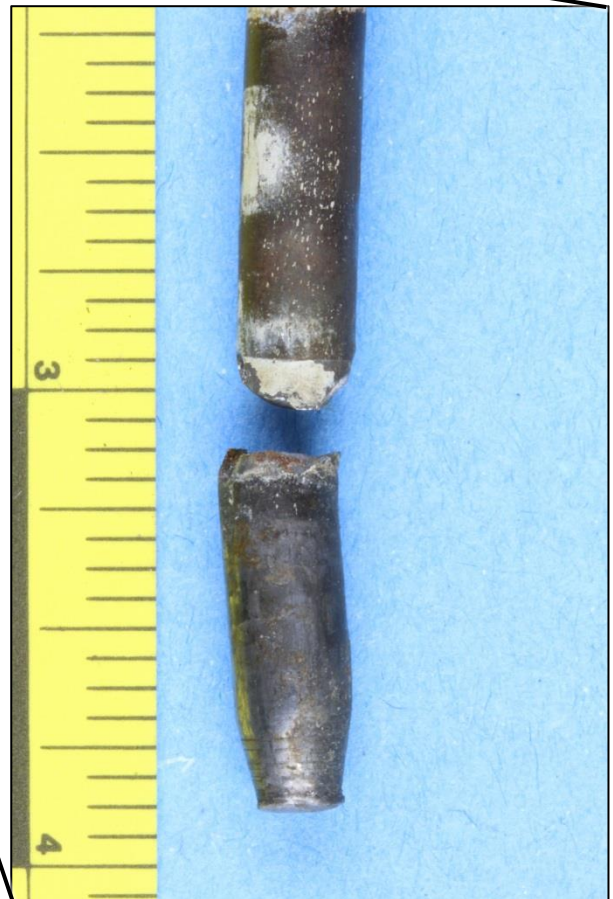
An overall view of the submitted components with a closer view of the fractured inboard seat-position lock rod are shown in figure 1. The pieces were from the forward right seat of the accident airplane. During the emergency response after the accident, the forward and aft outboard seat posts and the aft inboard seat post were reportedly cut, and the seat was reportedly rotated about the remaining inboard leg to facilitate removal of the seat from the airframe. Fire suppression materials were also applied during the emergency response, and the lower piece of the fractured inboard seat-position lock rod was recovered from a puddle of foam. The pin attaching the upper end of the fractured seat-position lock rod to the adjustment handle had been removed from the location indicated in figure 1 to facilitate shipment to the NTSB Materials Laboratory.

Figure 1. View looking aft showing the fractured inboard seat position lock rod and the outboard seat post piece with seat position lock rod piece.

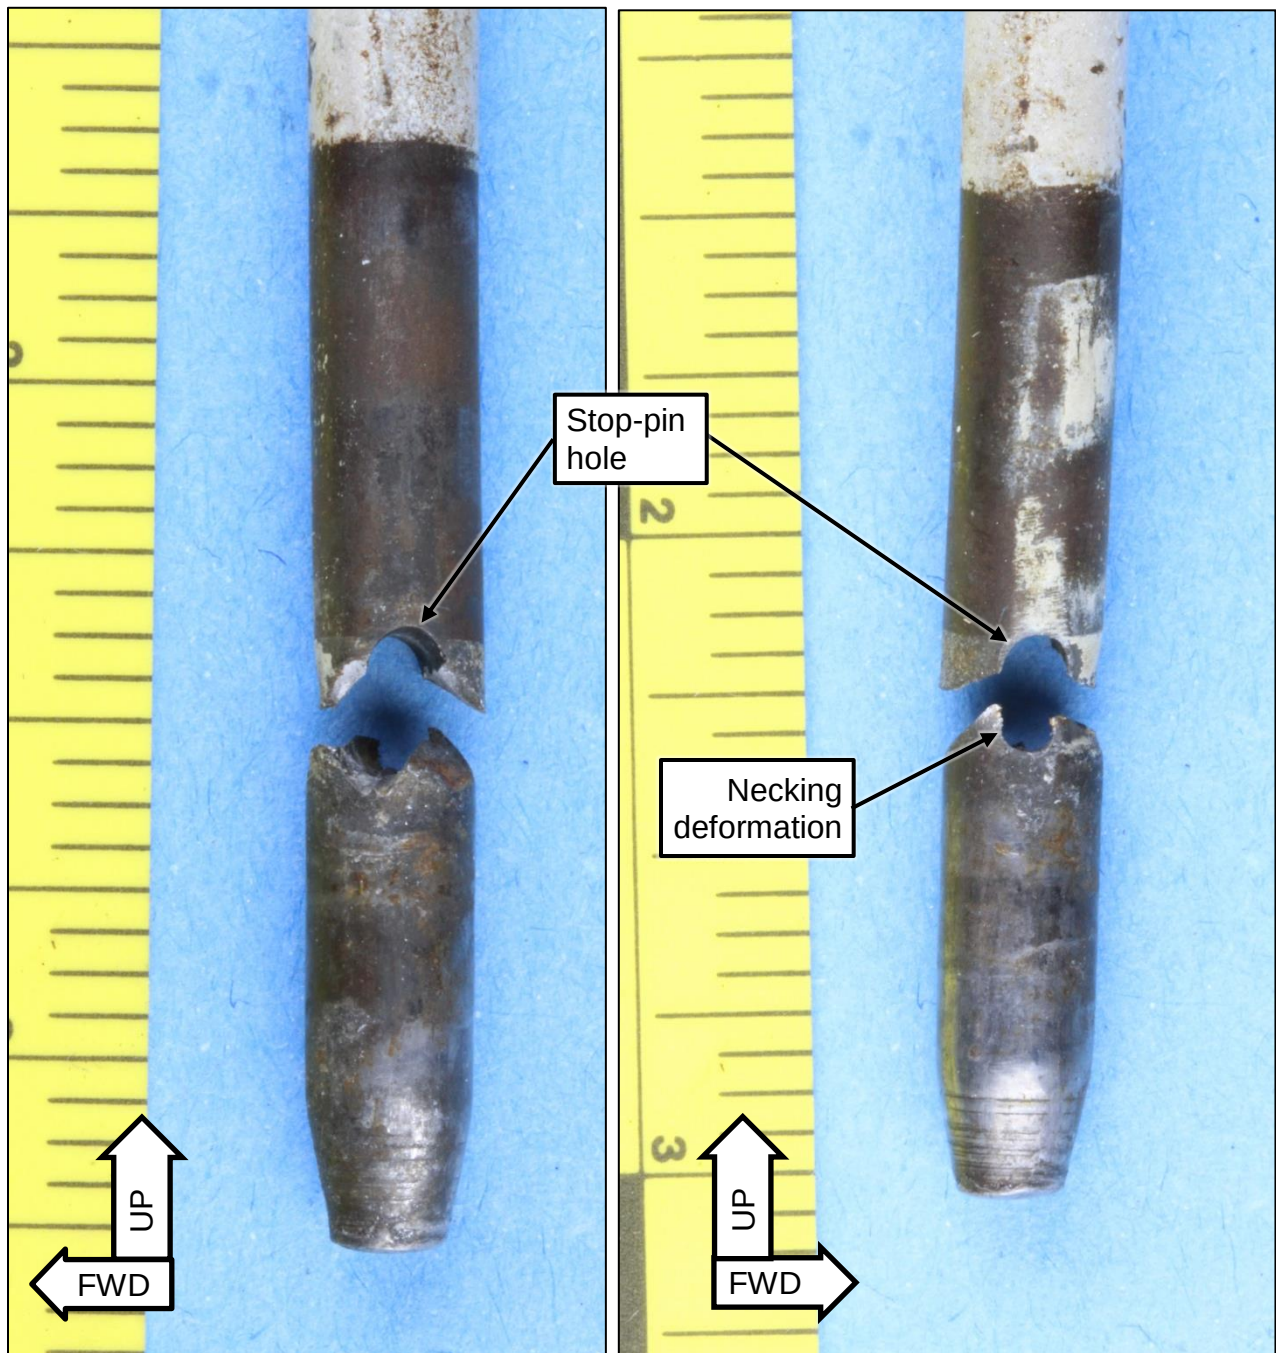
Views of the inboard and outboard sides of the inboard seat-position lock rod at the fracture location are shown in figure 2. As assembled, a roll-pin that acts as a stop to limit vertical displacement of the rod is inserted through the stop-pin hole indicated in figure 2. Fracture of the inboard seat-position lock rod intersected the forward and aft sides of the stop-pin hole on slant planes, a feature consistent with overstress fracture.

The overall deformation pattern adjacent to the fracture in the inboard seat-position lock rod was consistent with bending deformation where the outboard side of the rod was in tension and the inboard side was in compression. The stop-pin hole below the fracture surface on the outboard side of the rod showed necking deformation as indicated in figure 2, whereas the upper side of the hole remained close to its original diameter, consistent with the presence of the stop pin in the upper side of the hole as the lock rod was bent. Contact marks were observed on the lower side of the stop-pin hole at the inboard end of the hole consistent with contact along the roll pin split line on the compression side of the bending fracture.

Figure 2. Views of the inboard (left image) and outboard (right image) sides of the inboard seat-position lock rod at the fracture location showing the hole for the stop pin.

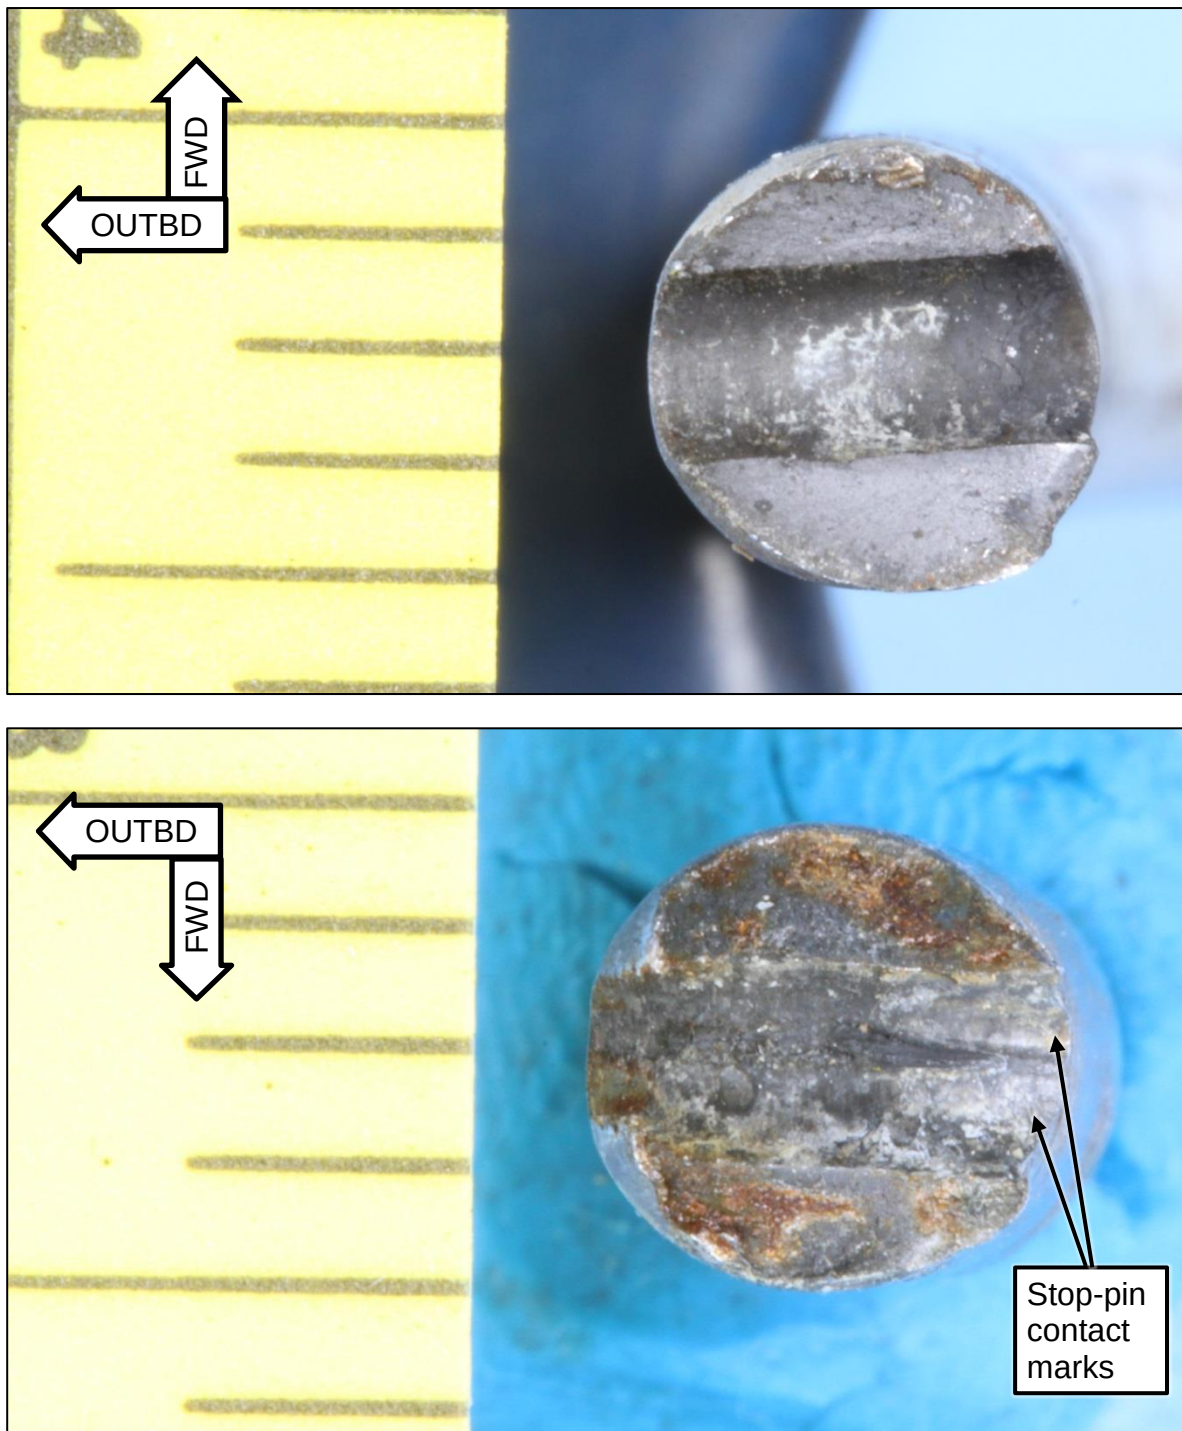
Close views of the upper and lower surfaces of the fracture in the inboard seat-position lock rod are shown in figure 3. The lower side of the fracture appeared dark gray and was partly covered with red and orange oxides. In contrast, the upper fracture surface was free of visible oxidation. The fracture surface on the upper side of the fracture had uniform matte-gray fracture features consistent with overstress fracture, and the surface showed no accumulation of grease.

Figure 3. Views of the upper (upper image) and lower (lower image) mating fracture surfaces for the inboard seat-position lock rod.

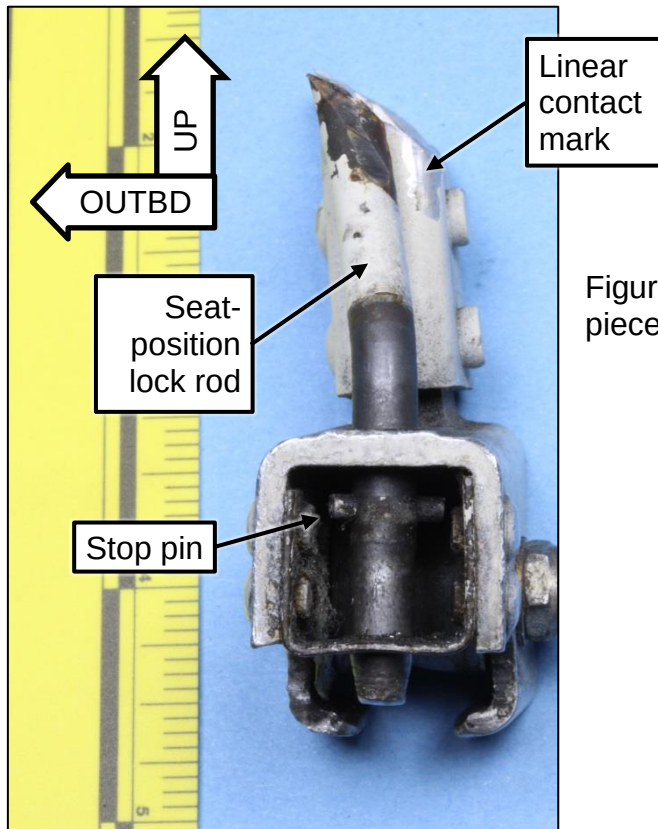
A close view of the lower piece of the forward outboard seat post is shown in figure 4. The seat-position lock rod moved freely within the wheel housing, and the stop-pin was in place within the lock rod as indicated in figure 4. The lock rod was bent adjacent to the cut surface, and a linear contact mark was present on the seat post piece at the location indicated in figure 4 corresponding to contact with the bent seat-position lock rod. Figure 5 shows the right seat post piece as viewed looking outboard with the seat-position lock rod aligned with the linear contact mark on the forward face of the seat post and with the cuts ends of the lock rod and the seat post aligned to the same plane.

Figure 4. Close view of the outboard seat post piece and seat-position lock rod.

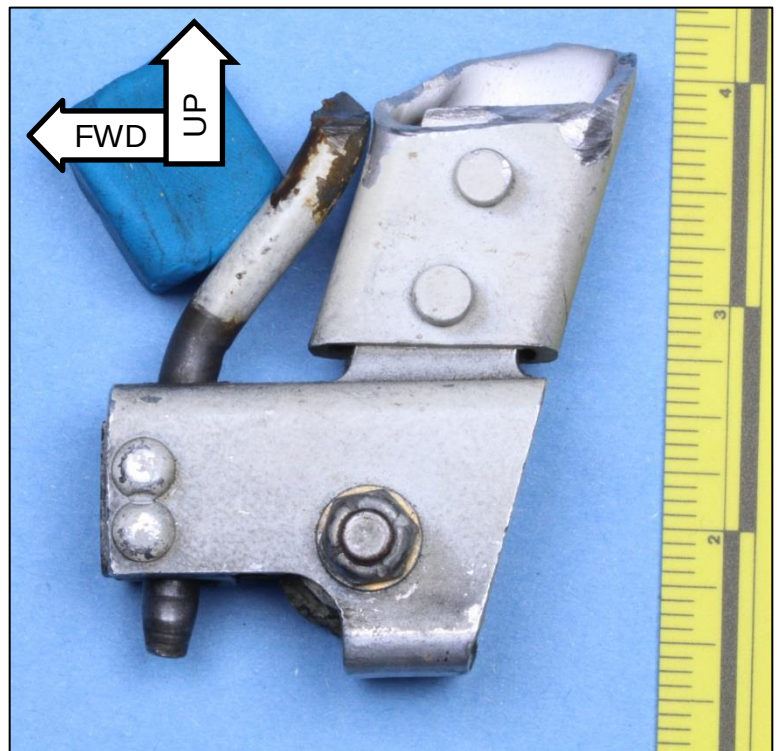
Figure 5. Side view of the outboard seat post piece with the seat-position lock rod positioned adjacent to the linear contact mark and with the cut ends aligned.
