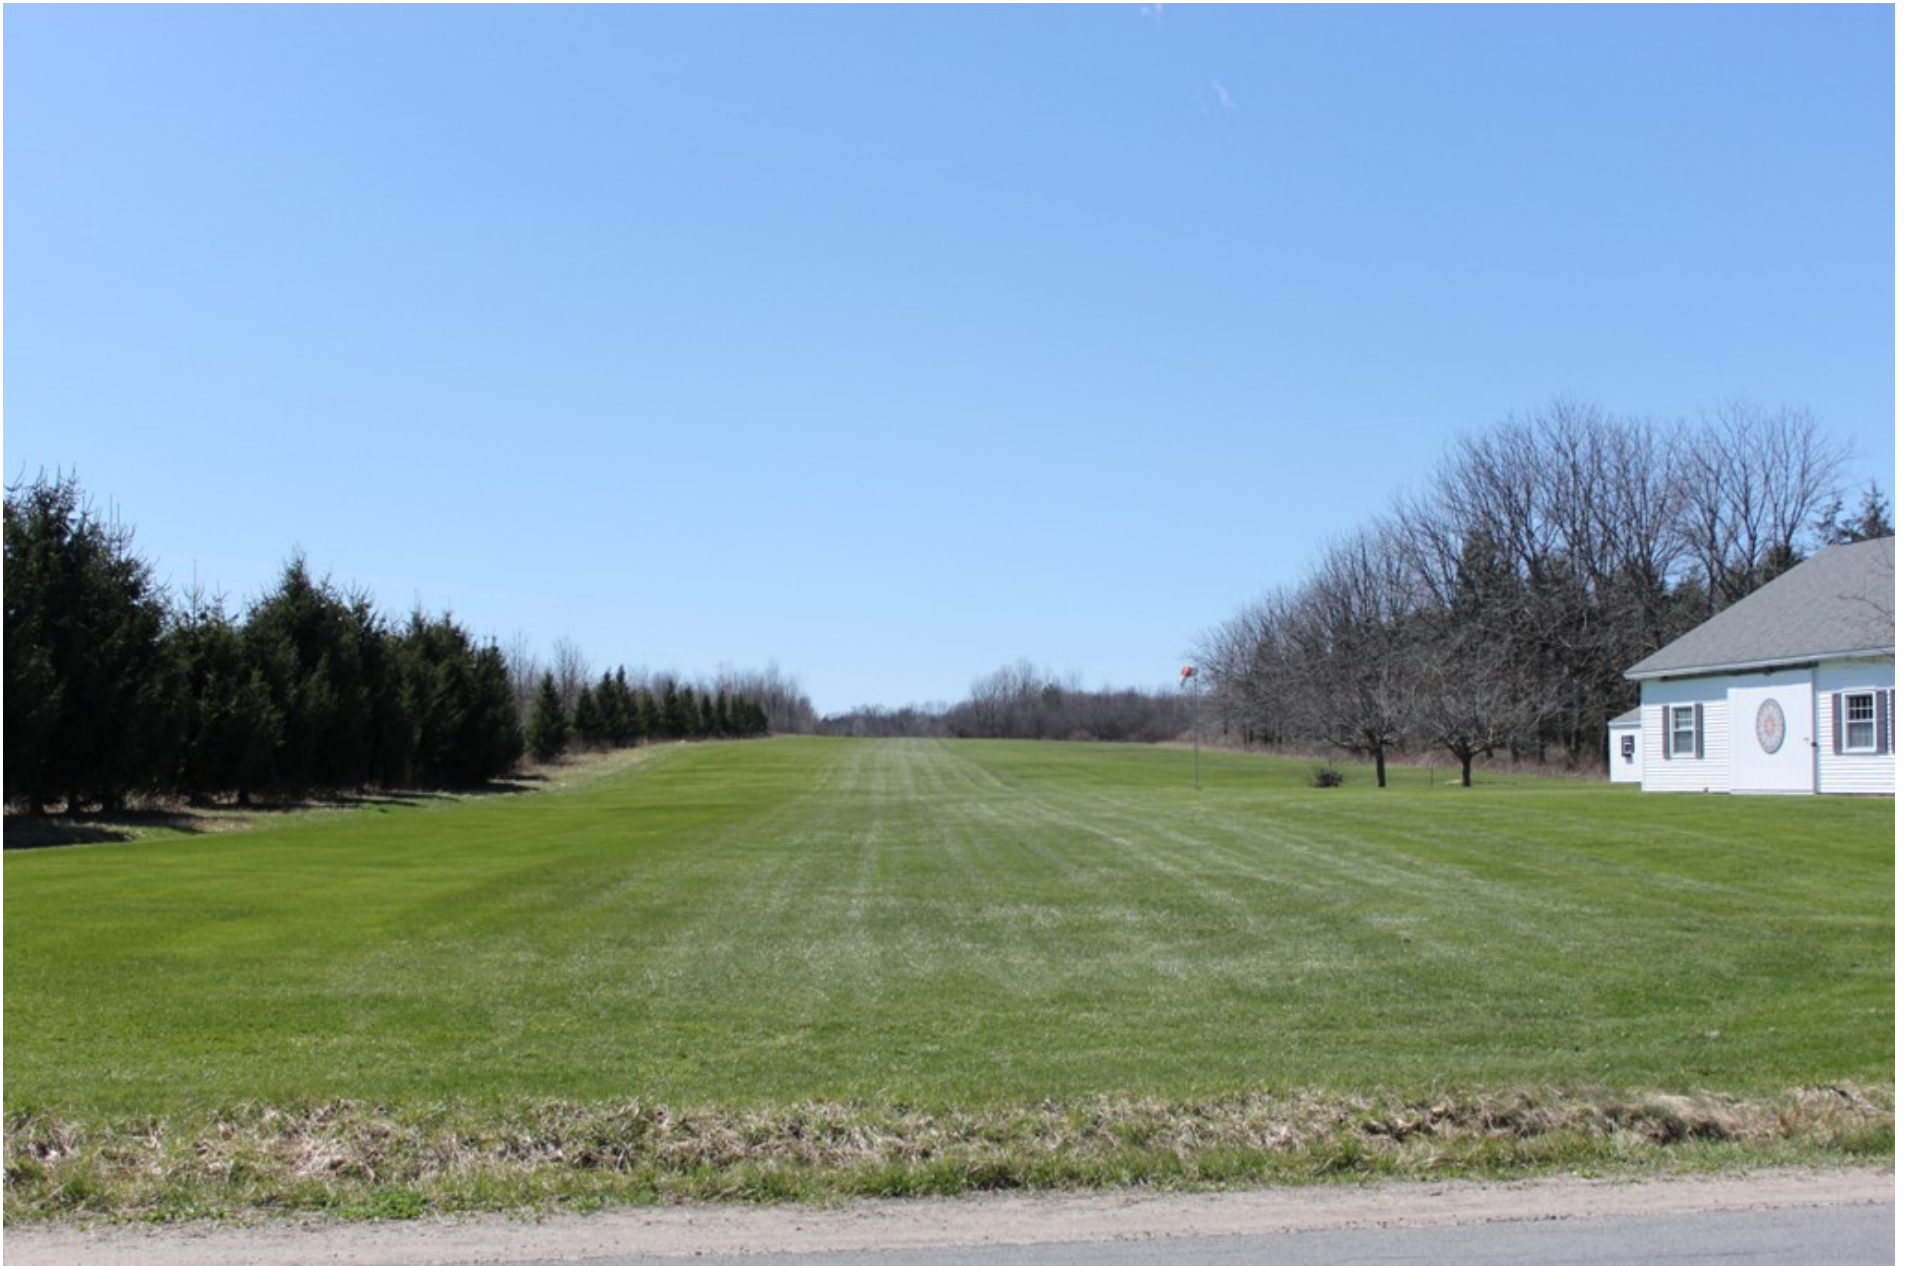
**Photo 1 – NTSB Digital Photograph. View taken at Departure End of East Runway Looking to the West.**

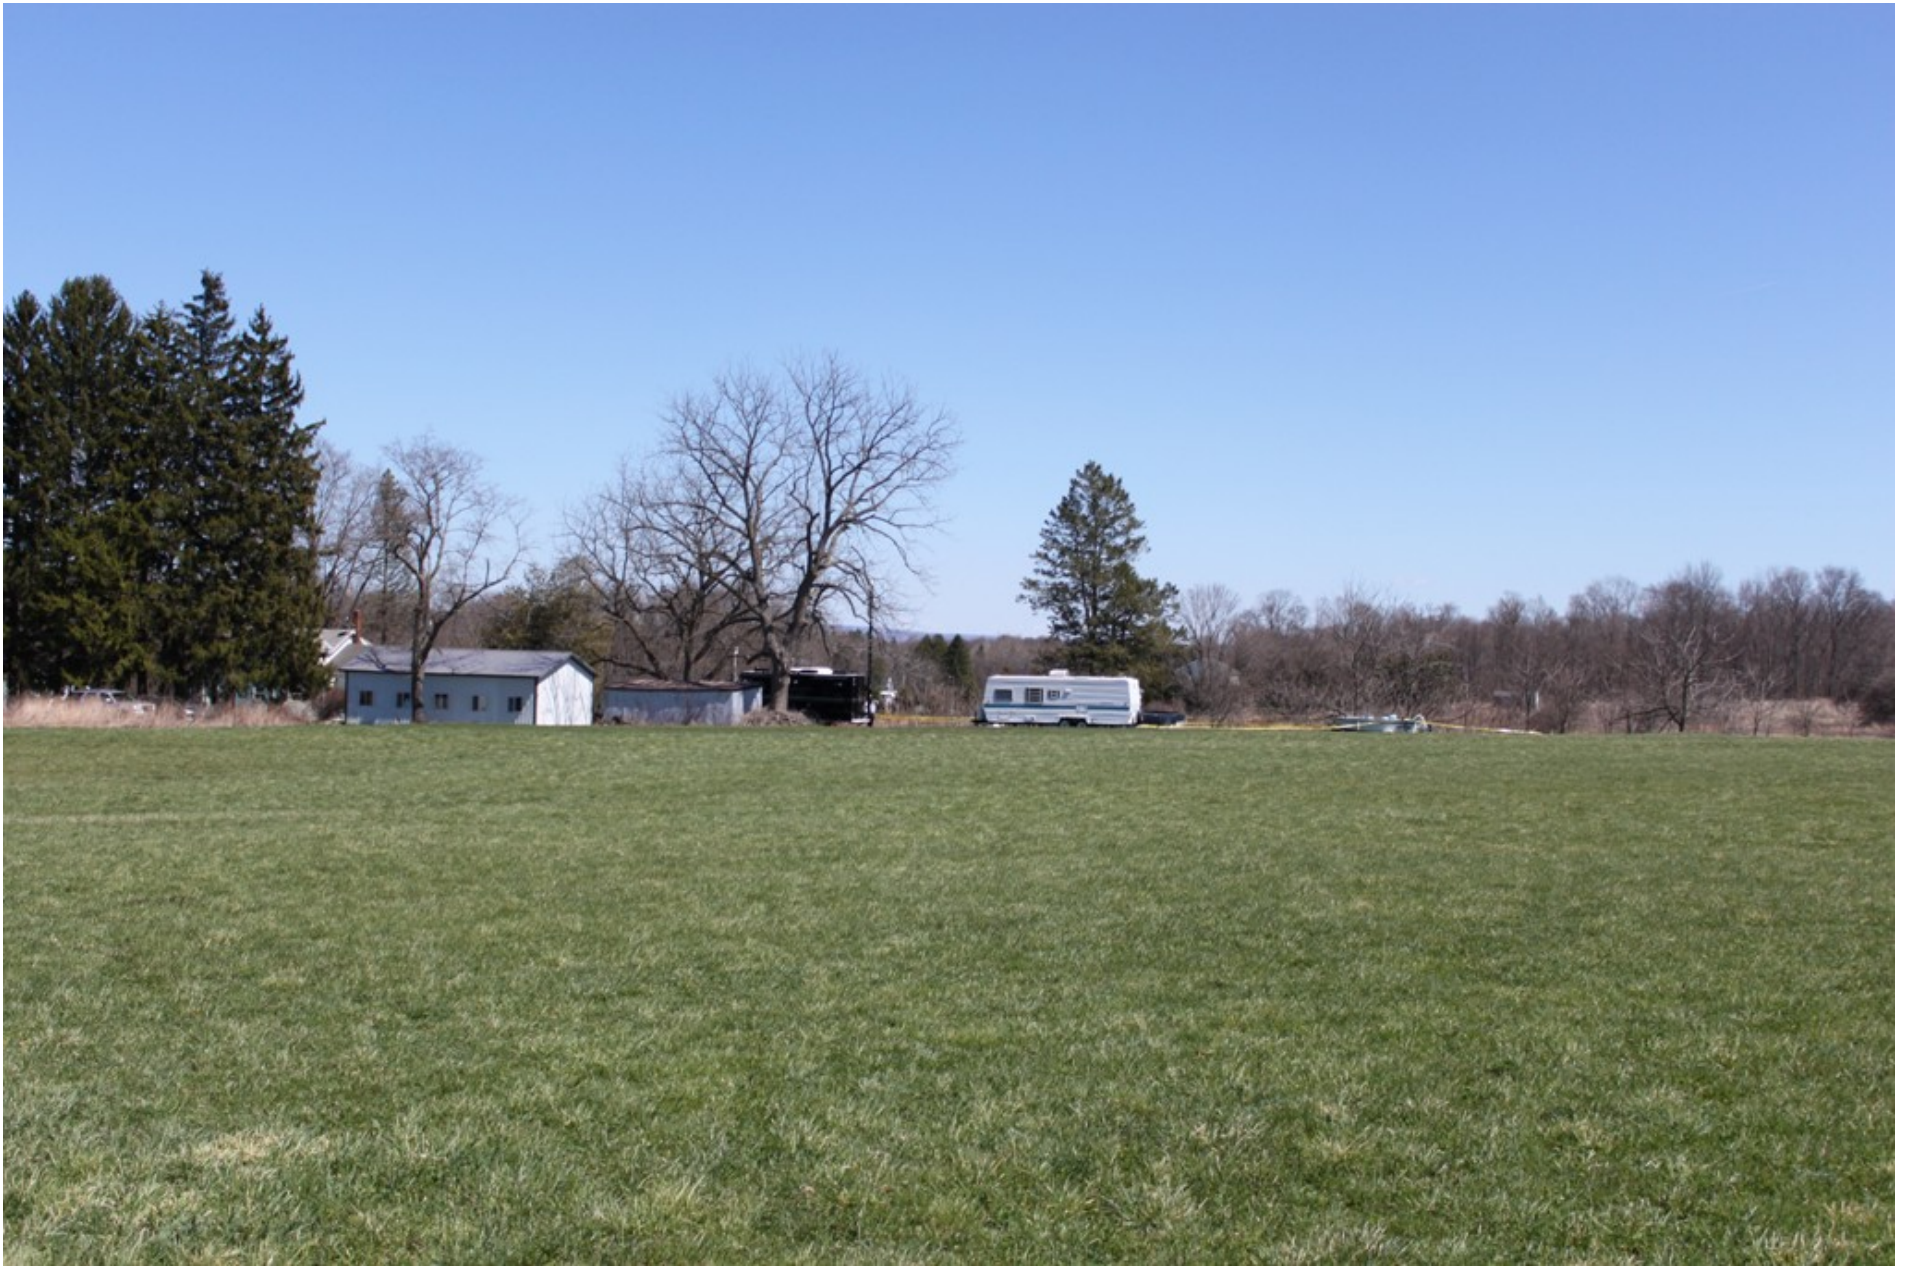
**Photo 2 – NTSB Digital Photograph. View Taken East of Departure End of East Runway, Looking towards Accident Site.**

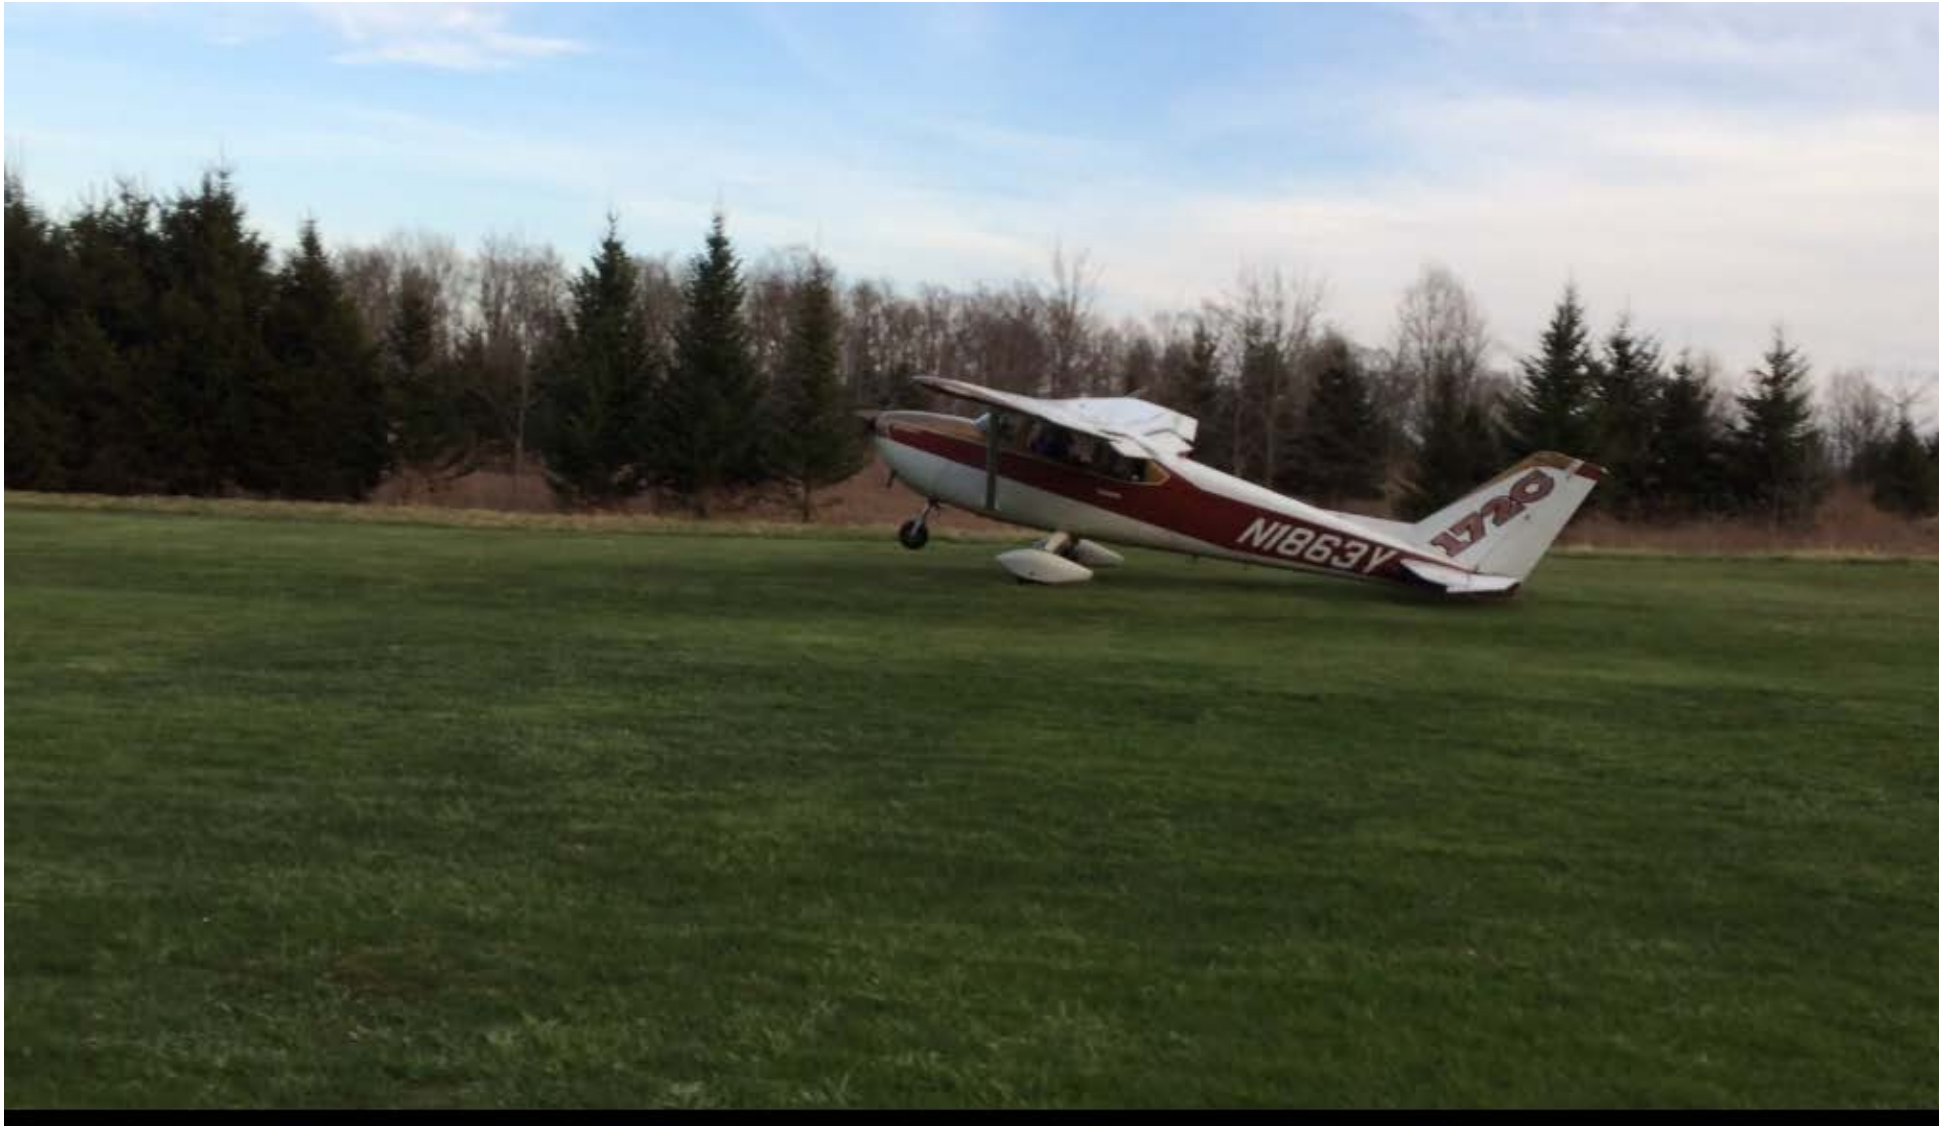
**Photo 3 - Screenshot from Video Taken by Airstrip Owner. Left Side View Taken Abeam Camera Operator Location.  
Note the Position of the Flaps and Elevator**

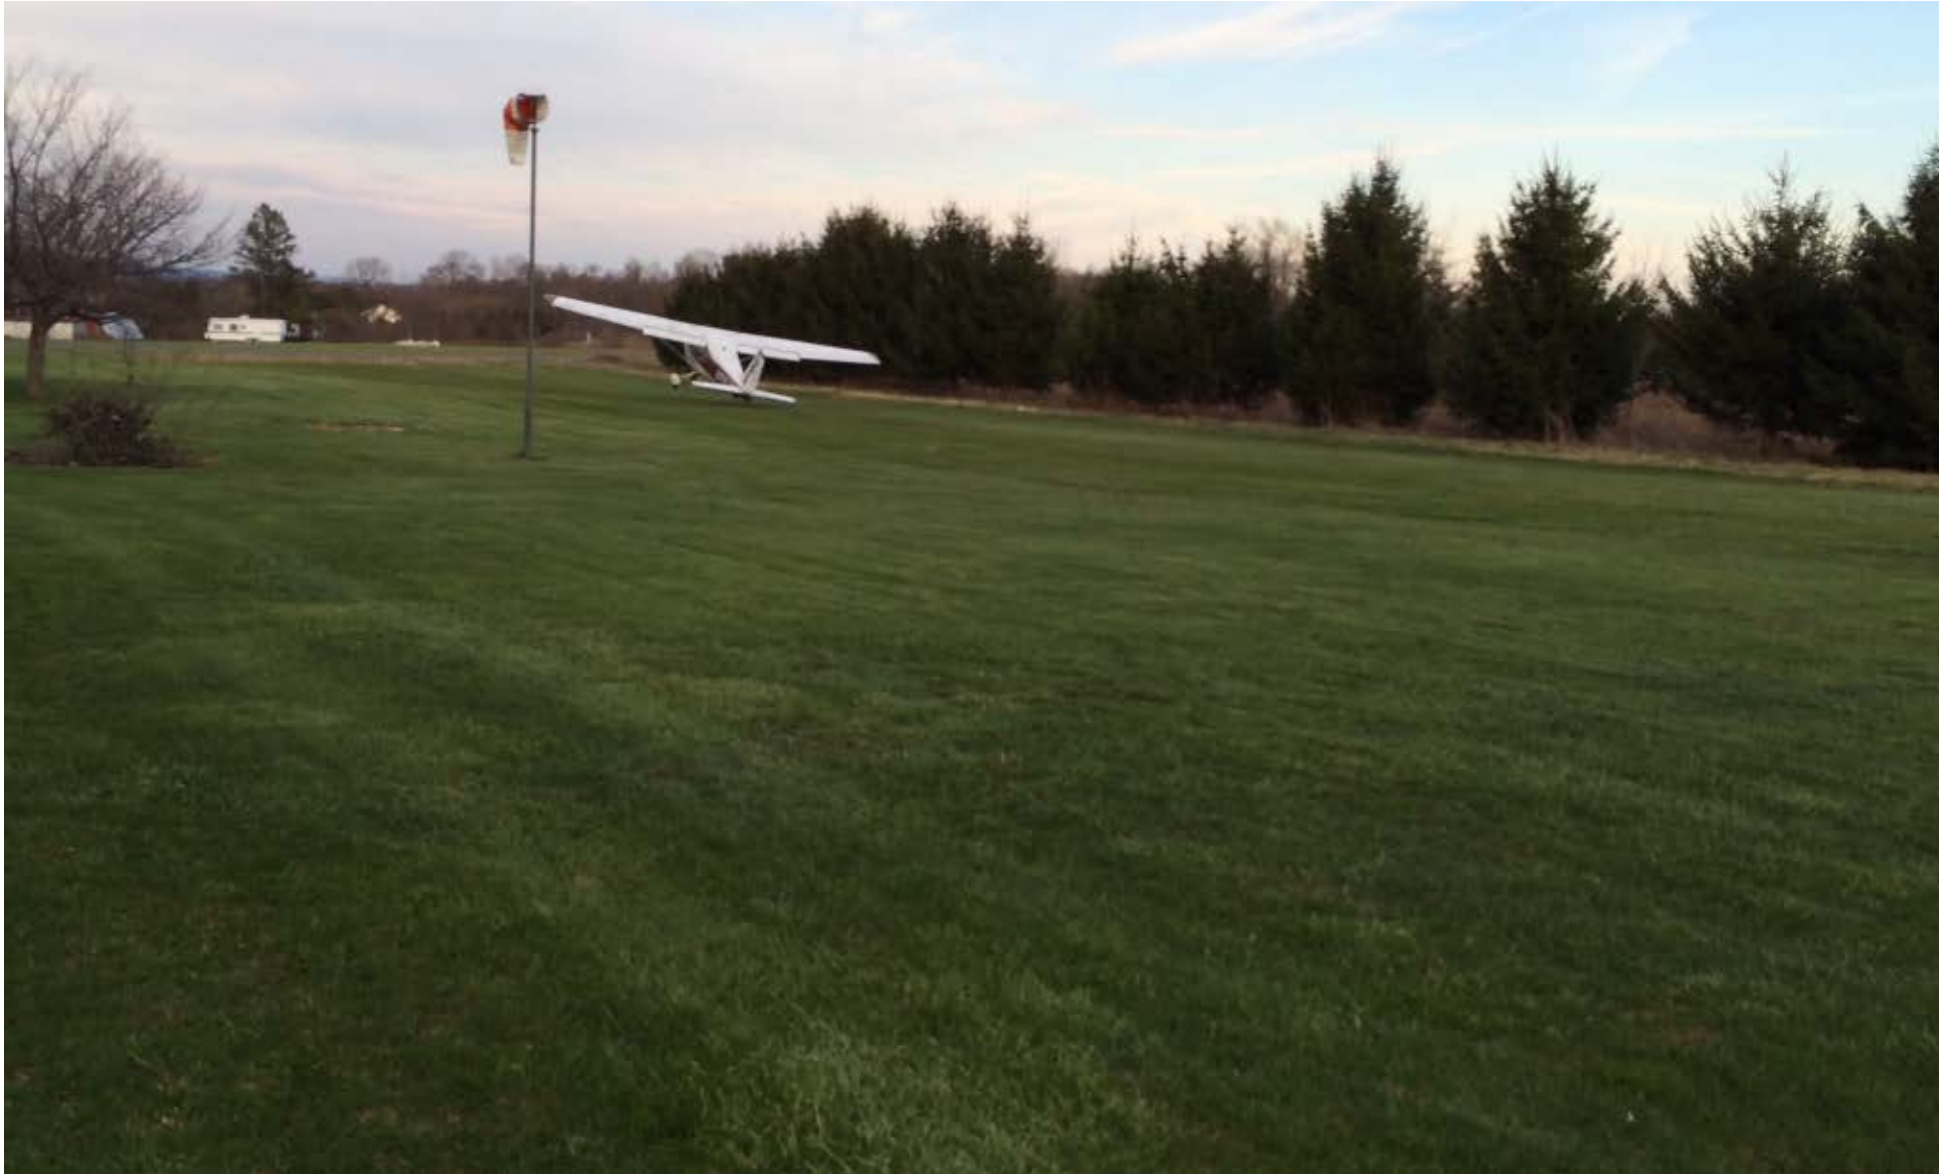
**Photo 4 - Screenshot from Video Taken by Airstrip Owner. Rear View Depicting the Airplane Being Airborne Past the Windsock**

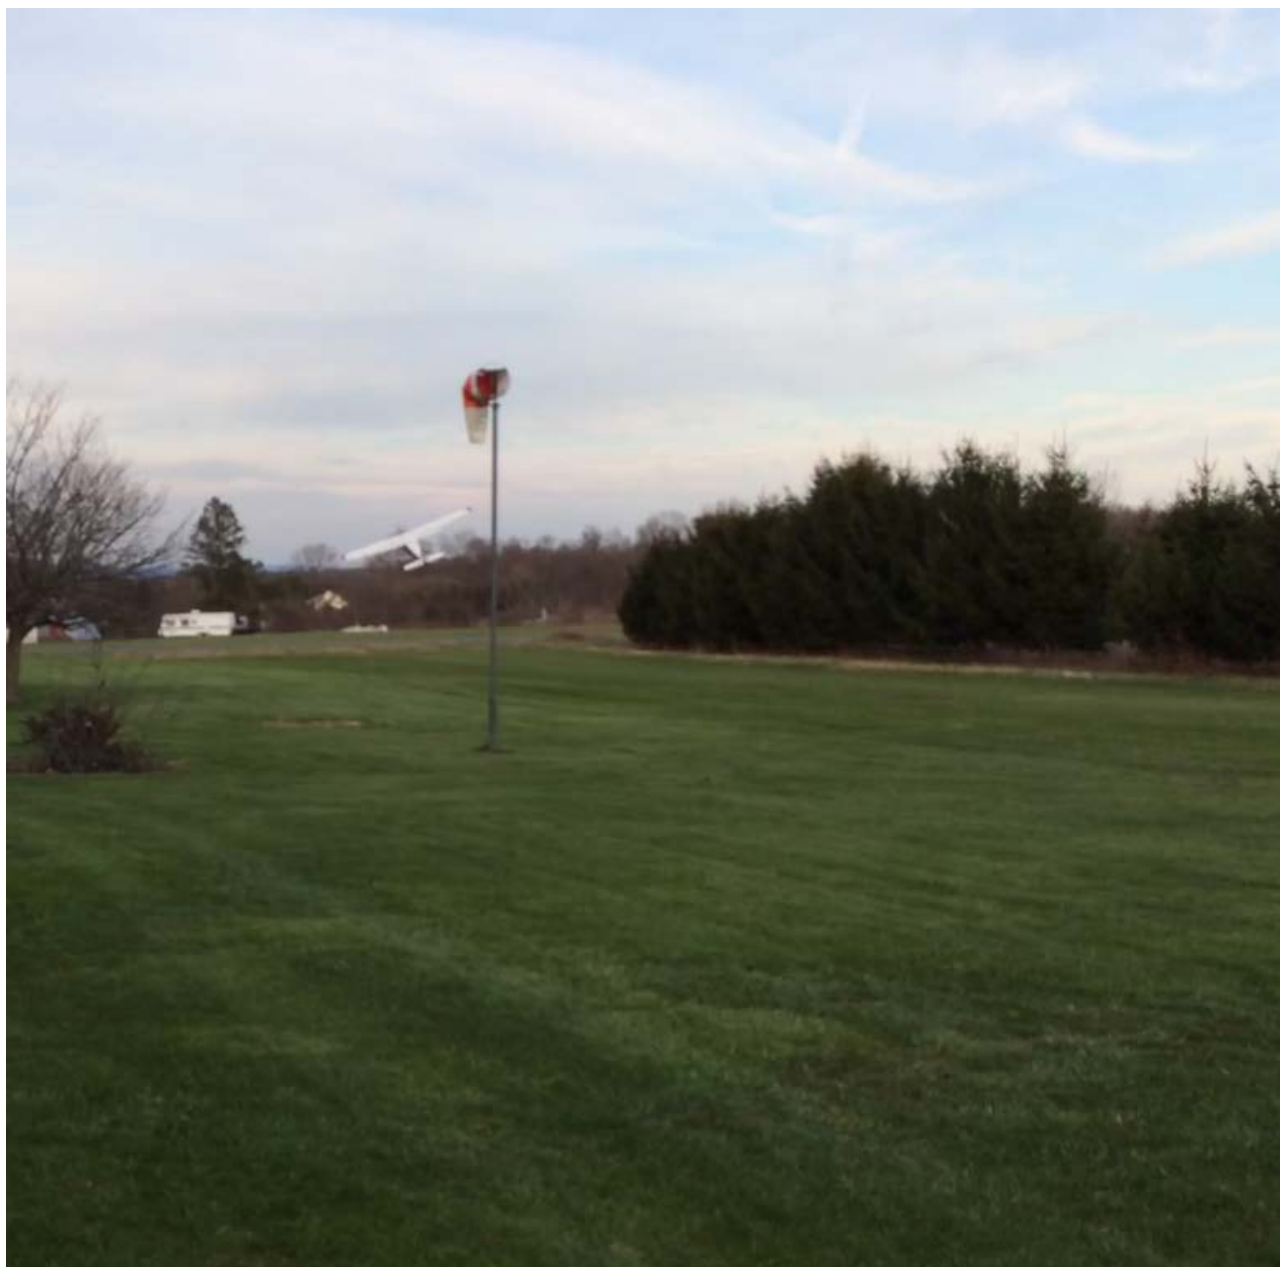
**Photo 5 - Screenshot from Video Taken by Airstrip Owner. Rear View Depicting the Airplane in a Left Roll and Nose-High Attitude While Airborne Past the Windsock. Note the Windsock Depicting The Wind From the West.**

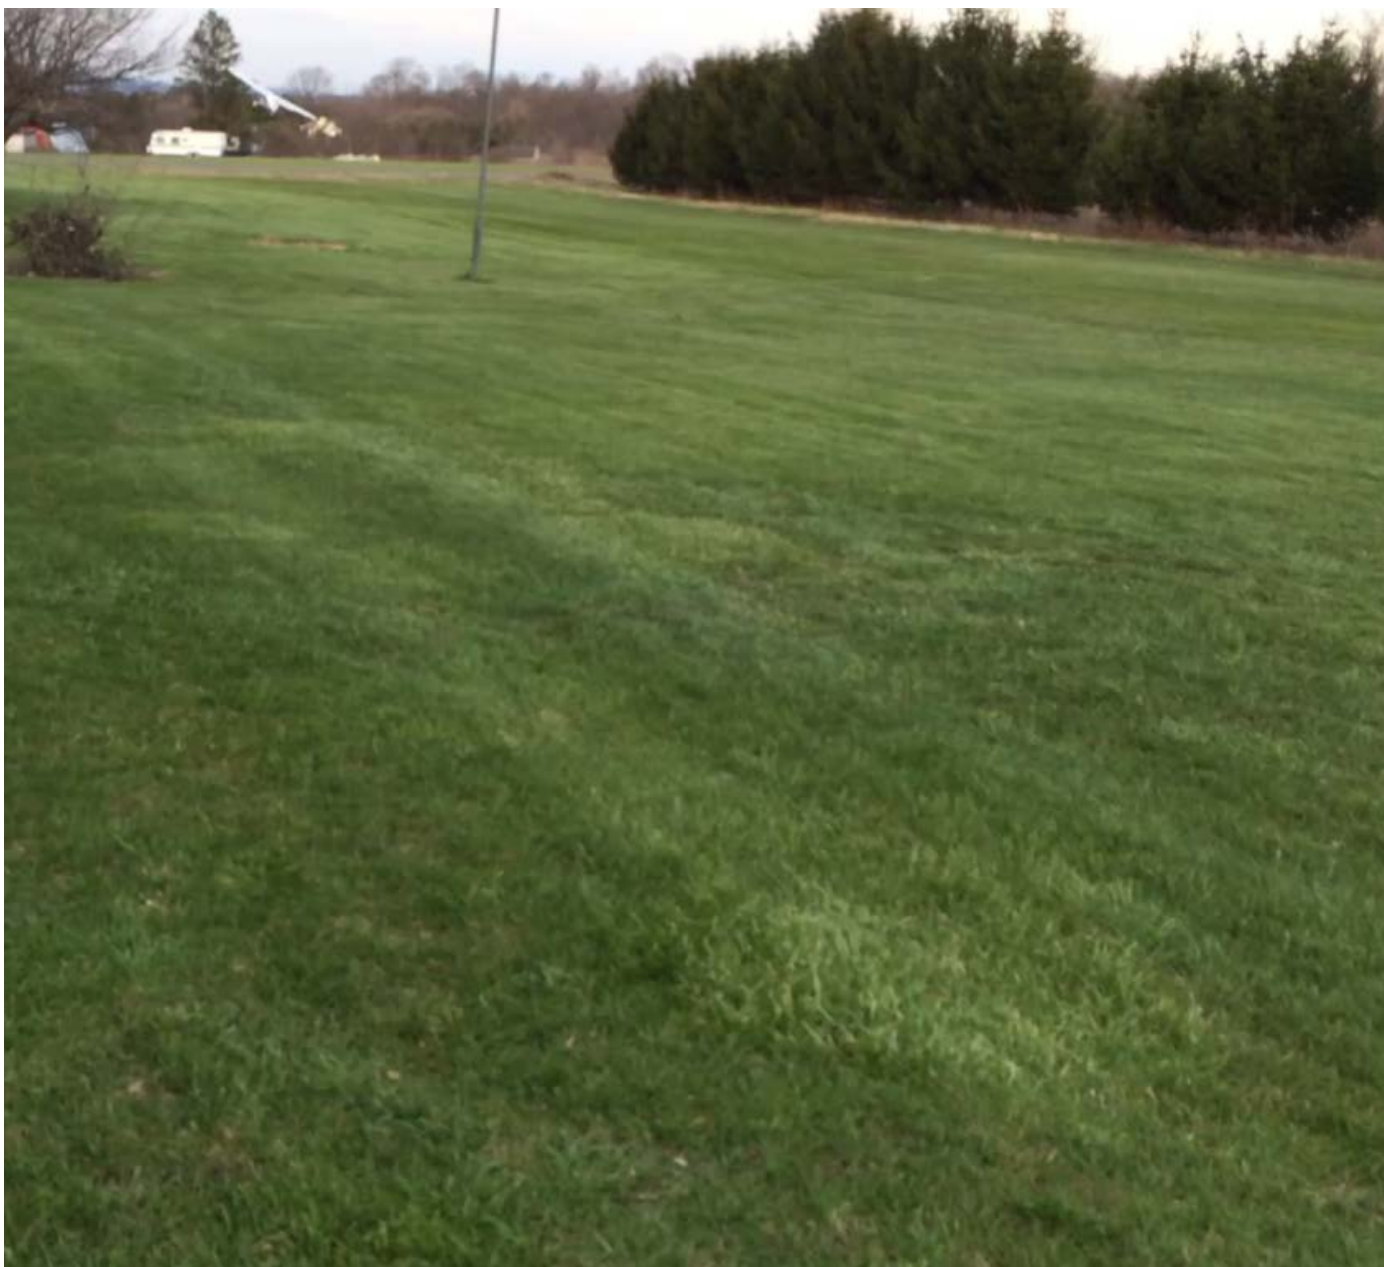
**Photo 6 - Screenshot from Video Taken by Airstrip Owner. Rear View Depicting the Airplane in a Right Roll and Nose-High Attitude Just Before Impact.**

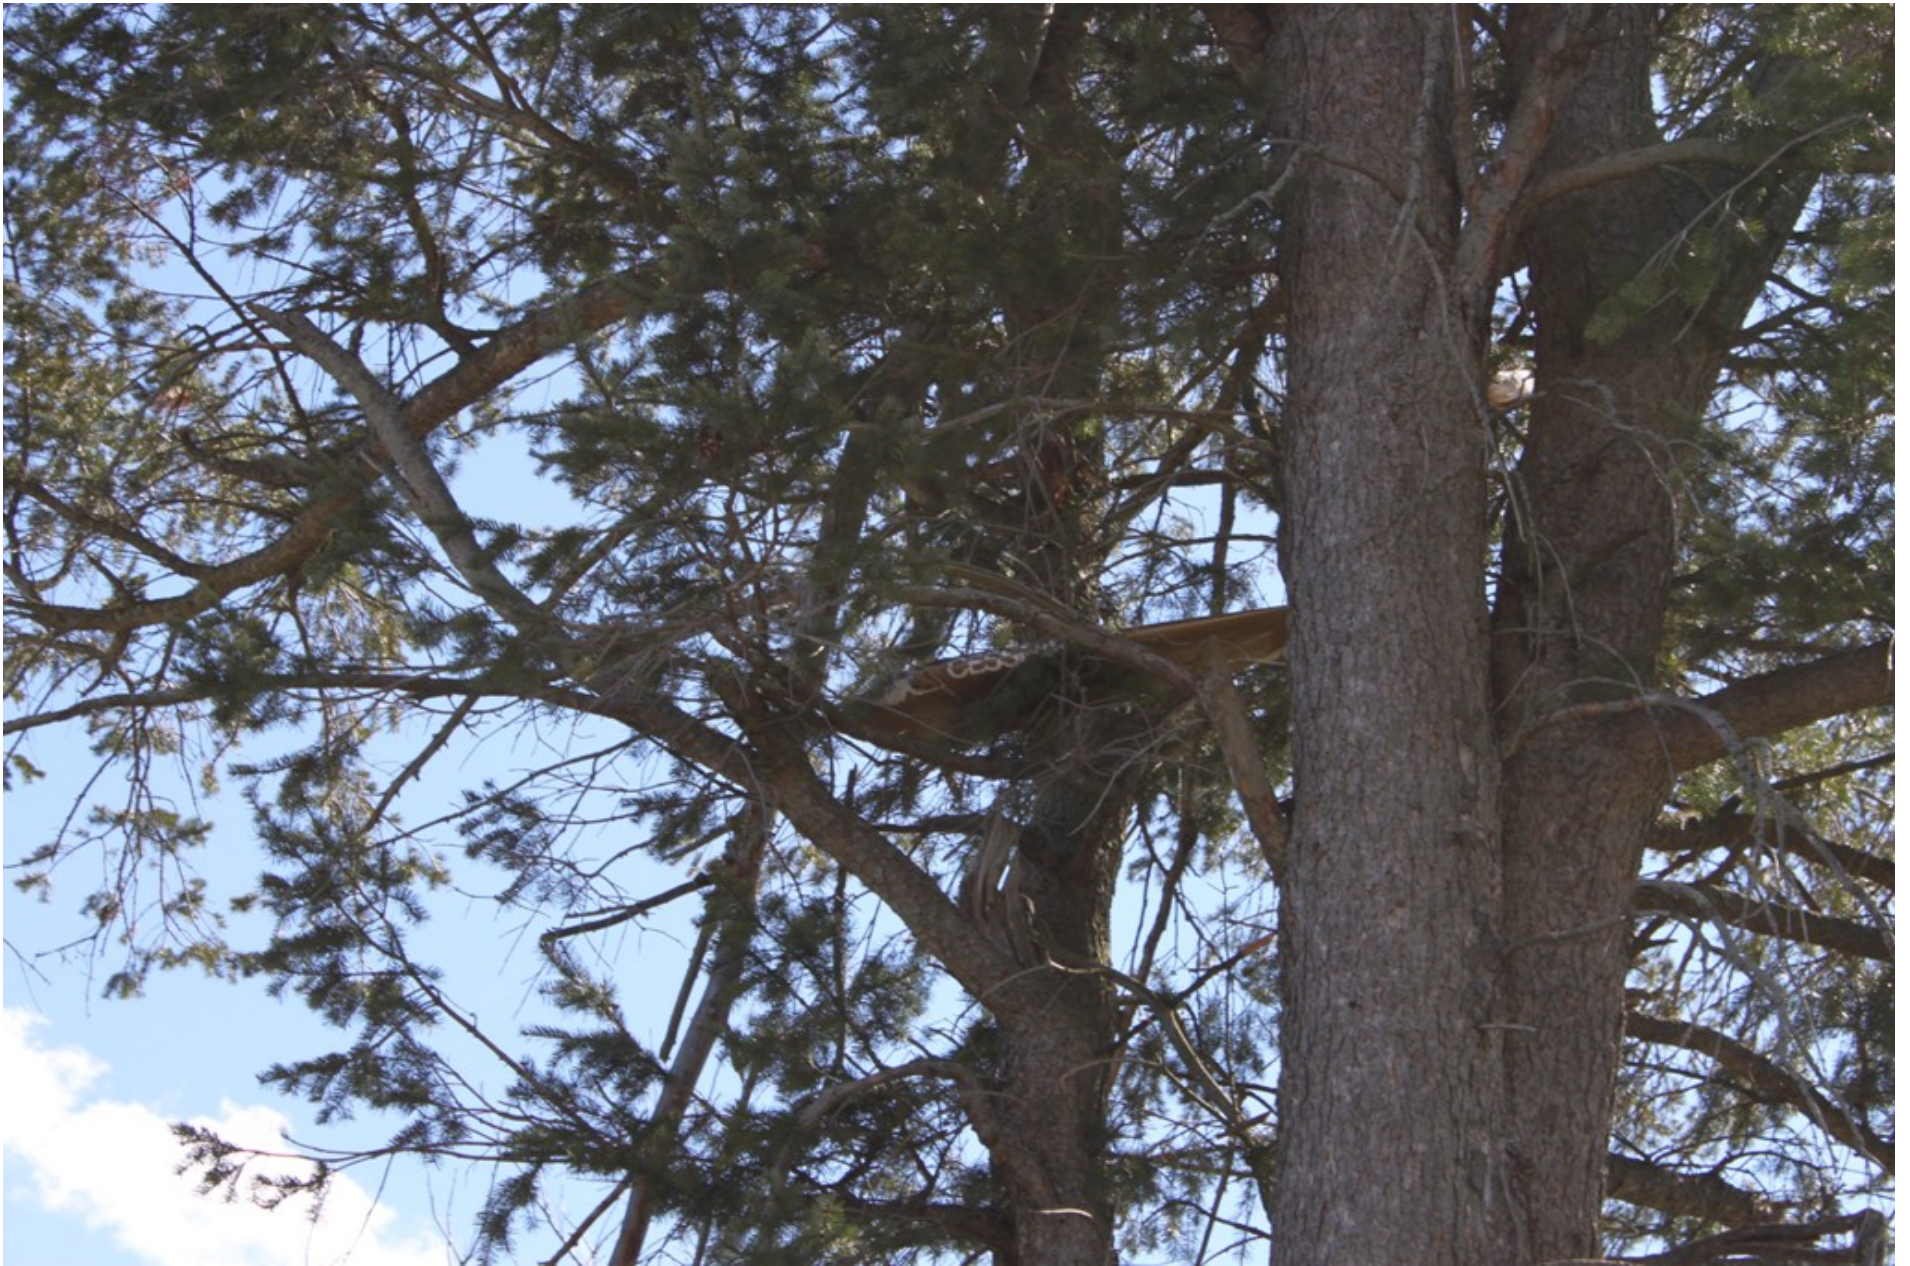
**Photo 7 - NTSB Digital Photograph. View Depicting the Left Wingtip in a Tree.**

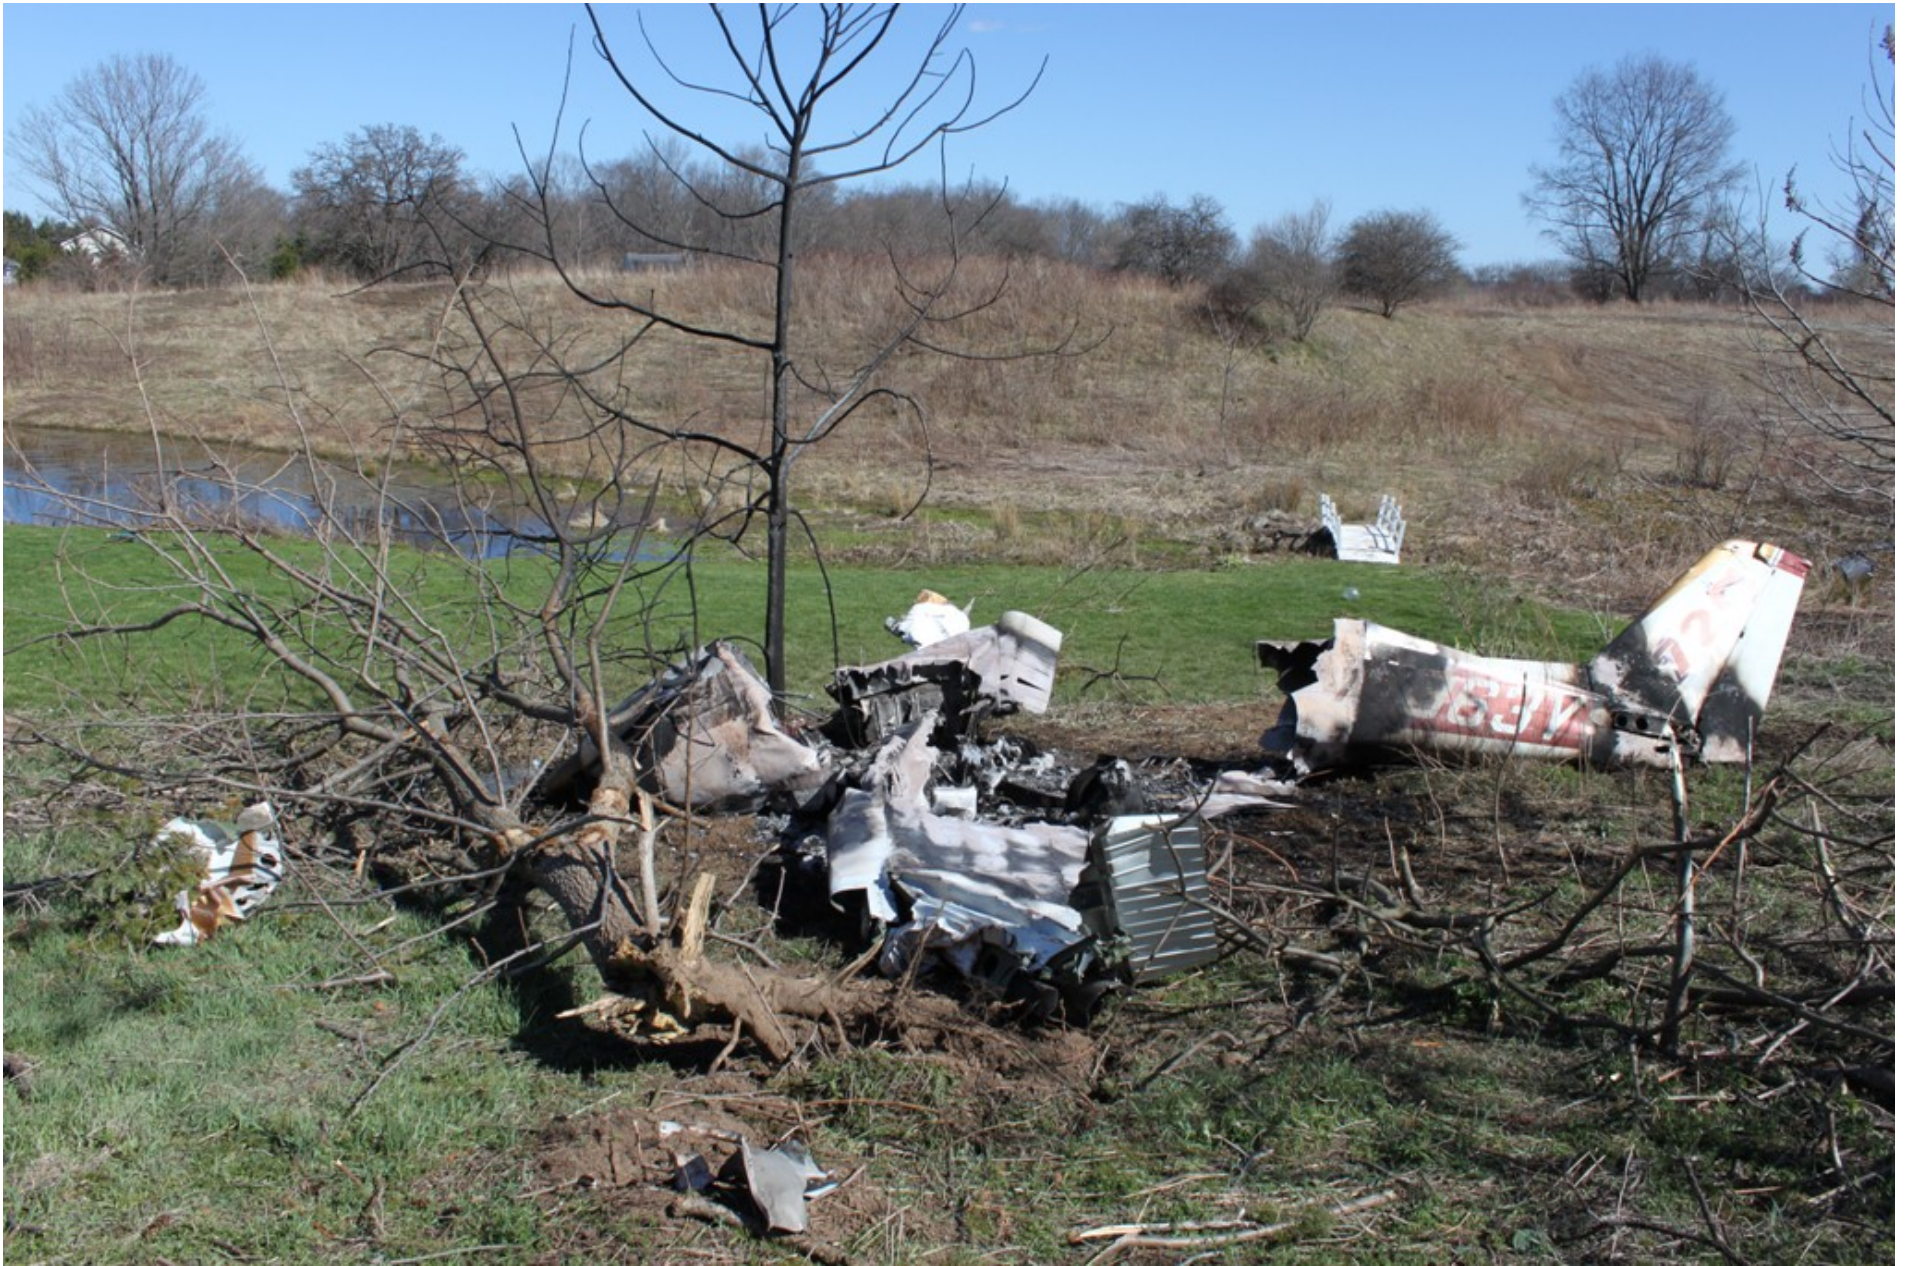
**Photo 8 – NTSB Digital Photograph. Left Side View of the Wreckage. Note the Extensive Fire Damage to the Cockpit and Fuselage.**

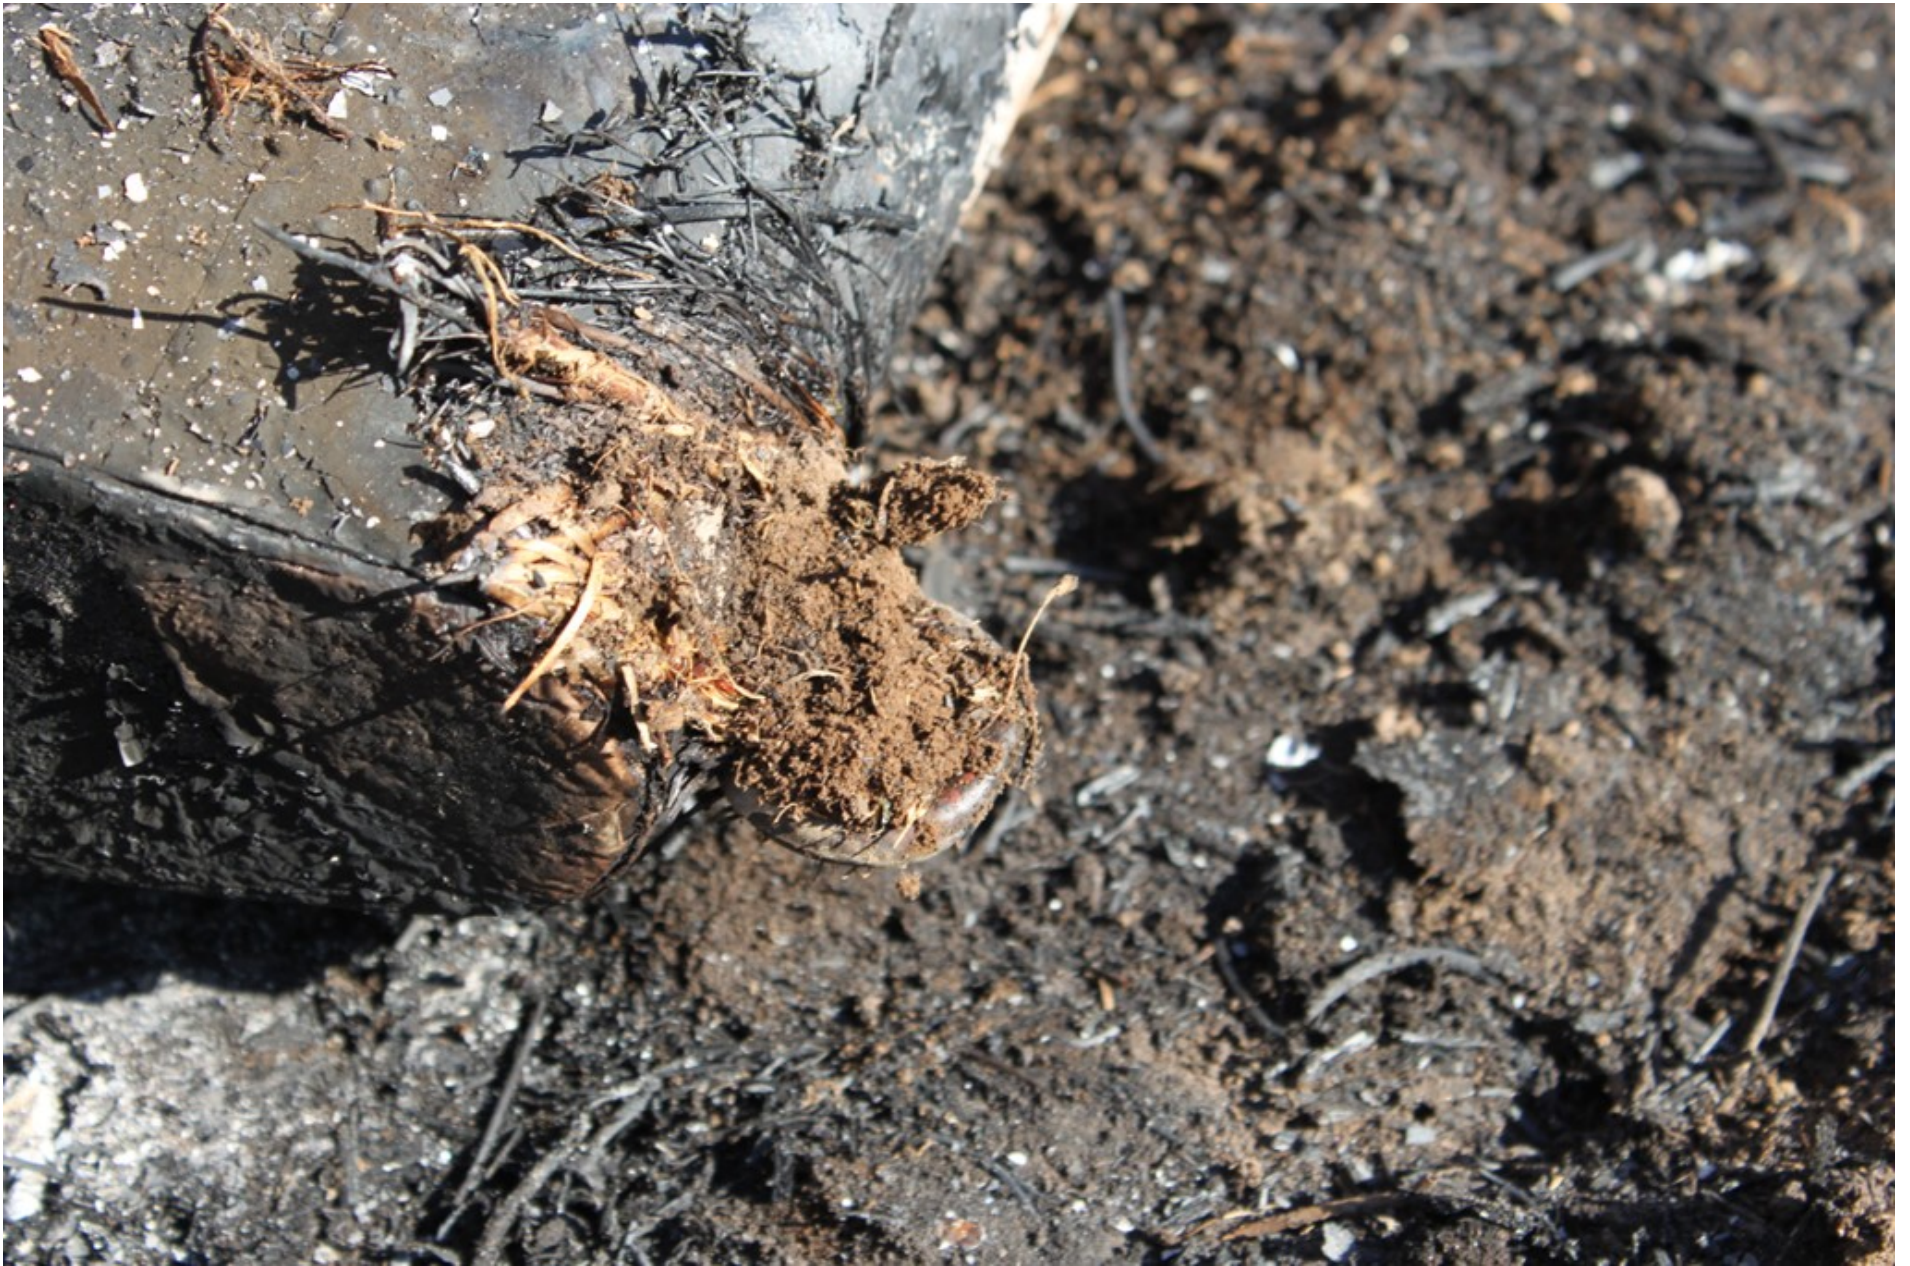
**Photo 9 - NTSB Digital Photograph. View of the Tail Tie Down With Dirt Adhering to It.**

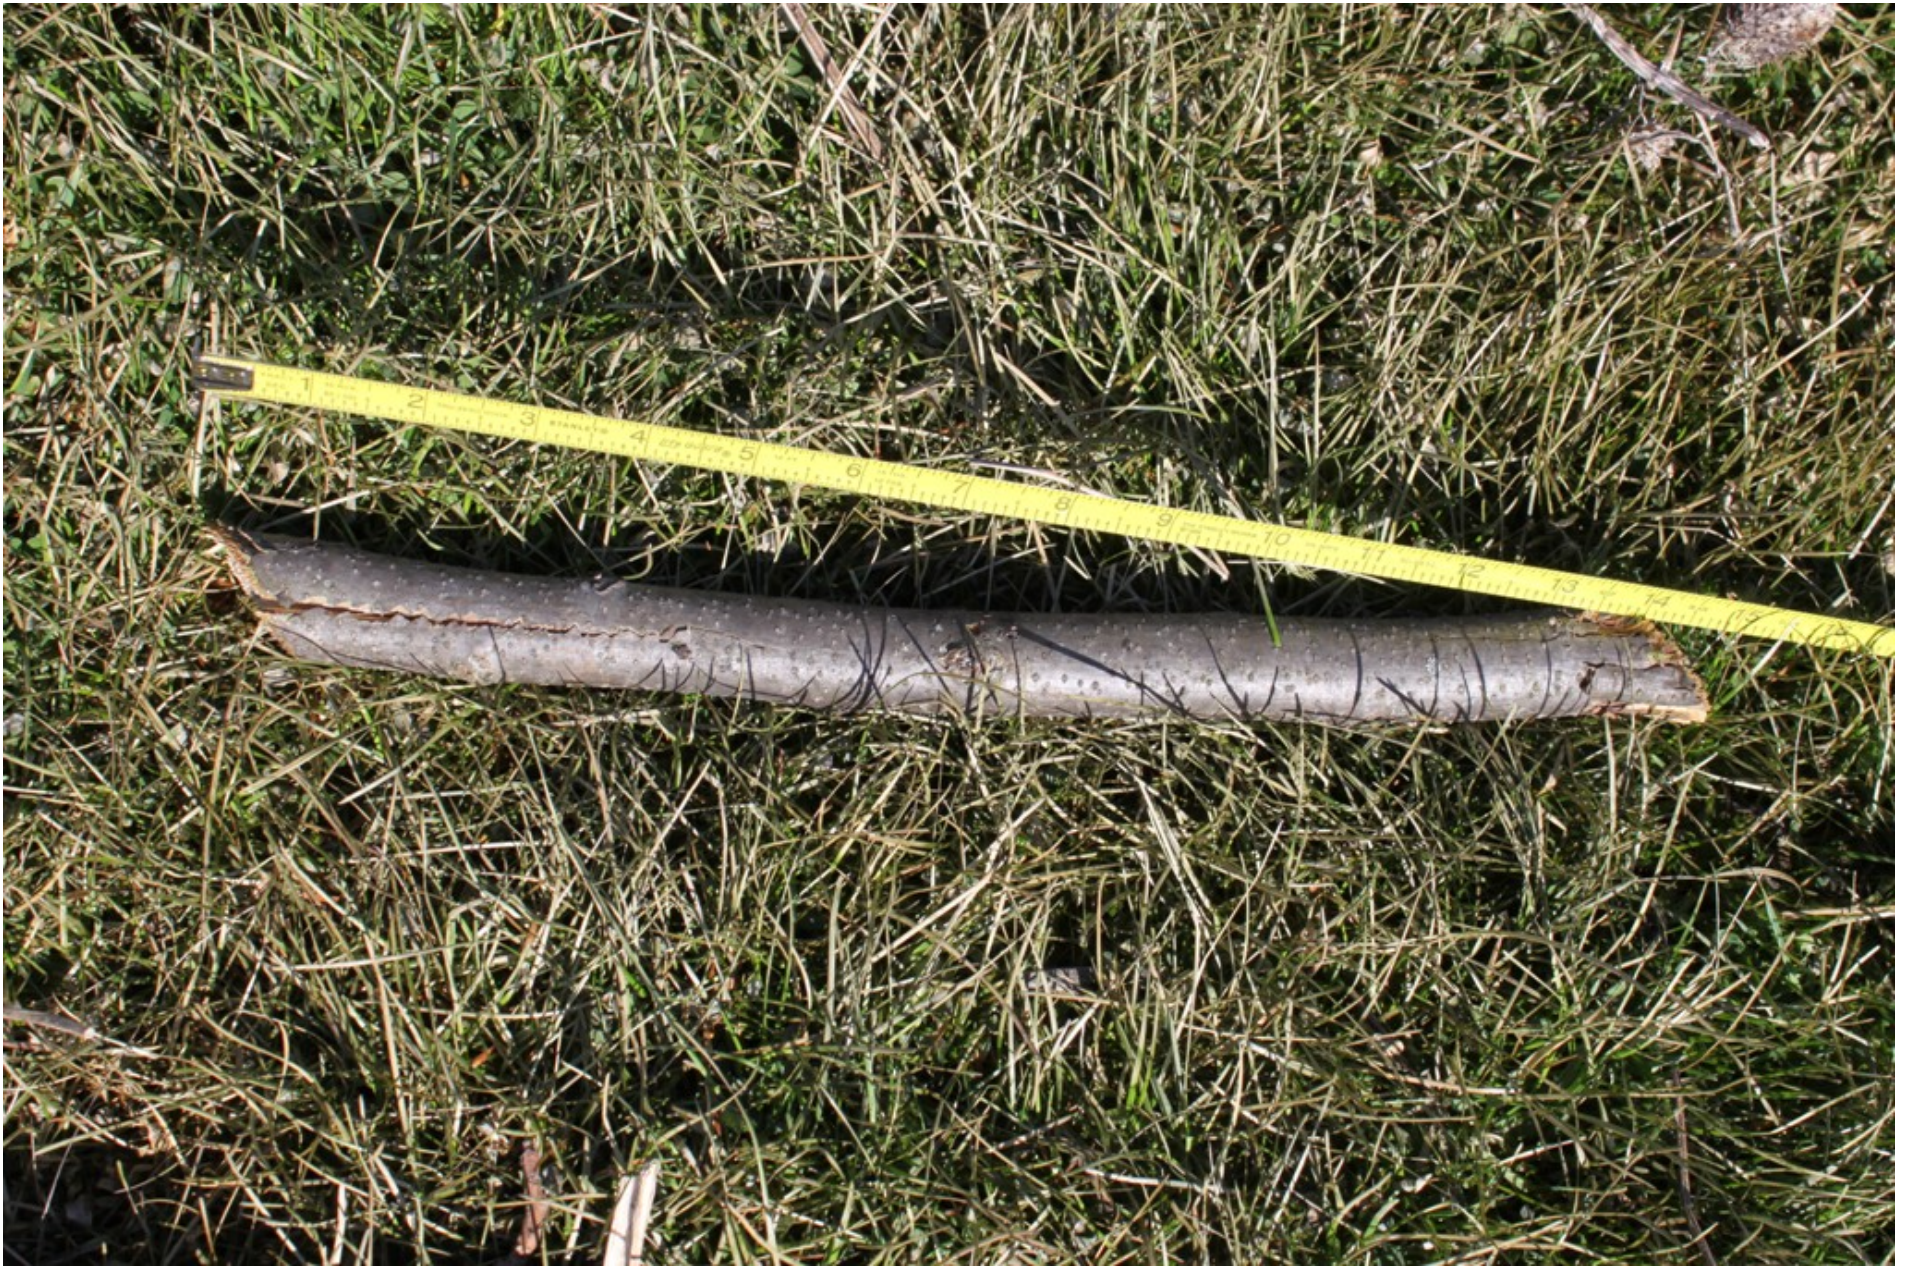
**Photo 10 - NTSB Digital Photograph. View Depicting 14 Inch Length of Tree Limb With Cuts at Both Ends.**
