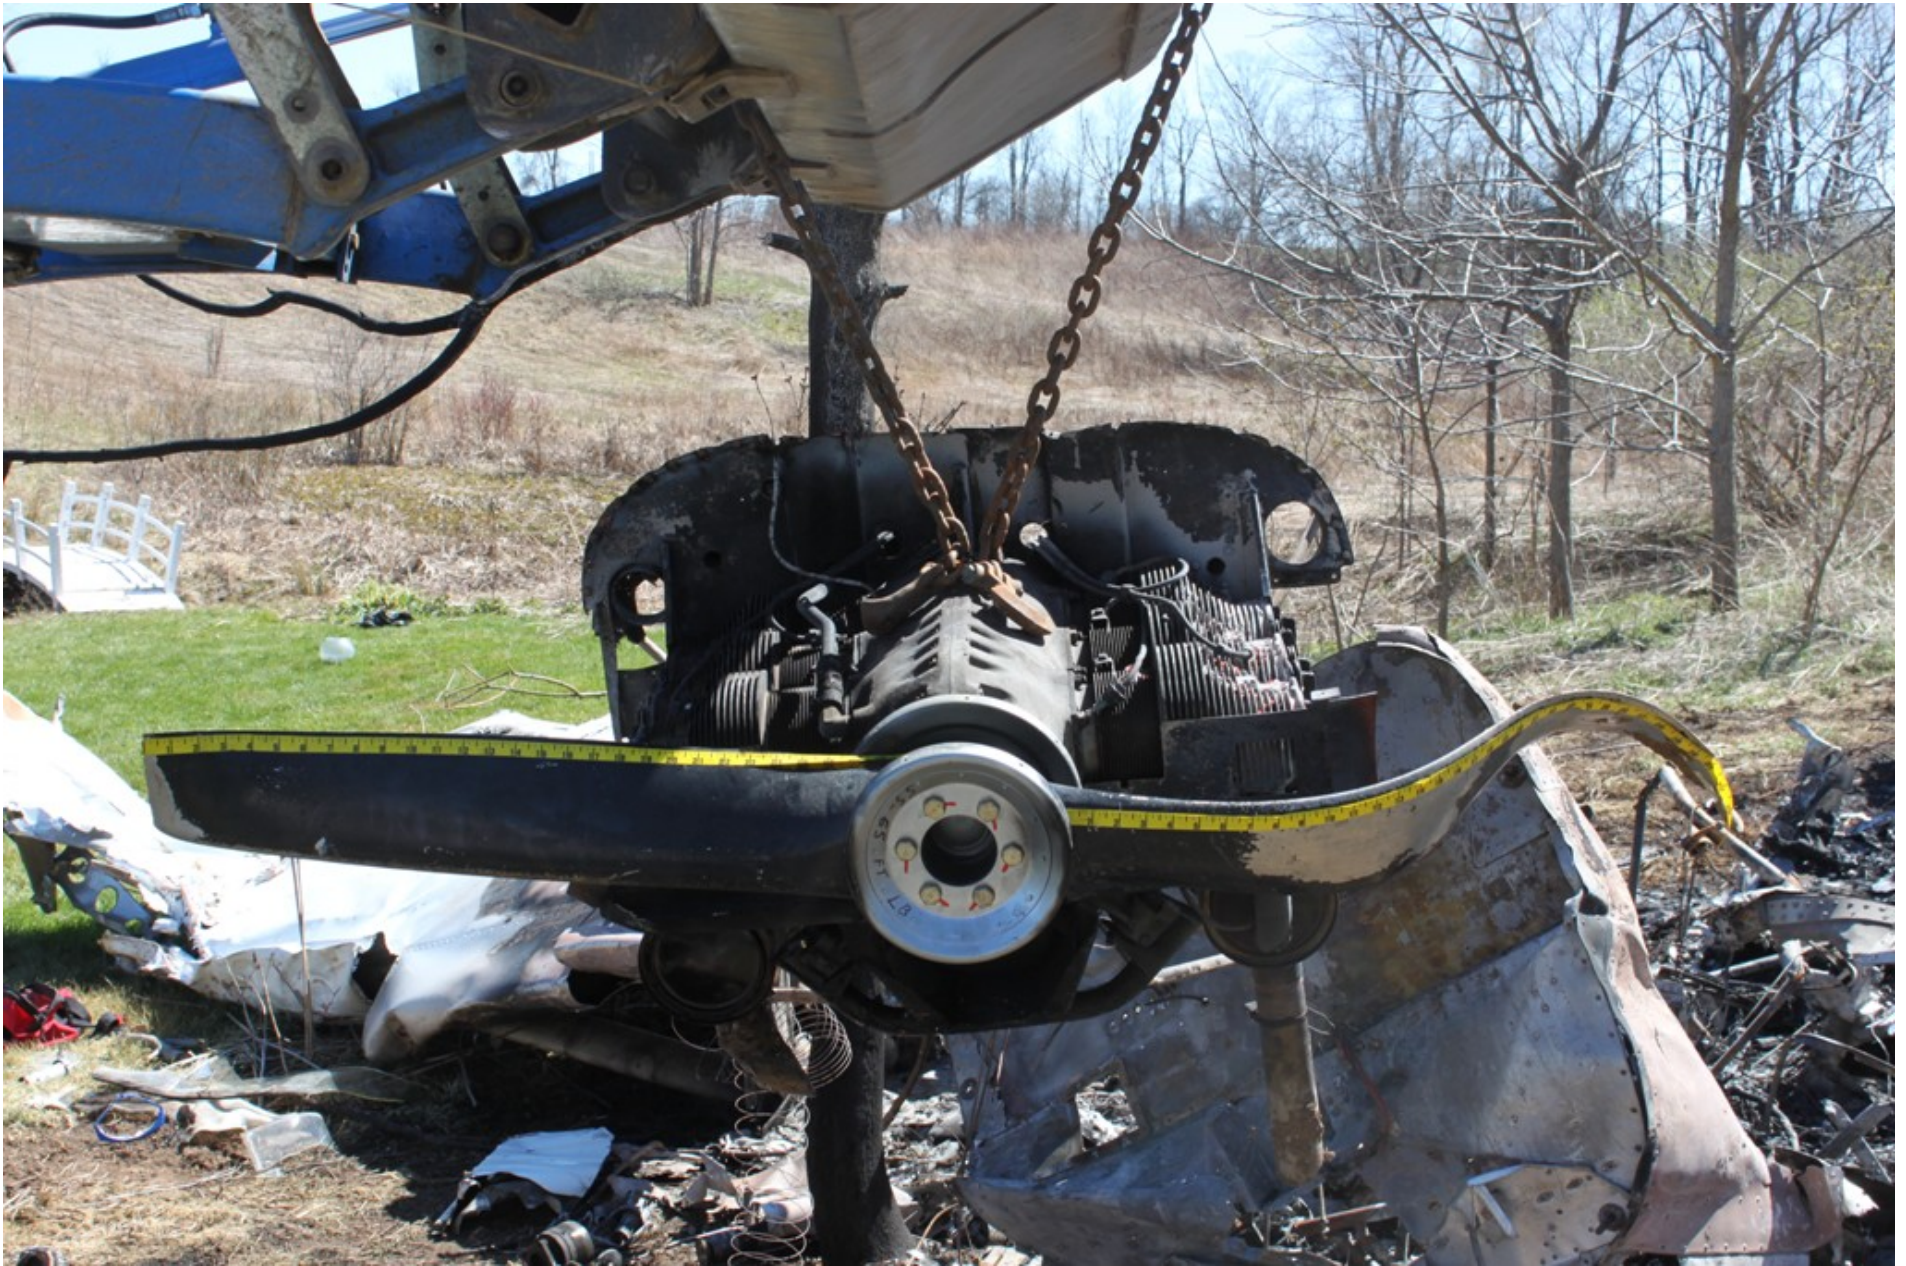
**Photo 11 - NTSB Digital Photograph. View of the Propeller and Engine Assembly. Note the Fractured Blade on the Left and Deformed Blade on the Right.**

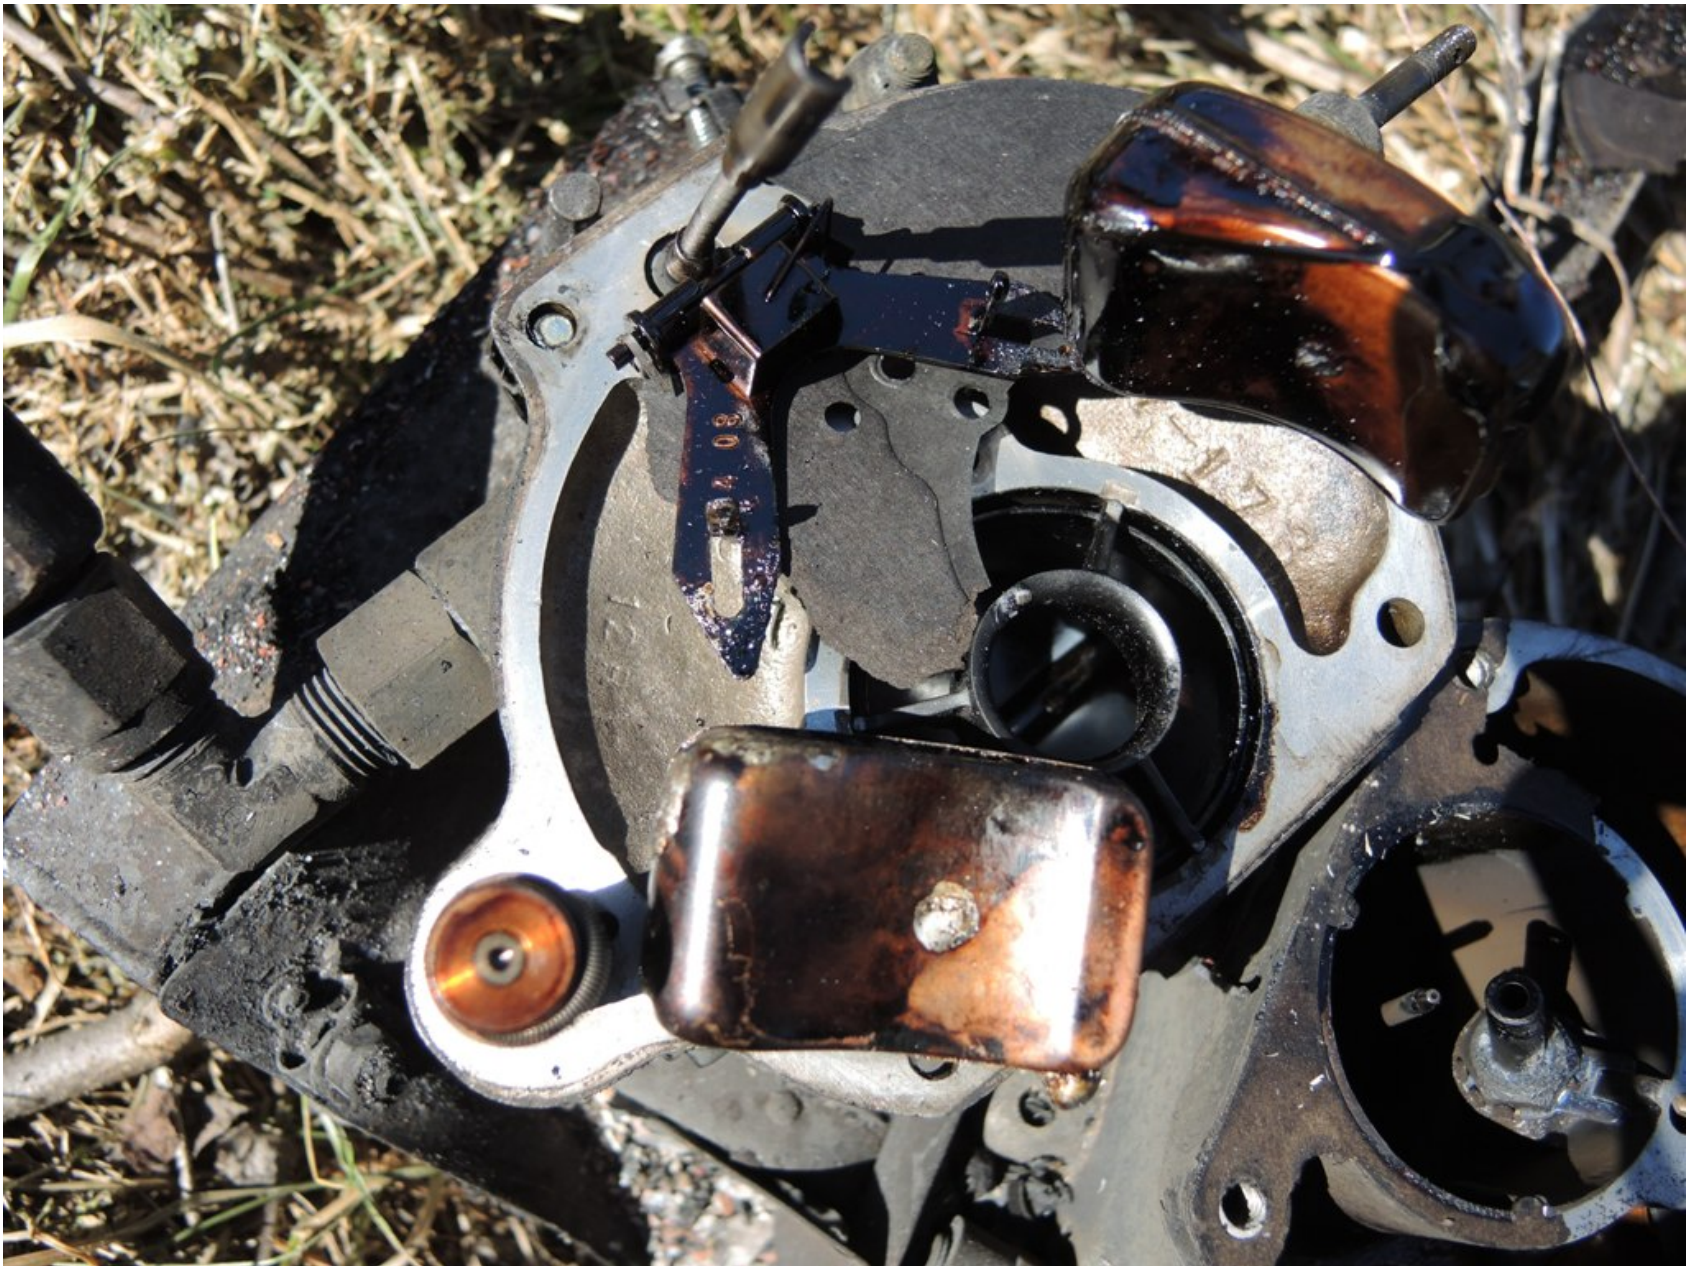
**Photo 12 - Textron Aviation Digital Photograph. View Depicting the Carburetor Float. Note the Separated Float on the Left and the Resolidified Solder On the Bottom of the Separated Float.**

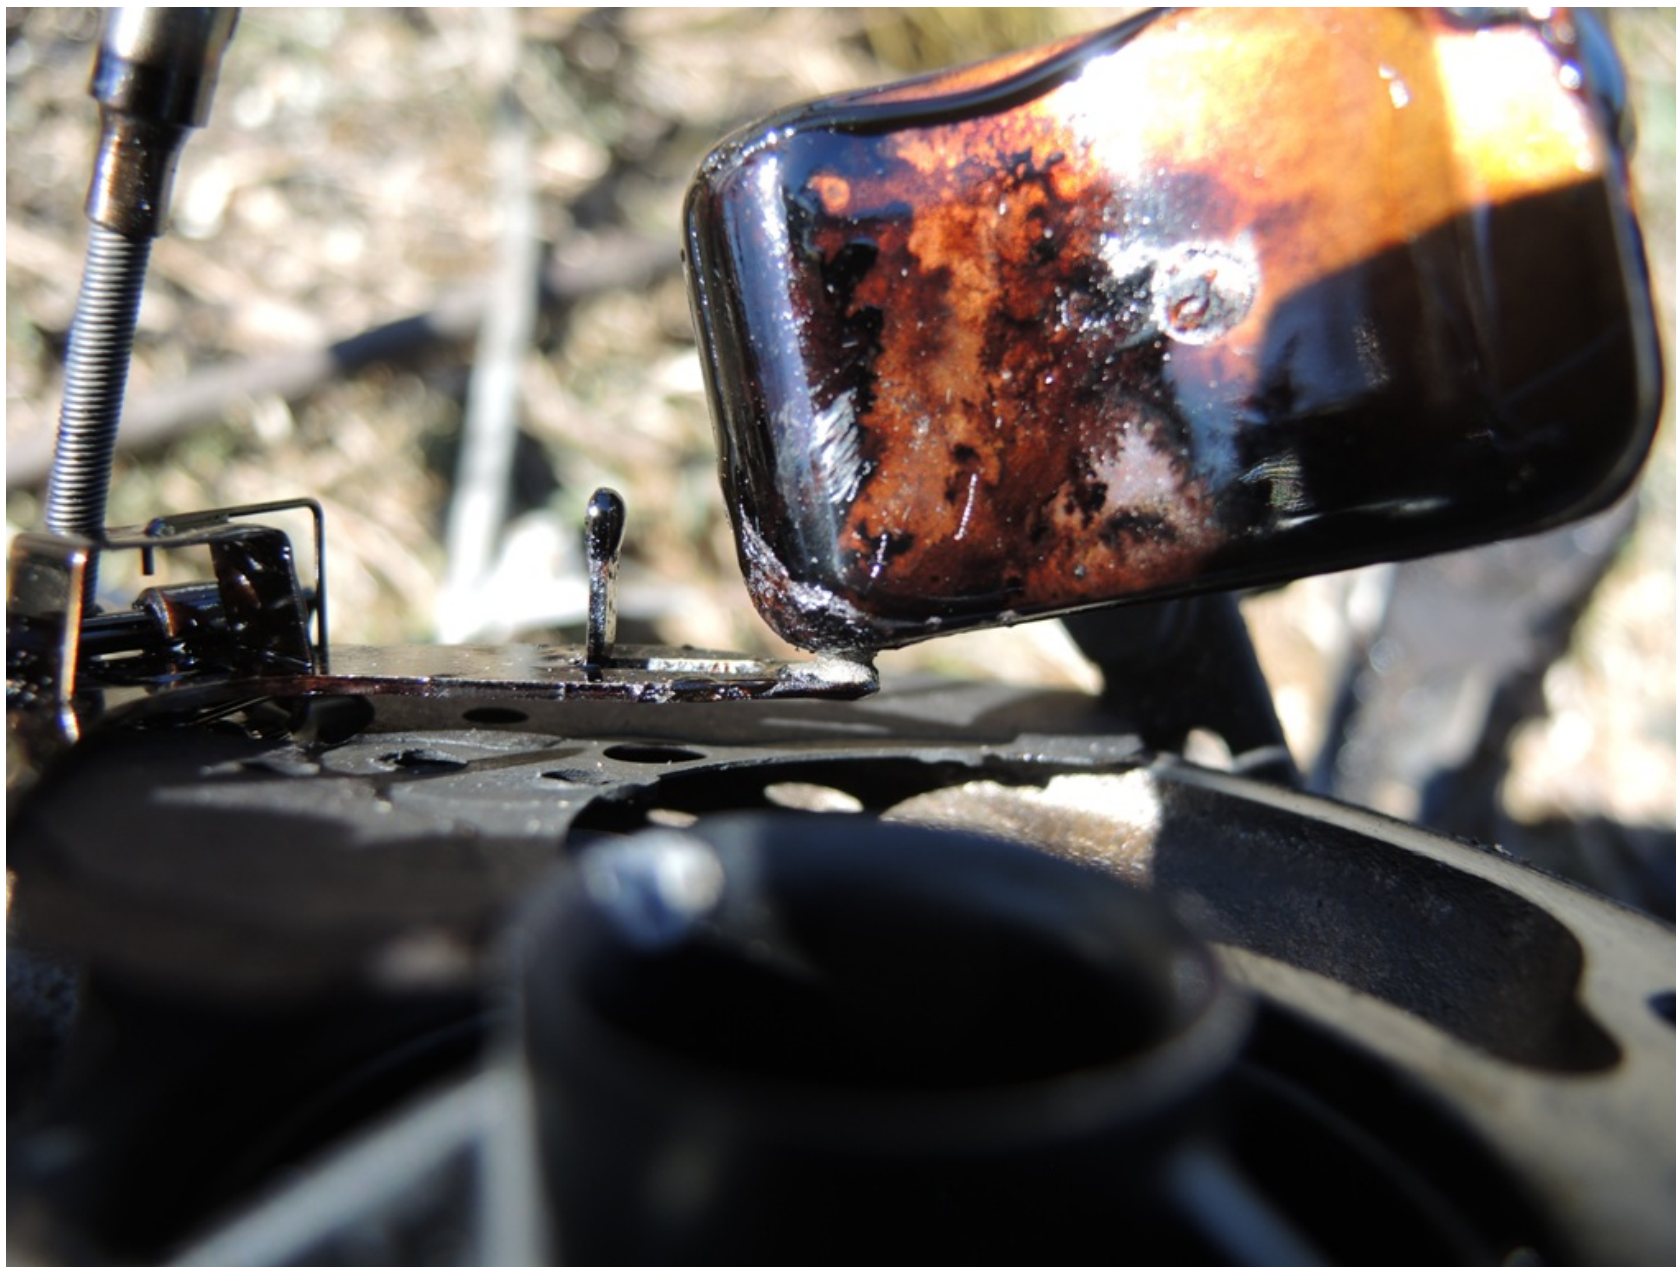
**Photo 13 - Textron Aviation Digital Photograph. View Depicting the Attached Carburetor Float and the Solder Joint.  
Note the Discoloration of the Float.**

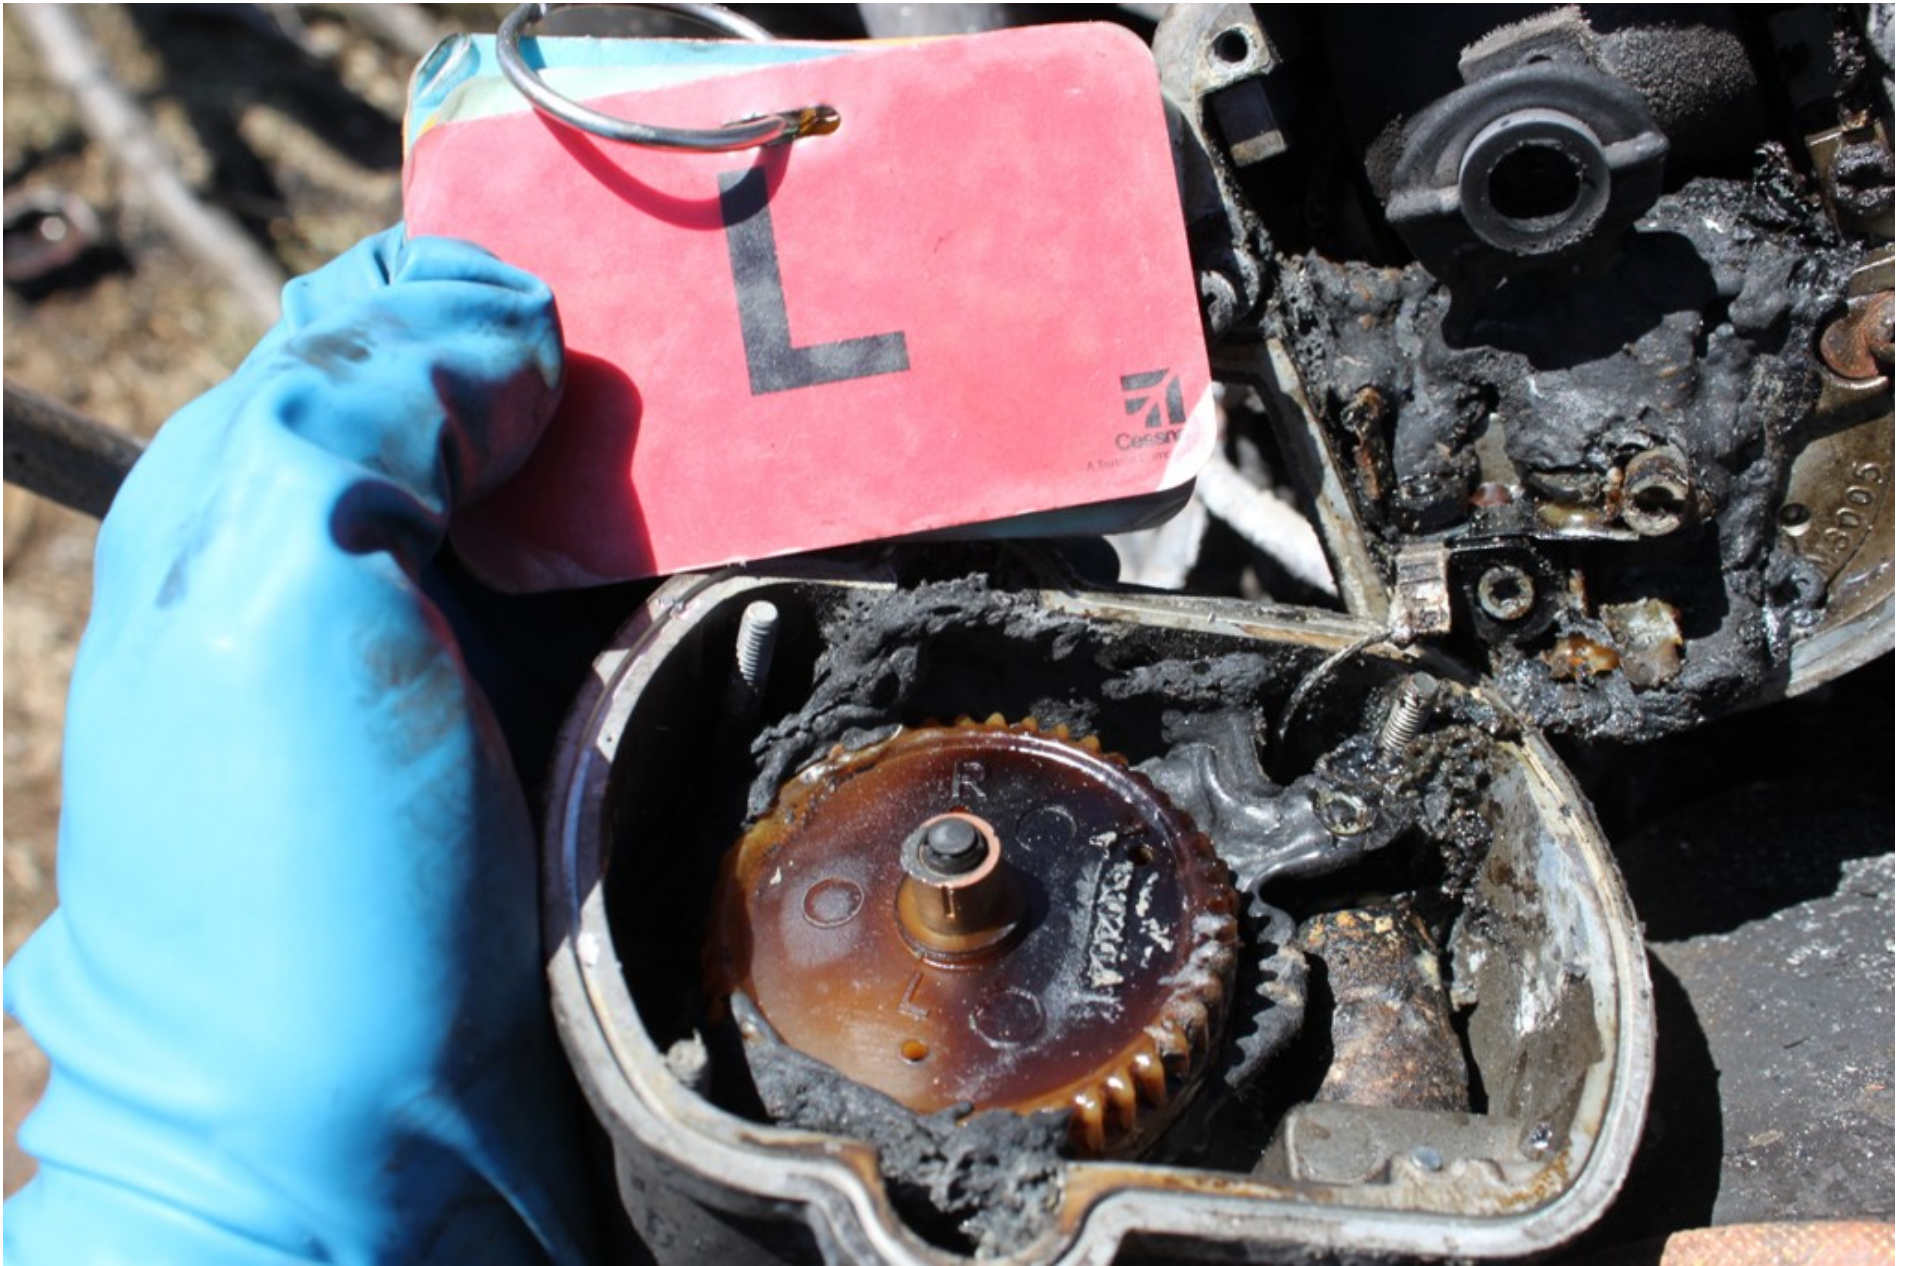
**Photo 14 - NTSB Digital Photograph. View of the Internals Of the Left Magneto.**

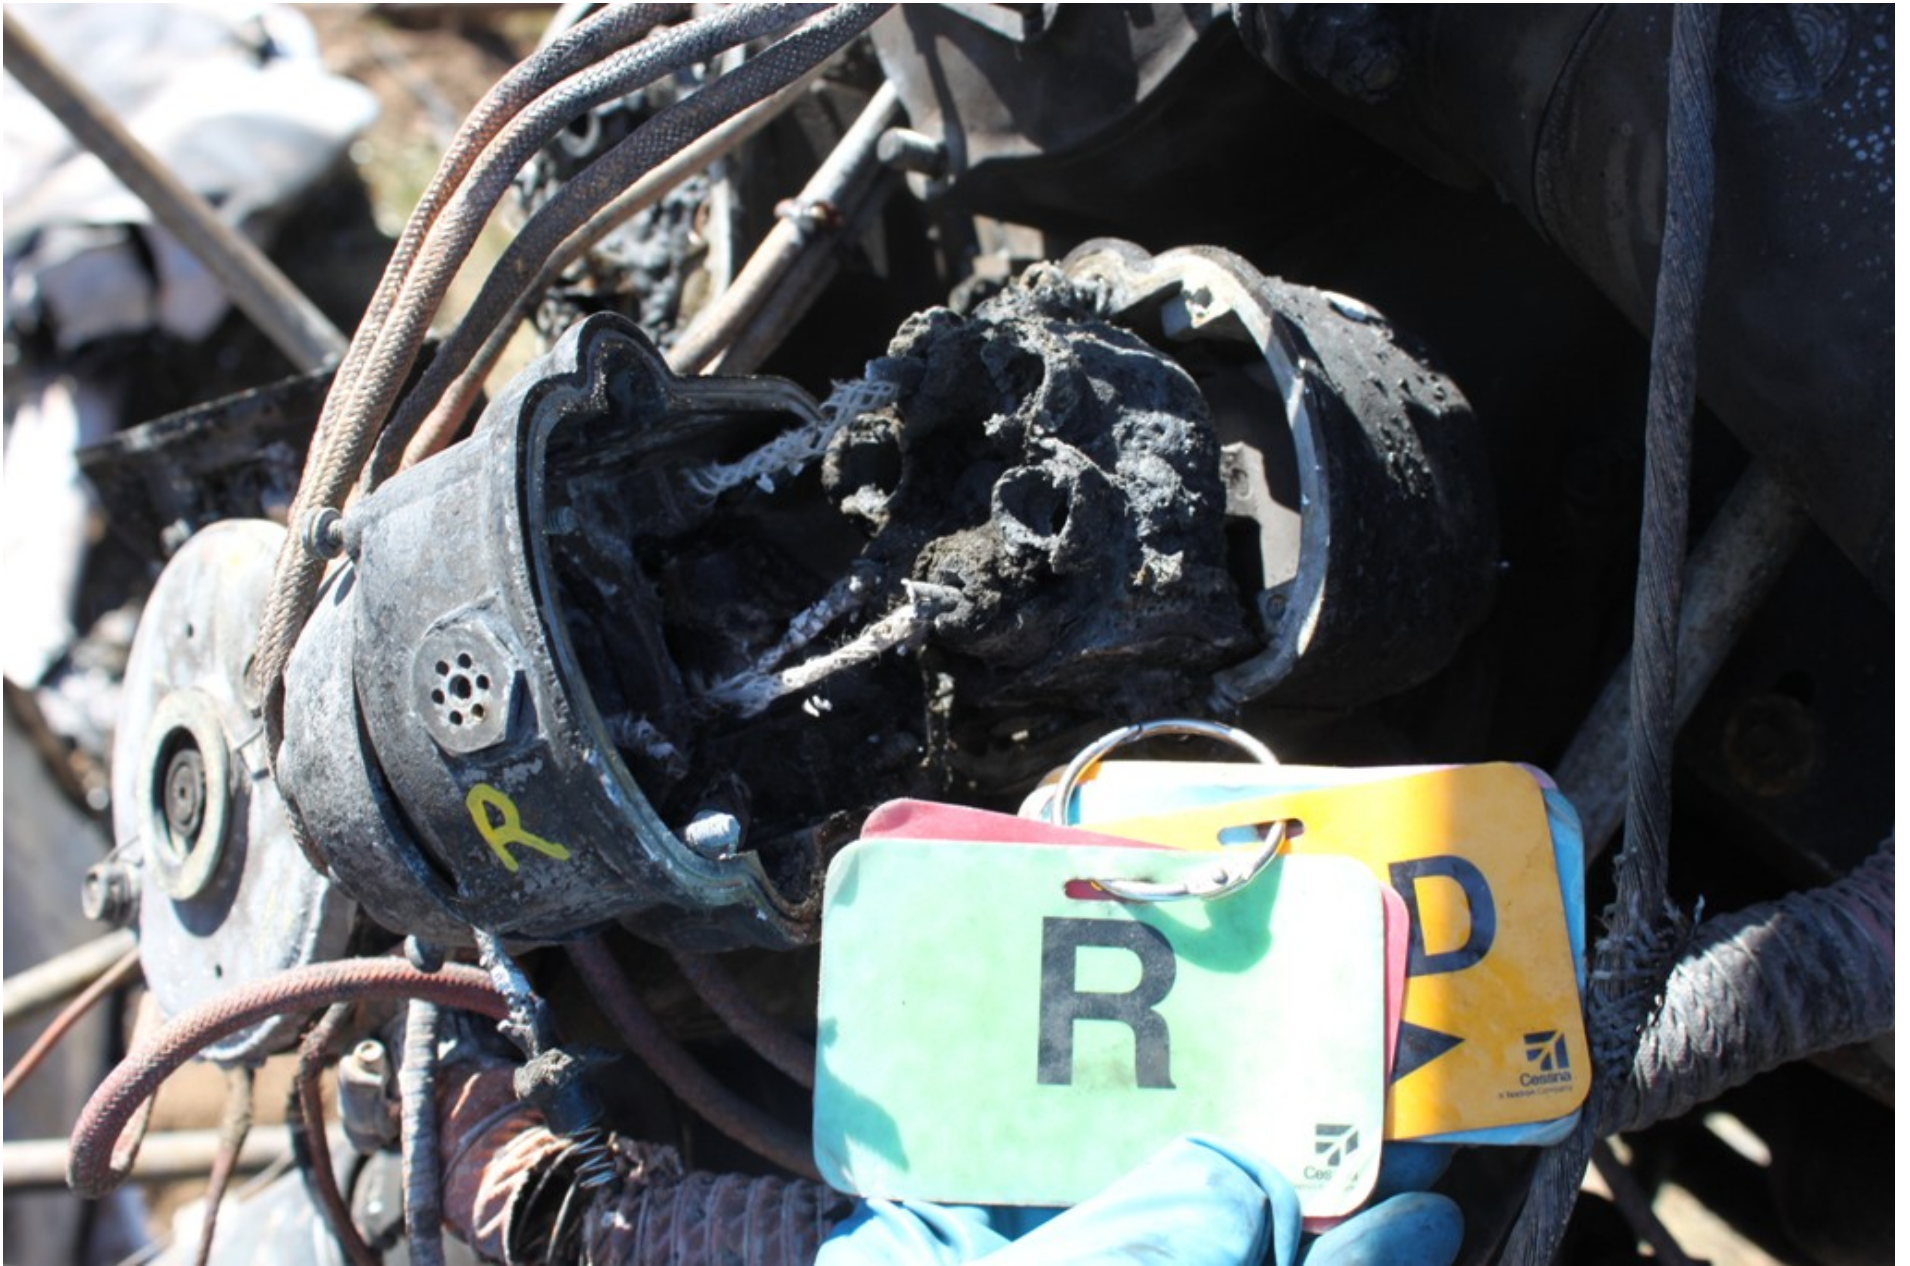
**Photo 15 - NTSB Digital Photograph. View of the Internals Of the Right Magneto.**
