# NATIONAL TRANSPORTATION SAFETY BOARD

## Speed Study

### Specialist's Study Report

Location: Westmoreland, New York  
Date: April 18, 2016  
Aircraft: Cessna 172C  
Registration: N1863Y  
Operator: Private  
NTSB Number: ERA16FA161

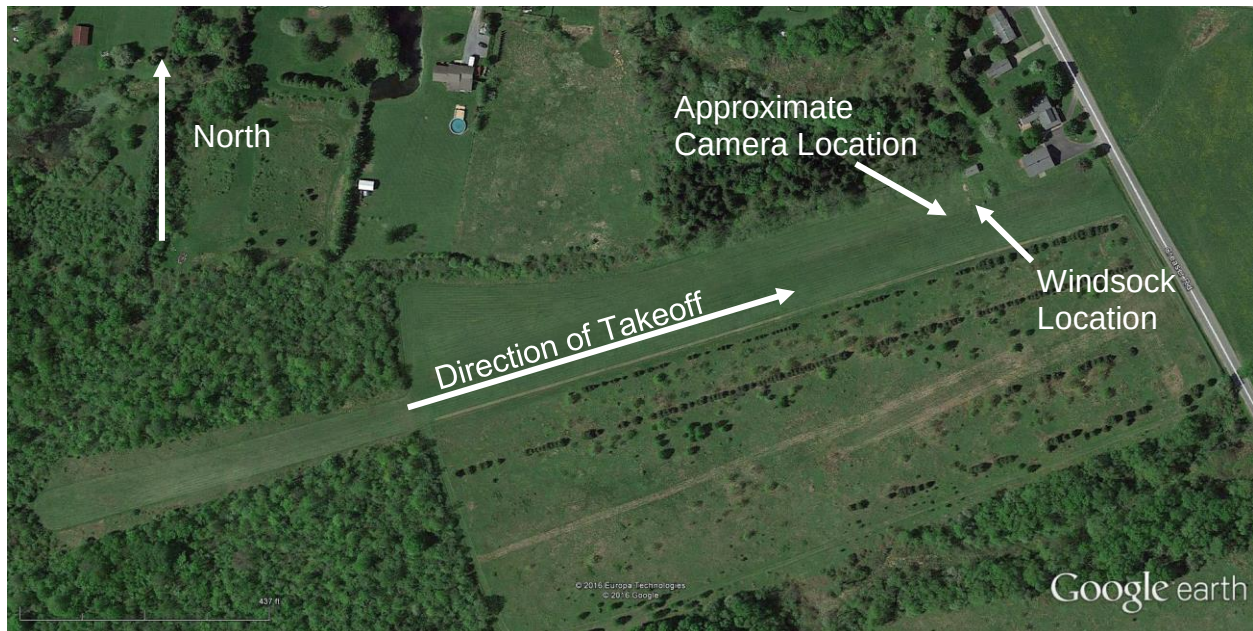
The aircraft began its takeoff approximately 2 seconds after the video began. The aircraft became airborne just after it passed the windsock noted in Figure 1, approximately 20 seconds after the aircraft began its takeoff roll. The windsock was pointing straight at the ground. The aircraft banked to the left and then to the right before the camera shifted toward the ground. Sounds of impact were heard approximately 28 seconds after the start of the takeoff roll. Due to the angle between the line of sight from the camera to the aircraft

**Figure 1.** Overview of accident location.
