**Date of Accident:** April 25, 2016

**NTSB File No.:** ERA16FA169

**Aircraft:** PA-32-300  
Type Certificate Data Sheet A3SO

**Propeller Teardown Report****Date of Investigation:** May 20, 2016**Location:** Hartzell Propeller Engineering Test Lab  
350 Washington Ave.  
Piqua, OH 45356**Propeller Model:** HC-C2YK-1(BF) with F8475D-4 blades**Representatives:** Les Doud                      Hartzell Propeller Inc.  
Bob Craig                      FAA Cincinnati FSDO**General Comments:**

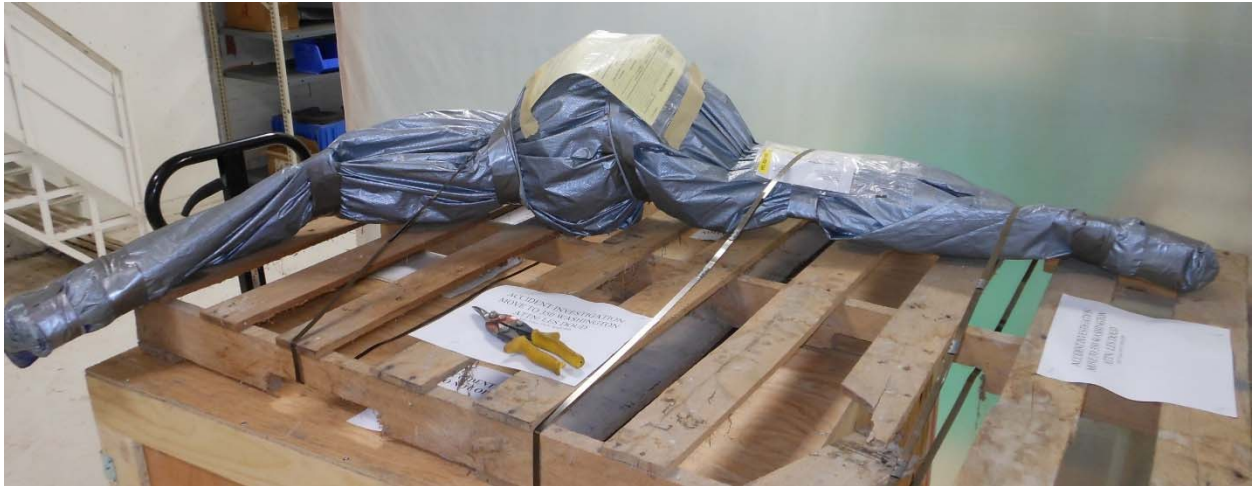
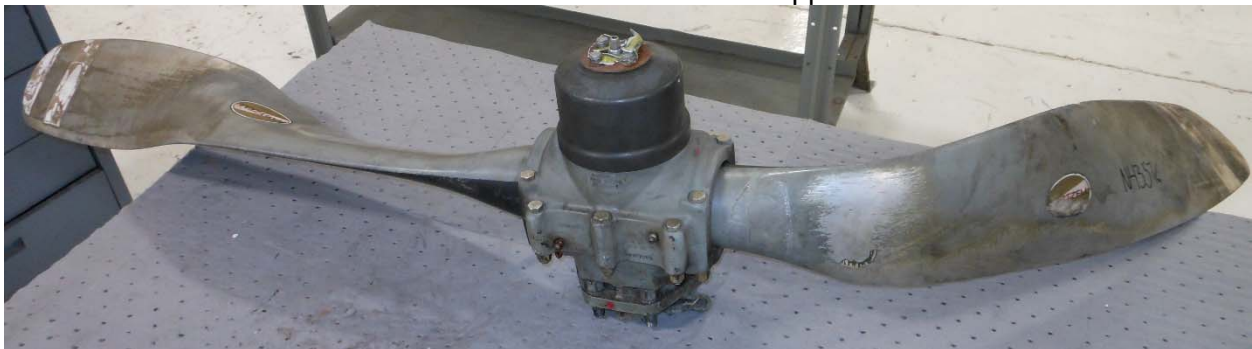
The propeller was removed from the engine and shipped to Hartzell Propeller in the condition shown in Photo #1 prior to the examination documented herein. The propeller mounting flange did not display any damage. One blade appeared to be in a high pitch position and could be partially rotated by hand force. Both blades had rotational/chordwise scoring; the camber side had the most severe scoring. One blade was bent aft and had spanwise scoring. The blade with the most prominent face side scoring displayed some S-bend characteristics.

Photo #1 – As-received

Photo #2 – As-received/unwrapped

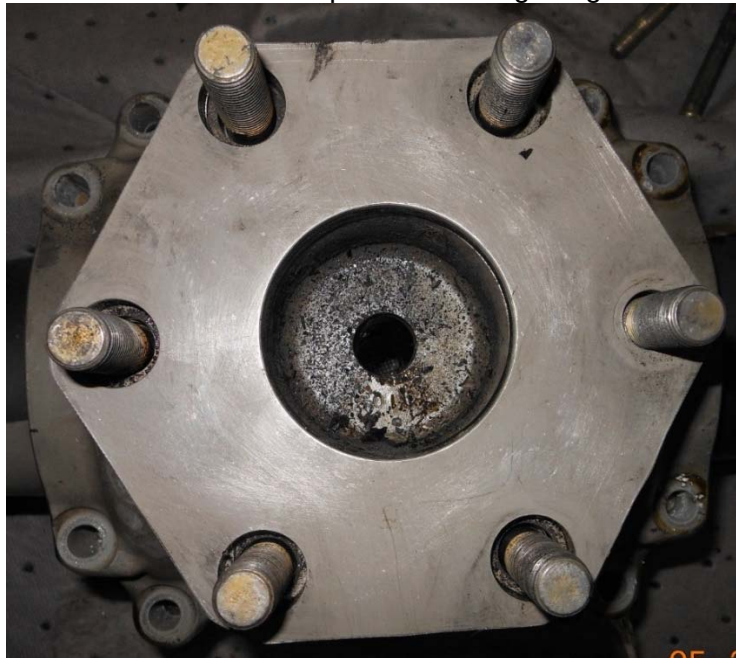
The propeller mounting flange and fasteners appeared undamaged. There were no indications of fretting or corrosion on the face of the mounting flange.

Photo #3 – Propeller mounting flange

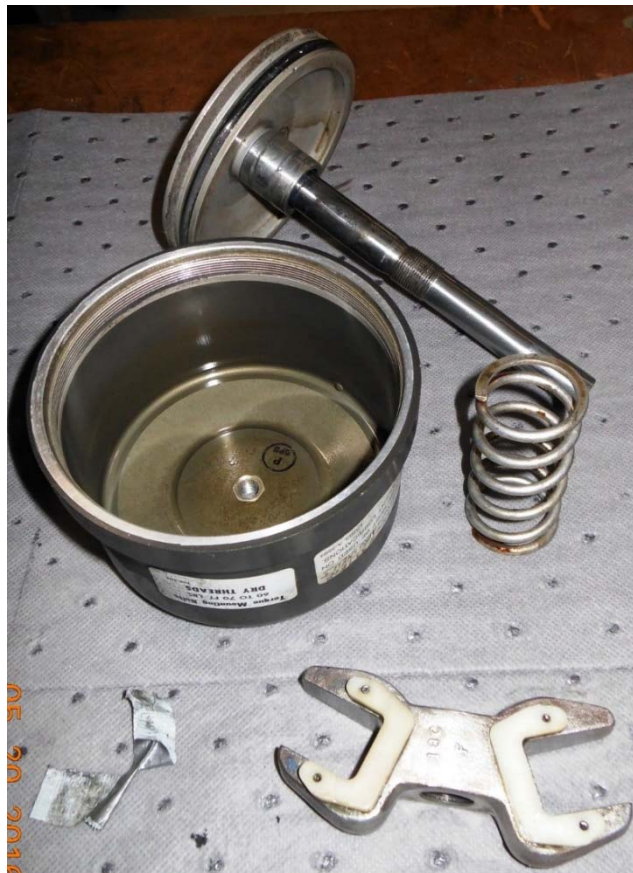
The piston and spring were intact and appeared functional. The piston had a small nick on the aft edge. The low and high pitch stops were intact and in proper position. The pitch change rod and fork appeared normal. The low pitch stop/pitch change rod contact surface did not have any remarkable impact impressions. The cylinder had one small dent – appeared to be impact damage – in the forward corner that was not deep enough to reach the piston area and did not appear to distort the overall shape of the cylinder.

Photo #4 – Pitch change components

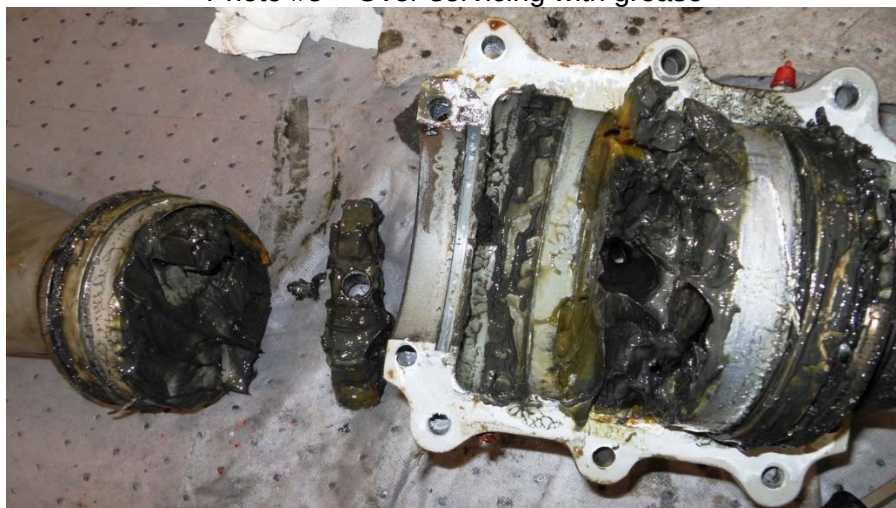
There were no visible cracks or fractures on the hub surface and all bolts were installed and secure. Upon separating the hub halves, it was evident the bearings had been over-serviced with grease; grease partially filled the hub cavity. The internal surfaces of the hub unit displayed impact damage to the preload plate contact surfaces on both the front and aft halves as well as the lead and trail edge areas.

Photo #5 – Over-servicing with grease

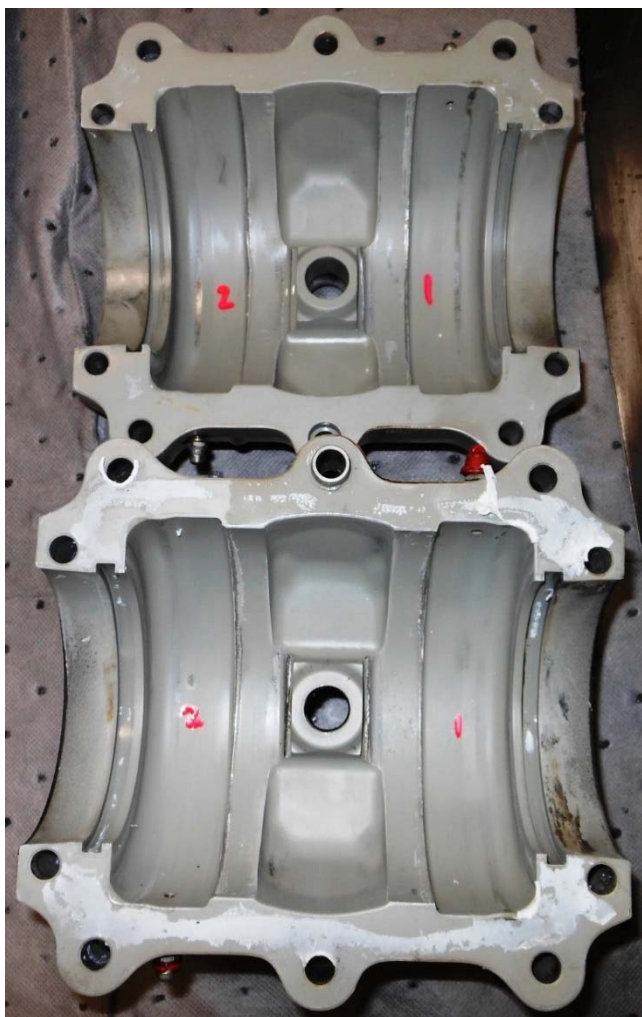
Photo #6 – Hub internal surfaces

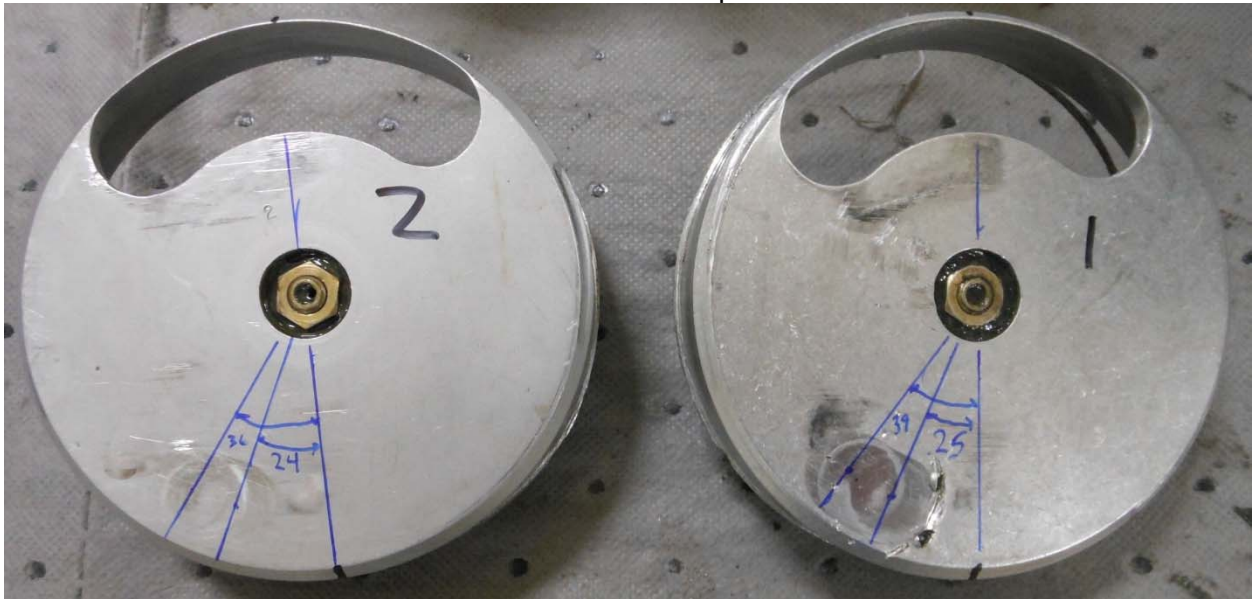
NOTE: For this propeller model, when the blade knob is aligned with the hub parting line, the blade angle at the reference station is  $46^\circ$  (knob  $\phi=10^\circ + 36 = 46^\circ$ ). On a two-blade Compact series propeller, pitch change knob impressions are sometimes made on the opposite-side preload plate during an impact sequence. The impression marks can be measured to provide some blade angle information.

In Photo #7 the knob impressions in the range  $24-39^\circ$  equates to blade angles of  $7-22^\circ$  which encompass the normal range of operation. Impressions below the low pitch setting of  $13.5^\circ$  could have been made during the impact sequence when the blades were forcibly twisted beyond the low pitch and either fractured the knob and/or rotated the preload plate out of position. The most prominent impression is on preload plate #1 near  $25^\circ$  which equates to a blade angle of  $21^\circ$  which is in the normal range of operation.

The preload plates were damaged around the periphery of the lip and at points where they impacted the internal hub surfaces. The forward end (low pitch end) of the pitch change knob slots also had damage where the knob and plate contacted during the impact sequence.

Photo #7 – Preload plates

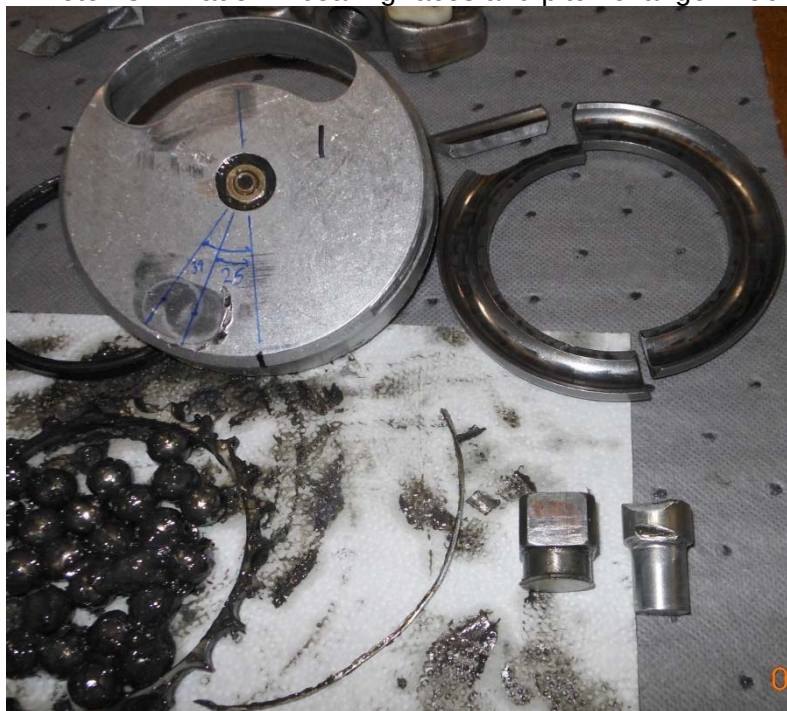
Both bearing assemblies (races and ball bearings) had an ample amount of grease, but the grease appeared dirty. Photo #8 shows the blade #1 bearing race fracture with ball bearing impressions near the fracture. Photo #9 shows the blade #2 bearing races.

The pitch change knob for blade #1 was fractured. Evidence indicates the knob was fractured when the blade rotated and forced the knob into the preload plate during the impact sequence. The pitch change block for blade #2 was fractured and fragmented. Blade #2 pitch change knob had a similar impact mark from the preload plate and was visually bent towards high pitch but was not fractured.

Photo #8 – Blade #1 bearing races and pitch change knob

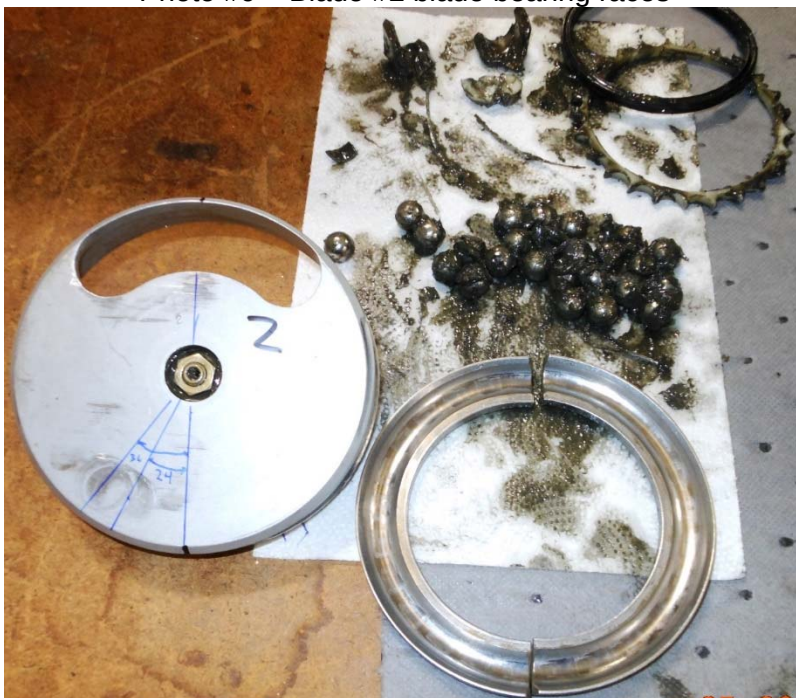
Photo #9 – Blade #2 blade bearing races

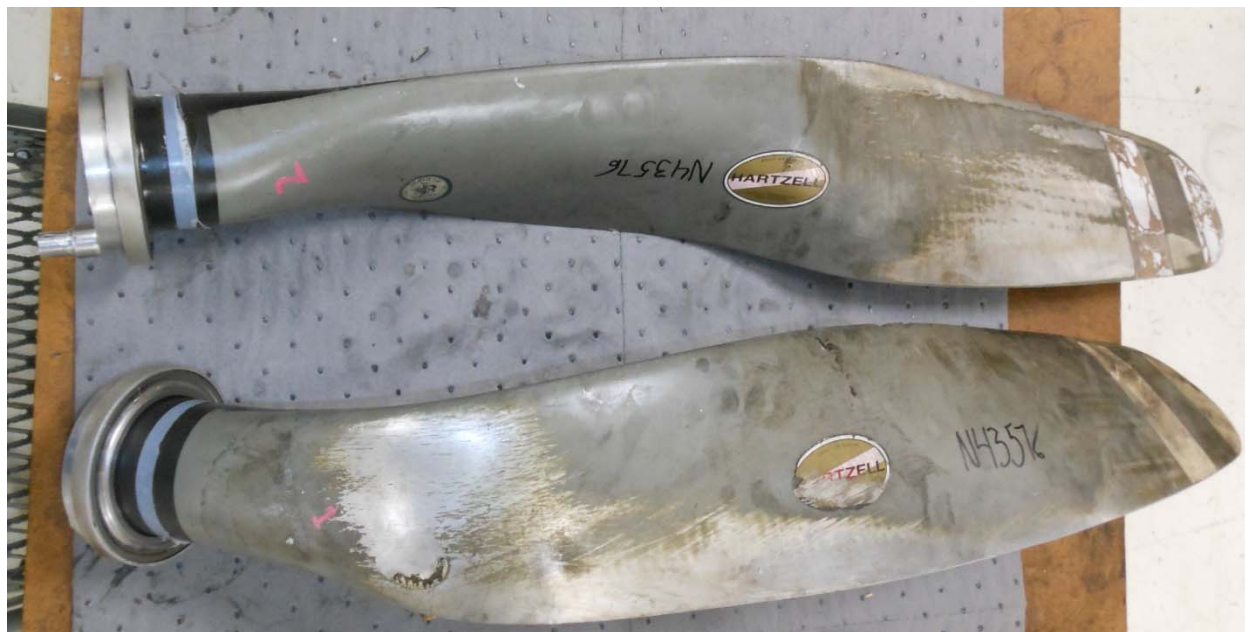
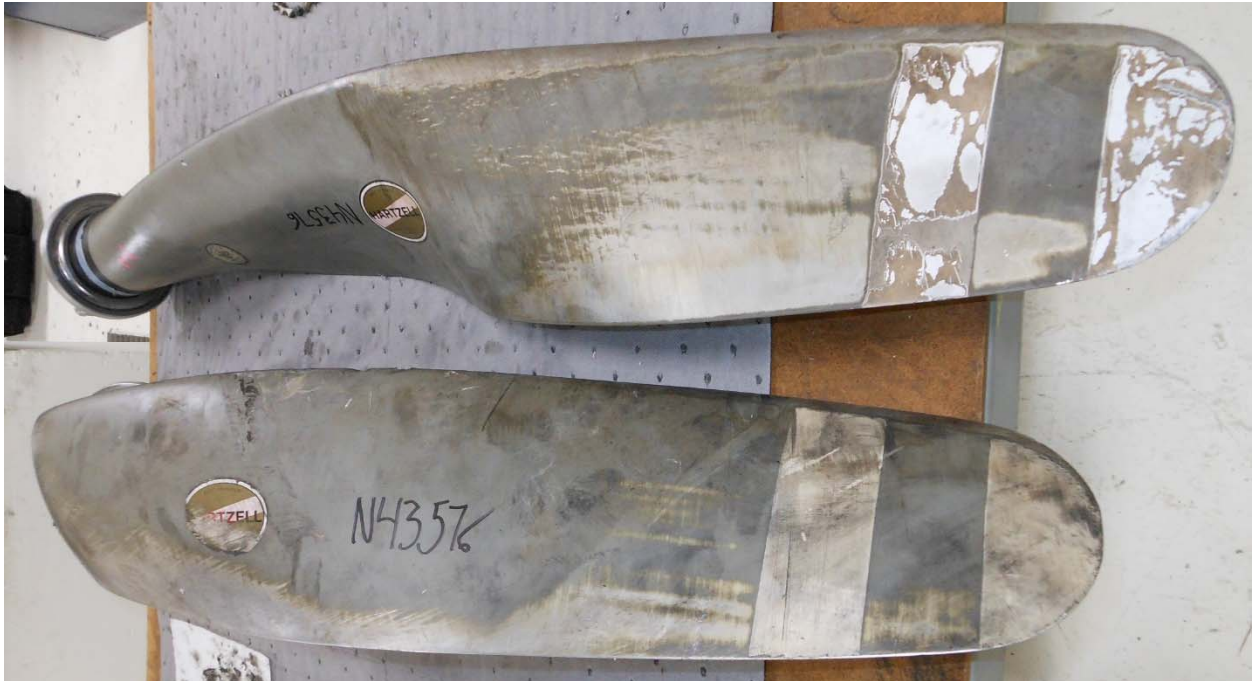
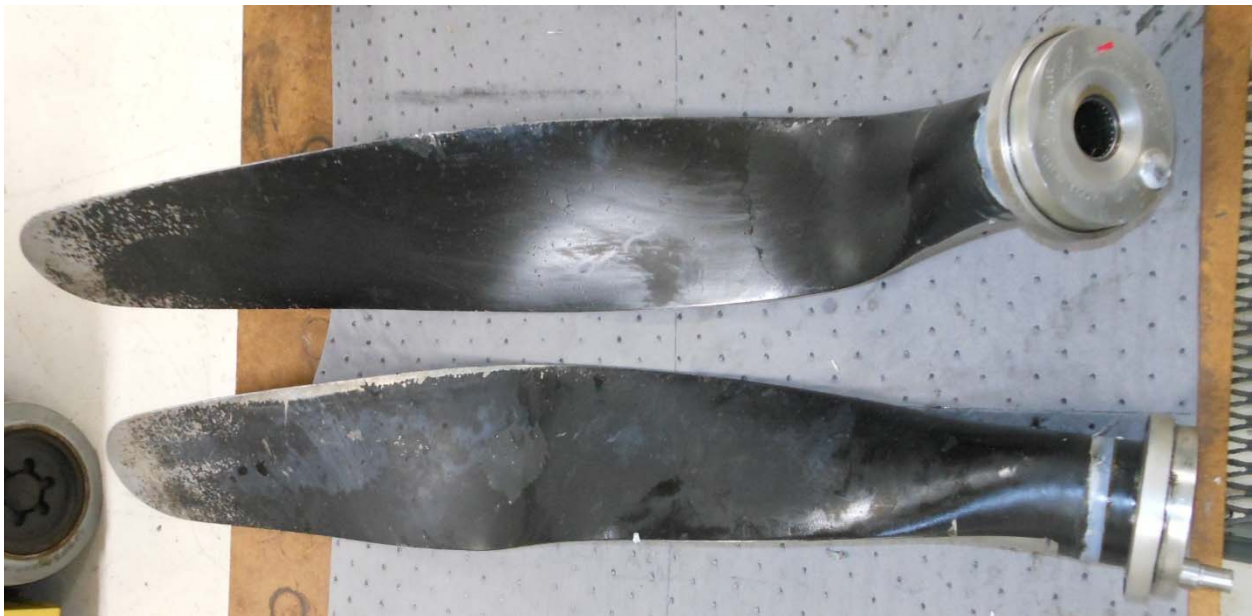
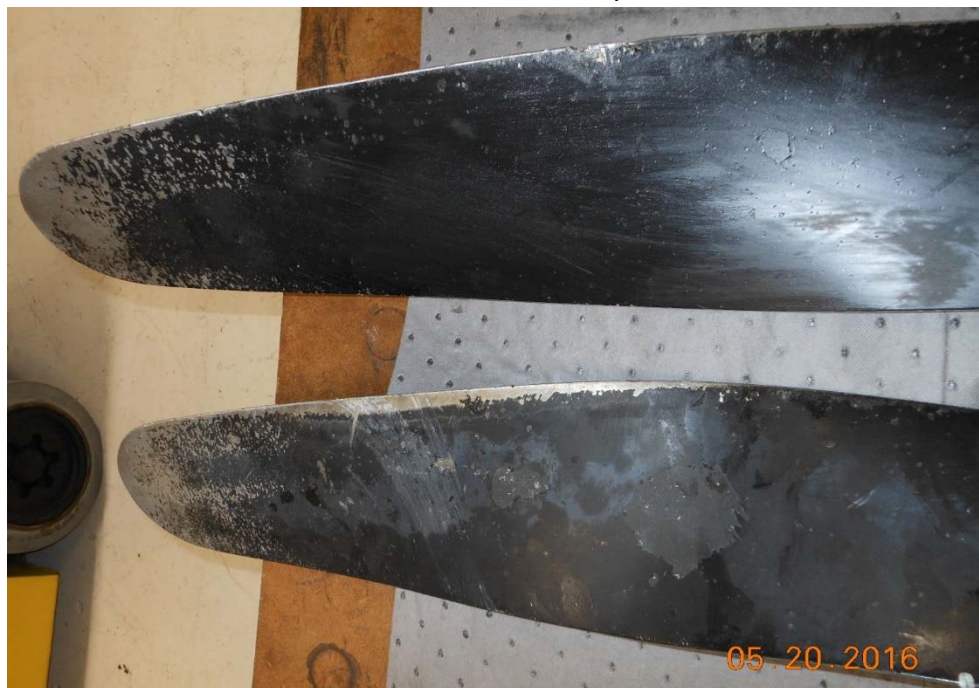
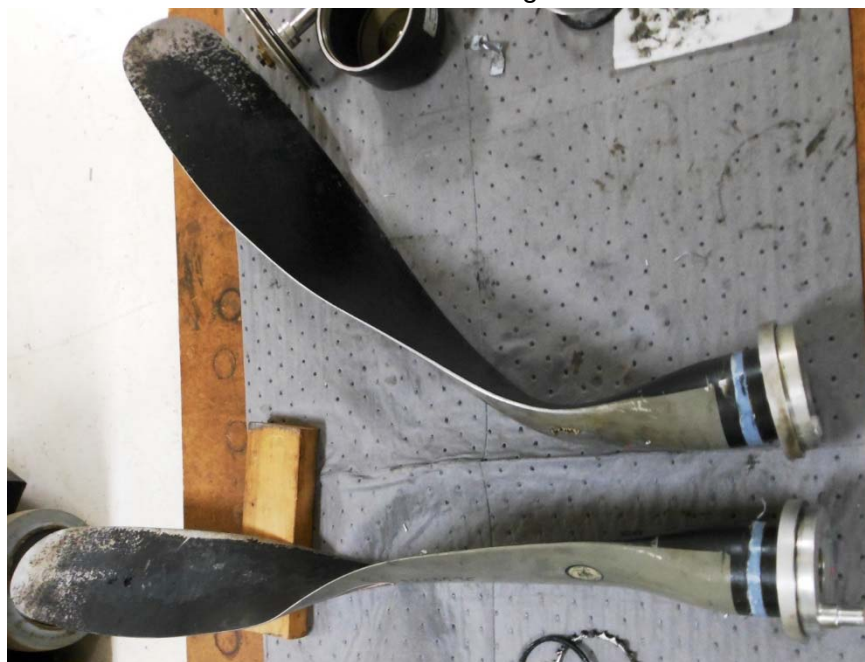
| paint, camber side | - Chordwise/rotational scoring and spanwise scoring from the shank outboard |
| paint, flat side | - Unremarkable, some evidence of charring |
| bend | - Bent aft starting 7" from butt |
| twist | - Leading edge down |
| lead edge damage | - Dents and gouges 24" from butt, nicks and aggressive erosion near tip |
| trail edge damage | - No remarkable damage |

| paint, camber side | - Chordwise/rotational scoring outboard 20" of blade |
| paint, flat side | - Chordwise/rotational scoring and abrasion 11" from tip |
| bend | - "S-bending" characteristics, bent forward at 20" from but, then aft near tip |
| twist | - Leading edge down starting at 20" |
| lead edge damage | - Aggressive/1" wide erosion outboard of mid-blade, nicks in tip region. |
| trail edge damage | - No remarkable damage |

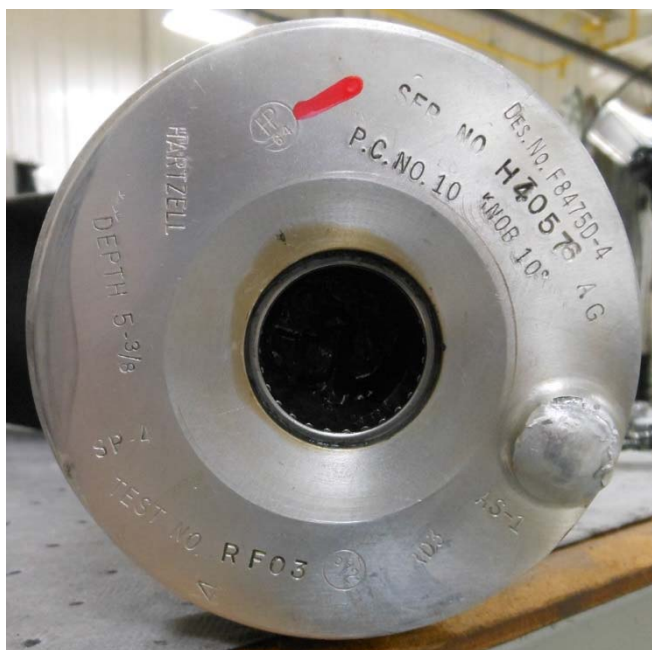
| knob condition | - Fractured/overload |
| blade butt | - Contact mark with preload plate on the face side |

Photo #15a – Blade #1 butt

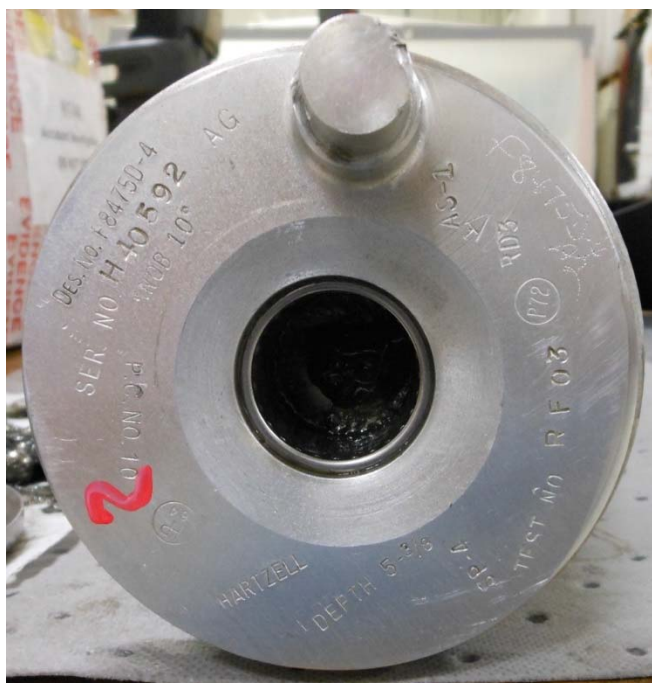
| knob condition | - Visually bent toward high pitch, impact damage with preload plate, pitch change block fractured and fragmented |
| blade butt | - Contact mark with preload plate in the face/trailing edge quadrant |

Photo #15b – Blade #2 butt
