NATIONAL TRANSPORTATION SAFETY BOARD  
Office of Aviation Safety  
Washington, DC 20594

# SURVIVAL FACTORS

## SPECIALIST'S FACTUAL REPORT

Airplane : Piper PA28 [N7031R]  
Location : Homestead, FL  
Date : May 16, 2016  
Time : 1646 eastern daylight time (EDT)<sup>1</sup>  
NTSB # : ERA16FA186

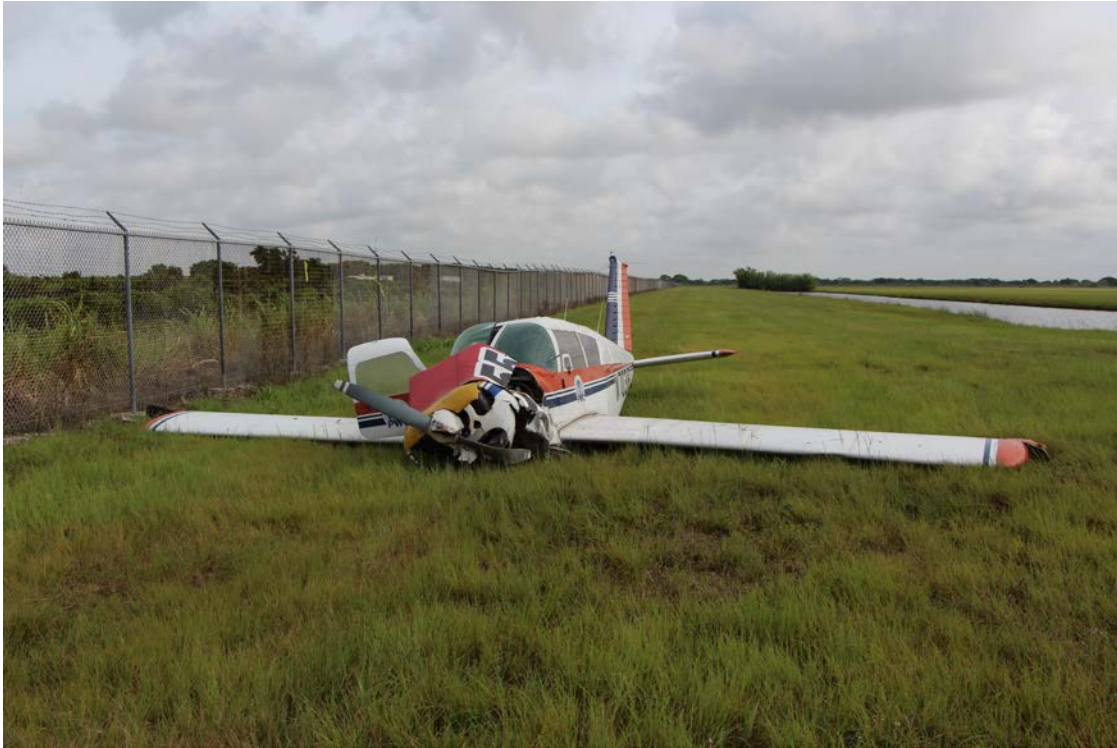
**Photo 1. Front view of N7031R.**

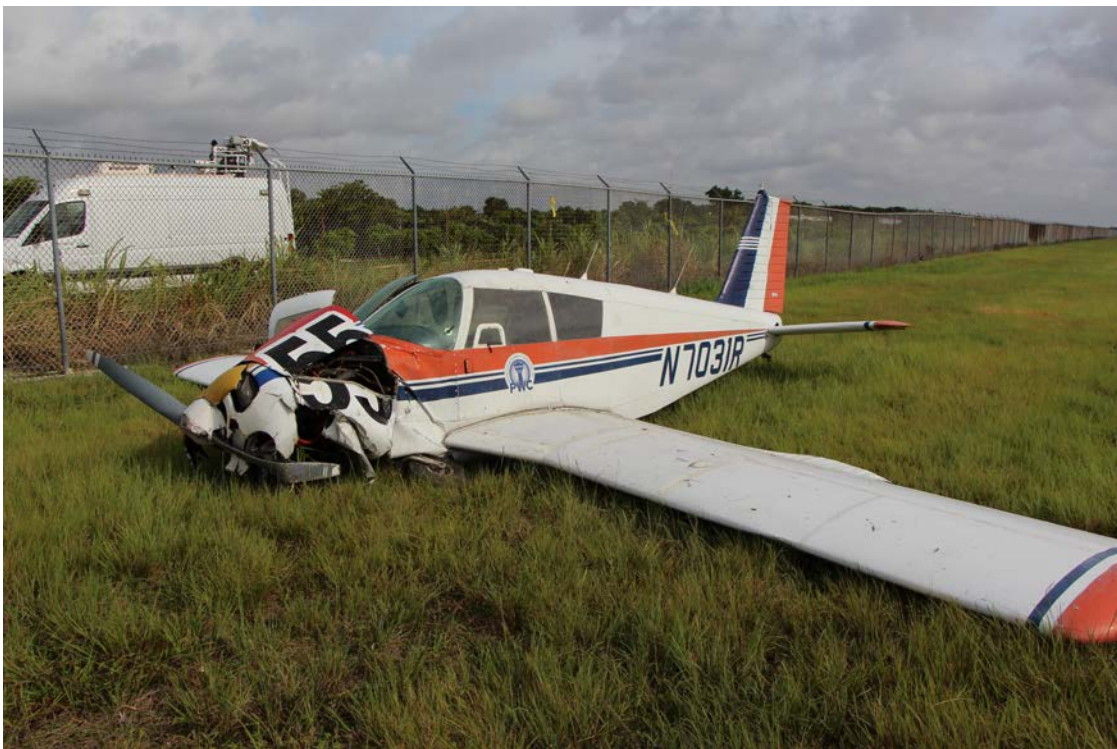
**Photo 2. The left side of N7031R.**

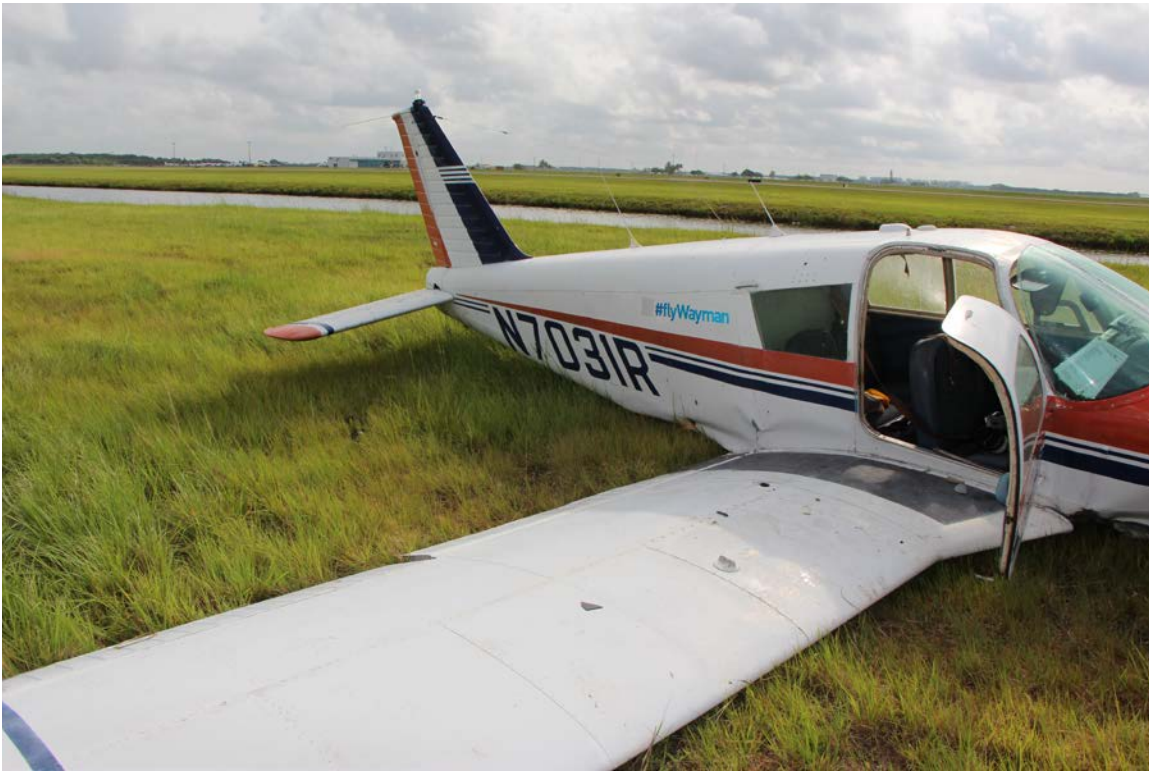
**Photo 3. The right side of N7031R.**

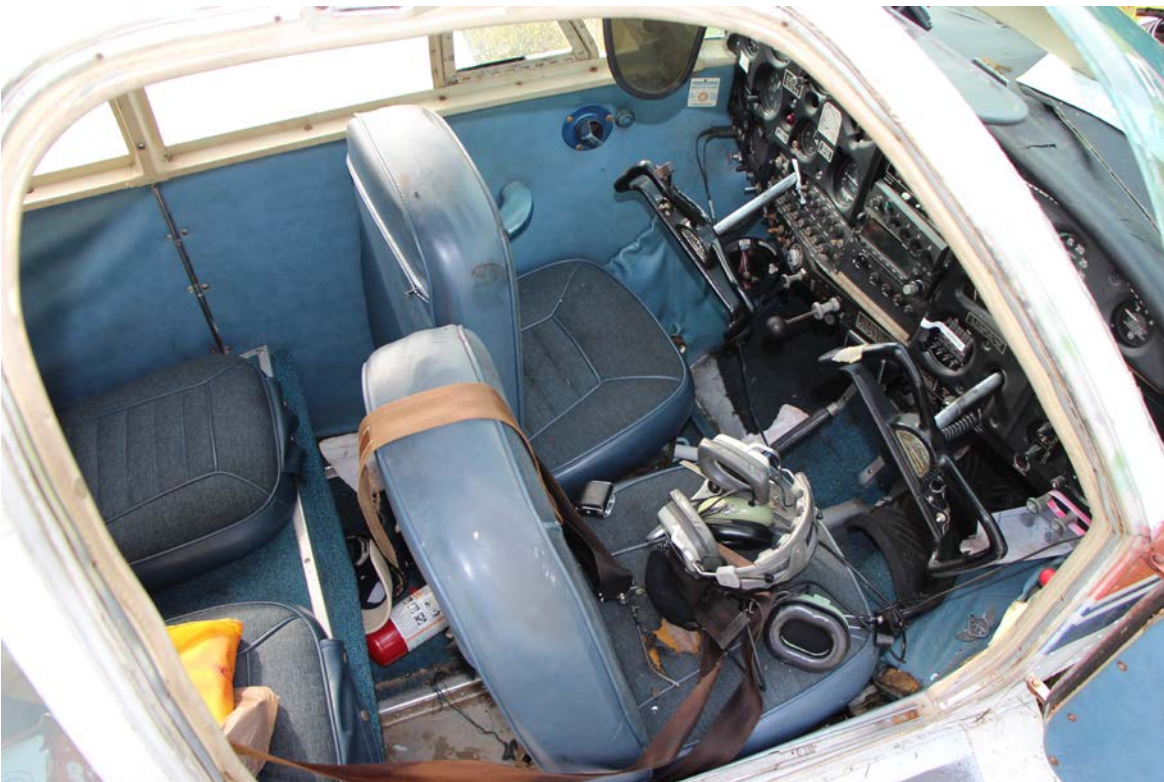
**Photo 4. Interior of N7031R.**

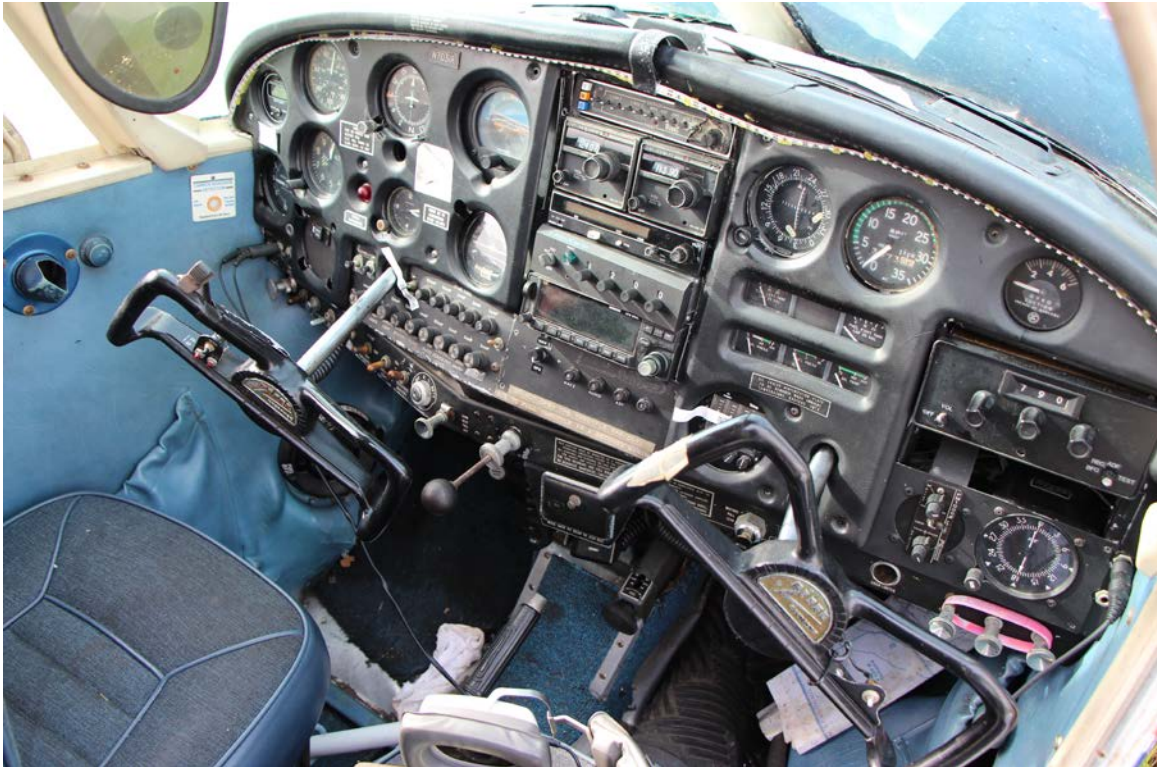
**Photo 5. Instrument panel of N7031R.**

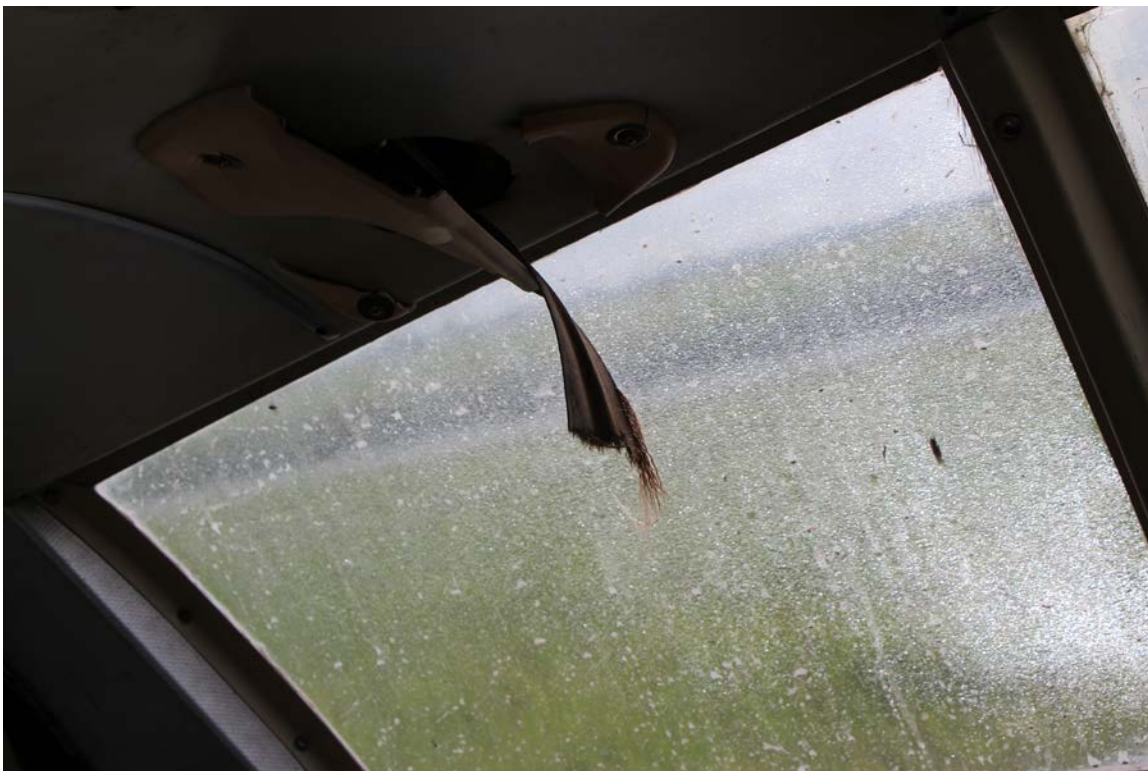
**Photo 6. Upper portion of pilot's shoulder harness.**

The pilot shoulder belt shown in the picture was definitely past due to be serviced due to the extreme fading condition. I suspect the faded section of the webbing is stiffer than the other sections. Also, I a [sic] suspect the fray on the top edge across the tear was a pre-existing condition before that accident.

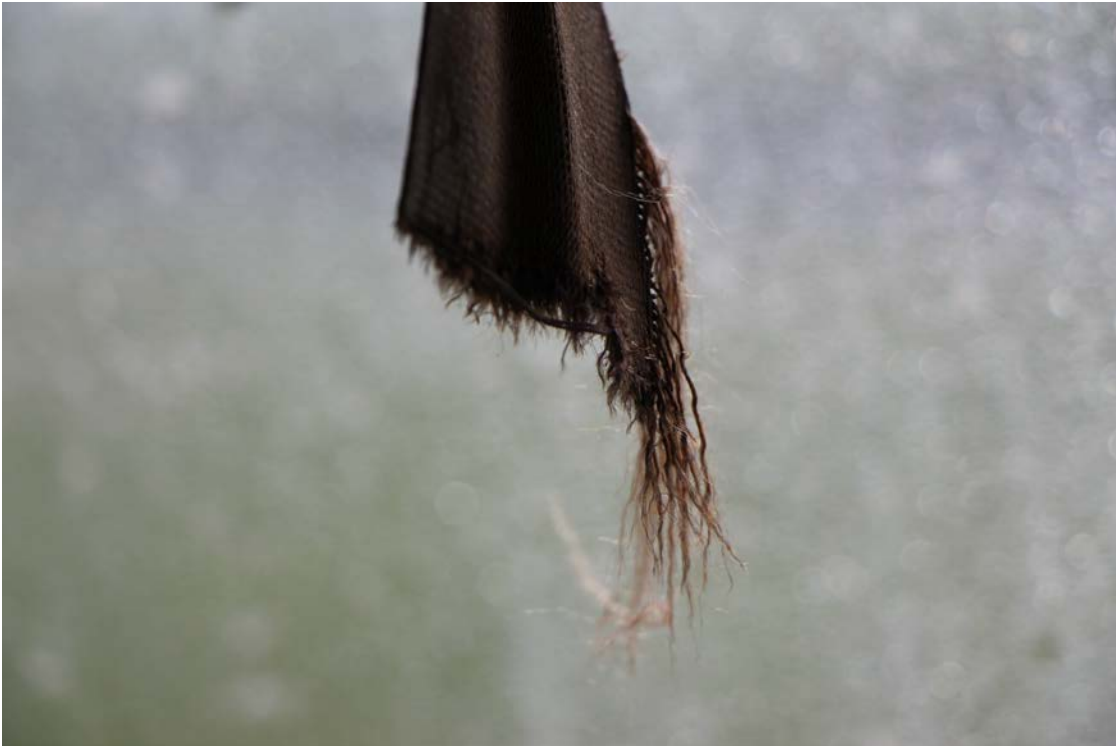
**Photo 7. Close-up of frayed end of pilot's shoulder harness.**

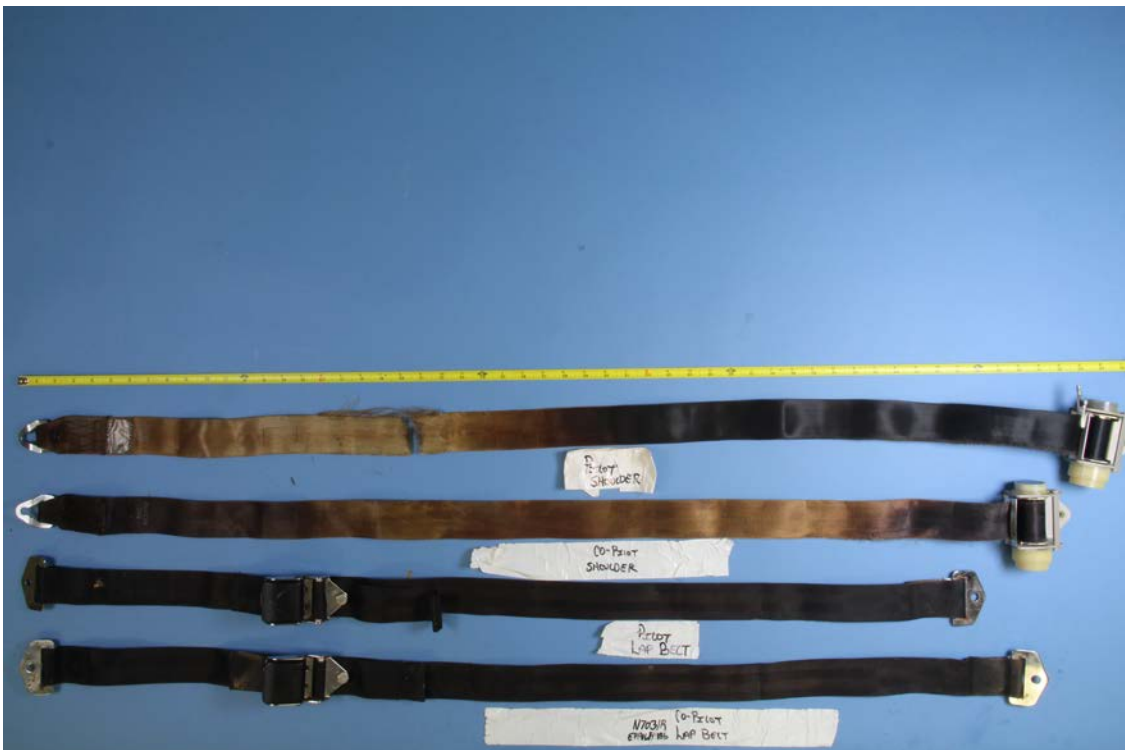
**Photo 8. Lapbelts and shoulder harnesses of both restraints.**

The Co-pilot shoulder belt would also qualify for needing service based on the photo.

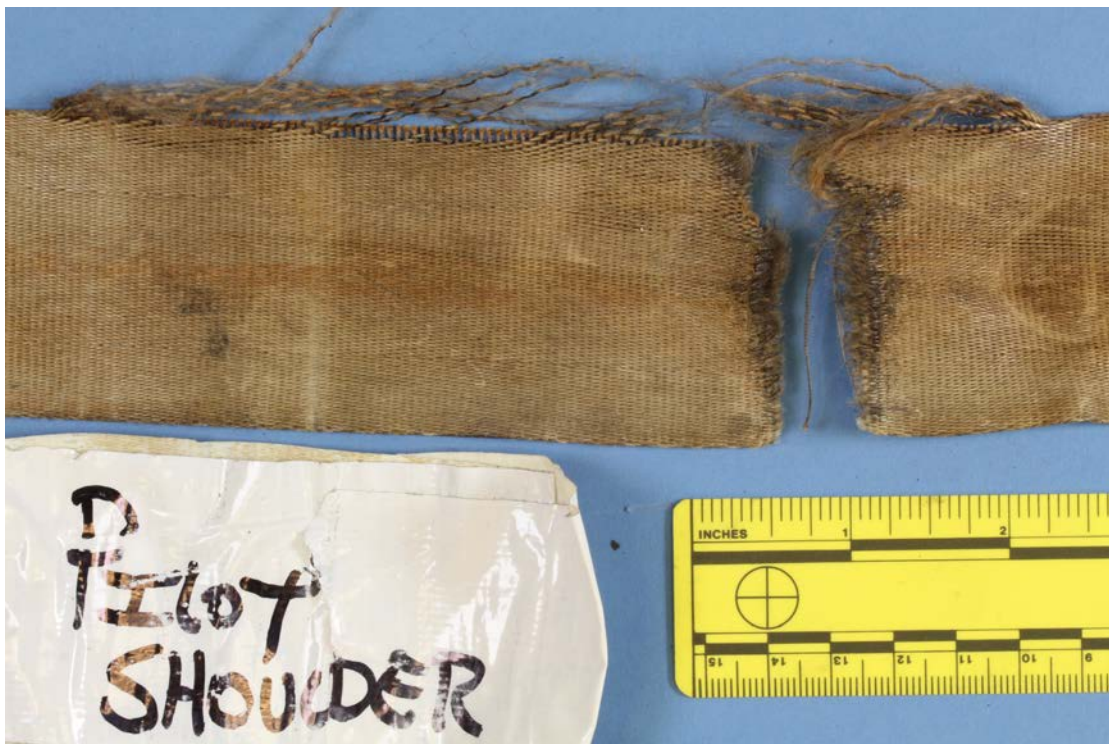
The pilot's seat was equipped with a three-point restraint system. The pilot's shoulder harness was manufactured by Pacific Scientific (P/N 1107447-05, rated strength 2000 lbs.). Equipped with an inertia reel and an end fitting designed to secure to a standoff button on the separate lapbelt, the belt webbing's total extended length was approximately 53 inches. The webbing retracted normally into the inertia reel. The distal 24 inches (the portion which did not retract into the inertia reel under normal conditions) of the shoulder harness webbing showed significant discoloration and fading. (see figure 8) The yellowed material in the discolored areas was noticeably stiffer and less pliable than that which retracted into the inertia reel, which appeared to be black in color. Some minor wear was noted on the edges of the belt that retracted into the inertia reel; however, there was a 6-inch section of significant abrasive wear approximately 15-21 inches from the distal end fitting. This section of wear involved the compromise of approximately 6 longitudinally woven threads (or 1/8 inch) at its deepest intrusion into the webbing. A complete transverse, frayed separation of the webbing was also noted at the point of deepest intrusion, approximately 20 inches from the distal end fitting. (see figure 9)

**Photo 9. Area of fraying and separation of the pilot's shoulder harness.**
