**Photo 1 – View of Wreckage Path Facing Opposite Direction of Travel (PSP)**

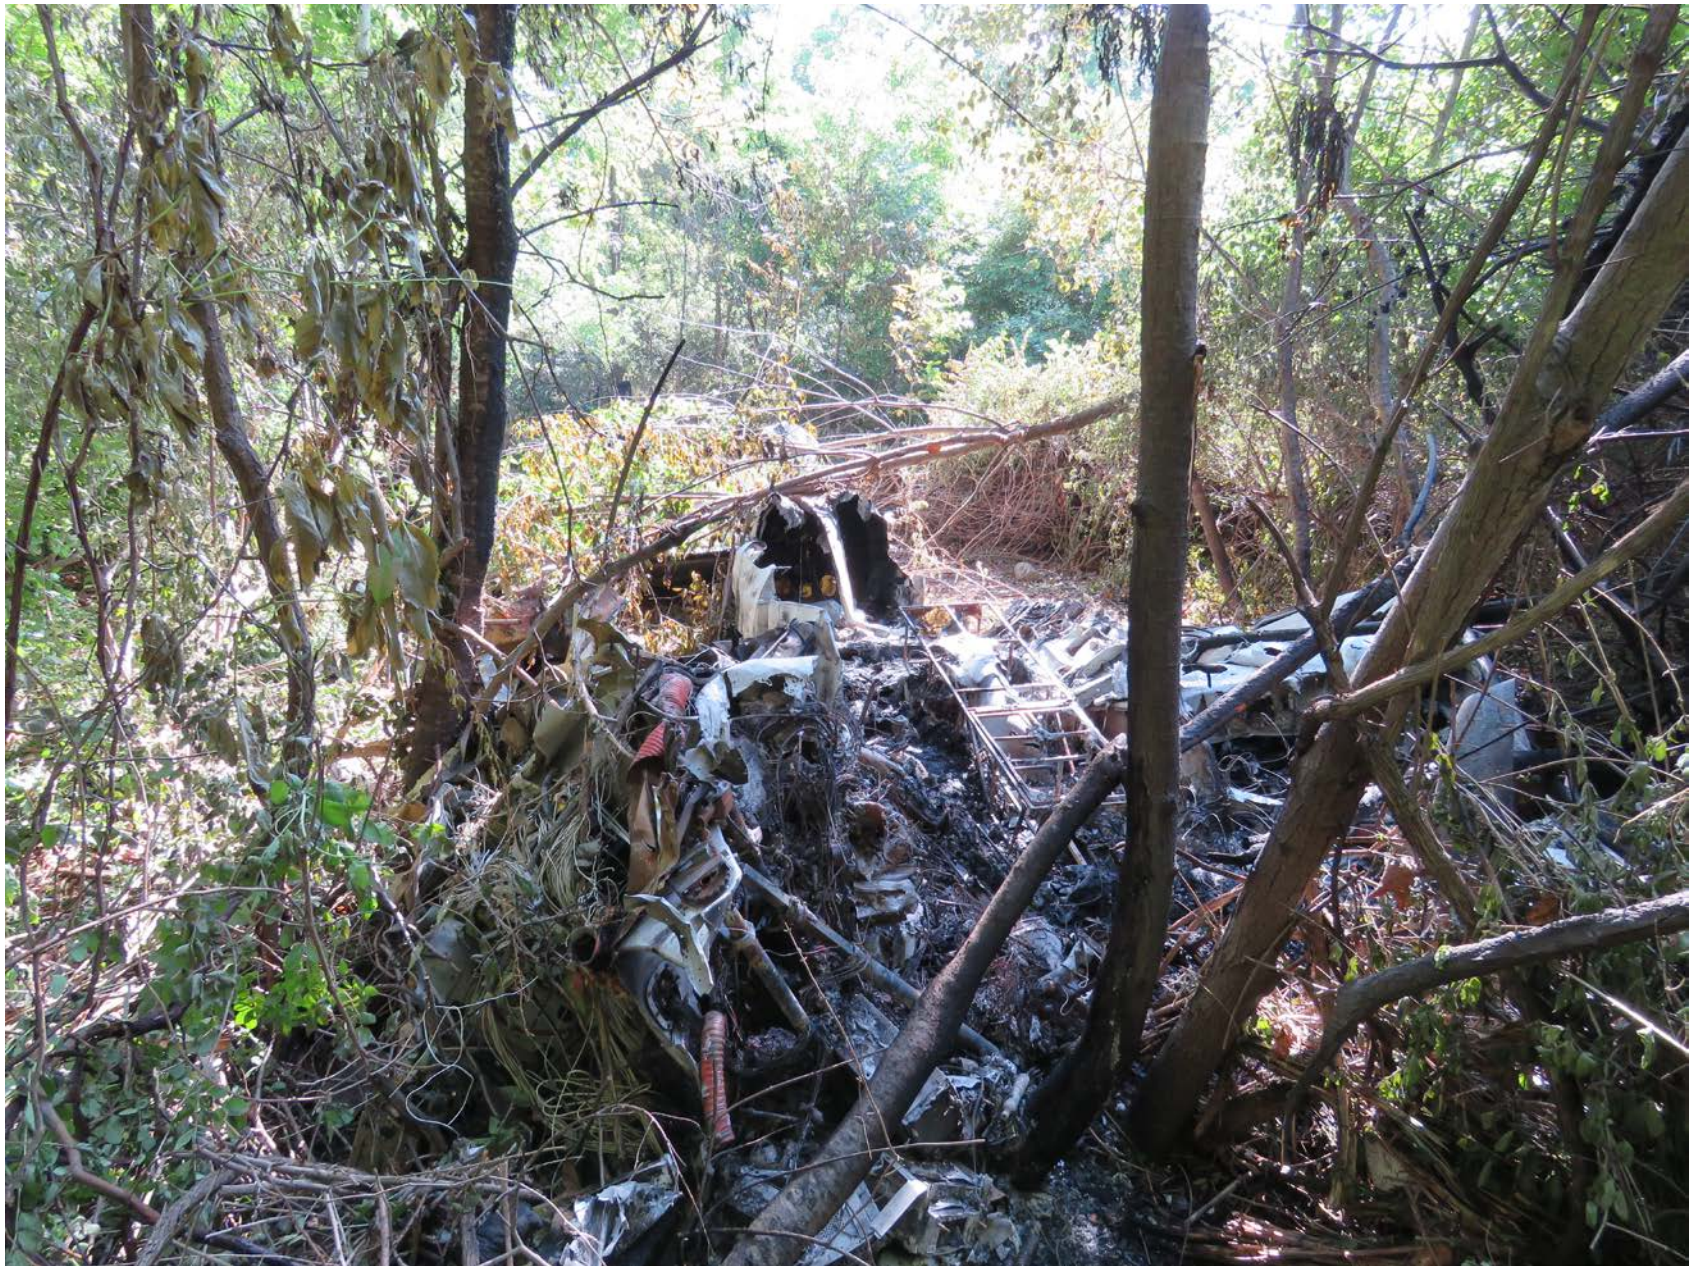
**Photo 2 – View of Main Wreckage Facing Opposite Direction of Travel (Lycoming)**

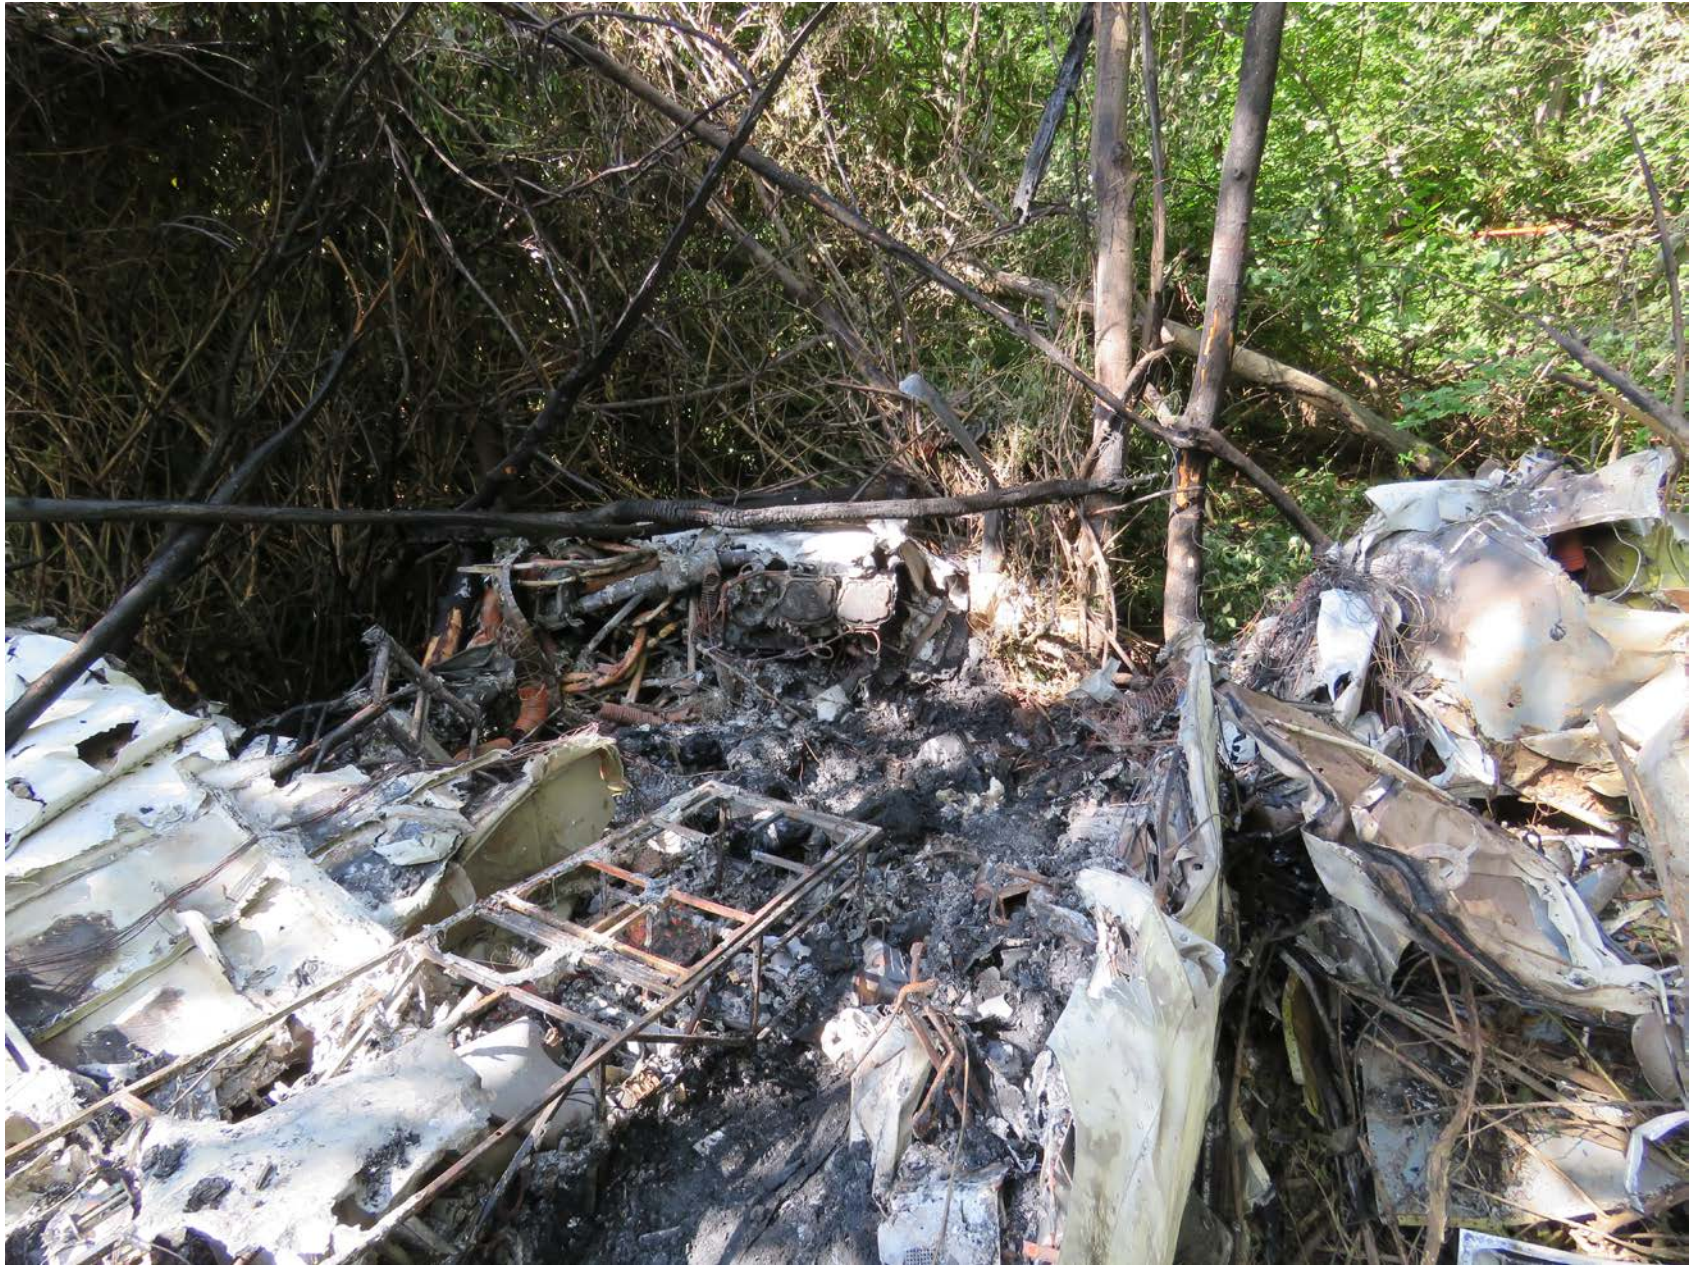
**Photo 3 – View of Cockpit Facing Direction of Travel (Lycoming)**

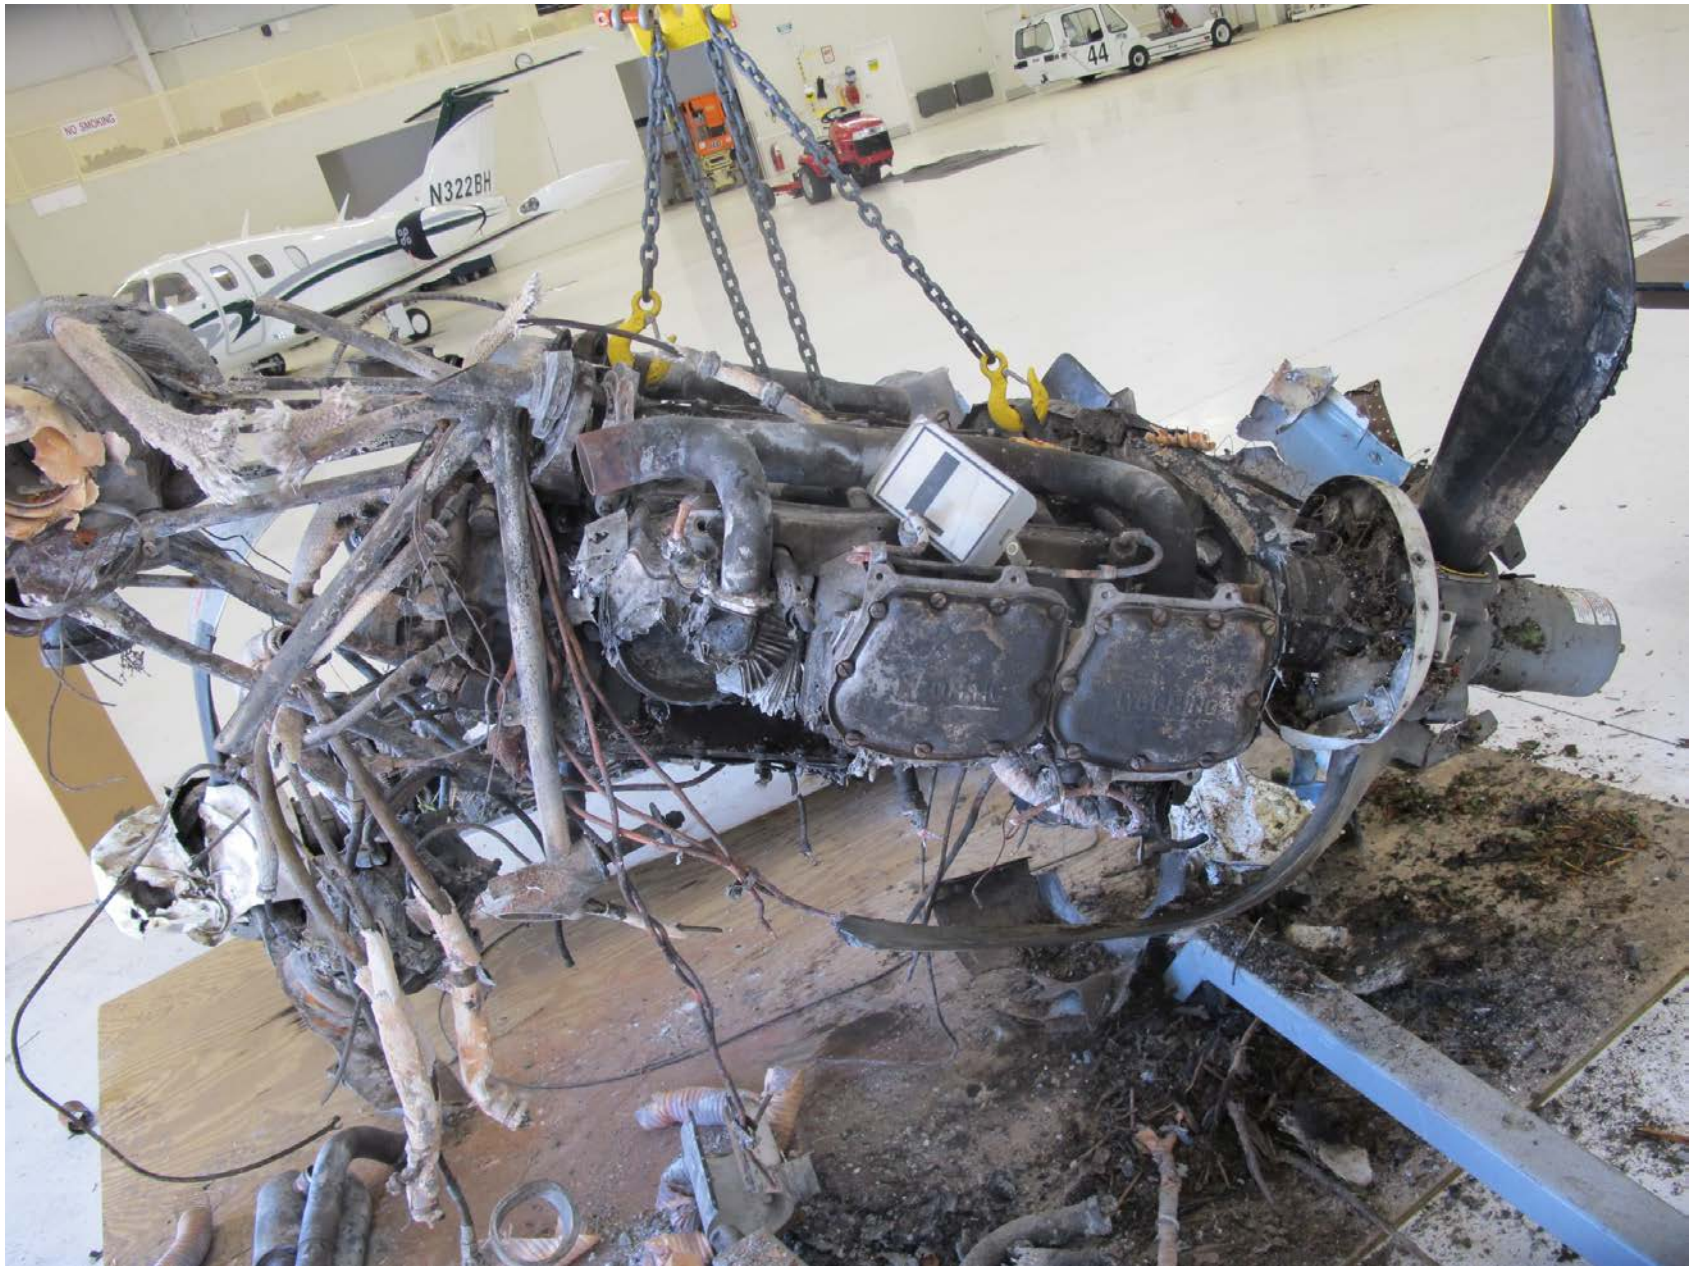
**Photo 4 – View of Left Engine After Recovery (Lycoming)**

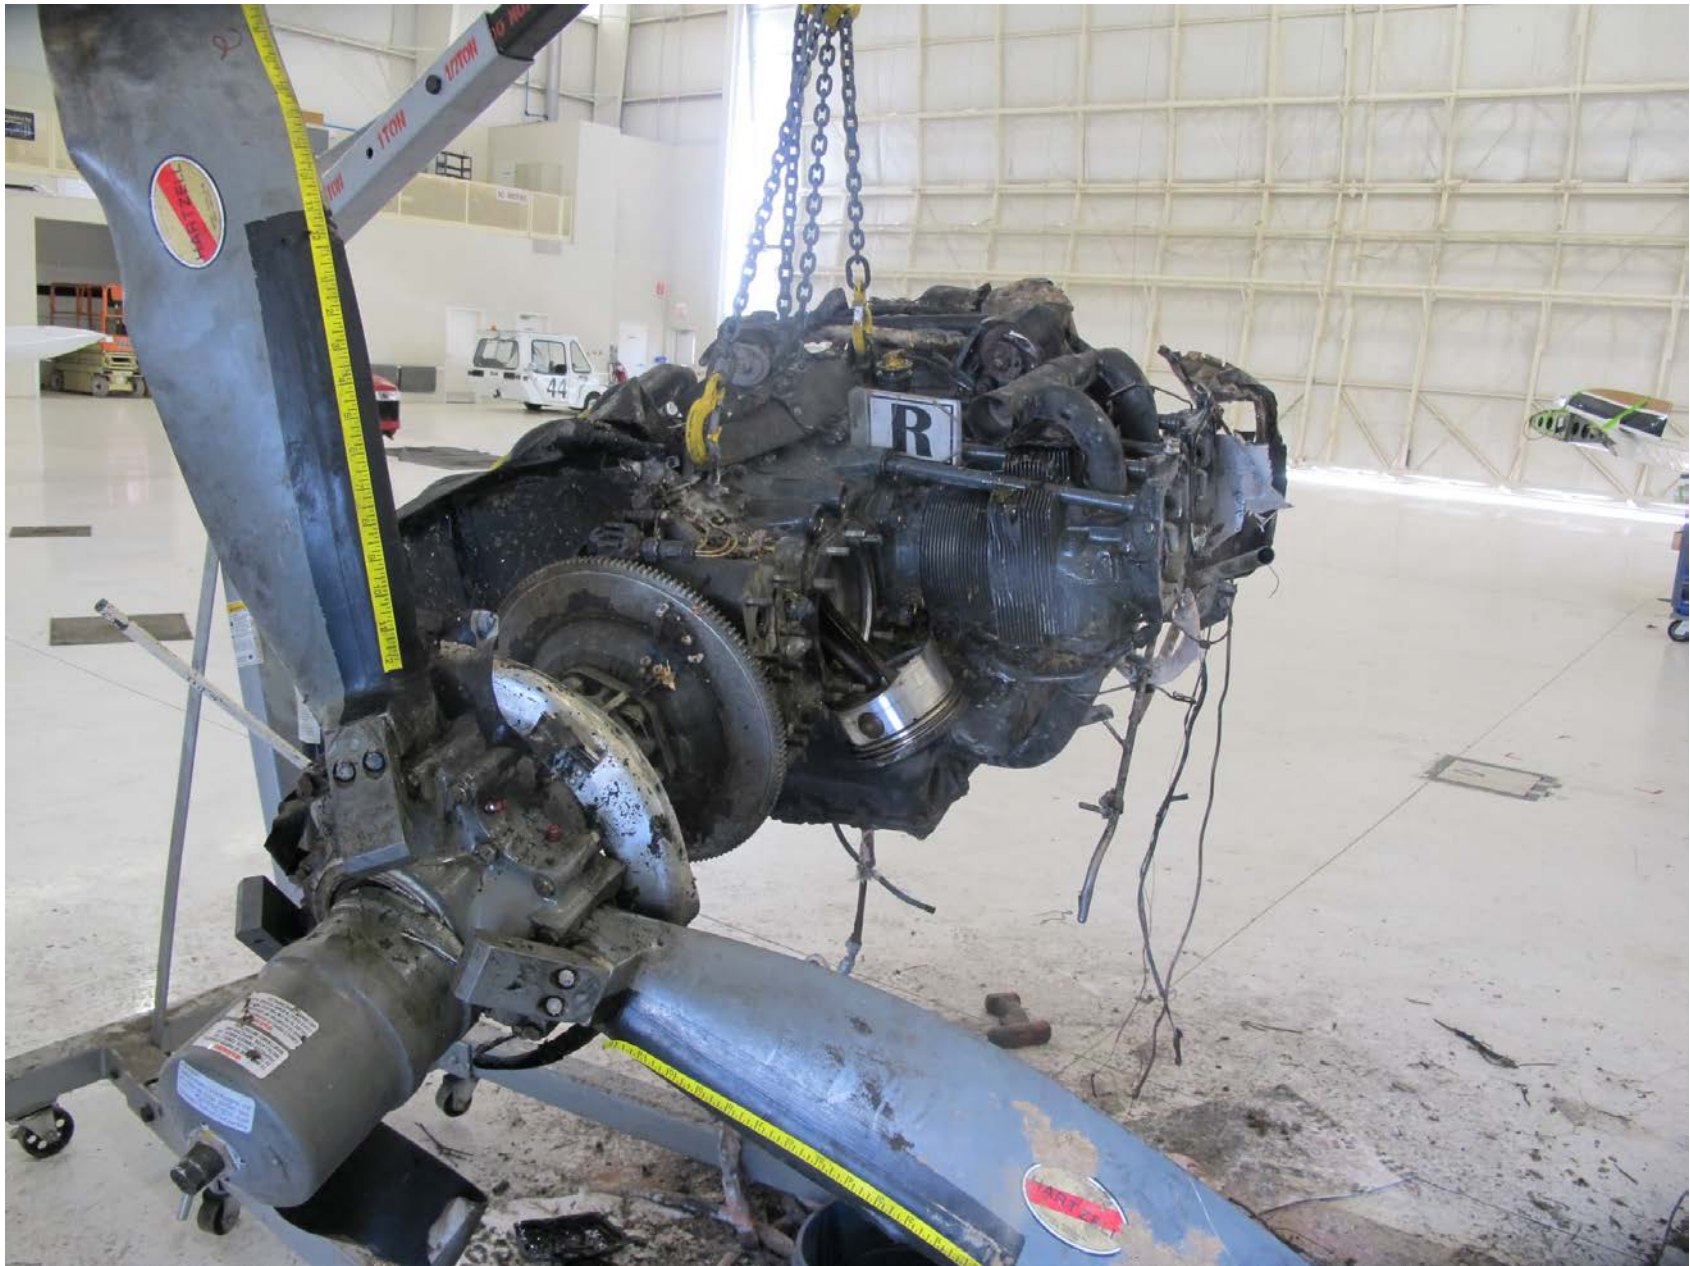
**Photo 5 – View of Right Engine After Recovery (Lycoming)**

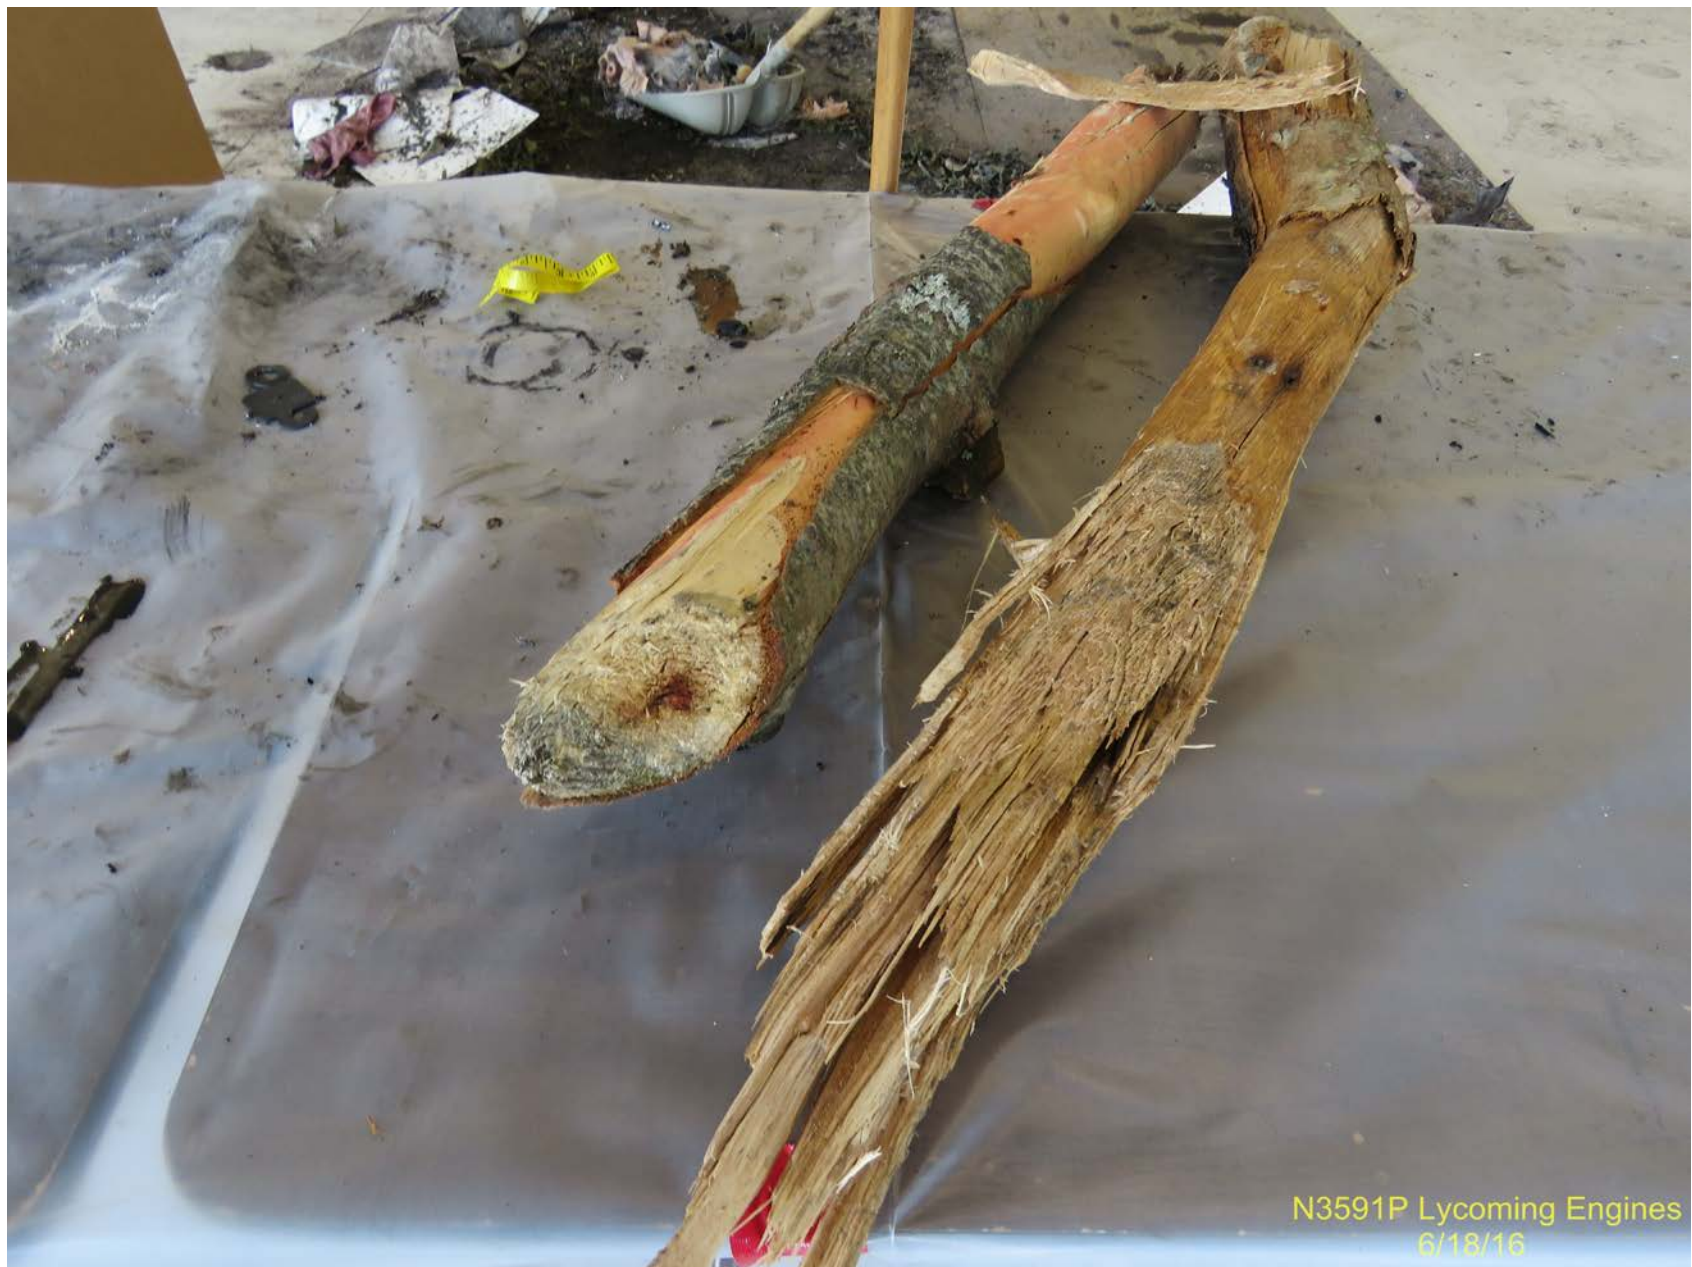
**Photo 6 – View of Angularly Cut Wood Recovered from Crash Site (Lycoming)**
