This is a record of interview with David Ingersoll, Airframe and Power plant mechanic at Tennessee Valley Authority (TVA) on 3 Aug 2016 at 2:25 pm at TVA Aviation facility (530 airport rd. Muscle Shoals AL 35662). The interview was conducted by Federal Aviation Administration, Aviation Safety Inspector Karlton R. White II at the request of National Transportation and Safety Board Investigator Ralph Hicks. The interview was conducted in regard to the accident involving helicopter N427TV, a Bell 407 sn.54106 that occurred on 11 July 2016 at 1123 CDT, at Hickory KY (NTSB # ERA16FA248) . The helicopter was operated by the TVA under public use but maintained to CFR part 91 standards. Bell Helicopter Illustrated parts breakdown (BHT-407-IPB) 67-99-00 p.77 figure 67-19 Rev.8 dated 30 Jan 2015 was used for reference during the interview, and was provided to Mr. Ingersoll.

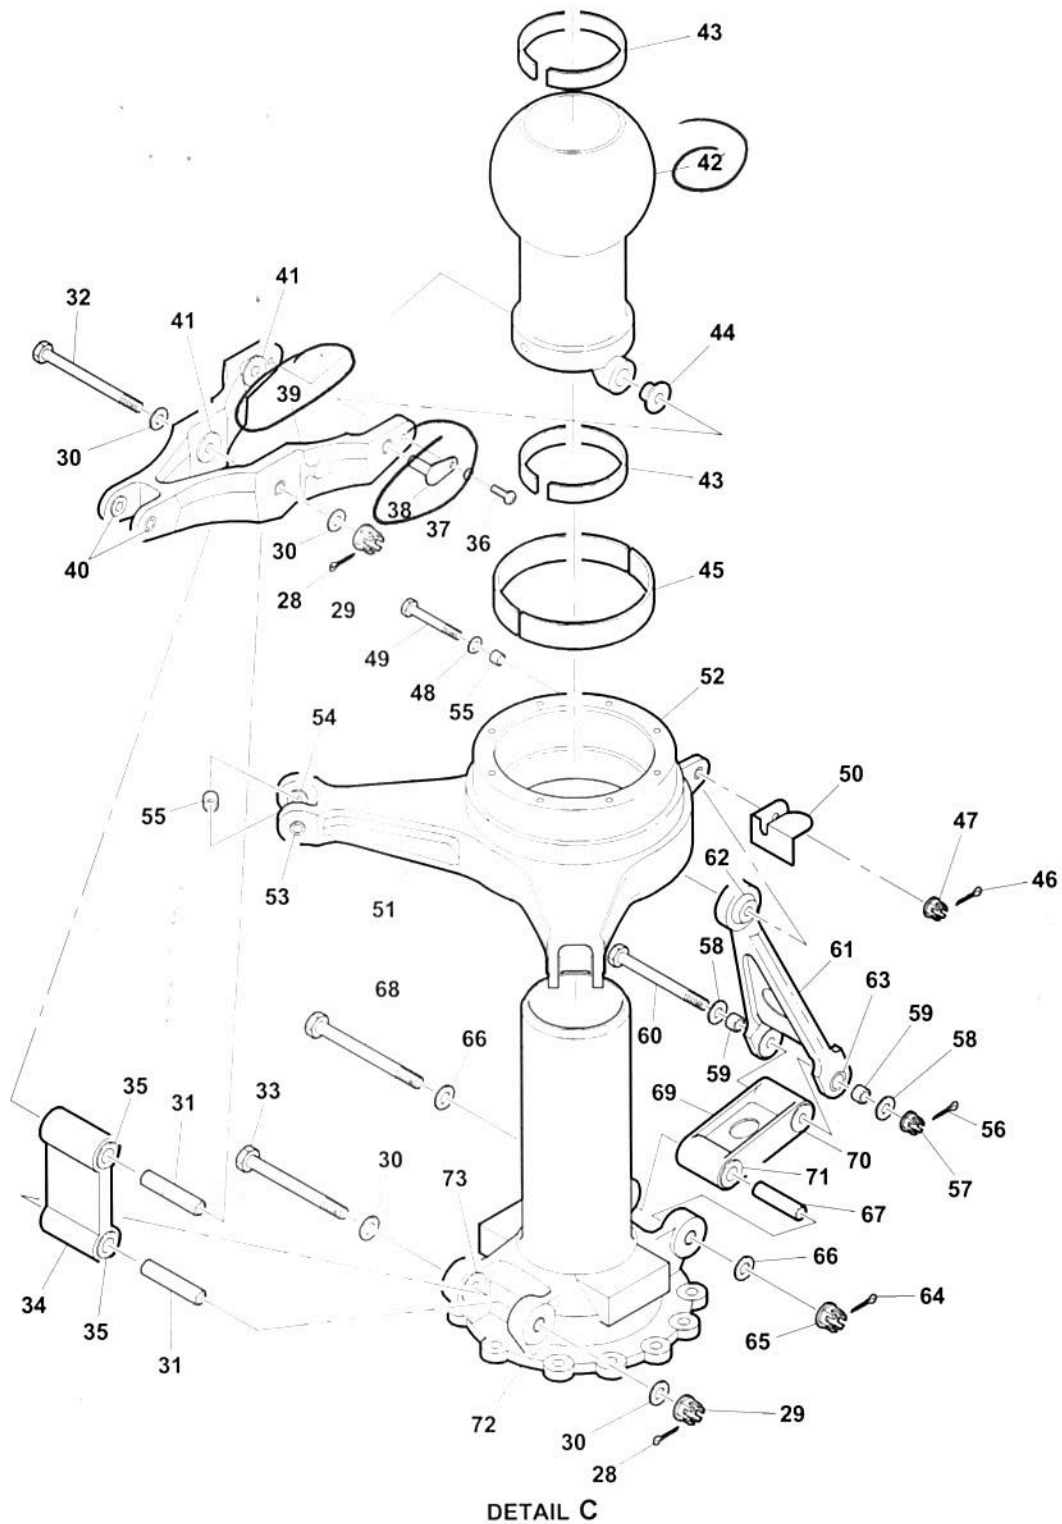
Figure 67-19. Swashplate and Support Assembly (S/N 53000 Thru 54299, 54300 and Subsequent)  
(Sheet 2 of 2)

- 1) Was the pivot sleeve removed? ( item 42, 67-99-00 p.77)  
Mr. Ingersoll stated, "No, it was not for this inspection."
- 2) Does anyone remember removing the pivot pin on the collective lever assembly? (item 38, 67-99-00 p.77)  
Mr. Ingersoll stated, "No."

- 3) Is there any reason why anyone would have removed Collective lever pivot pin? (item 38, 67-99-00 p.77)  
Mr. Ingersoll stated, "No, I don't remember doing it. If anyone would have done it, it would have been me, but I don't remember doing it."  
Mr. Ingersoll further stated he doesn't remember ever doing it on a 24 month flight control inspection or tilt friction check.

- 4) Were there any issues or problems with performing:
  - a) 24 month flight control bolt inspection -(Item 71, 67-99-00 p.77) Mr. Ingersoll stated "The teflon was worn on the anti drive lever."

Mr. Ingersoll stated, He does not remember removing pins (item 38, 67-99-00 p.77), but says that, if anyone would have removed them it would have been him. After much review, he still has no recollection of doing it, or why it would have been done. He further stated he does not believe it was someone else. He says he was the only mechanic for 6 months prior to Jose's (Arriola) arrival.
