This is a record of interview with Gordon Richey, Airframe and Power plant mechanic and Director of Maintenance at Tennessee Valley Authority (TVA) on 3 Aug 2016 at 1:09 pm at TVA Aviation facility (530 airport rd. Muscle Shoals AL 35662). The interview was conducted by Federal Aviation Administration, Aviation Safety Inspector Karlton R. White II, at the request of National Transportation and Safety Board Investigator Ralph Hicks. The interview was conducted in regard to the accident involving helicopter N427TV, a Bell 407 sn.54106 that occurred on 11 July 2016 at 1123 CDT, at Hickory KY (NTSB # ERA16FA248). The helicopter was operated by the TVA under public use but maintained to CFR part 91 standards. Bell Helicopter Illustrated parts breakdown (BHT-407-IPB) 67-99-00 p.77 figure 67-19 Rev.8 dated 30 Jan 2015 was used for reference during the interview, and was provided to Mr. Richey.

This statement is in reference to the work performed on N427TV under TVA Work Order # 1302 with regards to subject area of investigation.

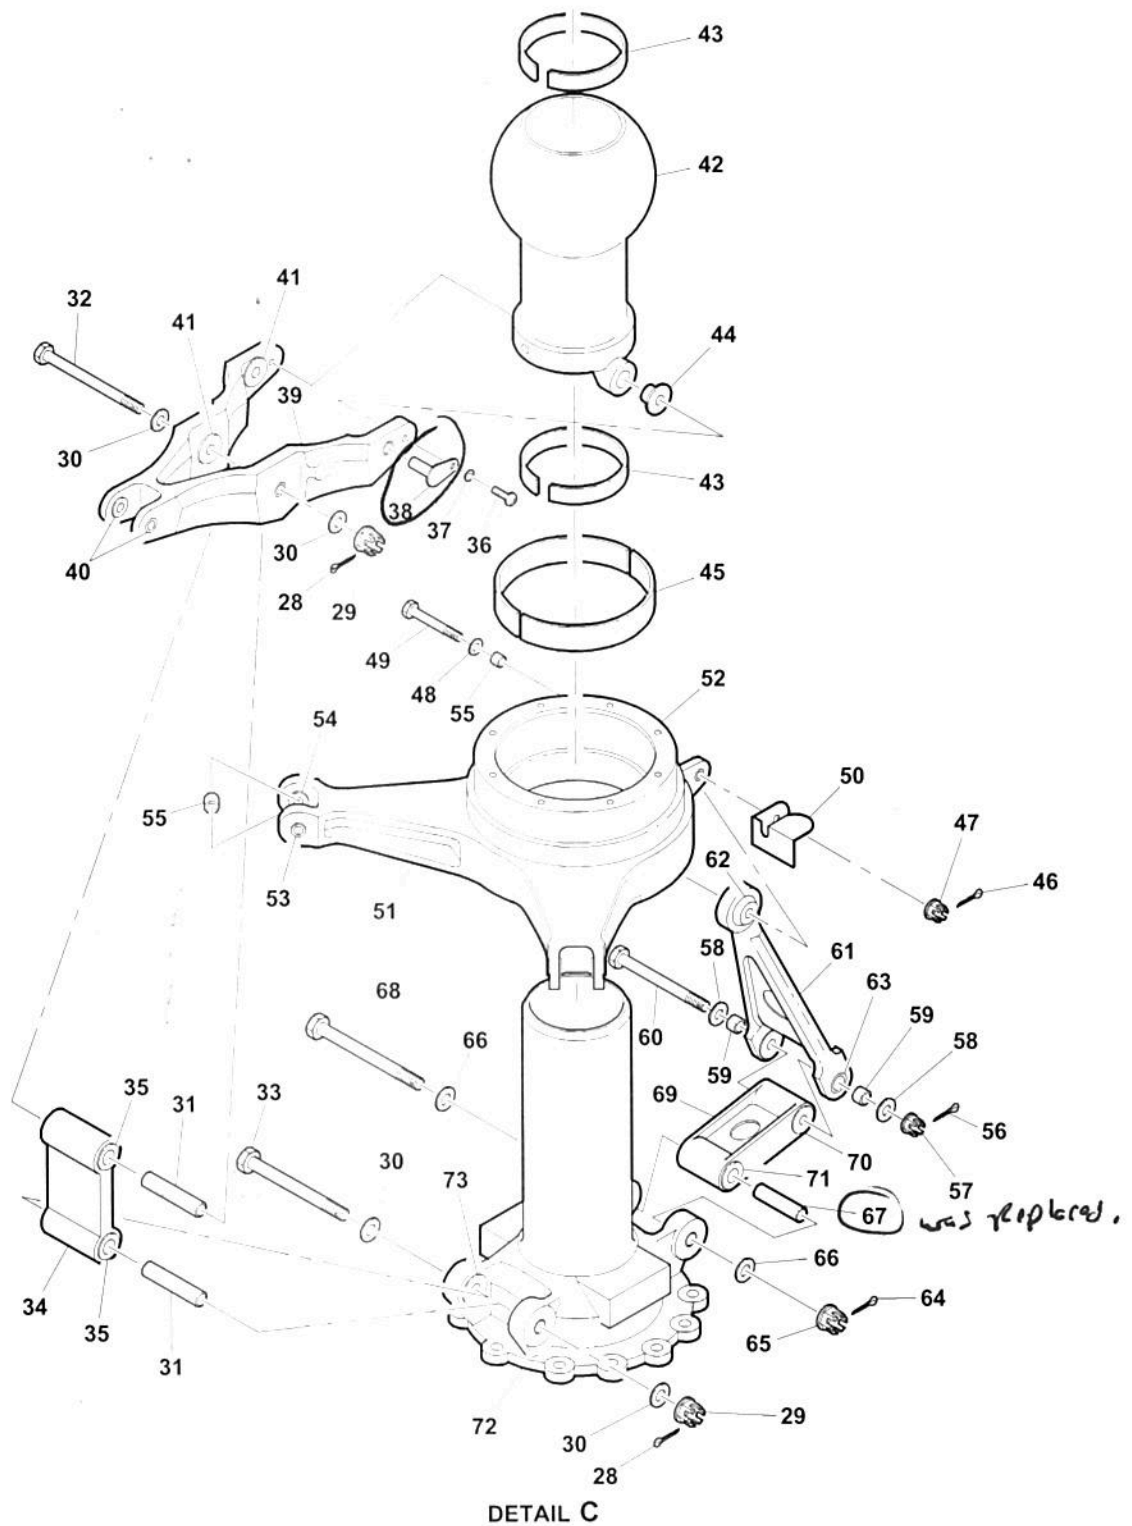
Figure 67-19. Swashplate and Support Assembly (S/N 53000 Thru 54299, 54300 and Subsequent)  
(Sheet 2 of 2)

A) First scenario, removed all cotter pins and cut wire on pins (pivot, item 38, 67-99-00 p.77) and forgot to install wire on pins after completing 24 month inspection.

B) Second, removed bolts and cotter pins for 24 month inspection and removed pins (pivot, item 38, 67-99-00 p.77) to look at them, and "Just run them in by hand", but forgot to torque/safety since it's not part of that inspection.

TVA mechanic David Ingersoll complied with the inspection of the swashplate assembly. I did not specifically inspect for the safety wire installation on the collective lever pivot pins as they were not required to be removed for the inspection nor were they noted as being removed for maintenance.
