# STATEMENTS

**REASON FOR STATEMENT: ACCIDENT INVESTIGATION N5940 7-25-2016 9:45 EST**

Witness Derek Hayes as told to ASI Stewart Beck  
7-25-16 N5940 YAK II

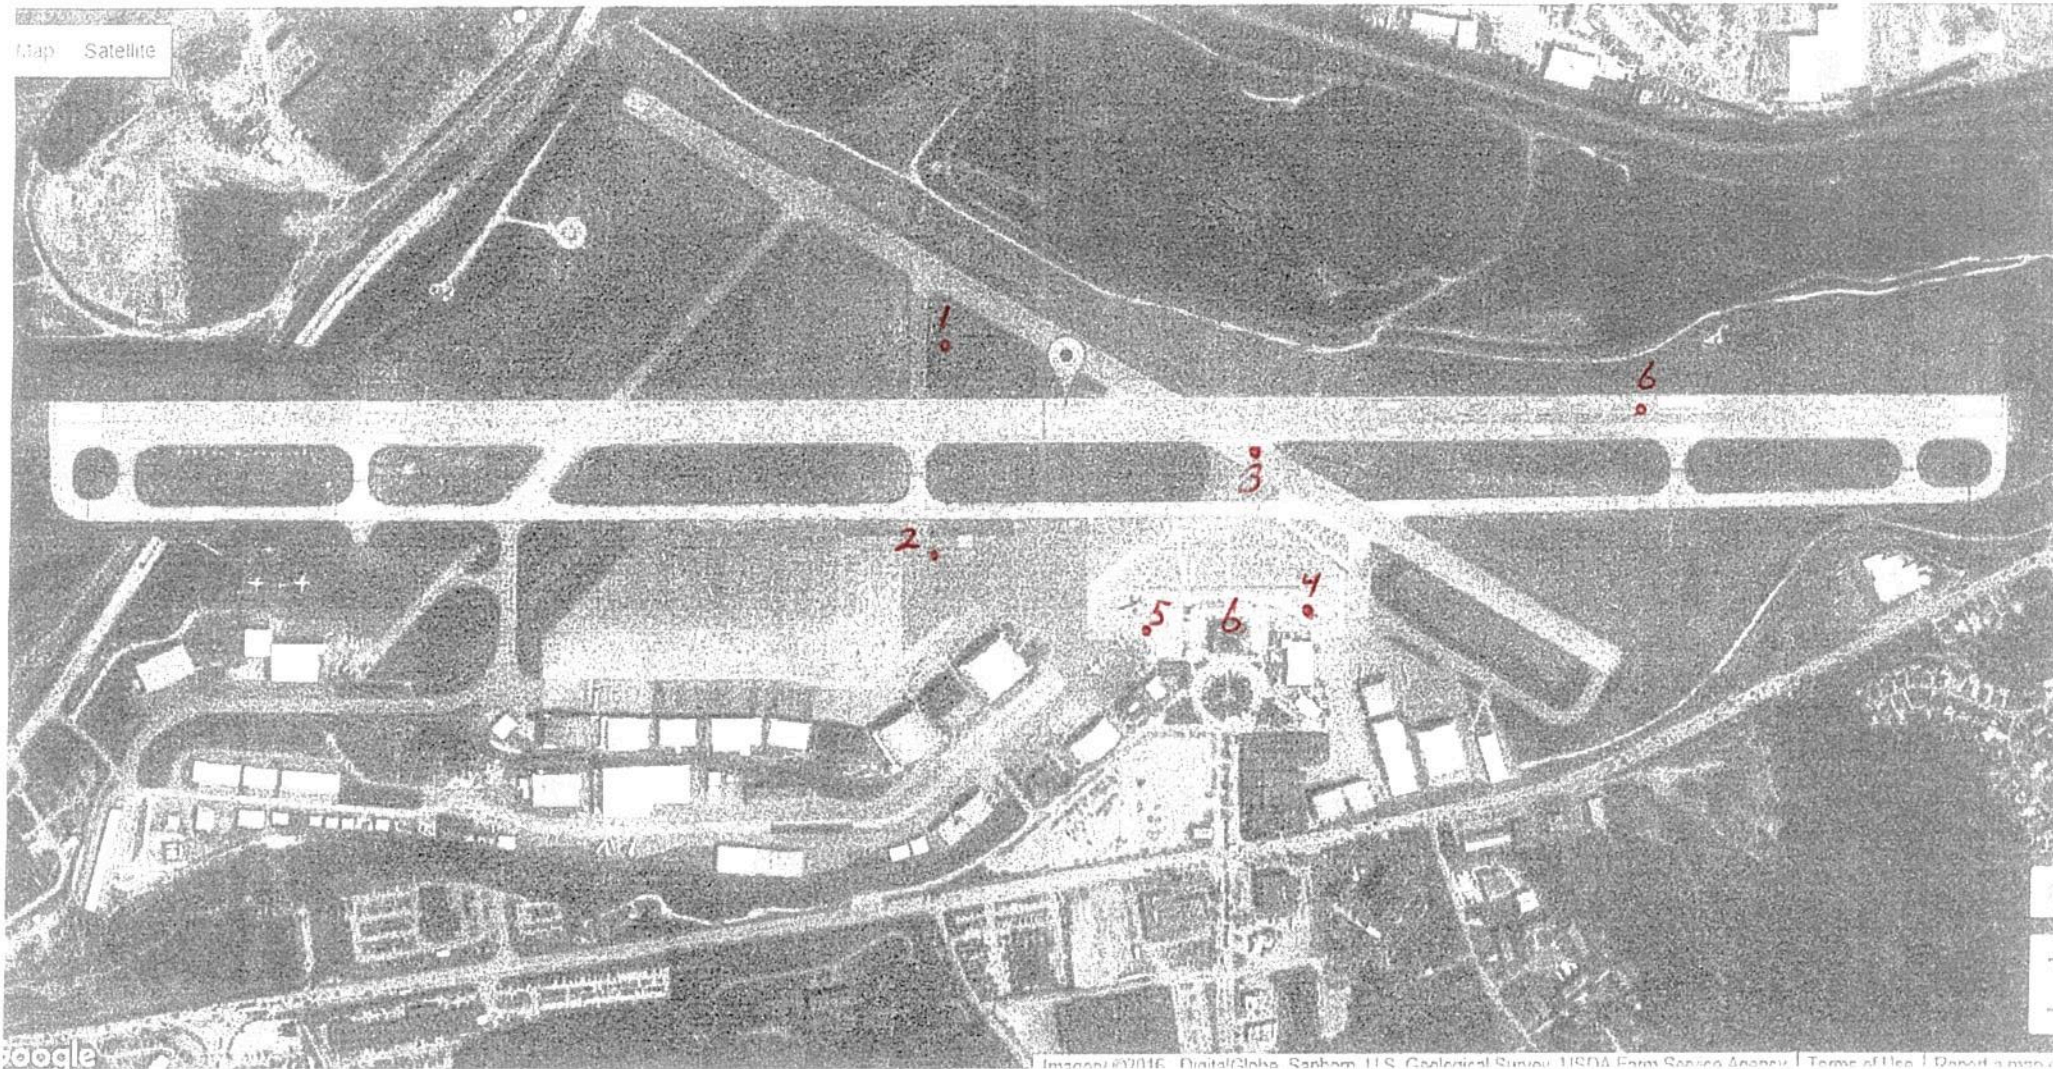
- 1 A/C came to rest
- 2 Mr. Hayes
- 3 Taxiway Charlie

4. Mr. Graham
5. Mr. Wilson
6. Tower

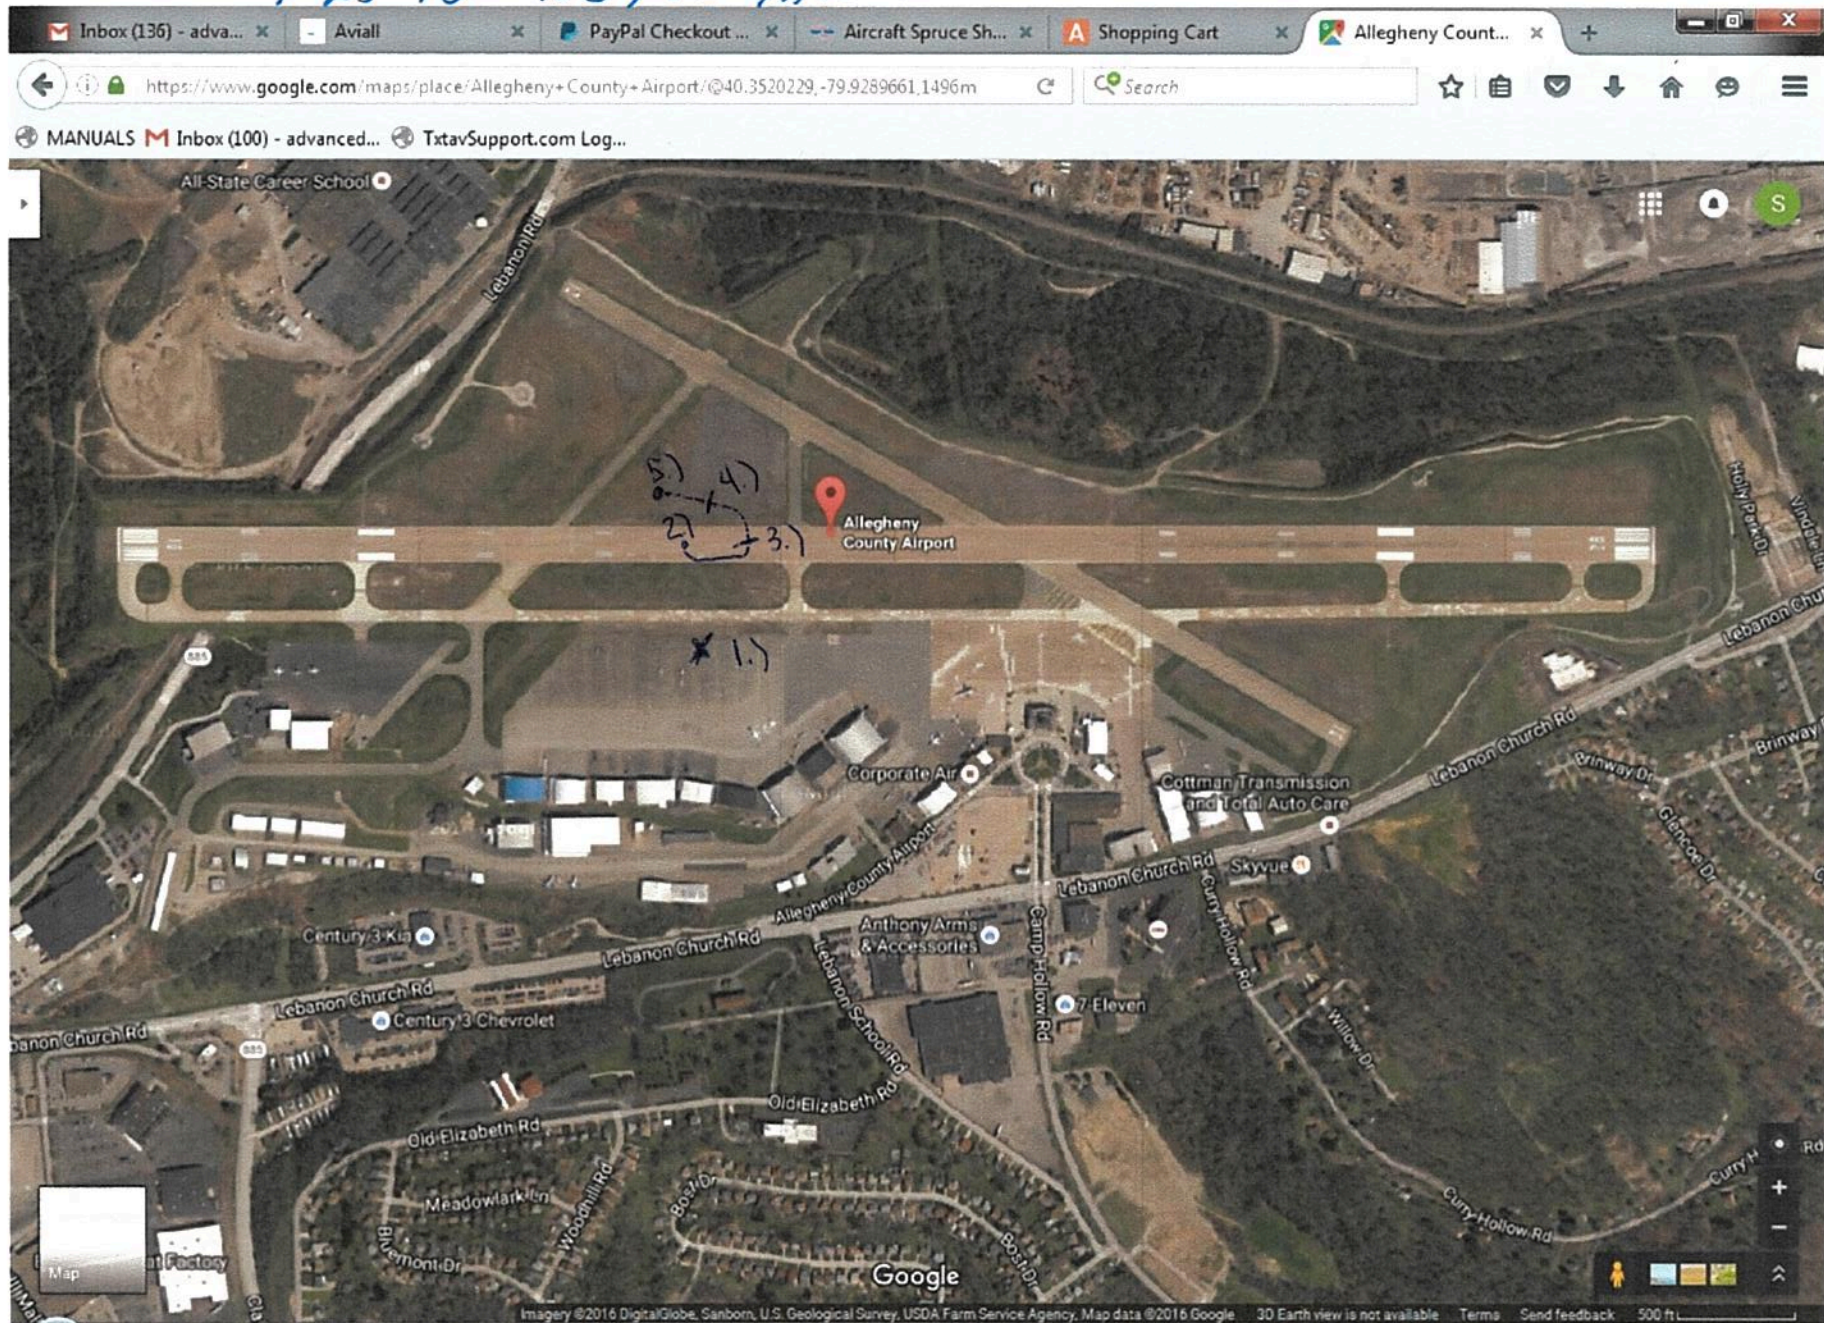
1.) My location

2.) Initially seen aircraft

3.) Seen a single flame

4.) Pilot exiting aircraft

5.) Aircraft stops
