**NATIONAL TRANSPORTATION SAFETY BOARD**

**MATERIALS LABORATORY FIRE FACTUAL REPORT**

Report No. 18-023

Place : West Mifflin, Pennsylvania  
Date : July 25, 2016  
Vehicle : Yakovlev 11  
NTSB No. : ERA16FA269  
Investigator : Todd Gunther AS-ERA

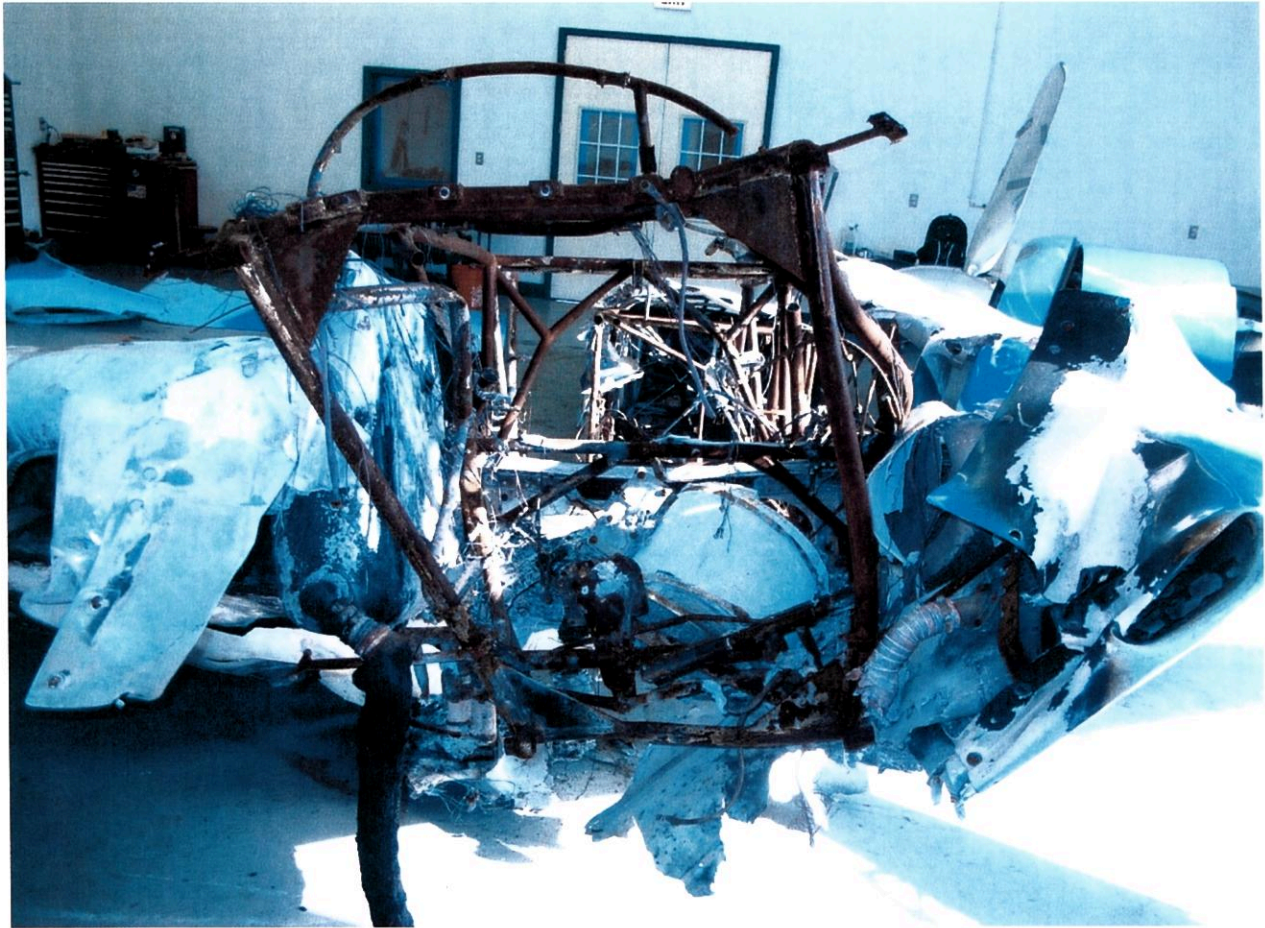
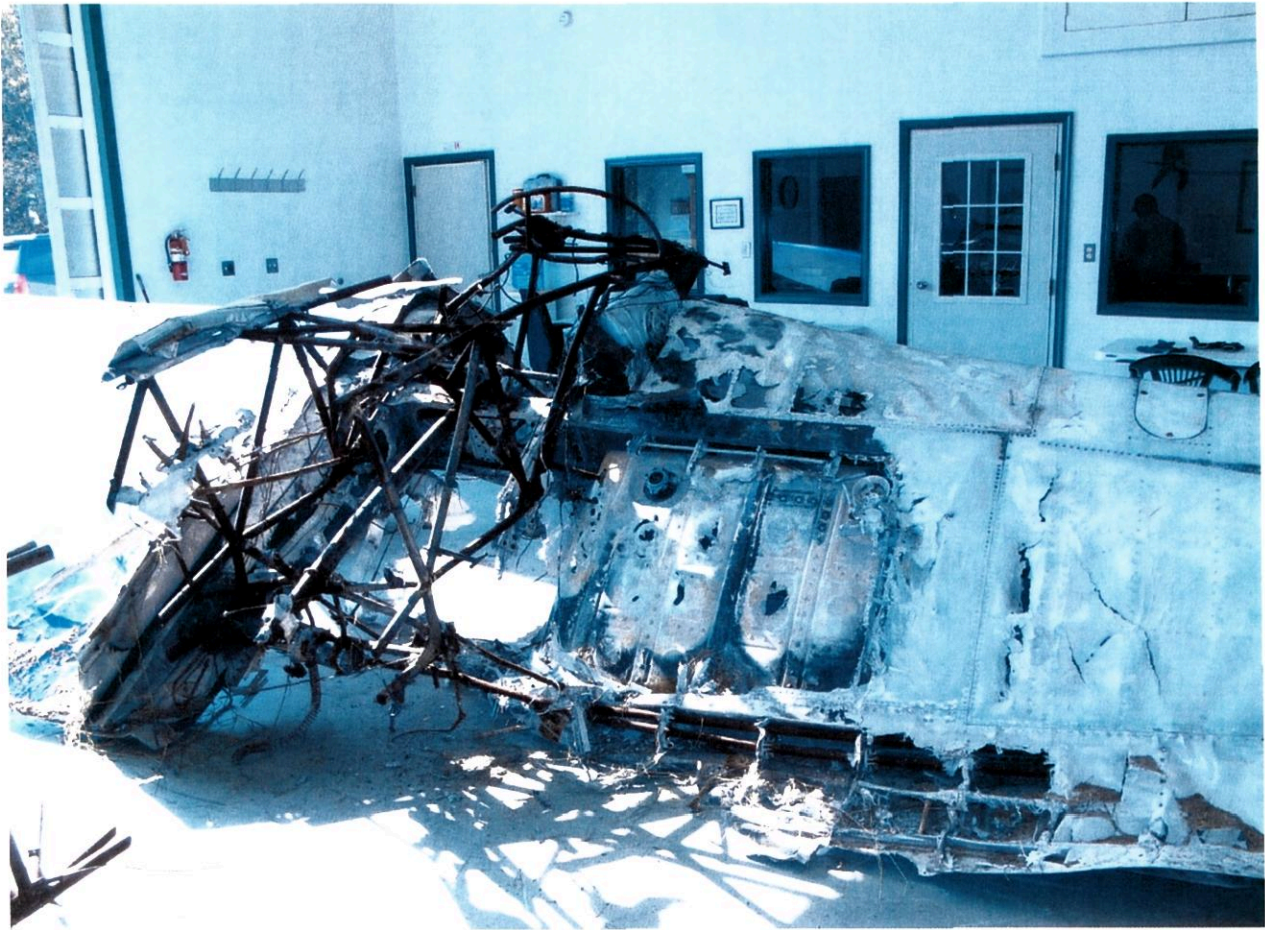
The metal and fabric fuselage skin in the areas of the cockpit, right wing, left wing root and forward portion of the empennage had been consumed by fire as shown in Figures 1 and 2. The cockpit was completely destroyed. The remaining metallic skin on the outboard section of the right wing and empennage exhibited extensive thermal damage—melting, oxidation of aluminum surfaces and brittleness. The wreckage was sooted with areas of vertically oriented resolidified globules of aluminum aircraft structure. The tail section, engine cowlings and the left wing were intact as shown in Figure 3.

Figure 1. Photograph of cockpit (facing aft).

Figure 2. Photograph of cockpit and inboard section of right wing (facing forward).

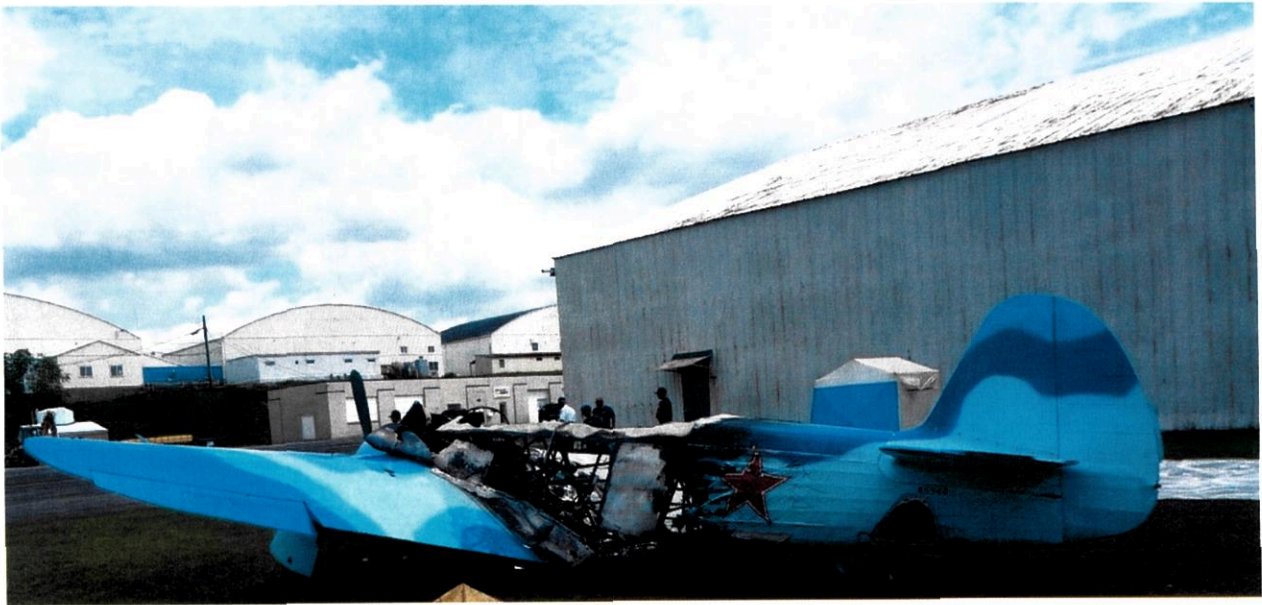
Figure 3. Photograph of left side of aircraft.

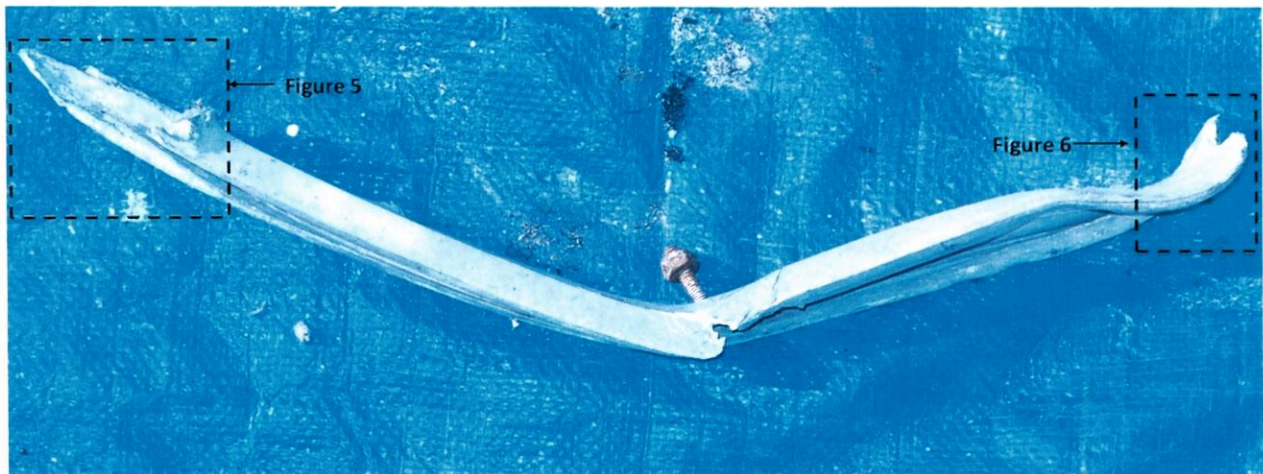
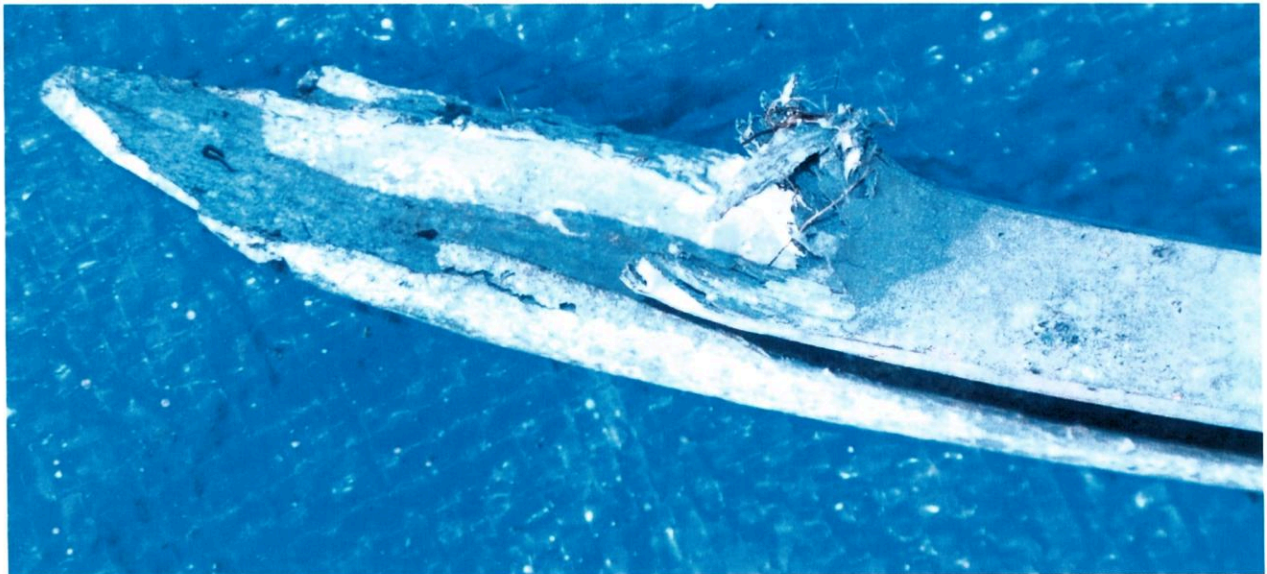
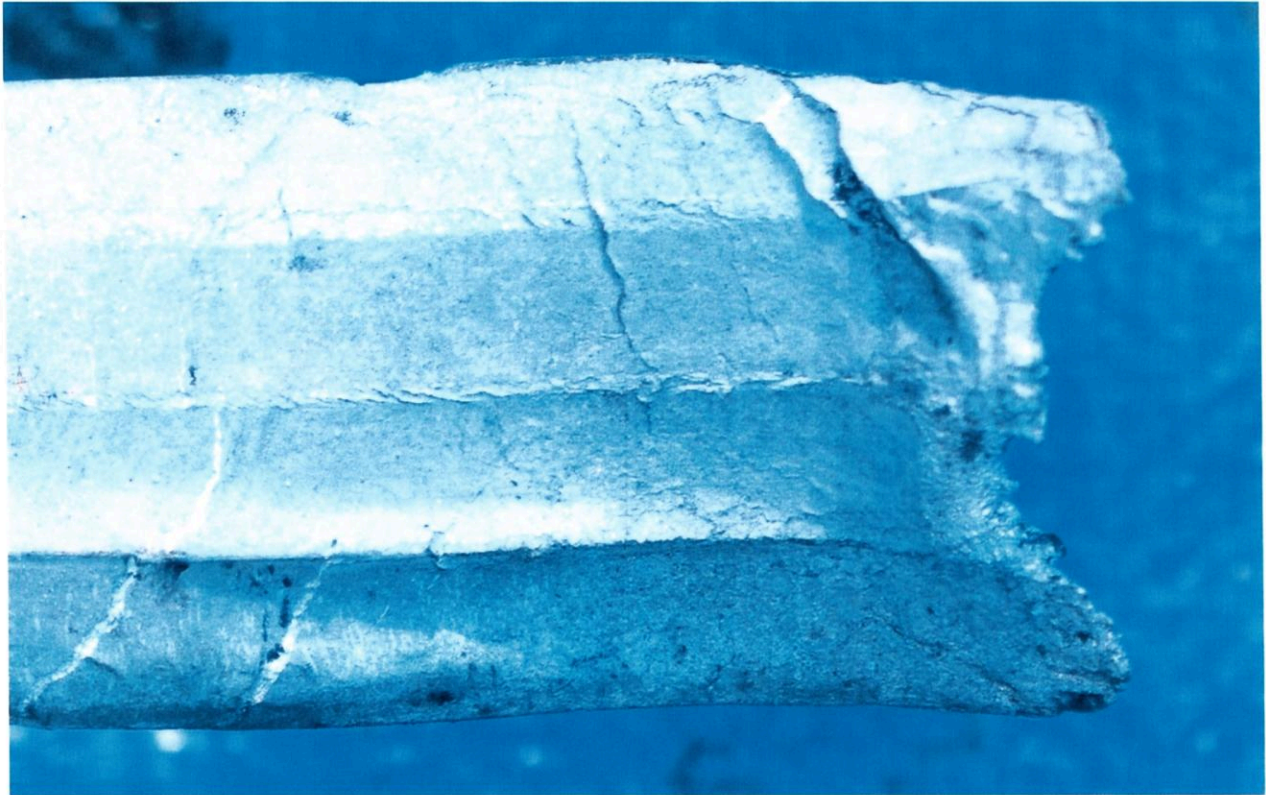
A section of aircraft structure was found separated from the wreckage displayed evidence of broomstrawing on both ends of the section shown in Figures 4-6<sup>1</sup>.

<sup>1</sup> Broomstrawing is a fire signature where a near-molten aluminum component subjected to a shock loading (e.g., impact) can take on the physical appearance of broomstraw or feather-like appearance.

Figure 4. Section of aircraft structure with broomstrawed ends.

Figure 5. Closeup photograph of one of broomstrawed end.

Figure 6. Closeup photograph of broomstrawed end.

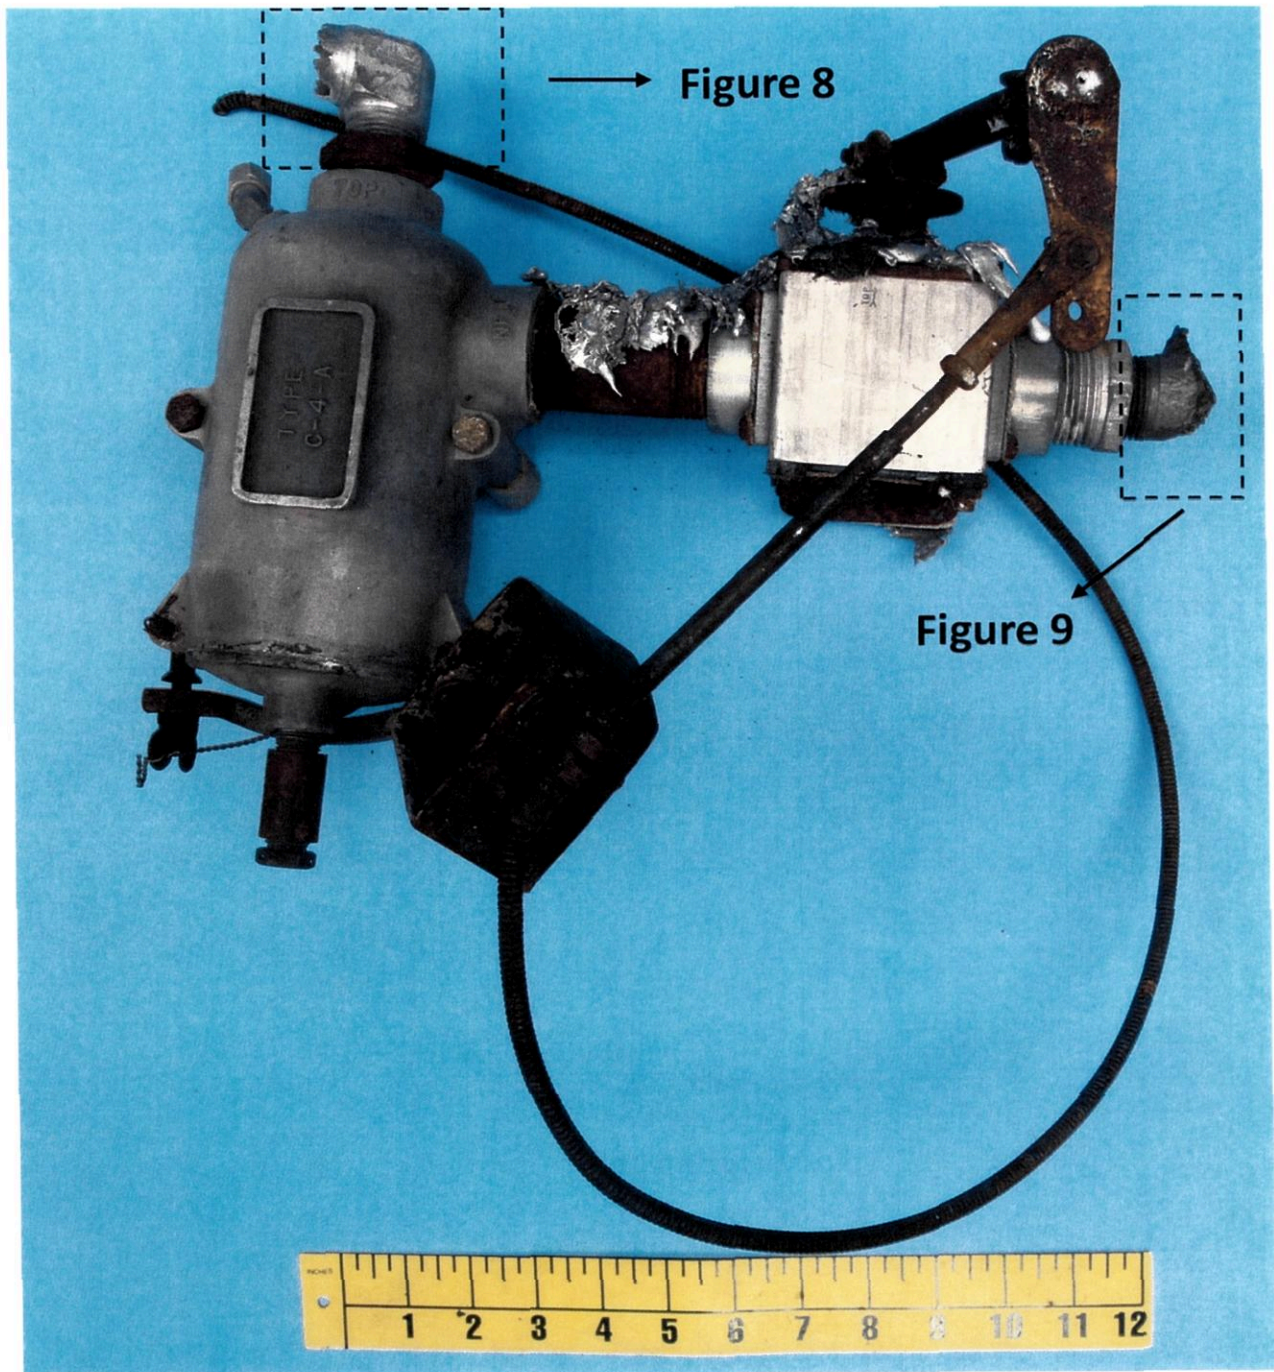
The fuel strainer fuel and shutoff valve unit is shown in Figure 7. There was no thermal damage to the main body of the unit. The outlet located near the top of the strainer section had a small section of aluminum fuel line still attached as shown in Figure 8. The section end exhibited high temperature deformation on the fracture surfaces as well as some areas indicative of overstress. The inlet located near the shutoff valve section also had a small section still attached as shown in Figure 9. The section end exhibited melting and thinning consistent with exposure to high temperatures.

Figure 7. Photograph of C-4-A fuel strainer and fuel shutoff valve.

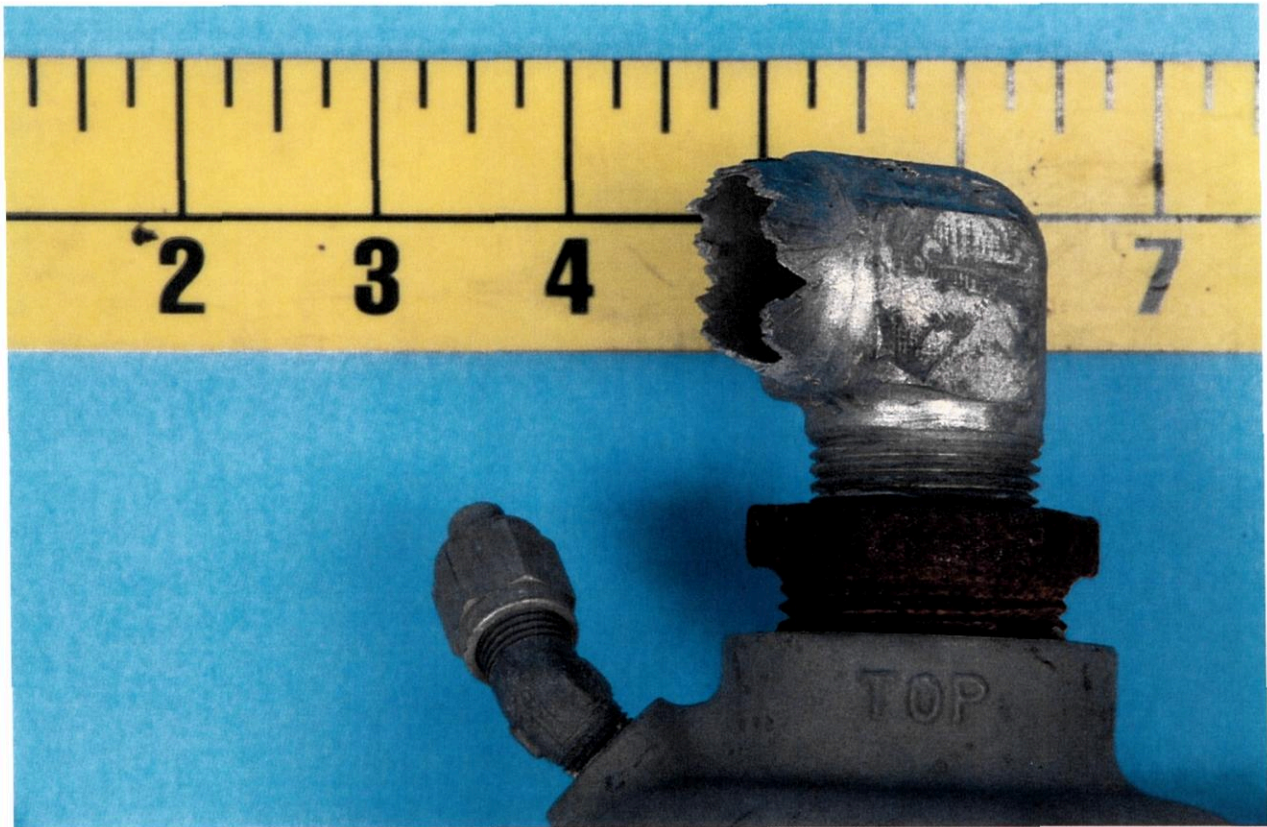
Figure 8. Photograph of outlet on top of fuel strainer.

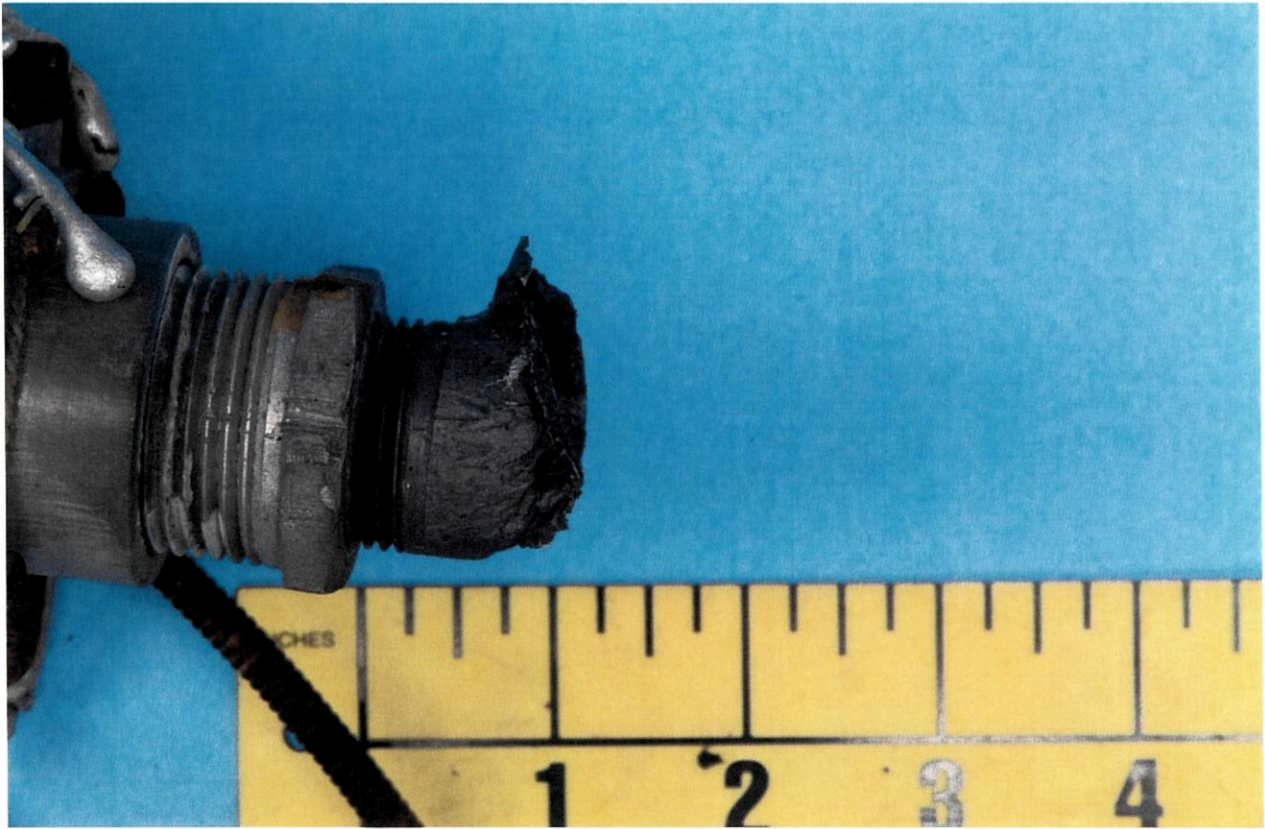
Figure 9. Photograph of inlet on fuel shutoff valve.

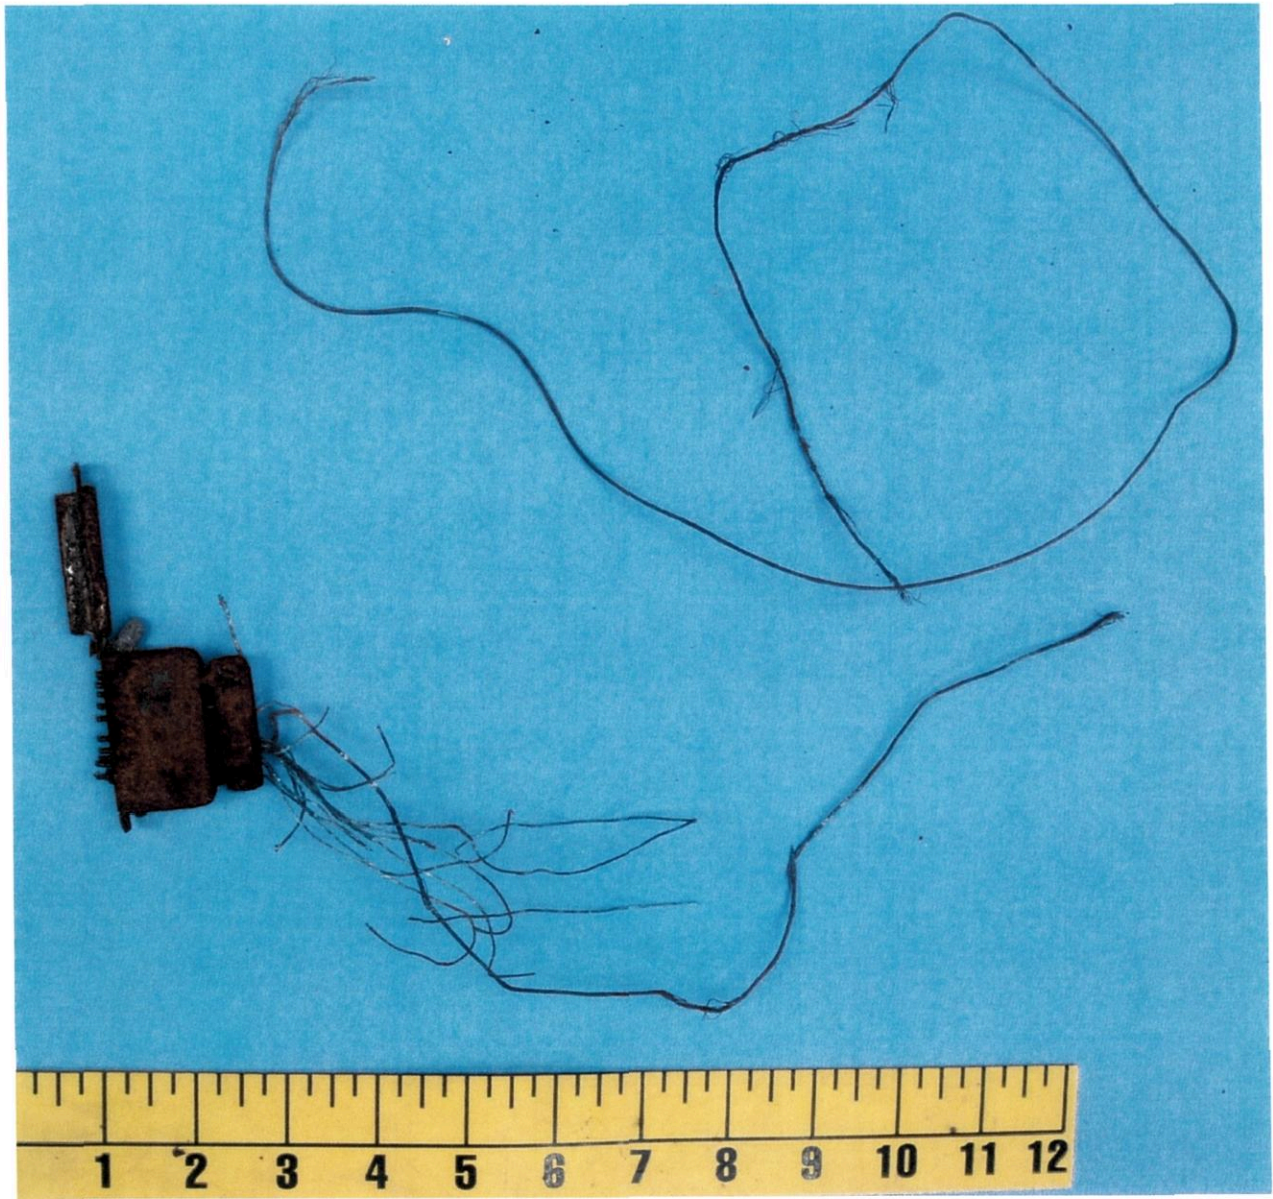
A section of avionics wiring is shown in Figure 10. One end of the section still had the connector attached. The opposite end exhibited fractures consistent with mechanical breaks. The exterior of the braided conductor surface was bare and exhibited an oxidized layer, both consistent of exposure of high temperatures. There were no signs of electrical arcing, beading or melting on any of the conductors.

Figure 10. Photograph of avionics wiring.

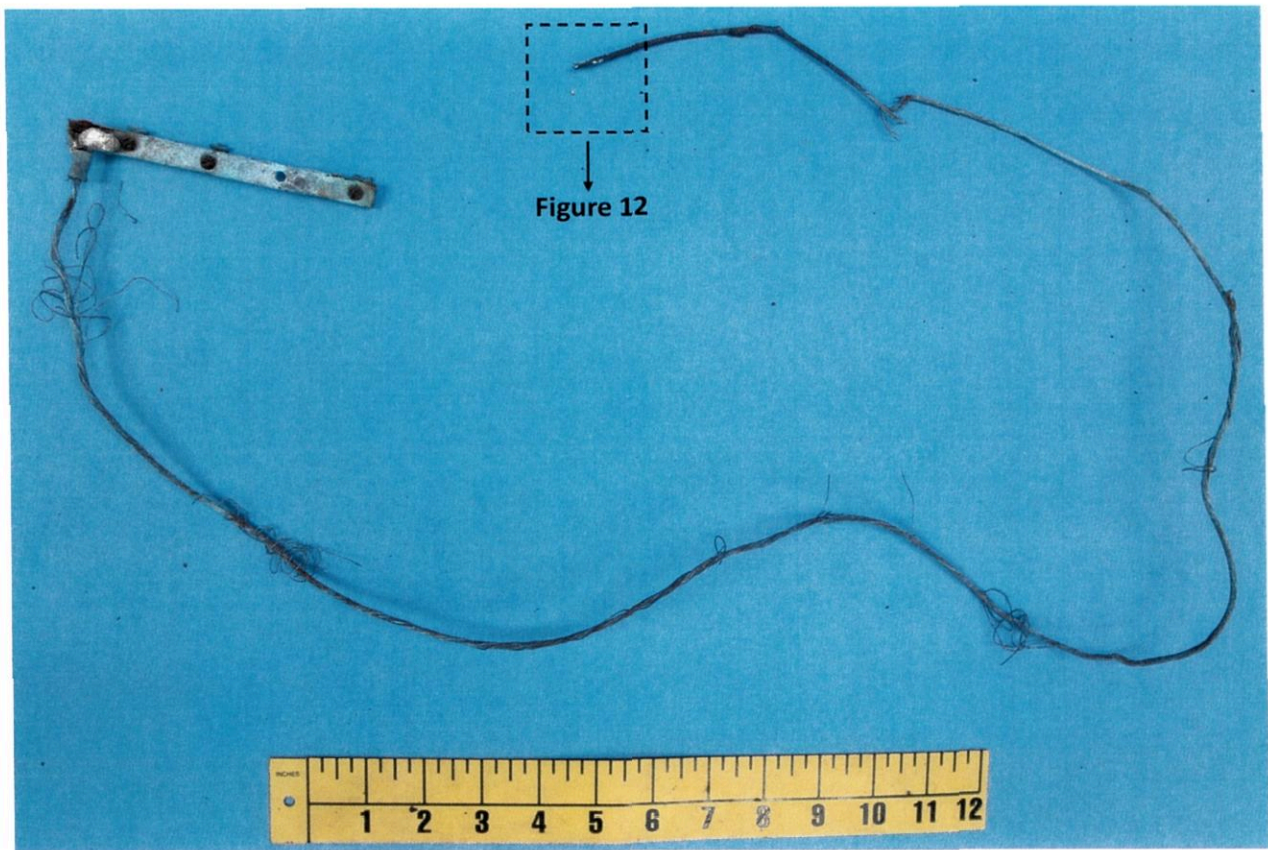
A section of power wiring is shown in Figure 11. The wiring was located on the right side of the cockpit during the wreckage examination. One end of the section was attached to a bus bar. The opposite end was fractured. The fracture end exhibited signs of arcing, beading, melting and welding of conductors as shown in Figure 12. The exterior of the braided conductor surface was bare and exhibited an oxidized layer, both consistent of exposure of high temperatures.

Figure 11. Photograph of power wiring.

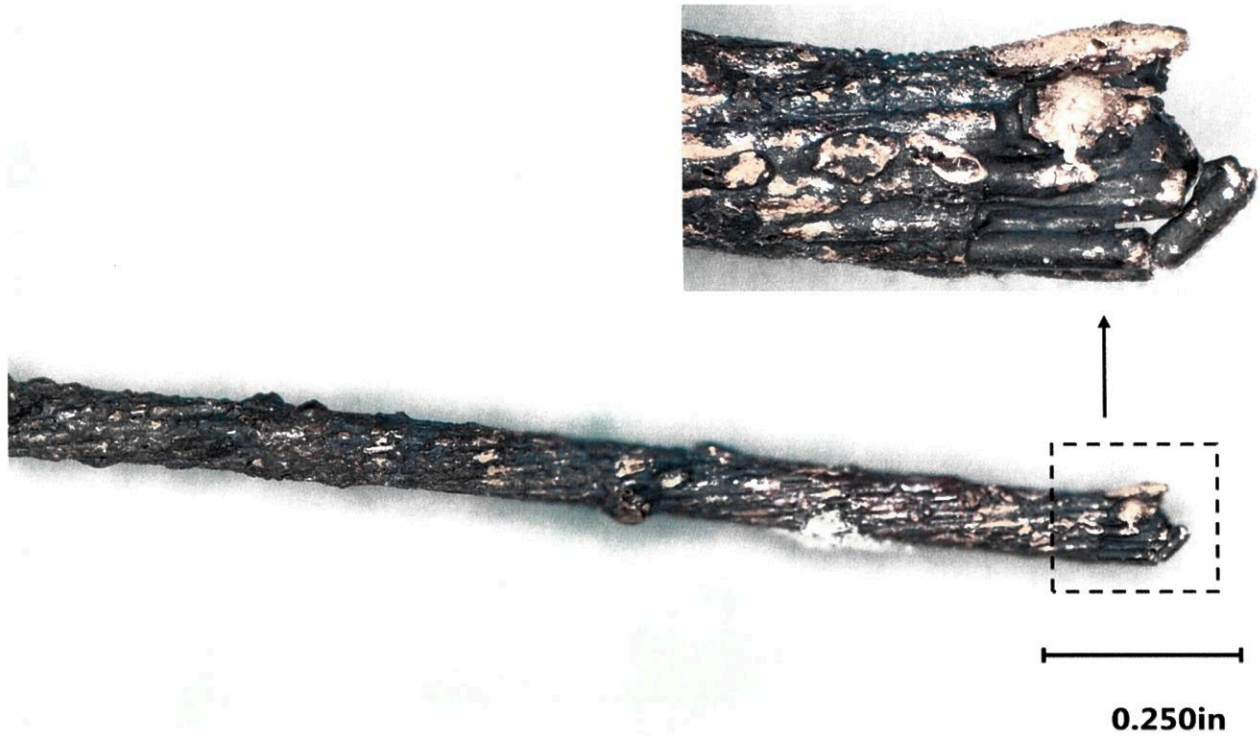
Figure 12. Closeup photograph of arcing, beading and melting damage to end of power wiring section.

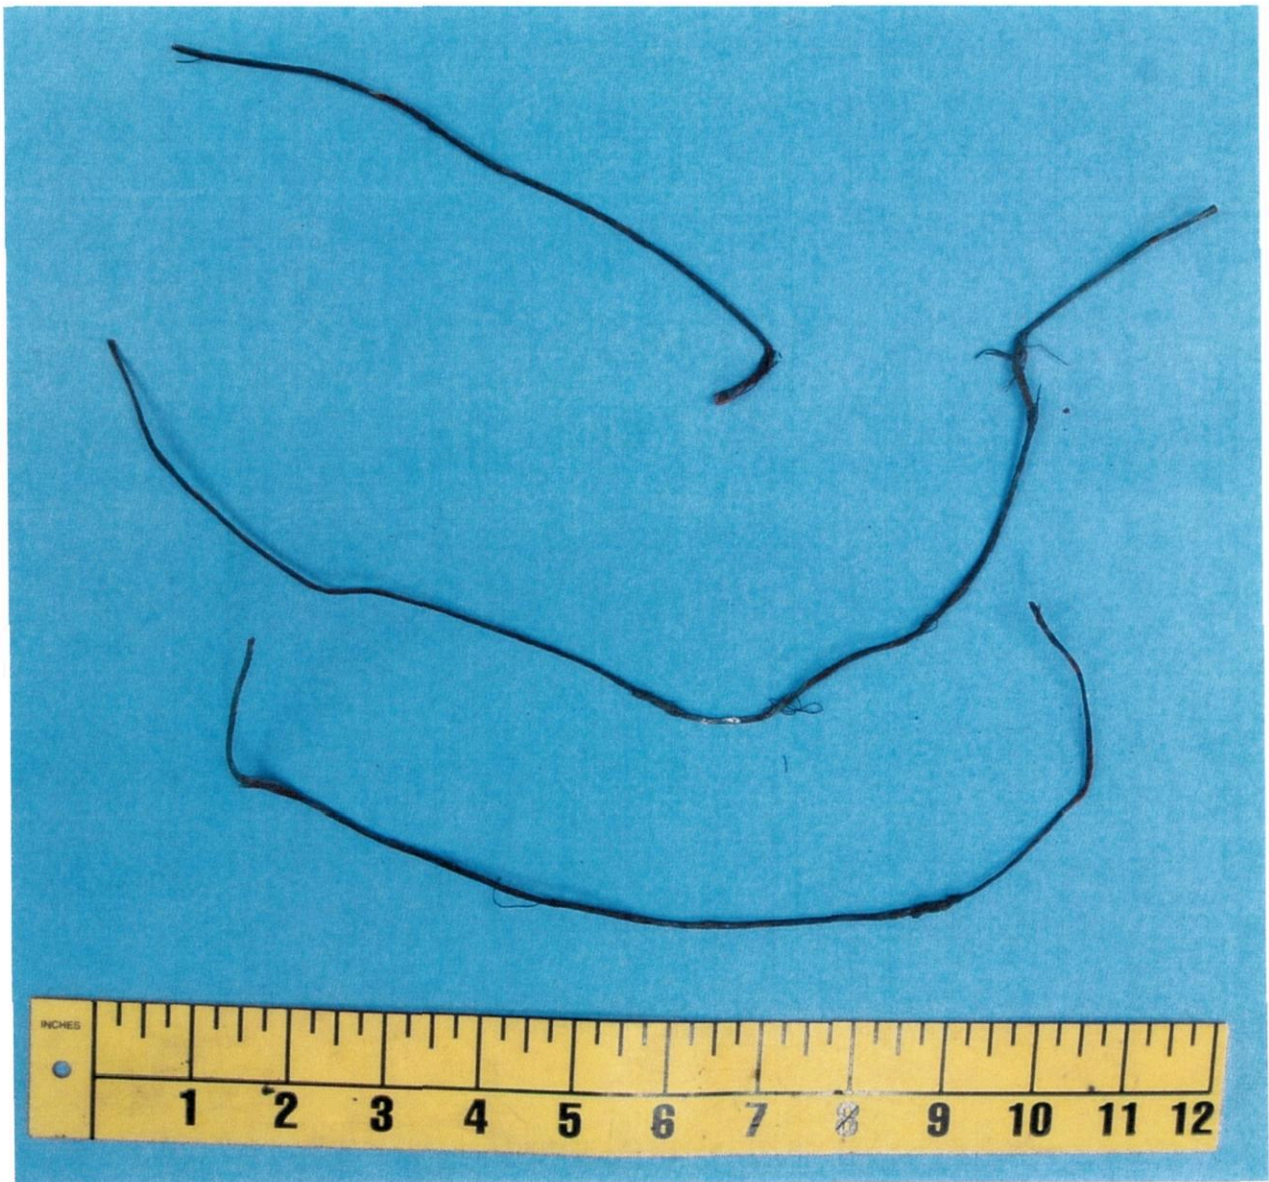
Three sections of fuel wiring are shown in Figure 13. All three sections exhibited end fractures consistent with mechanical breaking. Two of the wire sections had a twisted junction mid-length in the section. There were no signs of separations in the junctions and no sign of electrical arcing around the joined sections. There were no signs of electrical arcing, beading or melting on any of the conductors of the 3 sections.

Figure 13. Photograph of fuel sending wiring sections.

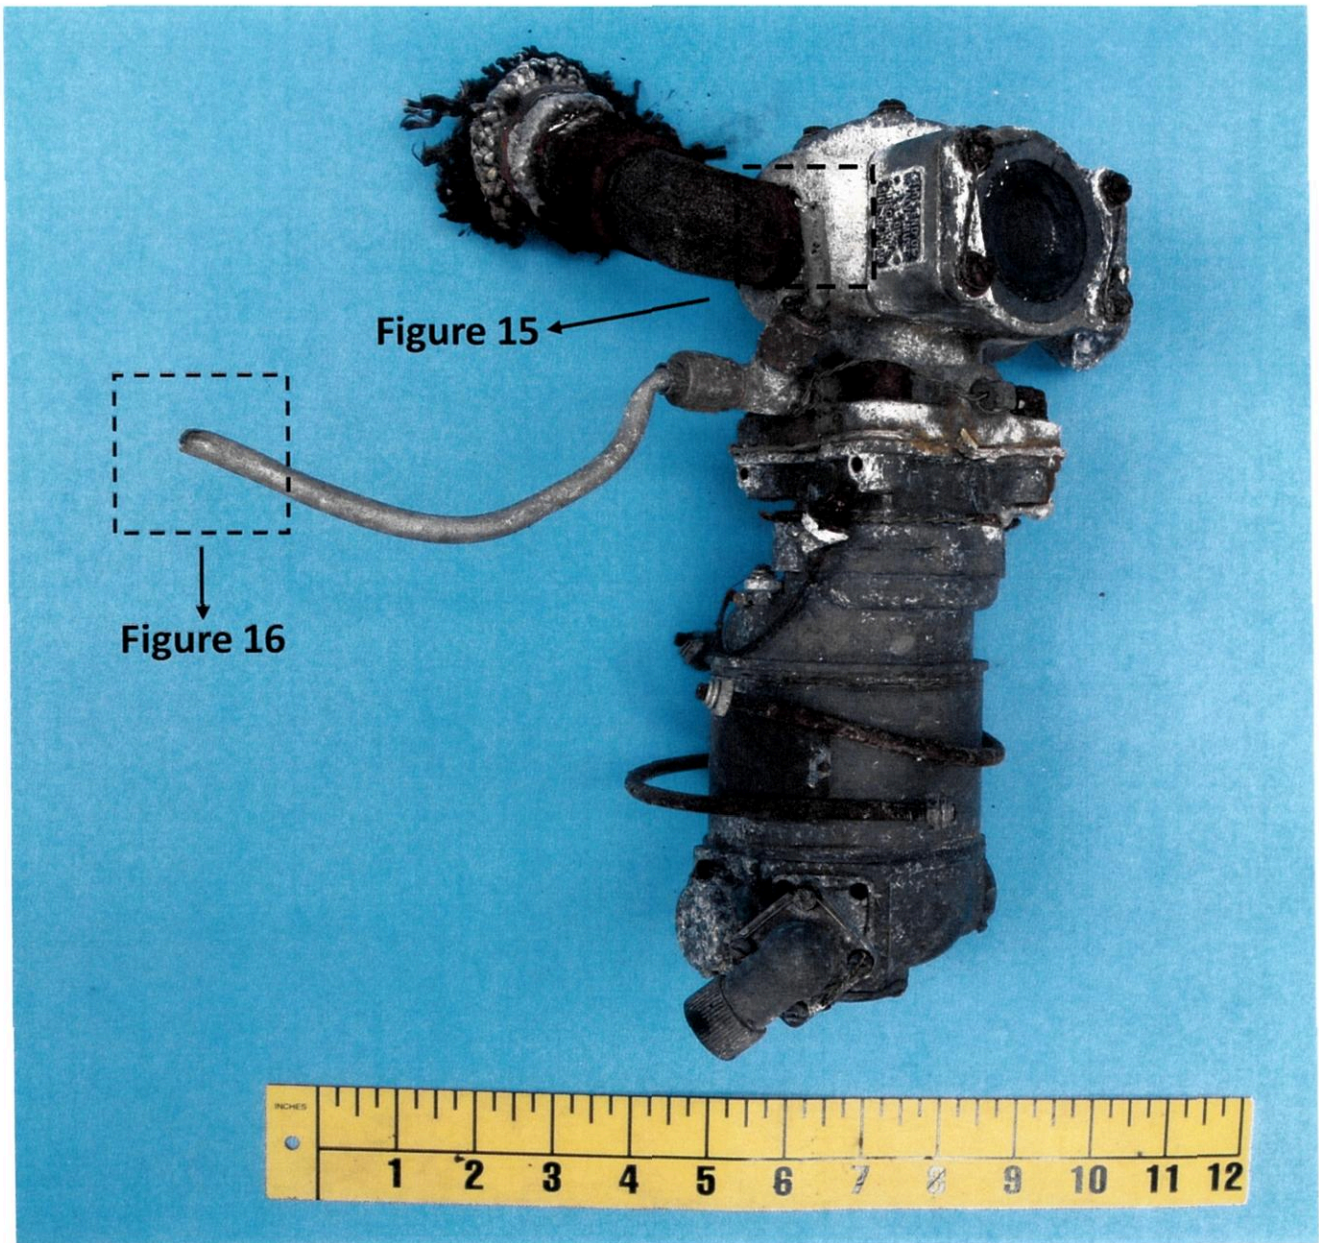
The electric fuel pump is shown in Figure 14. The main body of the fuel pump was intact and appeared undamaged by heat. One inlet had a small section of thermally damaged polymeric hose. Two small outlets, shown in Figure 15 and 16, showed evidence of thermal deformation, thinning and melting. These signatures are indicative of exposure to high temperatures.

Figure 14. Photograph of electric fuel pump.

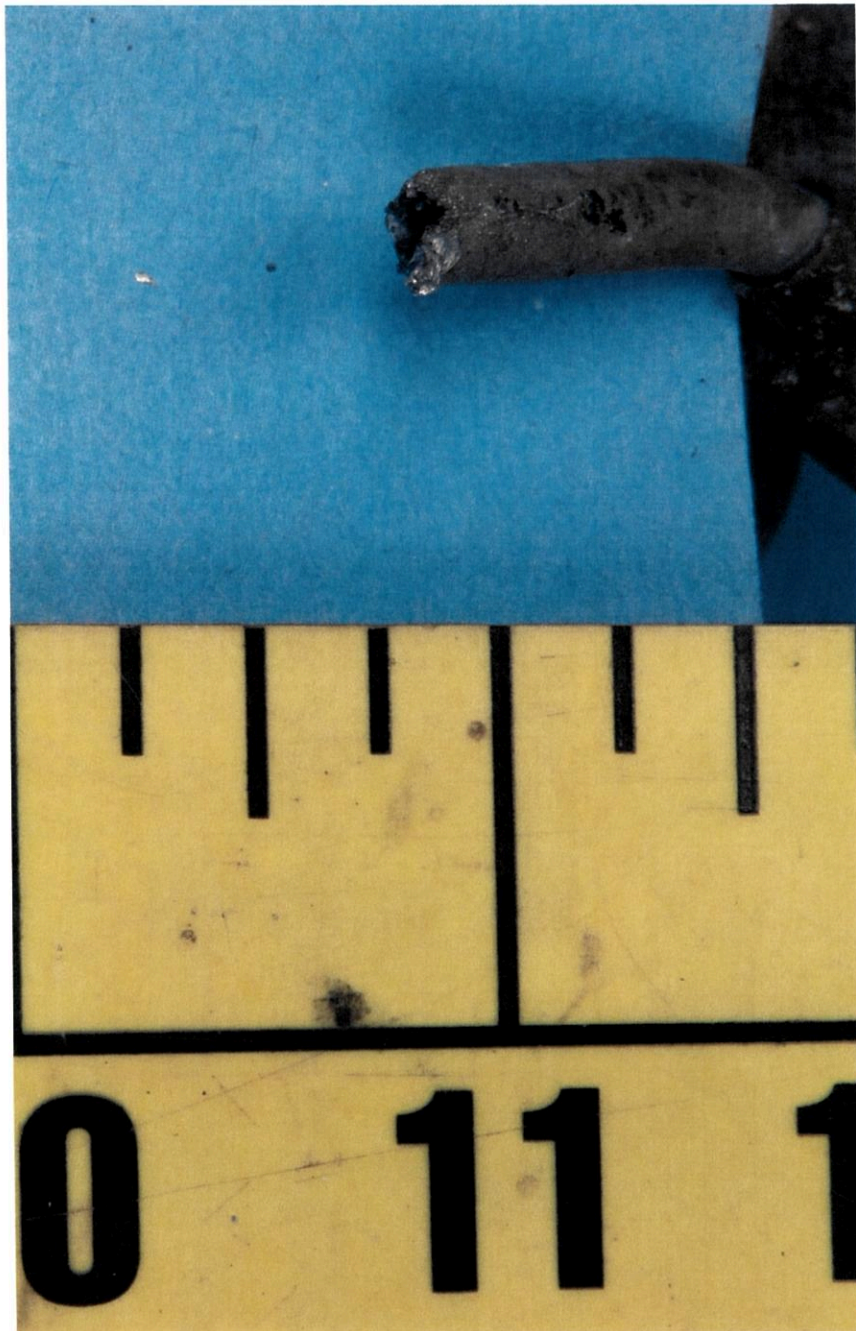
Figure 15. Closeup of one small outlet on fuel pump.

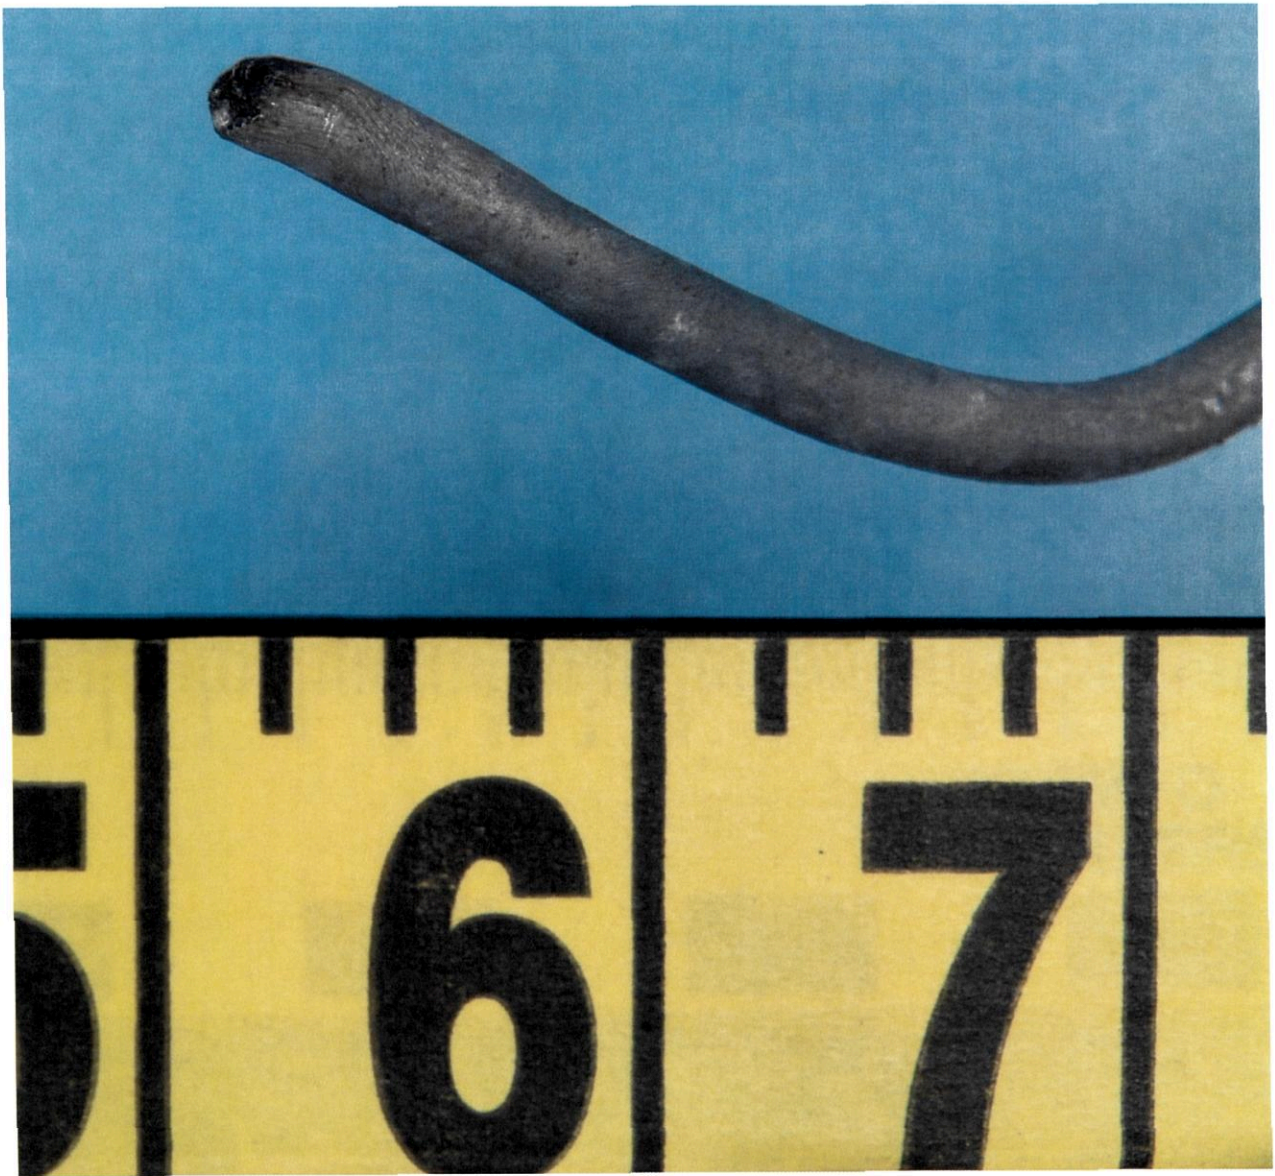
Figure 16. Closeup of second small outlet on fuel pump.
