## **ENGINE TEARDOWN/RUN REPORT INSPECTOR STATEMENT**

**Engine Model:** Continental TSIO-520-NB (Left Position)

**Registration Number:** N2735A

**Accident/Incident Number:** ERA 16 FA 279

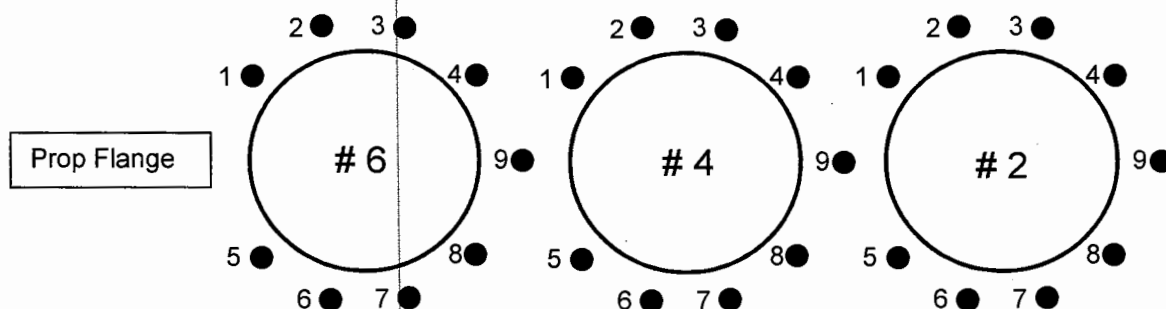
**Cylinder Through-Bolt and Deck Stud Break-Away (Tightening / Loosening) Torque Measurements (Foot-Pounds)**  
(Position numbers 1 and 5 are through-bolts)

| | Bolt<br>1 | Stud<br>2 | Stud<br>3 | Stud<br>4 | Bolt<br>5 | Stud<br>6 | Stud<br>7 | Stud<br>8 | Stud<br>9 |
|---|---|---|---|---|---|---|---|---|---|
| Cylinder #2 | Cracked | 801 /694 | 870/711 | 802/643 | Backed off | 816/640 | 757/586 | 790/665 | 640/550 |
| Cylinder #4 | Backed off | 813 /660 | 776/635 | 749/636 | Cracked | 874/680 | 841/649 | 787/609 | 562/467 |
| Cylinder #6 | 708 /693 | 824/640 | 831/713 | 884/694 | Cracked | 875/680 | 822/637 | 858/678 | 581/493 |

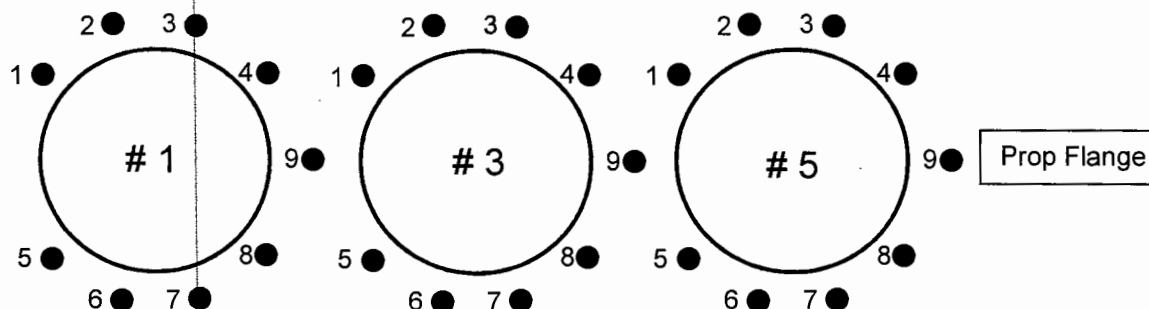
| | Bolt<br>1 | Stud<br>2 | Stud<br>3 | Stud<br>4 | Bolt<br>5 | Stud<br>6 | Stud<br>7 | Stud<br>8 | Stud<br>9 |
|---|---|---|---|---|---|---|---|---|---|
| Cylinder # 1 | 964/616 | 851/693 | 823/694 | 860/722 | Missing | 919/693 | 828/681 | 816/701 | 520/461 |
| Cylinder # 3 | Backed off | 839/704 | 804/614 | 740/612 | Cracked | 787/647 | 850/746 | 795/638 | 820/695 |
| Cylinder # 5 | Missing | 879/706 | 786/649 | 869/666 | Backed off | 851/655 | 803/646 | 807/676 | 600/508 |
