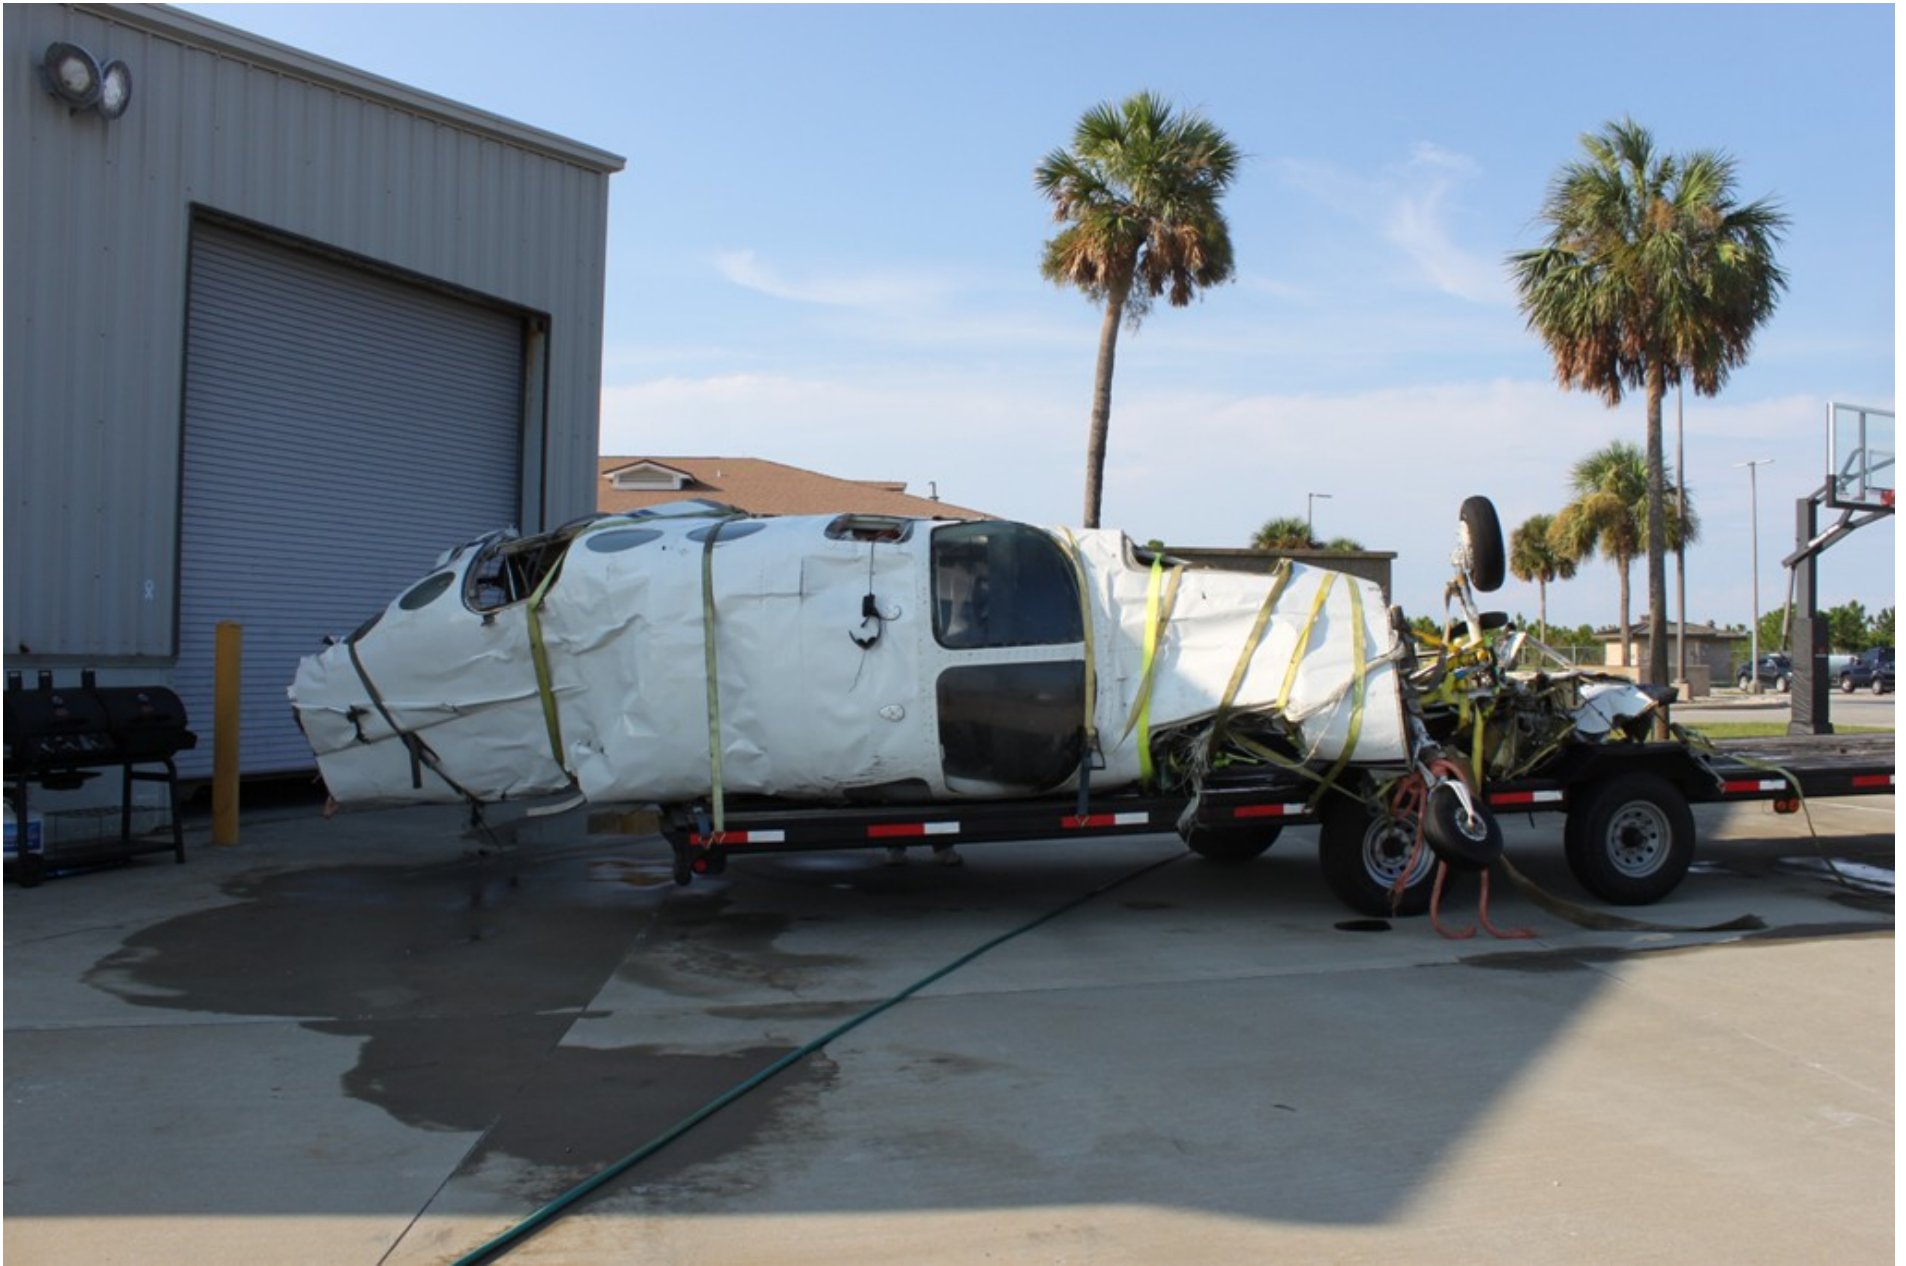
**Photo 1 – NTSB Digital Photograph. View of the Upper Side of the Fuselage Following Recovery from the Gulf of Mexico**

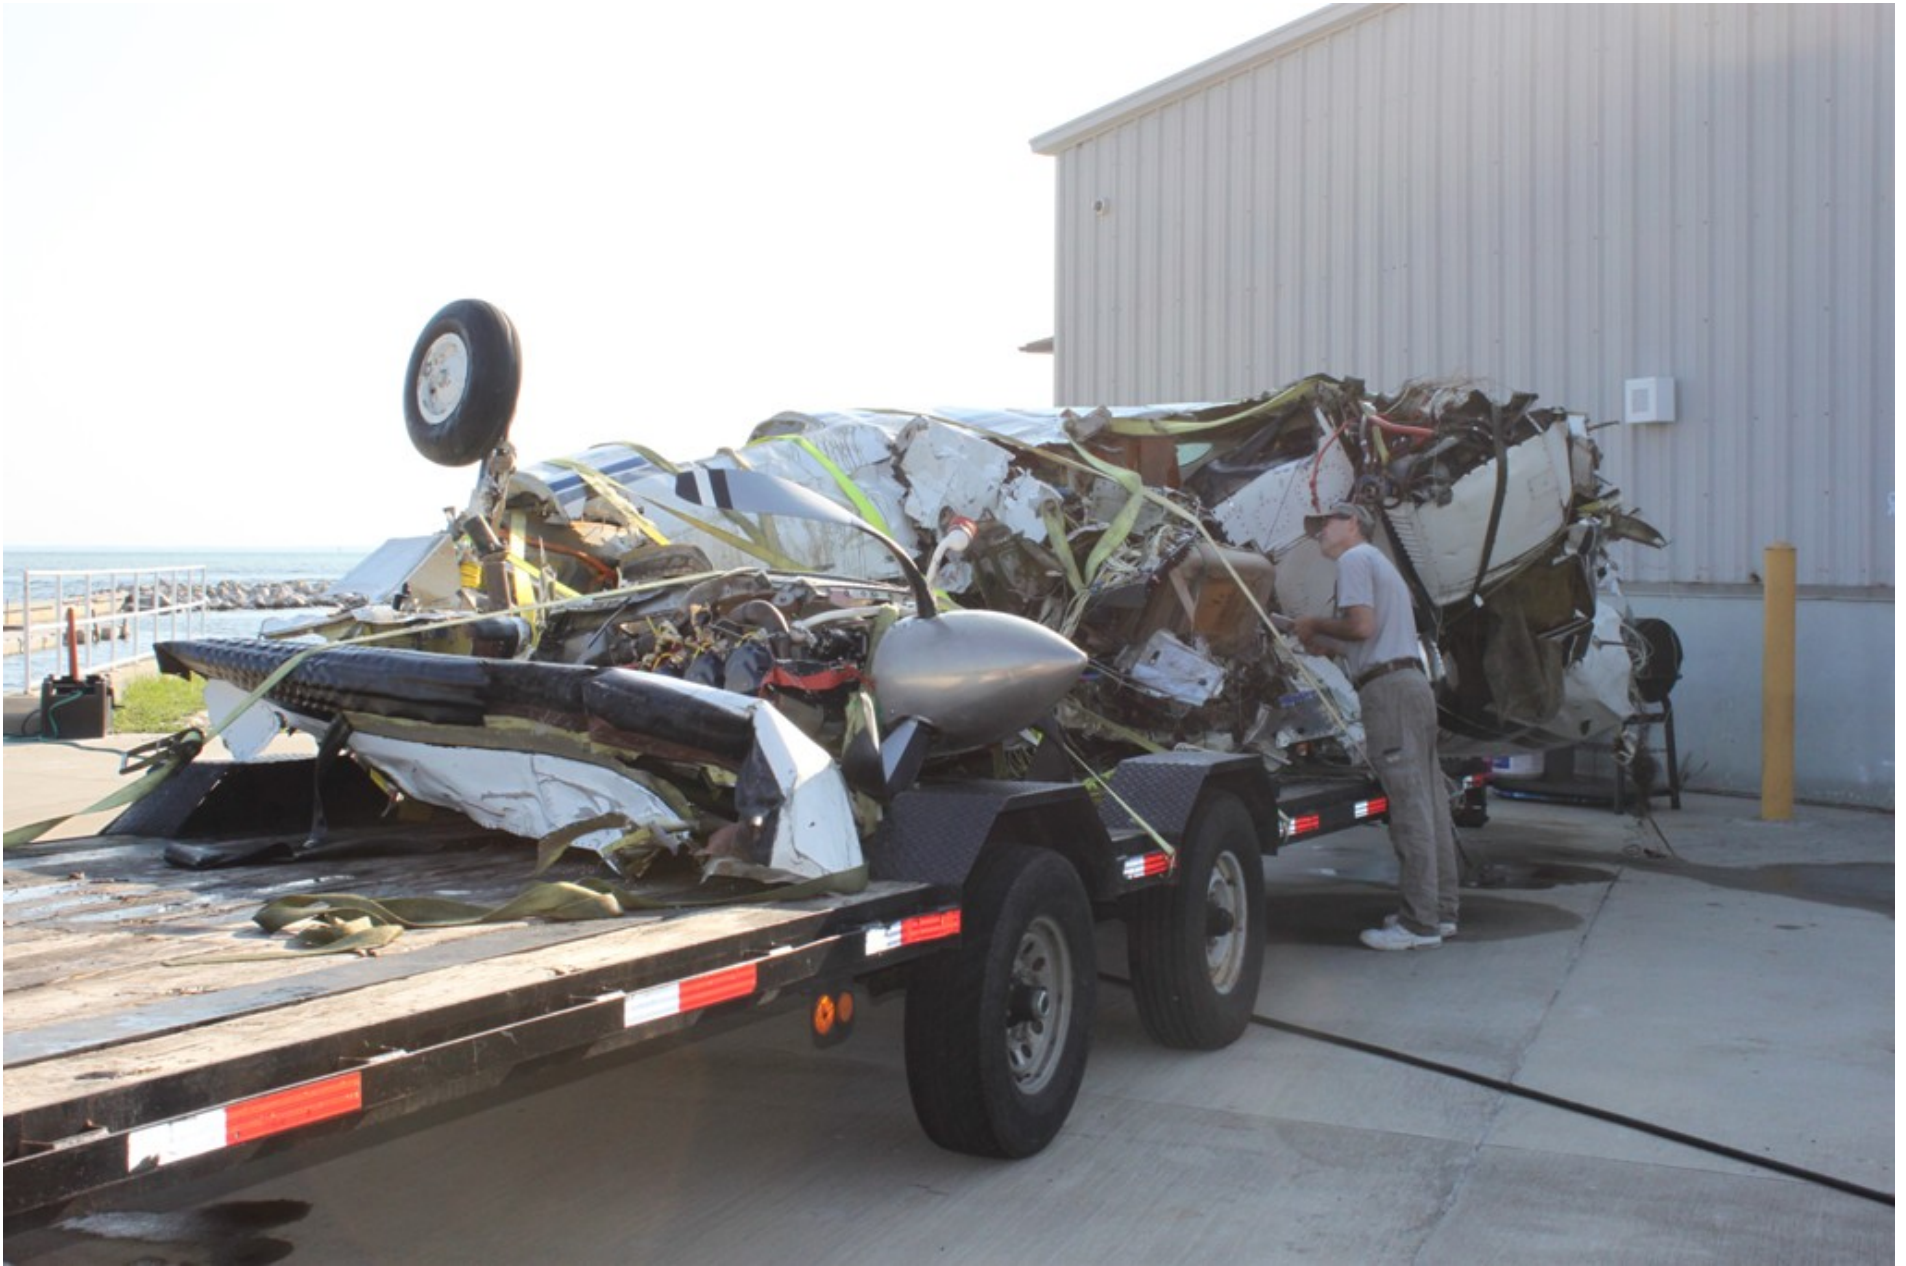
**Photo 2 - NTSB Digital Photograph. View of the Recovered Wreckage from the Gulf of Mexico**

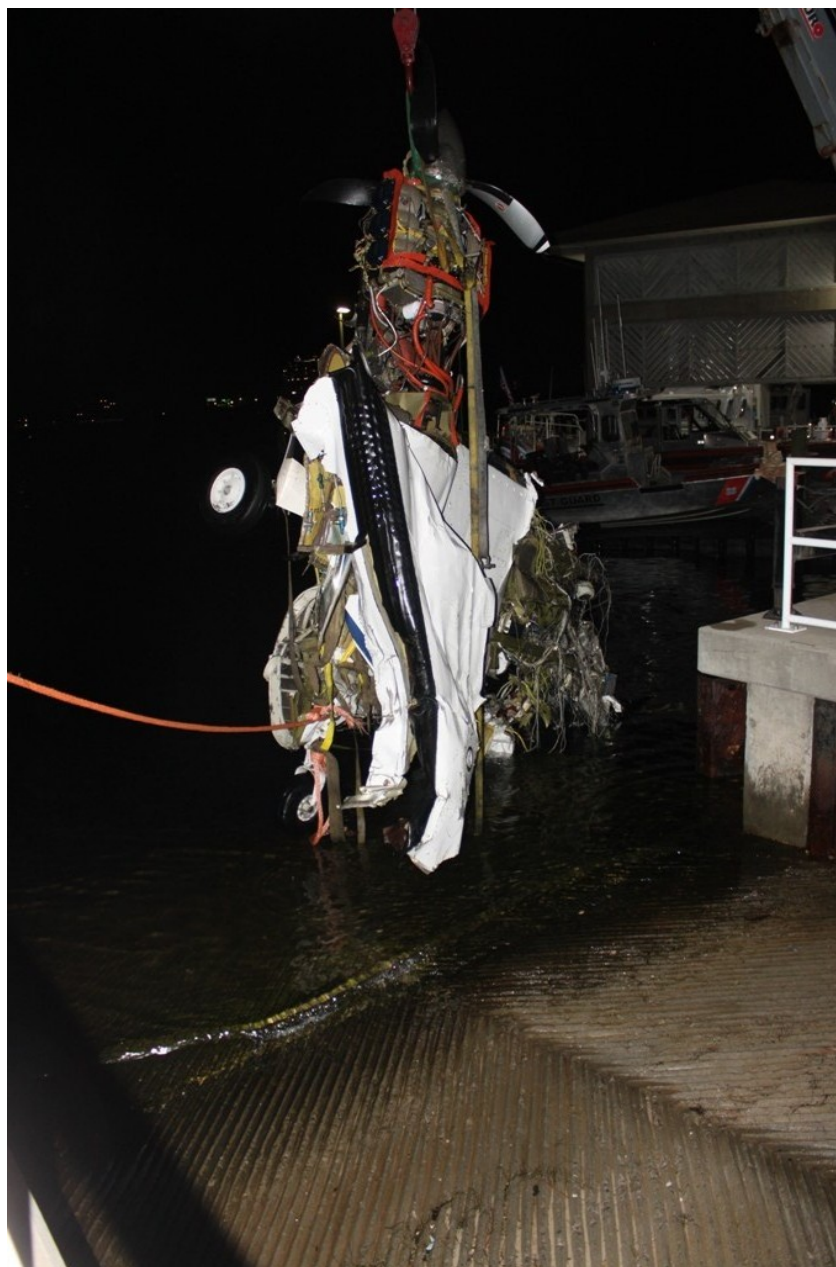
**Photo 3 - NTSB Digital Photograph. View of the Left Engine and Propeller, and Portion of Left Wing During Recovery**

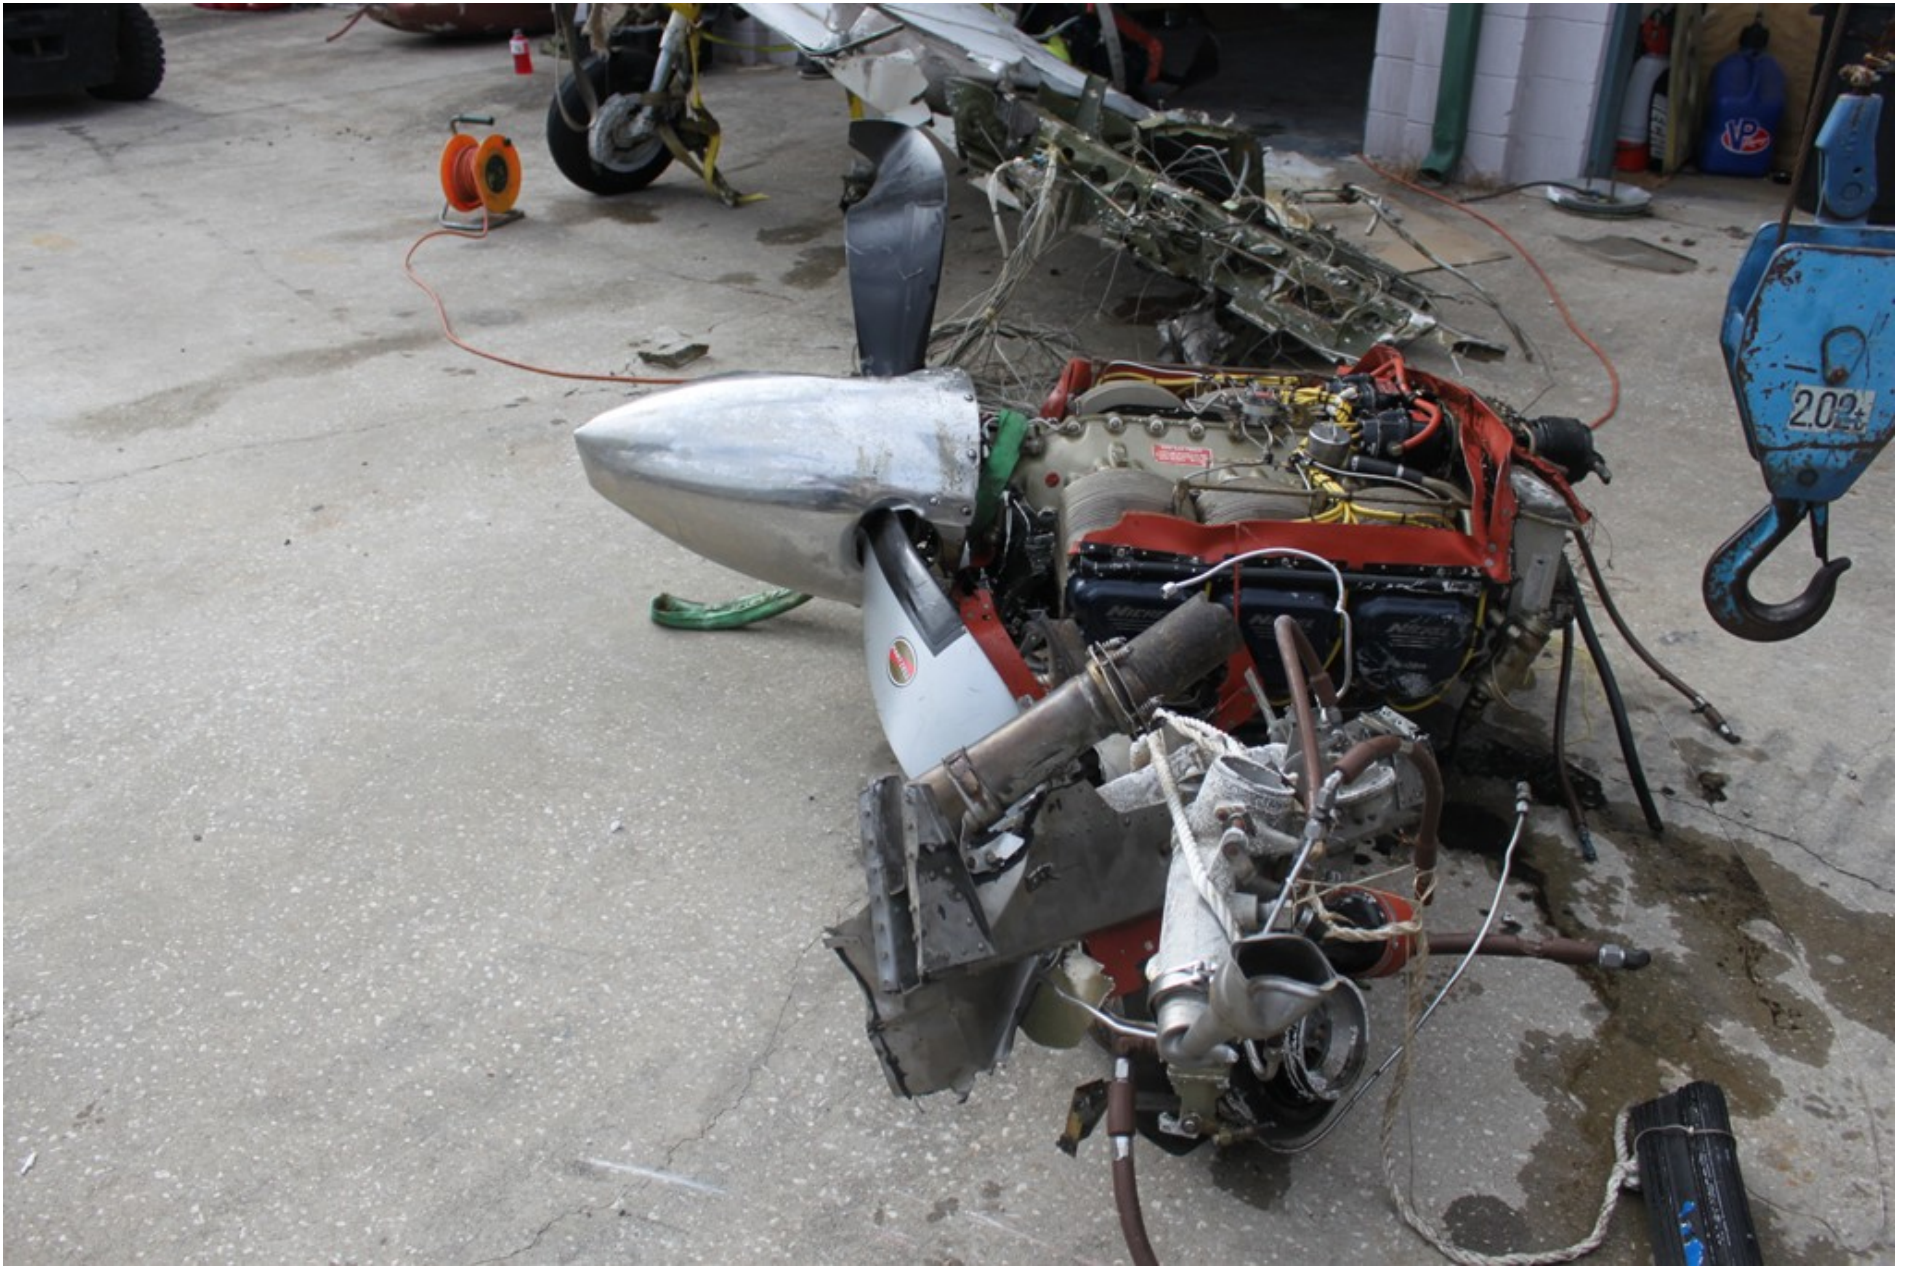
**Photo 4 - NTSB Digital Photograph. View of the Right Engine and Propeller Following Recovery**

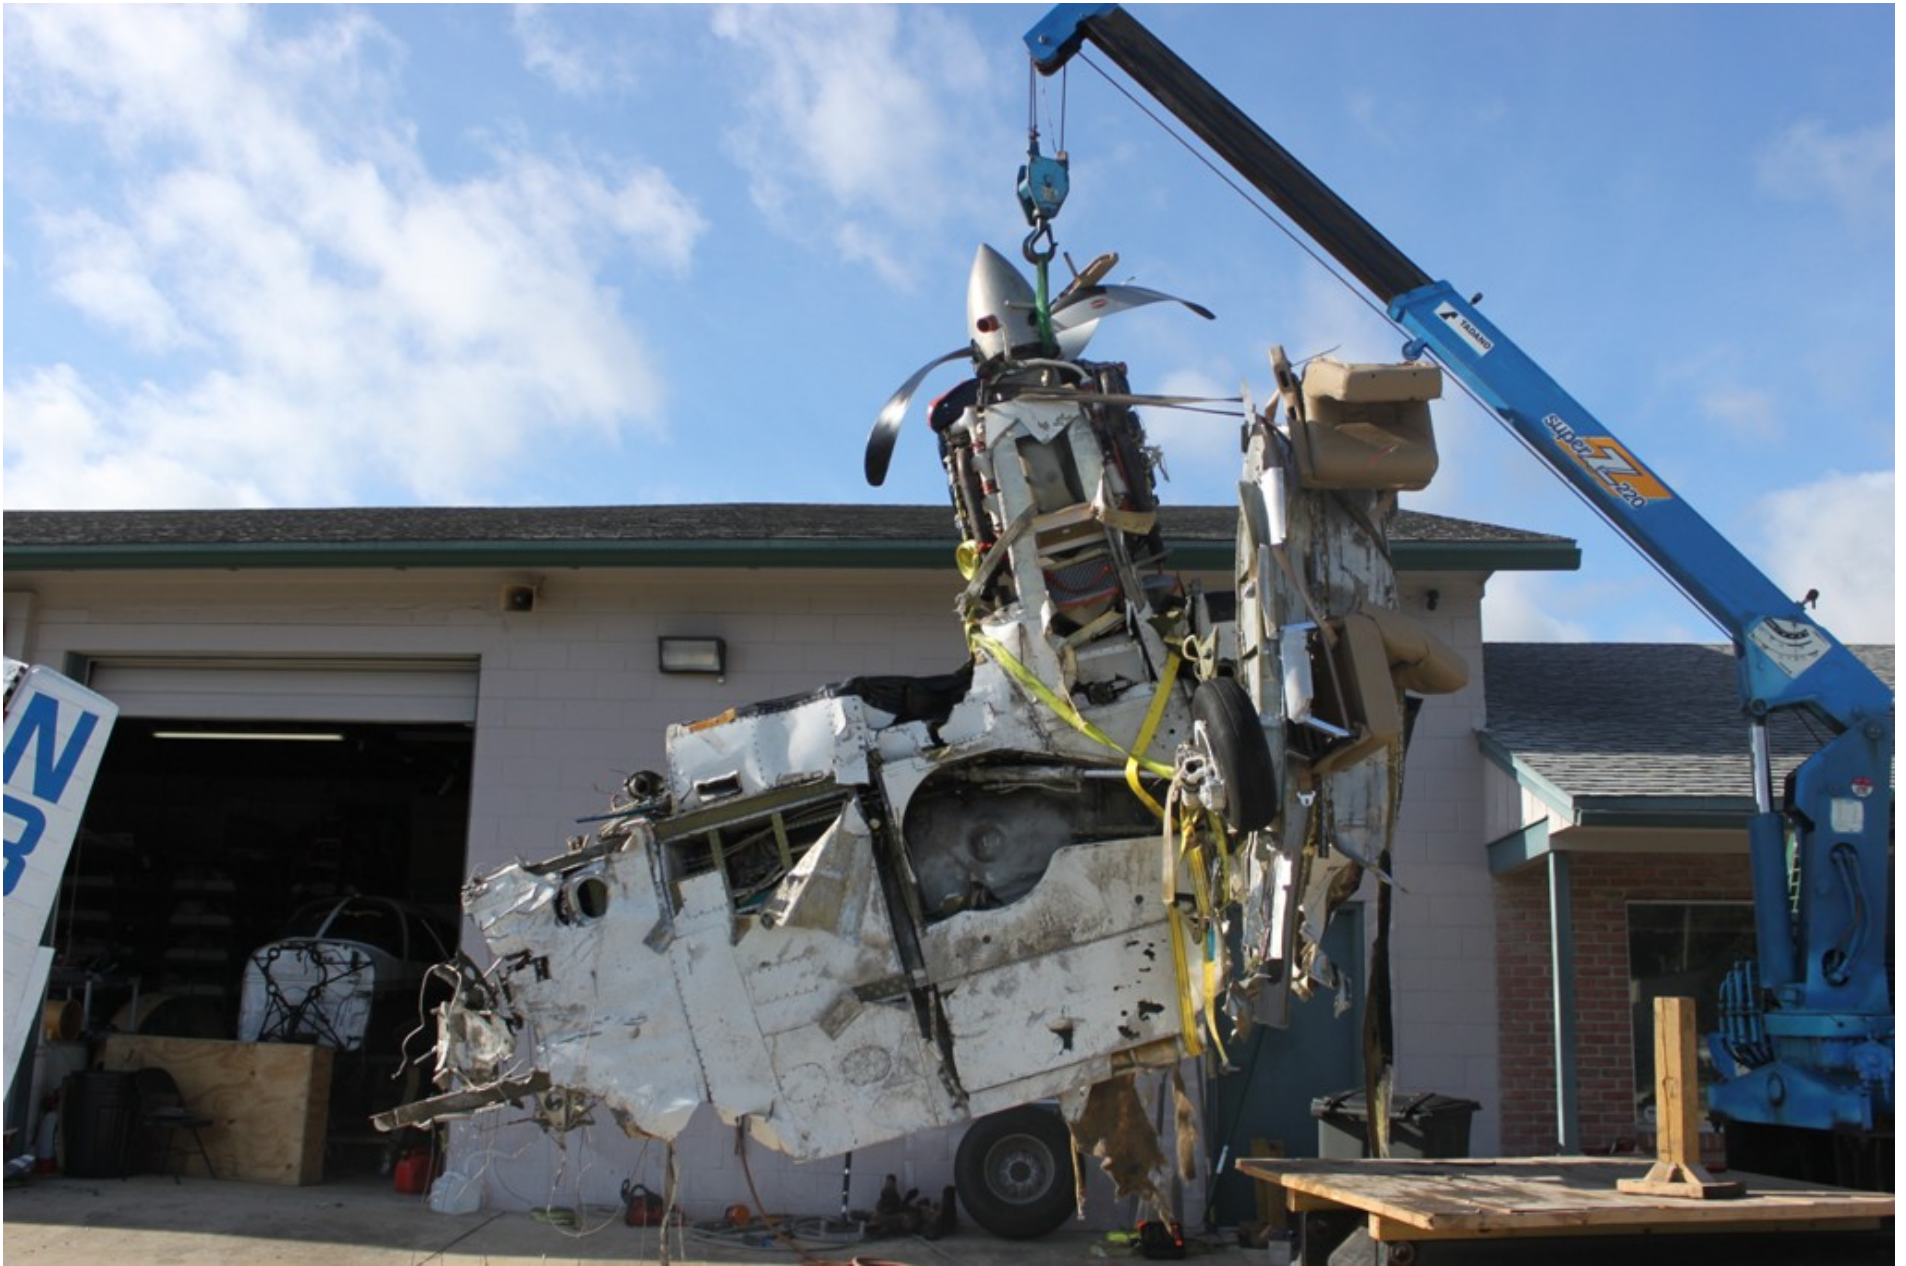
**Photo 5 - NTSB Digital Photograph. View of the Bottom Portion of the Left Wing, Left Engine and Propeller.**

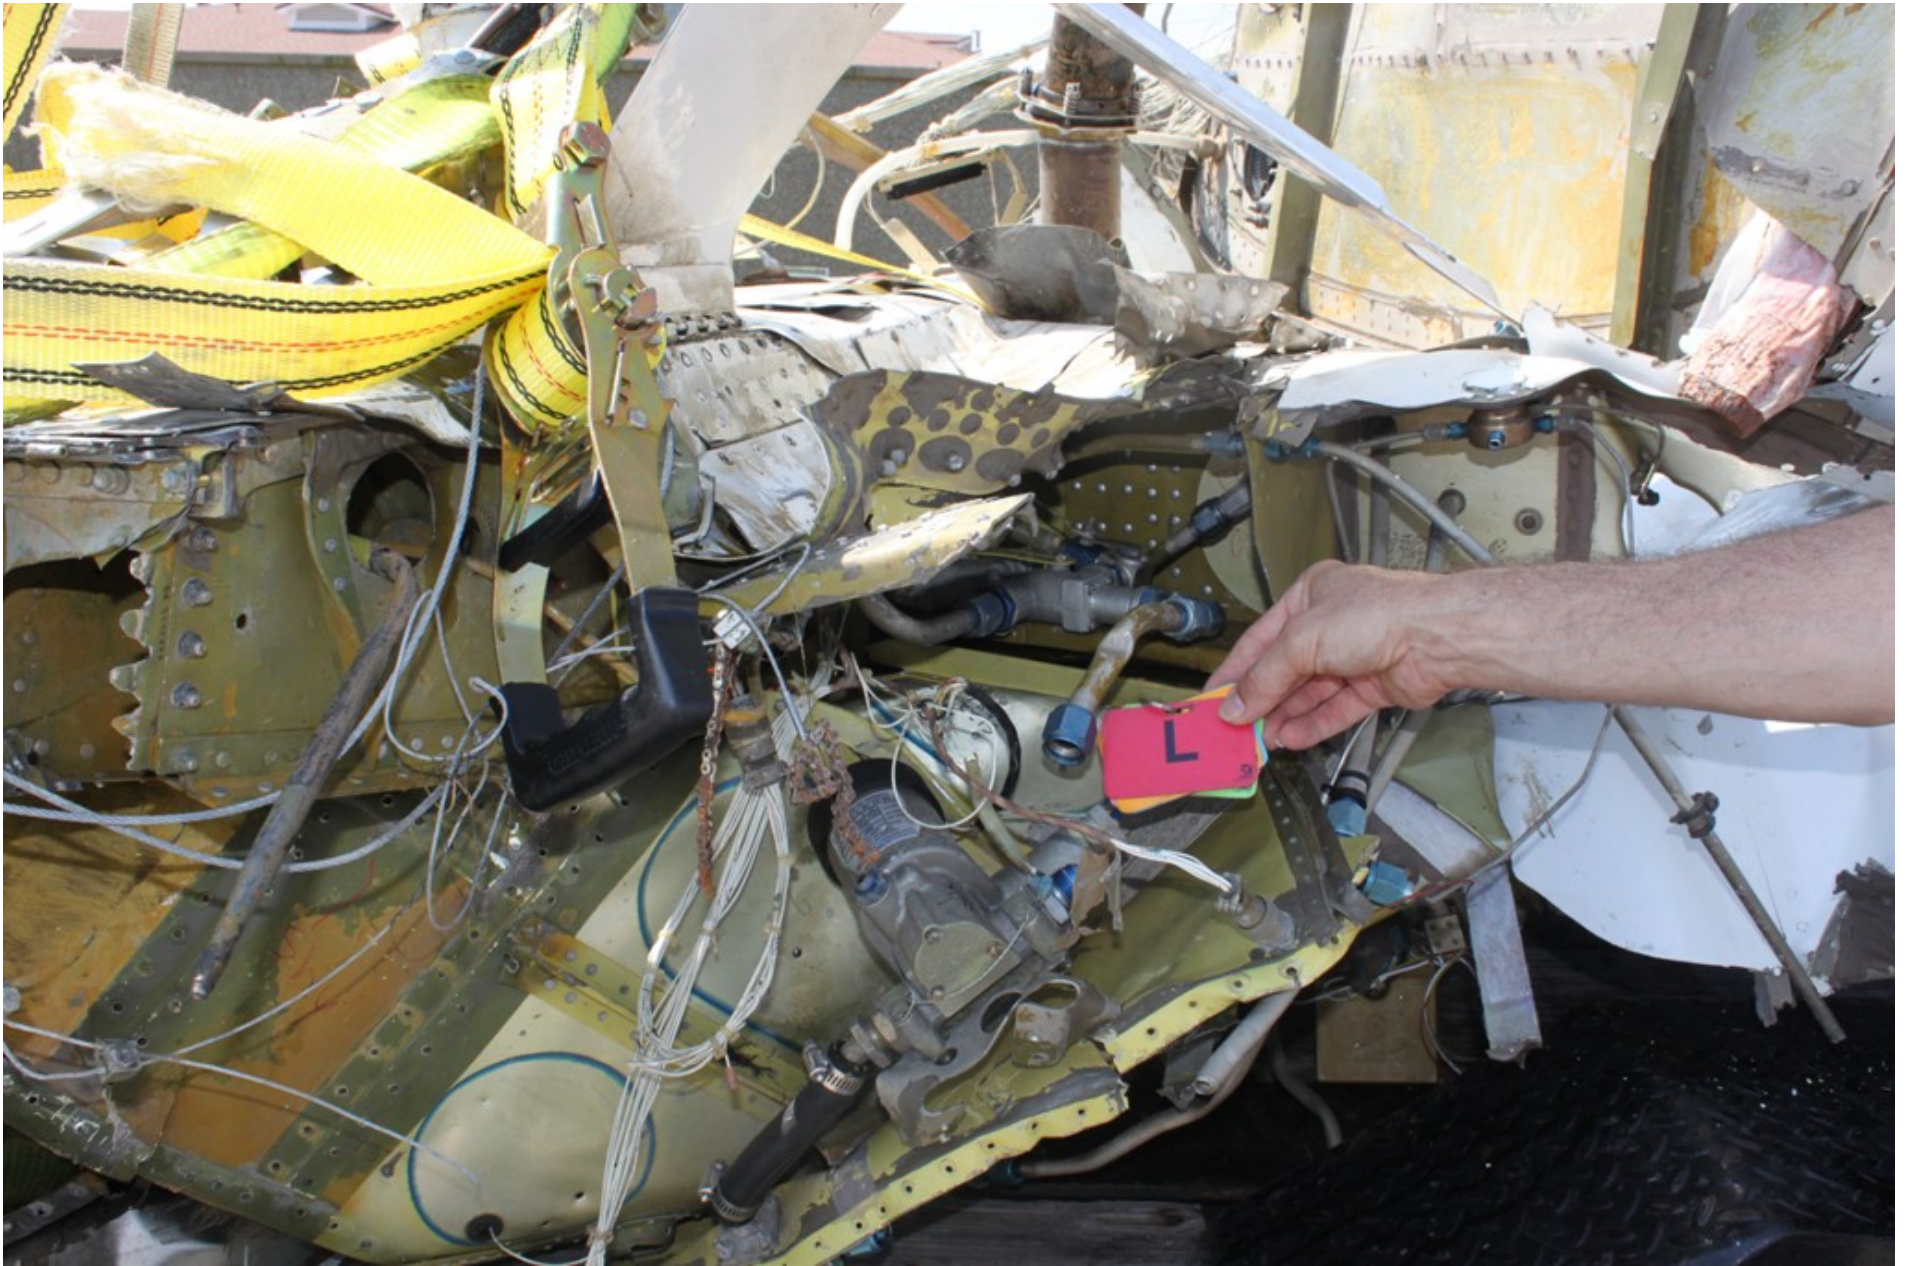
**Photo 6 - NTSB Digital Photograph. View Showing the Separated Outlet Fuel Line from the Left Auxiliary Fuel Pump.**

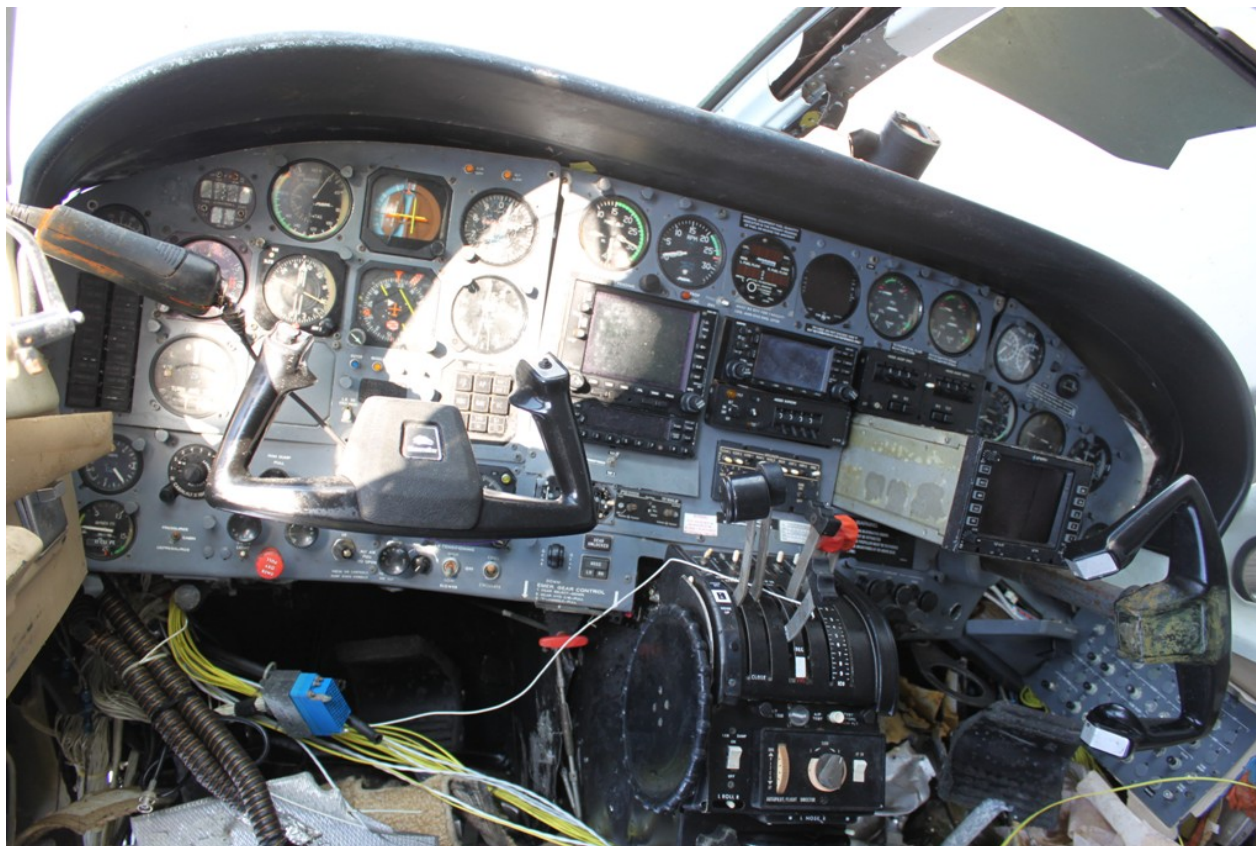
**Photo 7 - NTSB Digital Photograph. View Showing the Instrument Panel.**

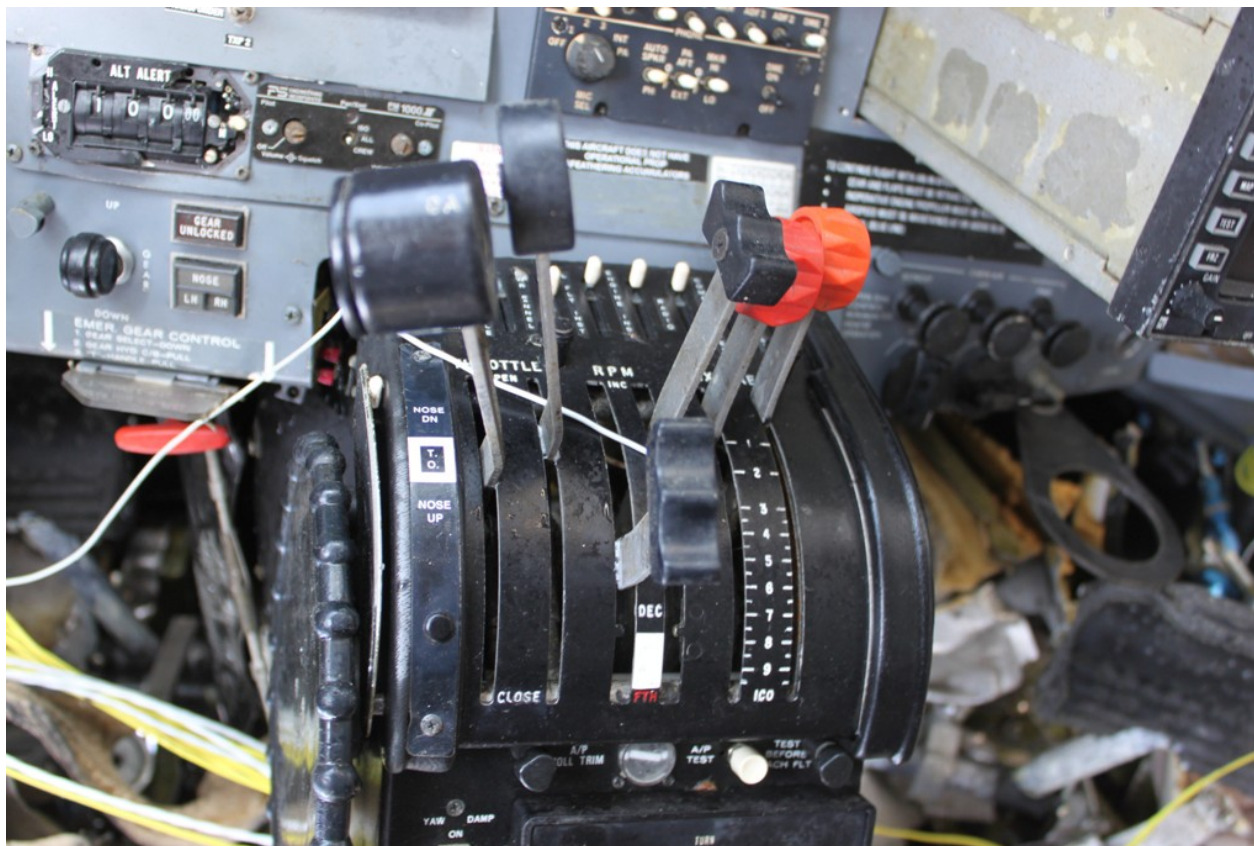
**Photo 8 - NTSB Digital Photograph. View Showing the Throttle Quadrant and Portion of the Instrument Panel.**

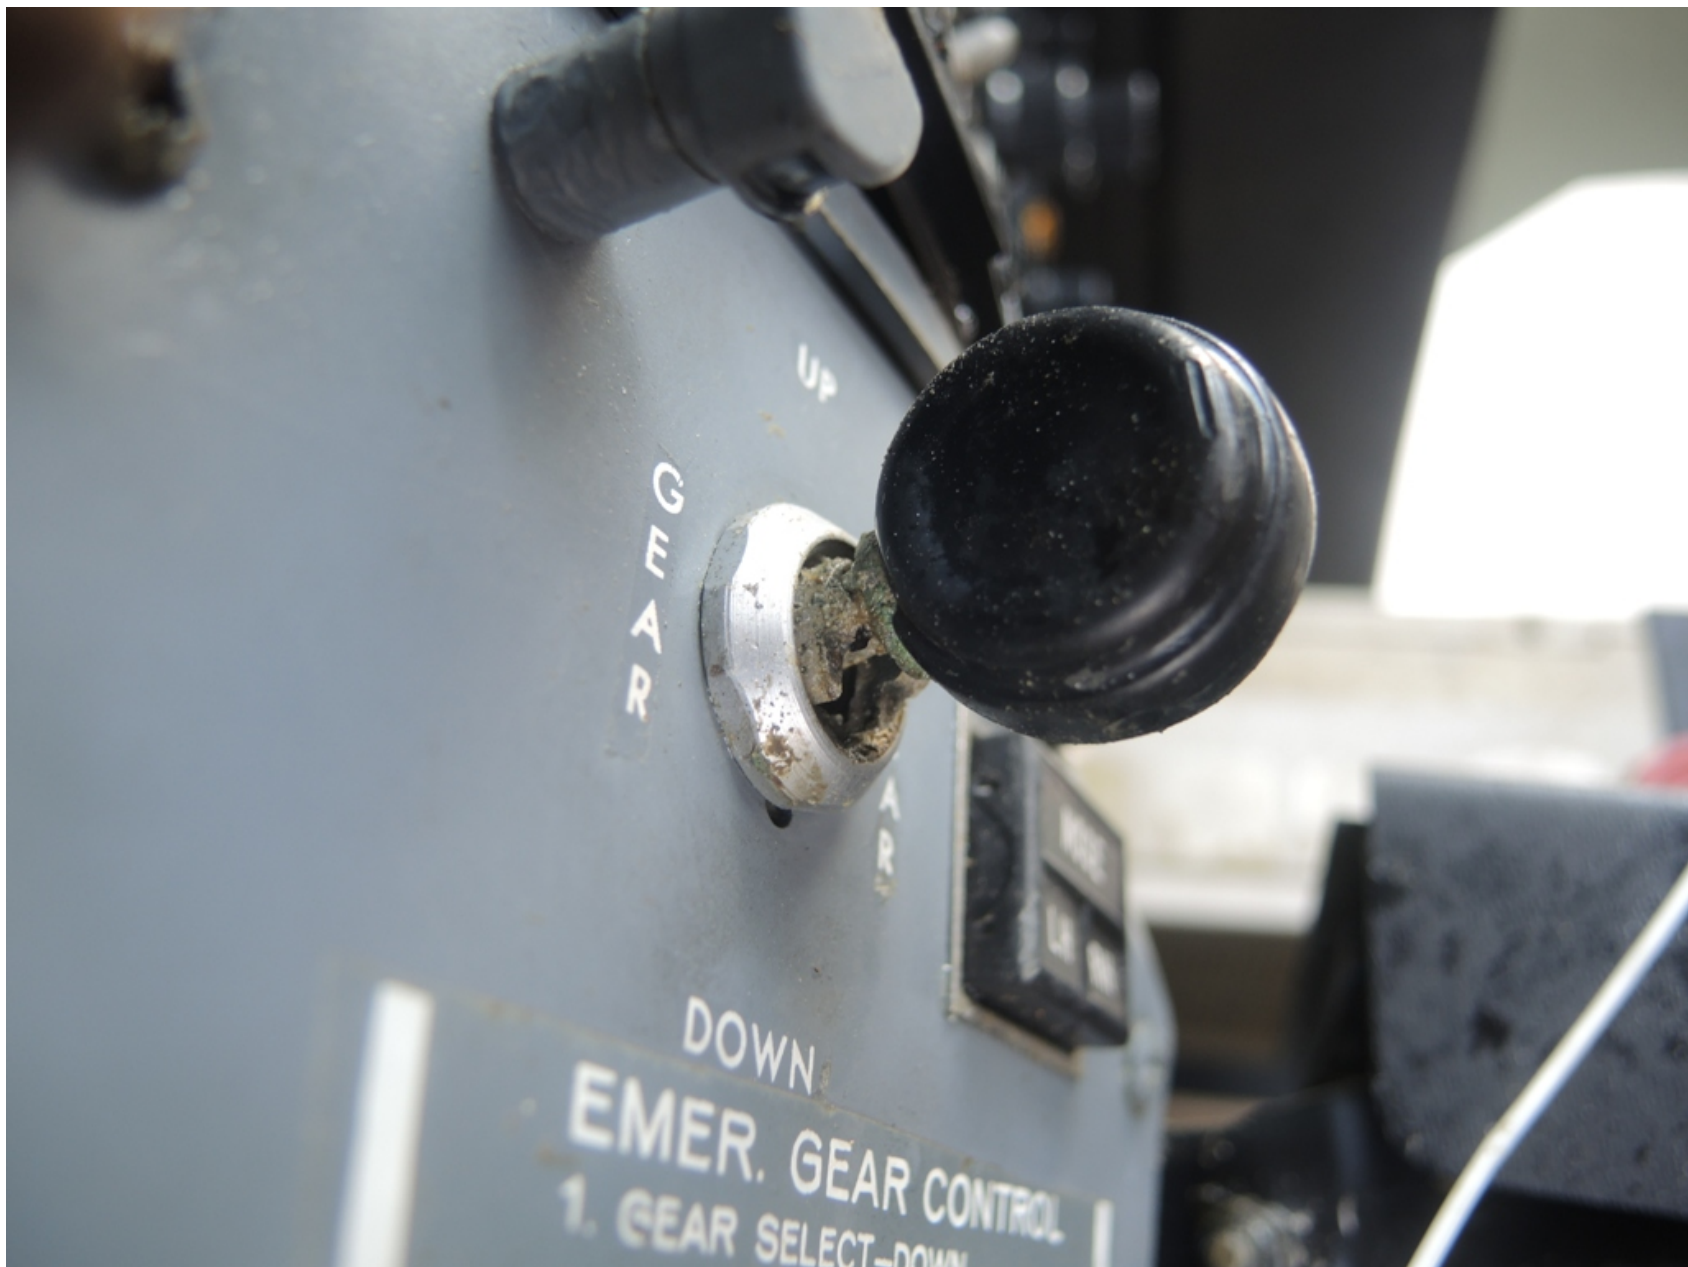
**Photo 9 – Textron Aviation Digital Photograph. View Showing the Position of the Landing Gear Selector.**

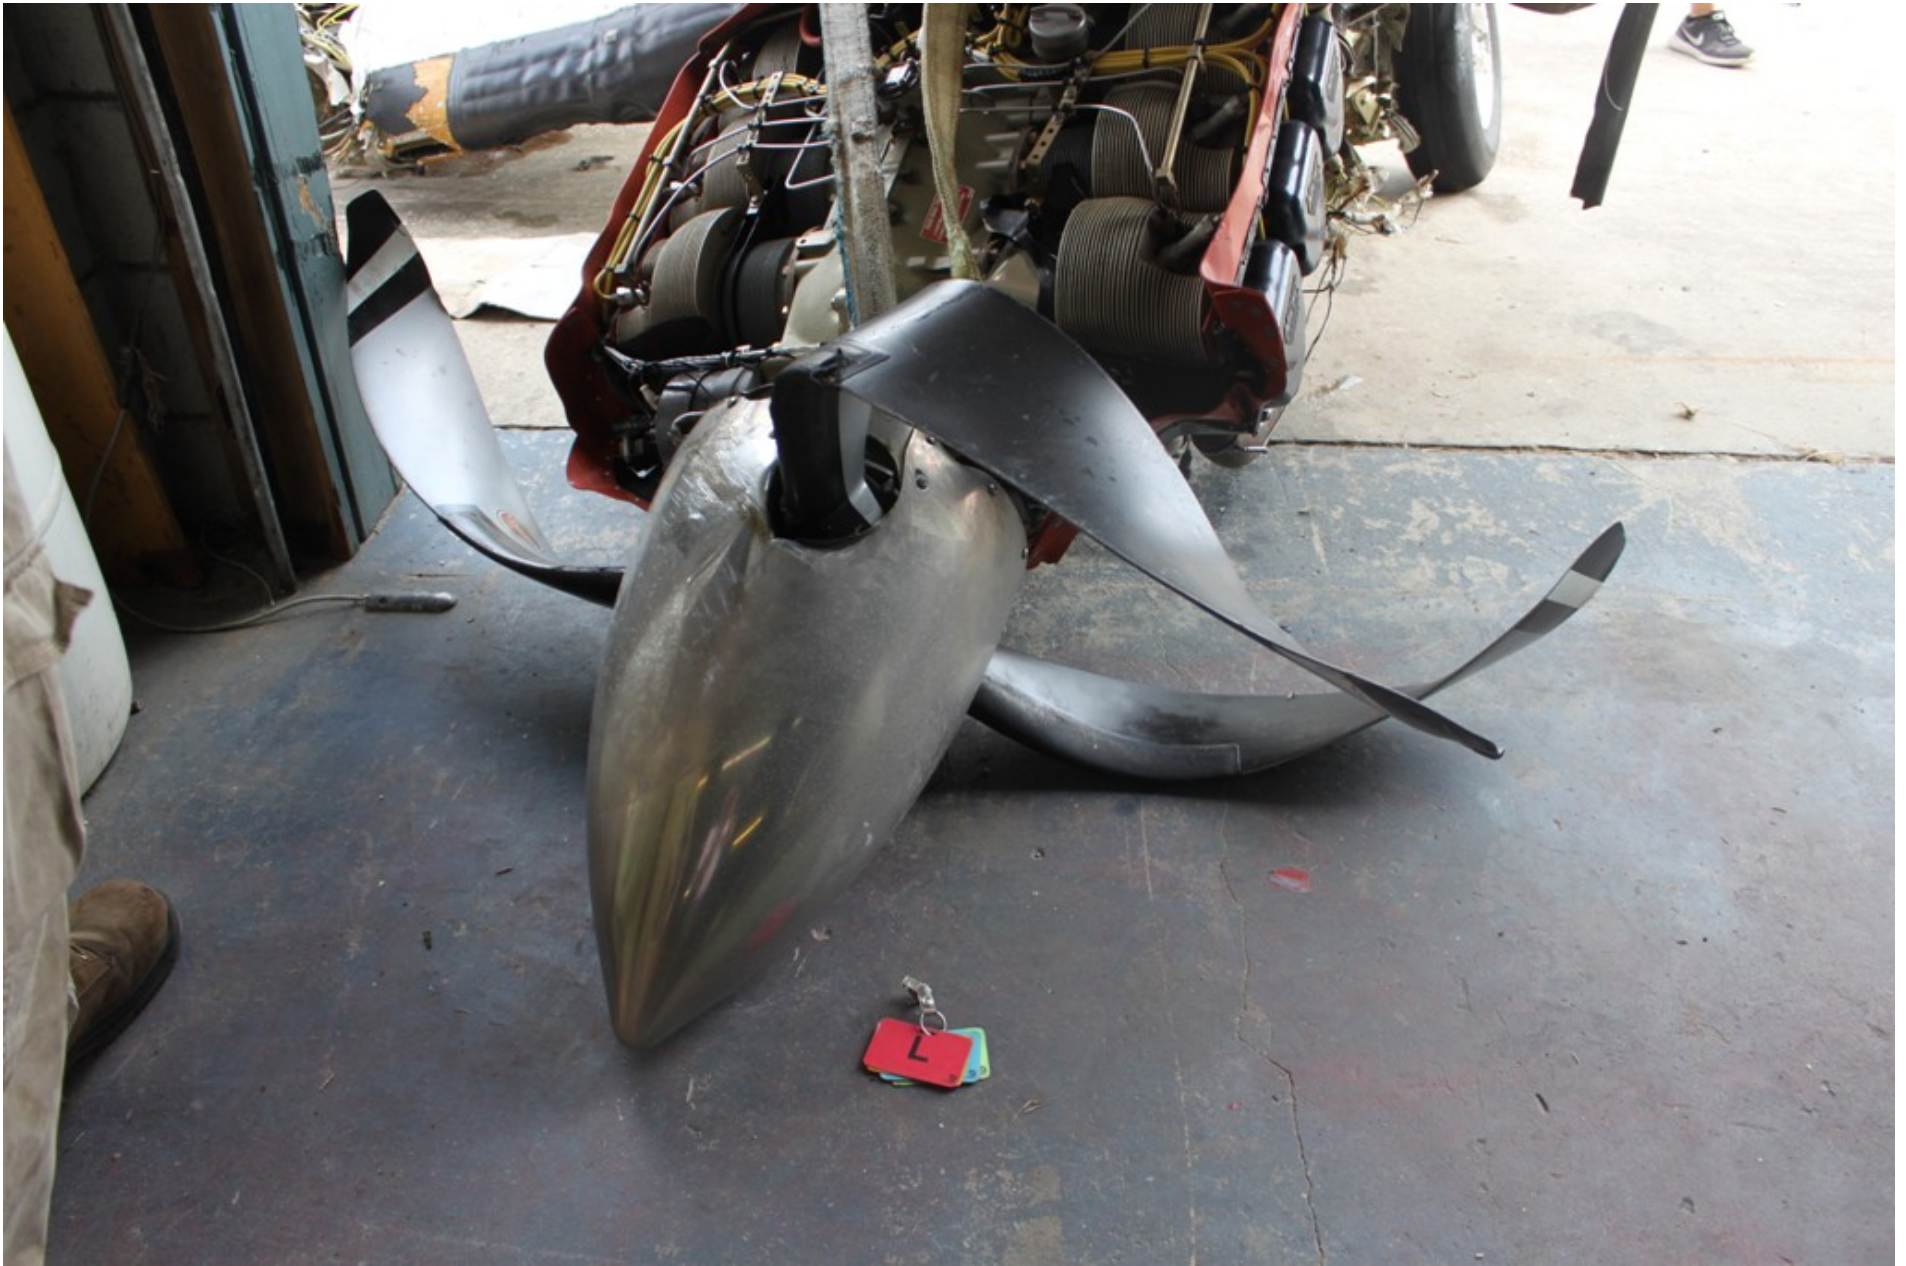
**Photo 10 - NTSB Digital Photograph. View Showing the Left Propeller and Portion of Left Engine.**

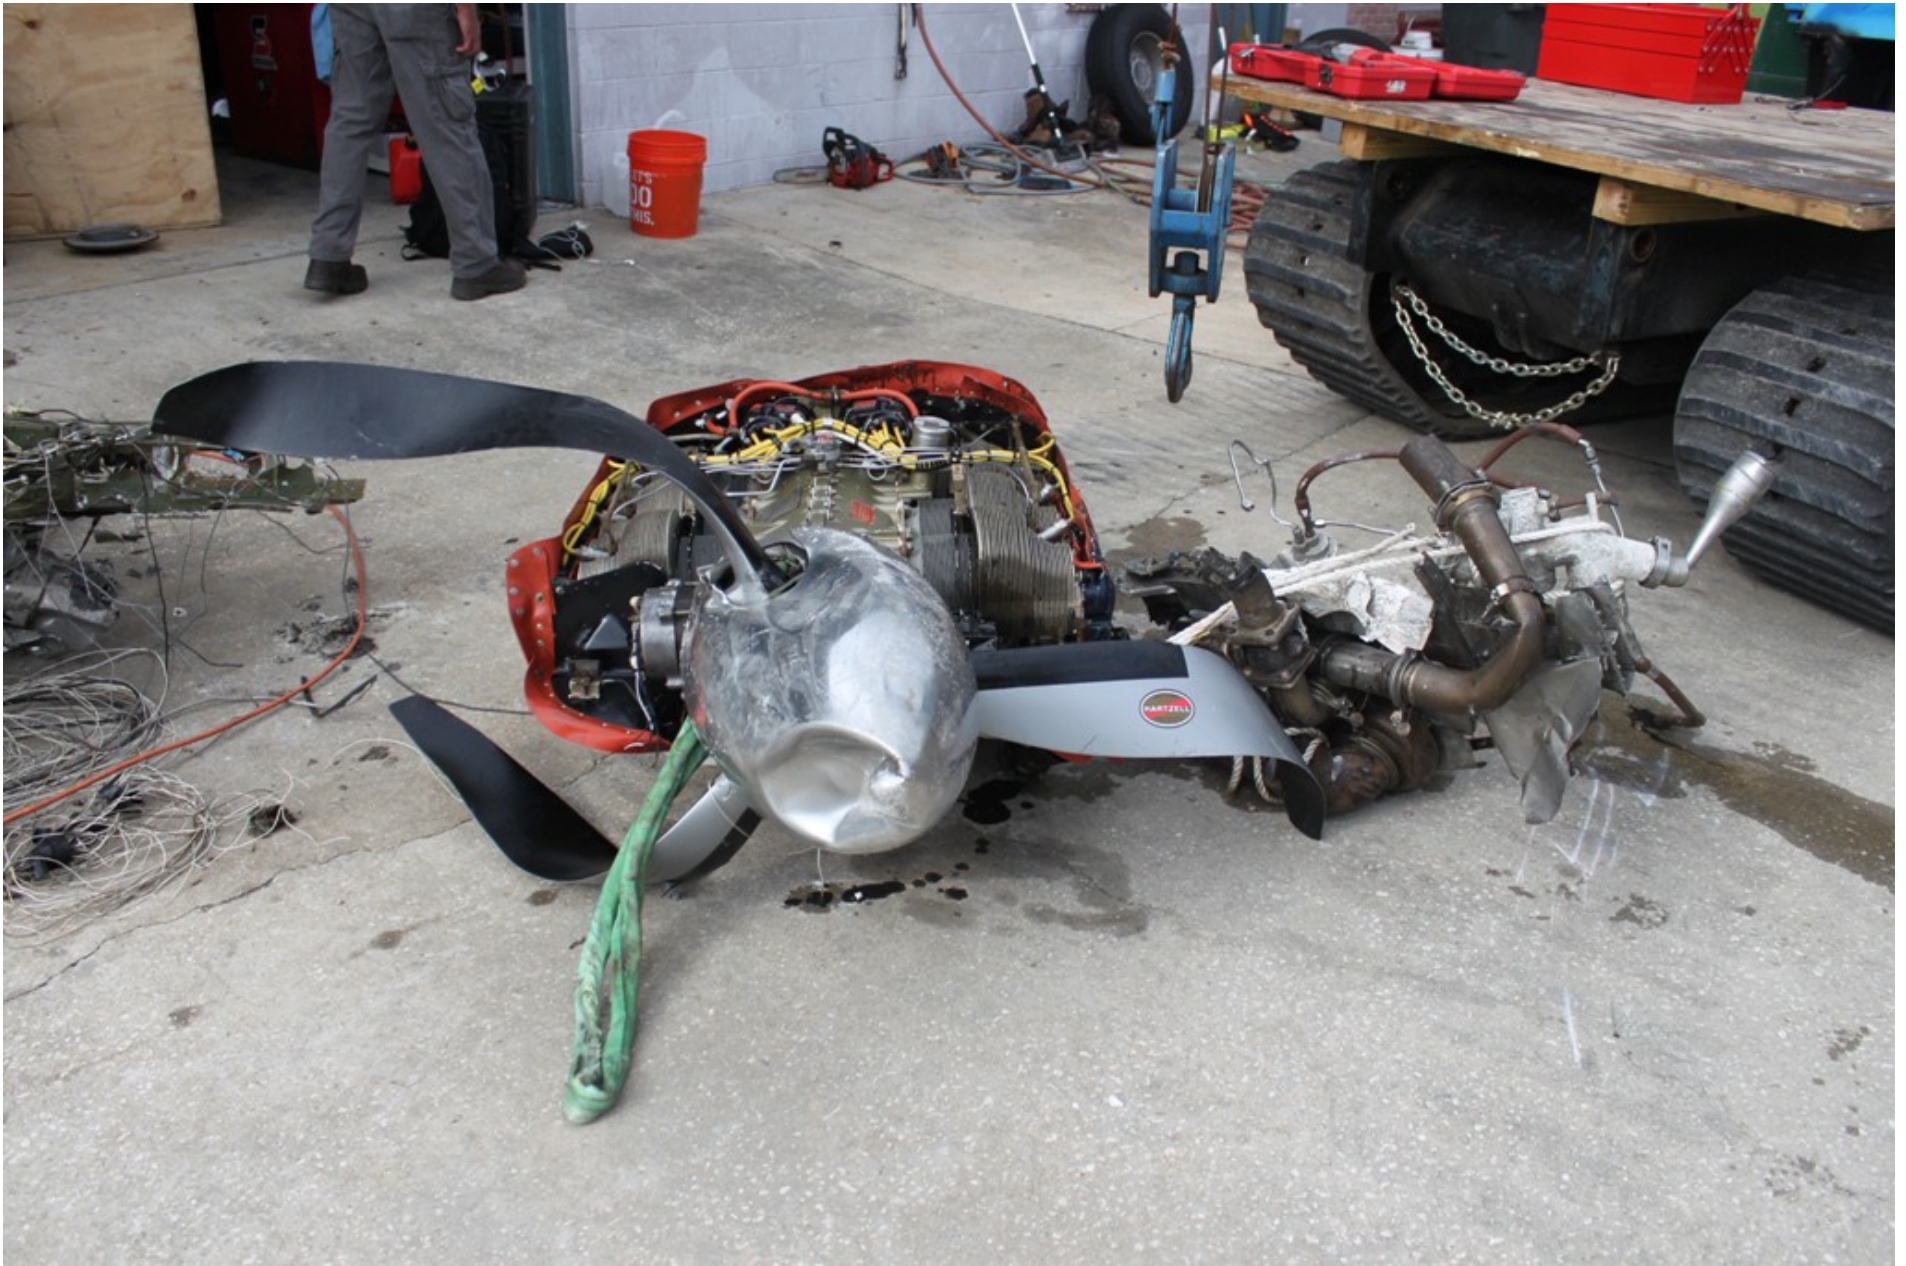
**Photo 11 - NTSB Digital Photograph. View Showing the Right Propeller and Portion of Separated Right Engine, and Right Engine Components.**
