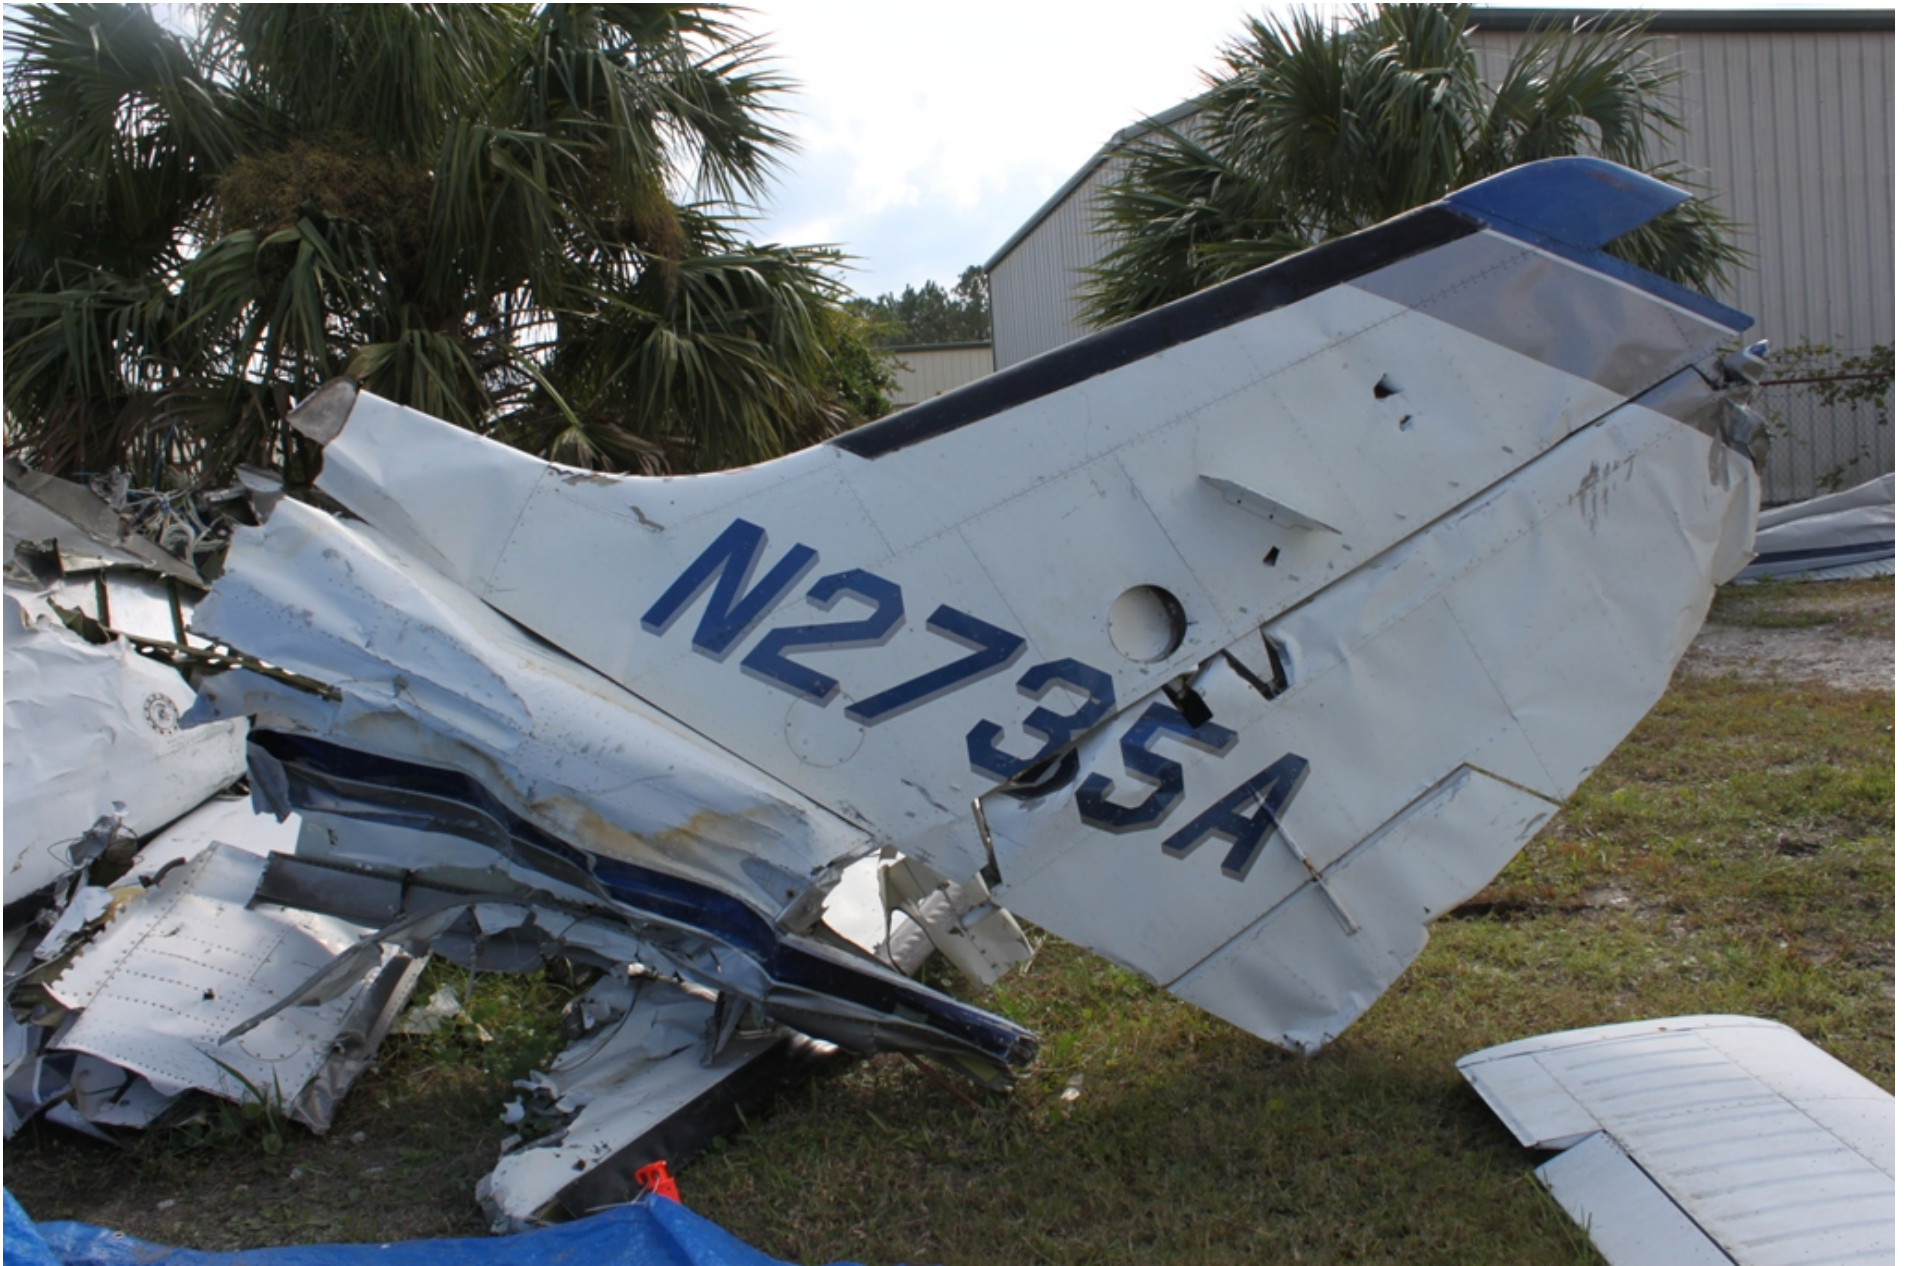
**Photo 12 - NTSB Digital Photograph. View Showing the Left Side of the Vertical Stabilizer, Rudder, Rudder Trim Tab, and Portion of Empennage.**

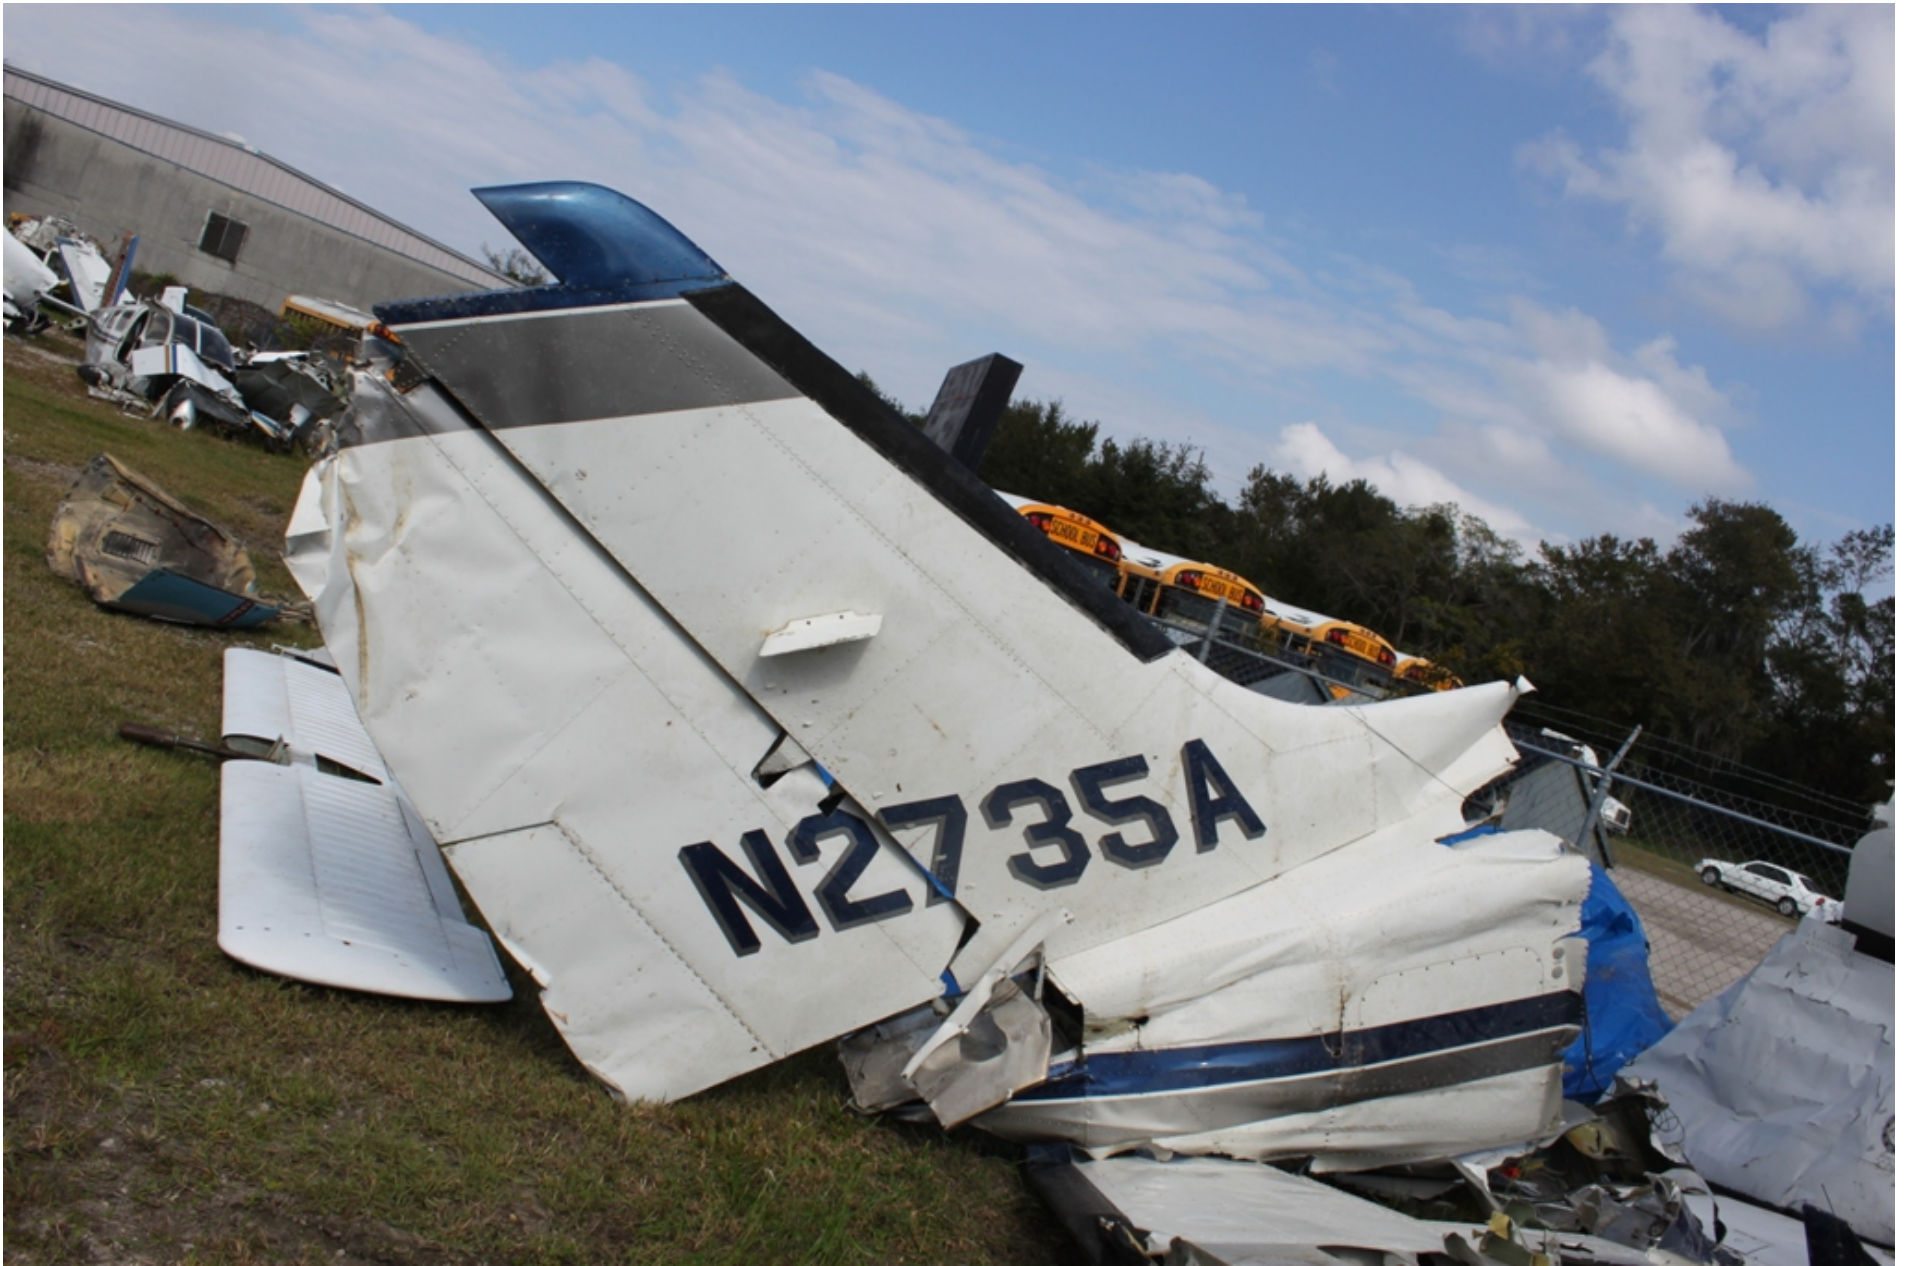
**Photo 13 - NTSB Digital Photograph. View Showing the Right Side of the Vertical Stabilizer, Rudder, Rudder Trim Tab, and Portion of Empennage.**

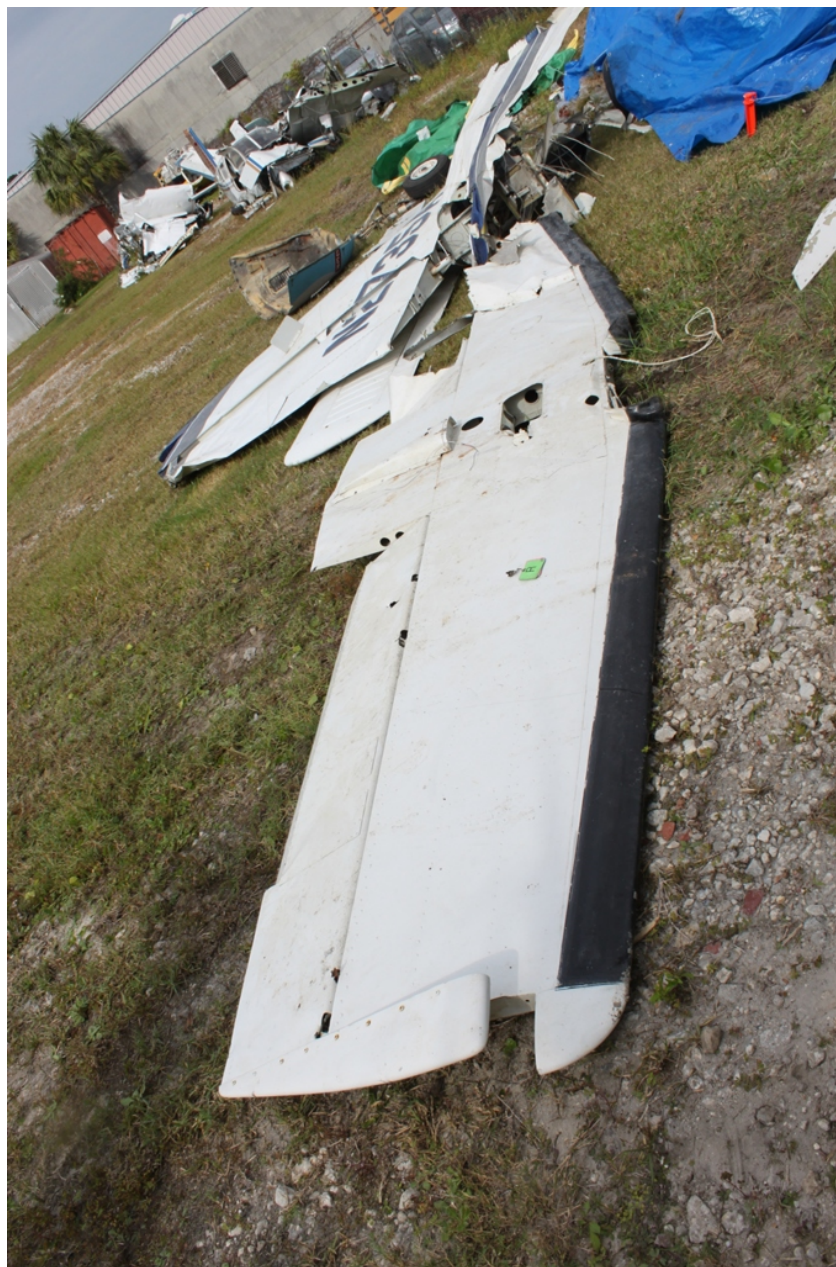
**Photo 14 - NTSB Digital Photograph. View Showing the Horizontal Stabilizer with Attached Elevators.**

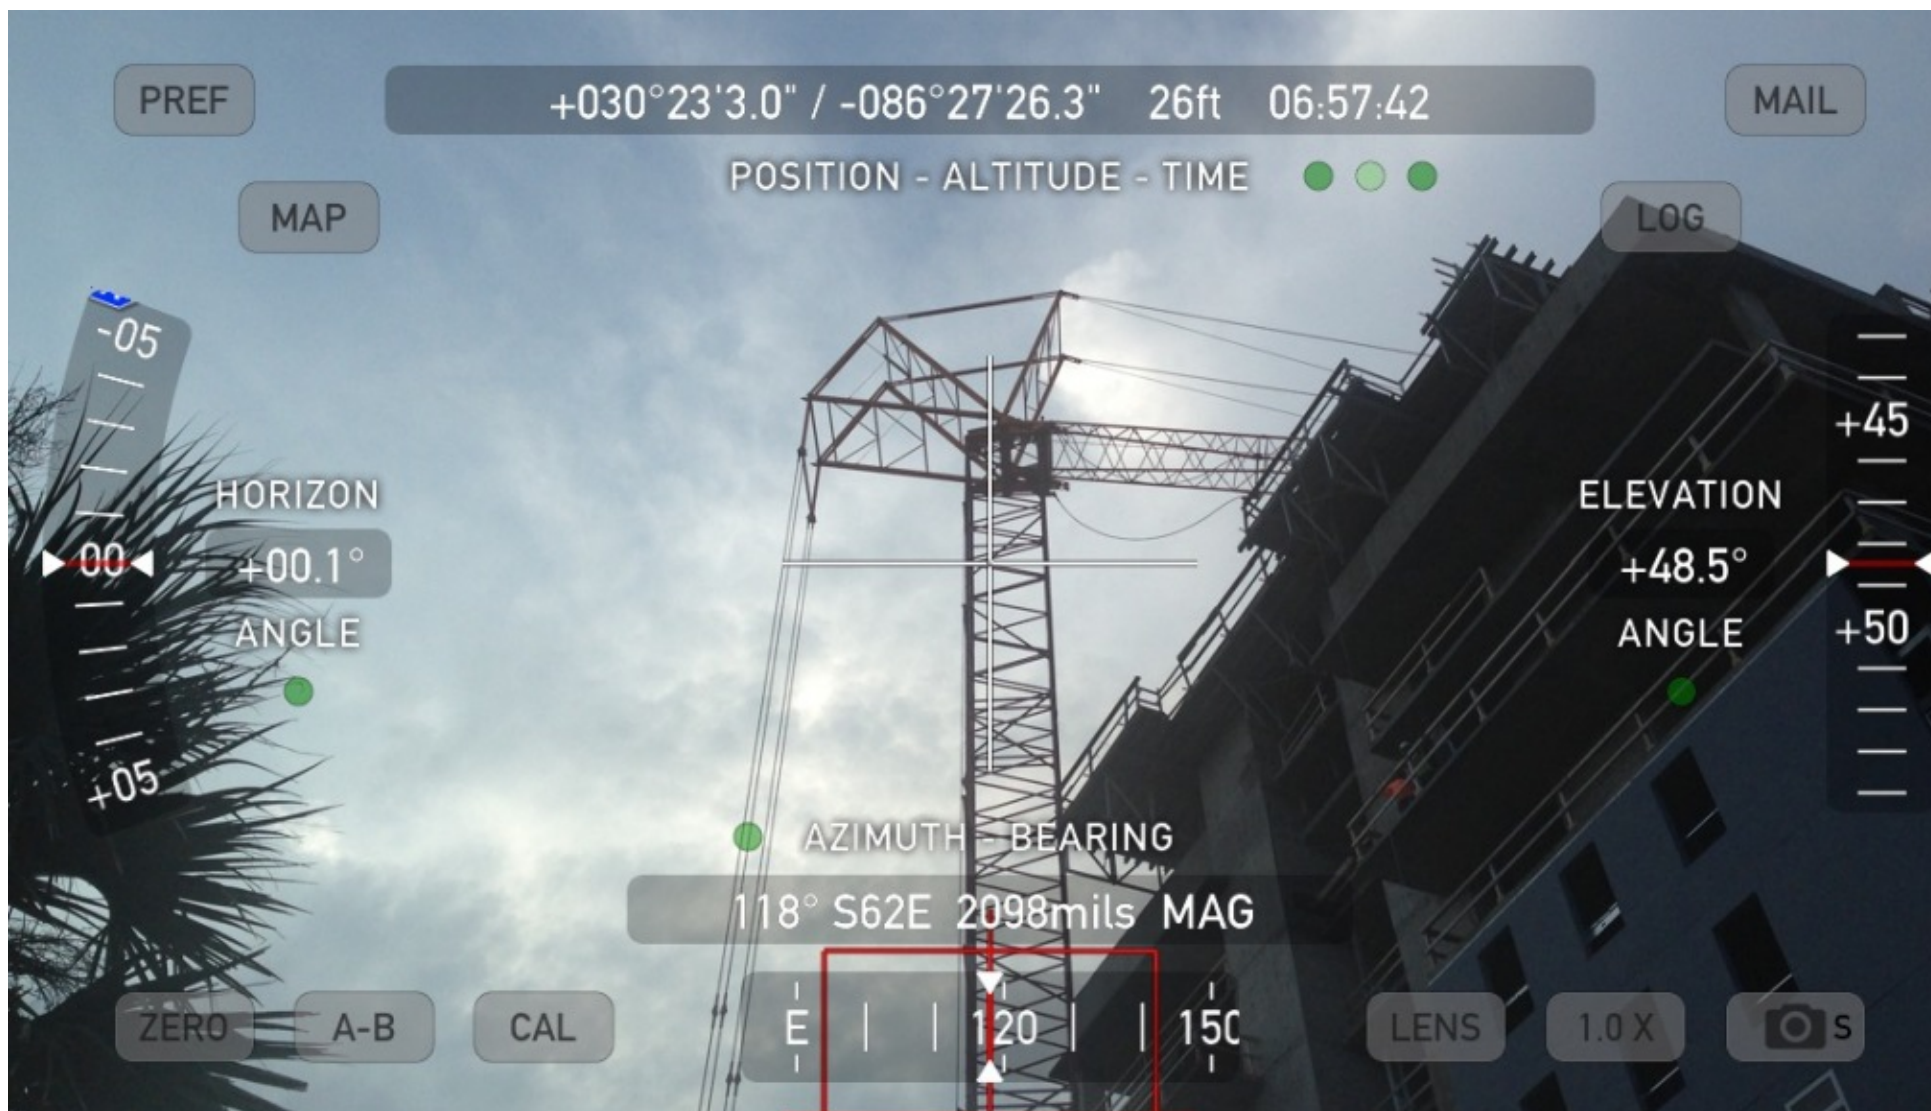
**Photo 15 - NTSB Digital Photograph. View Showing the Positioning and Location of the Crane Subject to NOTAM 12/003 As First Viewed August 5, 2016, 0657:42.**
