# NATIONAL TRANSPORTATION SAFETY BOARD

MATERIALS LABORATORY FACTUAL REPORT

Report No. 17-012

Place : Destin, Florida  
Date : August 2, 2016  
Vehicle : Cessna 414A, N2735A  
NTSB No. : ERA16FA279  
Investigator : Timothy W. Monville, ASI-ERA

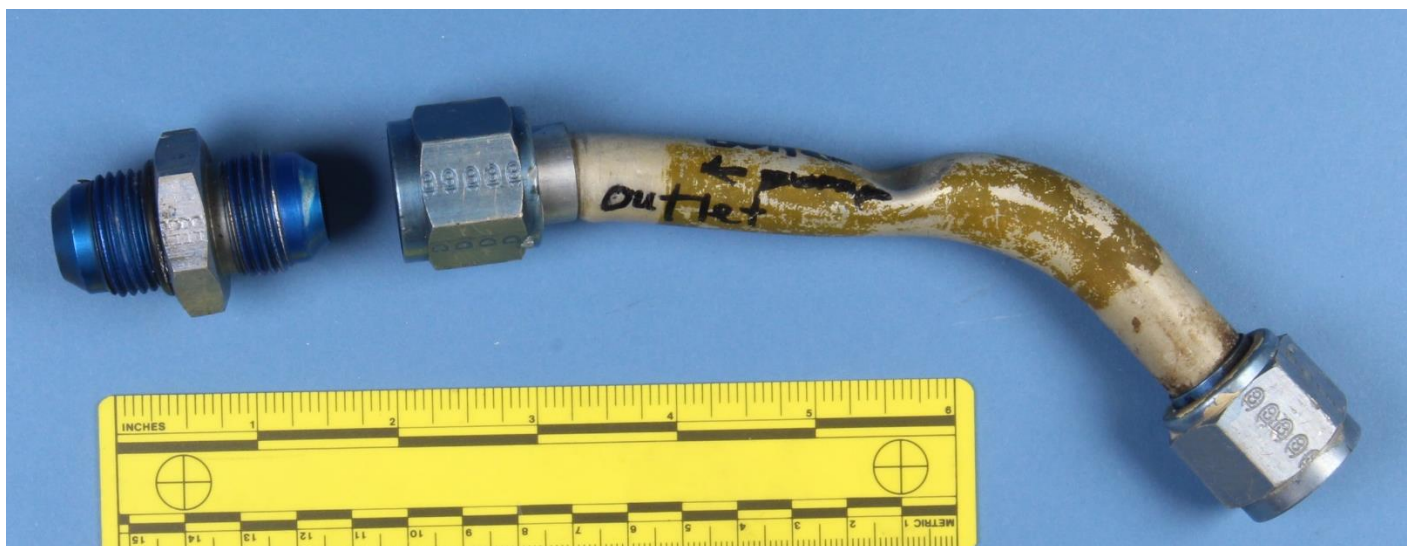
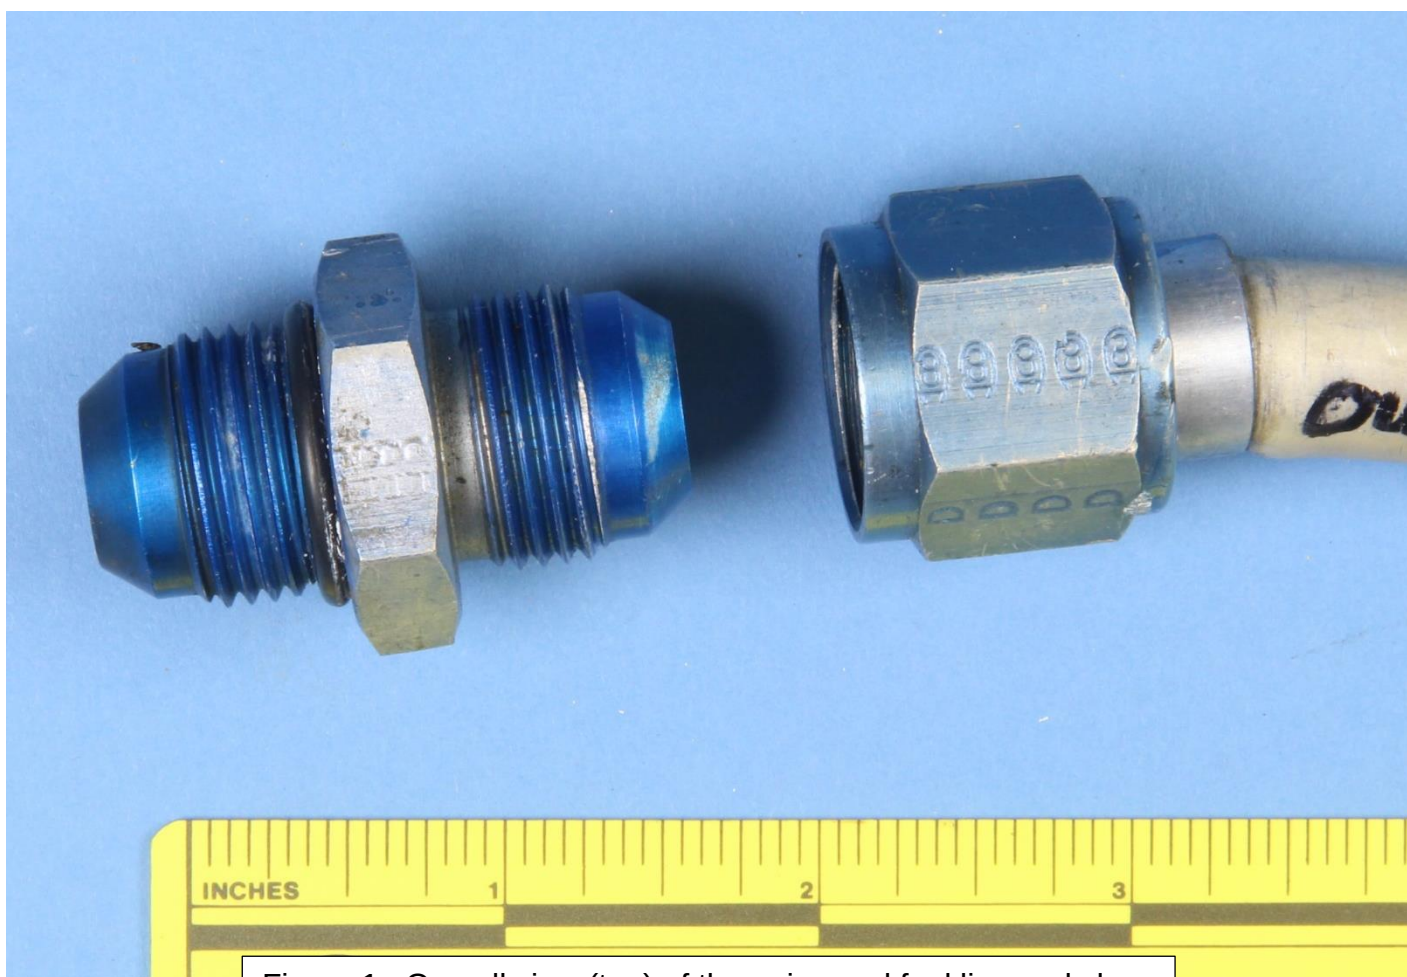
The as-received fuel line and union are displayed in figure 1. The line was reportedly found disconnected from the union. The fuel line was made up of a solid aluminum tube, about 0.5 inch inner diameter with flared ends and aluminum AN 818 nuts. The tube had a large dent at about mid length. The union was marked AN815 and D denoting an aluminum flared tube union with no safety wire holes. Dimensions of the tube nuts and union were consistent with AN818-10 components.

Figure 1. Overall view (top) of the union and fuel line and close up of the nut and union (below).

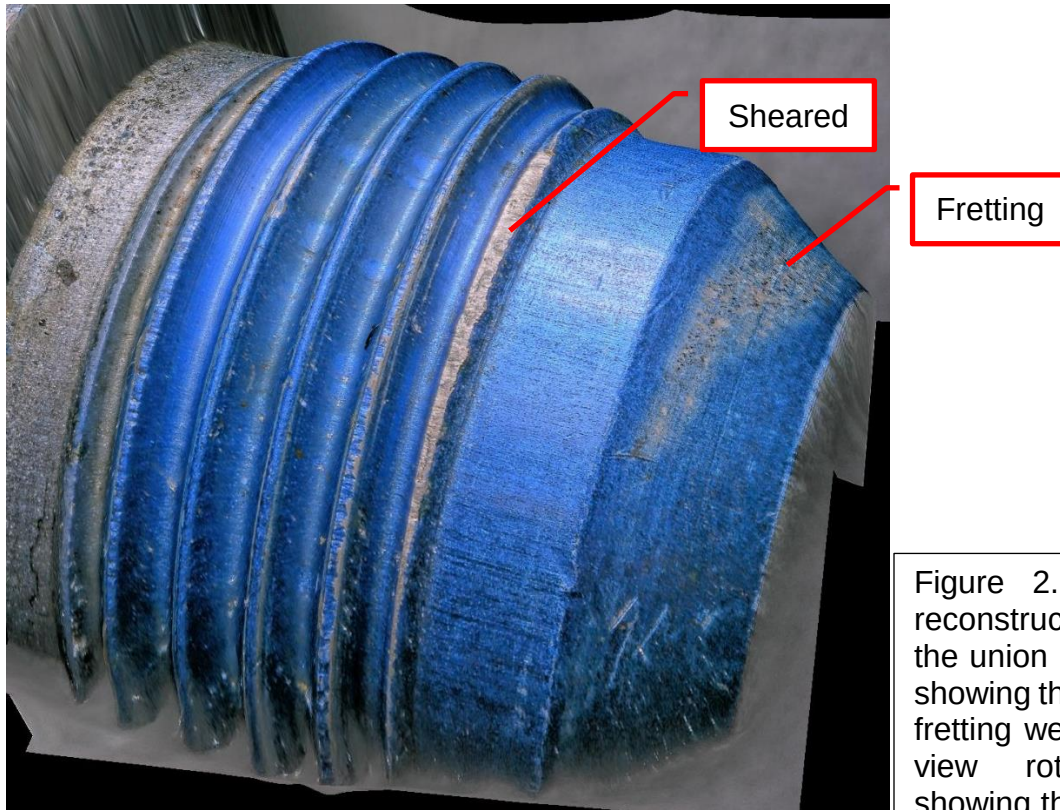
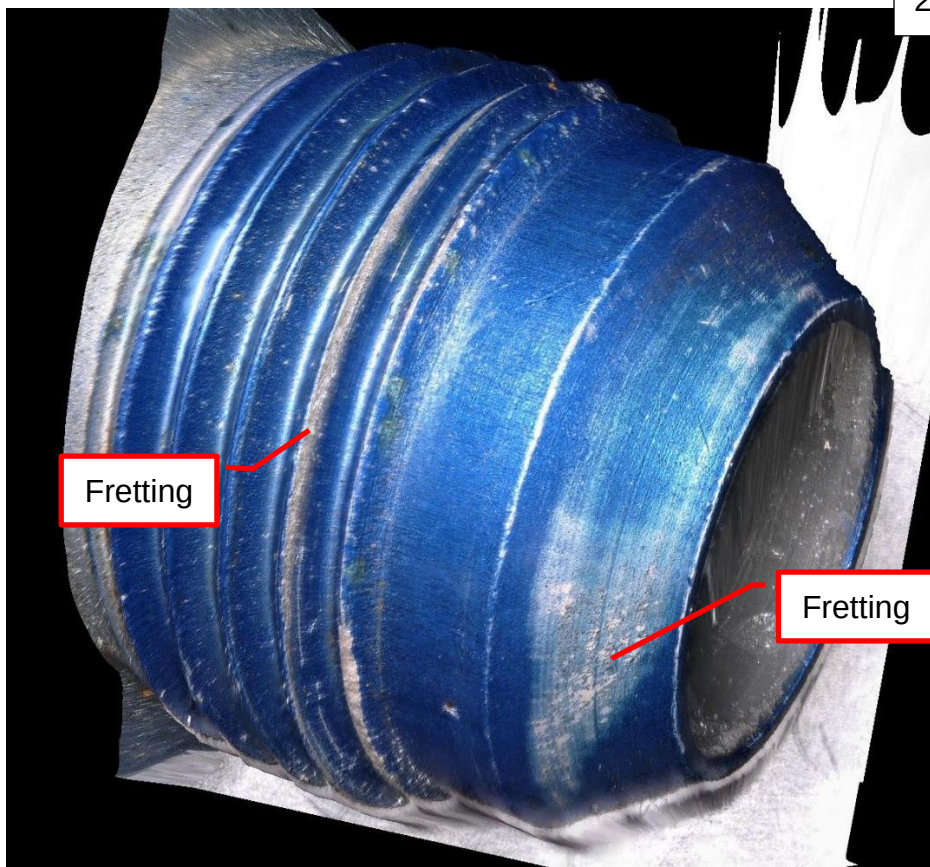
The threads of the union mating with the fuel tube were mostly intact and undamaged except for portions of first thread (partial) and the second (first full) threads. Magnified examination found that an approximate 90 degree arc of the first partial thread was fractured as shown in the upper view of figure 2. Examination found features consistent with overstress shearing of the thread toward the tube.

Close inspection of the second thread uncovered fretting wear scars to the flare side flank of the thread, as shown in the lower view of figure 2. The fretting wear damage completely penetrated the blue anodize coating over an approximate a 90 degree arc.

The flare portion of the union mating with the fuel line was undamaged except in an area where the blue anodized coating was worn through, see figure 2. Magnified examinations revealed features within the wear indicative of fretting wear.

Figure 2. Three dimension reconstructions of the threads on the union mating to the fuel line showing the thread shearing and fretting wear of the flare. Lower view rotated from above showing the fretting wear on the 2<sup>nd</sup> thread.

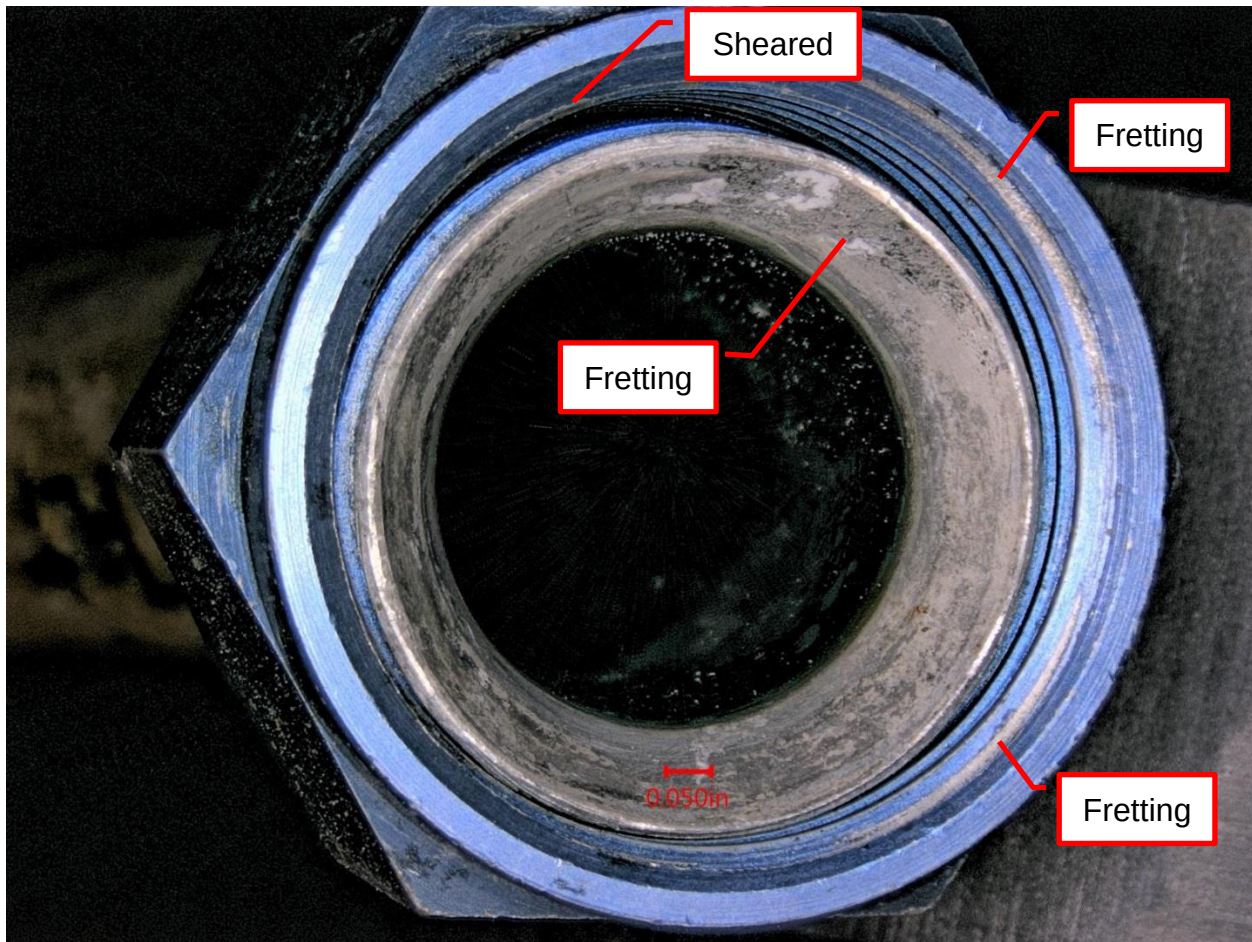
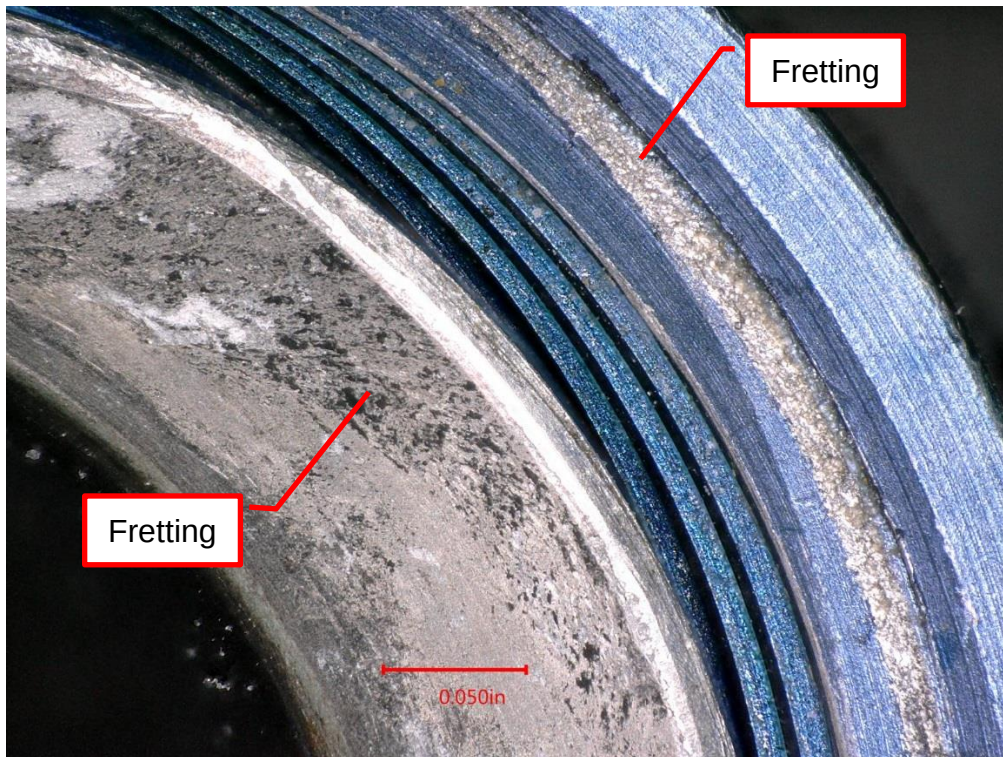
The mating nut threads were mostly undamaged except the first (partial) and second (first full) threads at the open end as shown in figure 3. The partial thread showed crest damage around about 270 degrees. The thread was overstress sheared toward the union in a portion of this region. The outward facing flank of the second thread had fretting wear damage in two locations, as noted in figure 3. The relative locations of the fretting wear on the thread flank approximates the location of the fretting wear scars noted on the threads of the union.

The internal surface of the fuel line flare had non-distinct contact patterns around most of the surface and an area of fretting wear, as denoted on figure 3. The shape of the fretting scars matched the general shape of the fretting scars previously noted on the flair of the union.

Figure 3. Views of the interior of the fuel line flare and nut. Lower view shows a close up of the thread and flare fretting wear.
