**ERA16FA289**

**Piper PA-31 – N447SA**

**NTSB FUEL PUMP EXAMINATION REPORT**

**January 10, 2017**

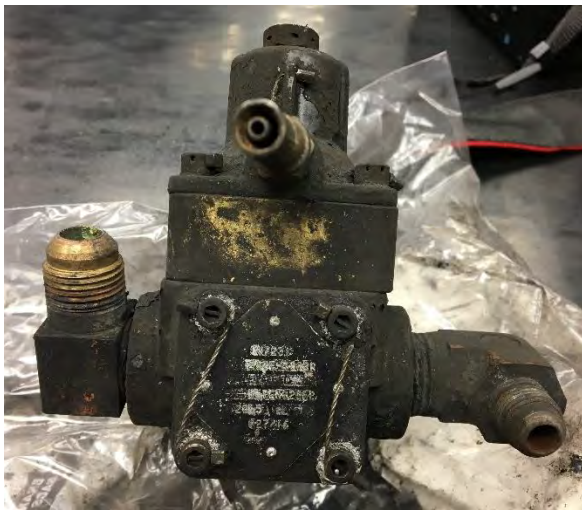
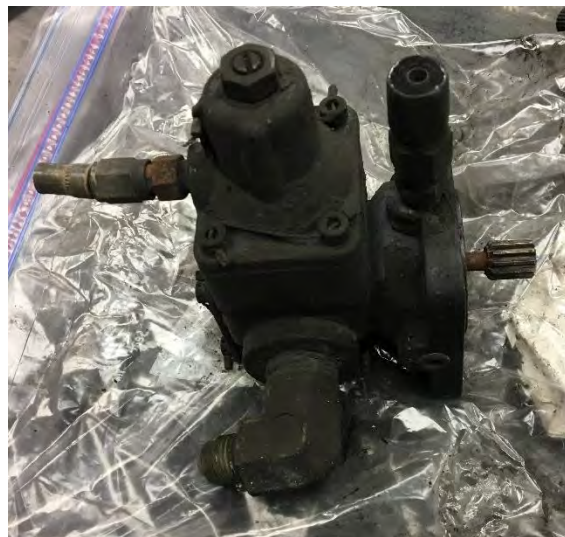
Picture 3. Views of Right Engine Driven Fuel Pump

- The exterior of the fuel pump was covered in soot.
- The fuel pump drive coupling was intact; not sheared.
- The safety wire was intact and the safety cable remained secure.
- The lock nut was finger tight and the safety wire was not present.
- There was no debris noted in the inlet or outlet port.
- The drive coupling retaining clip remained in place on the rotor shaft.
- The pump rotor shaft did not rotate.

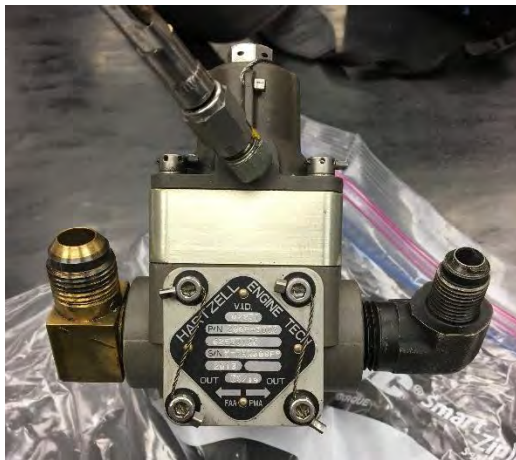
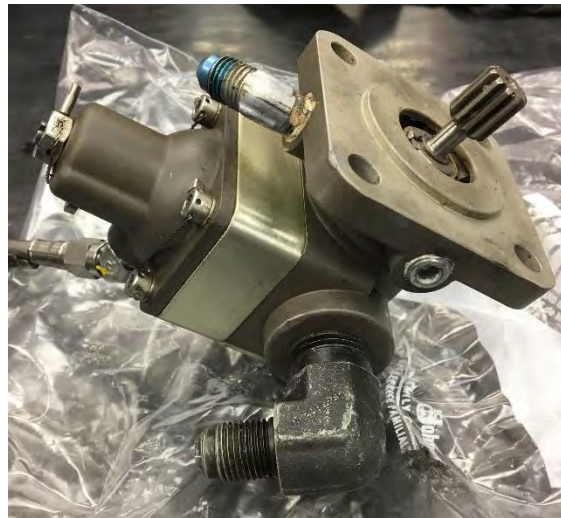
Picture 4. Views of Left Engine Driven Fuel Pump

- The exterior of the fuel pump did not exhibit impact damage.
- The fuel pump drive coupling was intact; not sheared.
- The overboard drain hose remained attached and was removed to facilitate further examination.
- No debris was noted in the inlet or outlet port.
- All safety wires were intact and remained in place.
- The pressure adjustment lock nut safety wire was in place and the lock nut was tight. The safety wire type was not the same type used by the manufacturer.
- The fuel pump rotated both direction when rotated by hand.
- No drive coupling spline teeth damage was noted.
- The drive coupling retaining clip remained in place.
- The turbo air reference fitting remained attached to the fuel pump housing and the torque stripe remained in place.

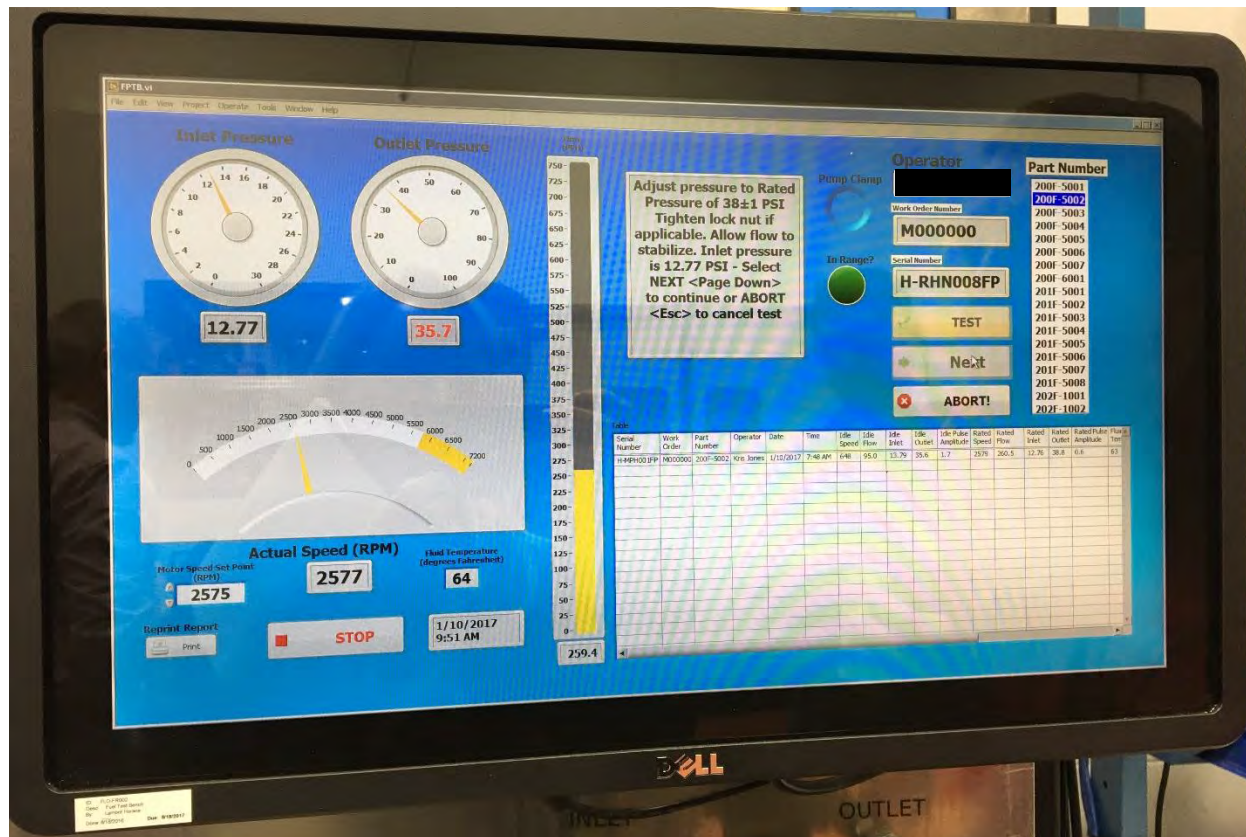
The fuel pump was mounted on a test bench in order to test the fuel flow through the pump. The pump required 9.5 oz-in (max allowed was 17 oz-in) of torque to get the pump to rotate. An internal pressure leak check demonstrated no leaks were noted.

The left engine driven fuel pump was flow tested as recovered in a cruise power setting and the pump had a low outlet pressure (35.7 psi versus 38.0 +/- 1.0 psi). A safety wire that was not the type of wire used at Hartzell Engine Technologies was cut in order to loosen the lock nut and make the adjustment to increase output pressure. When the adjustment screw was moved about a half turn, the pump passed cruise power flow requirements of the acceptance test procedure for the manufacturer. It is not uncommon for pumps to be readjusted to engine manufacturer standards once they leave Hartzell Engine Technologies.

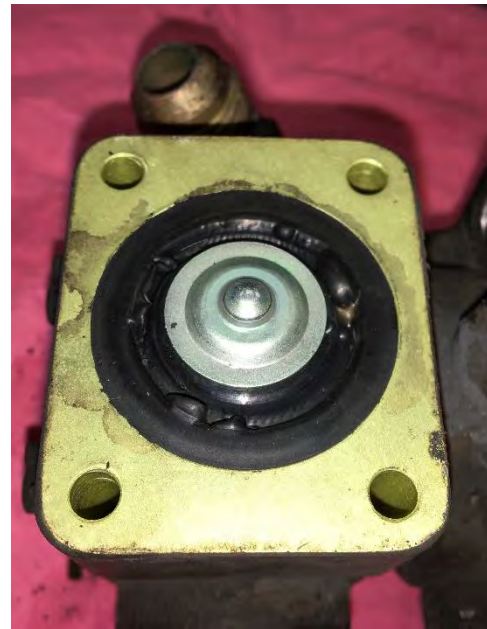
The safety wires were removed in order to facilitate further disassembly. The relief valve diaphragm remained intact, however, it exhibited heat damage (See Picture 5). It was removed for further examination. The relief valve body was removed and the relief valve gasket seal exhibited heat damage (See Picture 6). The drive coupling was removed, the drive tang did not exhibit any damage, and the drive spline teeth were all intact. The AN960L washers that were under the socket head cap screws stuck to the body cover of the pump. The rear bearing of the pump remained intact and not cracked. The rear bearing O-ring was pliable.

Picture 5. View of heat damaged relief valve diaphragm.

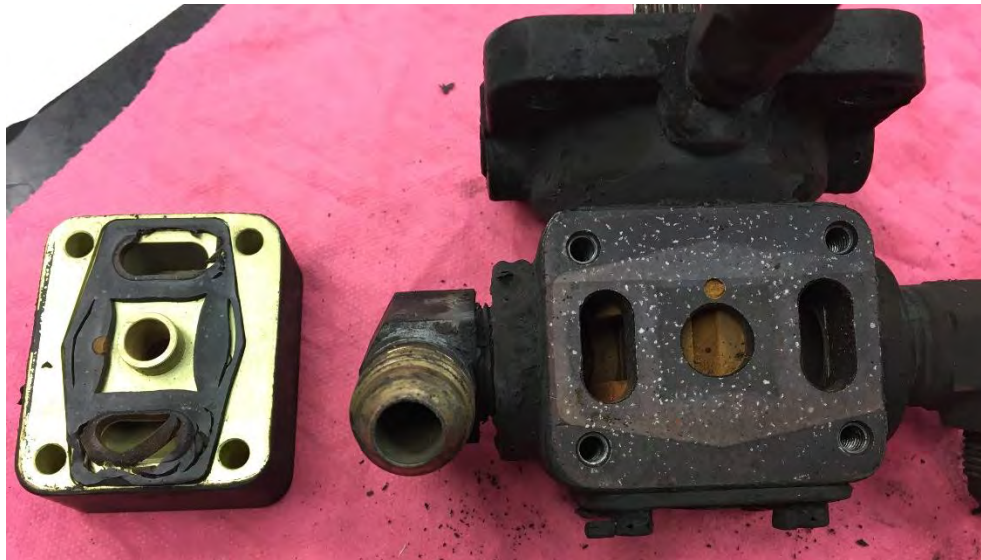
Picture 6. Relief Valve Body and Gasket exhibited heat damage.

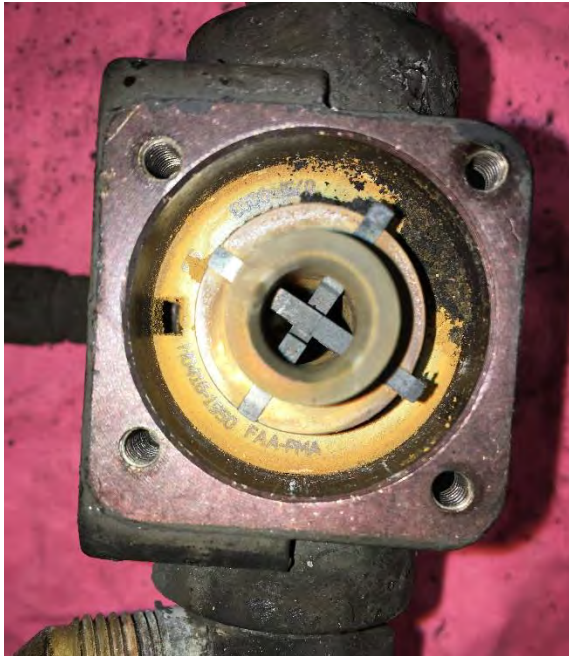
The rear carbon bearing was removed and revealed that the pump liner and rotor exhibited corrosion. The rotor vanes were seized in place but remained intact (See Picture 7). The rotor and vanes were removed for further examination.

Picture 7. View of Rotor and Vanes inside the Right Engine Driven Fuel Pump

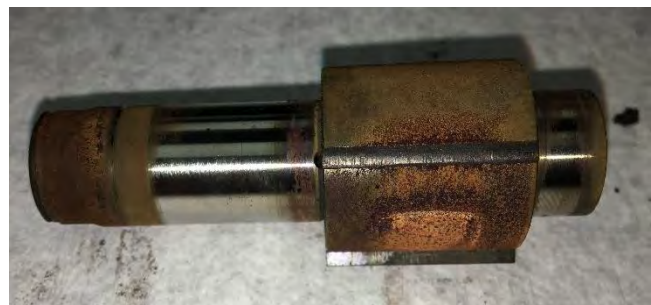
The rotor vanes sealing faces did not exhibit gouging. However, one chip was noted on the inboard section of a vane, that was 0.1805 inches in length. The rotor and vanes were removed. The rotor exhibited corrosion (See Pictures 8). An attempt to remove the vanes from the rotor was made, however, the vanes remained lodged in the rotor and were unable to be removed.

Picture 8. View of Rotor and Vanes Removed from Housing.

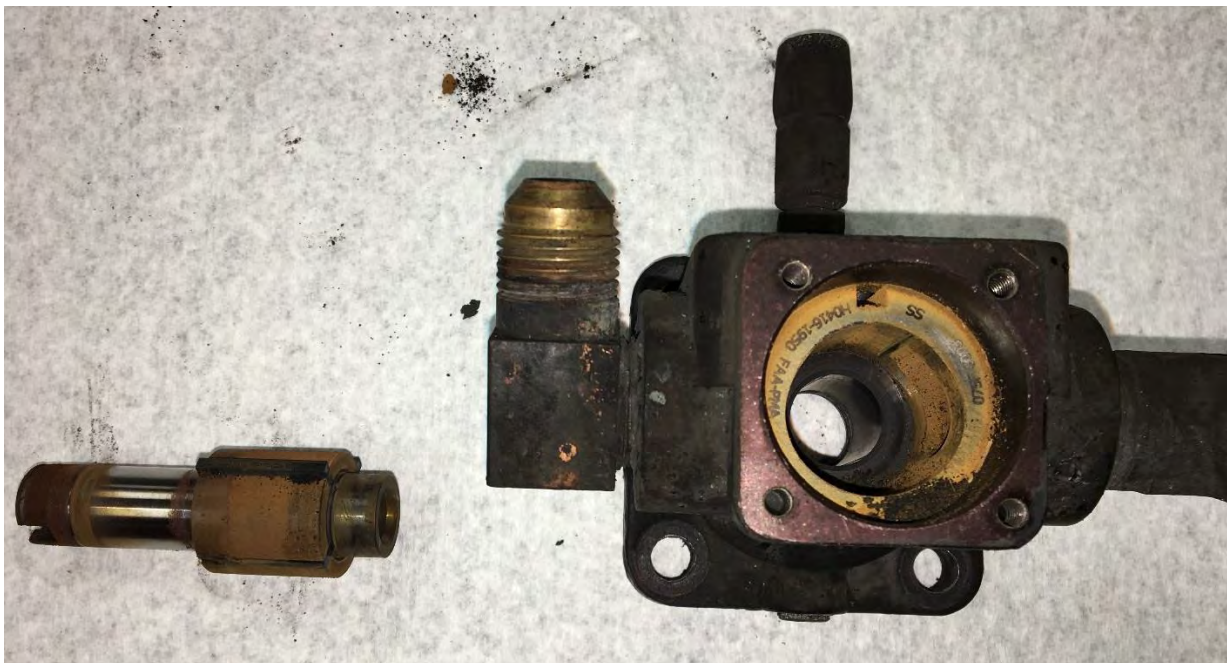
Picture 9. View of rotor and vanes removed from pump liner.

The fuel pump liner remained in place and exhibited corrosion (See Pictures 9). The main bearing did not exhibit any cracks or chips. The bore of the main bearing was examined and no anomalies were noted.

The examination and disassembly of the right engine driven fuel pump found that the interior of the fuel pump exhibited corrosion. It is likely that the right fuel pump drive shaft would not rotated as a result of the corrosion binding the vanes. In addition, since a postcrash fire ensued, the local fire department doused the fire with foam or water, that in turn entered the fuel pump. Also, the pump drive coupling incorporated a shear section, that remained intact, which demonstrated that it was unlikely that the rotor seized during engine operation. No anomalies were noted with the fuel pump that would have precluded operation prior to the accident.
