# NATIONAL TRANSPORTATION SAFETY BOARD

## MATERIALS LABORATORY FACTUAL REPORT

Report No. 18-022

Place : Alapaha, Georgia  
Date : September 16, 2016  
Vehicle : Cessna A188A  
NTSB No. : ERA16FA315  
Investigator : Adam Gerhardt

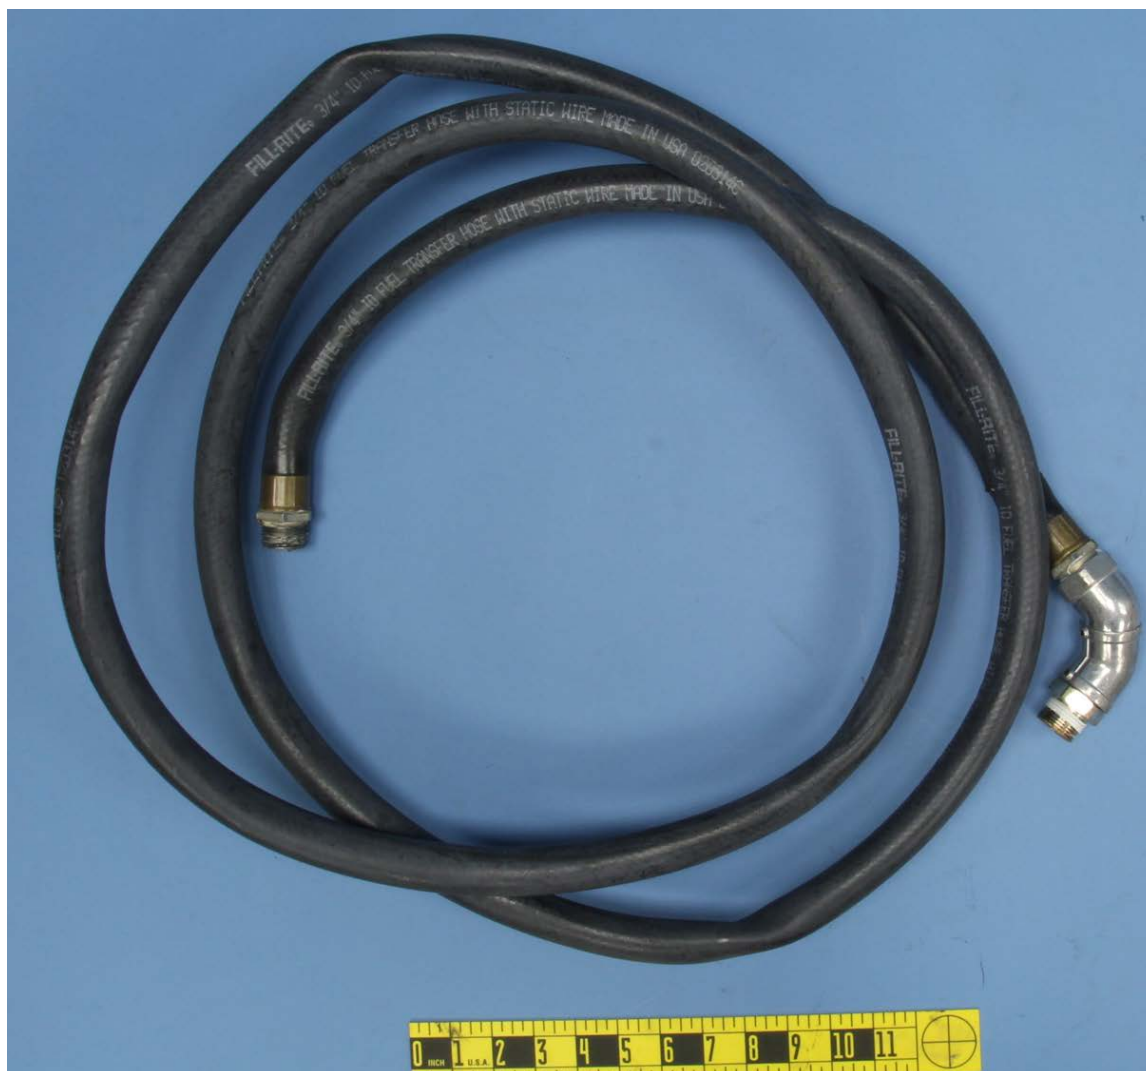
Hose #1 was a 0.75-inch diameter, black polymeric hose, approximately 12 feet in length. A manufacturer's identification (FILLRITE ID FUEL TRANSFER HOSE WITH STATIC WIRE MADE IN THE USA 02314C) was visible in regularly spaced intervals on the exterior. The hose comprised of a black polymeric material with an embedded metal wire mesh for static protection. Hose #1 was noticeably faded in color when compared to Hose #2. There was no obvious visible damage.

The Hose #1 and Hose #2 sample spectra had several similar peaks indicating that the two hose materials were the same material. That material contained the following combination of spectral peaks corresponding to particular functional groups found within molecular structure of the material. The presence of a strong doublet peak between  $\sim 2900\text{ cm}^{-1}$  and  $\sim 2850\text{ cm}^{-1}$  is indicative of a carbon-hydrogen (C-H) single stretching bond. The presence of a doublet peak  $\sim 2360$  and  $2340\text{ cm}^{-1}$  is indicative of a carbon-carbon (C-C) group (most likely in the form of elemental carbon or carbon black). It can also indicate the presence of a triple bonded carbon-nitrogen ( $\text{C}\equiv\text{N}$ ) group. The presence of a single peak  $\sim 1450\text{ cm}^{-1}$  is indicative of a carbon-hydrogen<sub>2</sub> ( $\text{C-H}_2$ ) bending bond. The presence of a single peak  $\sim 960\text{ cm}^{-1}$  is indicative of a carbon-hydrogen<sub>3</sub> ( $\text{C-H}_3$ ) bending bond. This combination of functional groups is consistent with a straight-chained hydrocarbon with an attached nitrile group. A spectral library search was performed on both hose sample spectra. The search found a very strong match to acrylonitrile/butadiene copolymer (n-butyl rubber or nitrile rubber) for both hoses. Based on the visual examination and the FTIR analysis, the hose material for both hoses was consistent with carbon black-filled nitrile rubber<sup>1</sup>.

Figure 1. Overall photograph of Hose #1.

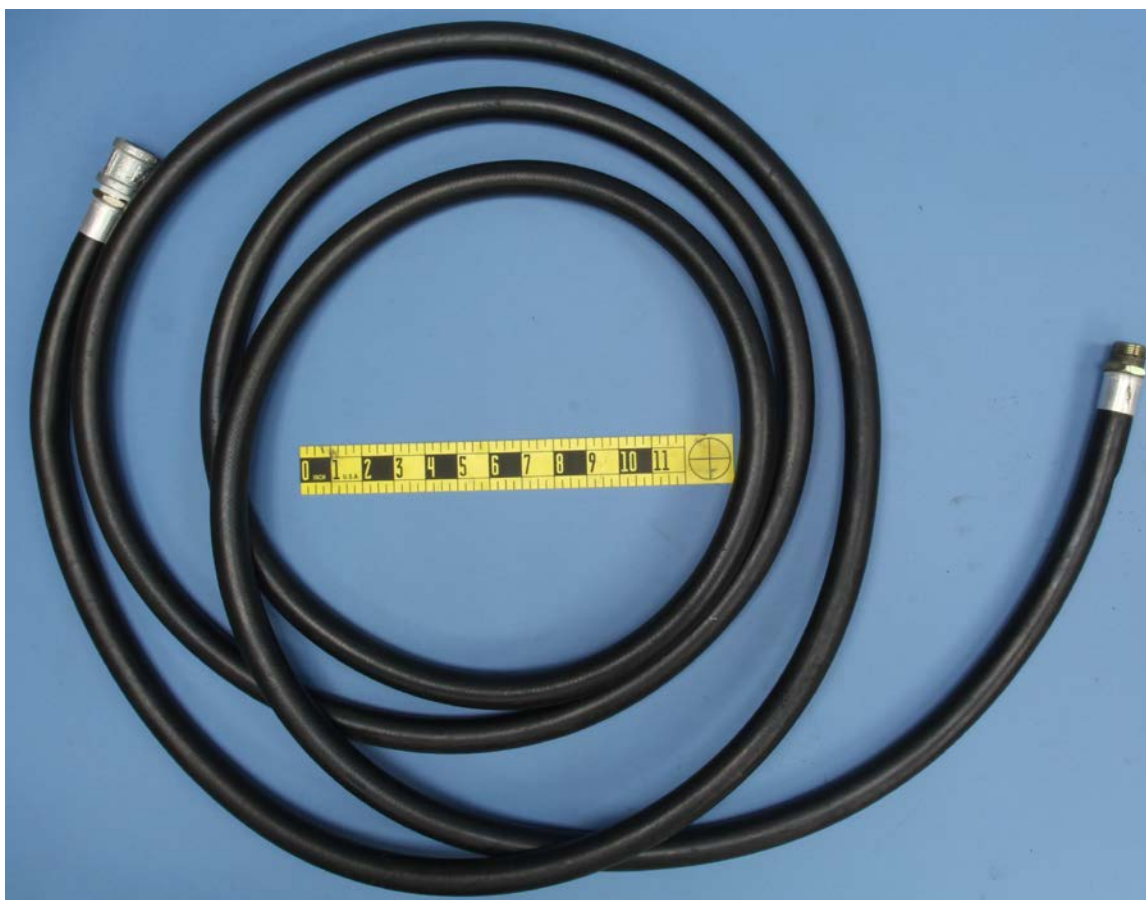
Hose #2 was a 0.75-inch diameter, black polymeric hose, approximately 20 in length. No lettering or identification markings were present on the exterior. Hose #2 comprised of a black polymeric outer layer and a braided steel inner layer. Springs were installed inside the hose at each of the connector ends to prevent hose kinking.

Figure 2. Overall photograph of Hose #2.

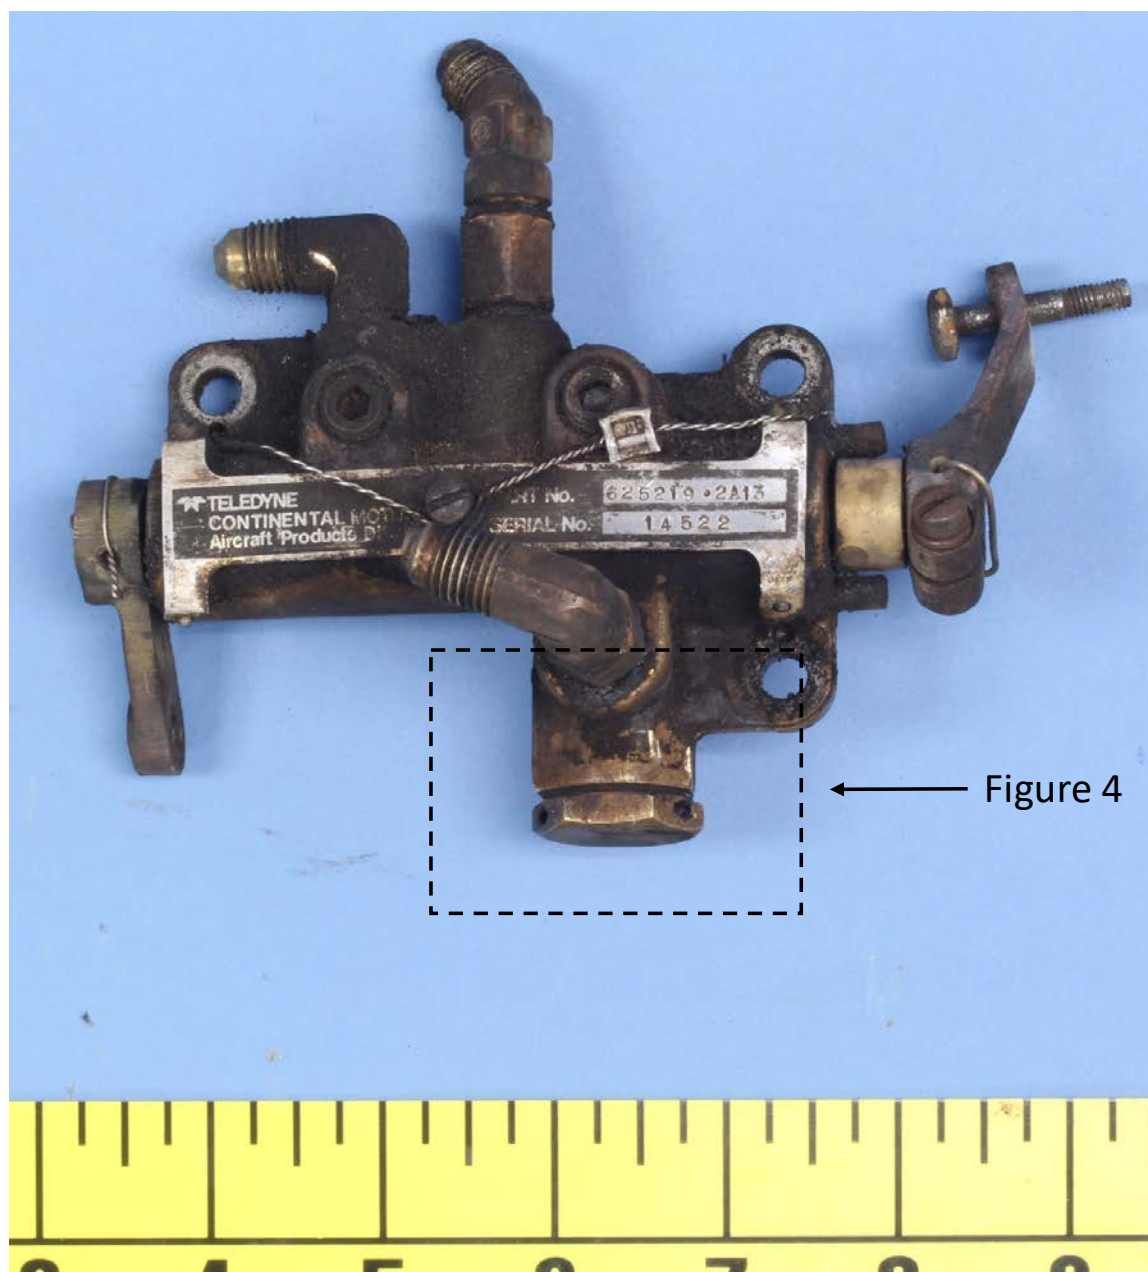
The throttle-body fuel screen was submitted to the Materials Laboratory for examination as shown in Figure 3. The finger screen was located on the bottom of the throttle body as shown in Figure 4. The thumbscrew holding the finger screen in place was removed. The screw is shown in Figure 5. The screen was torn away from the screw and the orifice was filled with a brown powdery debris. The remains of the finger screen and the thumbscrew are shown in Figure 6.

Figure 3. Overall photograph of the throttle-body fuel filter.

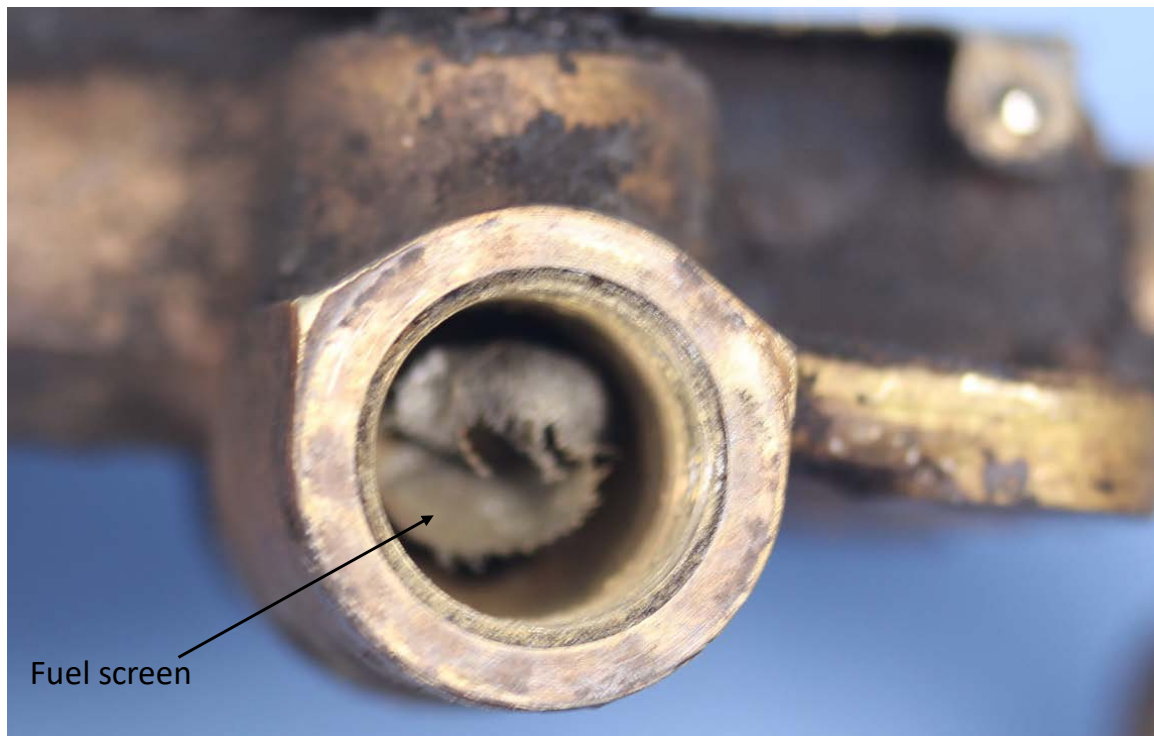
Figure 4. Close-up photograph of torn fuel screen in throttle-body.

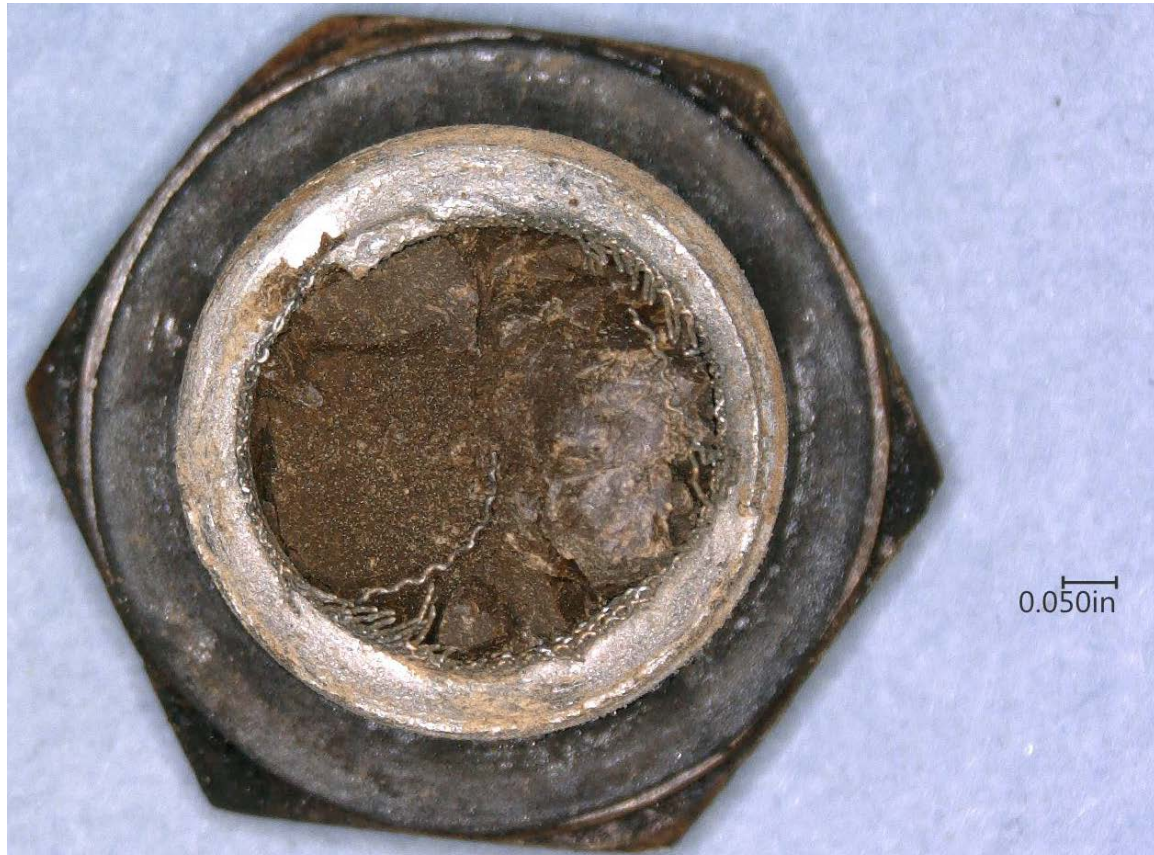
Figure 5. Close-up photograph of underside of fuel screen thumbscrew.

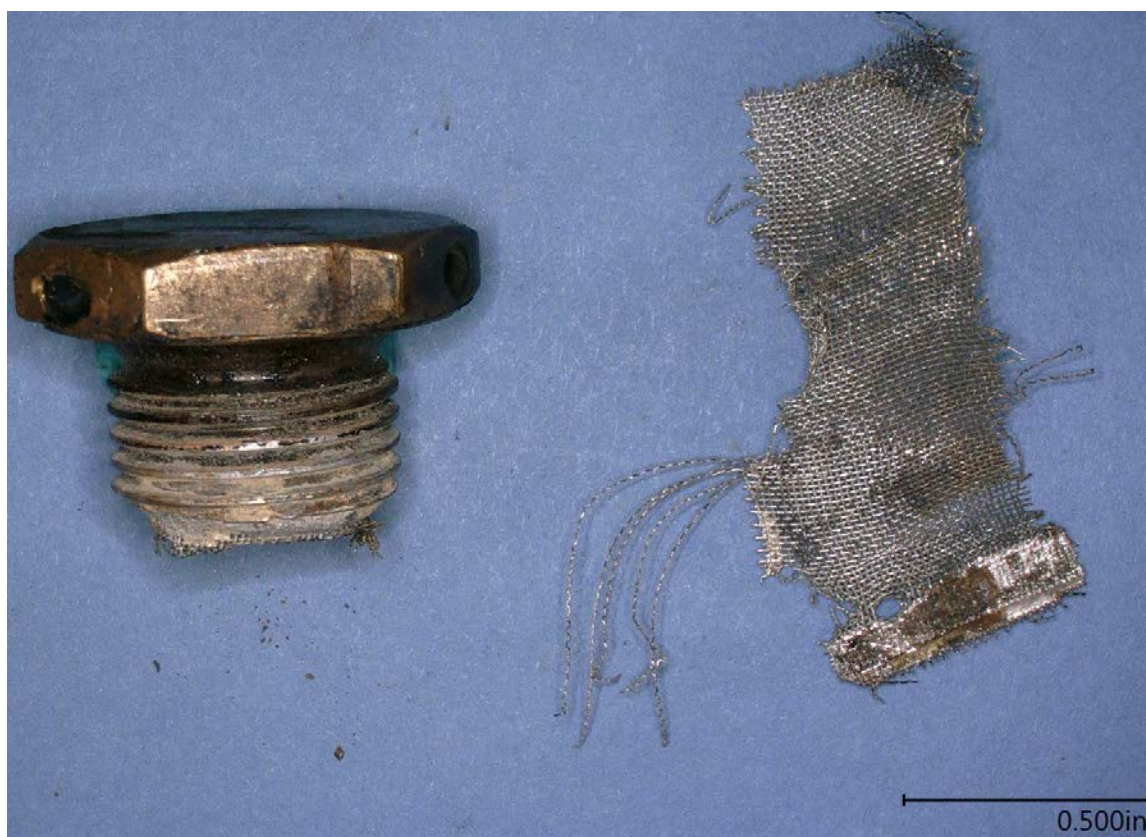
Figure 6. Photograph of thumbscrew and remnants of fuel screen.

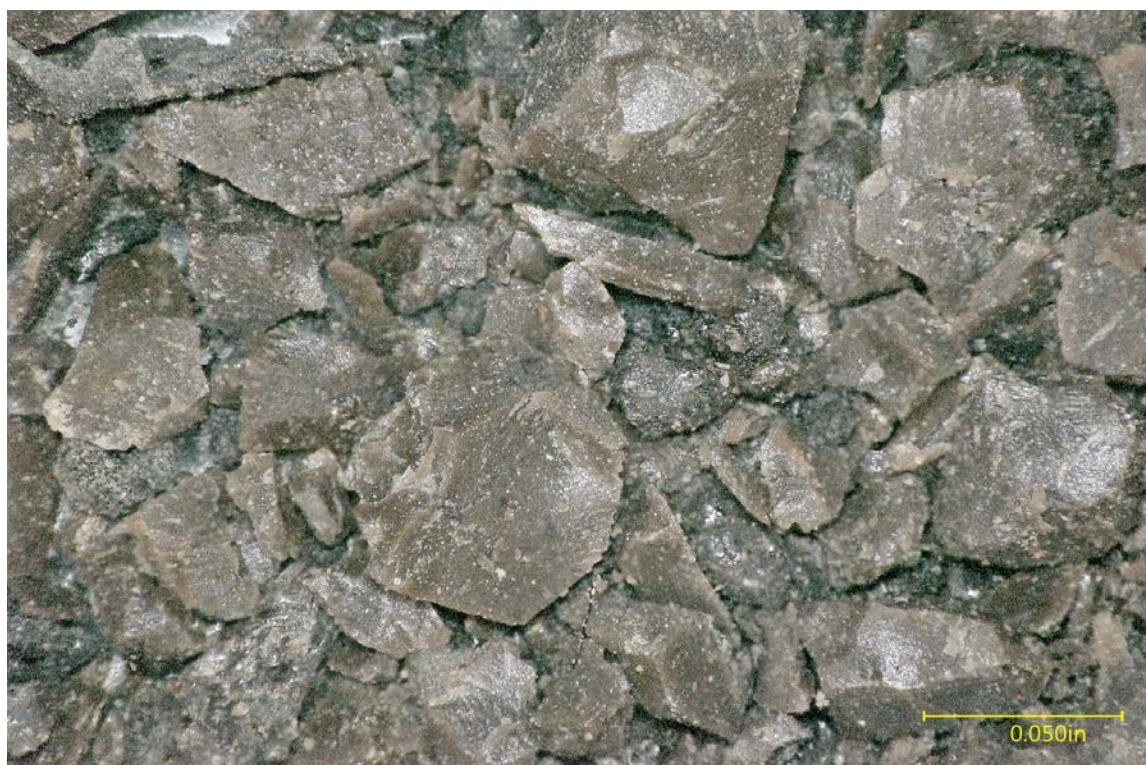
The debris was a brown crystalline powder. A close-up photograph of the debris is shown in Figure 7. The debris was analyzed using a handheld x-ray fluorescence (XRF) alloy analyzer. The analysis found the debris consistent of silicon (Si), titanium (Ti), chromium (Cr), iron (Fe), copper (Cu), zinc (Zn) and lead (Pb). Silicon is present in soil. The other materials can also be found in soil as well as material found in an airplane's fuel system.

Based on the visual examination and the XRF and FTIR analyses, the debris found in the finger screen was consistent with soil that had come in contact with aviation fuel.

Figure 7. Close-up photograph of debris found in fuel screen.
