# NATIONAL TRANSPORTATION SAFETY BOARD

## Global Positioning System (GPS) Device

**Specialist's Factual Report**  
**By Sean Payne**

Location: Alapaha, Georgia  
Date: September 16, 2016  
Aircraft: Cessna A188  
Registration: N3547Q  
Operator: Redacted<sup>1</sup>  
NTSB Number: ERA16FA316

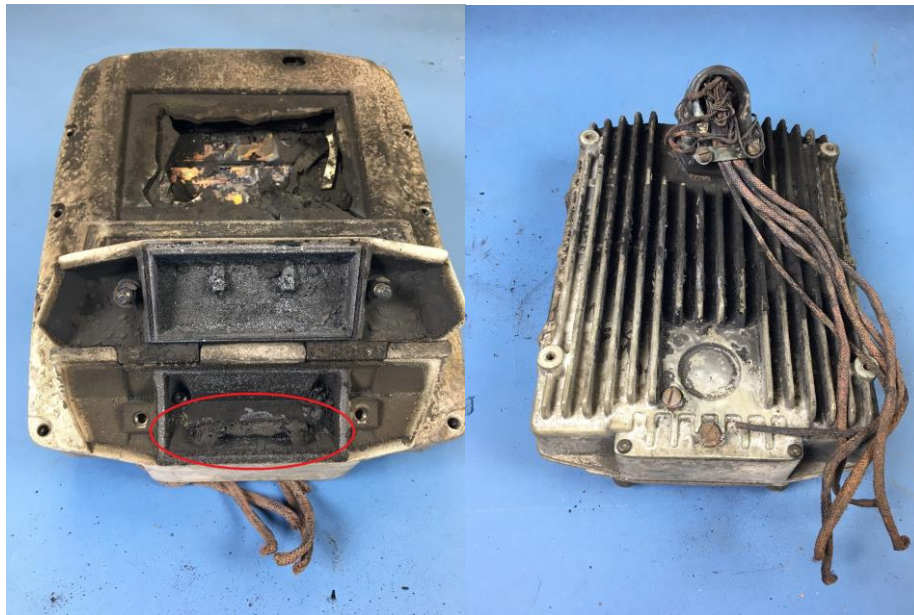
Upon arrival at the Vehicle Recorder Laboratory, an examination revealed the unit had not sustained extensive impact damage. The unit is shown in figure 1 with the device's cover that holds the unit's CF card open as well as the backside of the unit, as recovered. The CF card is seen in place and circled in red.

**Figure 1.** Photo of damaged unit

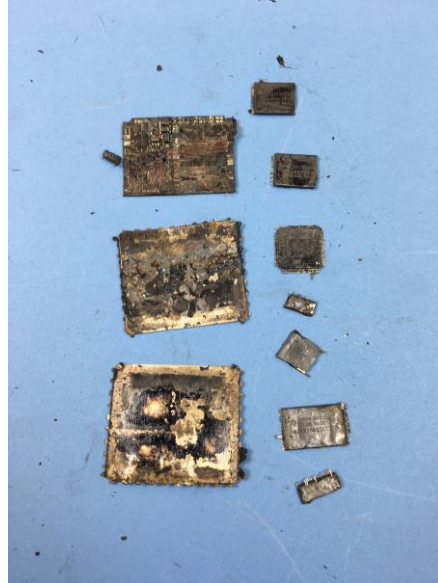
The CF card was removed. Upon removal from the unit, the CF card flaked apart and memory chips fell from the device. The type of damage associated with the CF card is associated with high temperature exposure. Figure 2 shows the condition of the CF card and associated non-volatile memory<sup>2</sup> (NVM) chips after removal from the unit.

**Figure 2.** Photo of damaged CF card and associated chips.

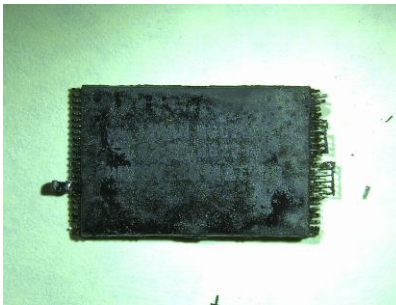
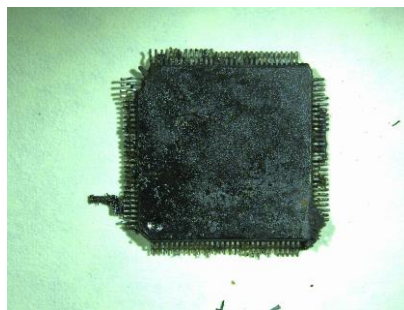
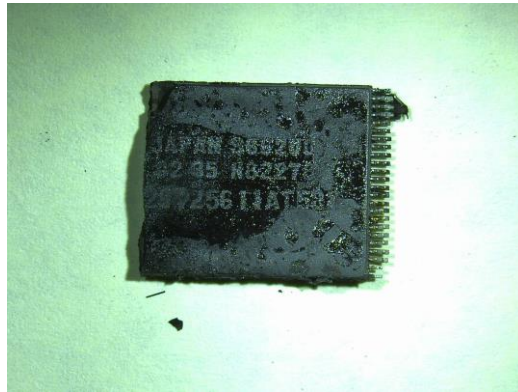
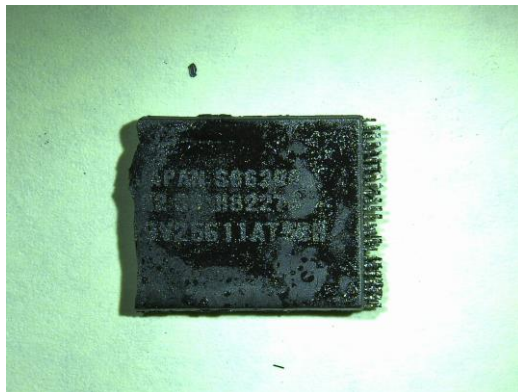
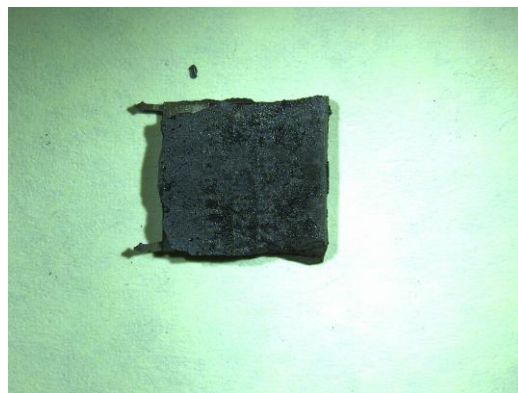
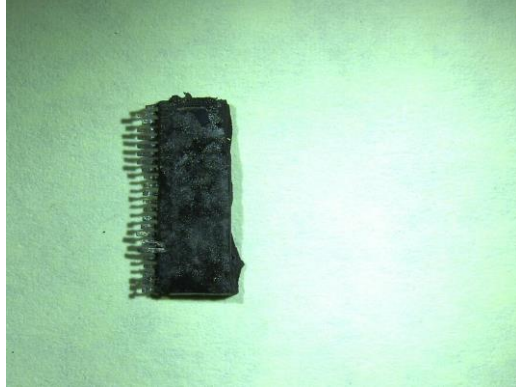
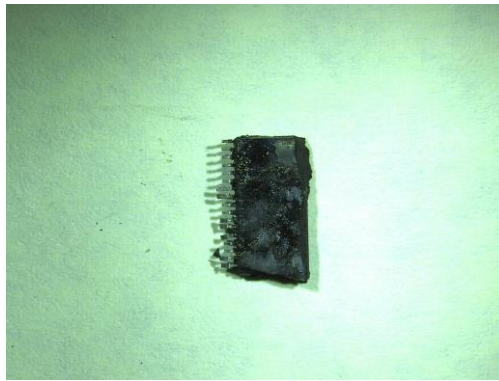
Figures 3 through 9 show the condition of each individual chip associated with the CF card. The photographs were taken using a digital stereoscope. Each chip exhibited fire and impact damage. Most chips were cracked in the silicon die which preclude data recovery. Other chips exhibited thermal bubbling along the surface which is indicative of high temperature exposure from fire and renders the chip unreadable.

**Figure 3.** Photo of damaged CF card NVM chip.

**Figure 4.** Photo of damaged CF card NVM chip.

**Figure 5.** Photo of damaged CF card NVM chip.

**Figure 6.** Photo of damaged CF card NVM chip.

**Figure 7.** Photo of damaged CF card NVM chip.

**Figure 8.** Photo of damaged CF card NVM chip.

**Figure 9.** Photo of damaged CF card NVM chip.

This device is capable of storing data in NVM via the device's CF card. The extent of the damage to the CF card and associated chips precluded normal recovery procedures and additional attempts were unsuccessful in yielding usable data. An internal inspection of the device's interior circuitry revealed the entire device was destroyed by fire. Therefore, no data pertinent to the event were recovered.
