**ERA16LA022**

**Piper PA-32-260, N43249**

**NTSB ENGINE EXAMINATION REPORT**

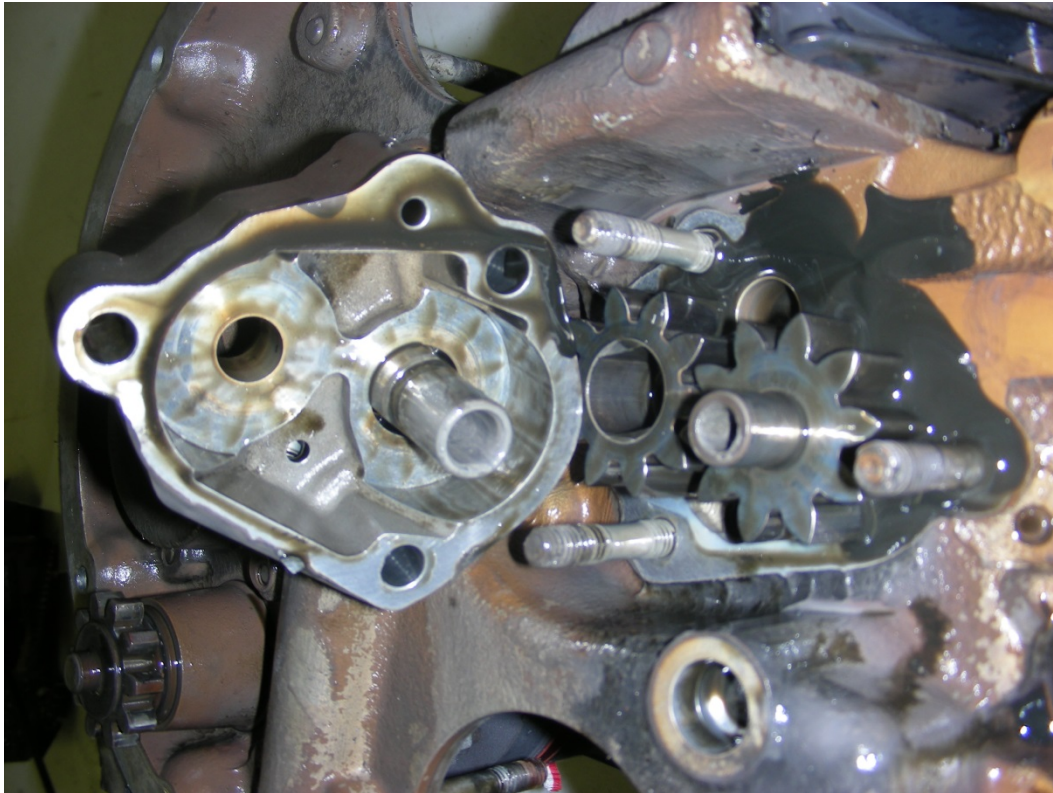
Photo 1. Engine Driven Oil Pump

The accessory section was removed and rust was noted. The oil pump was removed from the engine and rotated freely by hand. It was disassembled with no anomalies noted.

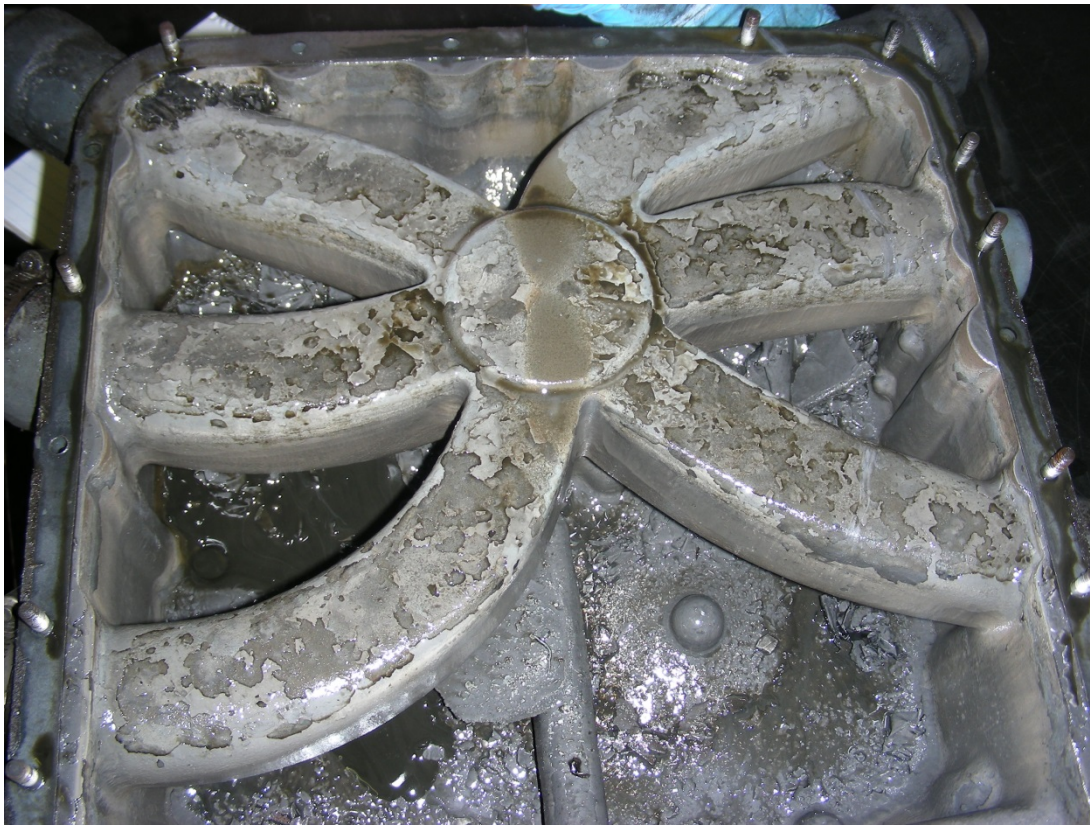
The engine oil sump was removed from the engine and there were multiple pieces and particles of metal in the oil sump.

Photo 2. View inside oil sump.

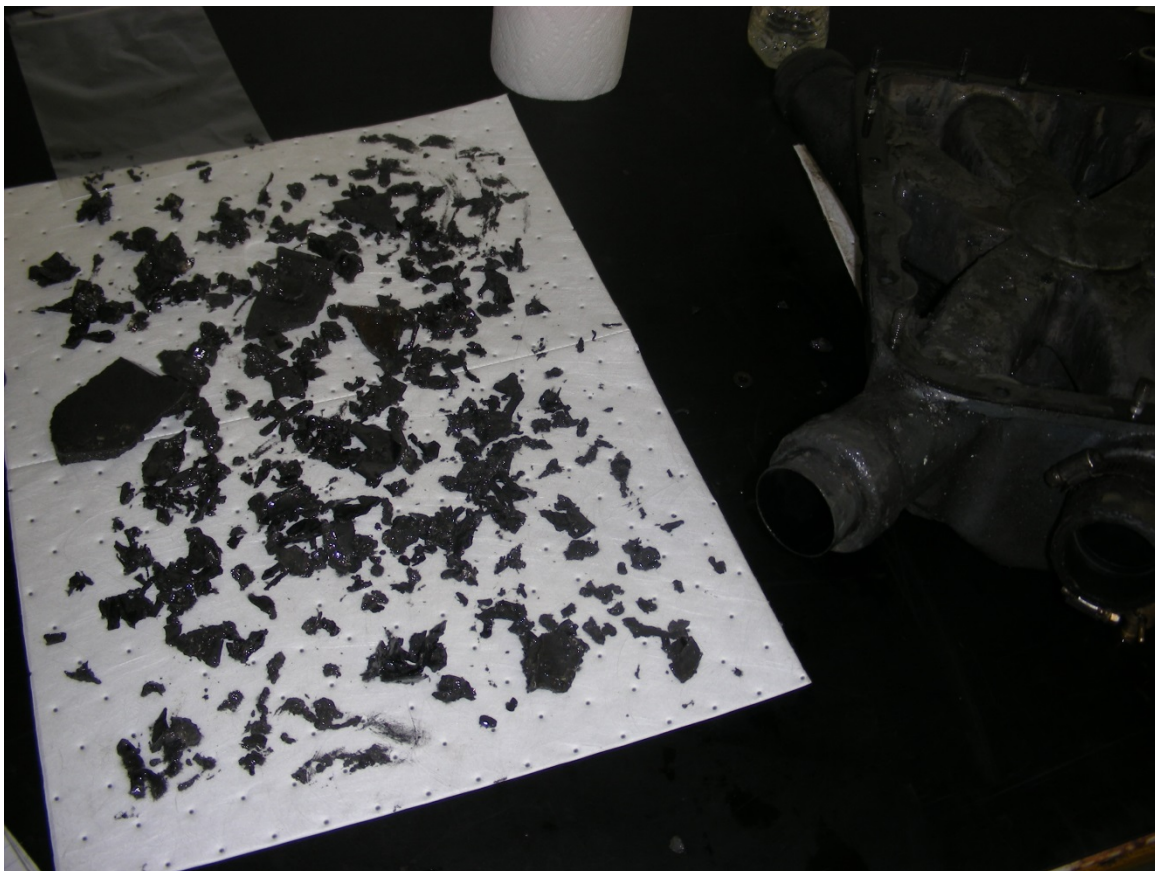
Photo 3. Metallic particles taken out of oil sump

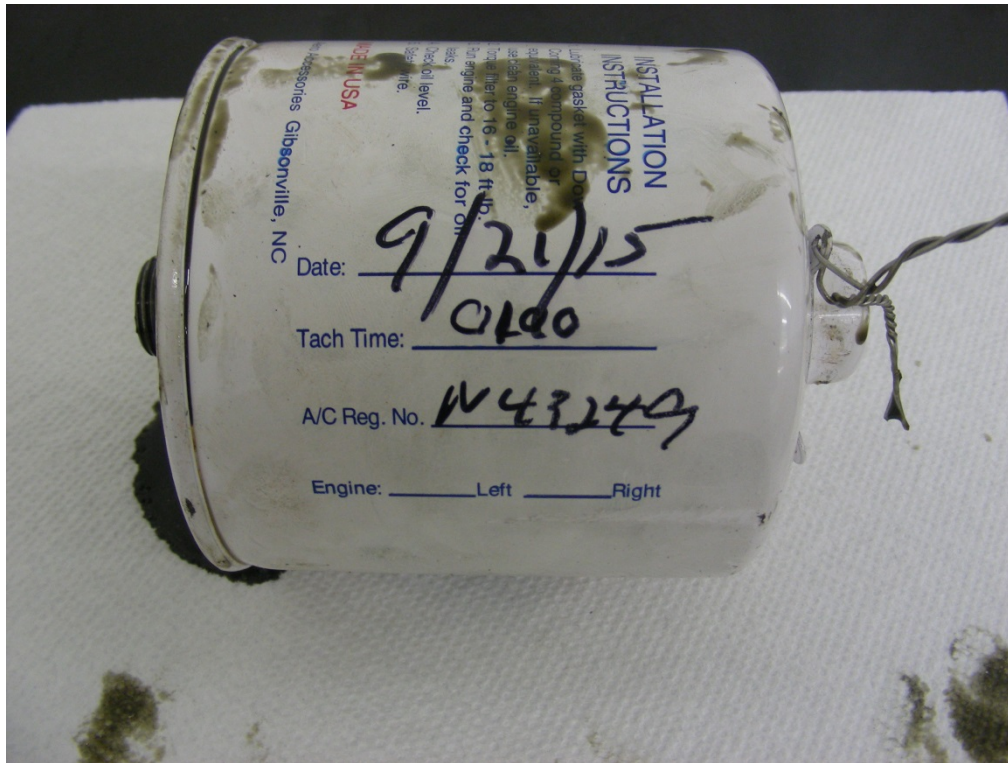
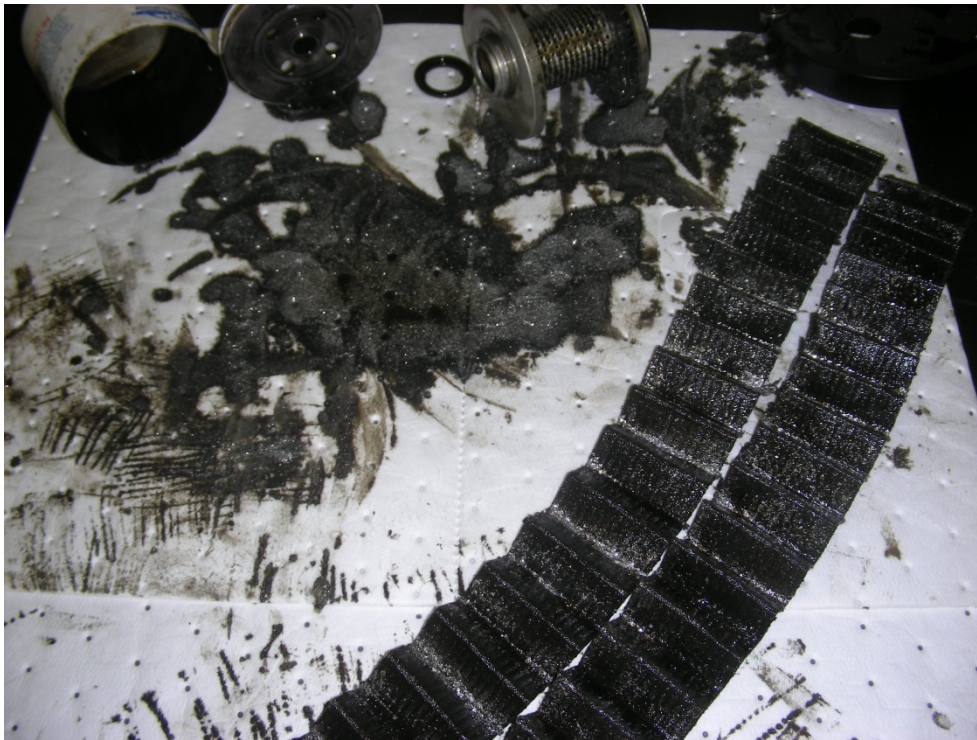
The oil filter was removed from the engine for examination. It had a date of 9/21/2015 on it and it indicated that it was changed at a tach time of 100 hours. The oil filter was disassembled and metallic debris was noted in the filter.

Photo 4. View of oil filter.

Photo 5. View of disassembled oil filter.

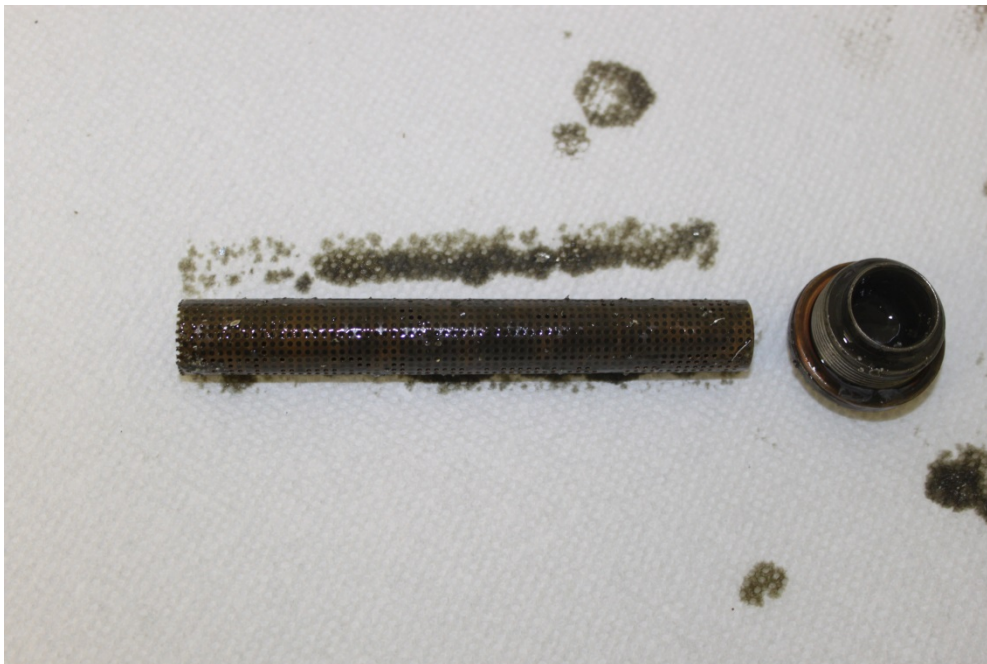
Photo 6. Oil suction screen

The oil suction screen was examined and debris was noted in the screen.

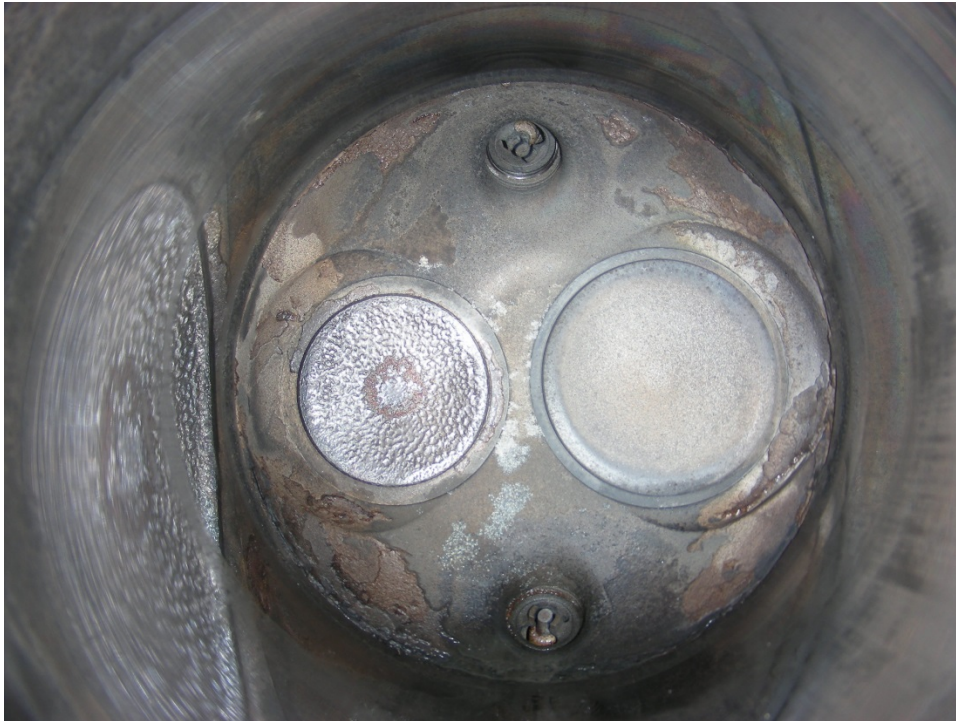
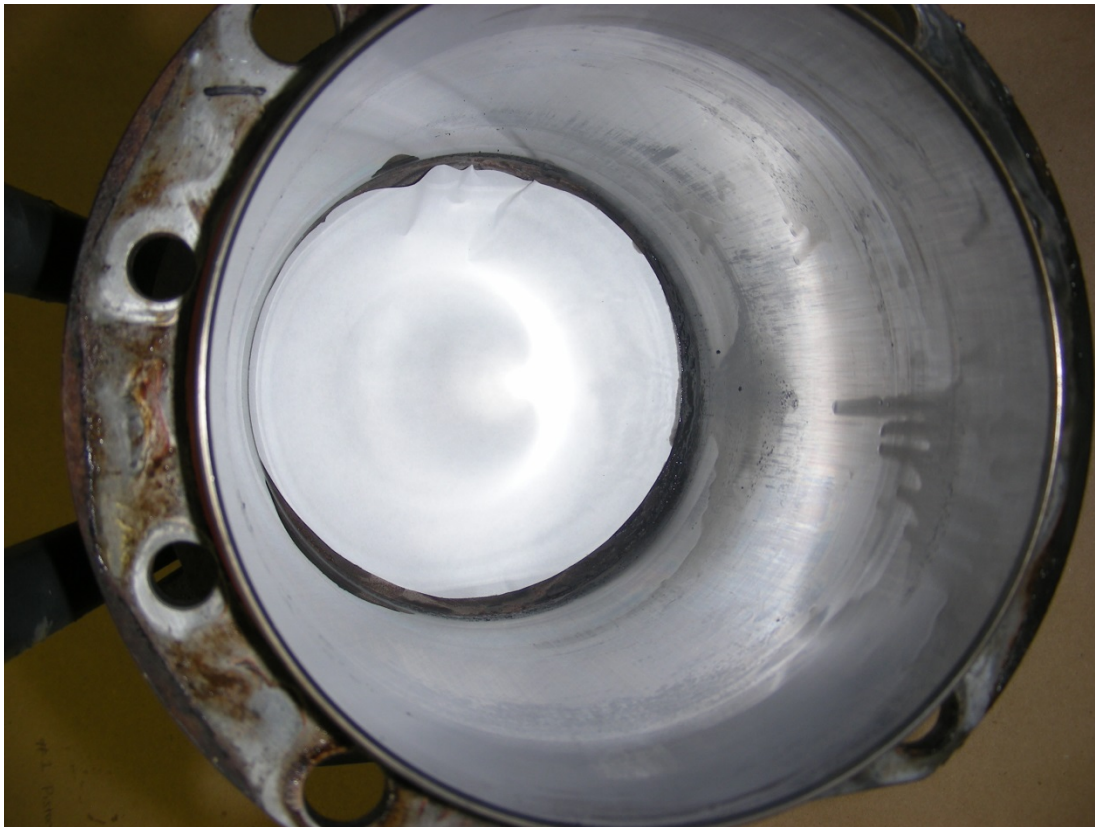
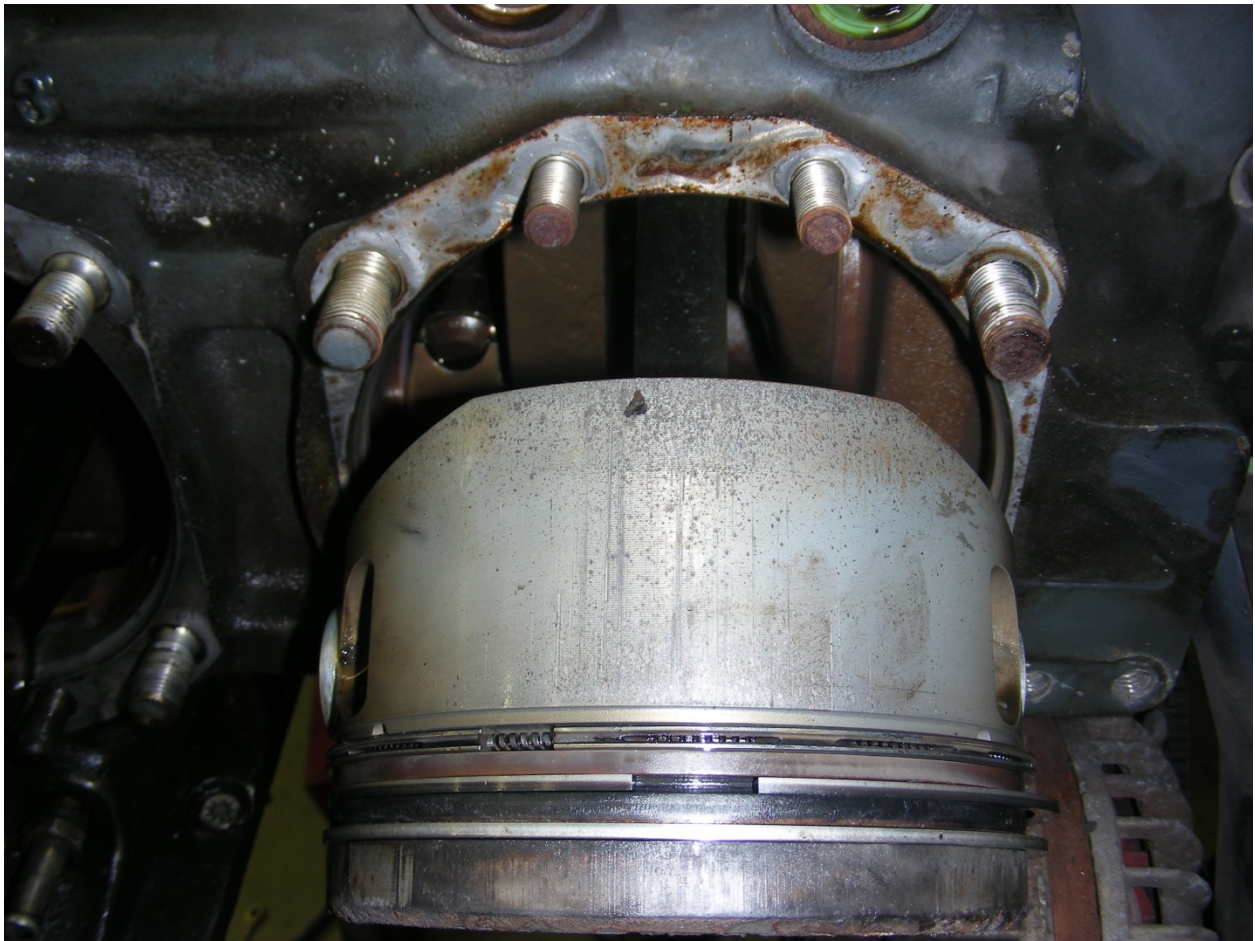
The cylinder was removed from the engine and scoring around the piston was noted.

Photo 7. Cylinder No. 1 Valves

Photo 8. View of No. 1 Cylinder walls

Photo 9. Side of No. 1 Piston

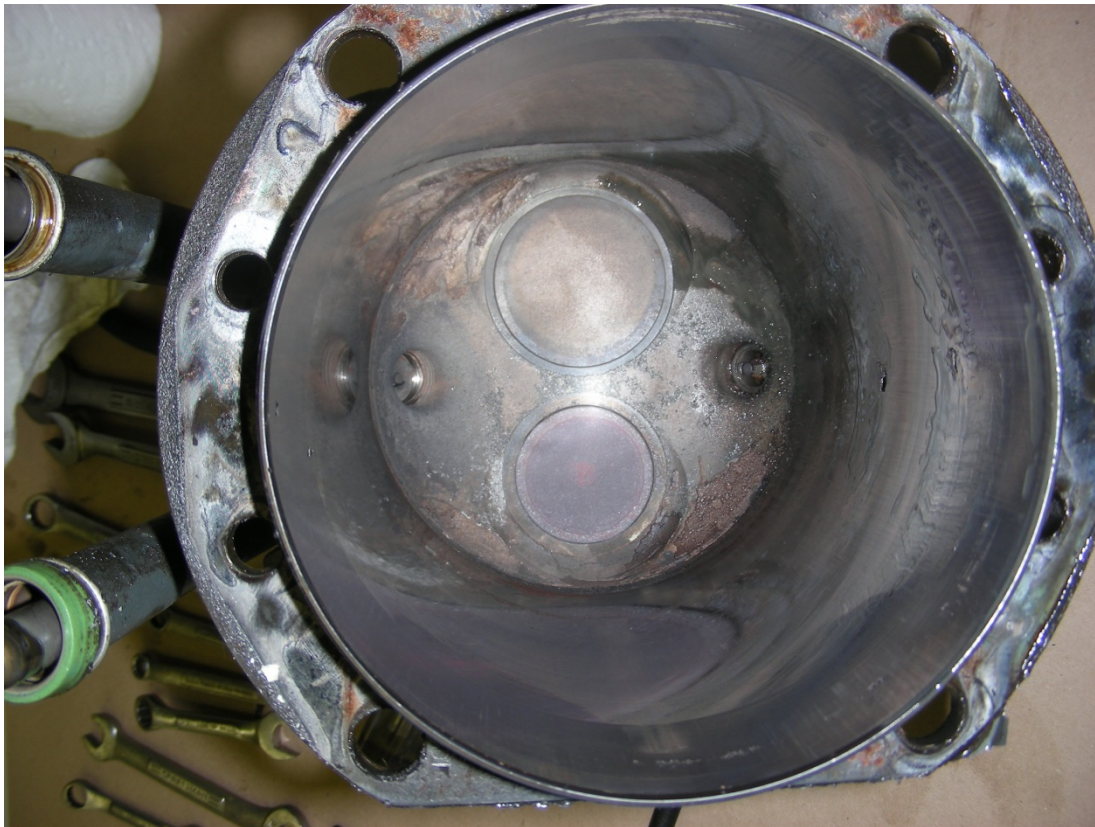
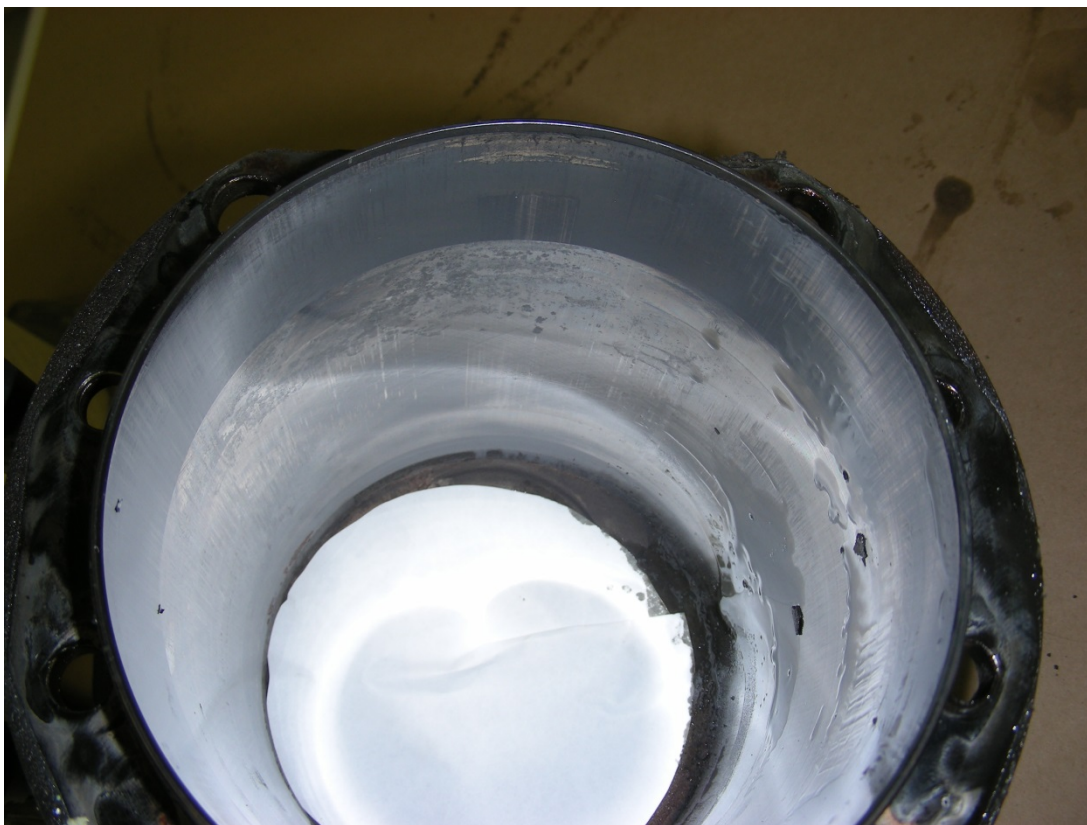
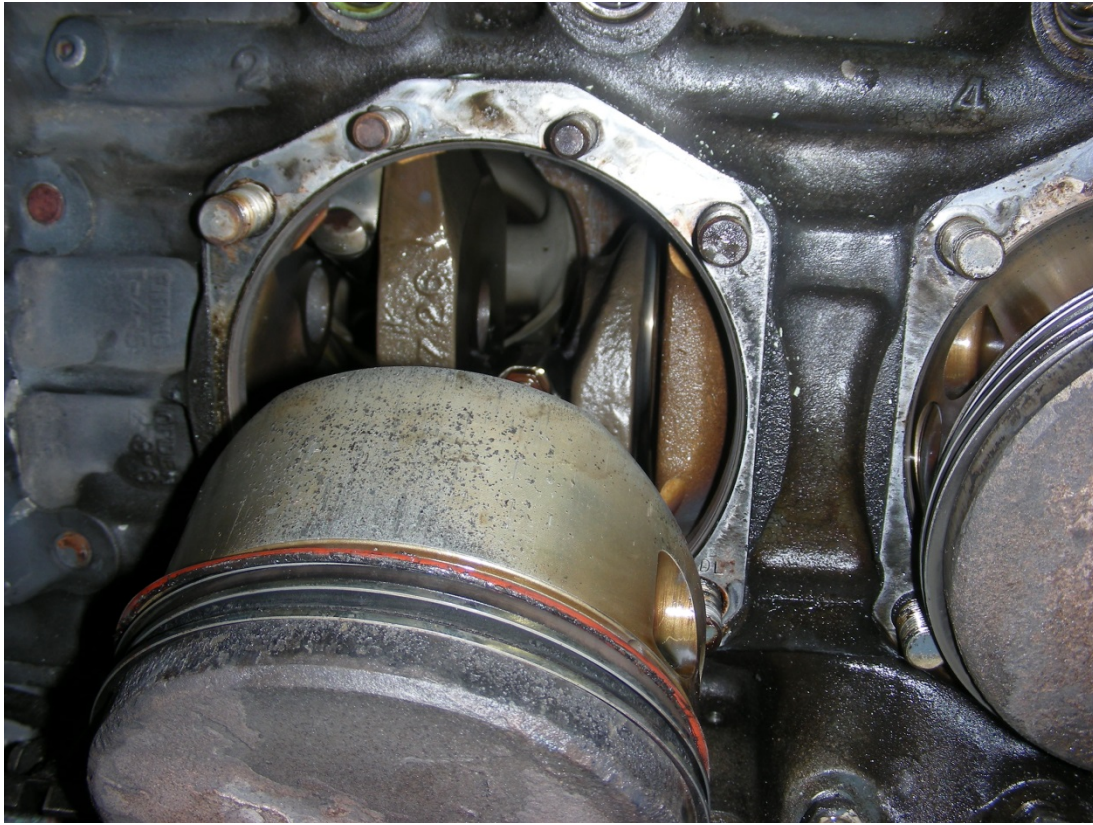
The cylinder was removed and scoring was noted on the piston. Corrosion was noted on the cylinder walls.

Photo 10. View of No. 2 Cylinder Valves

Photo 11. View of No. 2 Cylinder walls

Photo 12. No. 2 Piston

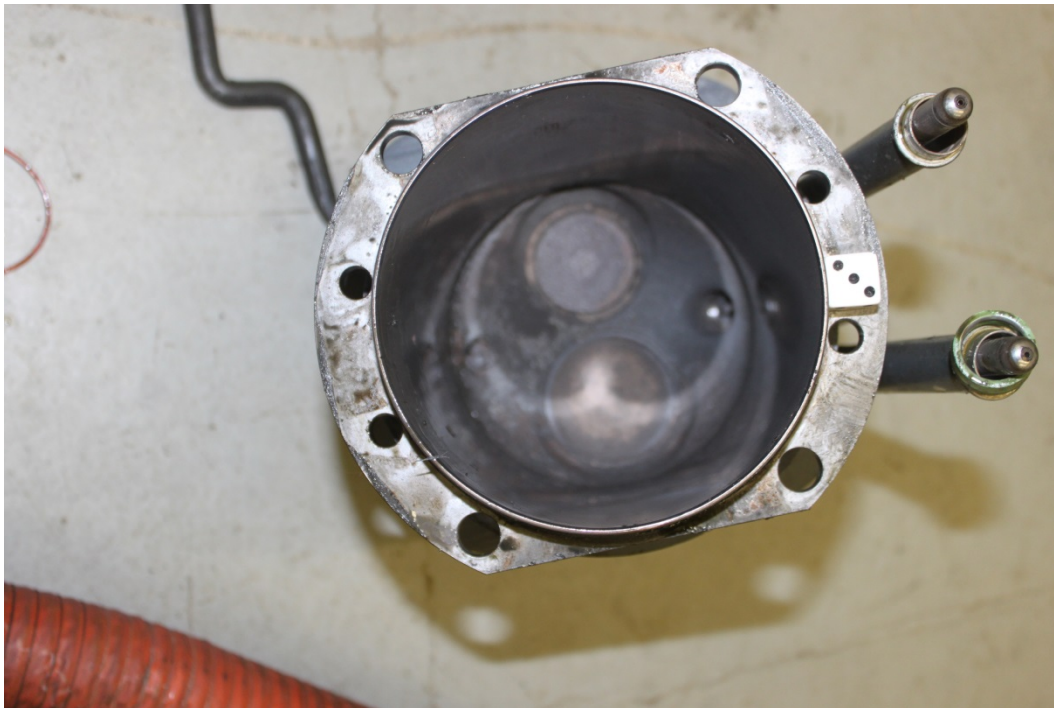
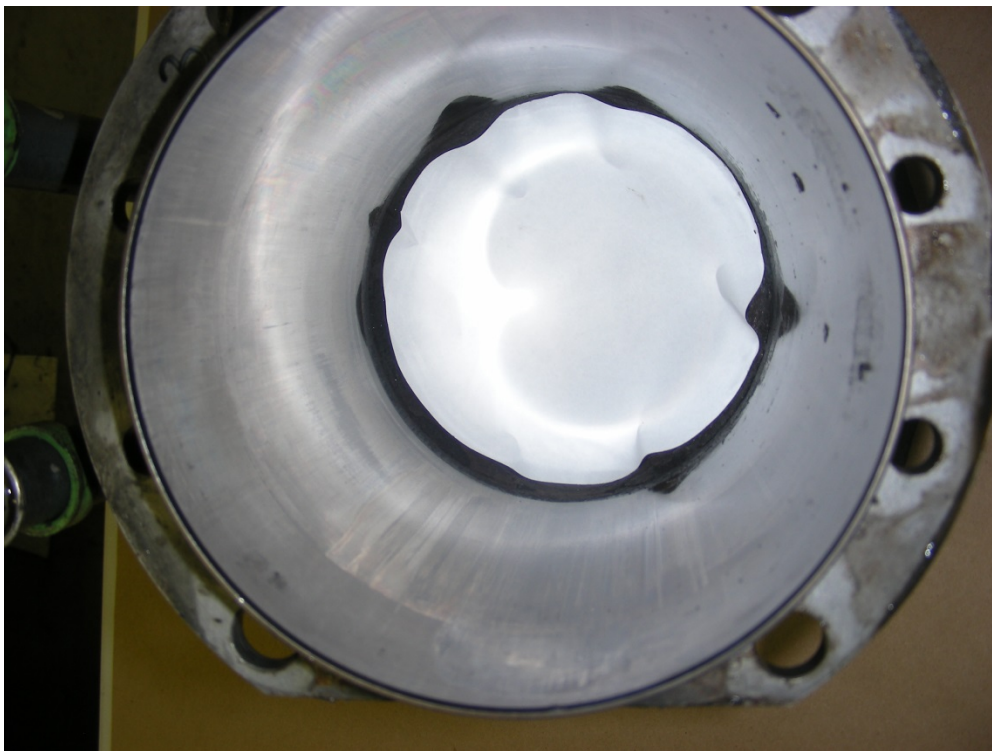
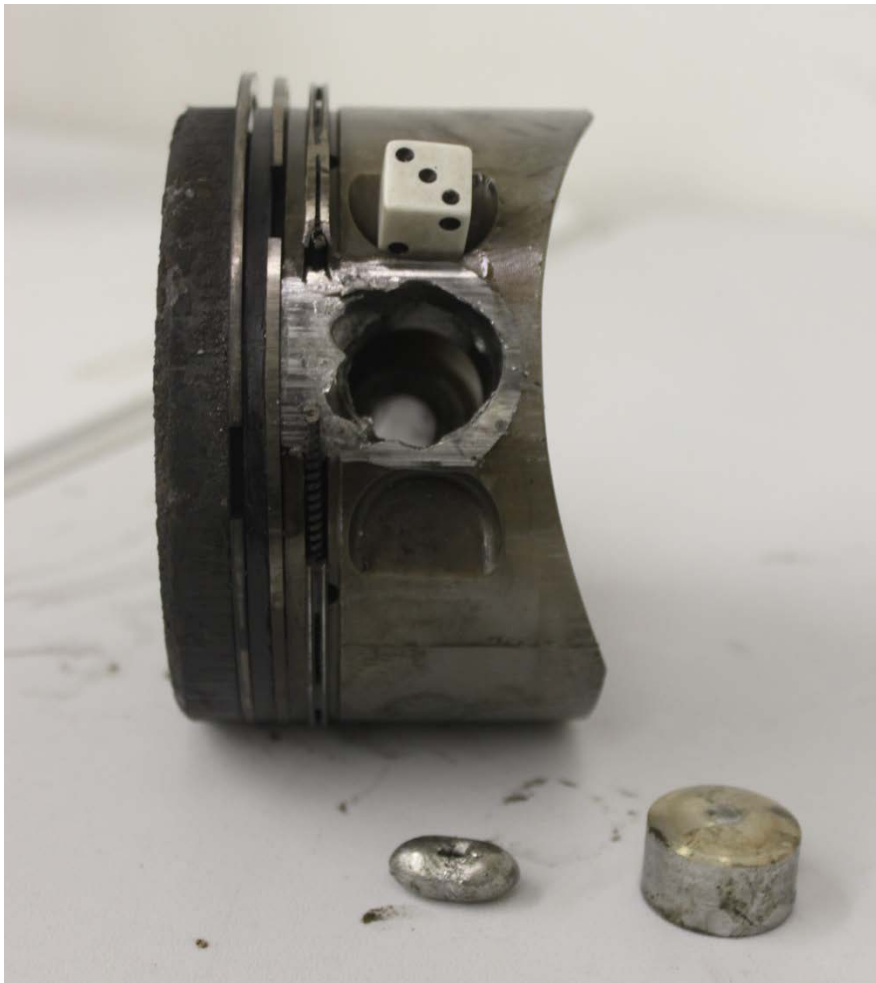
The cylinder was removed and the piston exhibited damage. There was scoring noted to the side of the piston and a piston pin cap was deformed. The other piston pin cap exhibited scoring.

Photo 13. interior view of No. 3 Cylinder

Photo 14. Cylinder No. 3 Walls

Photo 15. View of No. 3 Piston

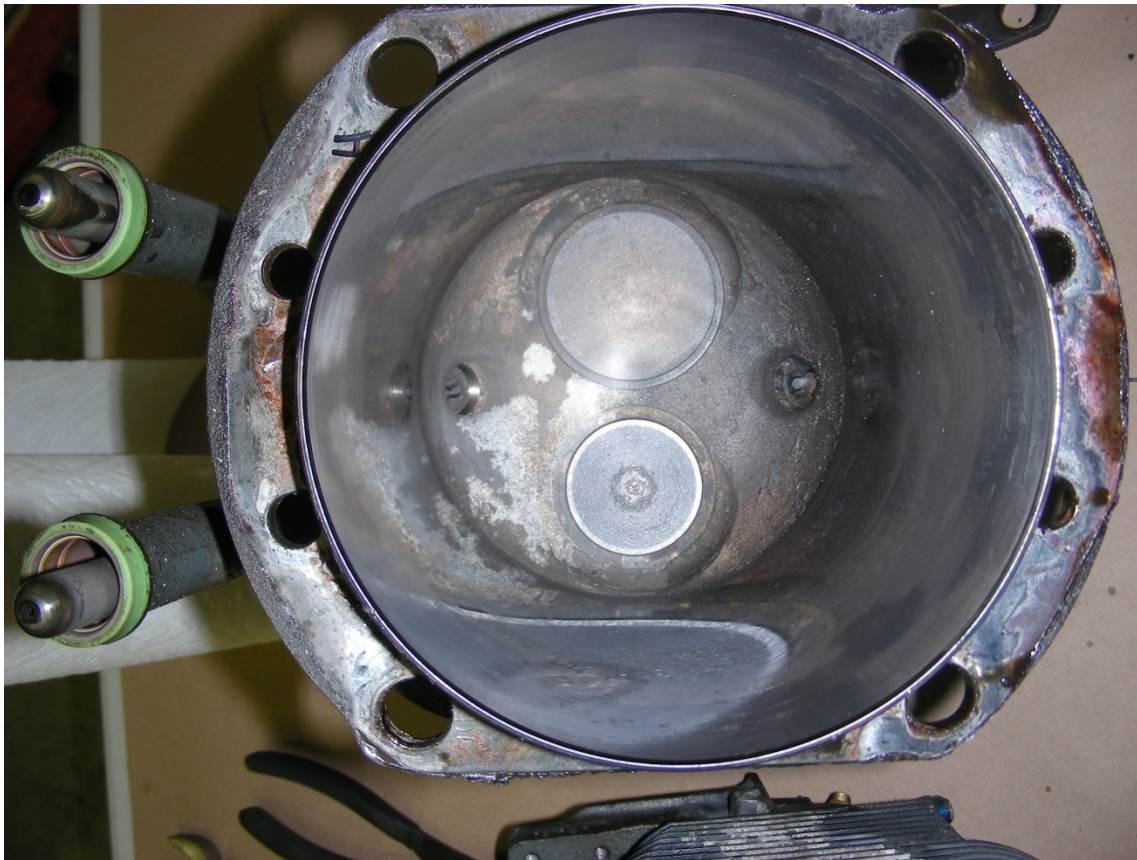
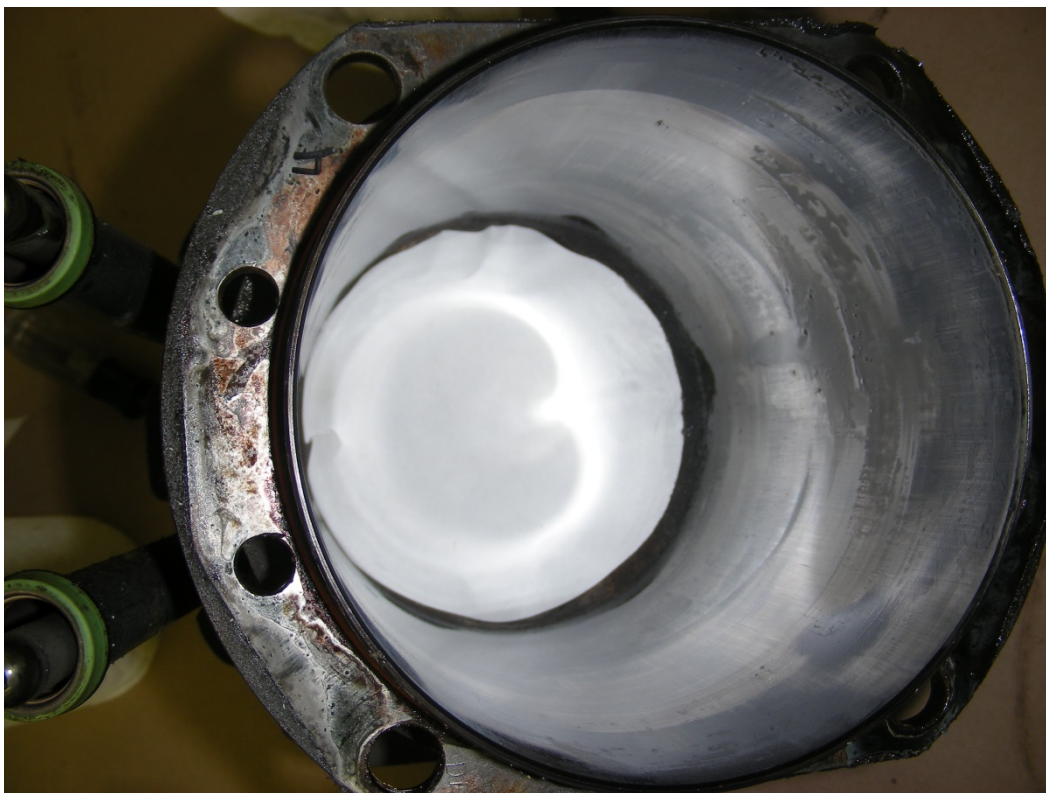
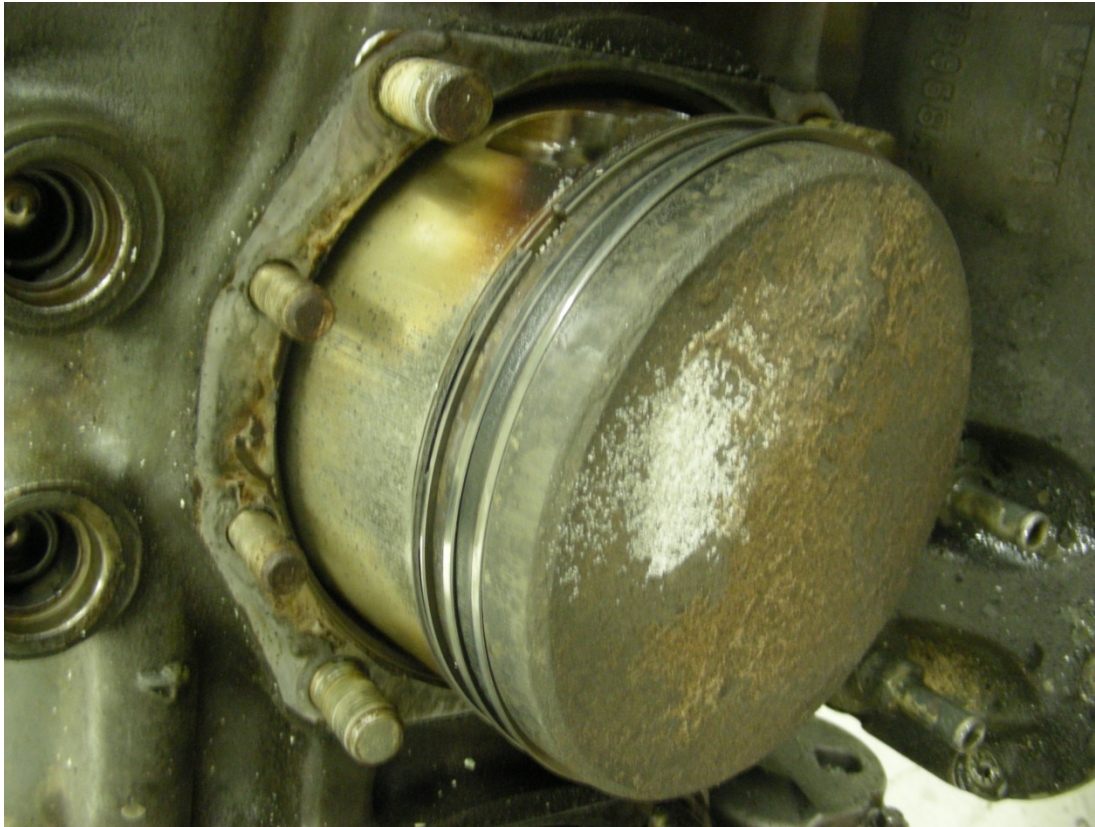
The cylinder was removed and corrosion was noted on the cylinder wall.

Photo 16. View of interior of Cylinder No. 4

Photo 17. View of Cylinder No. 4 walls

Photo 18. Piston No. 4

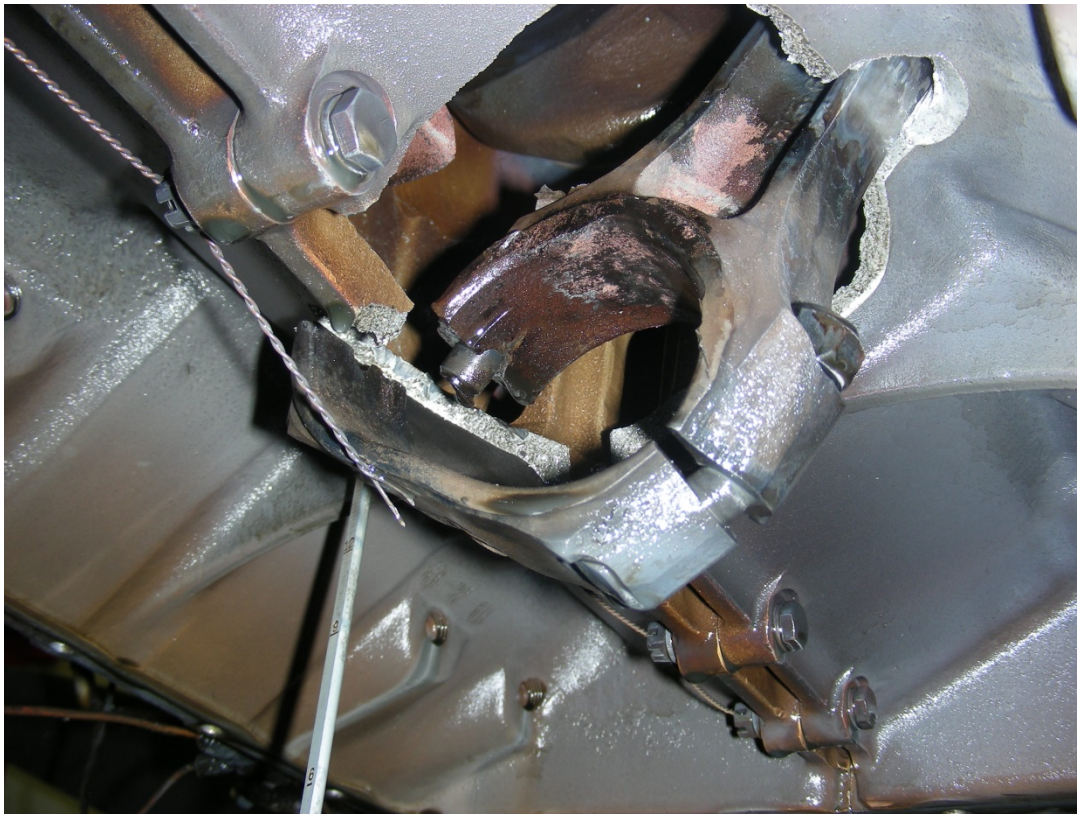
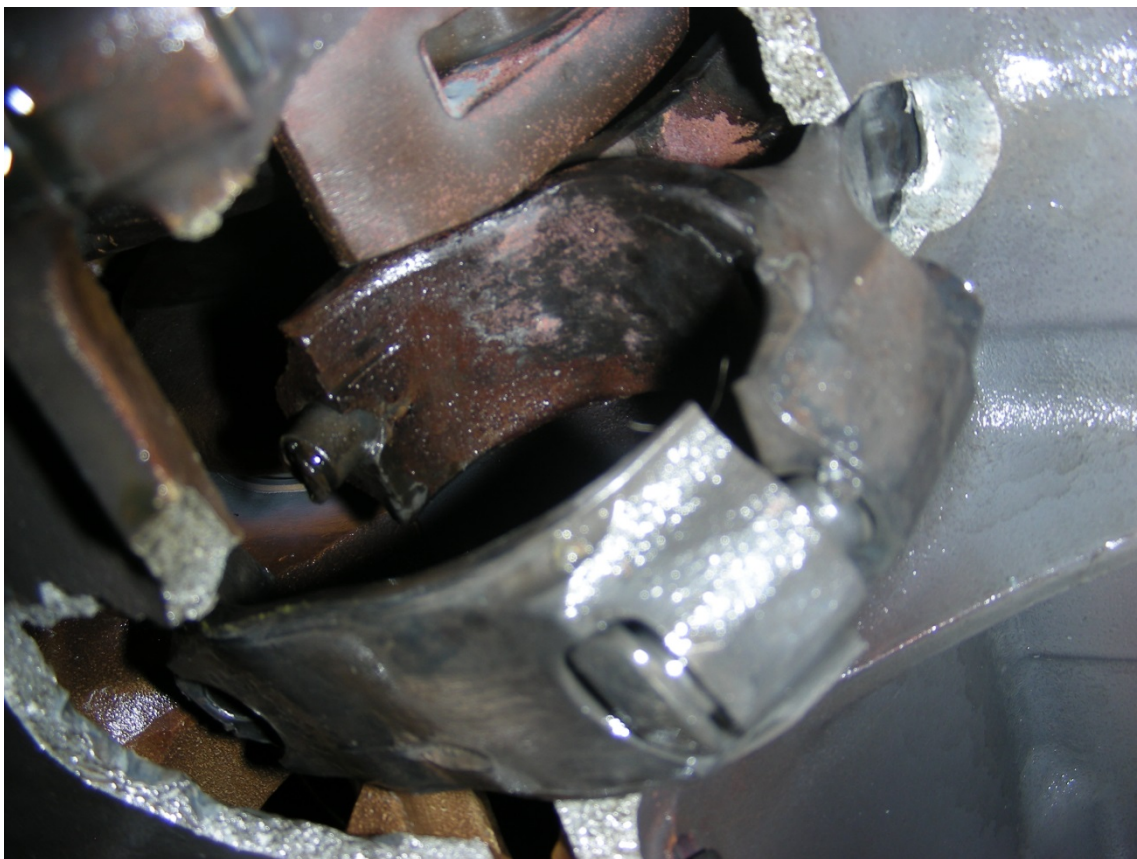
Cylinder No. 5 could not be removed. When the oil pan was removed, it was noted that the No. 5 connecting rod was separated from the crankshaft and rust was noted on the connecting rod surface that sat on a bearing around the crankshaft.

Photo 19. View of fractured No. 5 Connecting Rod

Photo 20. Alternate View of No. 5 Connecting Rod

The bottom of the crankcase was fractured near the No. 5 connecting rod. Also, several pieces of metal were located on the bottom of the interior part of the crankcase.

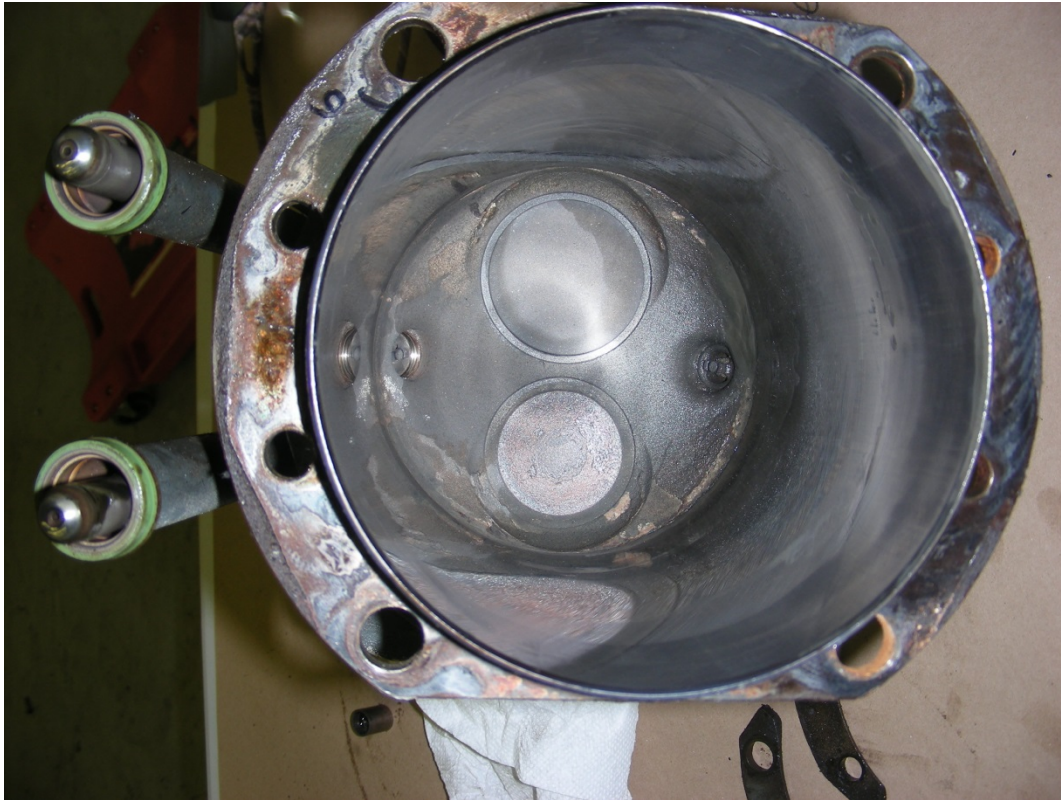
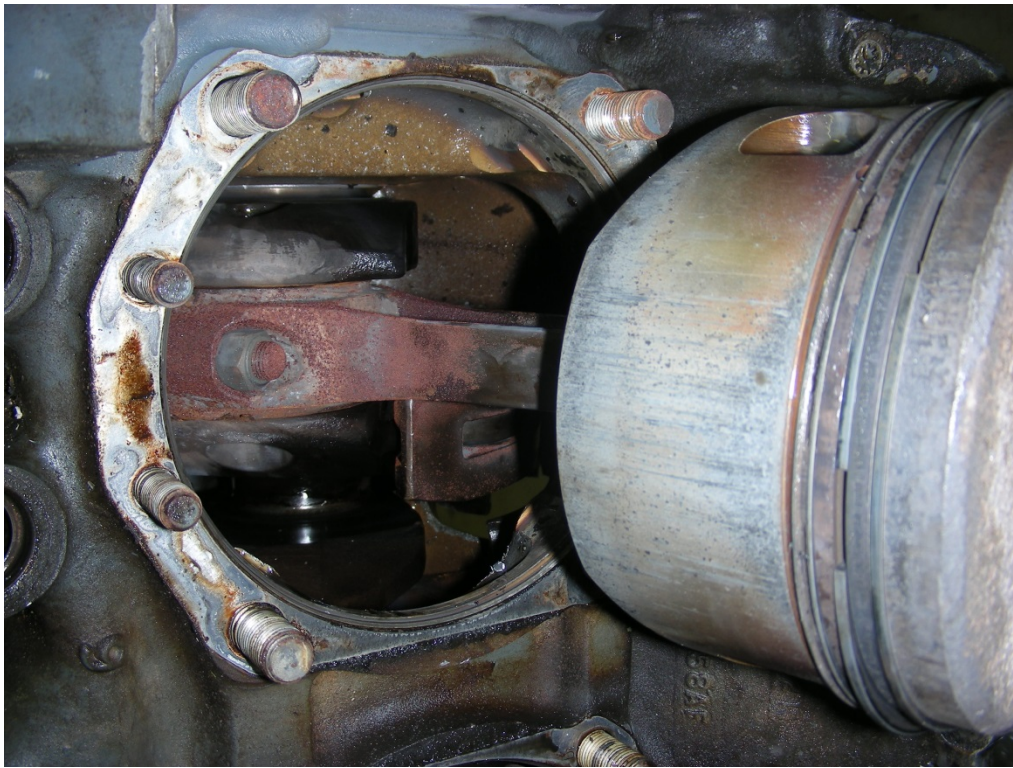
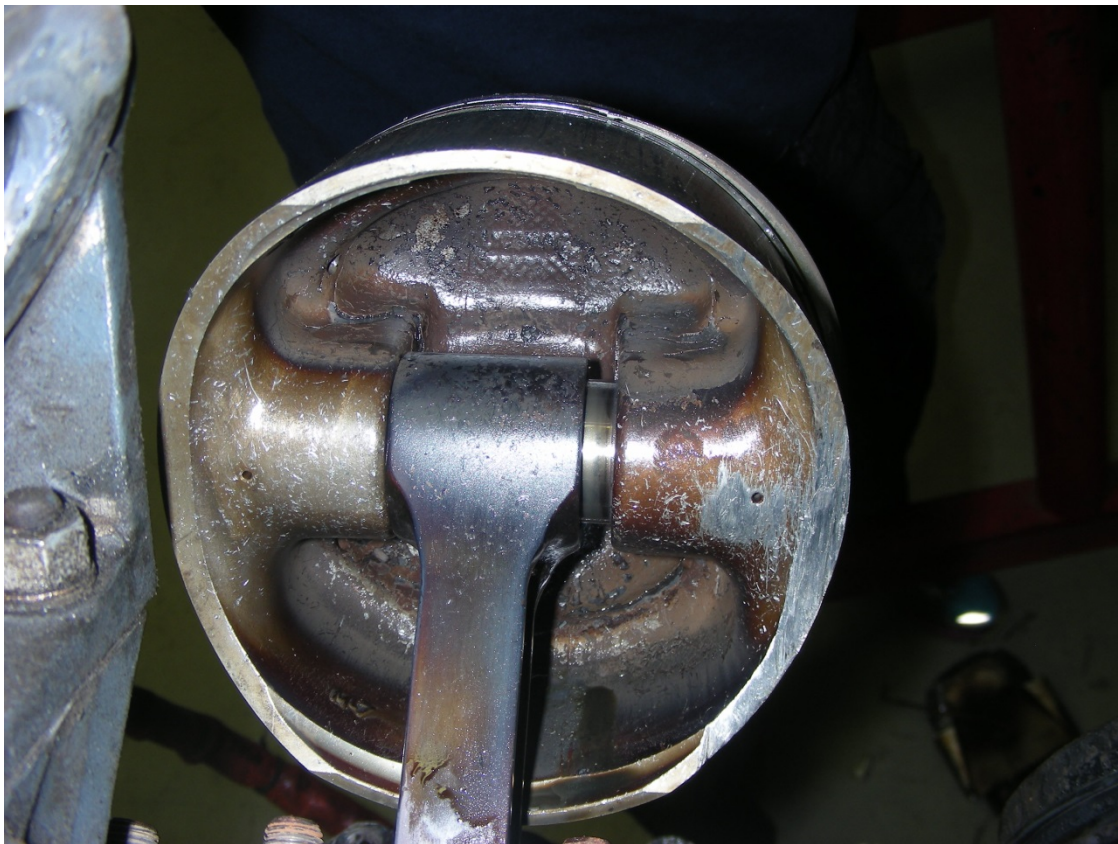
The cylinder was removed and the bottom of the piston exhibited scoring. Also, the connecting rod exhibited corrosion.

Photo 21. View of No. 6 Cylinder Interior

Photo 22. View of No. 6 Piston and Connecting Rod

Photo 23. View of Damage on No. 6 Piston
