# NATIONAL TRANSPORTATION SAFETY BOARD

## MATERIALS LABORATORY FACTUAL REPORT

Report No. 17-007

Place : Bluemont, Virginia  
Date : October 23, 2015  
Vehicle : Piper PA-32-260, N43249  
NTSB No. : ERA16LA022  
Investigator : Heidi Kemner, AS-ERA

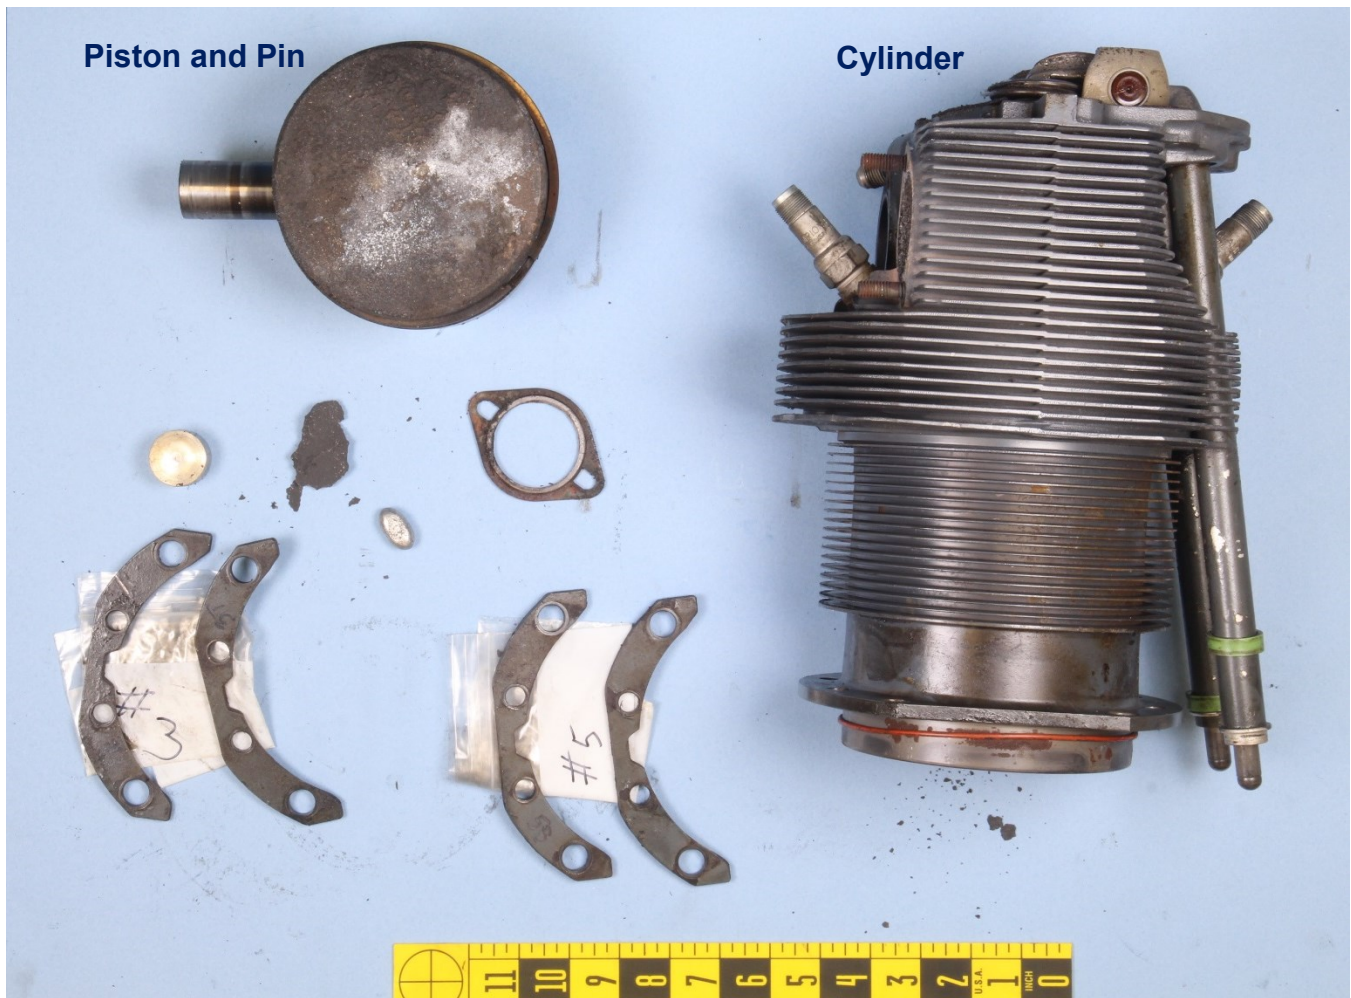
The outer surfaces of the cylinder were relatively undamaged, as shown in Figure 1. The inside of the cylinder contained some loose deposits, visible near the valves in Figure 4. These same deposits were found in the exhaust port past the valve. These deposits were not observed in the intake port.

Figure 1 – The components of the cylinder assembly, as received.

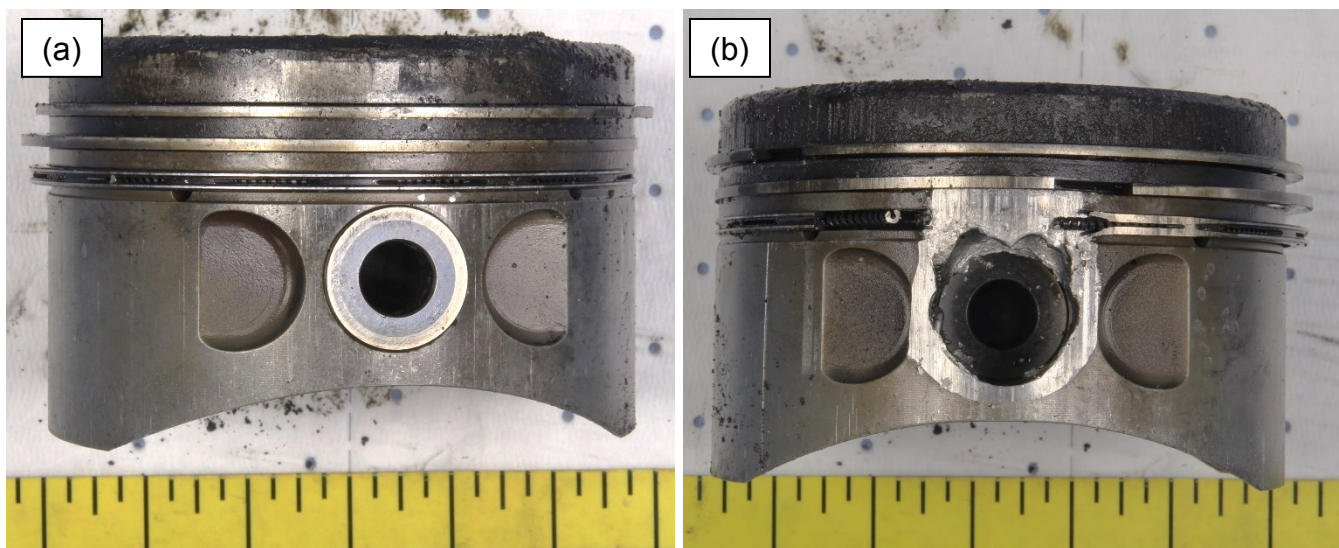
Figure 1 displays the parts received from the accident cylinder assembly. Of note in this investigation were the cylinder and the piston. The piston is shown in profile from the pin hole sides in Figures 2a and 2b. One of the sides of the piston exhibited a wear scar about the pin hole. The lines within the wear scar on the piston were consistent with reciprocating rubbing along the axis of the cylinder.

Figure 2 – The piston crown and pin from (a) the undamaged side and (b) the damaged side exhibiting a wear scar.

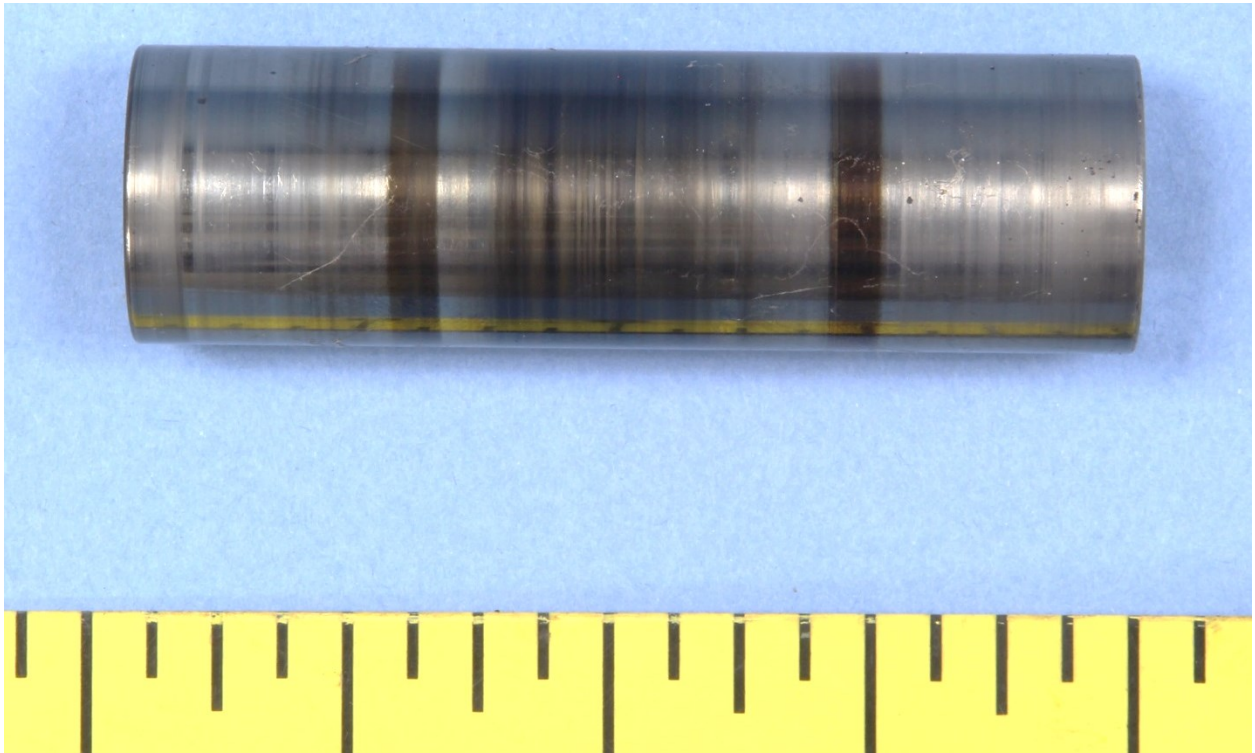
The piston pin was removed and is shown in Figure 3. The pin did not exhibit deformation, but it did exhibit some superficial circumferential wear scars, consistent with rotation inside the piston crown.

Figure 3 – The piston pin, after removal and cleaning.

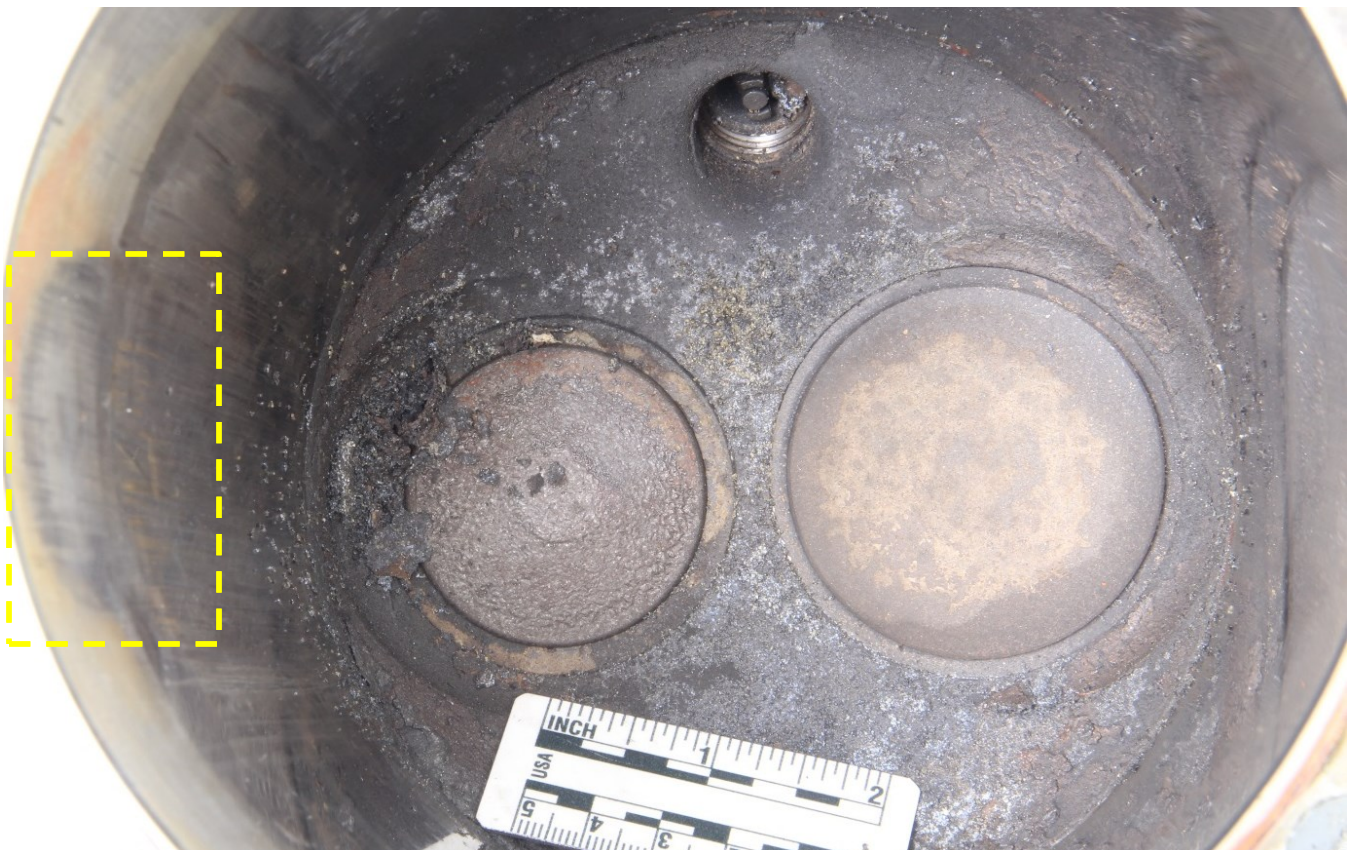
Of note on the inside walls of the cylinder was the presence of the brown-colored compounds, visible in Figures 4 through 6. These deposits were consistent iron oxide or rust. The location of the iron oxide was in the outer quarter of the inner cylinder wall, on one side (or 180°) of the cylinder.

Figure 4 – The inside of the cylinder, as received, showing the deposits near the valves. The area on the left shows indications of corrosion and wear (boxed area).

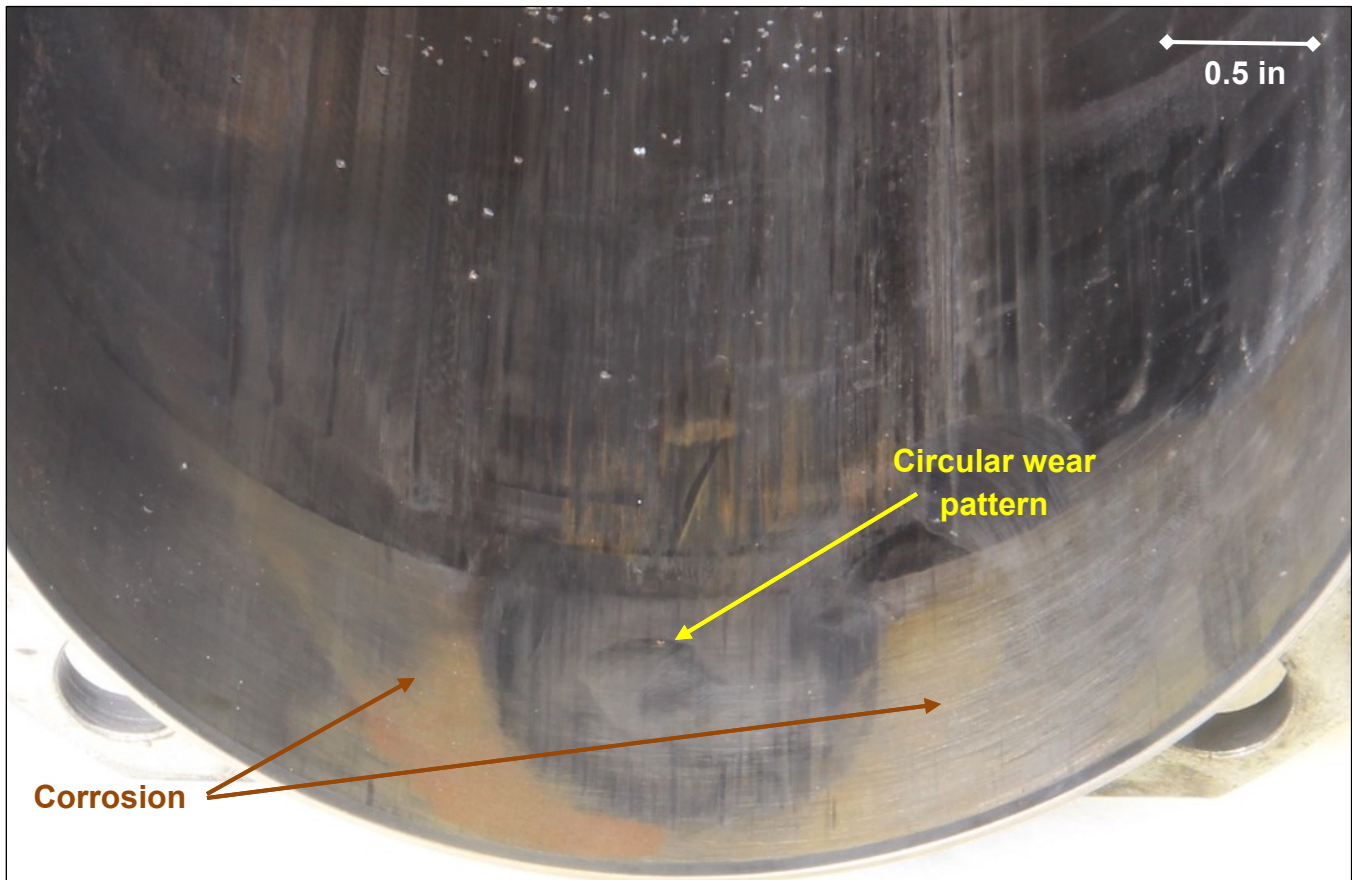
Another feature on the inner cylinder wall was the presence of a circular wear scar, shown in Figures 5 and 6. The size and shape of the wear scar was consistent with the shape of piston pin plug. There was a lack of corrosion in the circular wear region. These features suggest that the corrosion of the cylinder wall was present before the wear or rubbing between the piston assembly and the cylinder occurred.

Figure 5 – The boxed area in Figure 4, rotated to show the corrosion and the circular worn area.

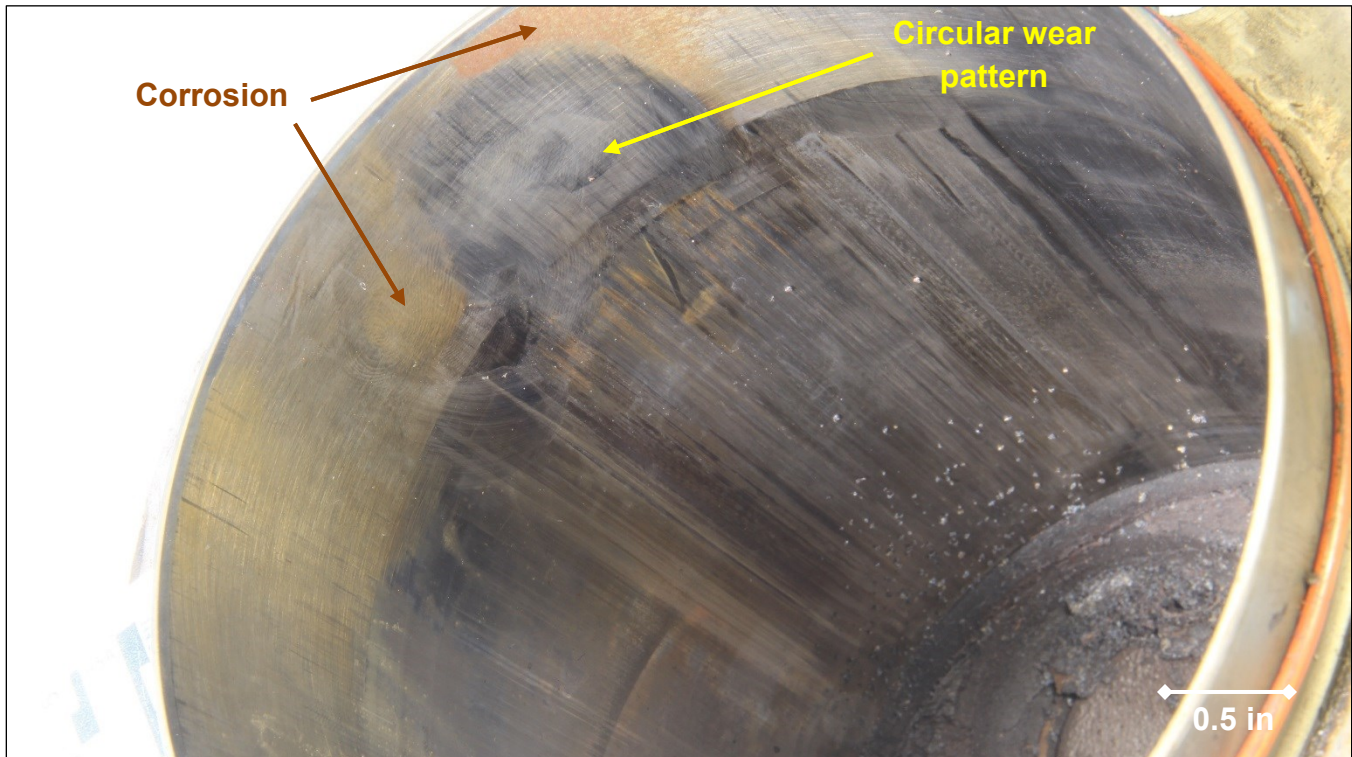
Figure 6 – The boxed area in Figure 4, rotated to show the corrosion and the circular worn area.

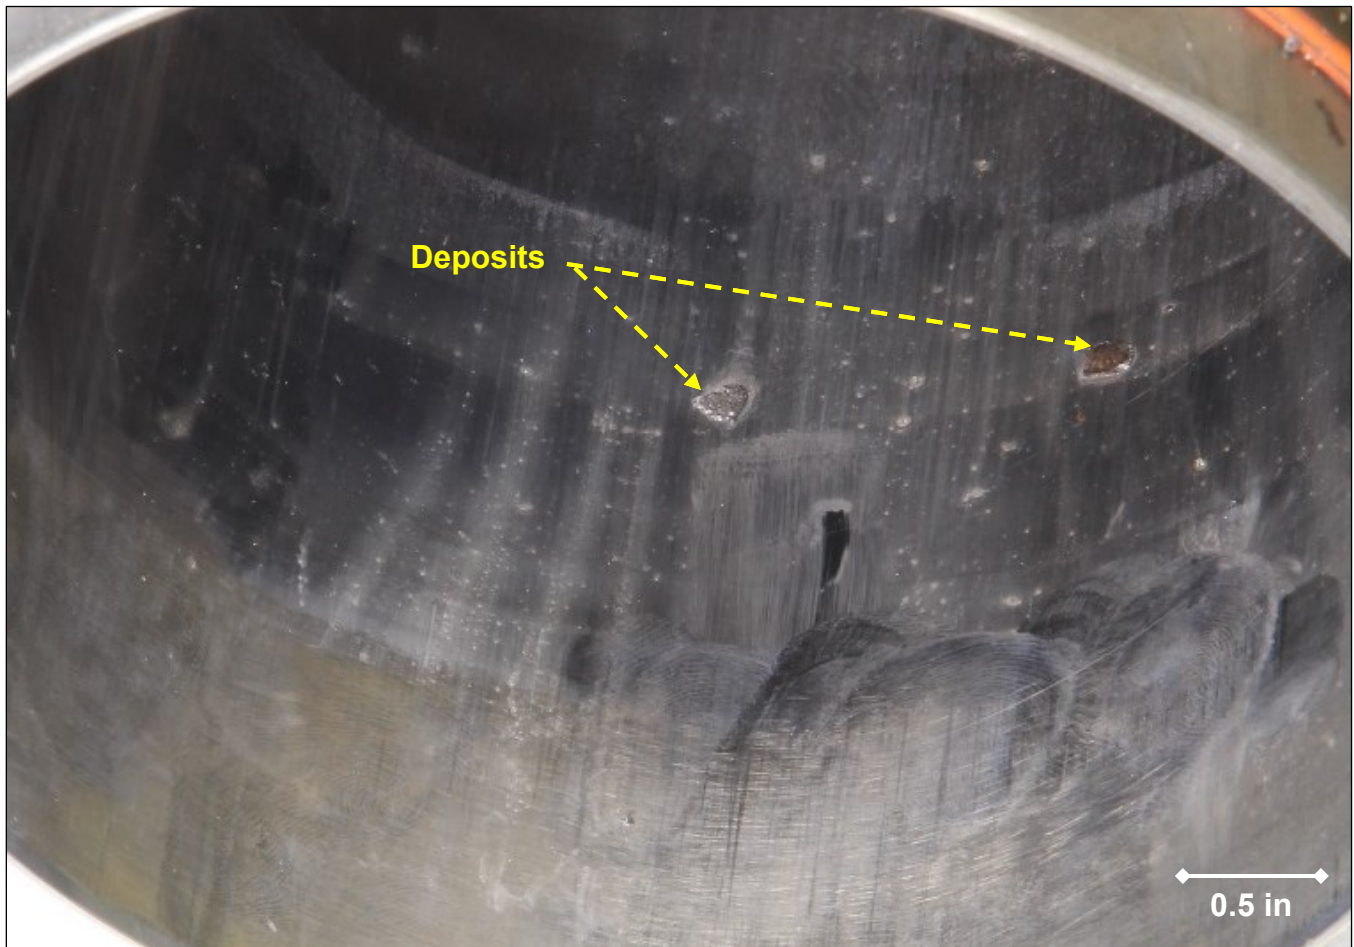
Additional deposits were found adhered to the inner walls of the cylinder farther inside the cylinder. Some of these deposits are illustrated in Figure 7.

Figure 7 – The inside of the cylinder, rotated 180° from Figure 5, showing two deposits on the inner surface.
