27-Oct-2015 1523 UTC | 30.354578, -88.682167  
Ocean Springs, MS 39564, USA

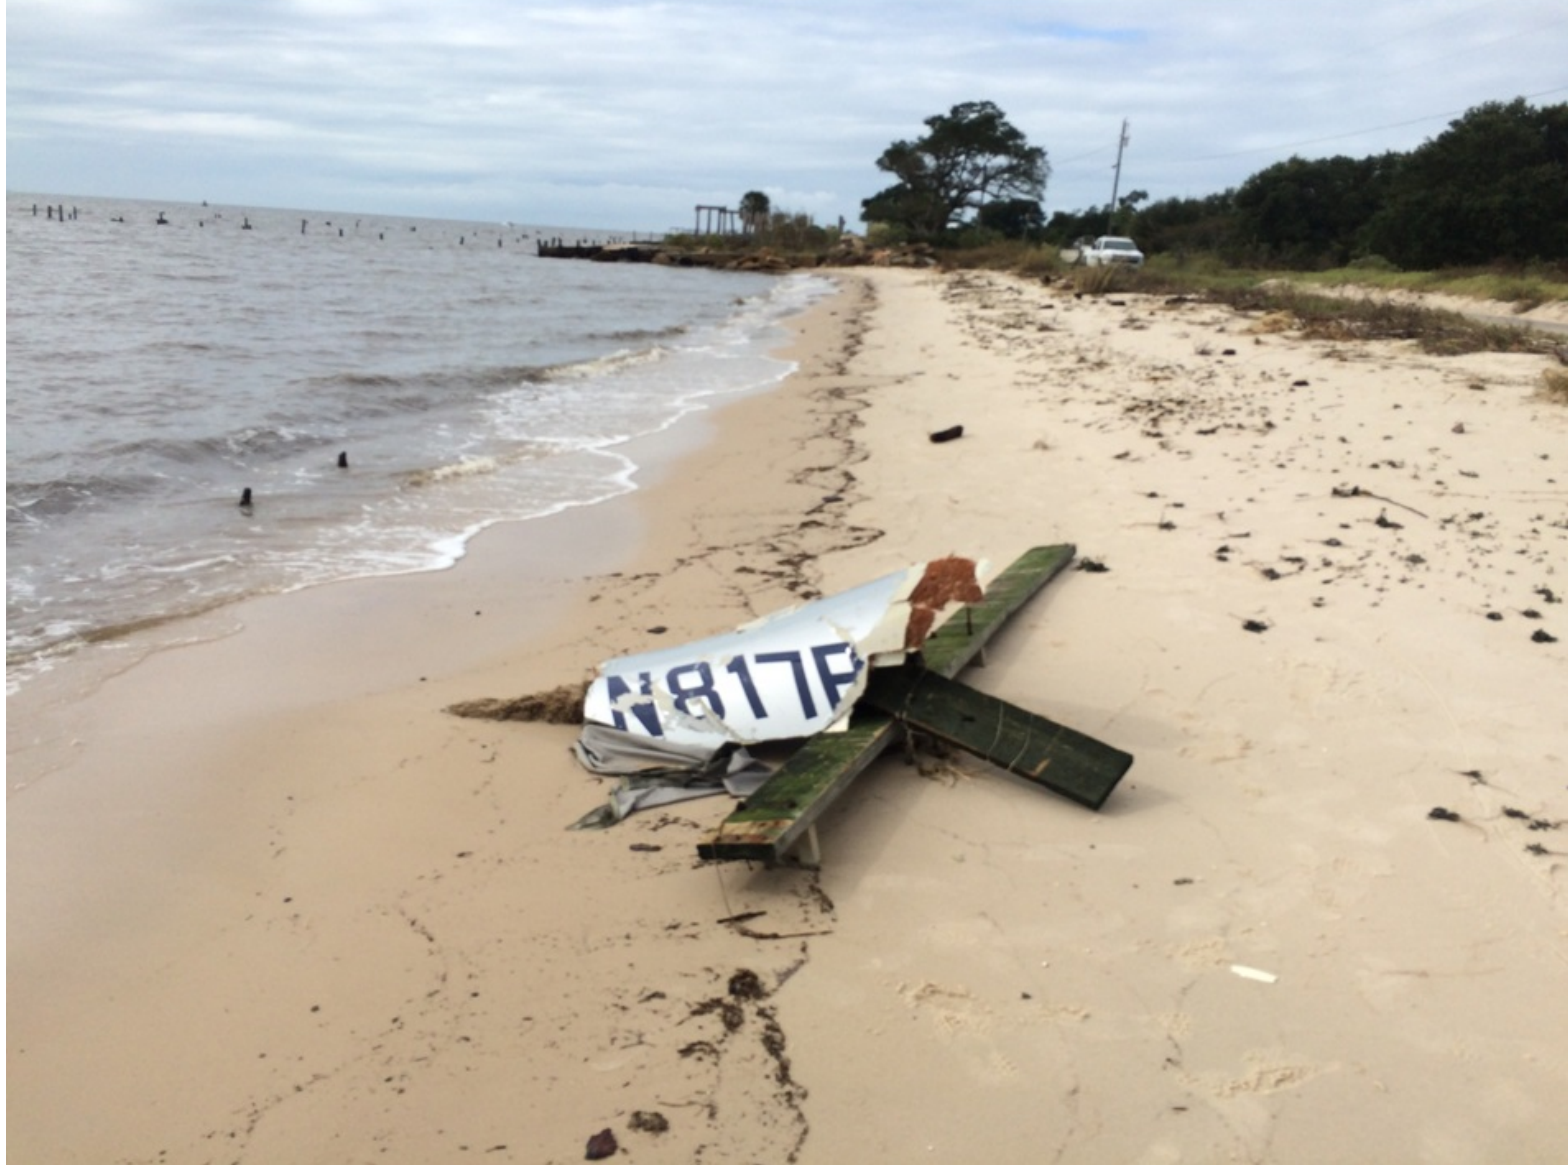
**Photo 1 – Fuselage Section with Partial Registration (Provided by MS Dept. of Marine Resources)**

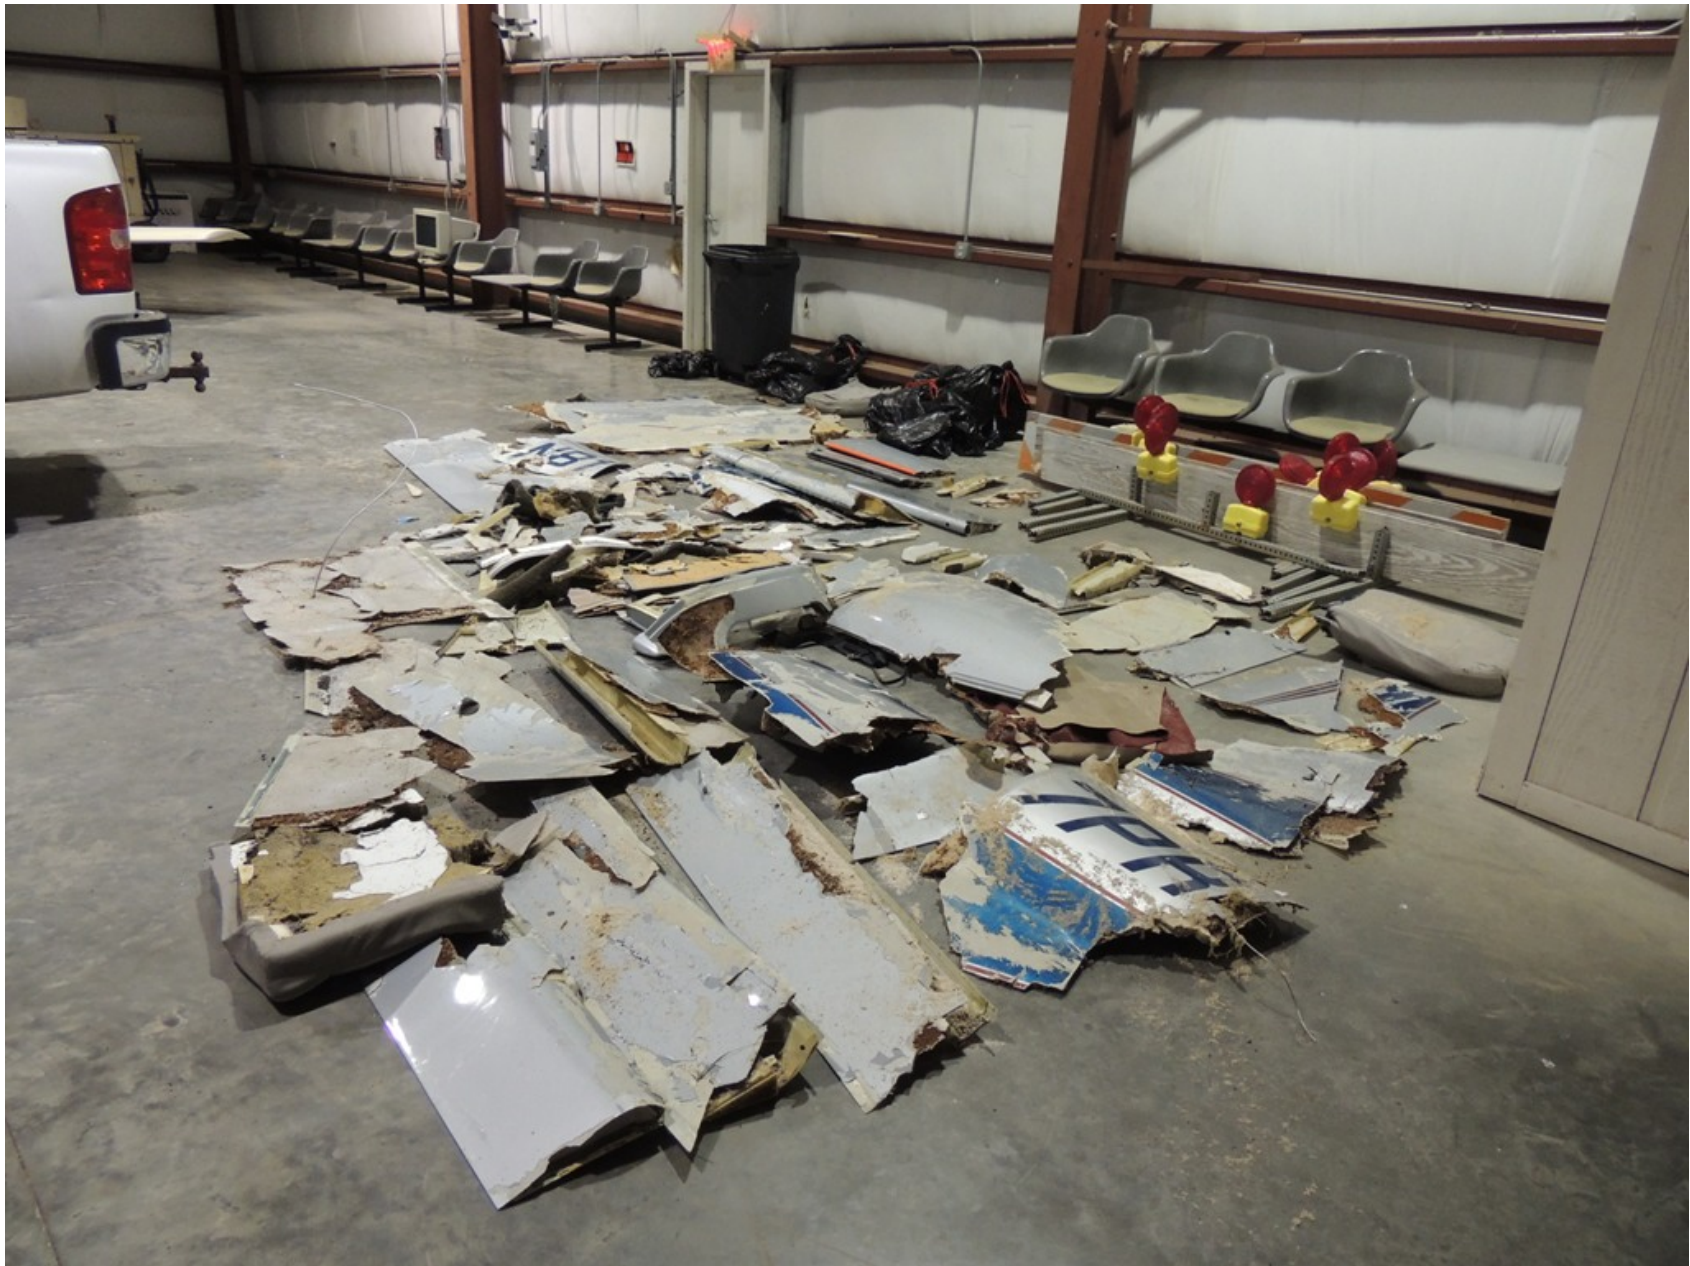
**Photo 2 – Airplane Debris on Hangar Floor (Provided by FAA)**

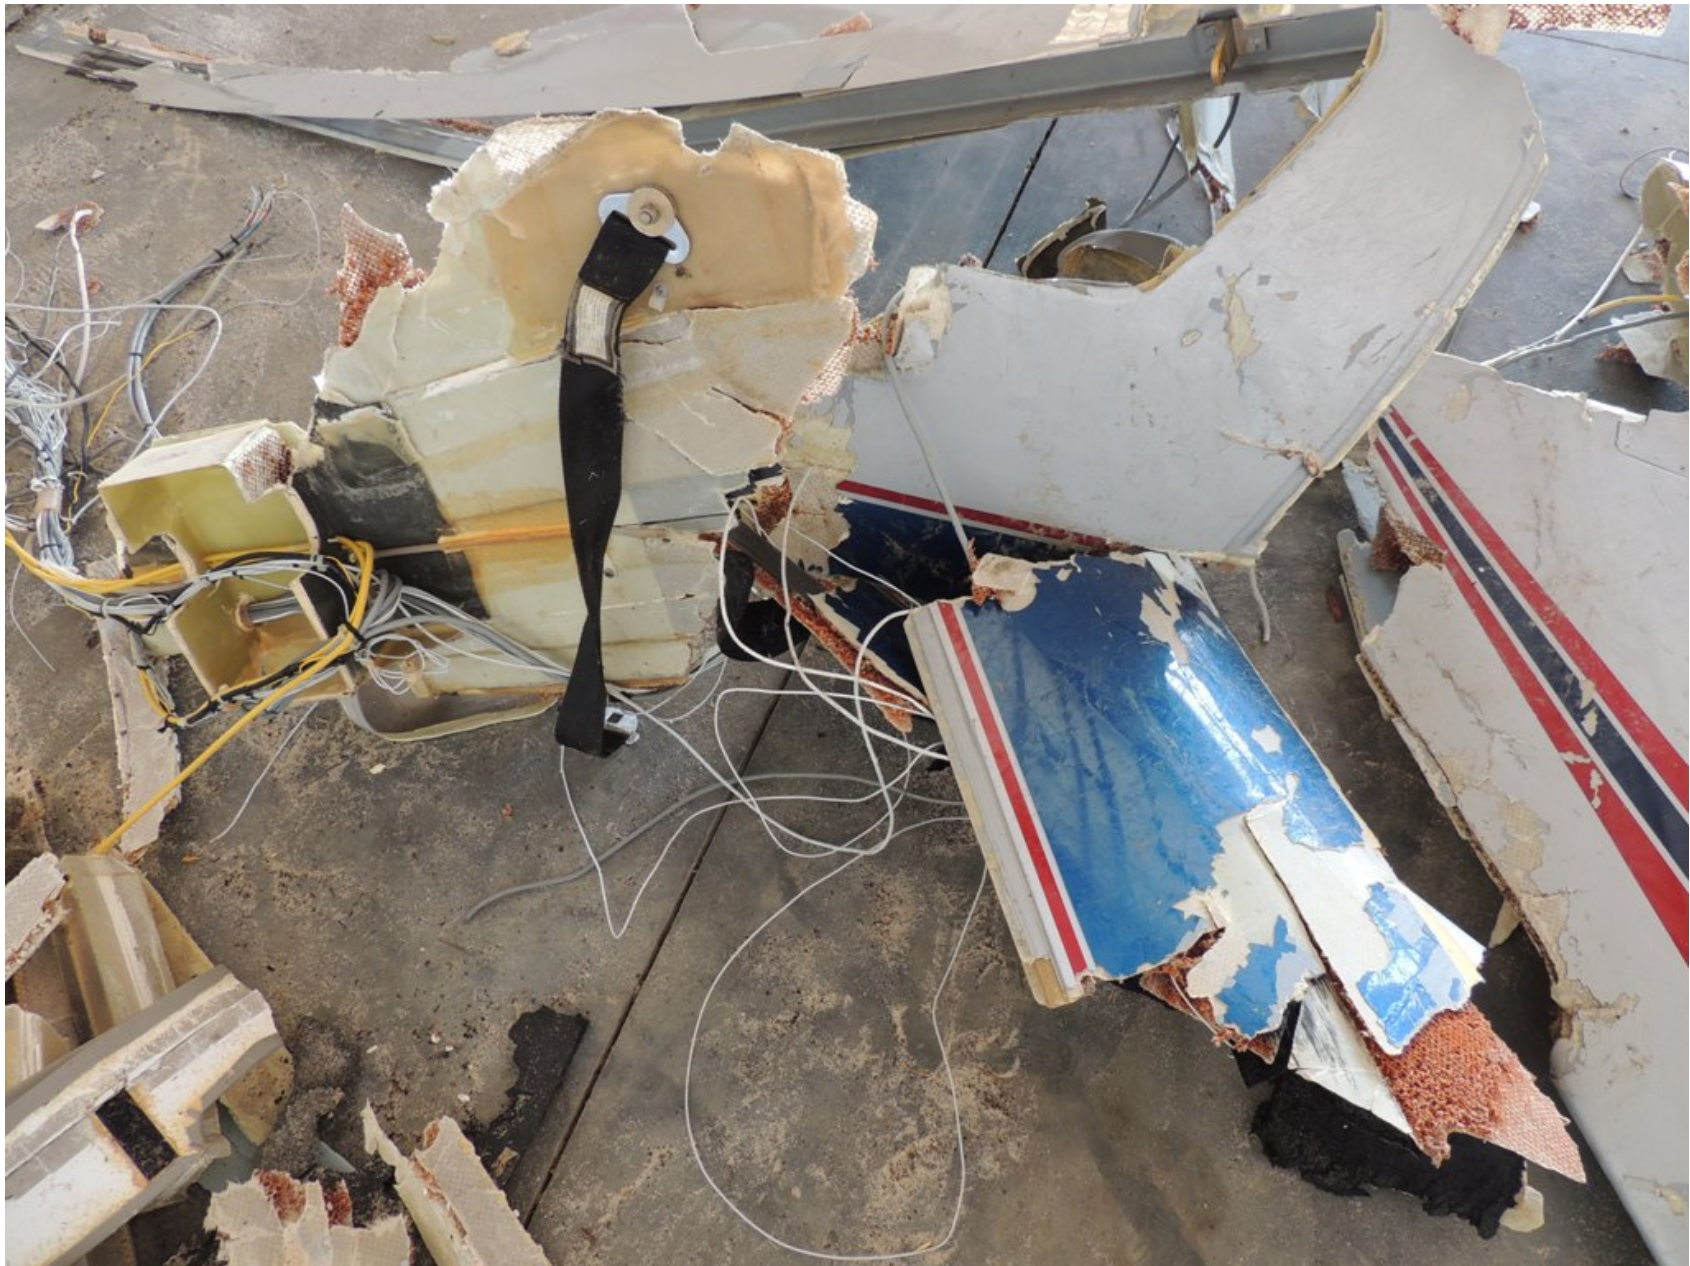
**Photo 3 – Airplane Fuselage Section with Partial Restraint (Provided by FAA)**

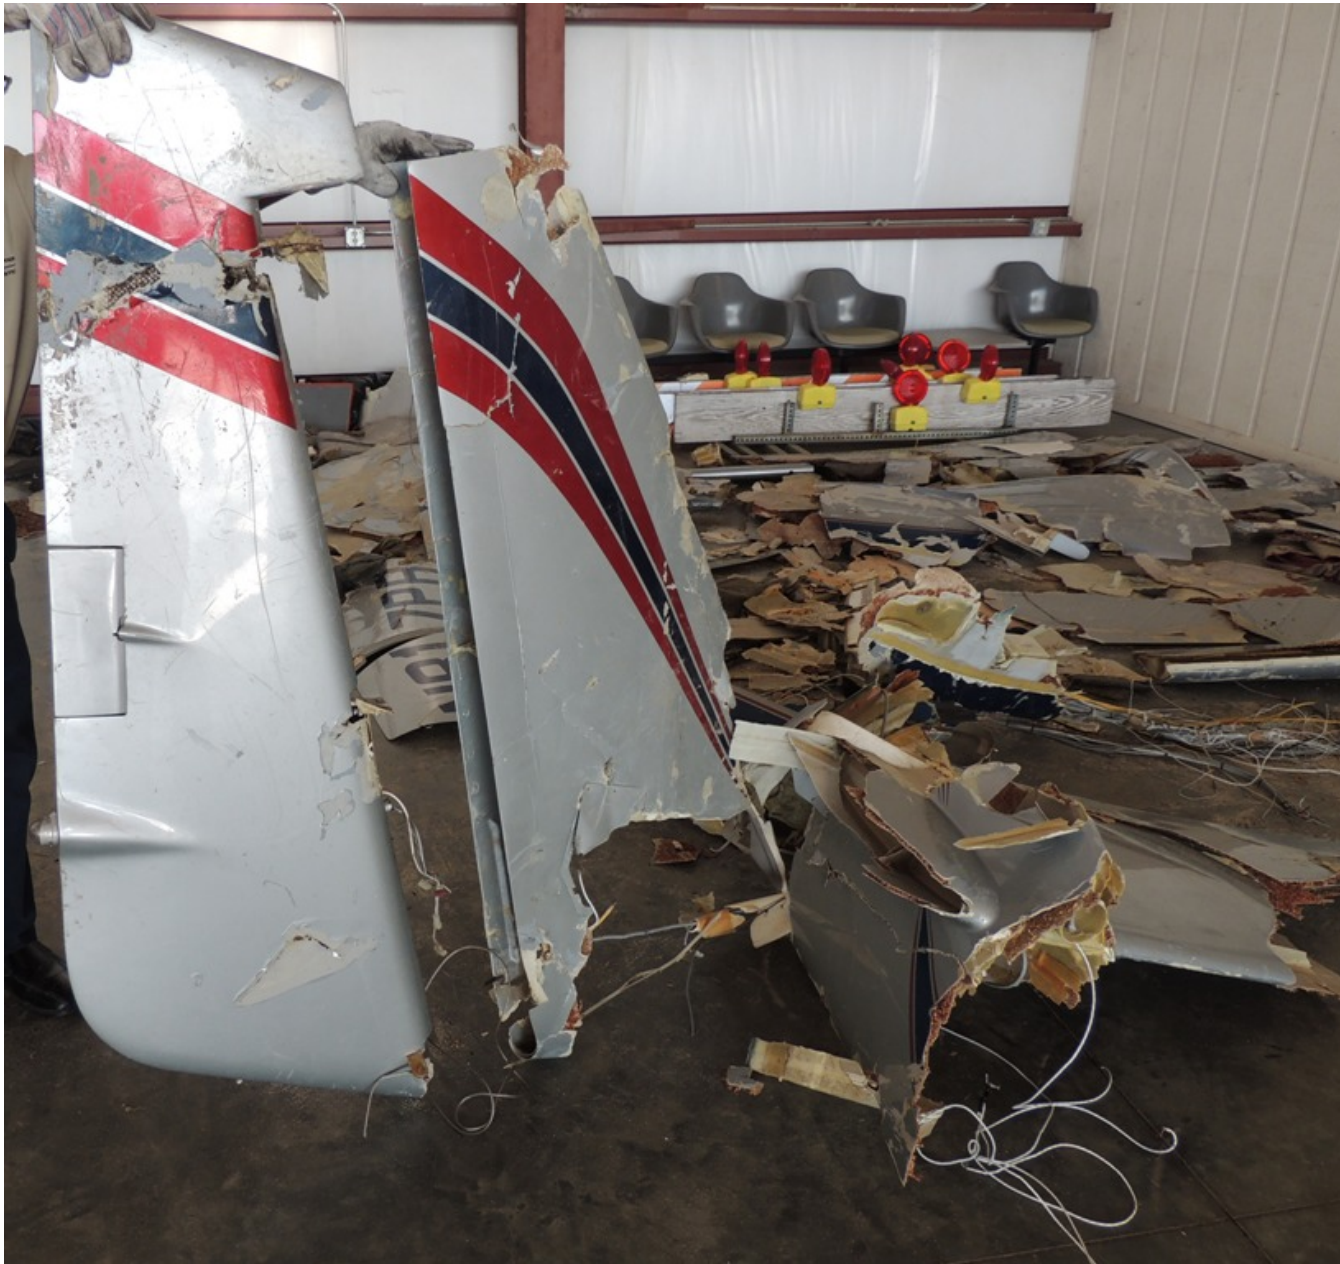
**Photo 4 - Rudder and vertical stabilizer (Provided by FAA)**
