**From:** Jack Mears [REDACTED]  
**Sent:** Thursday, September 01, 2016 6:59 AM  
**To:** Hicks Ralph  
**Subject:** N381MB

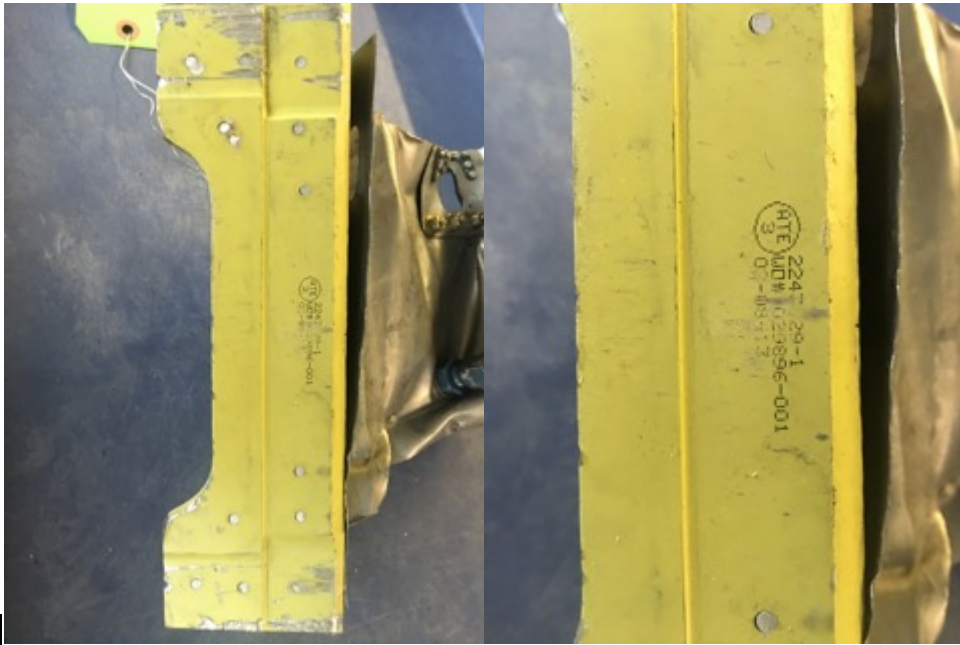
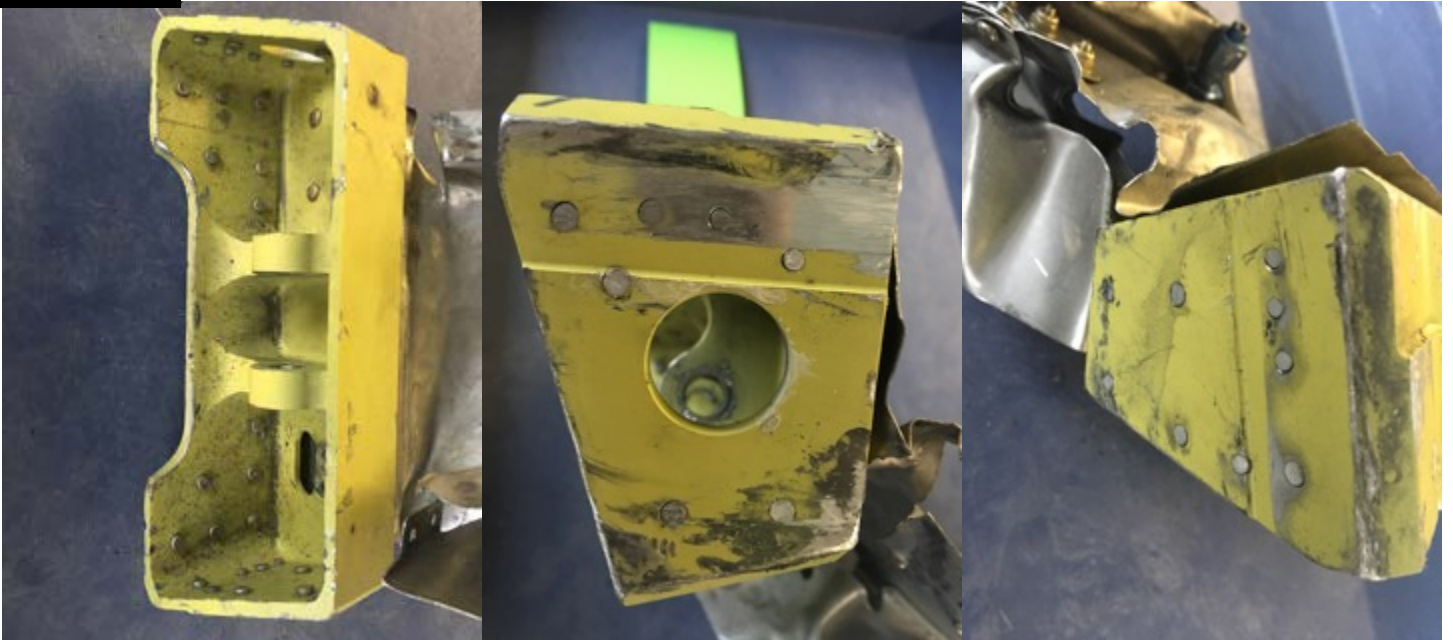
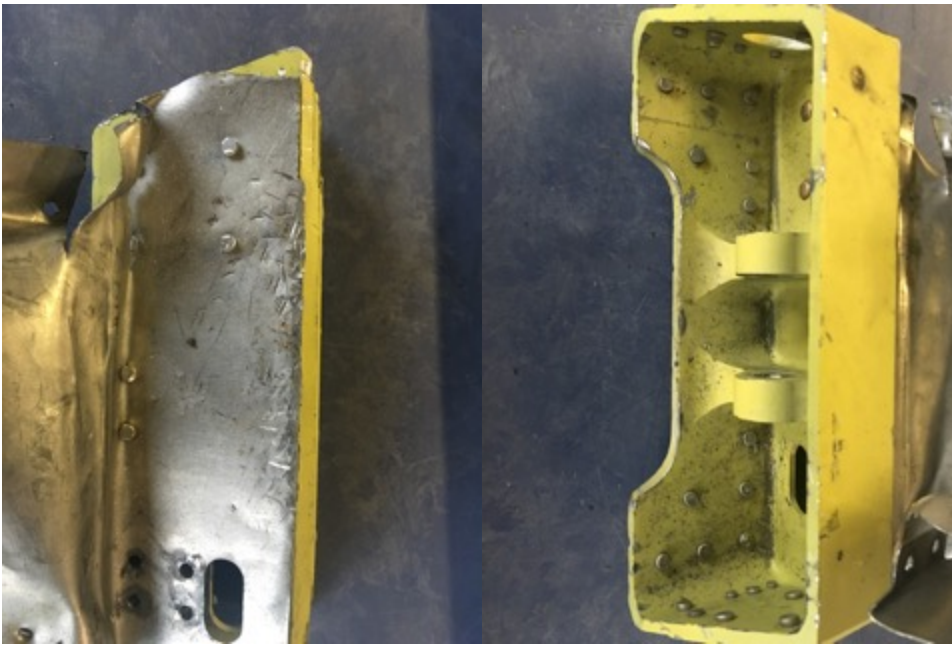
We have removed the nose gear assembly. I have attached pictures of the point of failure.

The rear attach fixture for the nose gear actuator was ripped out (probably due to a hard landing )

It sheared the rivets, you may not be aware according to the logs this part was replaced previously .

We were unable to take satisfactory pictures in the airplane but it had torn the attaching sheet metal as well and we had to cut it out for removal. The riveting was far from the best, I can ship you the part if you would like
