## Component Examination Report

| Engine Model: | IO-520-BB12B | | | Engine S/N: | 578107 | | | | | |
| Aircraft Make/Model: | Beech A36 | | | Aircraft S/N: | E-681 | | Reg. #: | N4314S | | |

## ENGINE FIELD INSPECTION REPORT

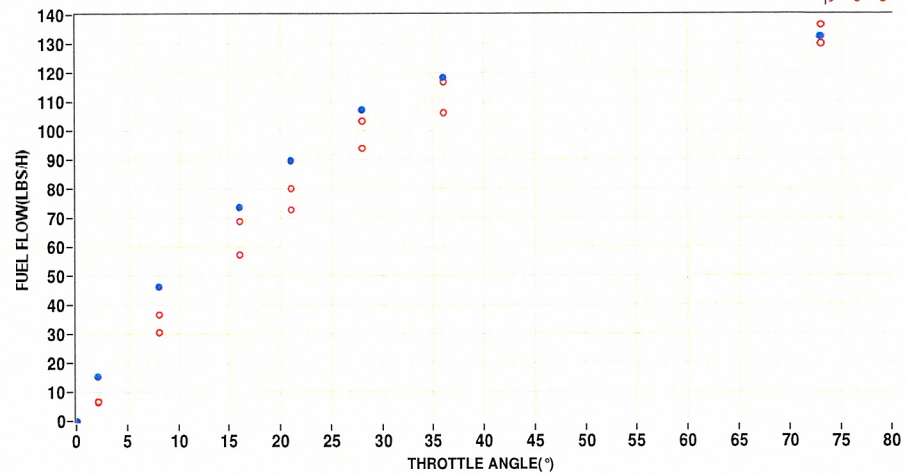
FUEL FLOW VS. THROTTLE ANGLE

**FUEL FLOW TEST  
FAILED!**

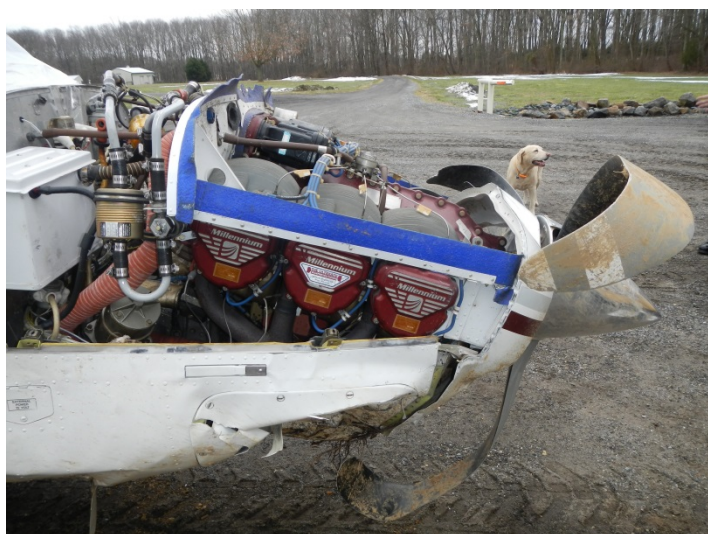
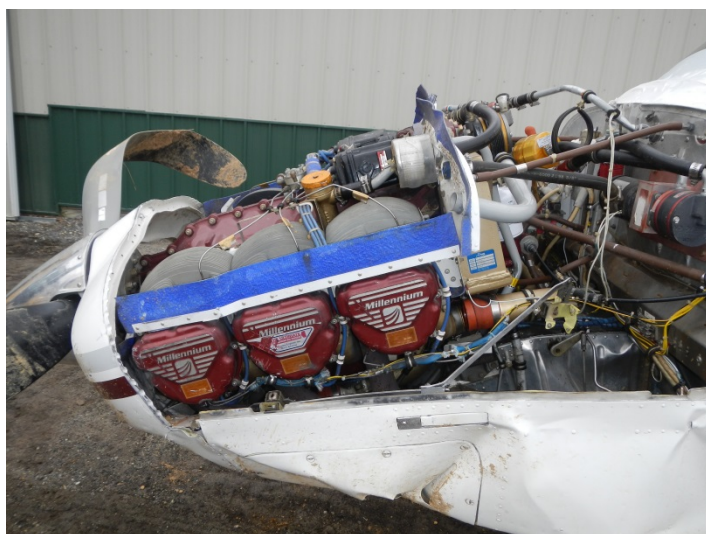
The engine remained attached to the airframe, but was displaced so that the front of the engine was lower than the rear. The three-bladed propeller remained attached to the engine crankshaft and all three blades remained attached to the hub.

The top cowling was removed and no external anomalies were noted with the engine. The throttle body/metering unit sustained impact-related damage that fractured a portion of the throttle body, fractured the oil sump area to which it was mounted, and displaced the induction tubes. The starter motor was separated from the adapter and the adapter's motor mount was fractured.

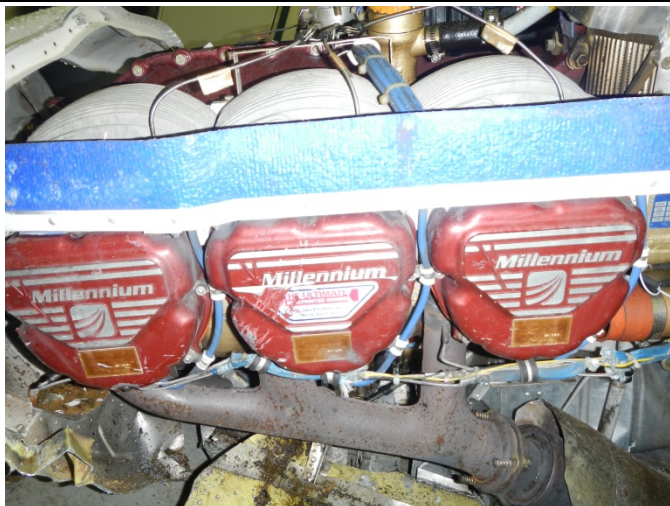
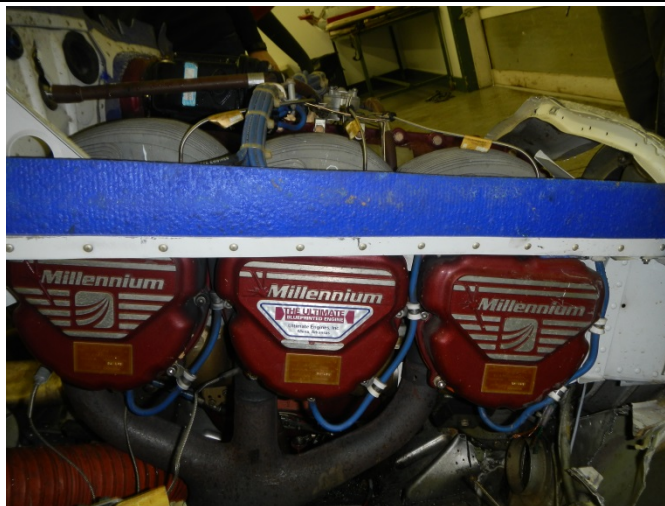
#### EXHAUST SYSTEM

Condition: The exhaust system remained intact with no signs of pre-accident anomalies noted.

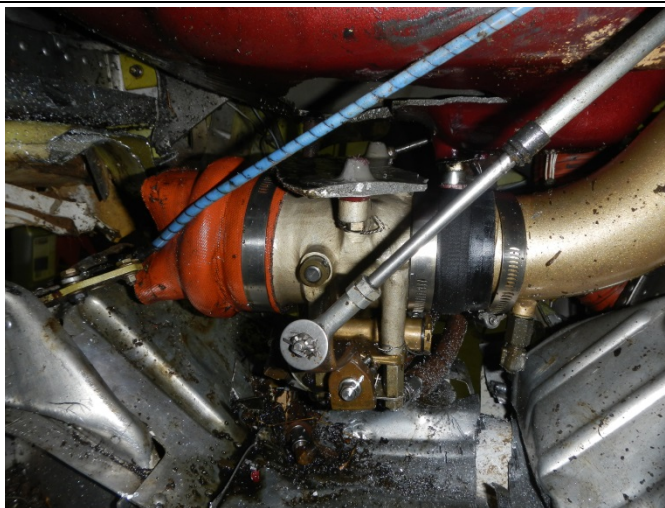
#### INDUCTION SYSTEM

Condition: The intake filter was distorted and contained dirt and debris from the accident site. The induction box was displaced and distorted. The throttle body was fractured and the throttle body inlet and outlet were partially displaced from their intake tubes. The wye plenum was displaced and separated from the intake manifolds. The intake risers remained attached to their respective cylinders. No pre-accident anomalies were noted with the induction system.

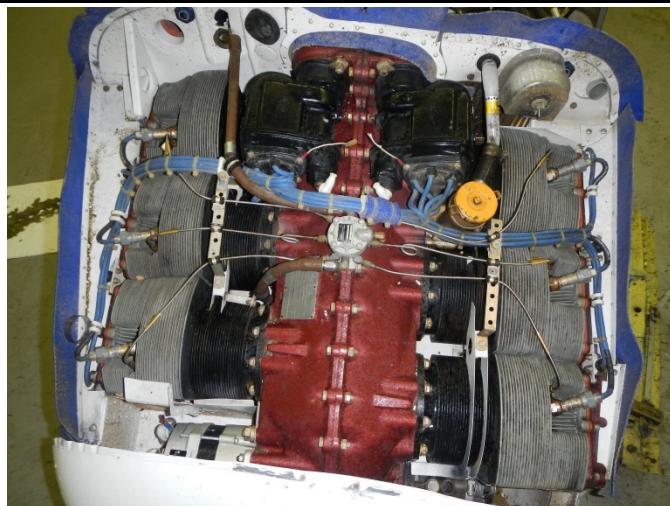
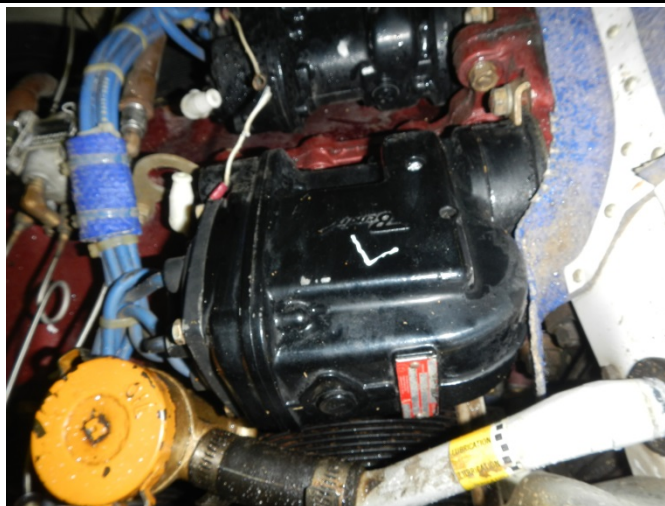
**LEFT  
MAGNETO**Manufacturer: Continental  
Motors S6RN-1225

**Condition:** The magneto remained in place on the topside of the engine with no signs of slipping or rotation on the mounting pad noted. The ignition harness remained attached to the magneto. Manual manipulation of the magneto revealed that it was secured in place. The top sparkplugs were removed from their cylinders and were attached to their respective terminals. The magneto's impulse coupling produced an audible snap during propeller rotation and a spark through the ignition system in firing order with no pre-accident anomalies noted.

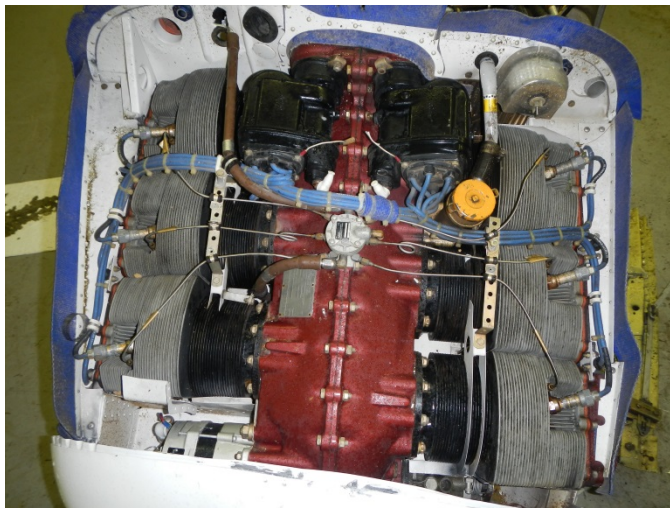
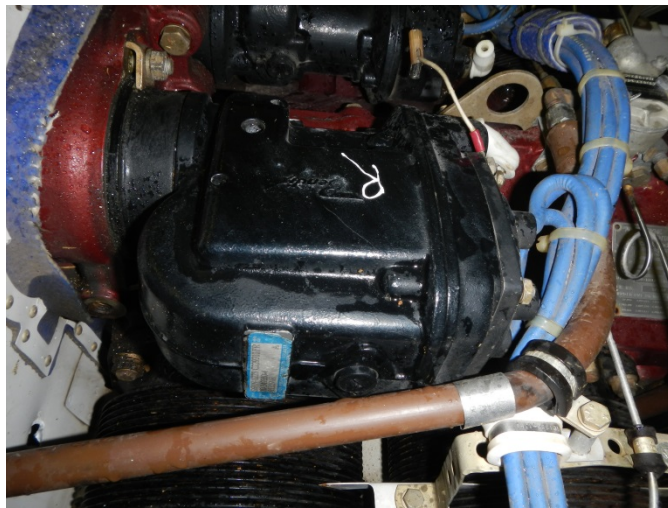
| <b>RIGHT MAGNETO</b> | Manufacturer: Continental Motors S6RN-1225 | P/N: 10-349350-4 | S/N: C229311FR |

**Condition:** The magneto remained in place on the topside of the engine with no signs of slipping or rotation on the mounting pad noted. The ignition harness remained attached to the magneto. Manual manipulation of the magneto revealed that it was secured in place. The top sparkplugs were removed from their cylinders and were attached to their respective terminals. The magneto's impulse coupling produced an audible snap during propeller rotation and a spark through the ignition system in firing order with no pre-accident anomalies noted.

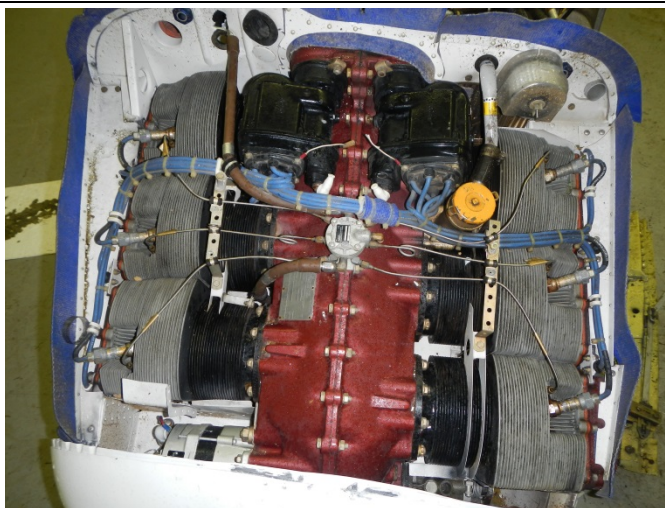
| <b>IGNITION HARNESS</b> | Manufacturer: Ultimate Engines | P/N: Unknown | S/N: Unknown |

**Condition:** The ignition harness remained secured to both magnetos and the terminals remained secured to their respective sparkplugs. There were no signs of pre-accident anomalies noted with any of the leads.

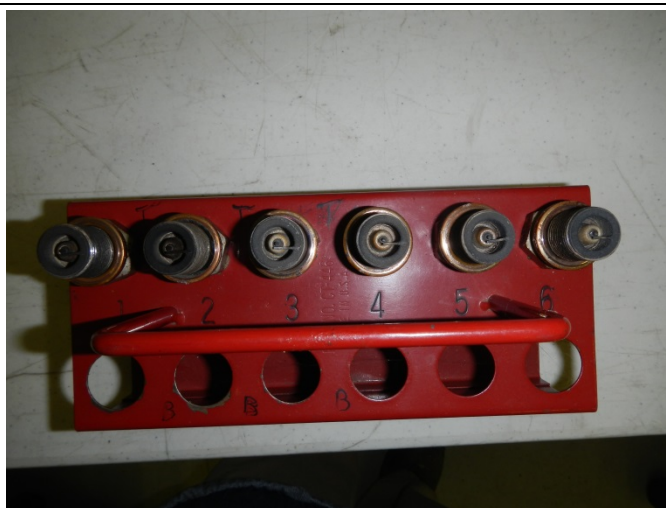
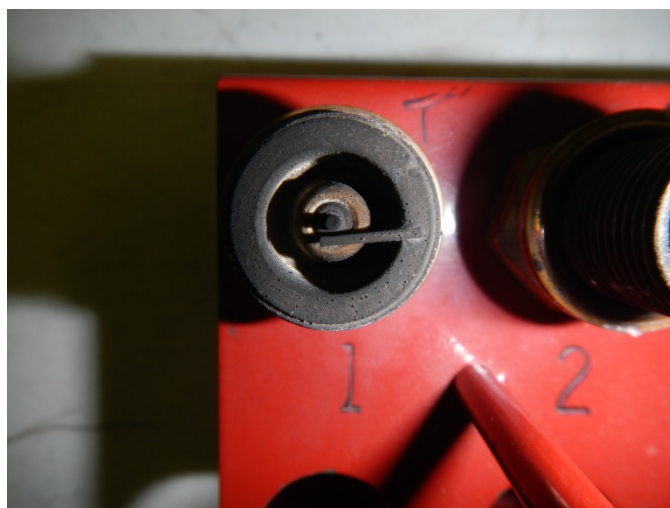
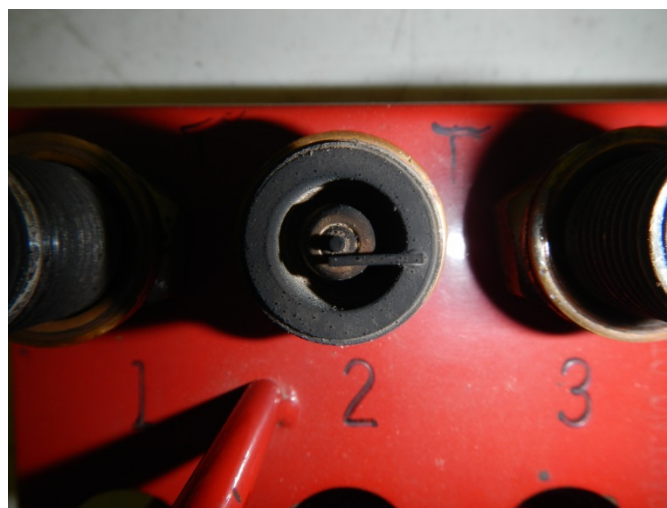
## SPARK PLUGS

The sparkplugs remained secured to their respective cylinders. The top sparkplugs were removed and none displayed evidence of carbon or lead fouling; however, the #2 top sparkplug was covered in dark soot. The top sparkplugs were reattached to their respective ignition lead and all produced a bright blue spark during propeller rotation.

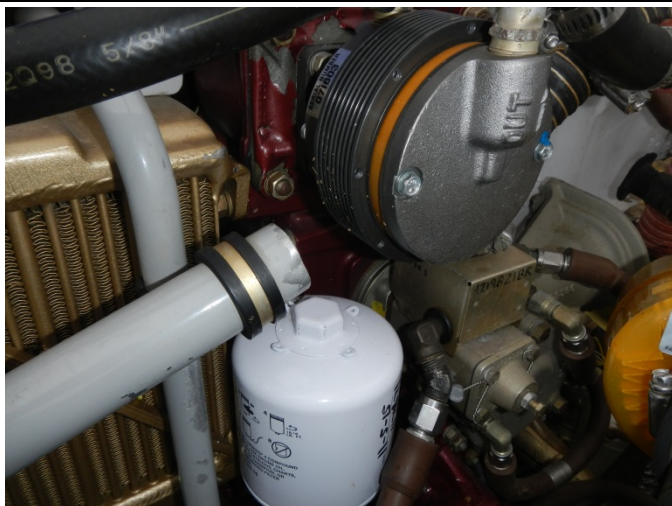
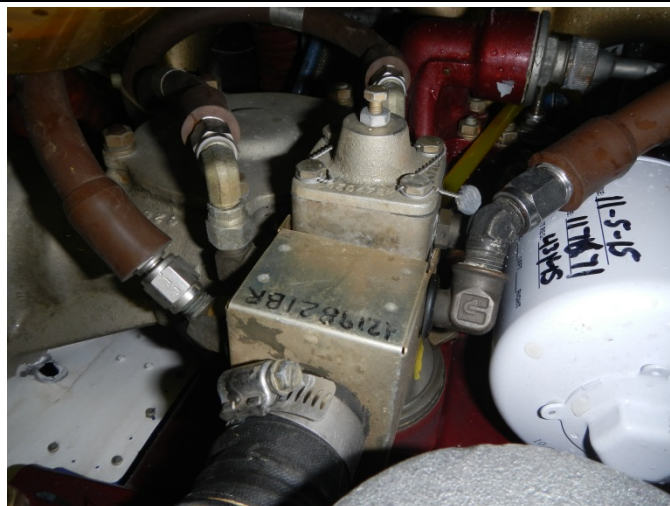
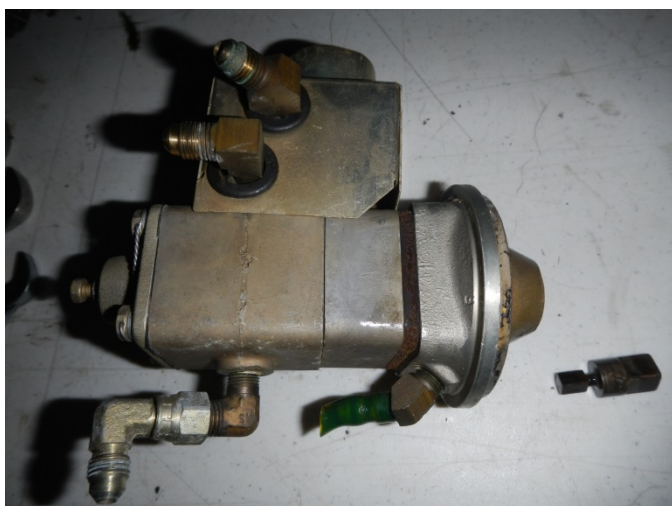
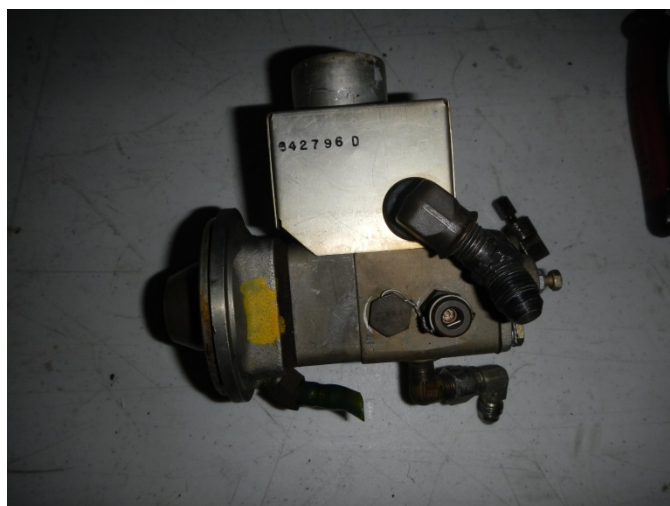
### FUEL PUMP

**Condition:** The engine-driven fuel pump remained secured to the backside of the engine with no external signs of operational distress noted. Residual fuel poured from the fuel pump fittings when the fuel lines were removed. The drive coupling was intact. Manual rotation of the drive coupling while installed in the fuel pump drive shaft resulted in a free rotation of the shaft with residual fuel coming from the fuel pump cavity. No pre-accident anomalies were noted. The fuel pump was retained by the NTSB for further testing at the Continental Motors factory.

Following the removal of the engine drive fuel pump, the aircraft's electric fuel boost pump was operated using battery power. Residual fuel was pumped in a steady stream from the fuel supply line to the engine driven fuel pump. No pre-accident anomalies were noted with the aircraft's fuel supply system.

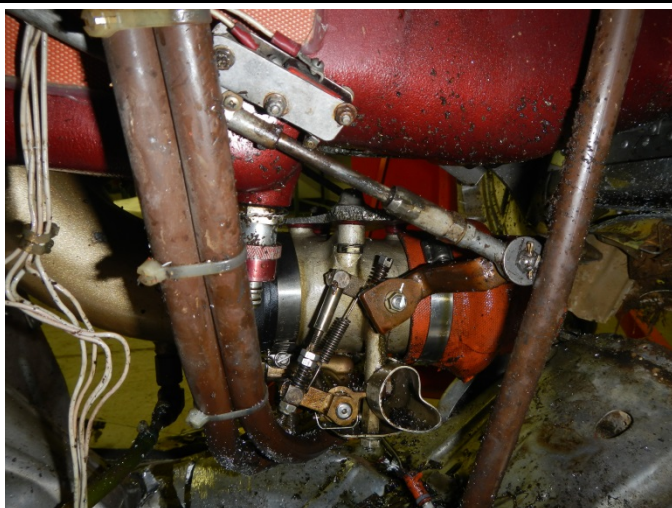
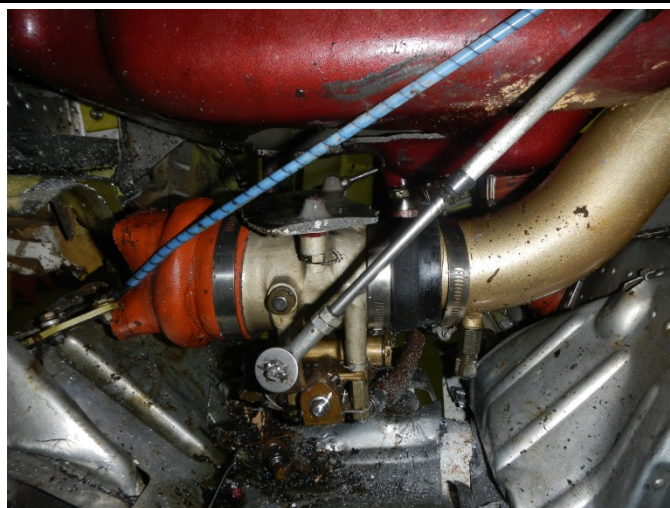
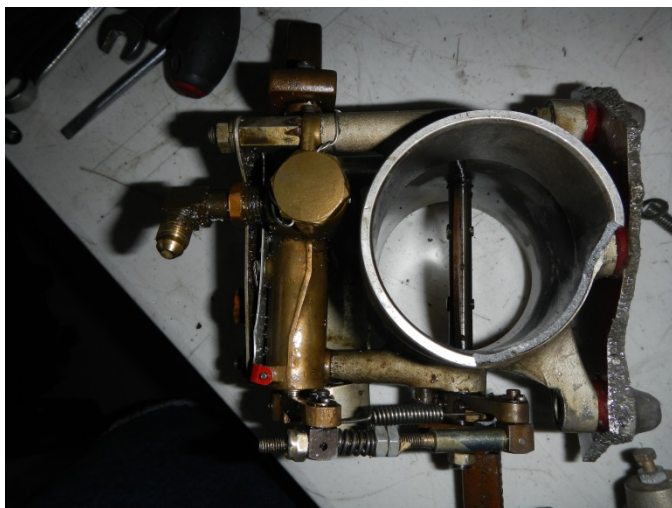
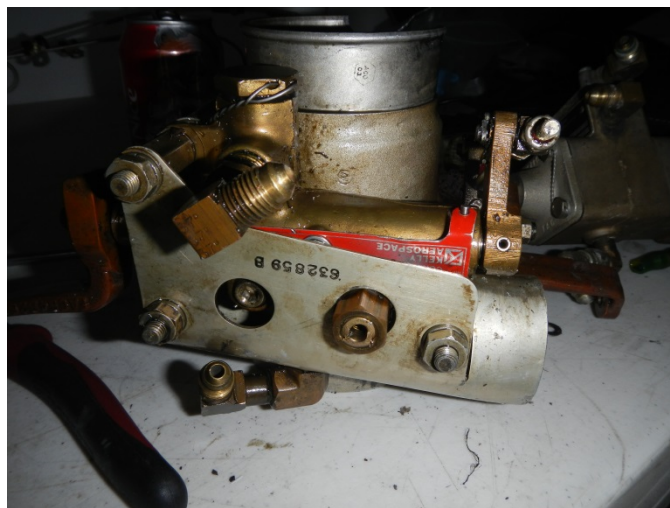
## THROTTLE BODY METERING UNIT

The throttle body remained in place and secured to its mountings on the bottom side of the oil sump; however, that section of oil sump was fractured and separated from the engine. The fuel inlet and return lines remained attached to the metering unit, but the outlet fitting (to the fuel manifold valve) was fractured. The throttle and mixture control cables remained attached to their respective levers/shafts. The throttle and mixture control cables were displaced in the engine nacelle due to the distortion of the airframe structure and movement of the control levers through manual manipulation of the cockpit controls was not possible. The cables were removed as were the attached fuel lines. The throttle and mixture control levers were manually rotated through their normal range of motion with no signs of slipping or binding noted. Residual fuel poured out of the fuel fittings during the removal of the unit. The inlet fuel screen remained in place and secured with safety-wire. It was not removed. The throttle body/fuel metering unit was shipped to Continental Motors for testing.

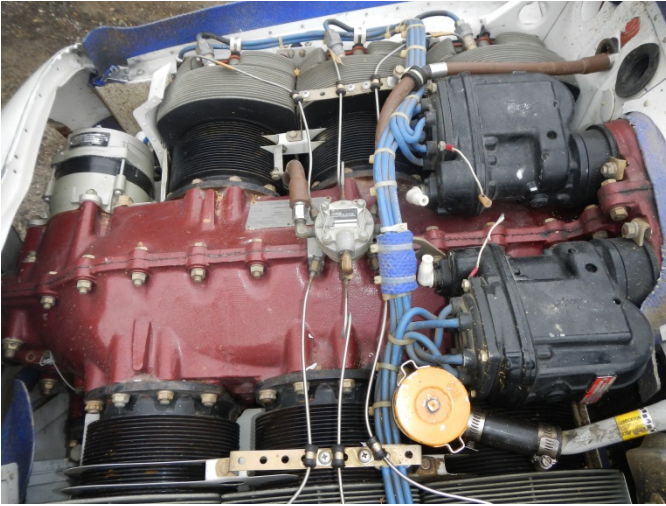
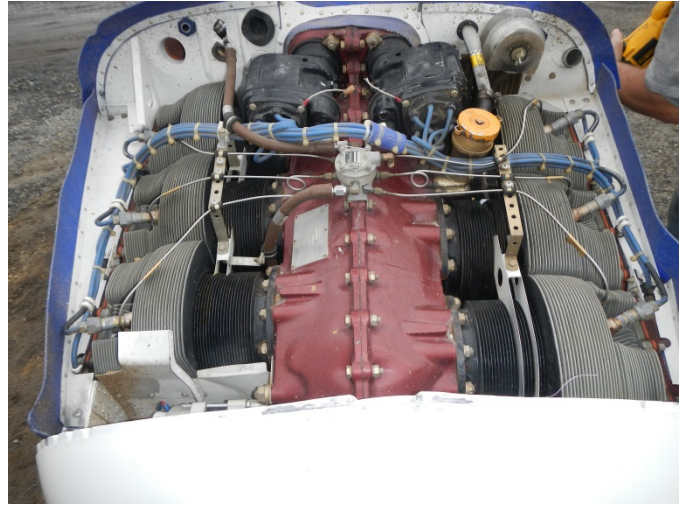
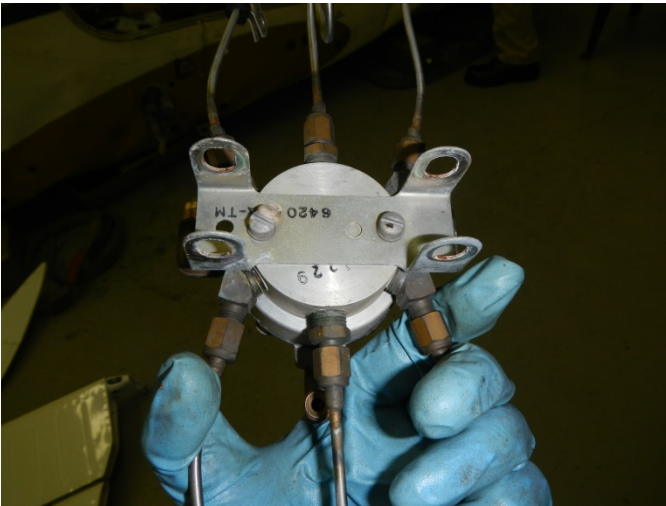
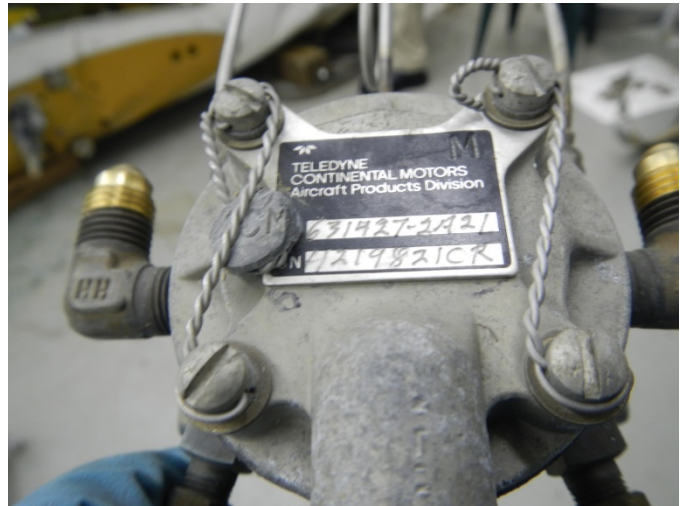
**PAGE 12 of 29****FUEL MANIFOLD  
VALVE**Manufacturer: Continental  
Motors

The fuel manifold valve remained secured to the topside of the engine. The fuel inlet and injector lines remained attached to the manifold valve, though the fuel supply line was fractured at the metering unit fitting. The fuel manifold valve cap remained secured to the body and the safety-wire was in place. No pre-accident anomalies were noted. The unit was not disassembled as it will be returned to Continental Motors for flow testing. Residual fuel poured from the inlet fitting when the manifold valve was removed from the engine.

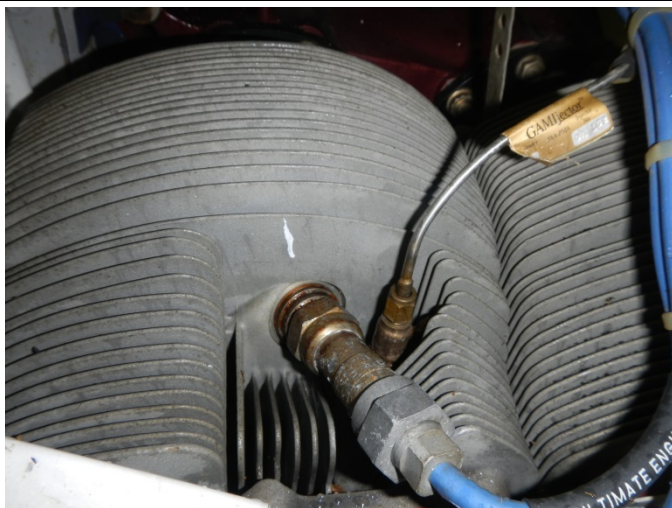
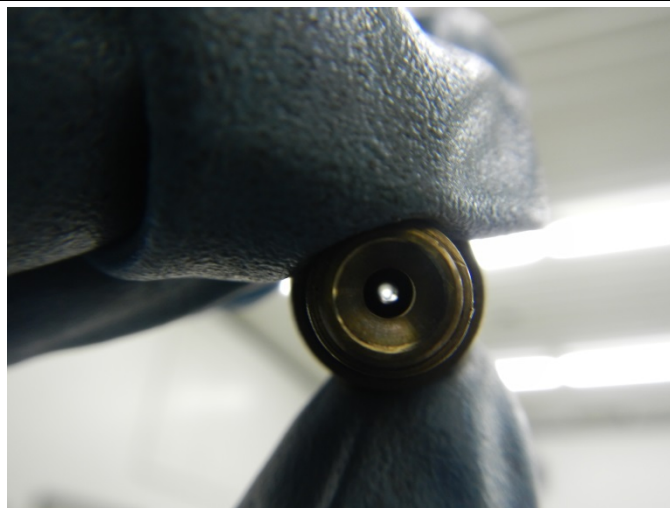
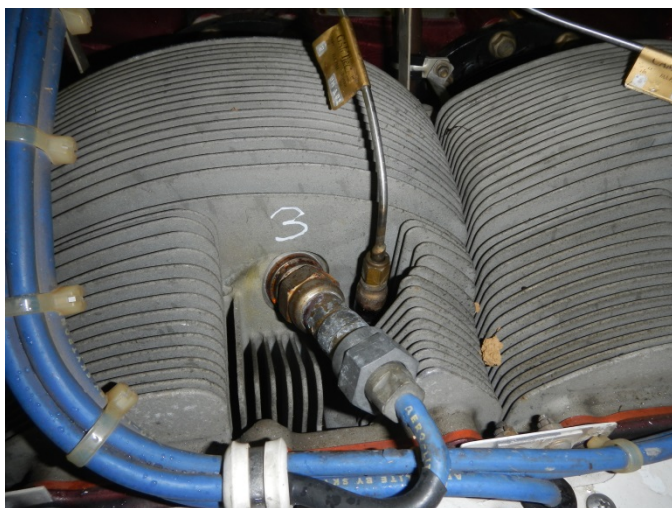
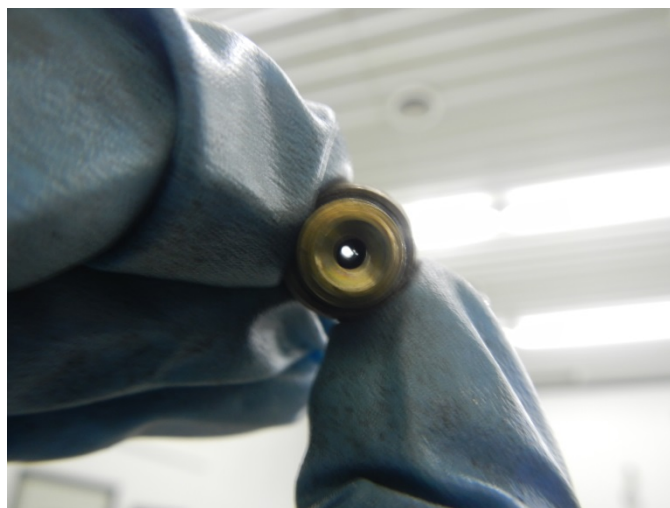
### FUEL NOZZLES AND LINES

The fuel injector nozzles were attached to their injector lines and their respective cylinders. The bases of the #2, #4, and #6 fuel injector nozzles showed signs of blue staining and dark discoloration. The fuel injector nozzles were removed and examined; none displayed any signs of blockage. The fuel injector nozzles were reattached to the fuel injector lines for shipment to Continental Motors for testing.

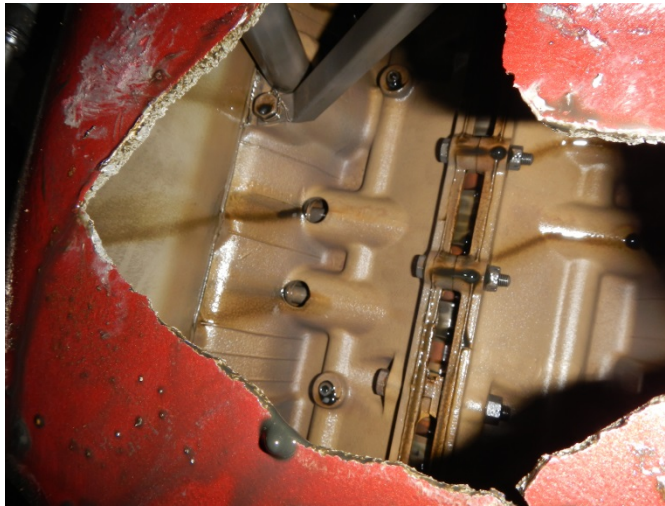
#### OIL SUMP

**Condition:** The oil sump remained secured to the bottom side of the engine, but it was fractured in the area to which the throttle body mounts. The bottom side of the engine was visible through the fractured sump and no pre-accident anomalies were noted.

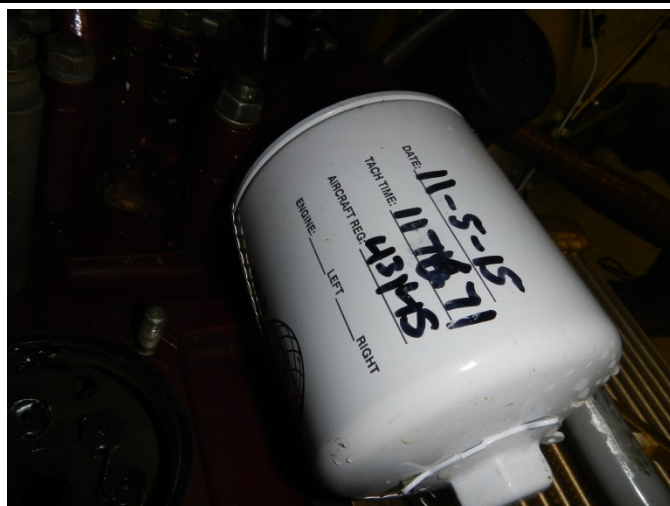
## OIL FILTER

Condition: The oil filter remained secured with safety-wire and had the following date and tachometer time written on the side: "11-5-15 1176.71". There were no external anomalies noted.

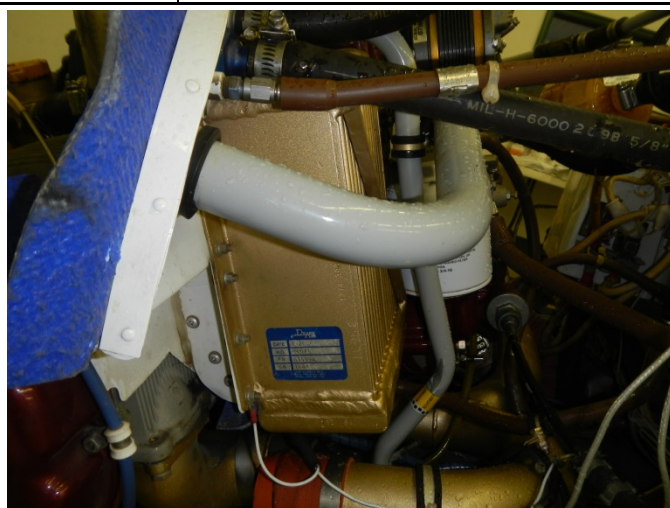
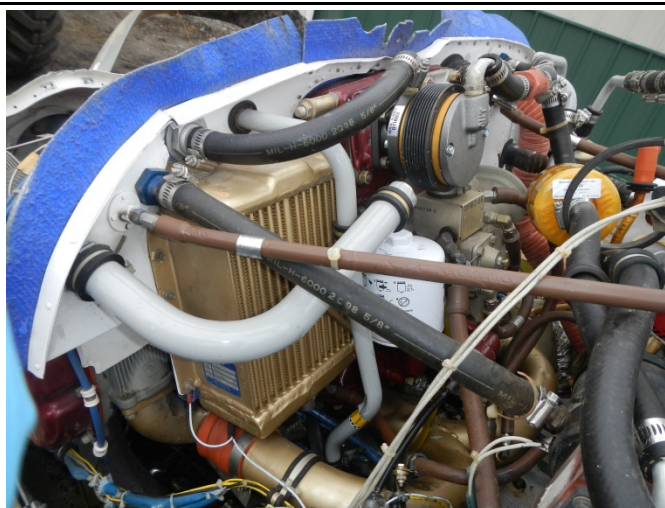
## OIL COOLER

Condition: The oil cooler remained attached to the back left side of the engine with no signs of pre-accident anomalies noted.

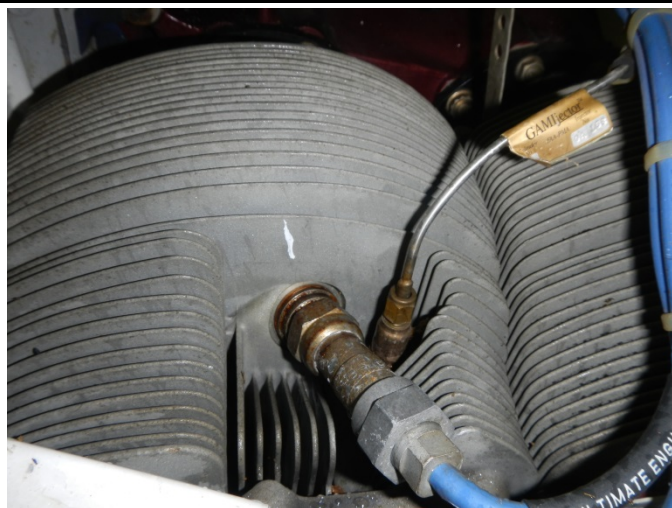
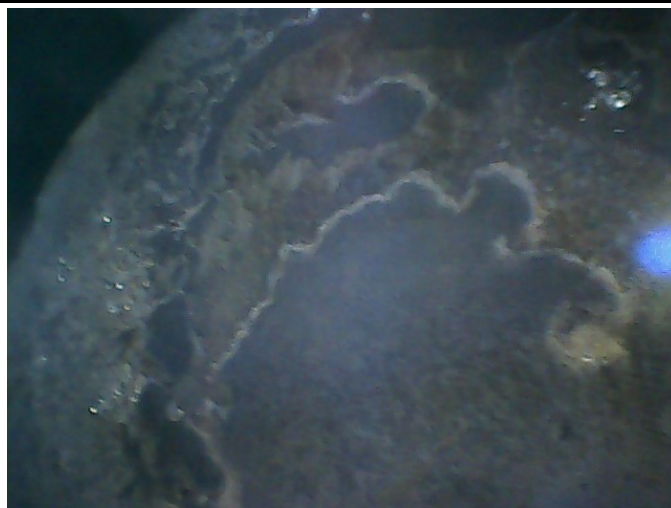
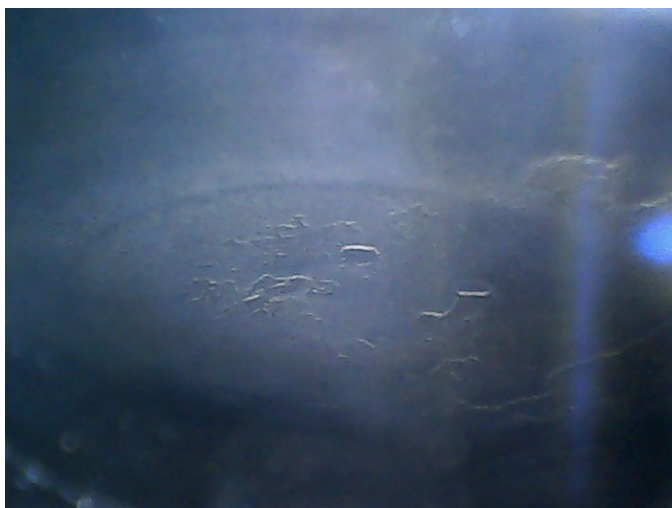
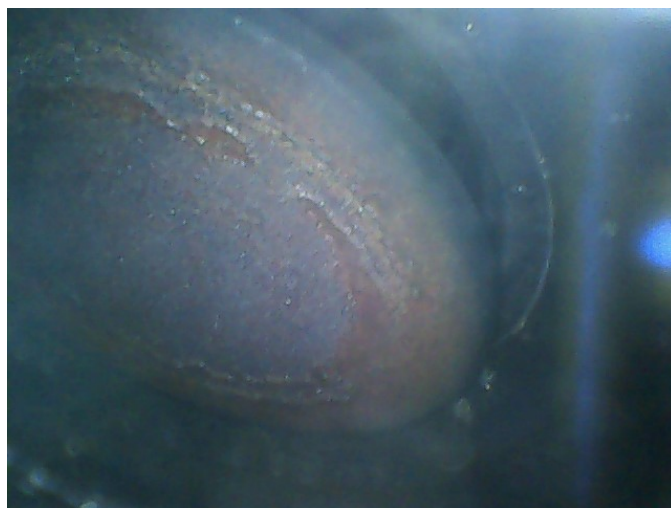
#### CYLINDER #1

Condition: The cylinder remained secured to the crankcase and there were no external signs of operational distress. The torque putty was not present on the cylinder attaching hardware. The cylinder was borescope inspected through the top sparkplug hole and no pre-accident anomalies were noted with the cylinder barrel, cylinder head, piston, valves, or valve seats. A thumb compression test resulted in strong suction and compression from the cylinder.

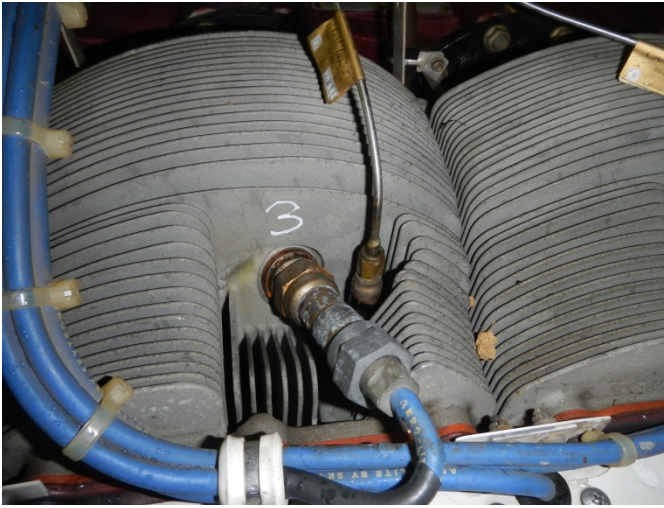
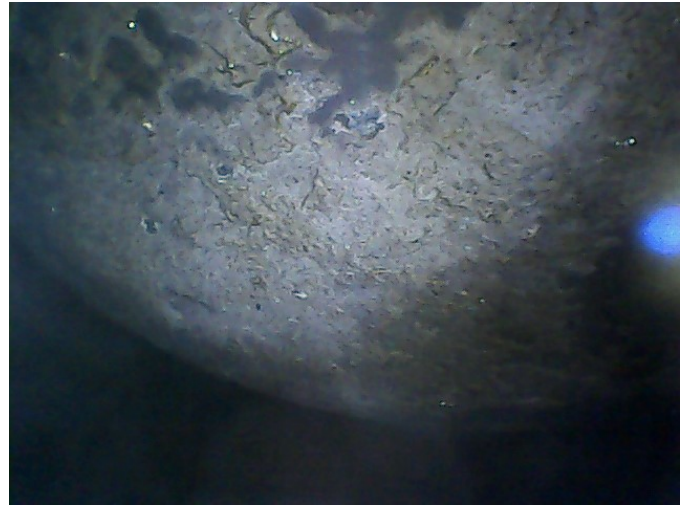
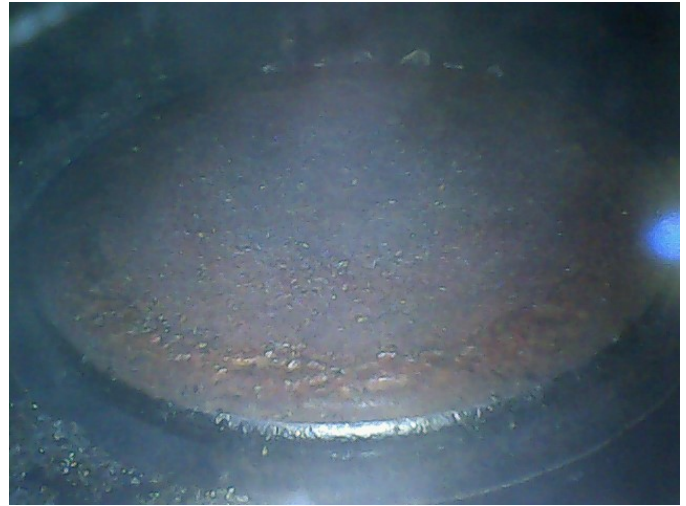
### CYLINDER #3

Condition: The cylinder remained secured to the crankcase and there were no external signs of operational distress. The torque putty was not present on the cylinder attaching hardware. The cylinder was borescope inspected through the top sparkplug hole and no pre-accident anomalies were noted with the cylinder barrel, cylinder head, piston, valves, or valve seats. A thumb compression test resulted in strong suction and compression from the cylinder.

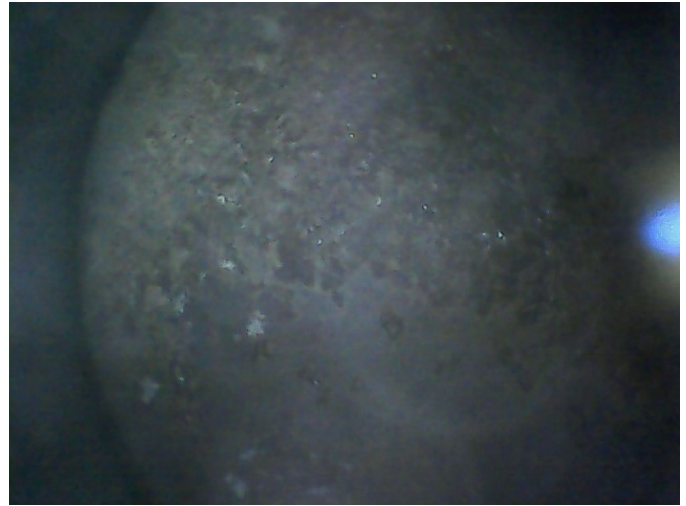
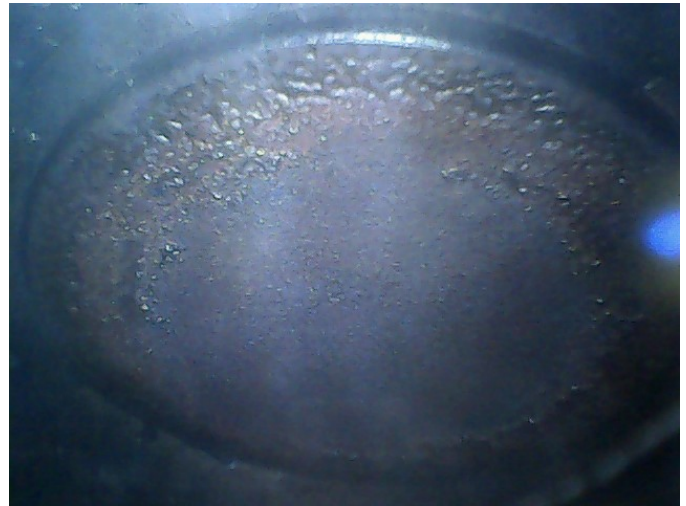
### CYLINDER #5

Condition: The cylinder remained secured to the crankcase and there were no external signs of operational distress. The torque putty was not present on the cylinder attaching hardware. The cylinder was borescope inspected through the top sparkplug hole and no pre-accident anomalies were noted with the cylinder barrel, cylinder head, piston, valves, or valve seats. A thumb compression test resulted in strong suction and compression from the cylinder.

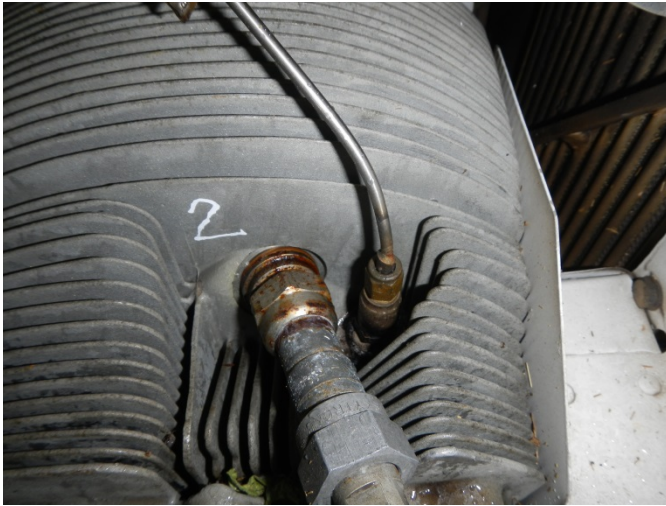
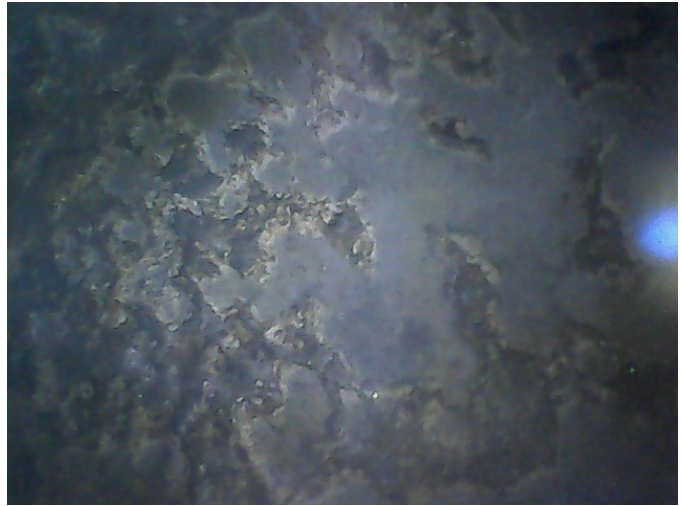
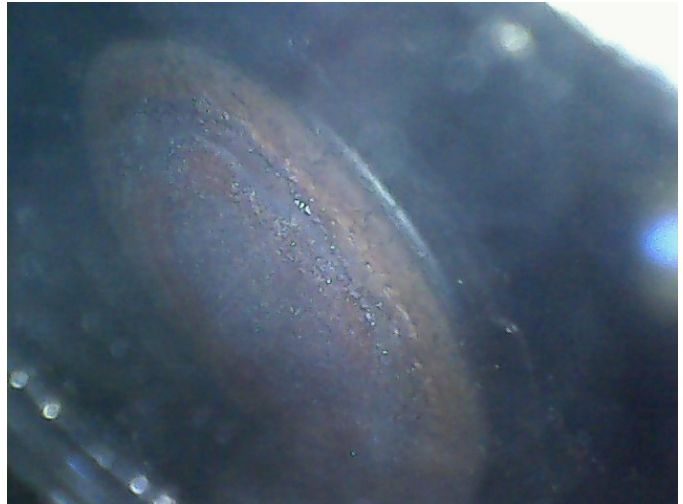
### CYLINDER #2

Condition: The cylinder remained secured to the crankcase and there were no external signs of operational distress. The torque putty was not present on the cylinder attaching hardware. The cylinder was borescope inspected through the top sparkplug hole and no pre-accident anomalies were noted with the cylinder barrel, cylinder head, piston, valves, or valve seats. A thumb compression test resulted in strong suction and compression from the cylinder.

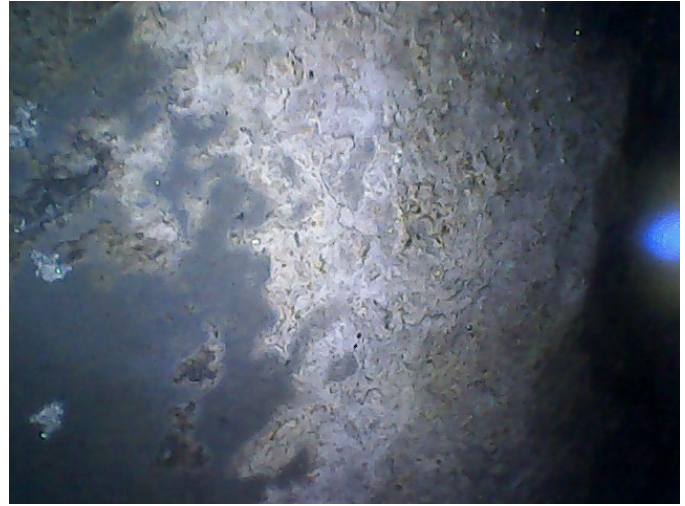
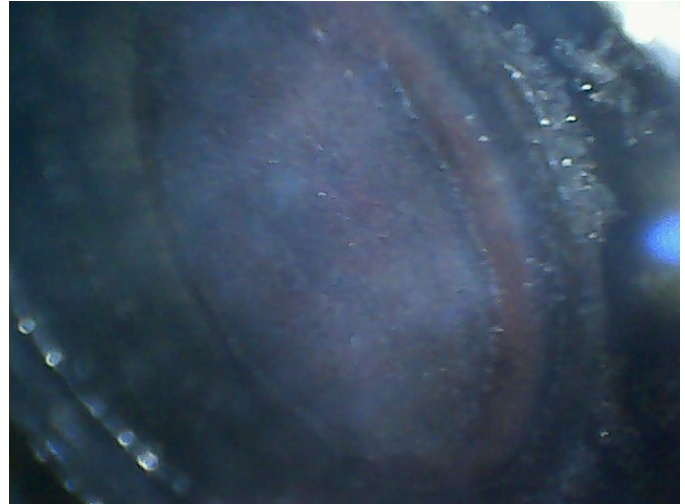
### CYLINDER #4

Condition: The cylinder remained secured to the crankcase and there were no external signs of operational distress. The torque putty was not present on the cylinder attaching hardware. The cylinder was borescope inspected through the top sparkplug hole and no pre-accident anomalies were noted with the cylinder barrel, cylinder head, piston, valves, or valve seats. A thumb compression test resulted in strong suction and compression from the cylinder.

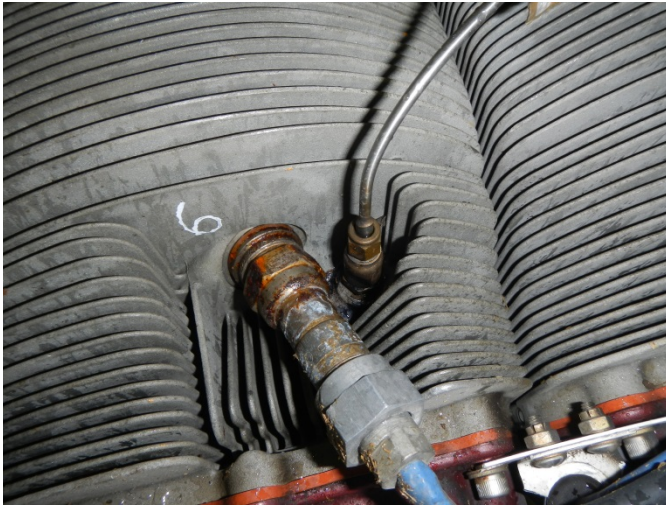
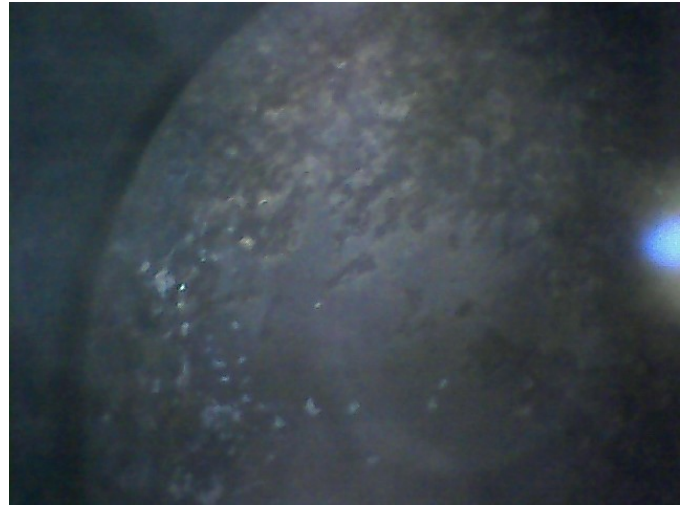
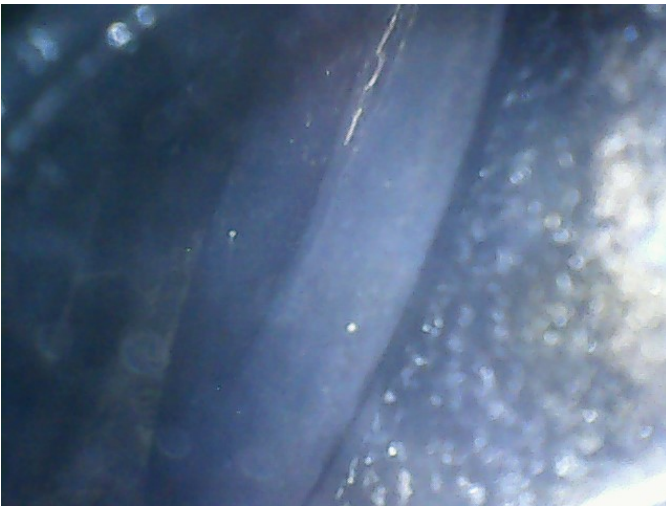
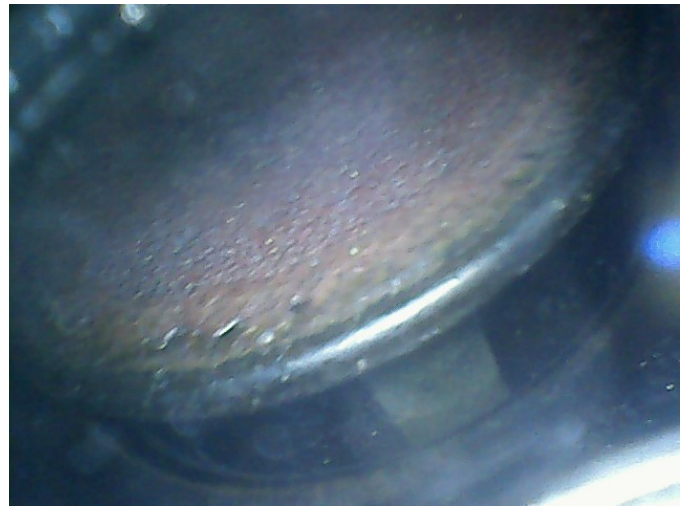
### CYLINDER #6

Condition: The cylinder remained secured to the crankcase and there were no external signs of operational distress. The torque putty was not present on the cylinder attaching hardware. The cylinder was borescope inspected through the top sparkplug hole and no pre-accident anomalies were noted with the cylinder barrel, cylinder head, piston, valves, or valve seats. A thumb compression test resulted in strong suction and compression from the cylinder.

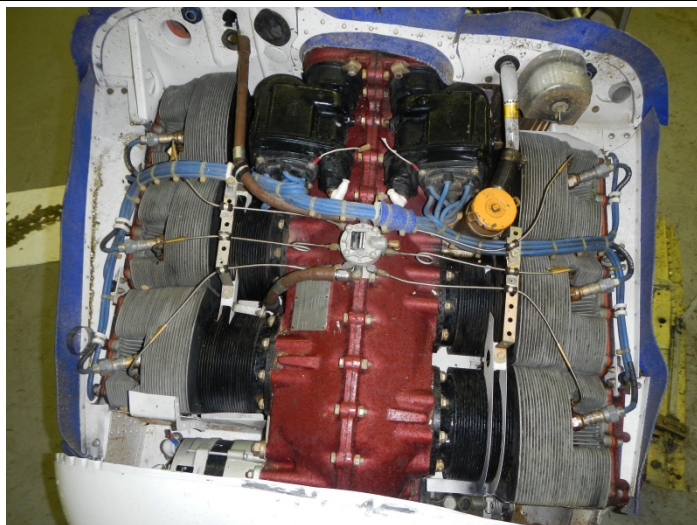
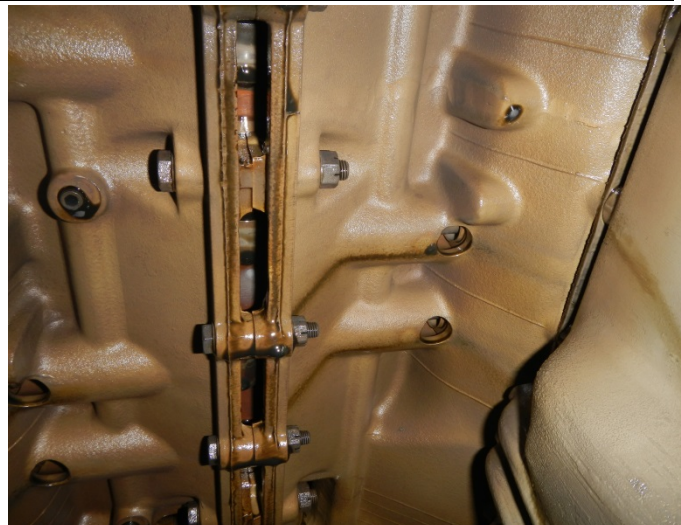
#### CRANKCASE

**Condition:** The crankcase remained intact and did not display any external signs of operational distress. Examination of the bottom crankcase halves through the fractured oil sump also revealed no pre-accident anomalies.

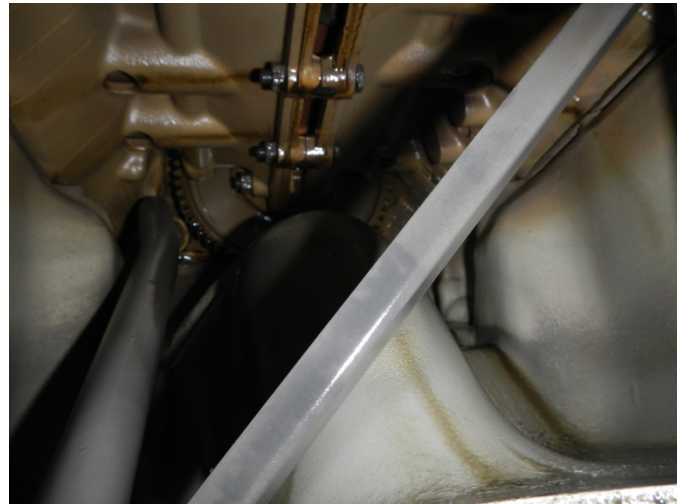
#### CAMSHAFT

Condition: Portions of the camshaft were observed through the fractured oil sump. No pre-accident anomalies were noted with the visual portions and camshaft continuity was confirmed during the compression test.

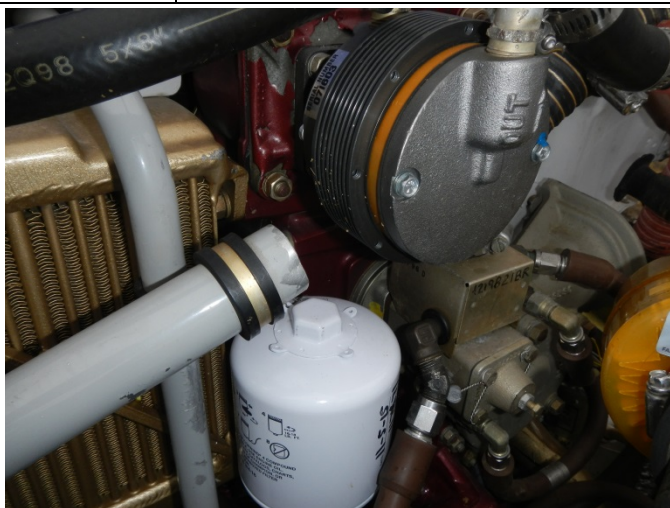
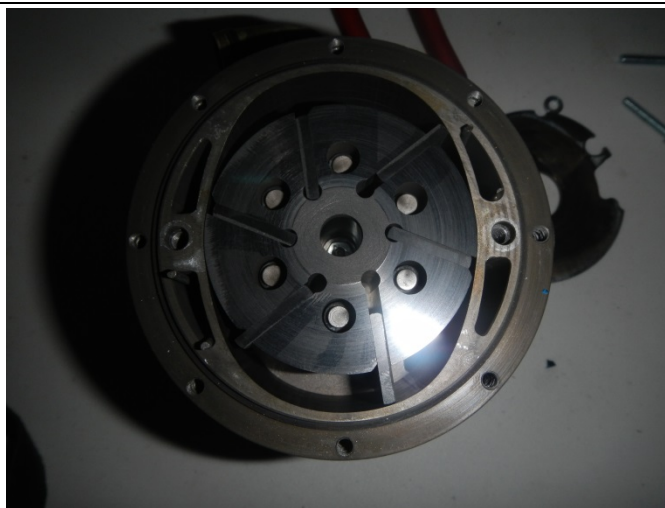
## VACUUM PUMP #1

**Condition:** The vacuum pump remained attached to the backside of the engine. The drive coupling remained intact. Disassembly of the vacuum pump revealed that the rotor and vanes were intact and there were no pre-accident anomalies noted.

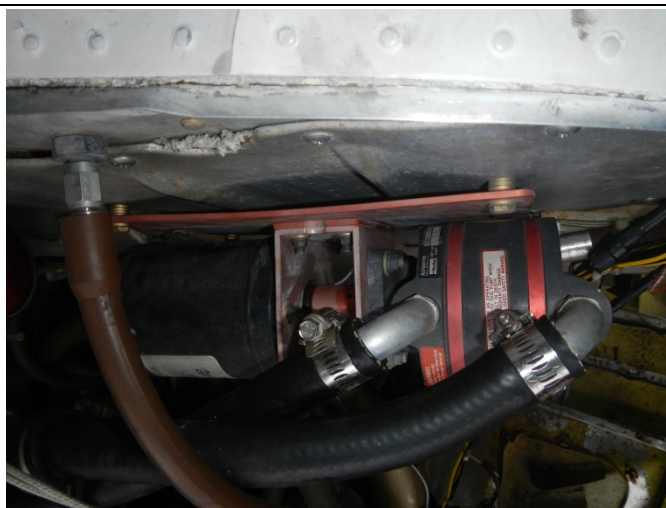
## VACUUM PUMP #2

**Condition:** The standby vacuum pump remained secured to its electrical motor and mount. When battery power was applied to the electric motor, the standby vacuum pump operated and resulted in a leveling of the vacuum-driven gyro instruments. No pre-accident anomalies were noted with the unit.
