## Component Examination Report

| Engine Model: | IO-520-BB12B | | | Engine S/N: | 578107 | | | | | |
| Aircraft Make/Model: | Beech A36 | | | Aircraft S/N: | E-681 | | Reg. #: | N4314S | | |

## ENGINE FIELD INSPECTION REPORT

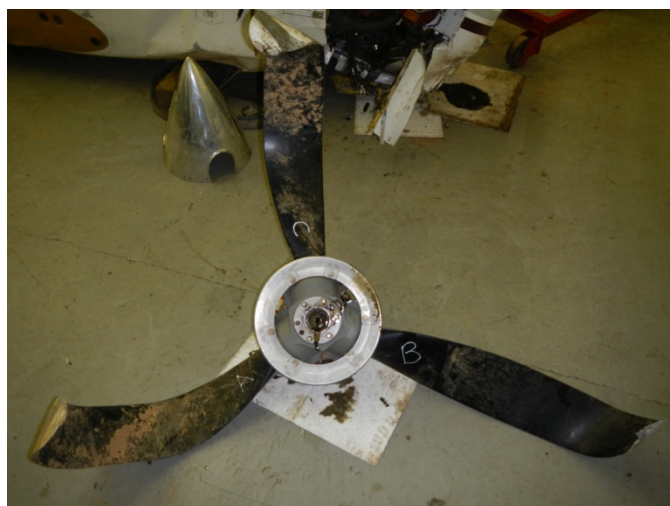
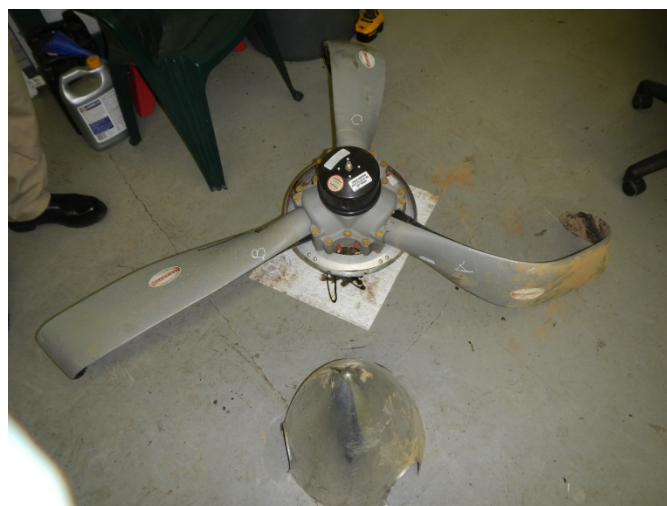
**PROPELLER**

The propeller hub remained secured to the crankshaft's propeller flange and all three blades remained attached to the hub. The blades were labelled A, B, and C for the purposes of the examination. The outboard sections of all three blades were curled toward low pitch and all displayed leading edge and chord-wise gouges near the tips. The blade that was labeled A was loose in the hub indicating that its pitch change link was fractured.
