ERA16LA111

N6449P / Cessna 152 S/N 15285015

Engine/Airframe Examination

Theodore Sandoval & James Lopez Jan. 27, 2017

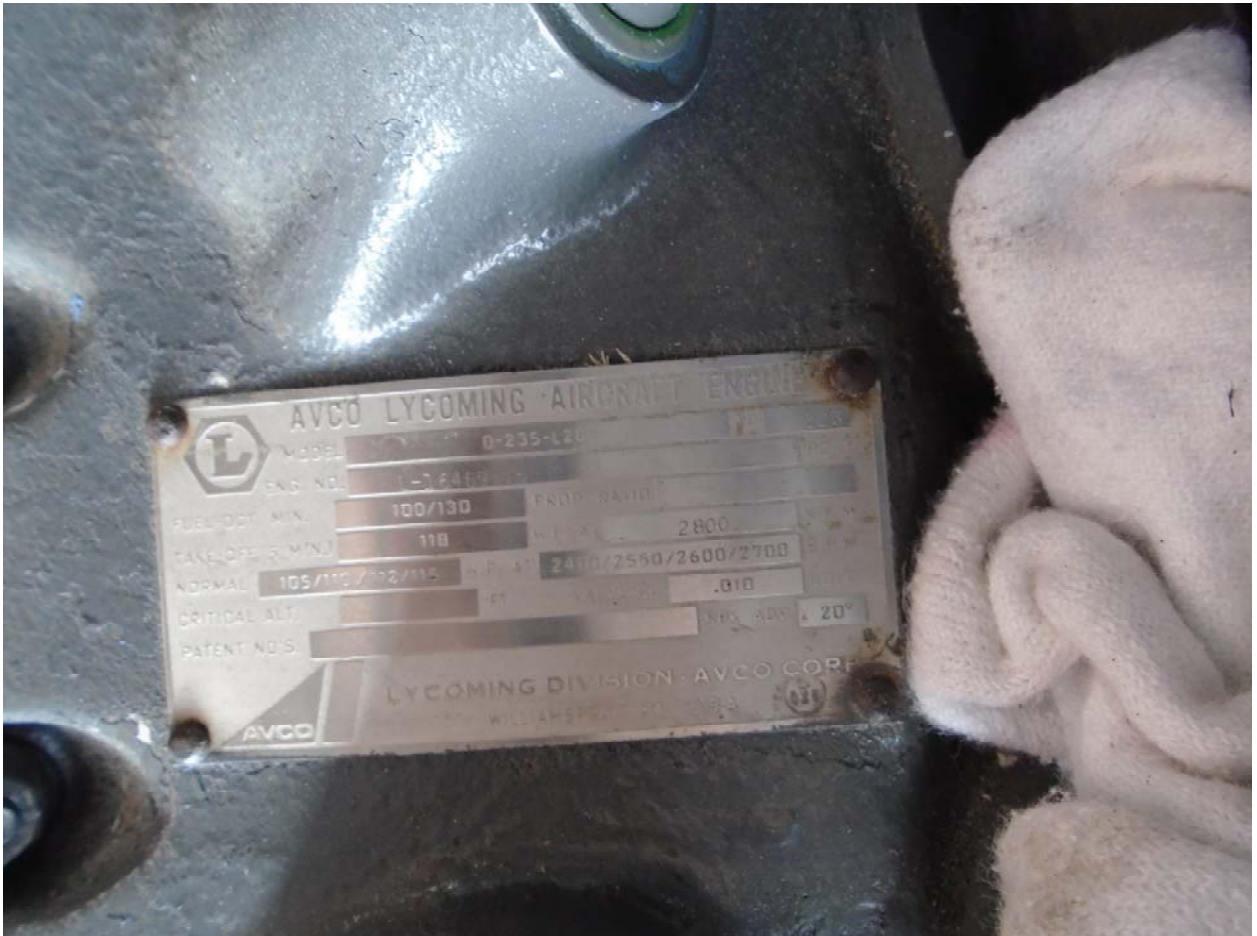
1. Photograph and document the engine data plate for valve clearance markings.

Engine Lycoming

Model O-235-L2C

Number L-16469-15

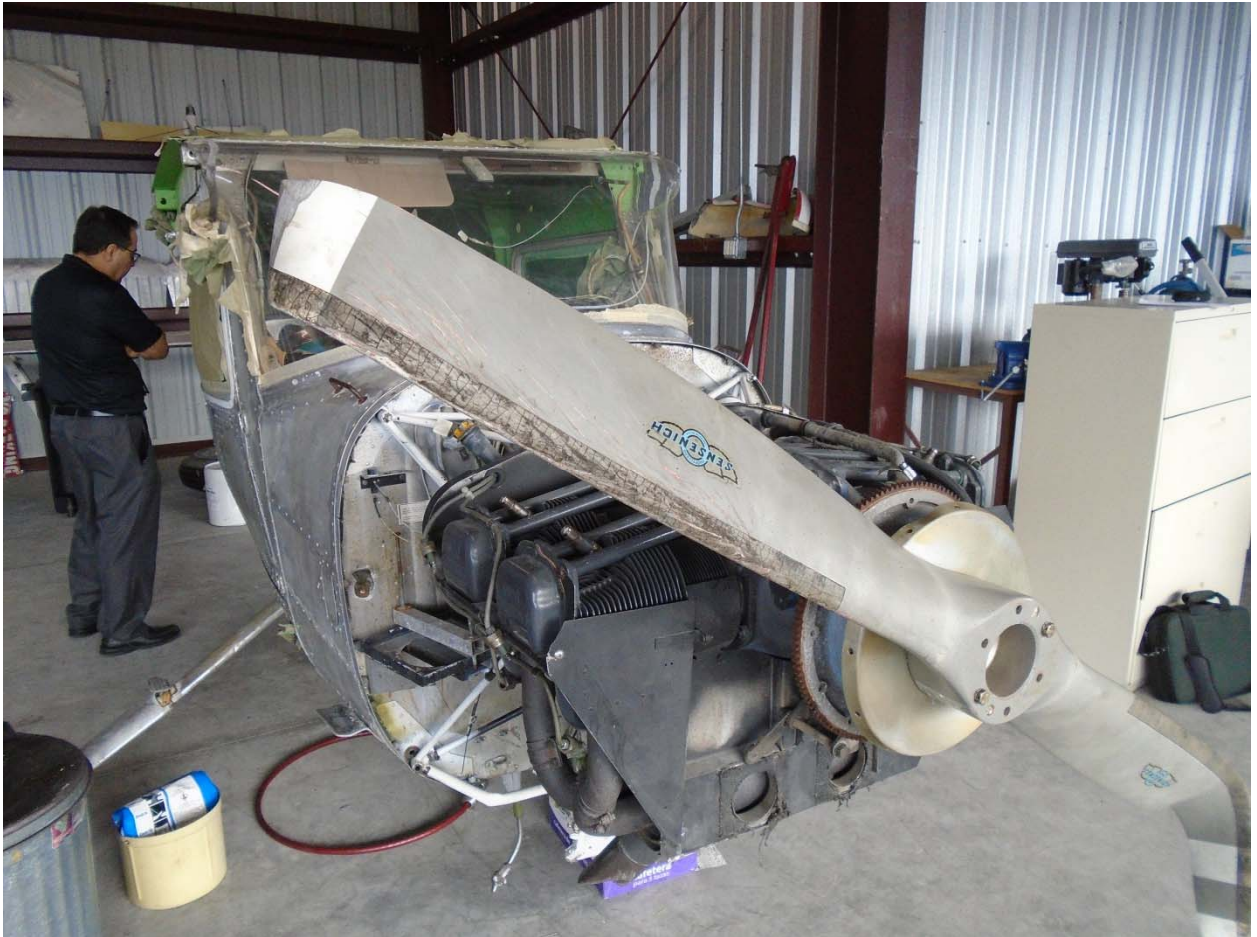
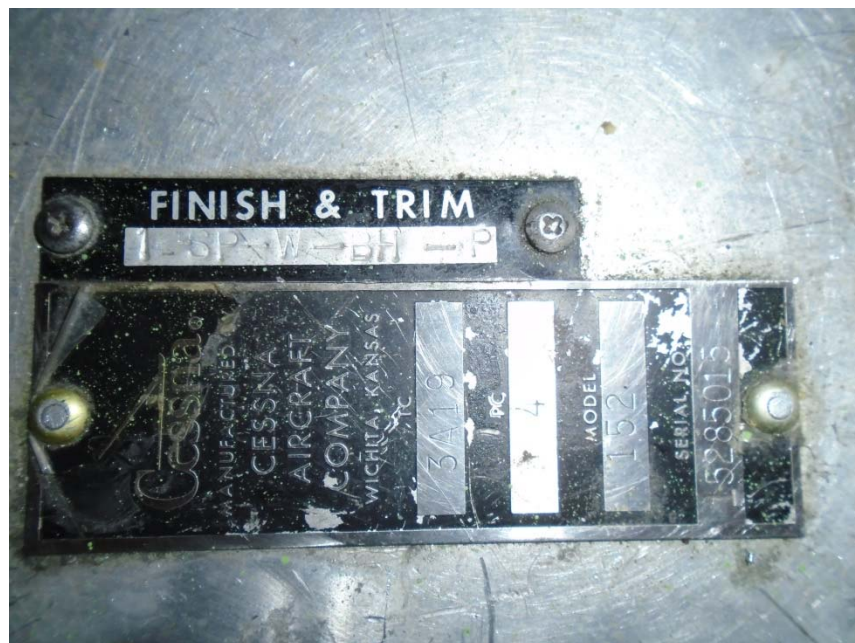
2. Photograph engine exterior, propeller (front, back, leading edges) and fuselage and wings.

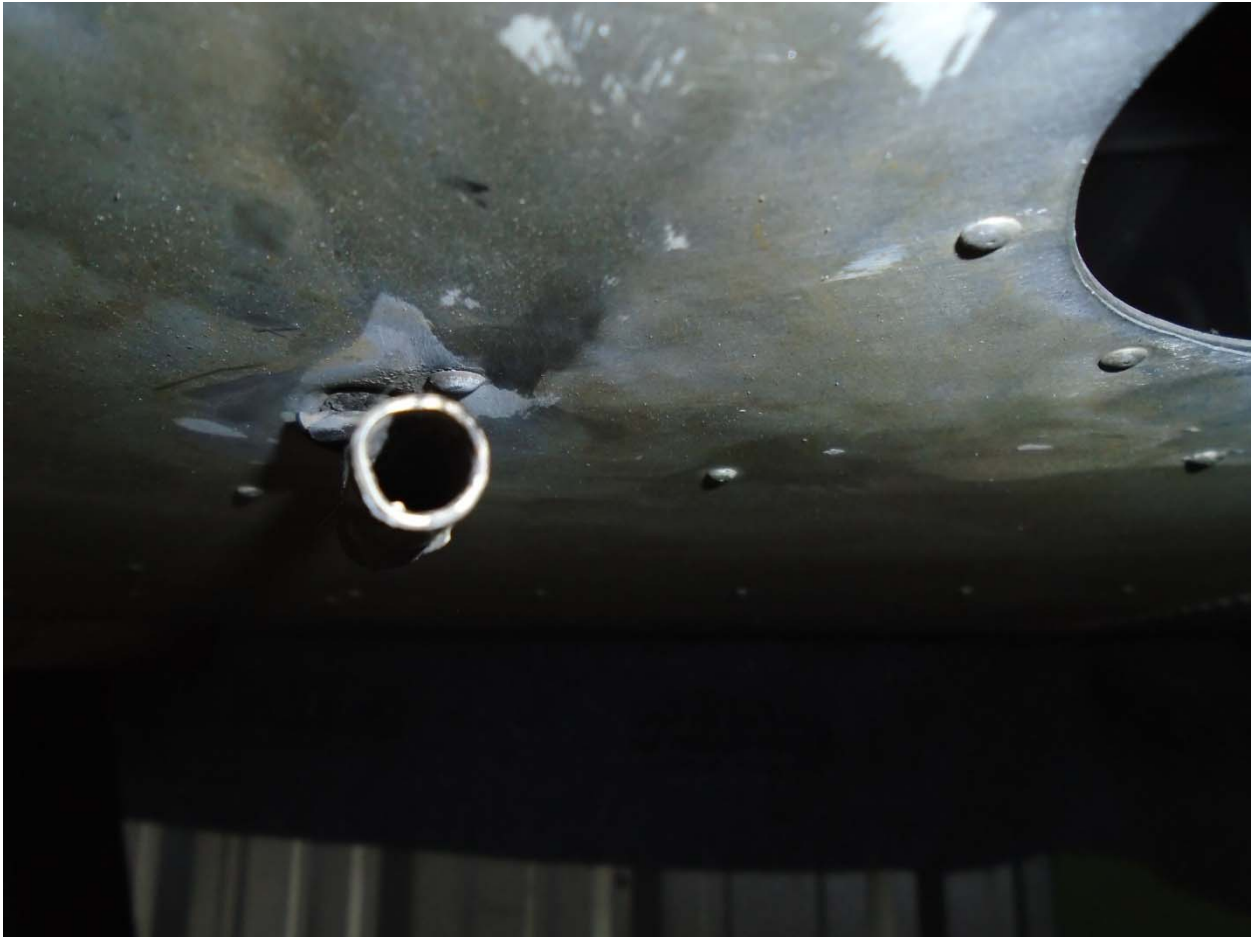
3. Photograph left fuel tank vent line exterior.

**No obstructions other than Mud Dauber could be detected, but aircraft has been partially disassembled.**

**Mechanic stated that the blockage was due to Mud Dauber. It is impossible to know if the Mud Dauber was in the vent line at the time of the incident, we suspect not. Aircraft sat for approx. a year since incident.**
