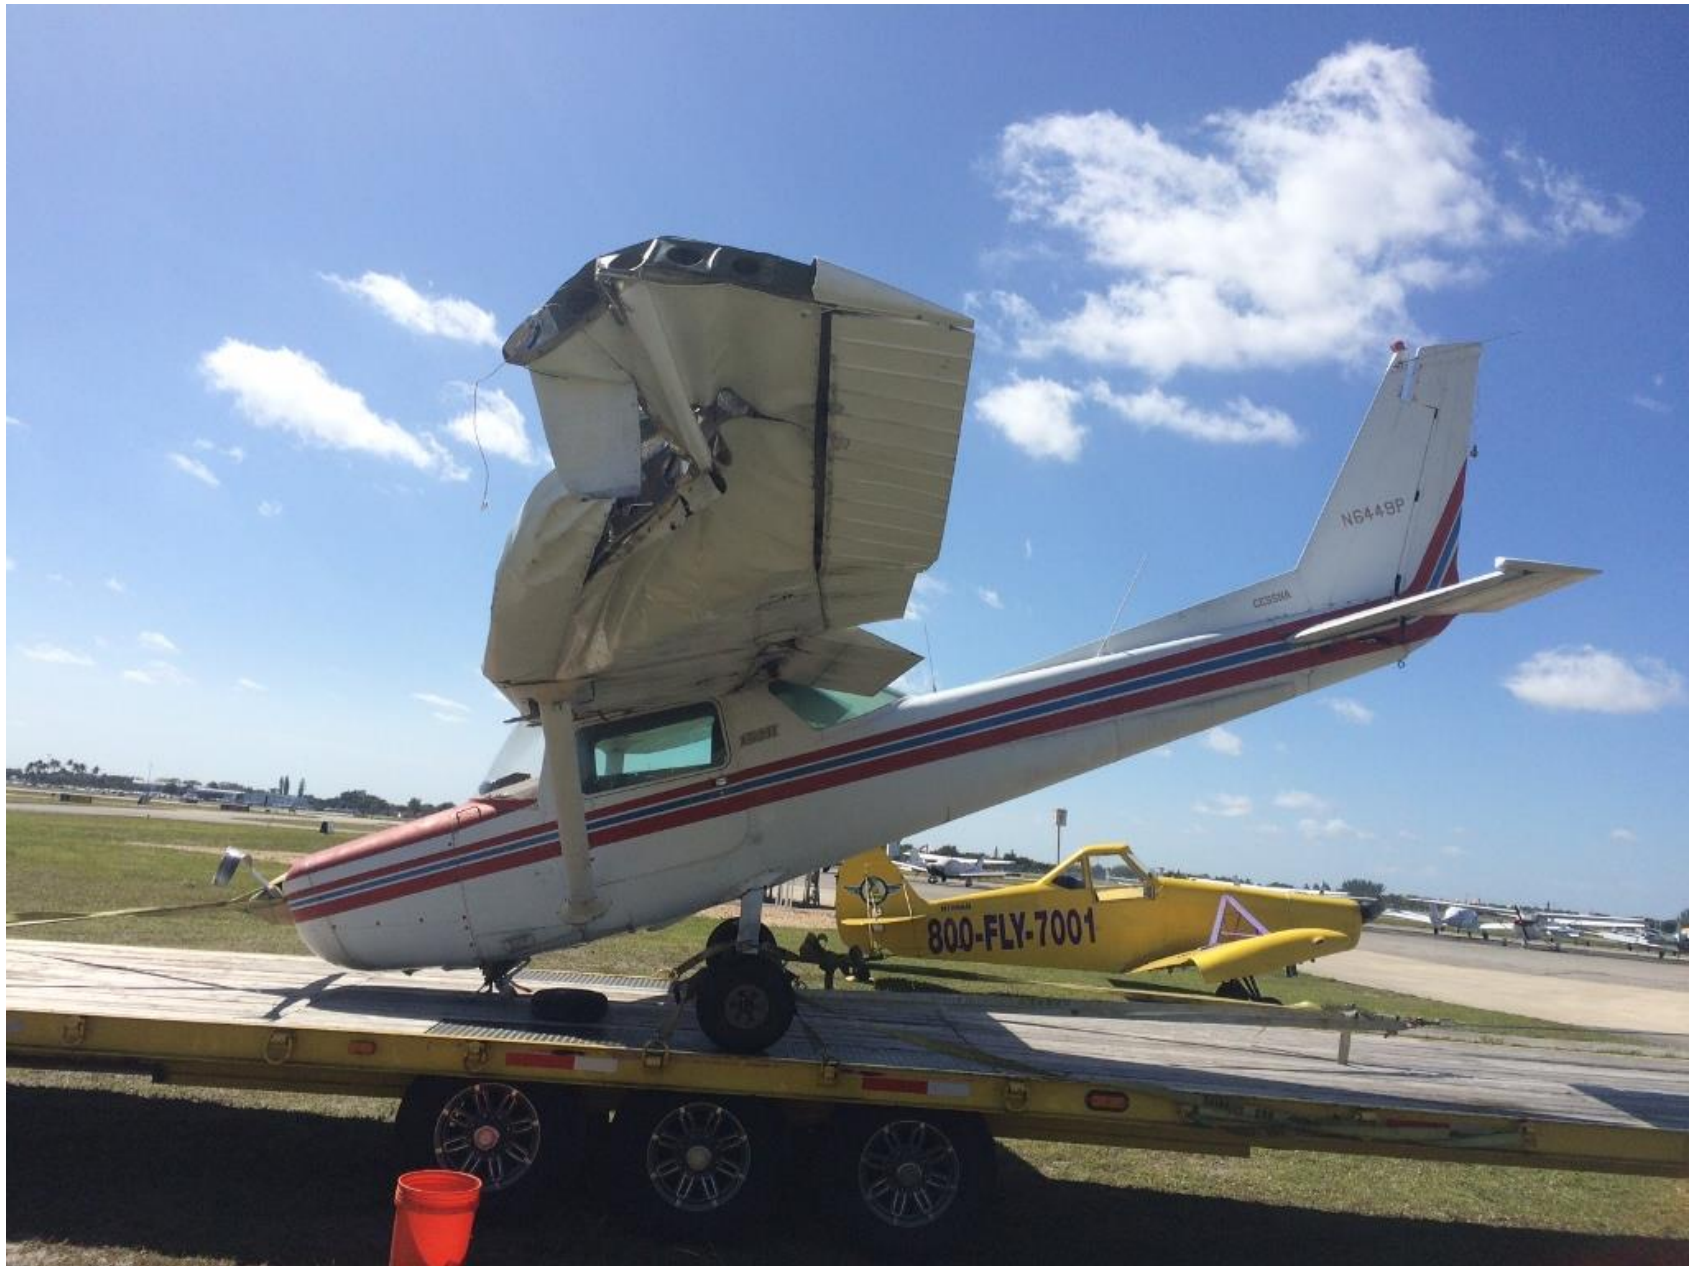
**Photo 1 – FAA Digital Photograph. View Following Recovery Depicting the Damage to the Left Wing and Separated Nose Landing Gear**

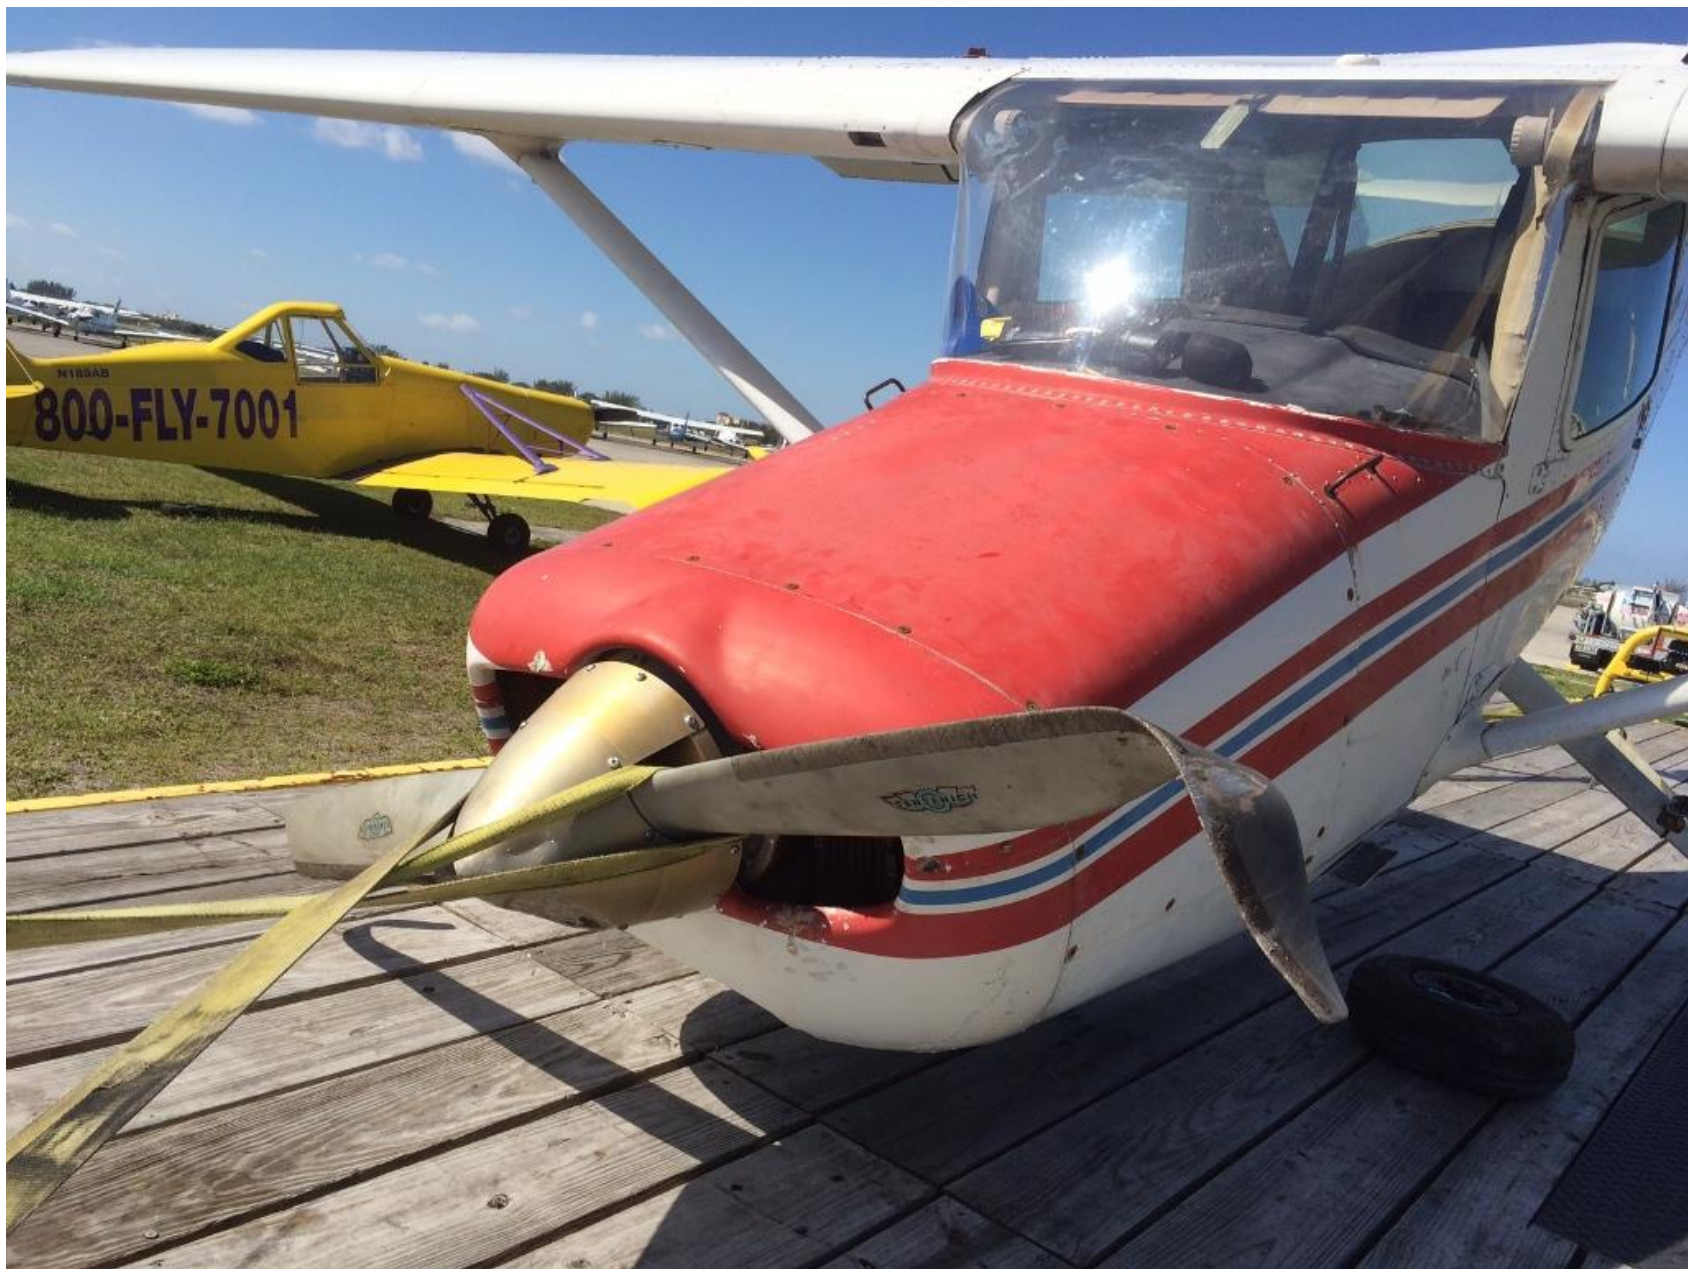
**Photo 2 - FAA Digital Photograph. View Following Recovery Depicting the Damage To One Propeller Blade.**

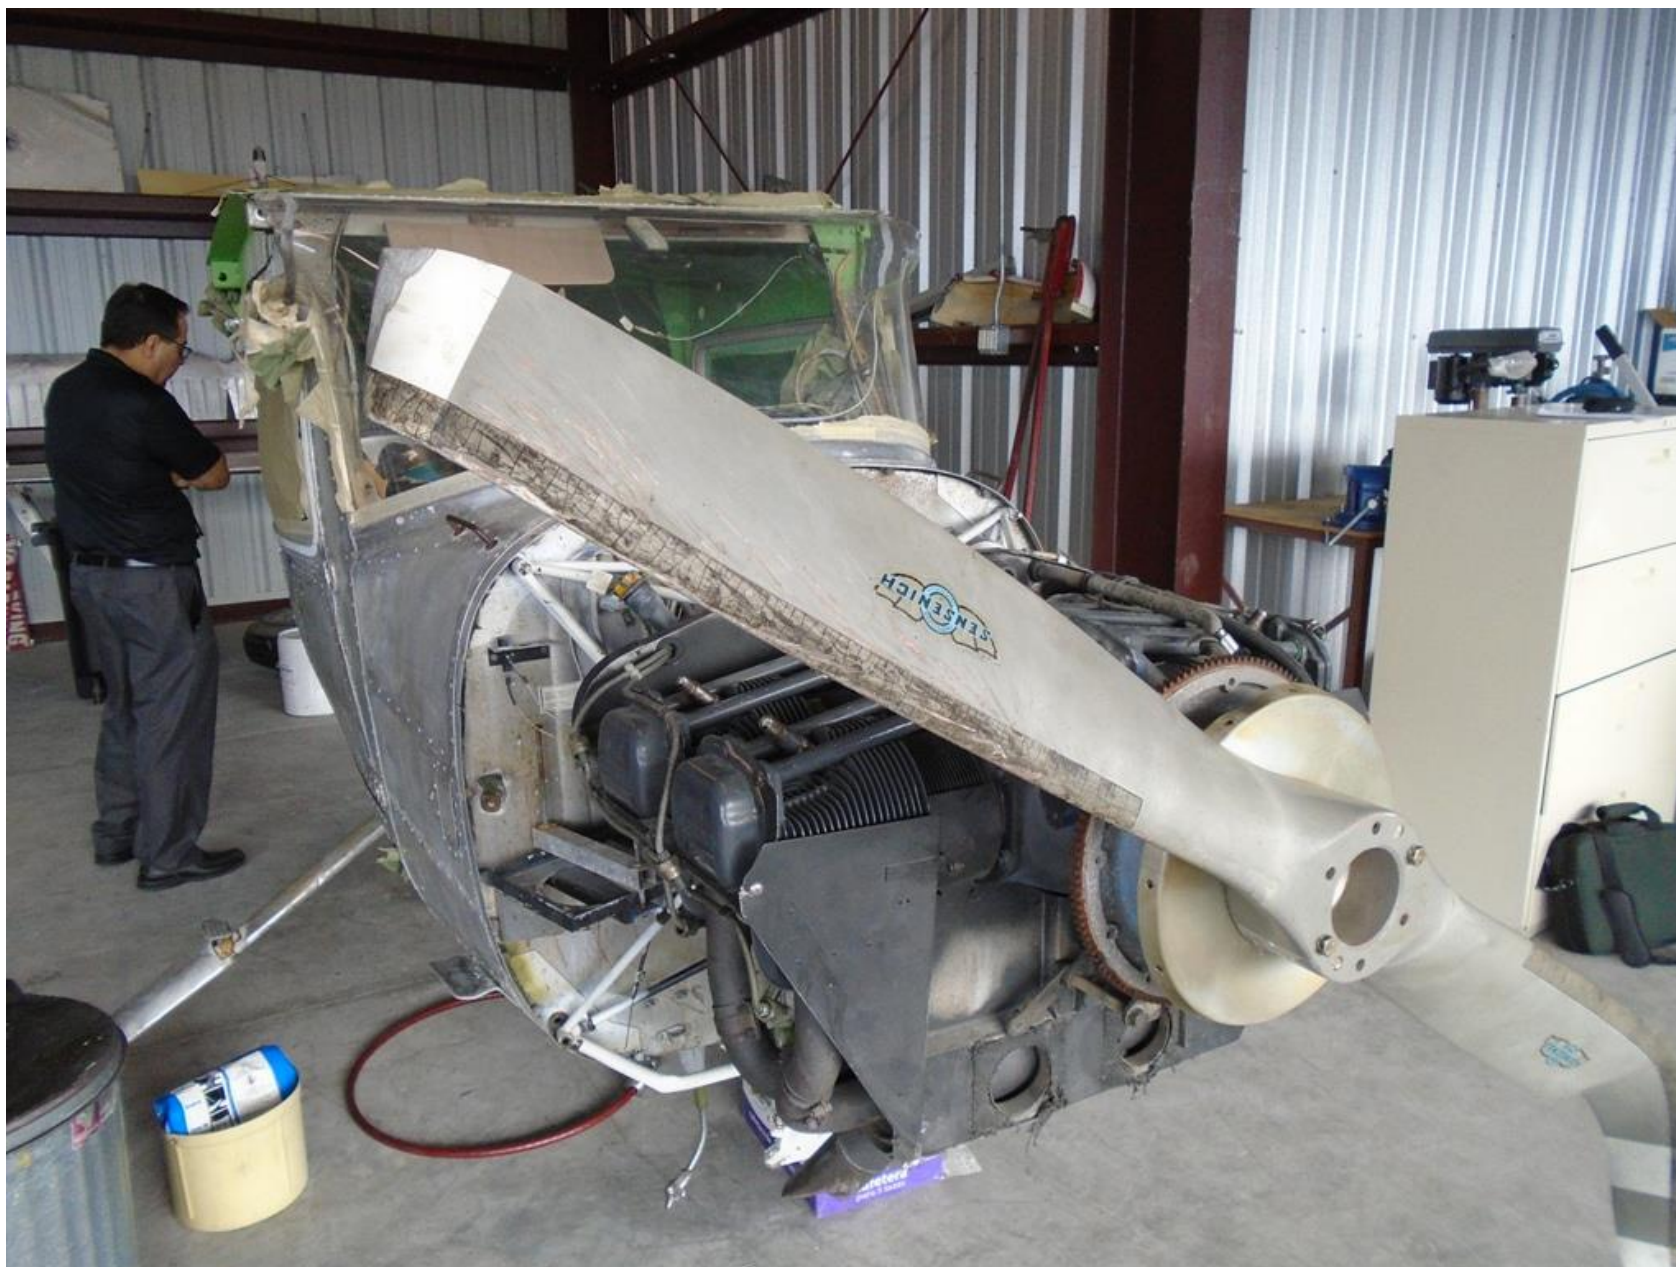
**Photo 3 - FAA Digital Photograph. View Following Recovery Depicting the Damage To Other Propeller Blade**
