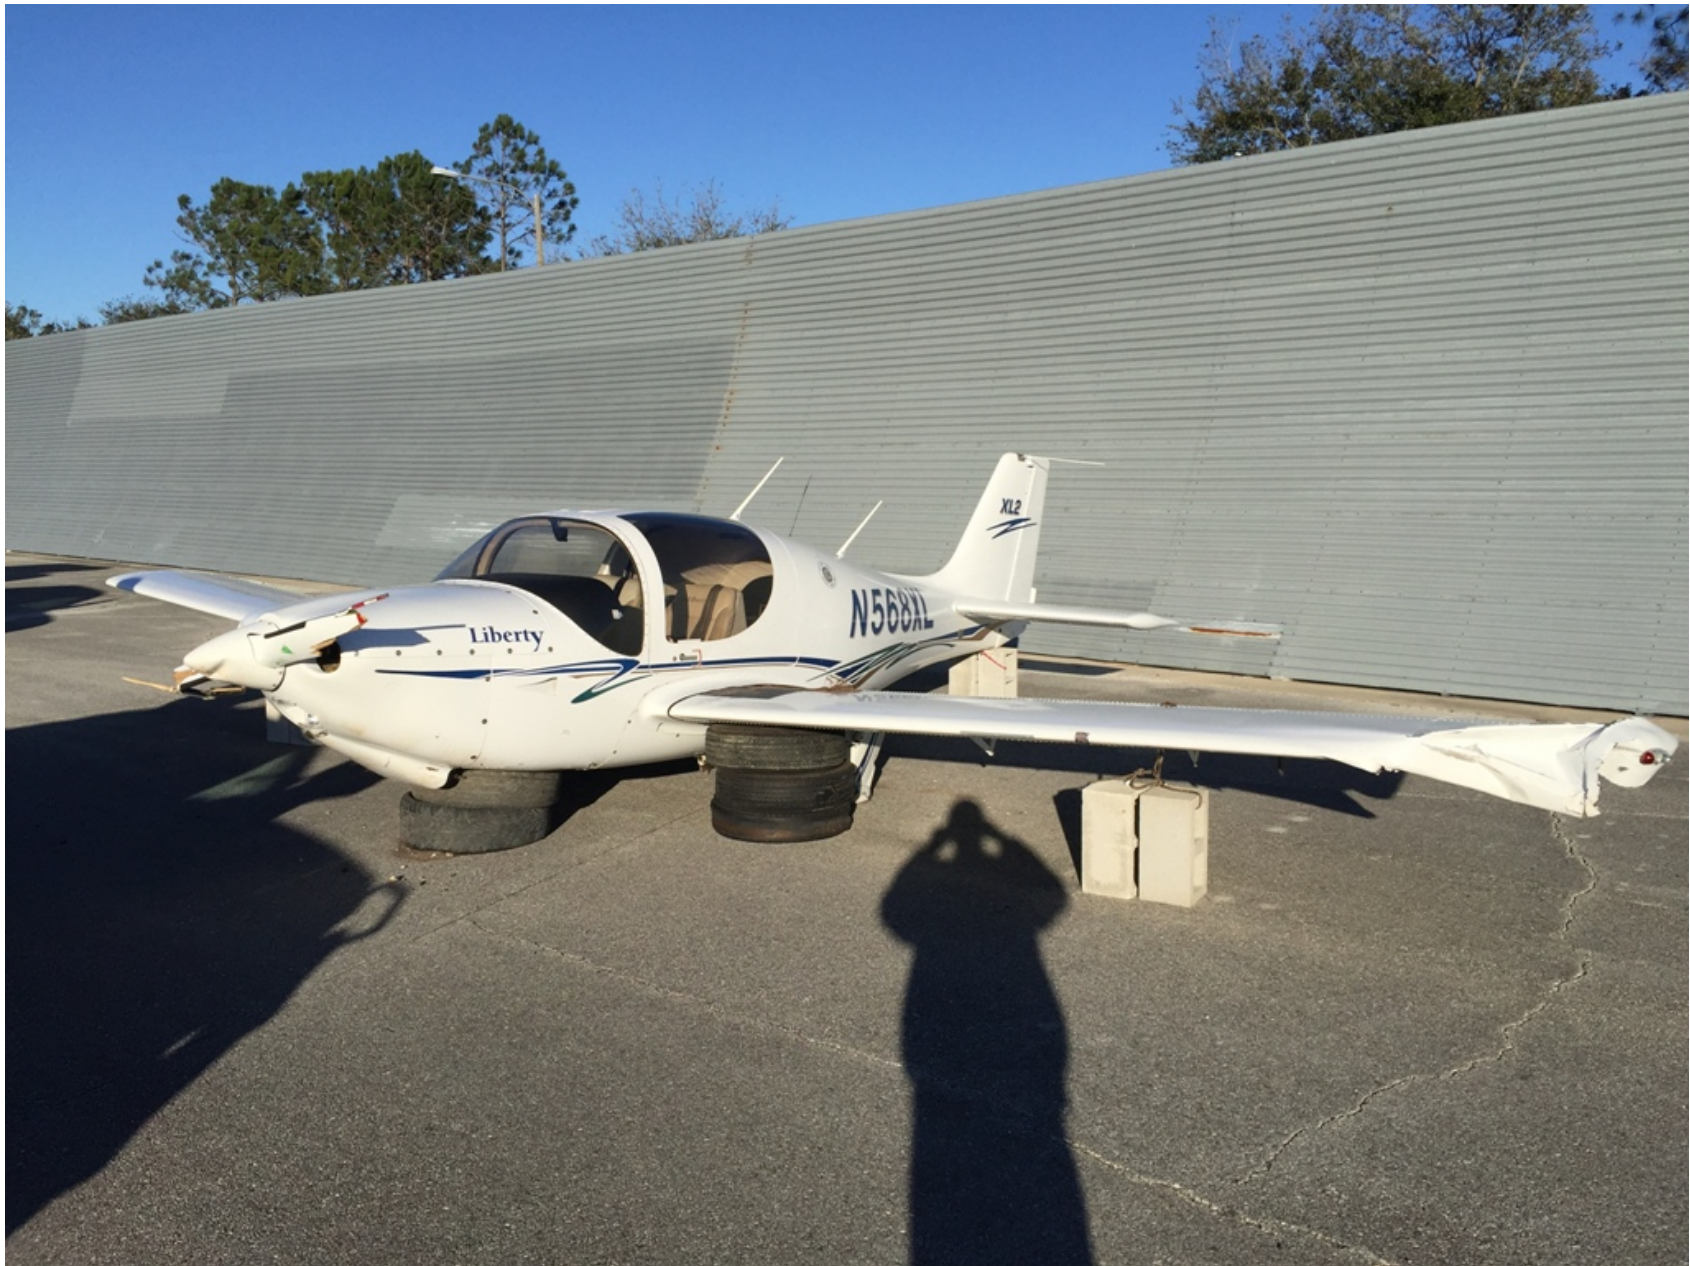
**Photo 1 – Photograph Provided by Recovery Company. Left Forward Quartering View of the Left Side of the Airplane**

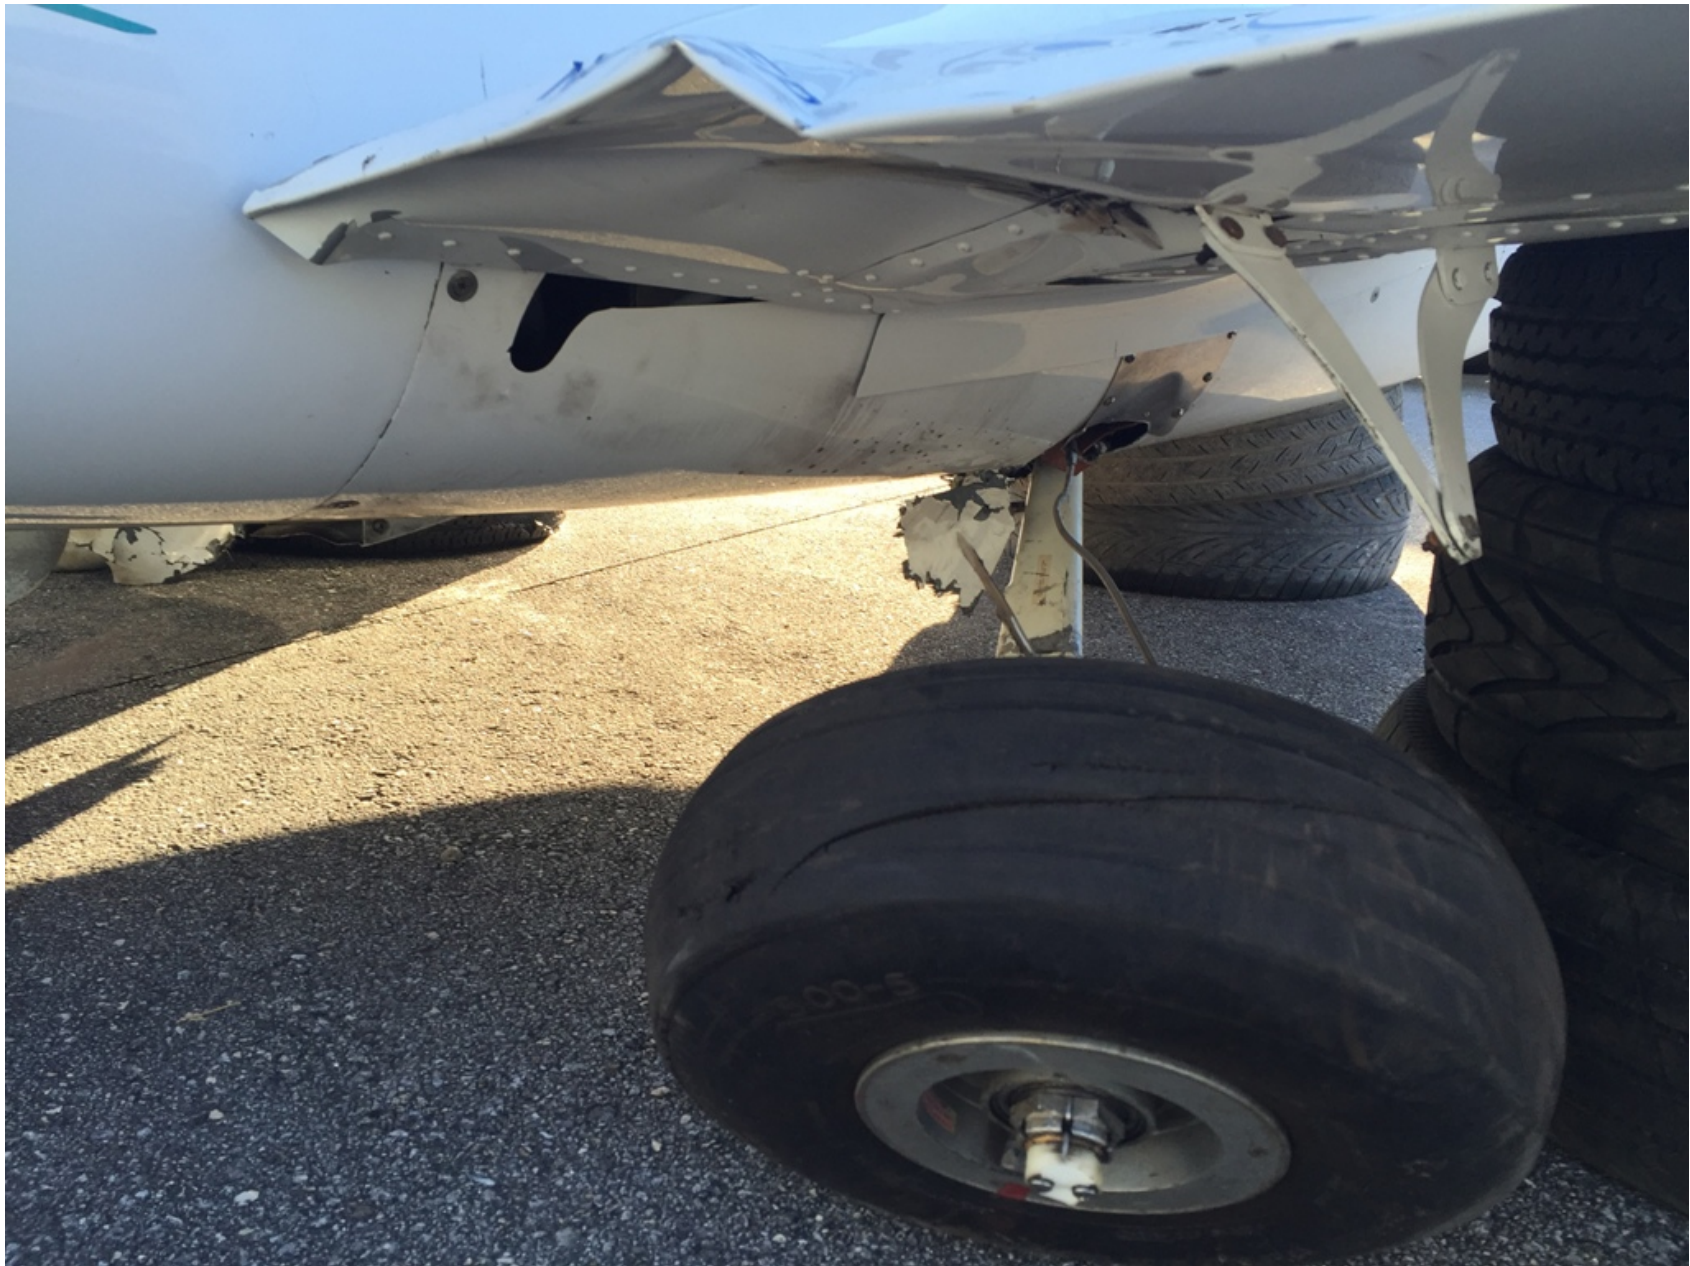
**Photo 2 - Photograph Provided by Recovery Company. View of the Right Main Landing Gear**

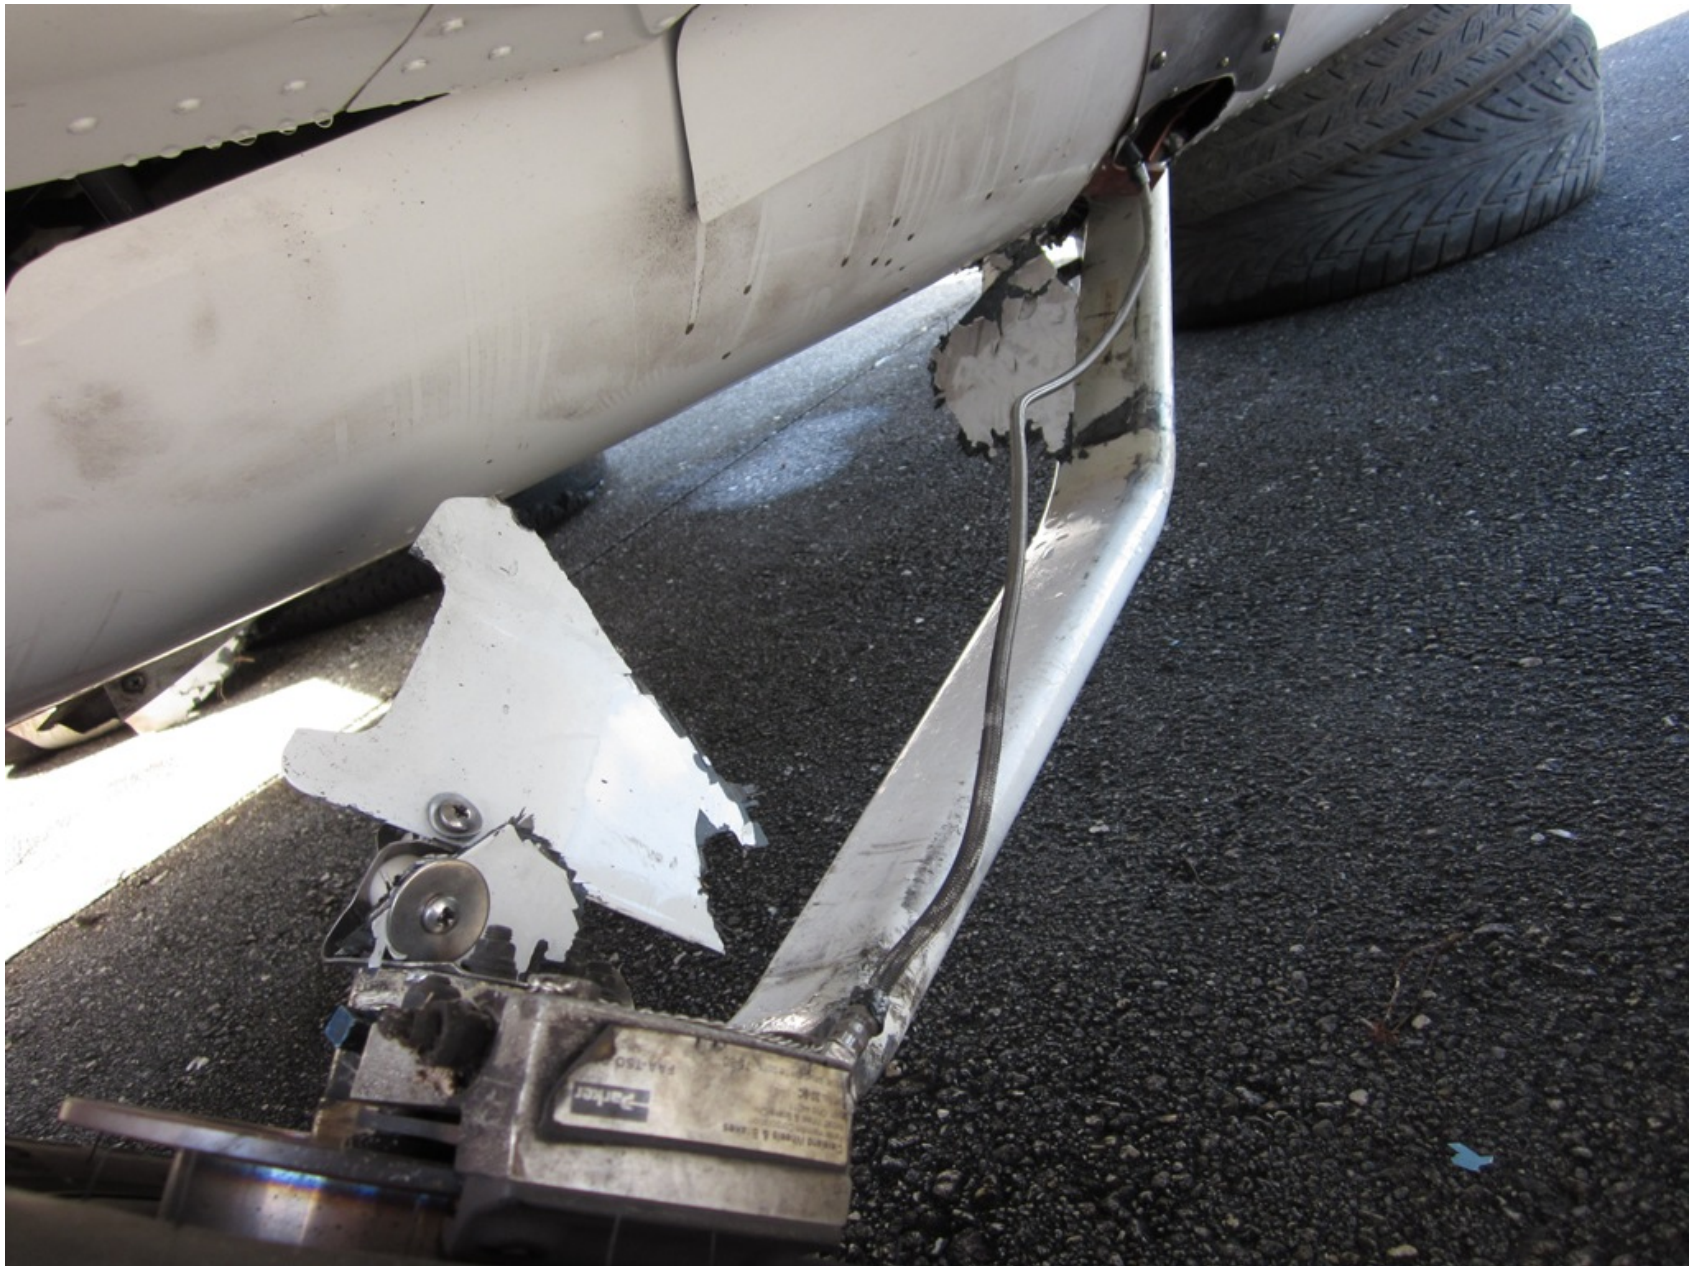
**Photo 3 – FAA Digital Photograph. View Depicting the Right Main Landing Gear, Right Brake, and Right Brake Line Before Being Disconnected by Recovery Crew**

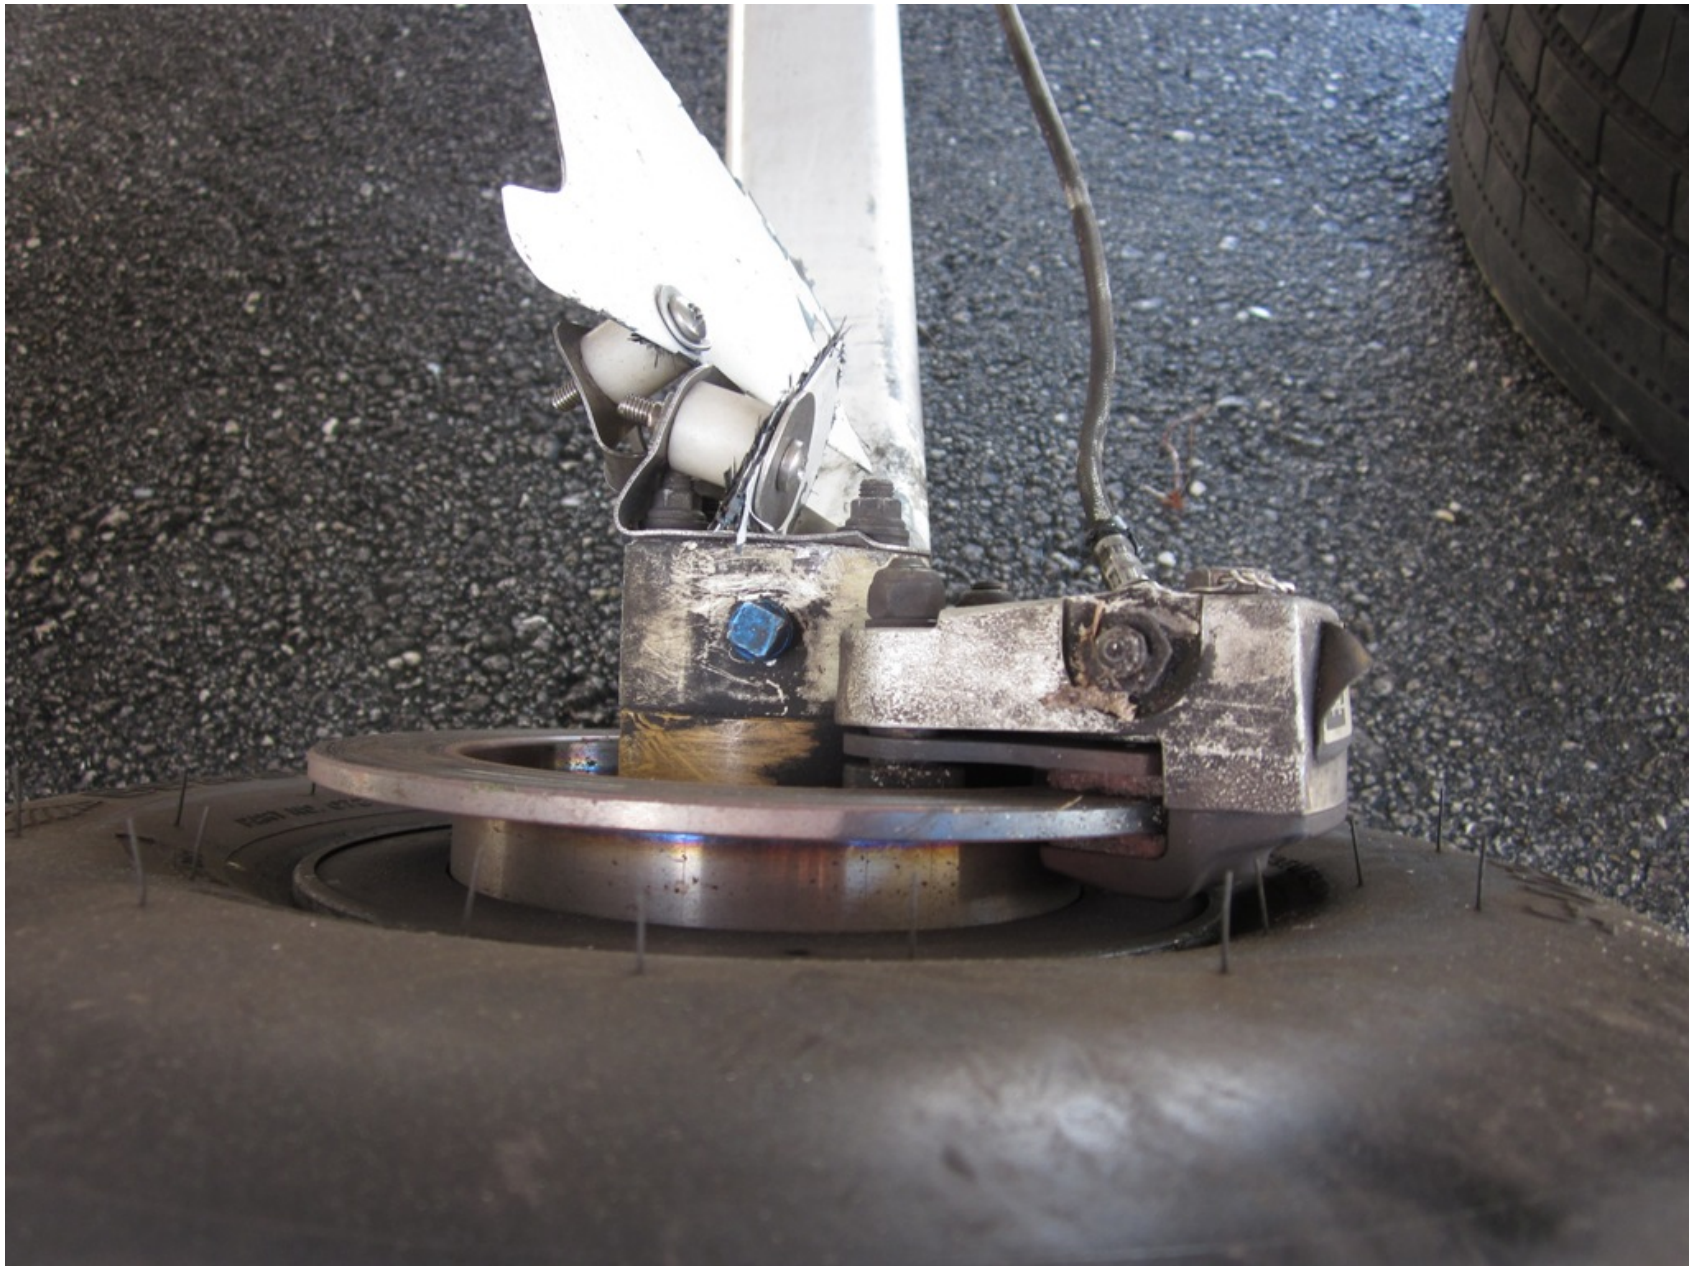
**Photo 4 - FAA Digital Photograph. View Depicting the Right Brake Caliper, Brake Disk, and Portion of Right Tire.  
Note the Blue Discoloration on portions of the Brake Disk**

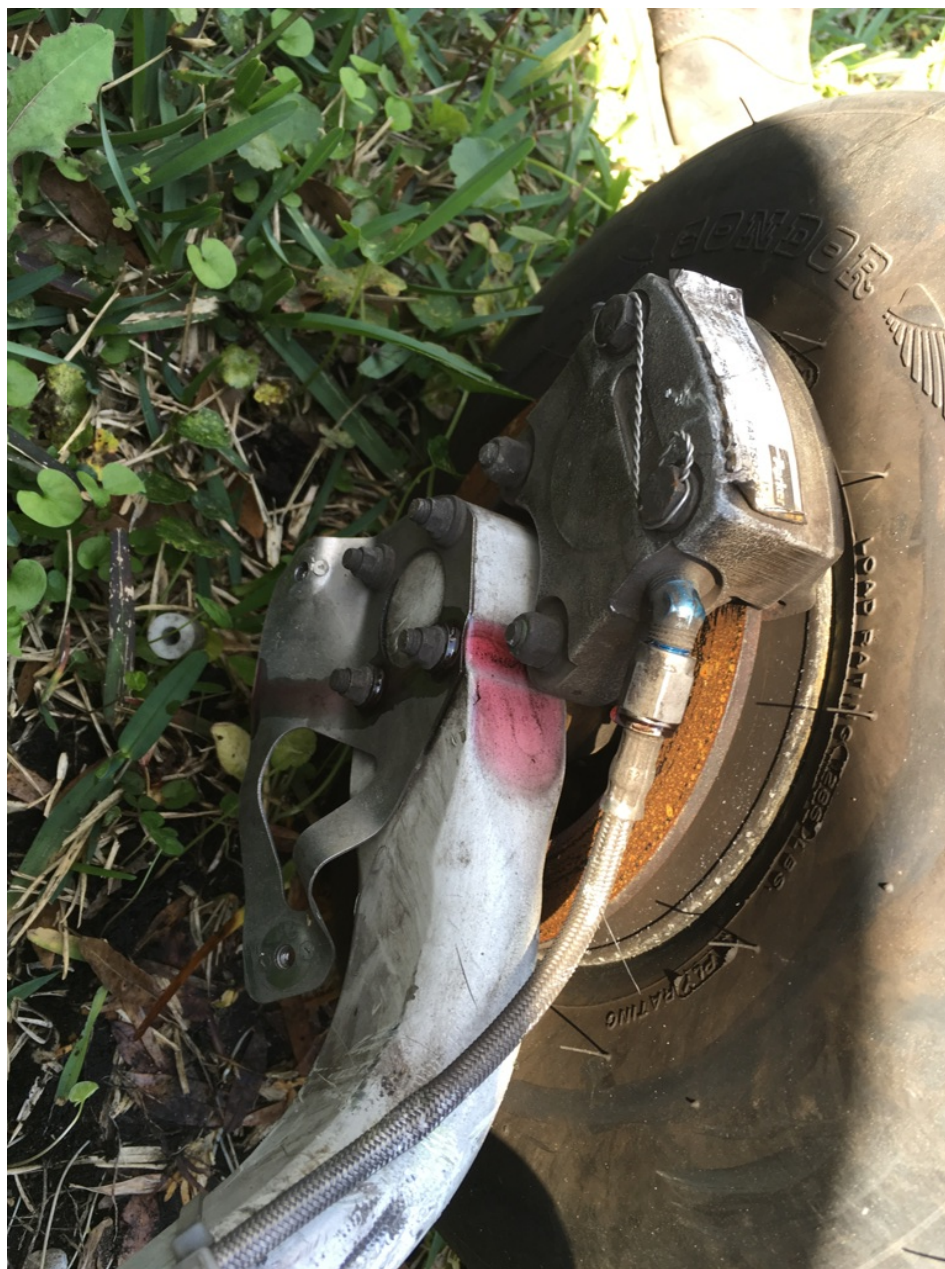
**Photo 5 - FAA Digital Photograph. View Depicting Fluid Draining from Loosened Line at Left Brake Caliper**
