## Attachment

## Photographs

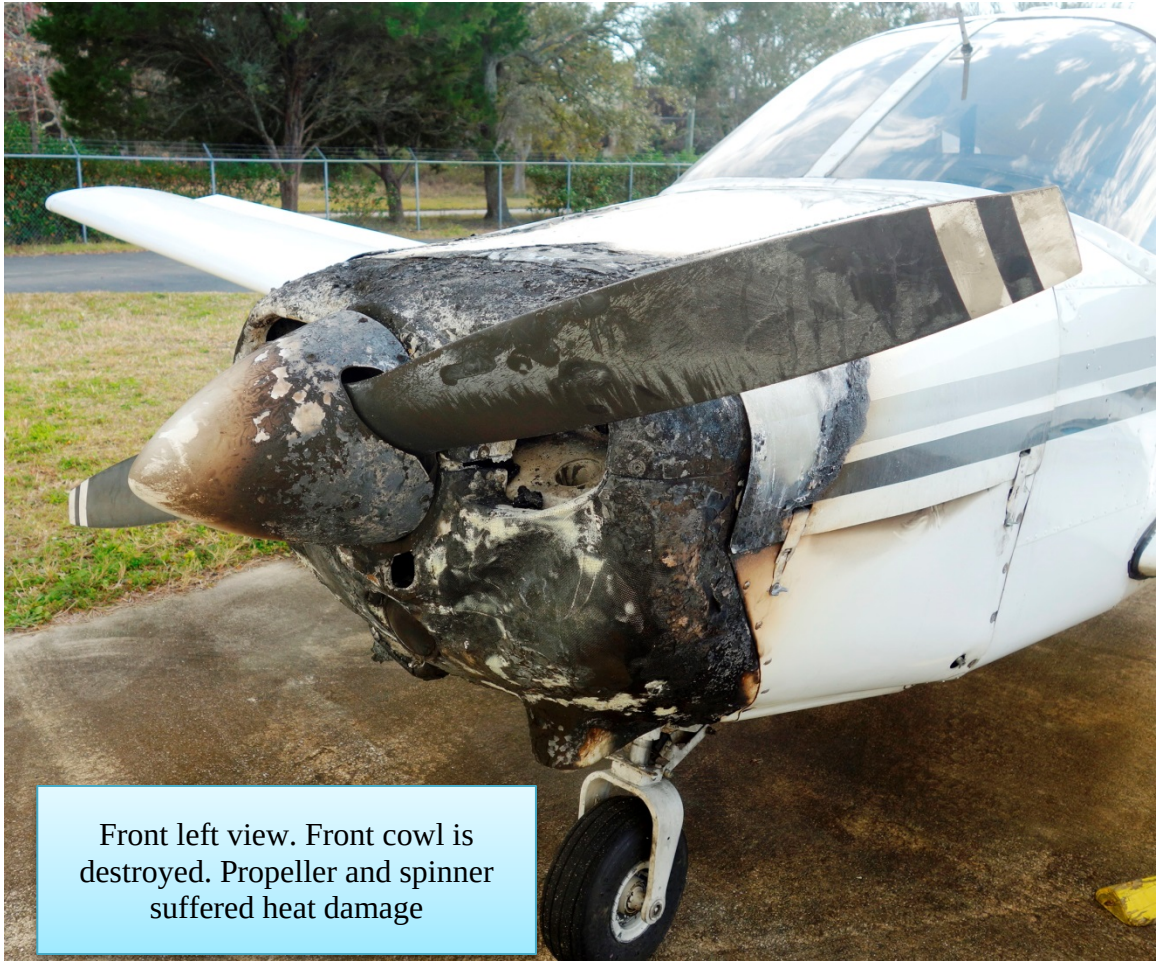
Front left view. Front cowl is destroyed. Propeller and spinner suffered heat damage

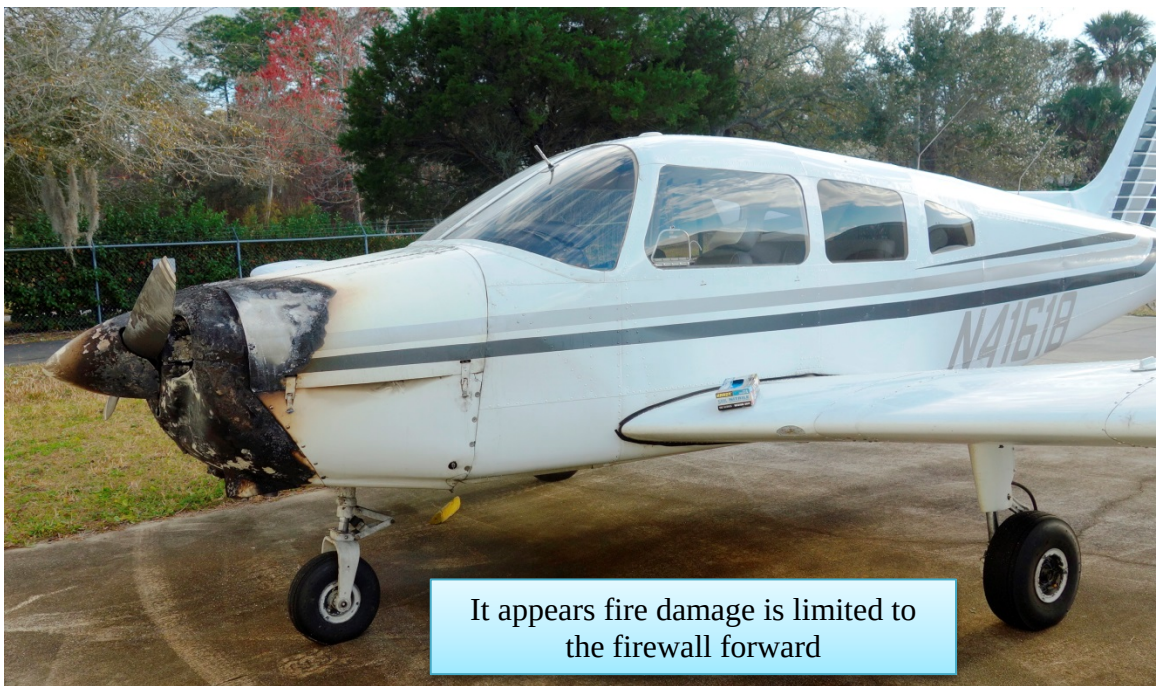
It appears fire damage is limited to the firewall forward

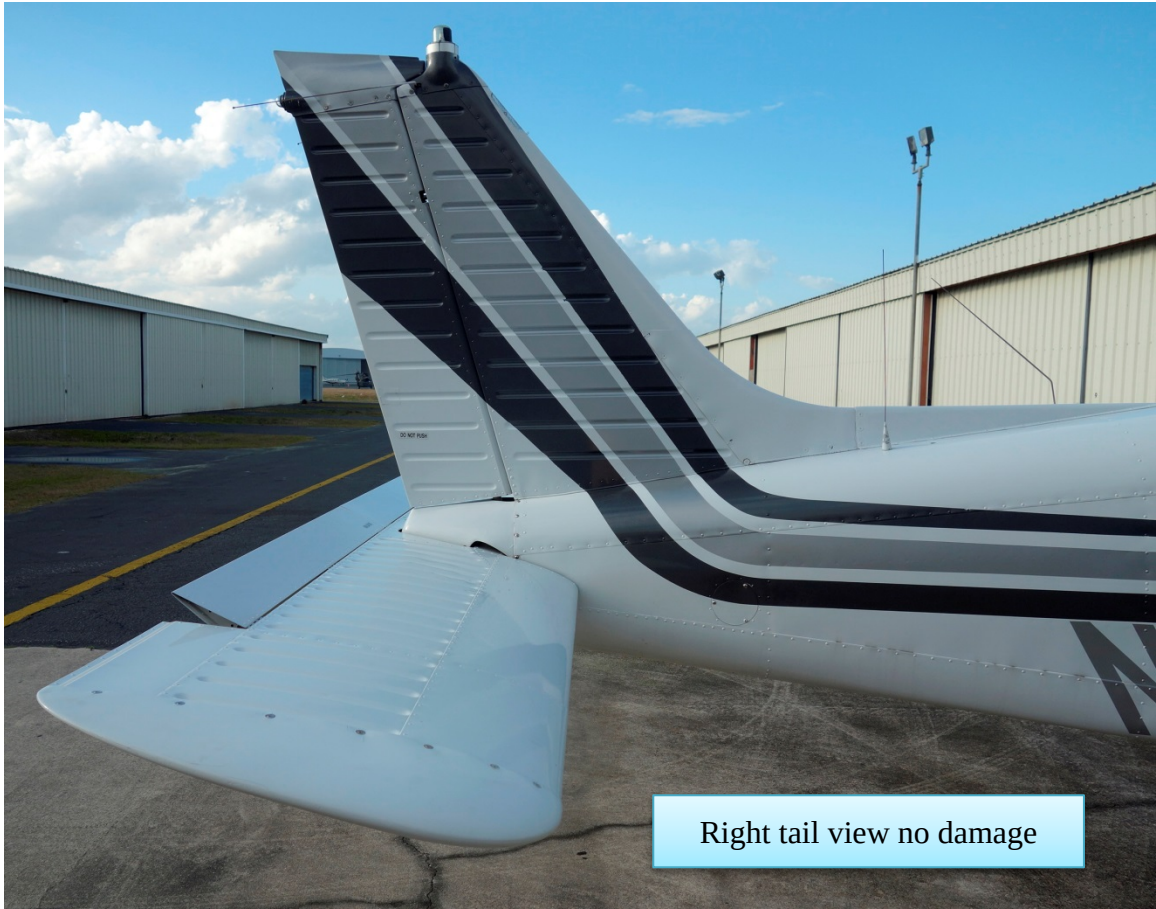
Right tail view no damage

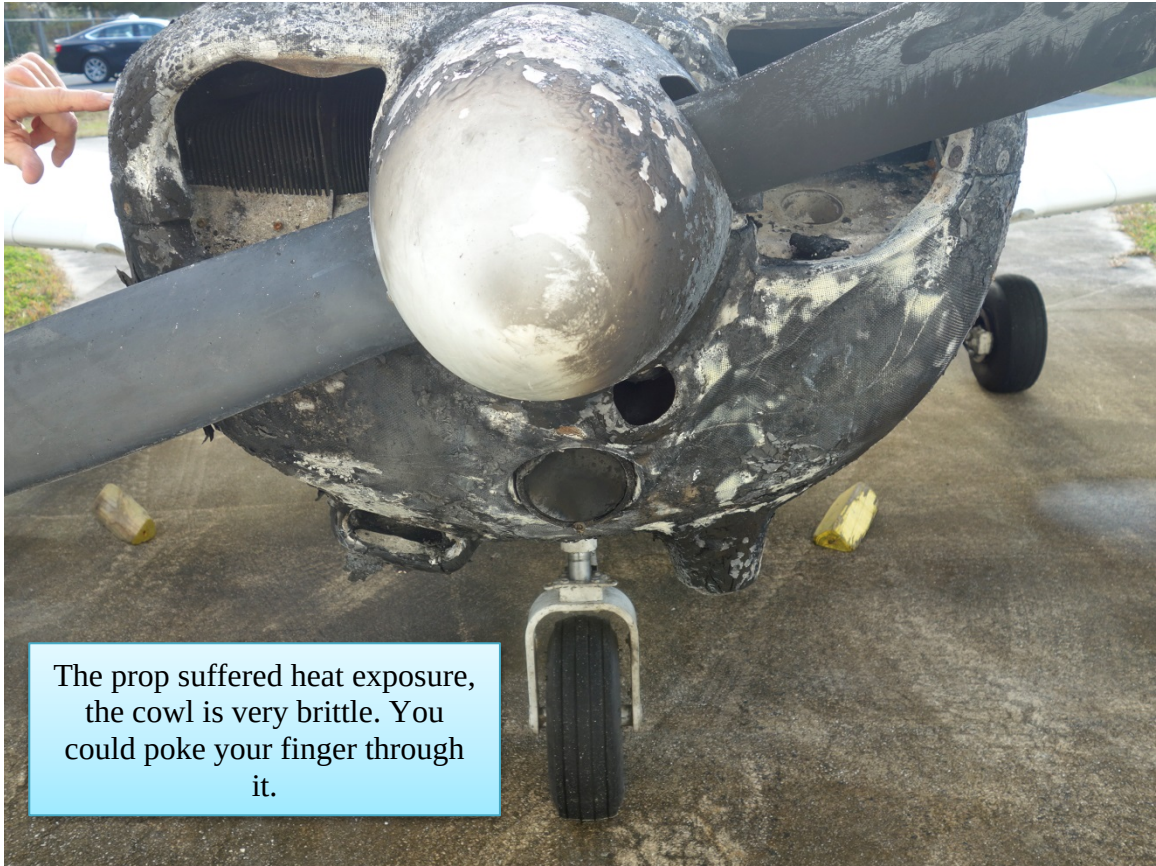
The prop suffered heat exposure, the cowl is very brittle. You could poke your finger through it.

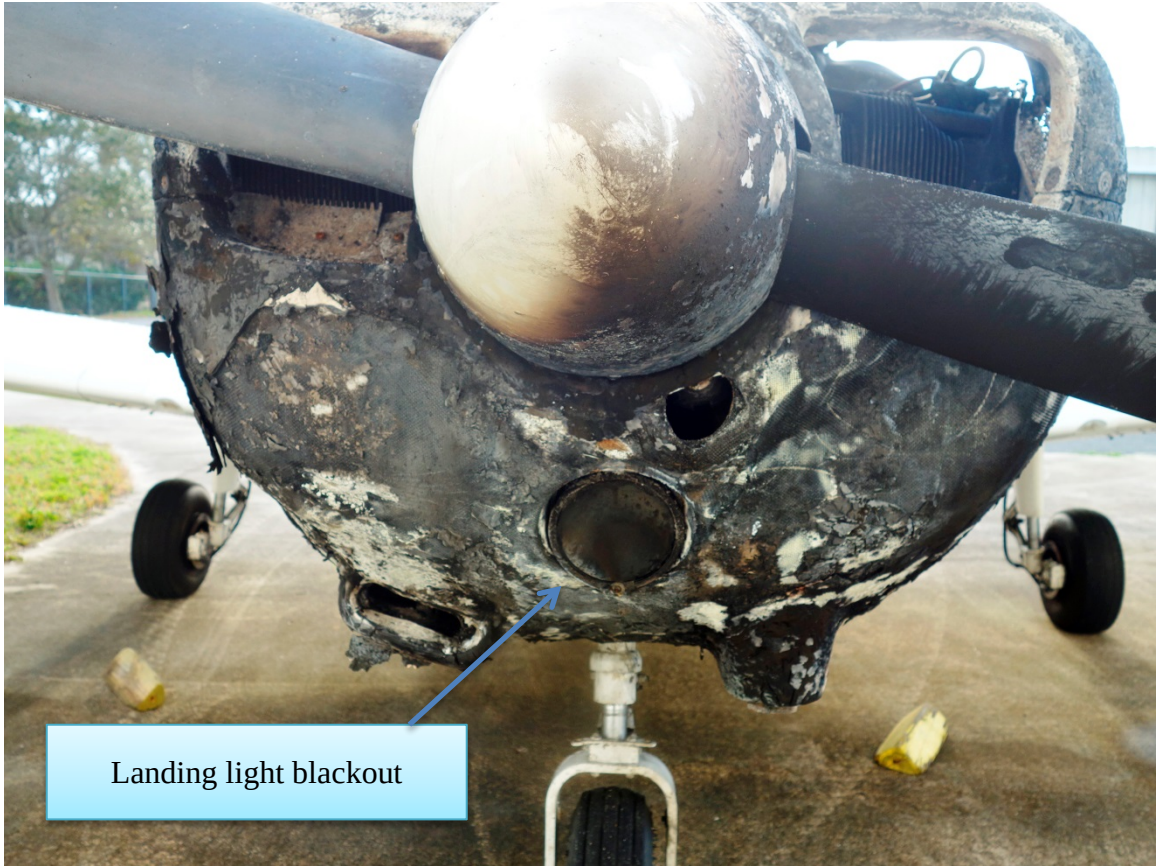
Landing light blackout

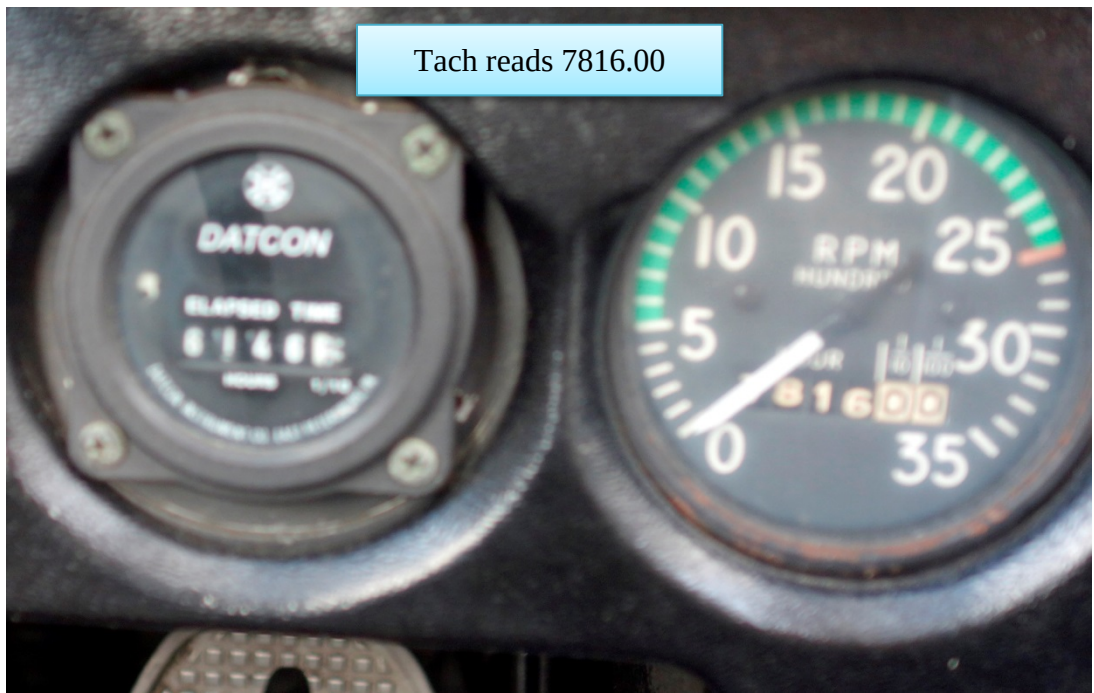
Tach reads 7816.00
