**NATIONAL TRANSPORTATION SAFETY BOARD**

**MIXTURE CONTROL CABLE EXAMINATION FIELD NOTES**

**Location:** Hurley, Mississippi  
**Date:** April 2, 2016  
**Time:** 1707 central daylight time  
**Aircraft:** Cessna 175B

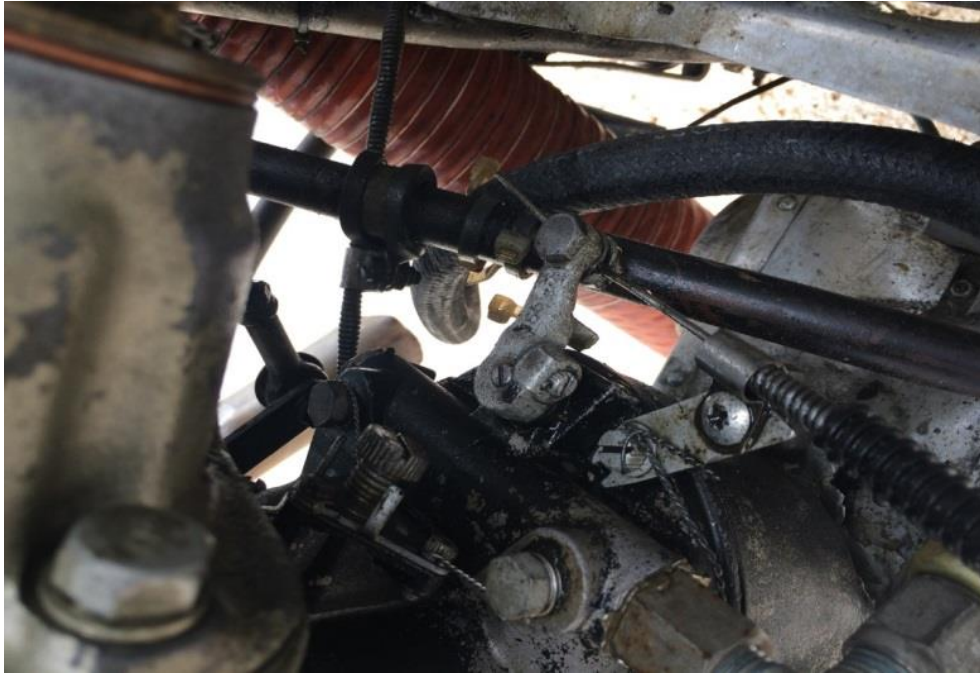
baffle and the mixture control lever at the carburetor. Additionally, the mixture control cable and plastic sheath were loose within a clamp near the carburetor, and no rubber grommets within the clamp was noted. The mixture lever in the cockpit was moved from full lean to full rich, but the mixture control lever at the carburetor only moved a fraction of an inch and flexing of the mixture control cable was noted. The oil level and overall condition of the engine was checked and it was determined that a field test run could be performed, although damage to the engine mount and propeller precluded full static run-up or prolonged engine run.

Figure 1: View of mixture cable, clamp, and sheathing as first viewed

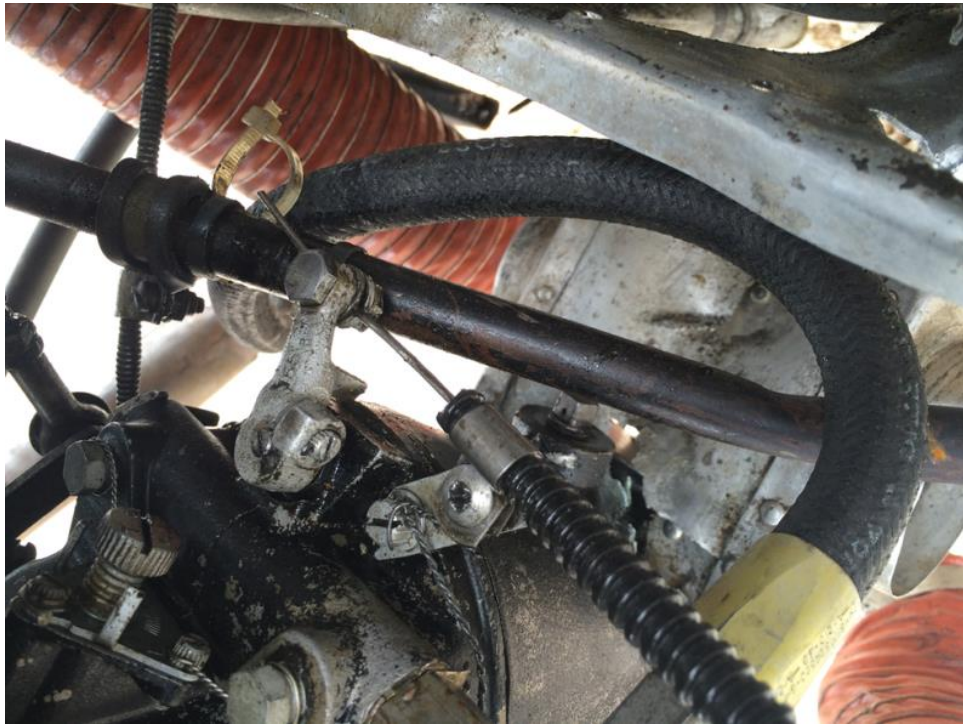
Fuel drained from the wings was supplied directly to the fuel line at the left wing root for an attempted engine run. The mixture control was placed in the full rich position in the cockpit and the engine was then started. With the engine operating, the mixture control in the cockpit was moved toward the lean position, but the engine began to quit. The mixture control in the cockpit was then pushed to full rich but it had no affect and the engine quit.

Figure 2: Mixture control sheathing installed in clamp for 1<sup>st</sup> engine run

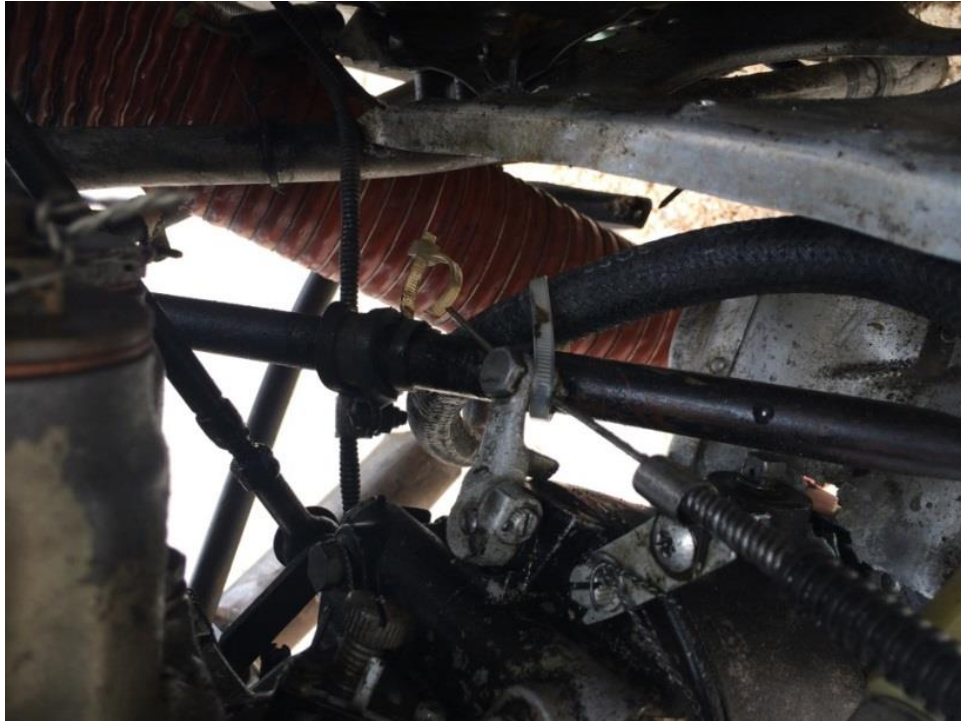
In advance of a third test run, the mixture lever at the carburetor was fixed in the full-rich position. The engine started uneventfully and was allowed to idle. The power was increased to 1,800 rpm and a magneto check was conducted. Both magnetos dropped approximately 50 rpm during the checks, and the engine oil pressure was noted in the green arc. Engine operation at a higher rpm was not performed due to safety concerns. Additionally, the engine was not allowed to operate to obtain normal operating temperatures. No anomalies were noted with the engine during the engine run with the mixture control fixed in the full-rich position.

Figure 3: Mixture control fixed in full-rich for 3rd engine run

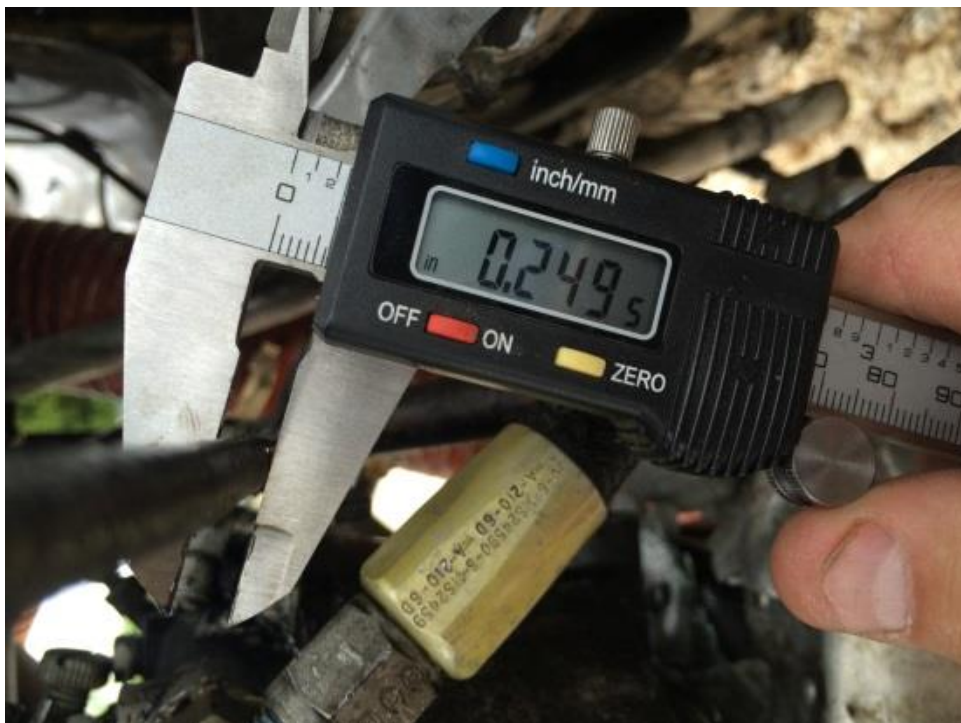
Figure 4: Measurement of plastic sheathing
