# NATIONAL TRANSPORTATION SAFETY BOARD

## MATERIALS LABORATORY FACTUAL REPORT

Report No. 16-058

Place : Bayport, New York  
Date : April 10, 2016  
Vehicle : Piper PA-28-180, N95118  
NTSB No. : ERA16LA152  
Investigator : Leah Read

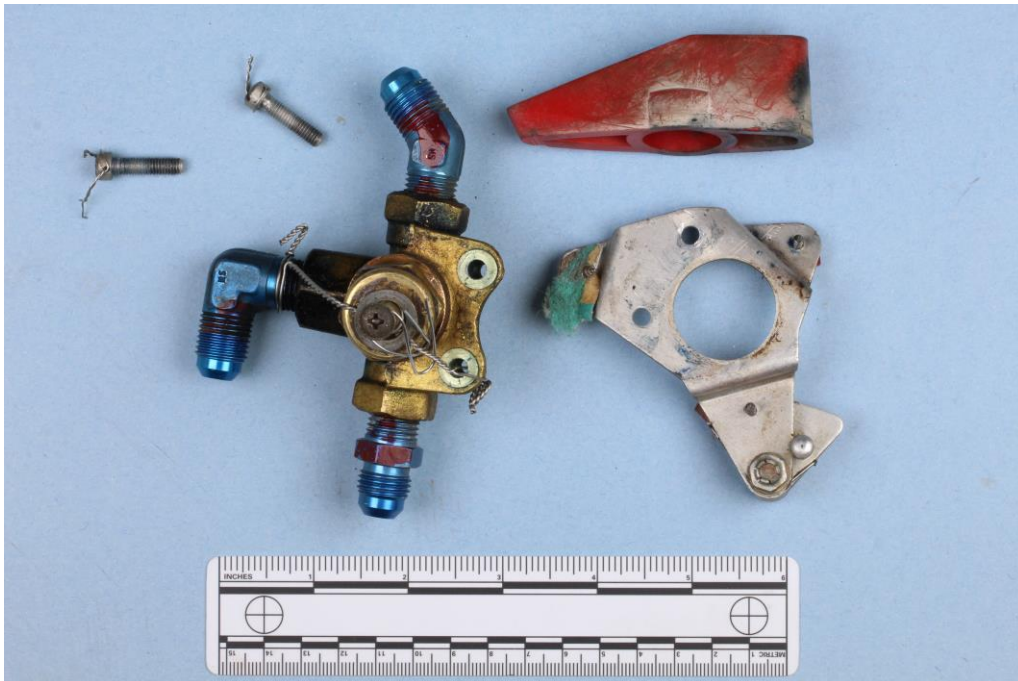
A fuel selector valve, a portion of the valve cover and the handle (figure 1).

Figure 1: Fuel selector valve and associated parts as received.

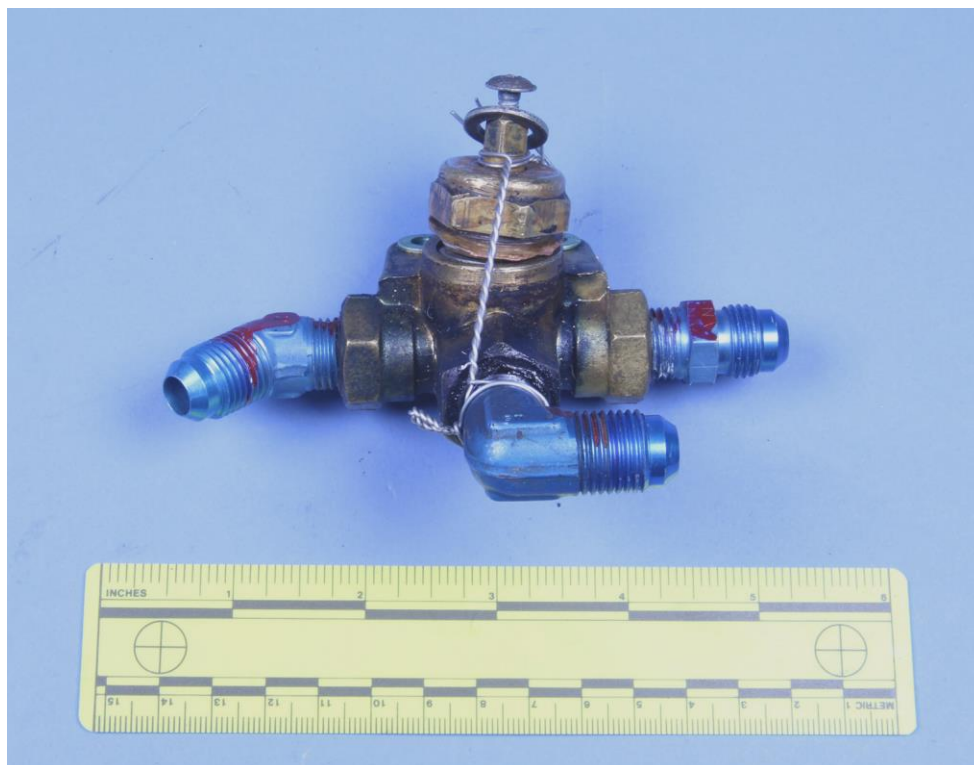
The fuel selector valve had been previously disassembled before being shipped to the materials laboratory. Safety wire was used to secure the valve cap to the valve body (figure 2). The valve body exhibited blue staining consistent with a fuel leak. This blue staining was concentrated around the port perpendicular to the other two ports (figures 1,2). This port with the concentrated staining and its associated fuel fitting did not have paint markers to indicate if the fuel fitting had rotated from its original position. The other two ports and fuel fittings had paint markers indicating that their fittings had not rotated. After removal of the safety wire, the valve cap moved away from the valve body due to a spring inside the valve (figure 3). The valve cap had multiple tool marks on the hex flats indicating that it had been disassembled many times. The valve components were removed one by one revealing the internal component stack up as shown in figure 4. Comparison of the stack up with the illustration in the Piper Cherokee service manual indicated that component labeled #4 should have been between components #1 and #2 as depicted in figure 4. The valve's internal components exhibited wear and in particular the position washer (component #1 in figure 4). The position washer exhibited wear on both sides consistent with having been flipped over and reused instead of having been replaced (figure 5). The valve stem and plug cock assembly were seized within the valve body and could not be rotated. The portion of the fuel selector valve cover contained a spring loaded metal stop.

Figure 2: Fuel selector valve cap safety wired to valve body.

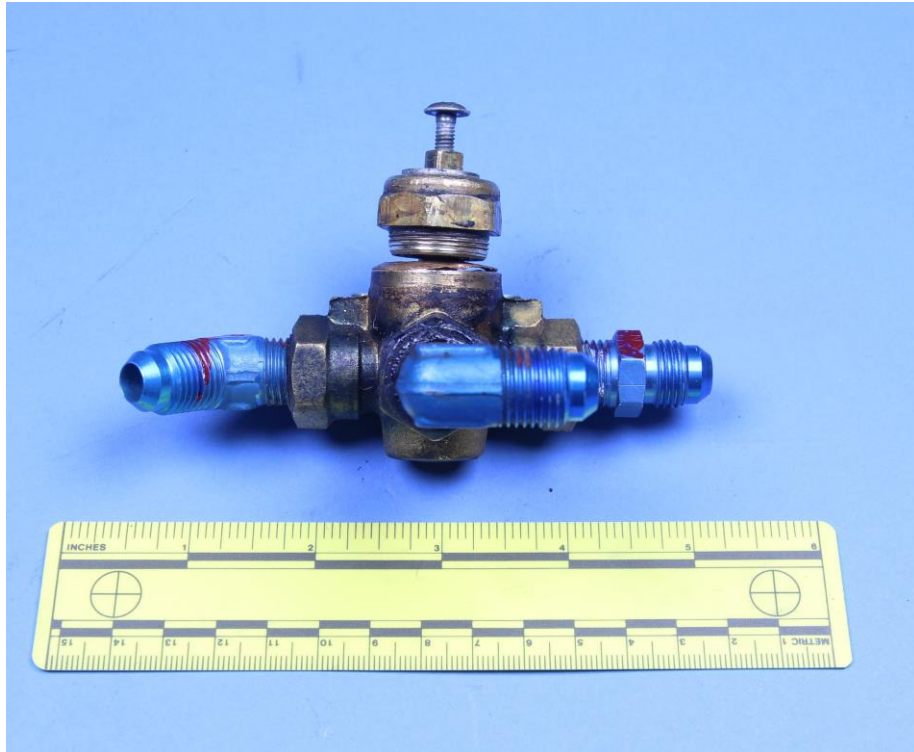
Figure 3: Fuel selector valve after safety wire removal.

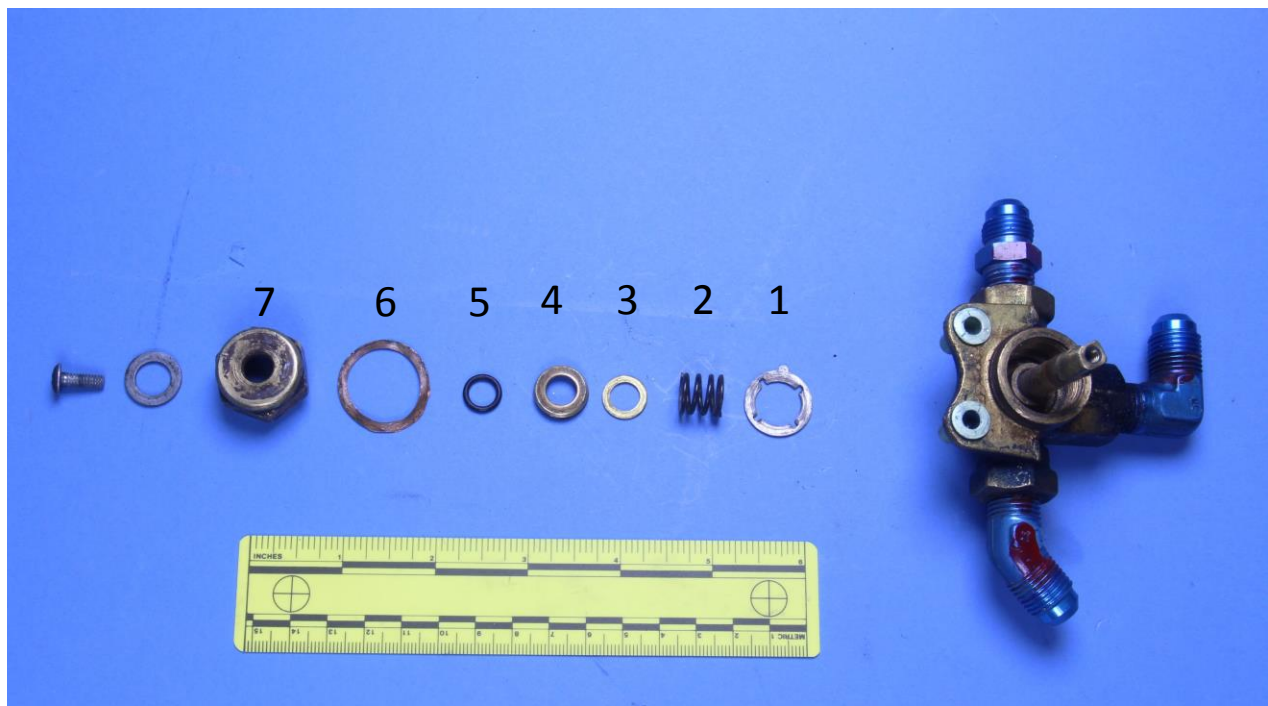
Figure 4: Fuel selector valve component stack up as received.

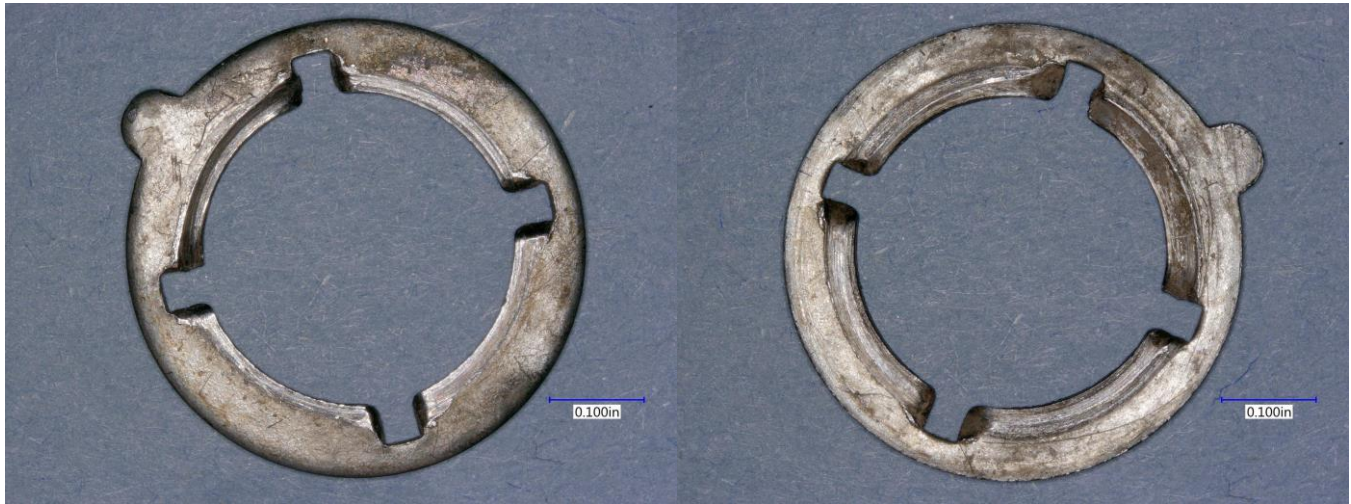
Figure 5: Both sides of the position washer.
