| Report number: <b>ML5204</b> | |
| <p><b>Continental Motors, Inc.</b><br/> <i>Powering Aircraft Since 1929</i></p> <p><b>CONTINENTAL MOTORS<br/>METALLURGICAL REPORT</b></p> | <p><u>Distribution</u></p> <p>1) Phillip Grice</p> |
| Subject: Engine Serial 5204 | |

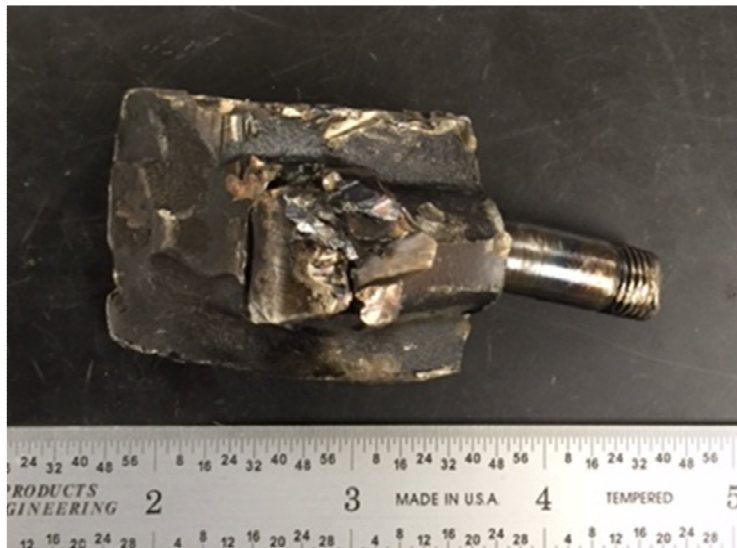
The cap of the number six connecting rod is shown in figures 1-3. There is substantial damage, but beach marks are still visible indicating a fatigue crack growing from the oil transfer hole in the center of the cap. Figure 4 shows a magnified picture of these beach marks.

- 1) The number six rod cap fractured in fatigue, from a crack at the oil transfer hole.
- 2) The crack growth indicates the fracture was primary in the events of the engine failure.

Figure 1 Fractured cap and bolt

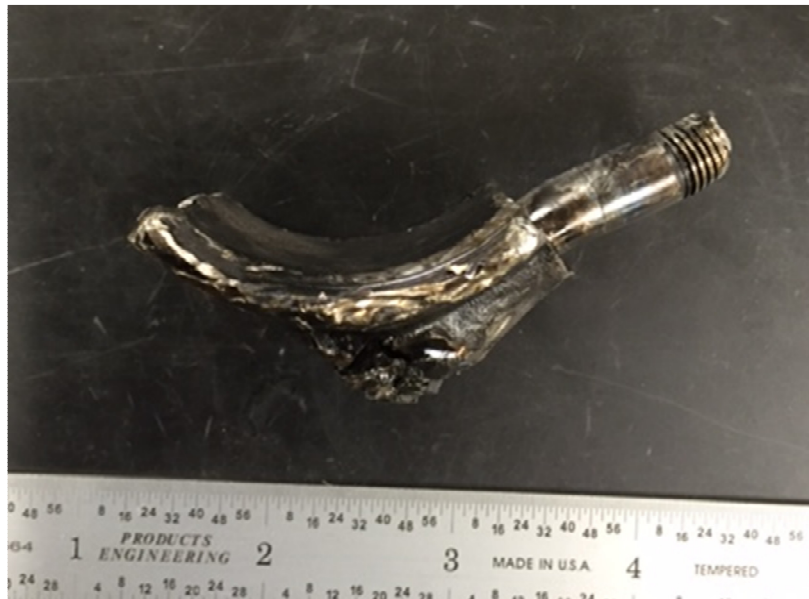
Figure 2 Fractured cap

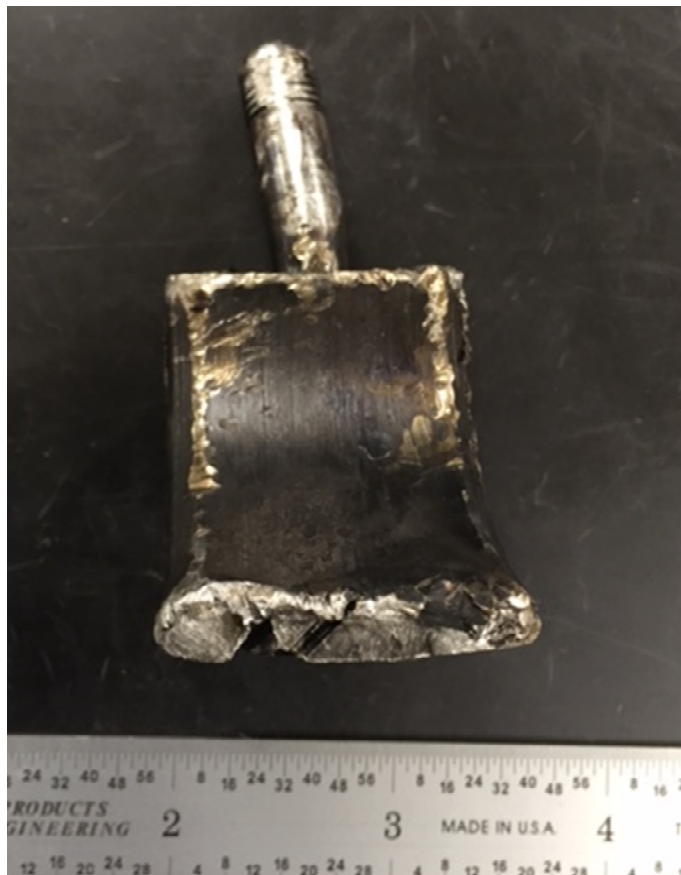
Figure 3 Fractured cap and bolt

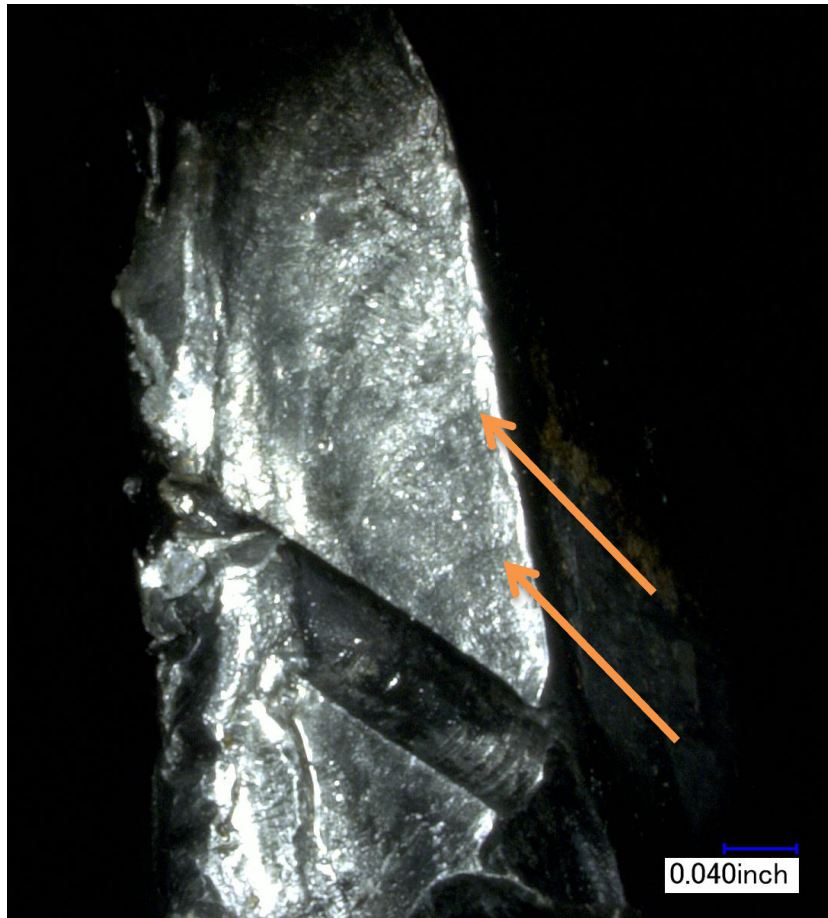
Figure 4 Fracture surface with beach marks originating from the oil transfer hole
