# NATIONAL TRANSPORTATION SAFETY BOARD

## MATERIALS LABORATORY FACTUAL REPORT

Report No. 16-075

Place : Littleton, NC  
Date : April 24, 2016  
Vehicle : Maule M7-235B, N367FS  
NTSB No. : ERA16LA181  
Investigator : Heidi Kemner, AS-ERA

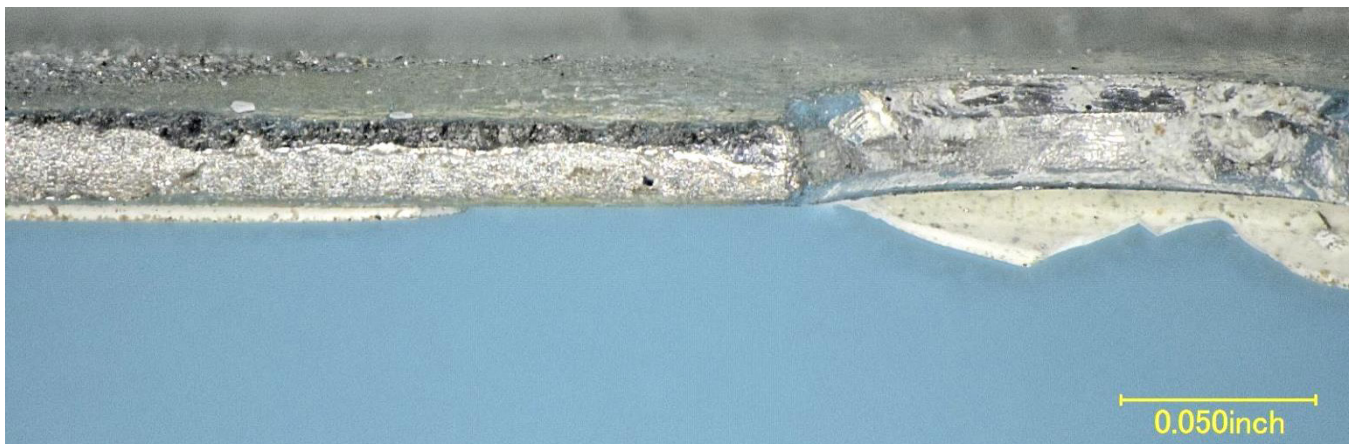
The fracture surfaces were examined visually, as shown in Figure 2 through Figure 4. The fracture surfaces of all of the parts exhibited single or double shear lips with associated necking of the wall thickness as shown in Figure 2 and Figure 4. The fracture surfaces exhibited a generally rough texture, with a dull luster. Examination using a scanning electron microscope (SEM) revealed dimple rupture (Figure 5). All of these features were consistent with failure from overstress on a thin-walled structure.

Figure 2 – A portion of the fracture surface on section 1B, showing a cup-shaped morphology near a chamfered rivet hole.

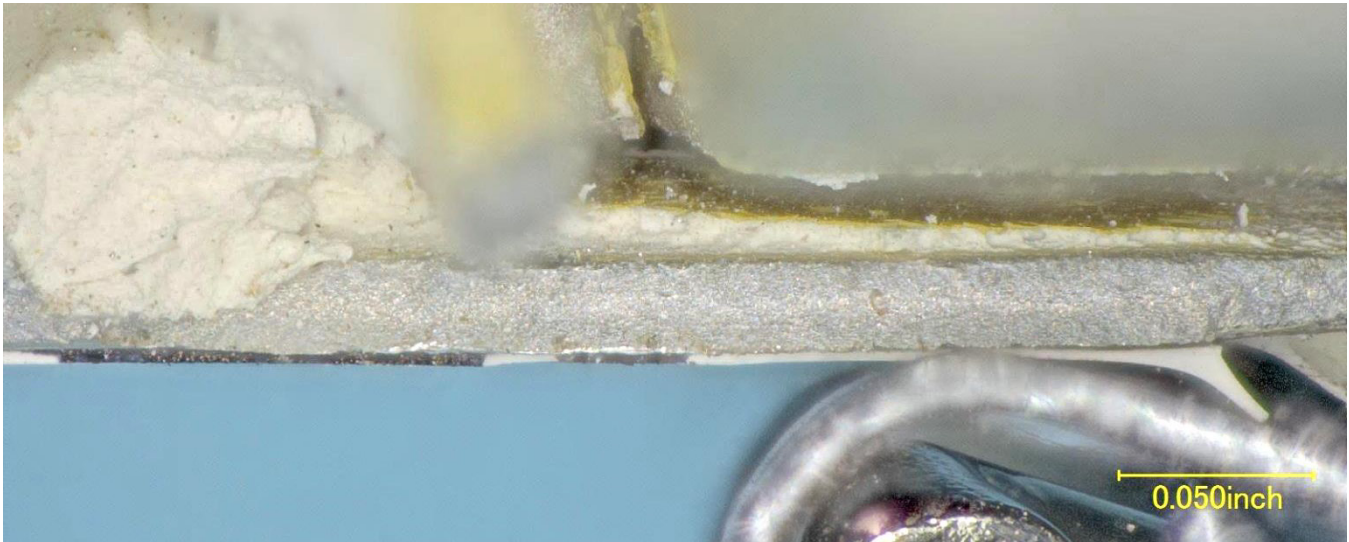
Examination of the rivet holes revealed that they had been chamfered (see Figure 3). Some of the fracture surface area exhibited some more reflective regions, but these were consistent with post-fracture smearing. There were no indications of abusive machining defects on the sections submitted.

Figure 3 – View of the cup-shaped fracture surface of section 1B, near a marked area of interest at the edge of the fracture line.

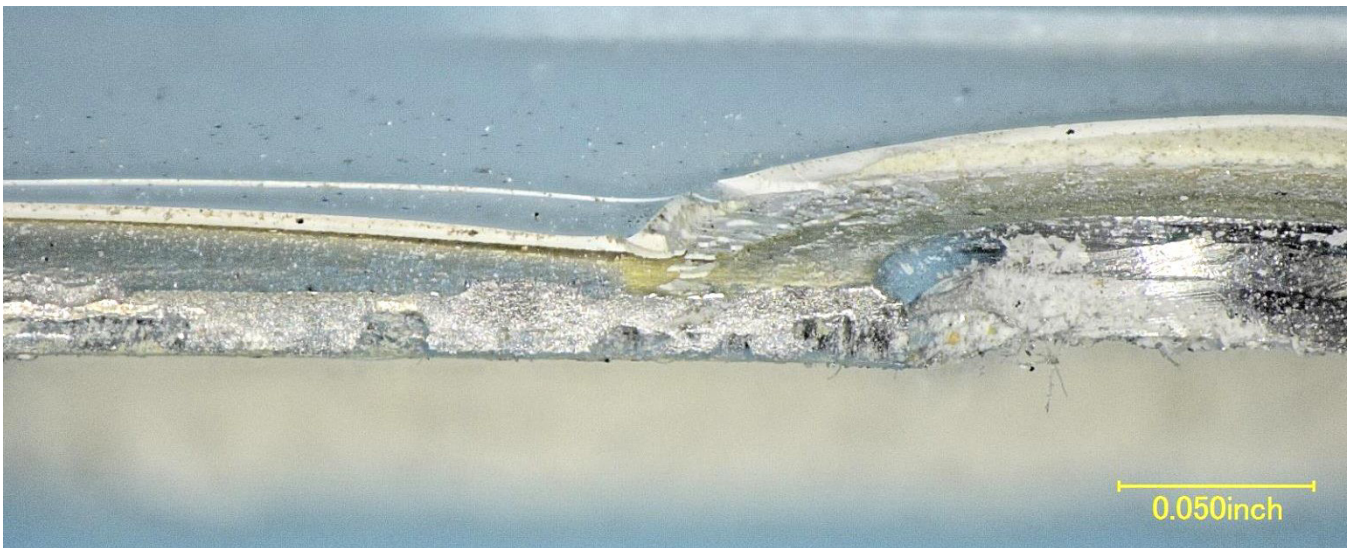
The sections labeled 2 were from outside of the left float behind the left main gear bulkhead. The largest piece (2A) was 7.25 inches long, with the main fracture surface along 14 rivet holes. Like the other pieces, the outer white paint exhibited spalling near the rivet holes, with cracking parallel to the fracture surface.

Figure 4 – An area of section 2A, with a 45° slanted fracture surface near a chamfered rivet hole.

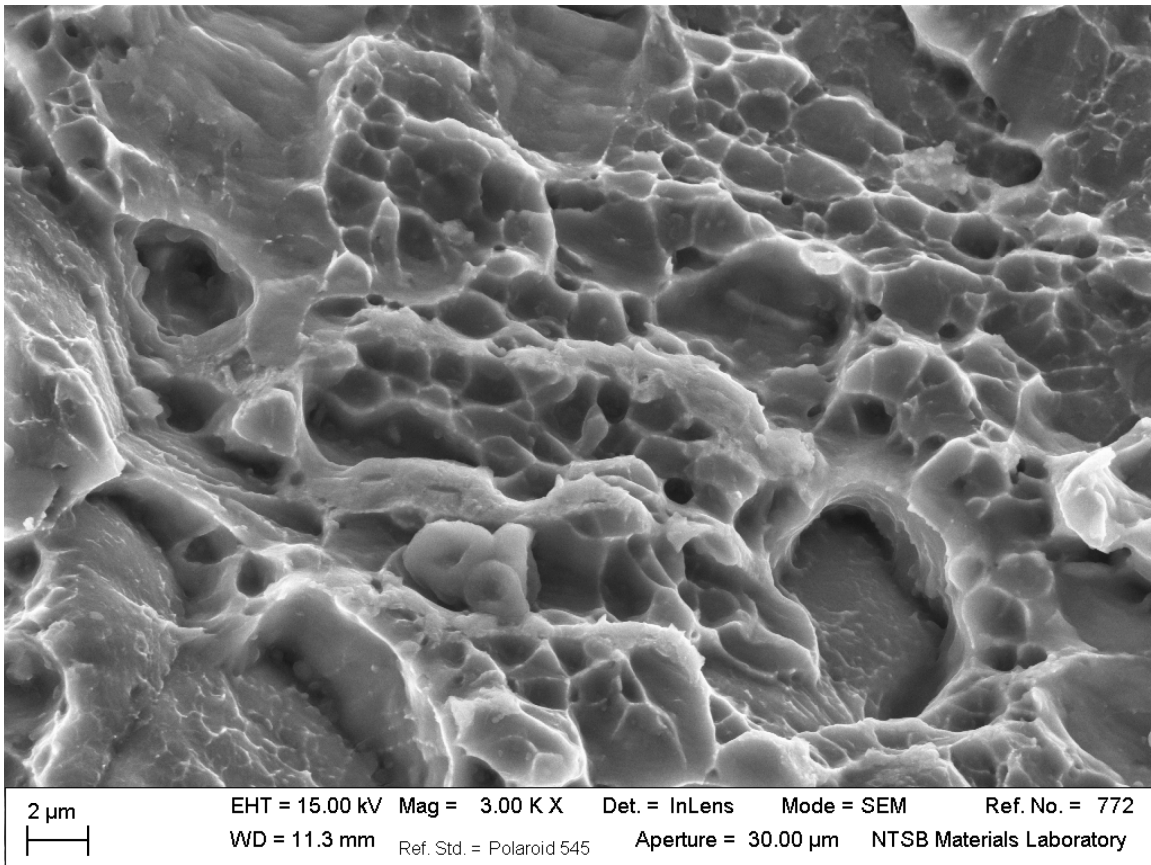
Figure 5 – Secondary electron (SE) micrograph of dimple rupture observed on the fracture surface of section 2B.
