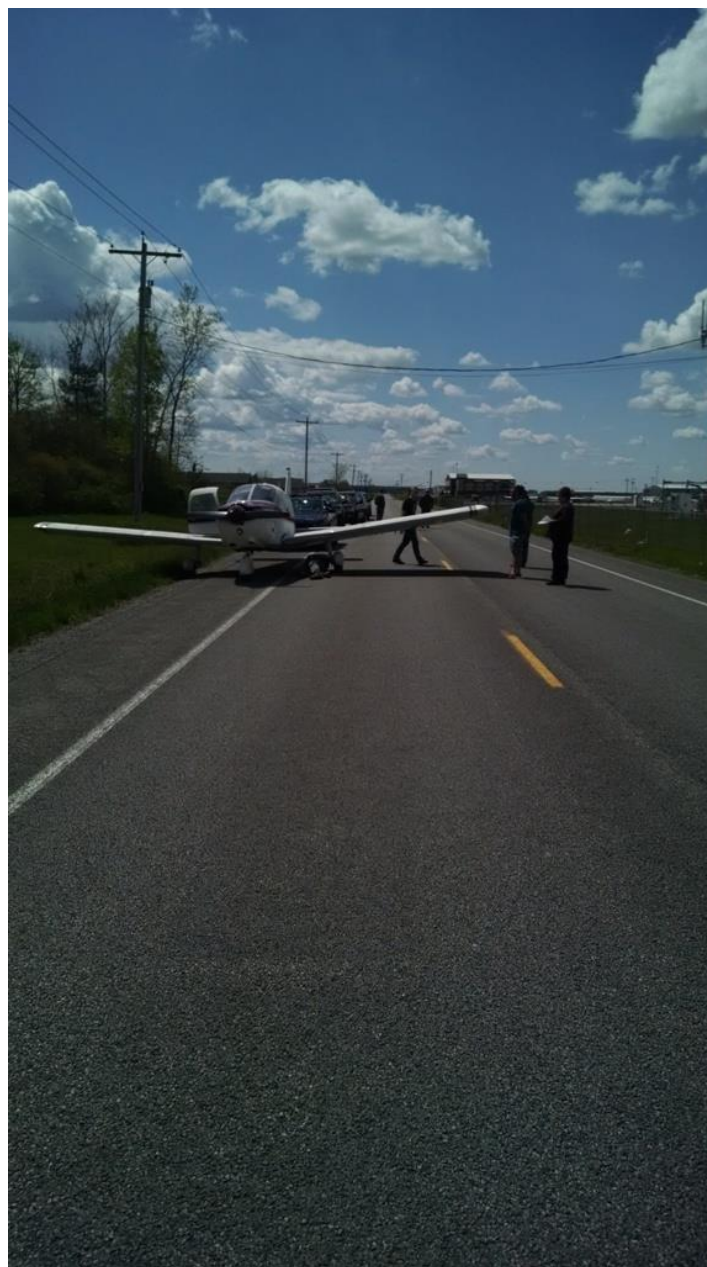
**Photo 1 – FAA Digital Photograph. View of the Airplane where it Came to Rest**

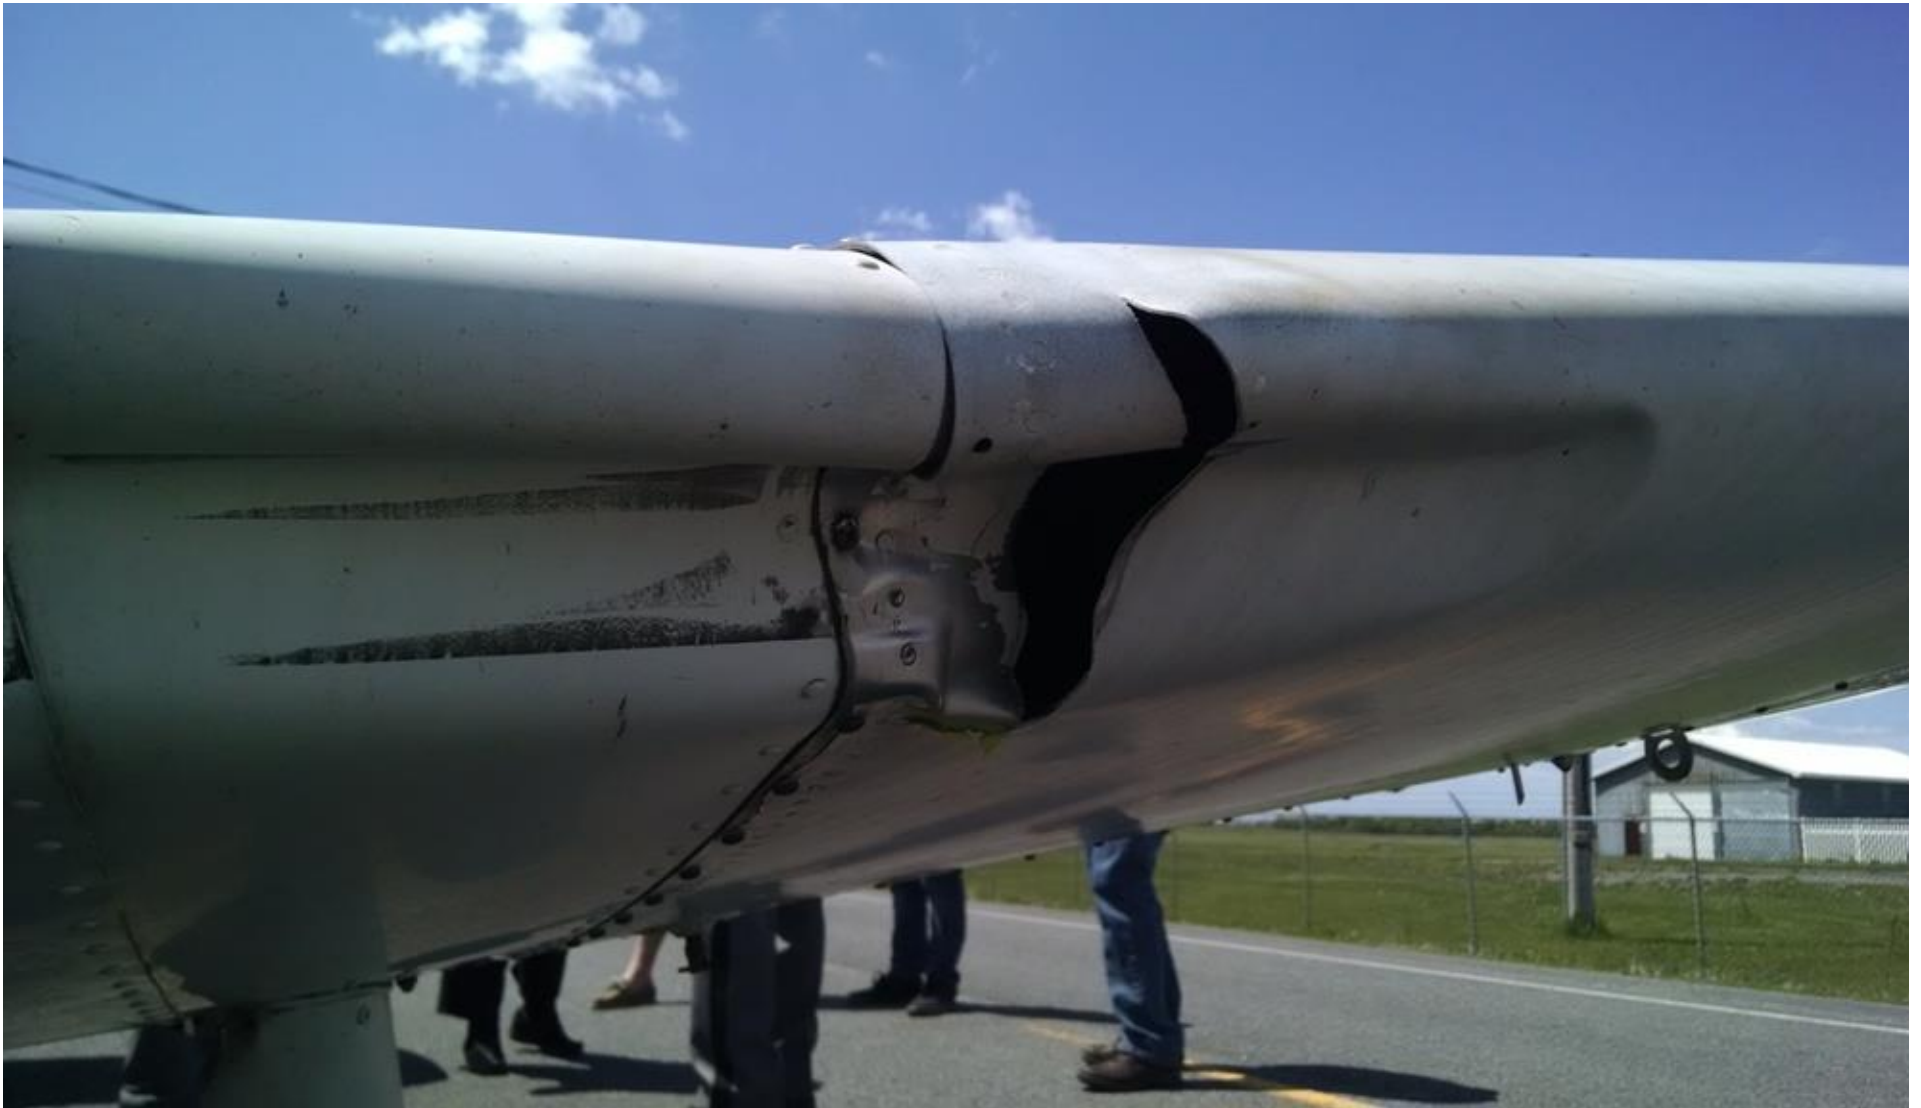
**Photo 2 - FAA Digital Photograph. View Depicting the Damage to the Left Wing**

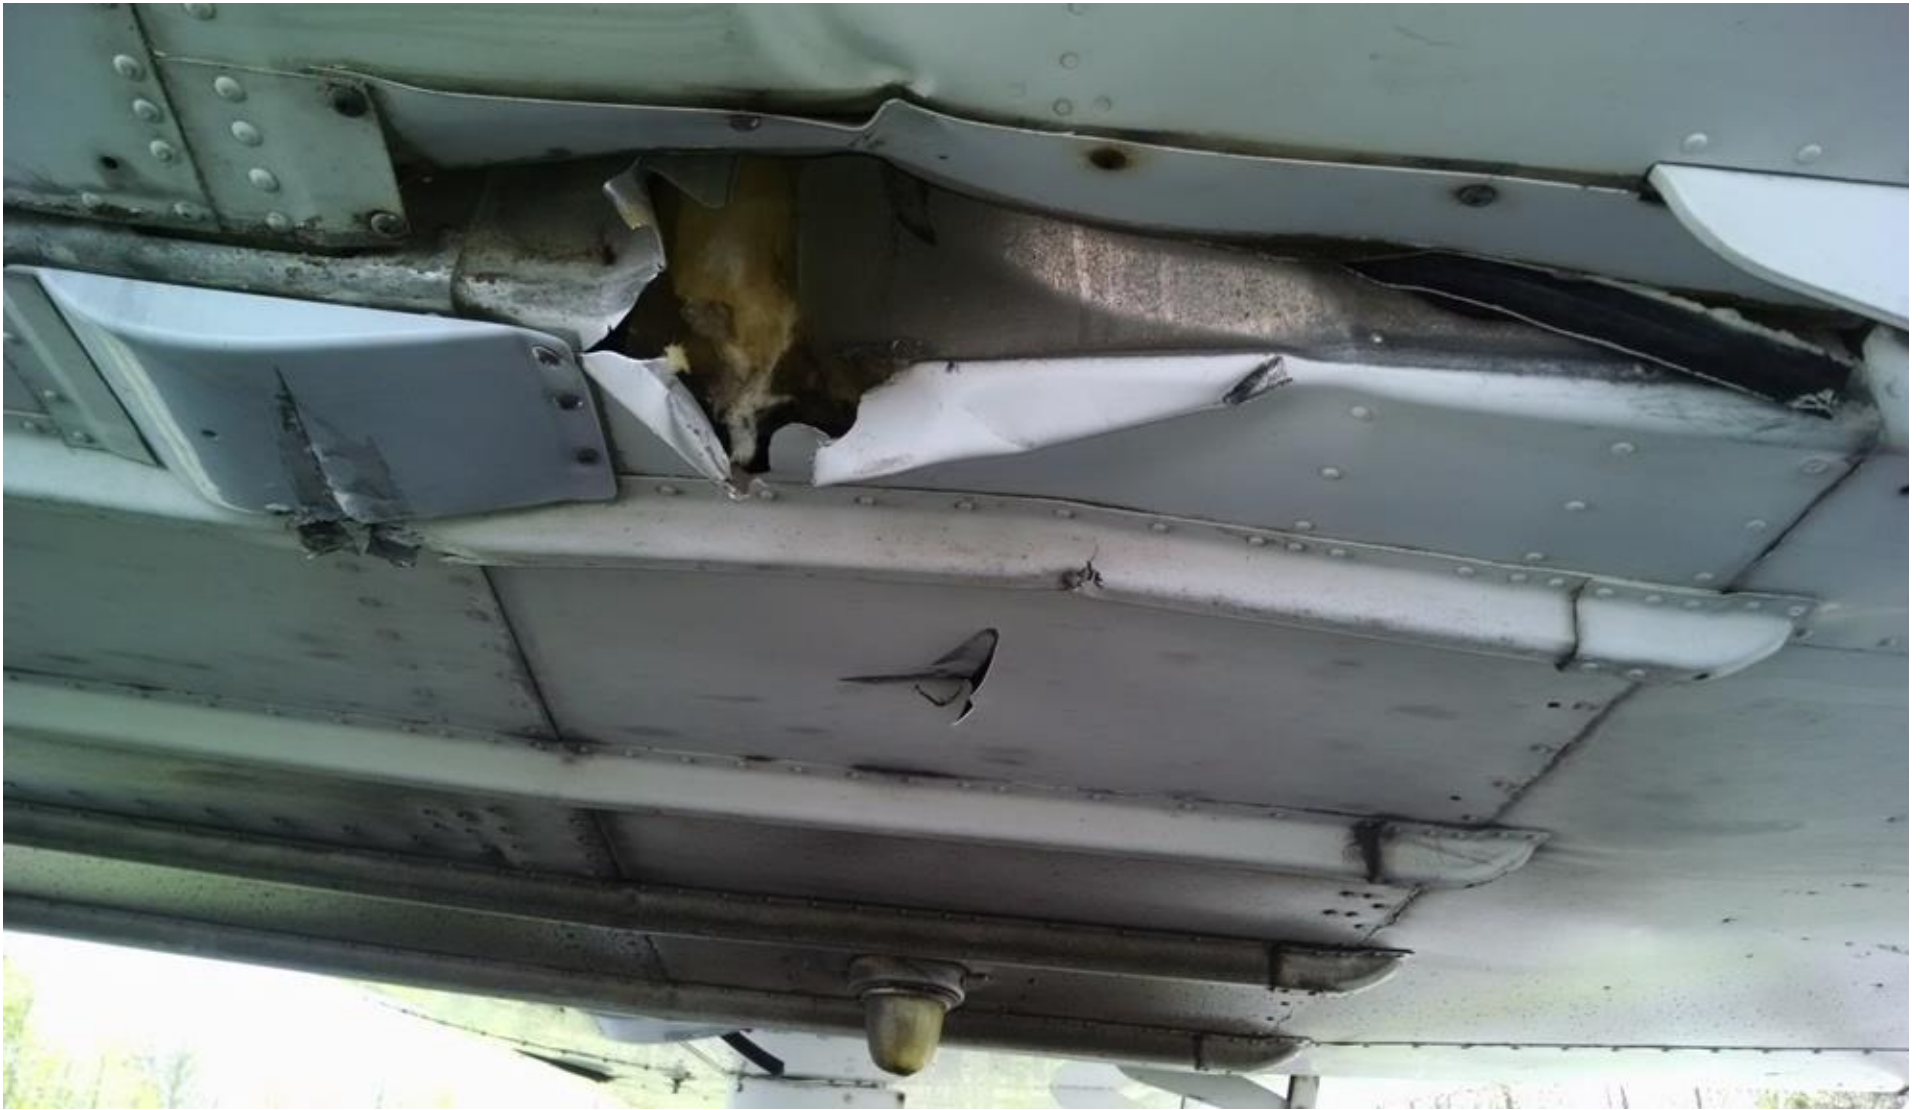
**Photo 3 - FAA Digital Photograph. View Depicting the Damage to the Bottom of the Fuselage**

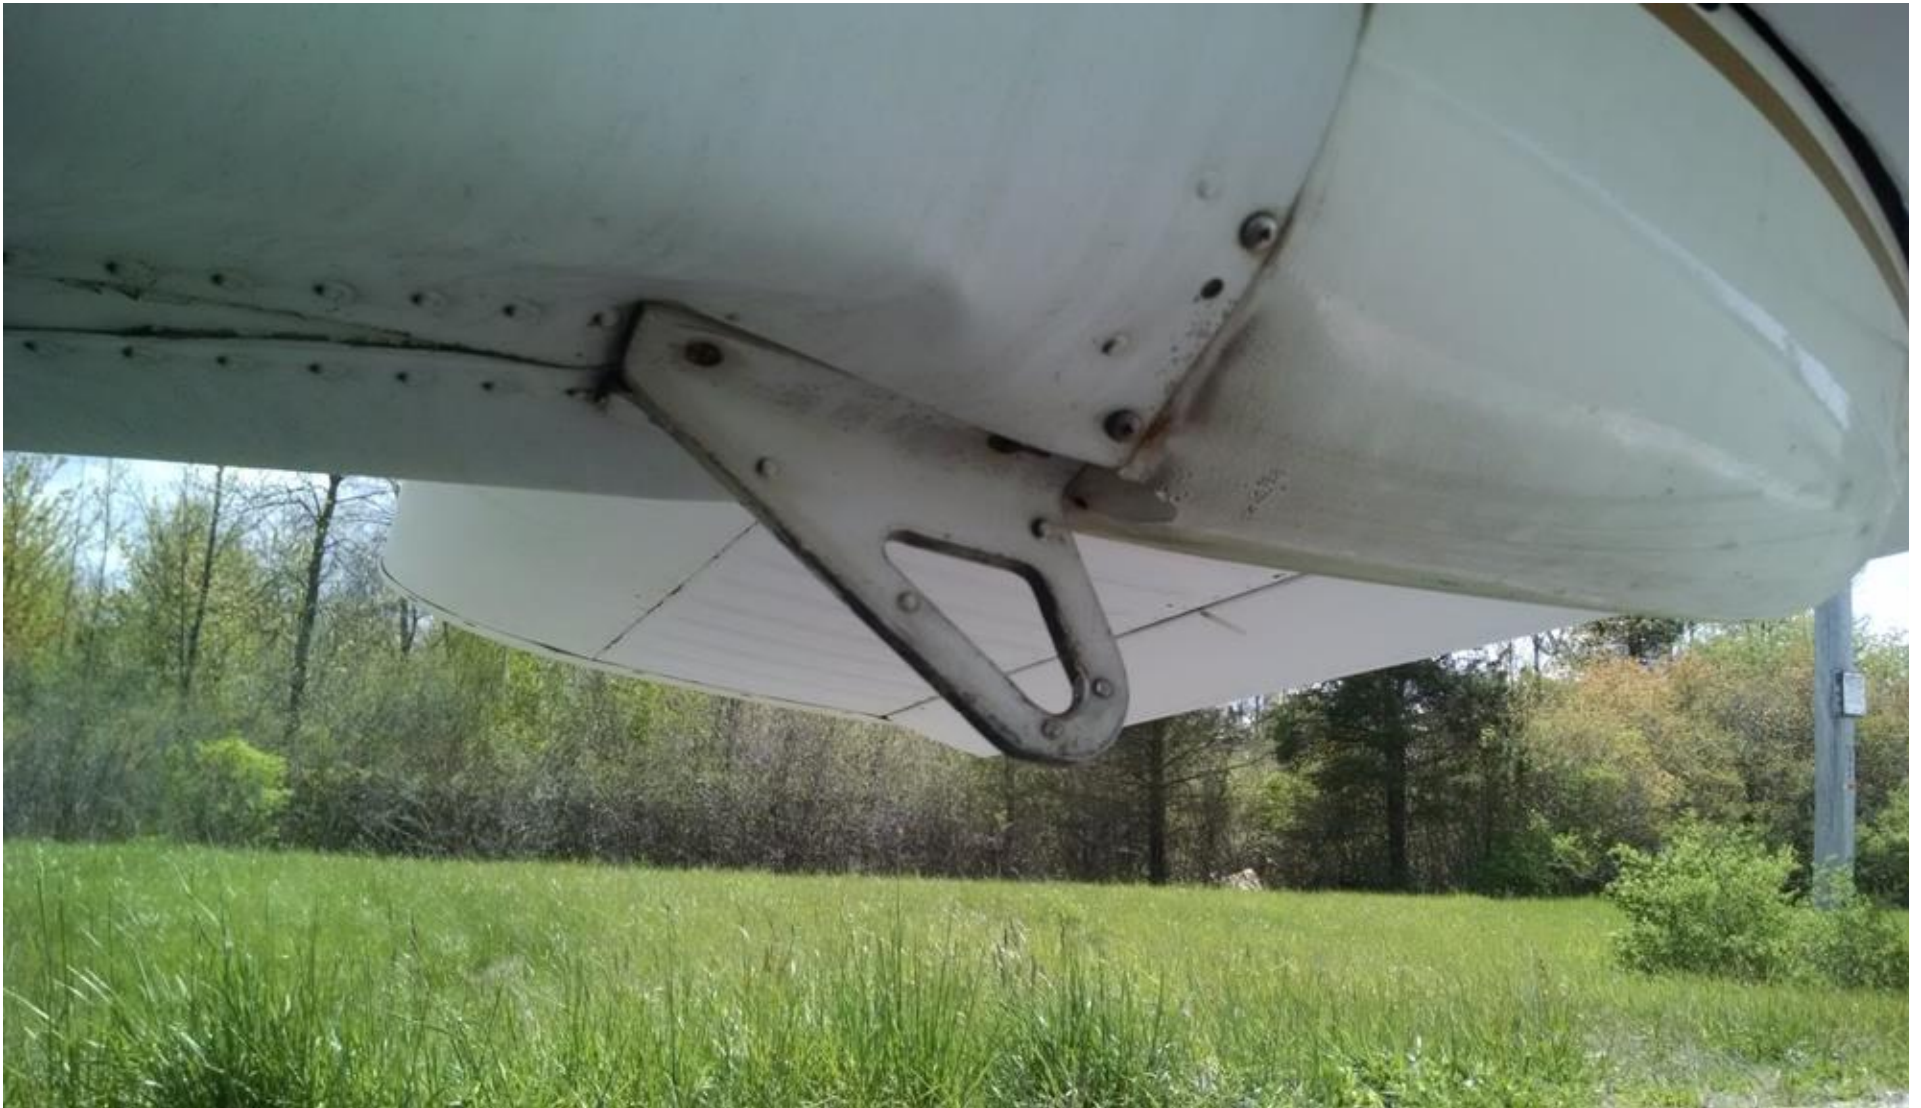
**Photo 4 - FAA Digital Photograph. View Depicting the Damage to the Bottom of the Fuselage Near the Tail Tie-Down**

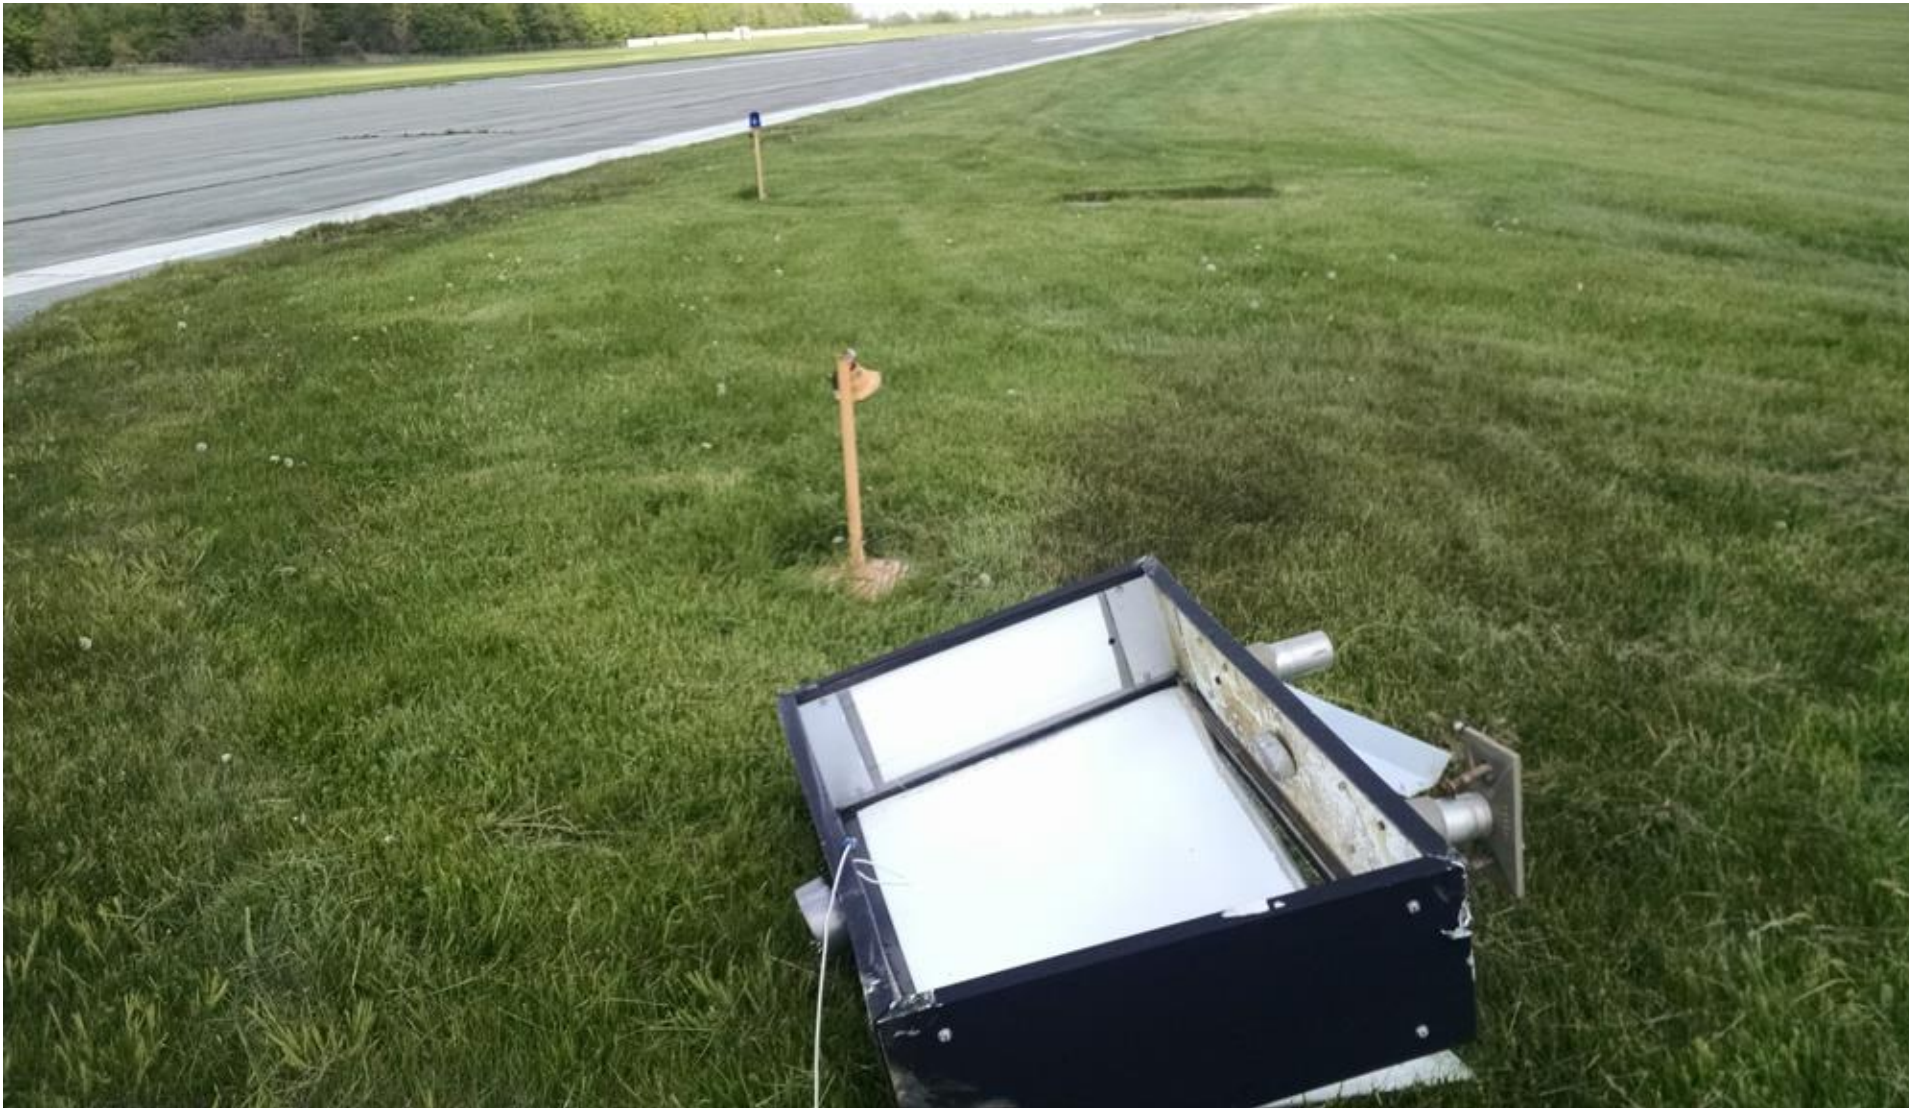
**Photo 5 - FAA Digital Photograph. View Depicting the First Sign Damaged**

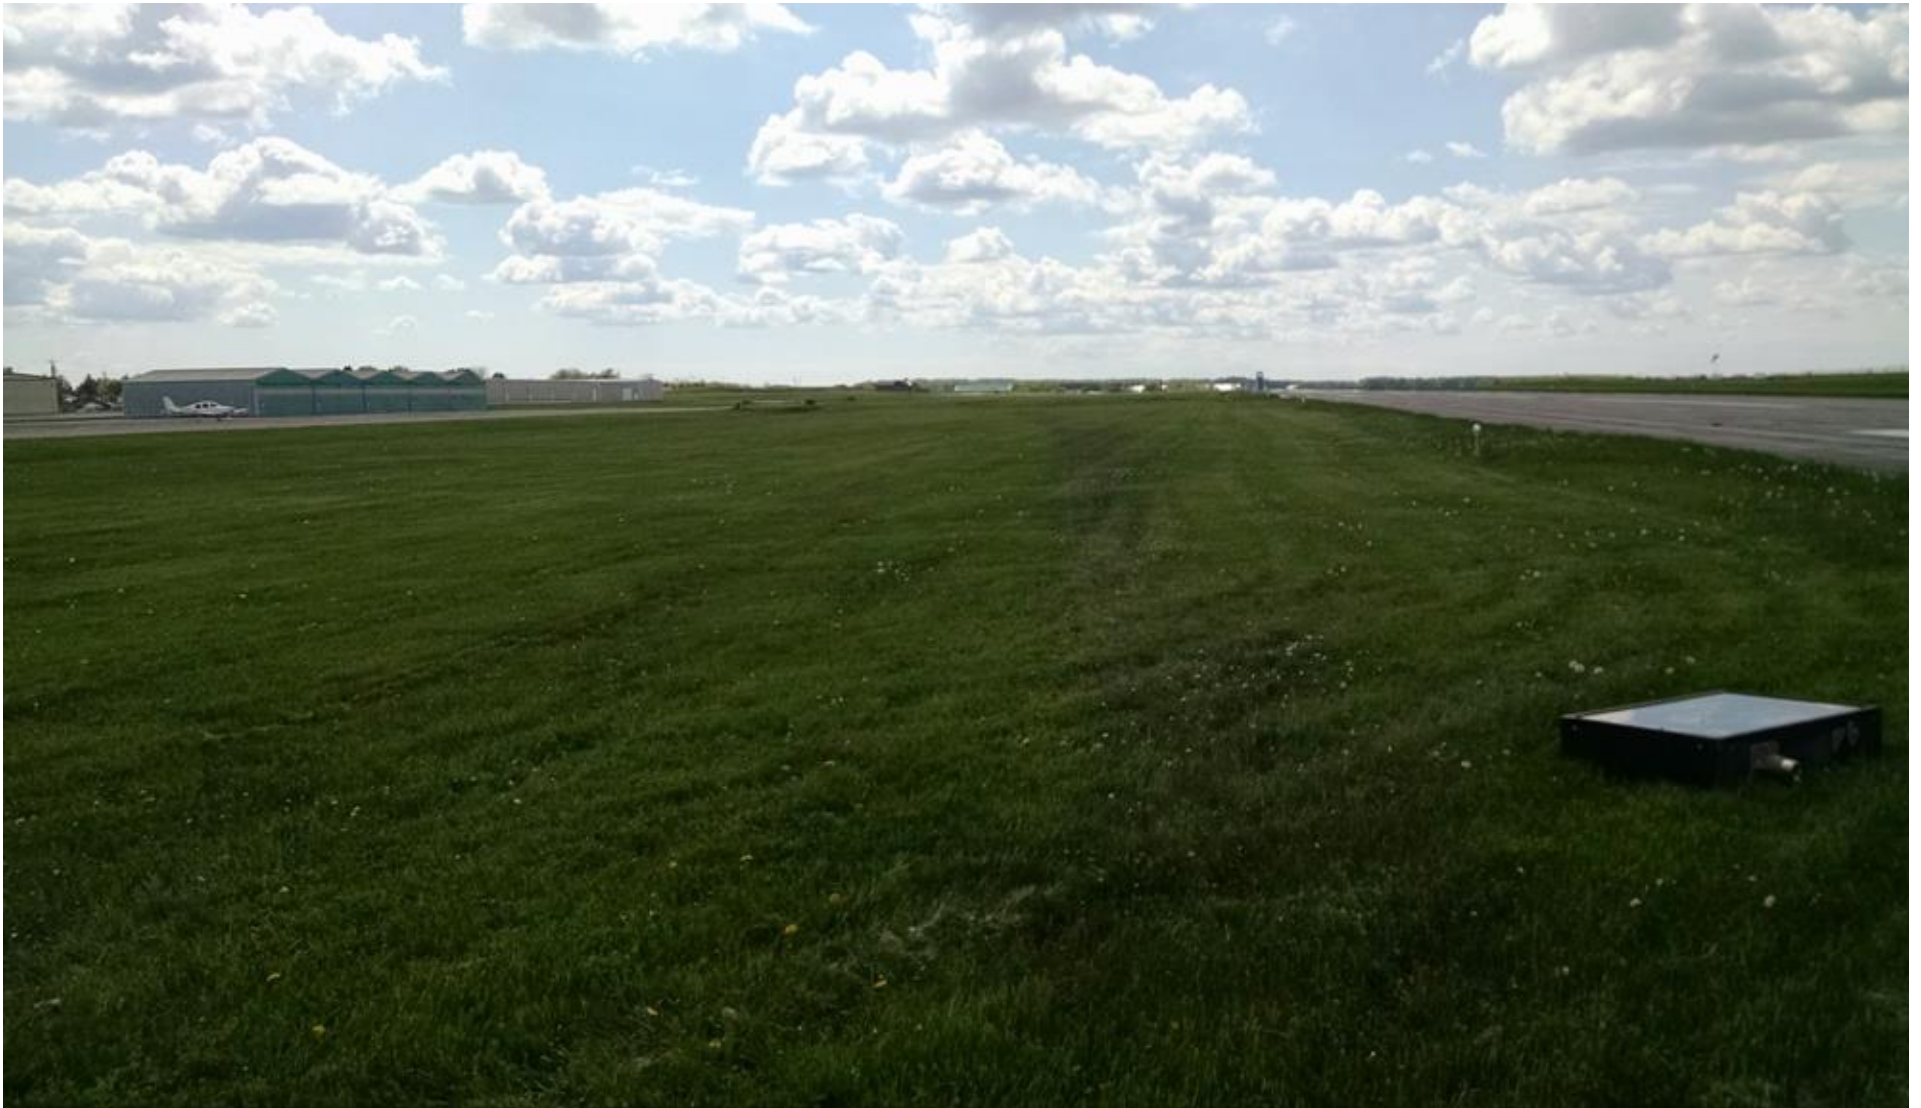
**Photo 6 - FAA Digital Photograph. View Depicting the Second Sign Damaged**

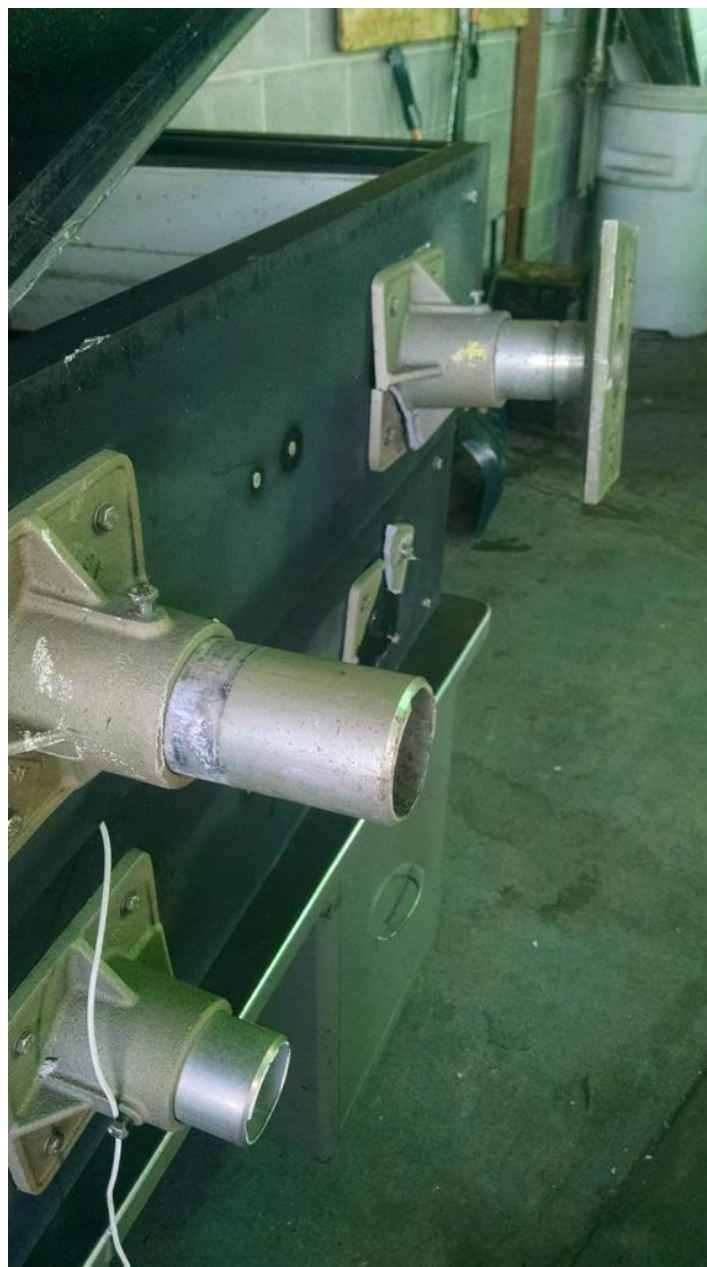
**Photo 7 - FAA Digital Photograph. View Depicting Both Damaged Signs. Note the 2 fractured Frangible Posts in the Foreground.**

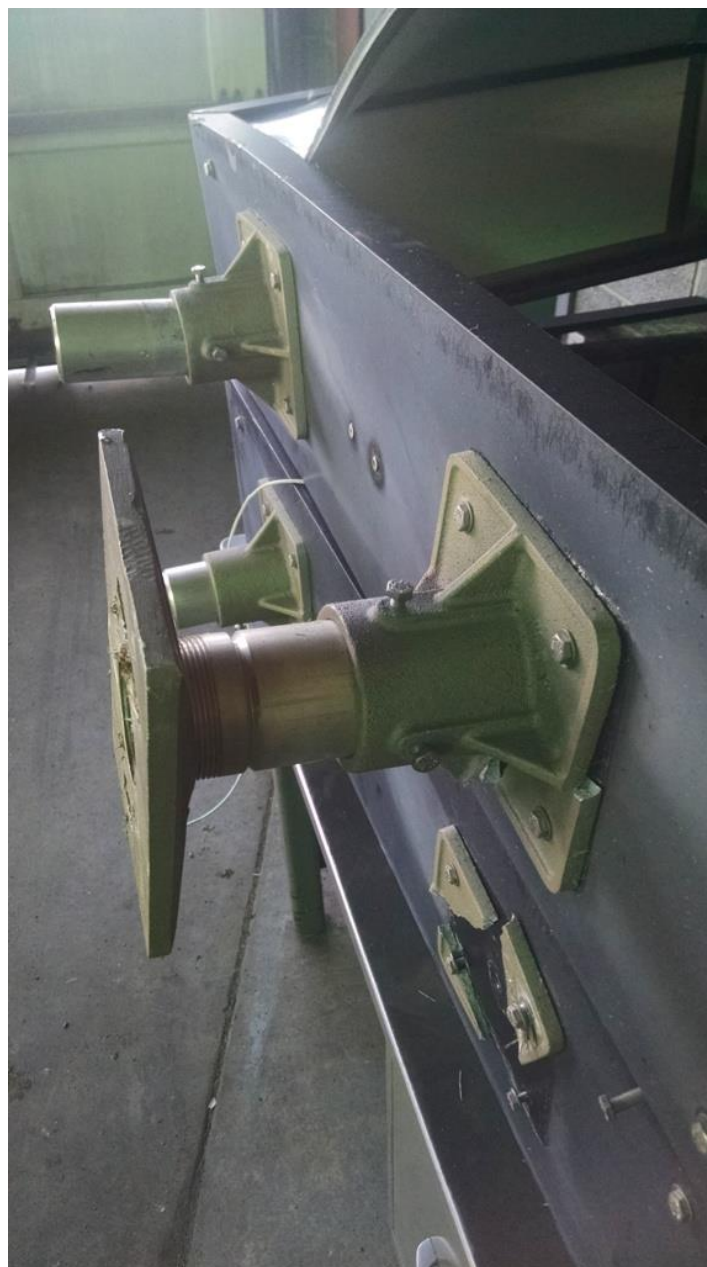
**Photo 8 - FAA Digital Photograph. View Depicting 1 Non-Fractured Frangible Post**

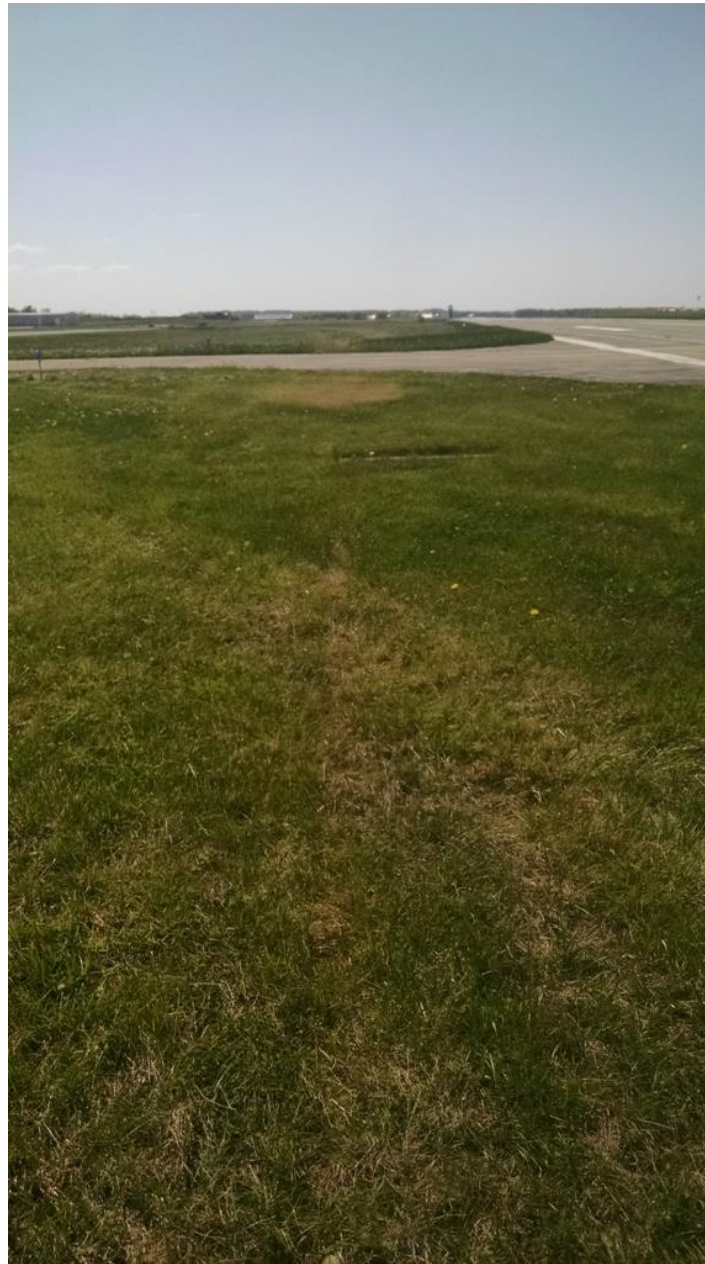
**Photo 9 - FAA Digital Photograph Taken 4 days After the Accident. View Depicting Browning of Grass Beyond the First Impacted Sign**

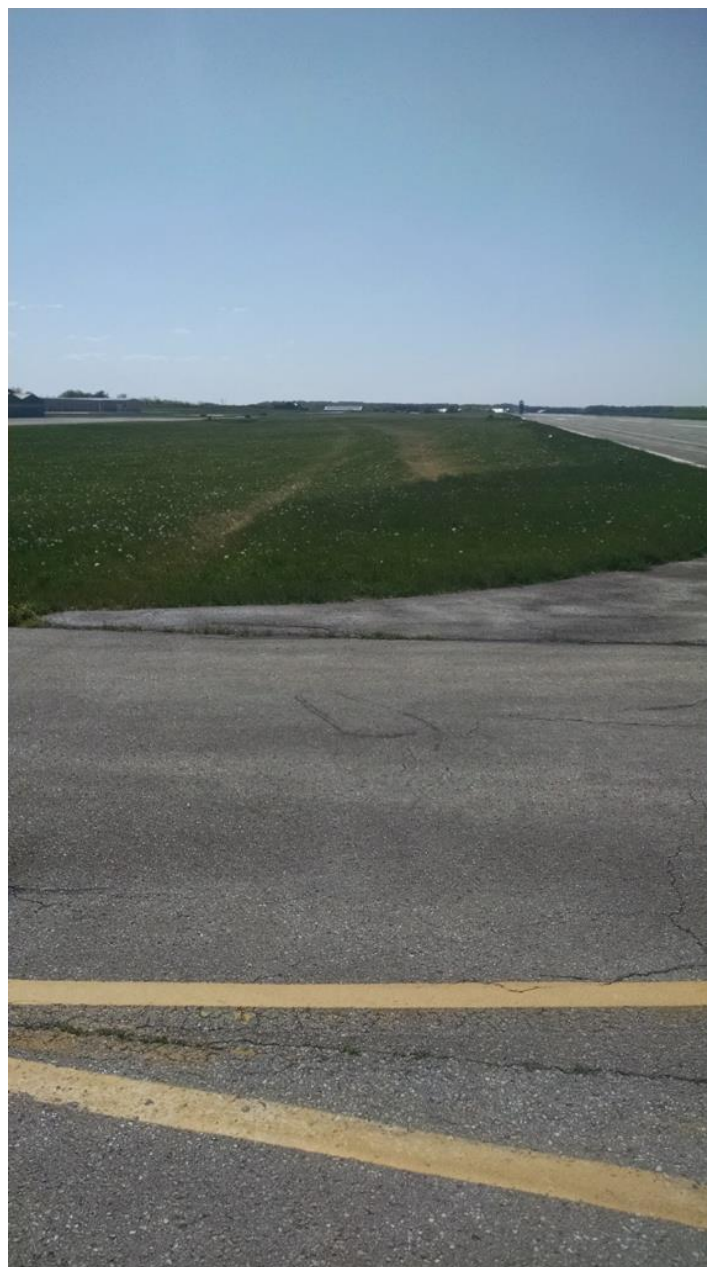
**Photo 10 - FAA Digital Photograph Taken 4 days After the Accident. View Depicting Browning of Grass Beyond the First and Second Impacted Signs**

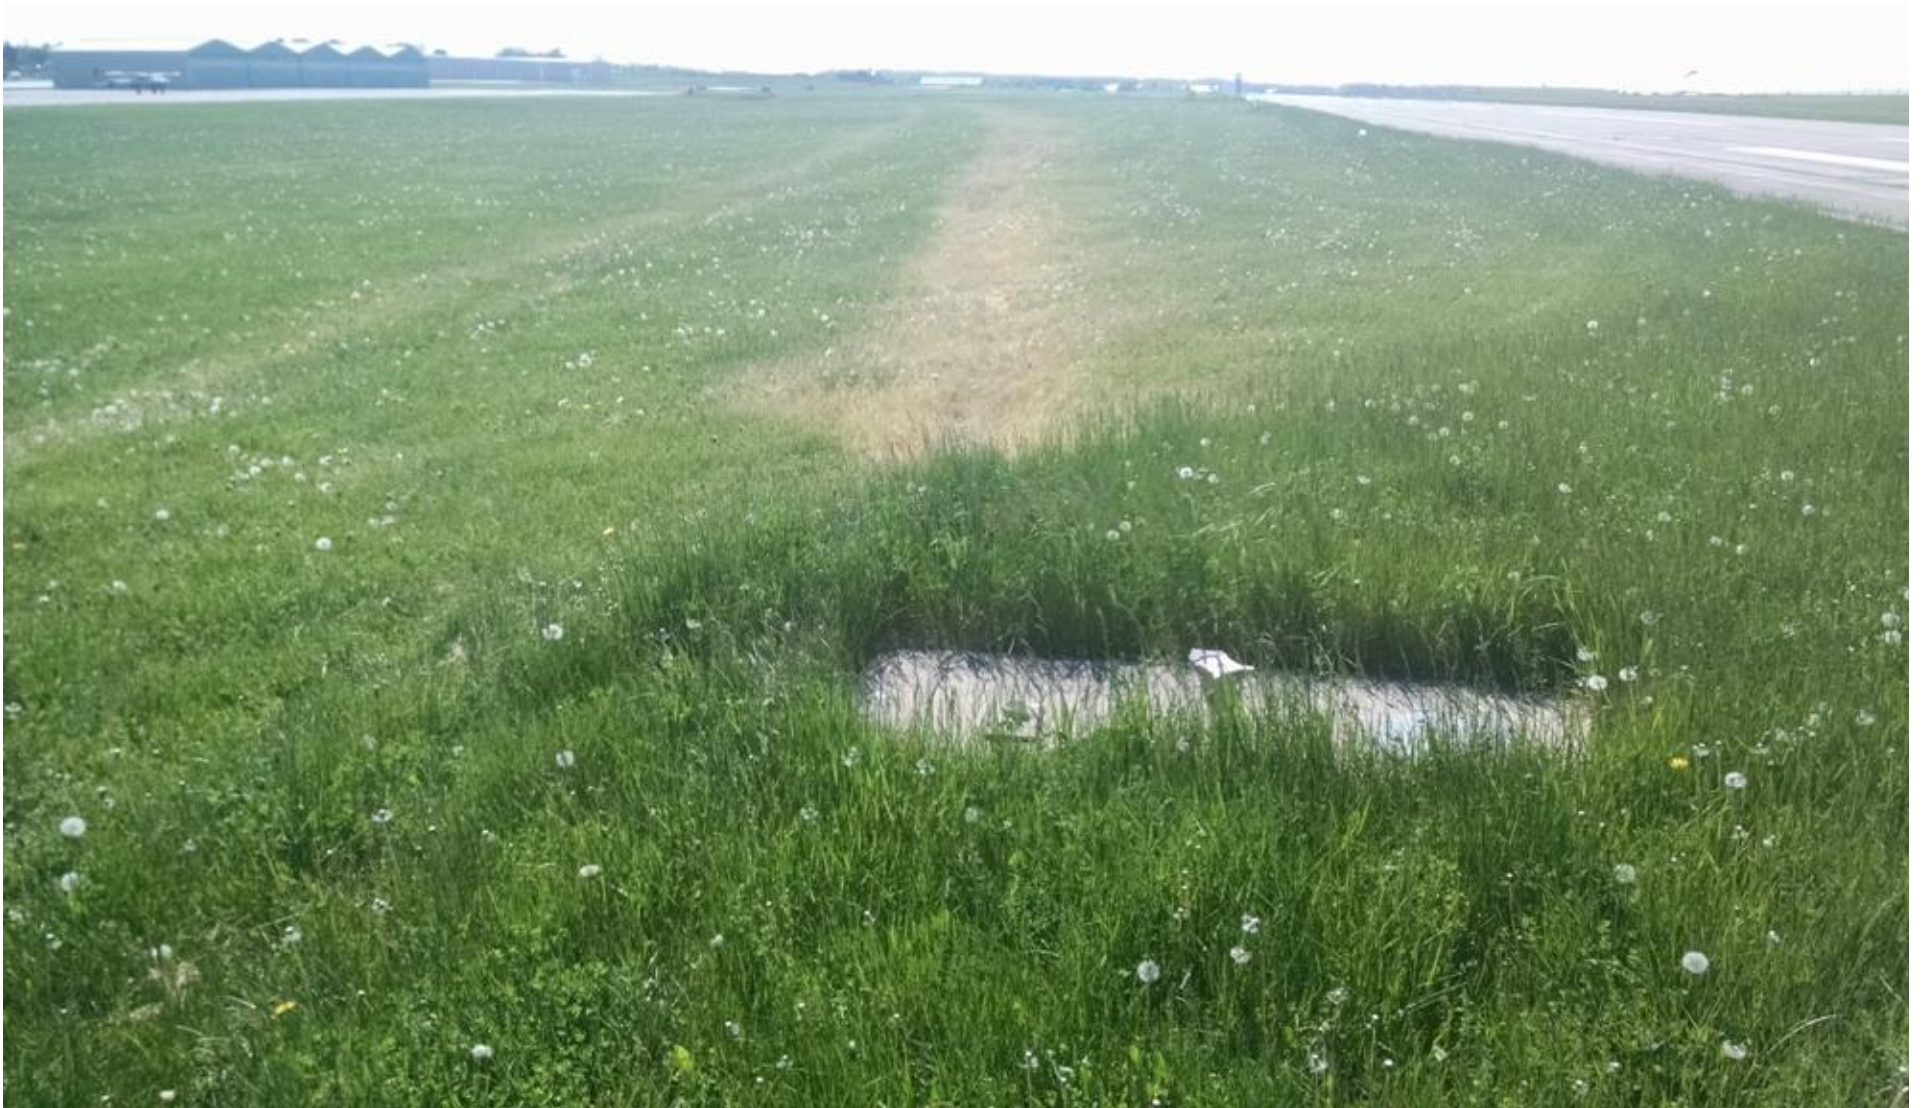
**Photo 11 - FAA Digital Photograph Taken 4 days After the Accident. Close-Up View Depicting Browning of Grass Beyond the Second Impacted Sign**
